Site Number 7-38-033

**Oswego Castings Site
Annual Monitoring Report**

Third Quarter 2012

Prepared by:
ARCADIS/Malcolm Pimie, Inc.
855 Route 146
Suite 210
Clifton Park
New York 12065
Tel 518 250 7300
Fax 518 250 7301

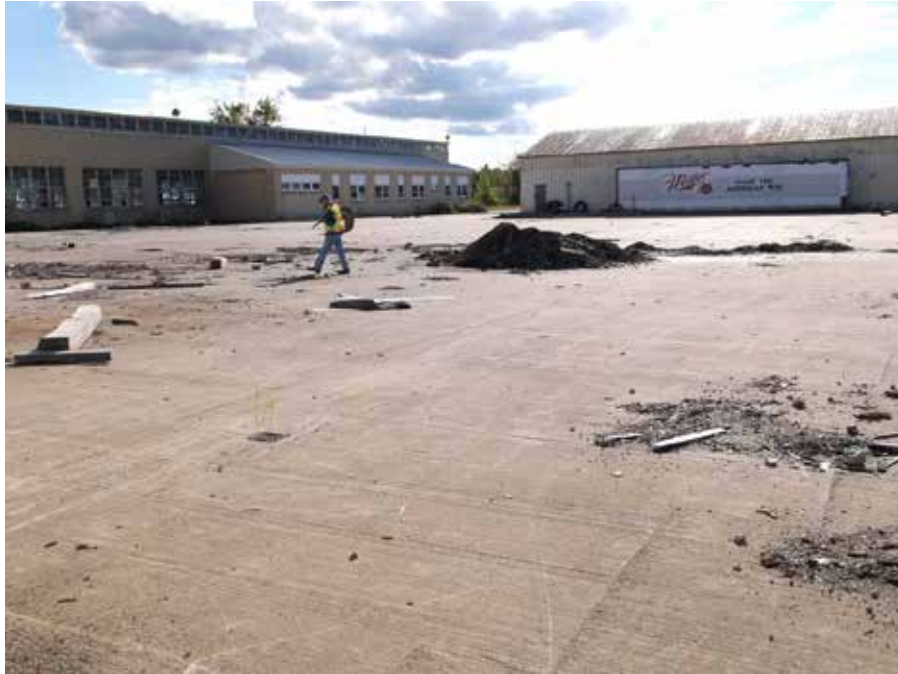
A visual inspection of the concrete cover was performed to inspect the integrity of the remedy. As shown in Appendix A, the concrete cap had minor cracks but did not contain evidence of settlement or other damage. As shown in Appendix A and B, debris (primarily wood chips and boards) were present on the concrete cap.

Yard Area, facing southeast.

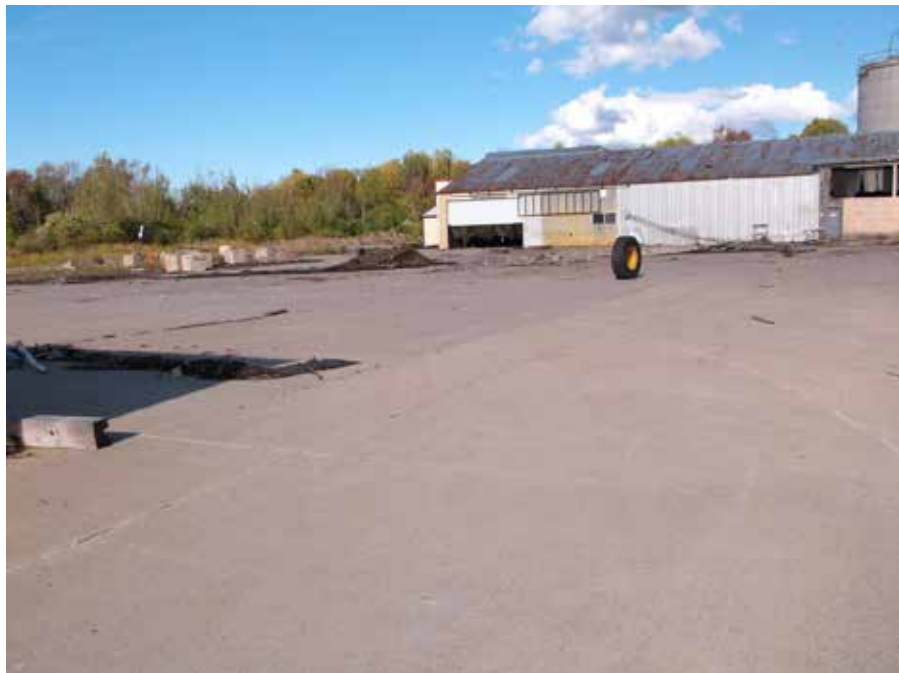
Yard Area, facing northwest.

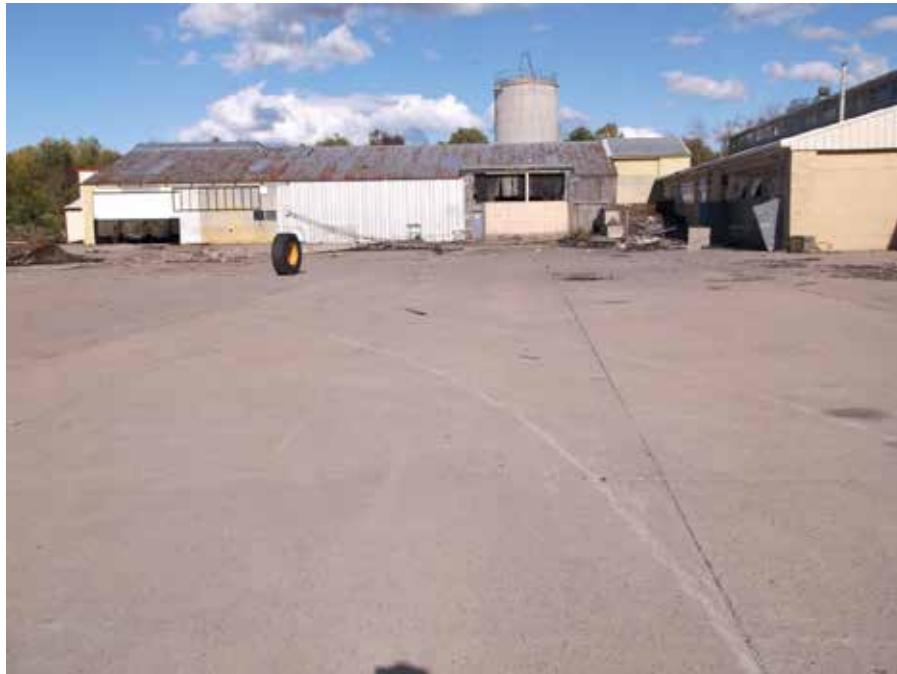
Yard Area, facing north.

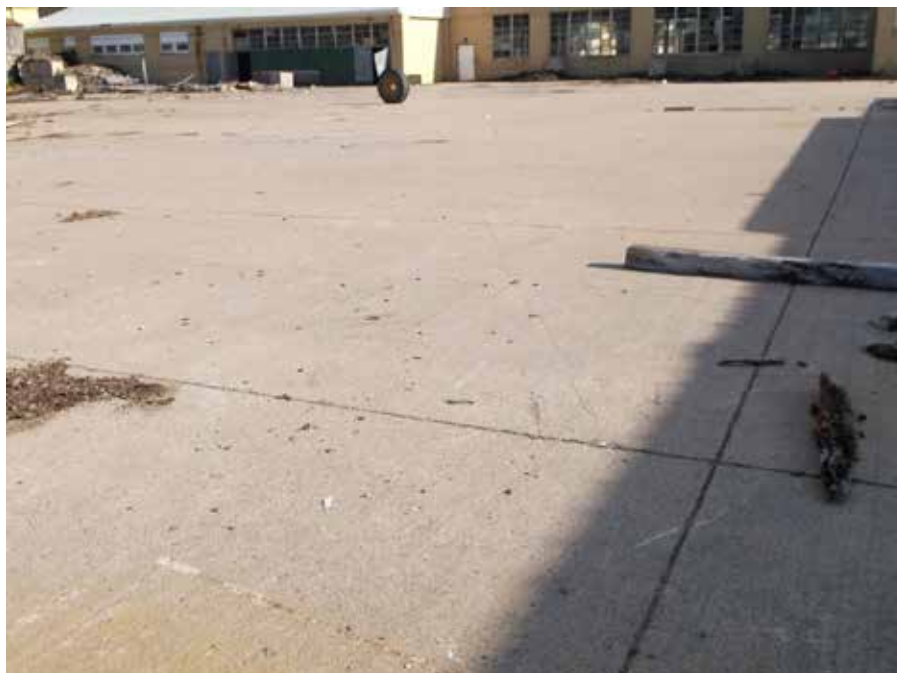
Minor cracks in concrete cap.

Minor cracking in concrete cover.

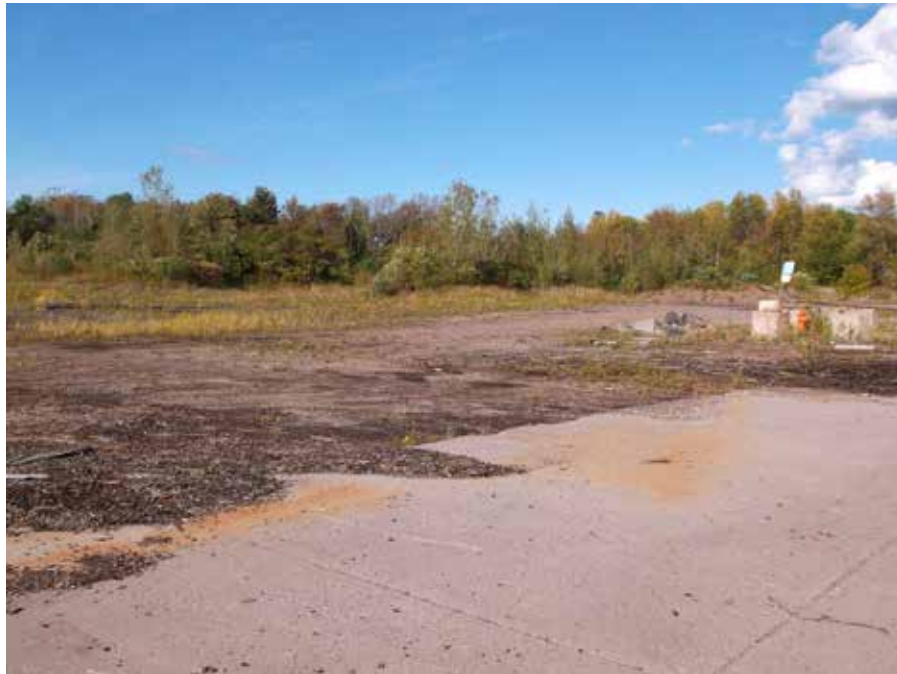
A visual inspection of the landfill cover was performed to assess the landfill for erosion, settlement, ponded water, burrowing rodents, and brush or woody vegetation. As shown in the O&M Checklist (Appendix A), wood chips, apparently from the former saw mill operation, were covering the landfill area but did not appear to be impacting the performance of the cover.

Layer of wood chips from former saw mill covering land fill area.

Landfill area, facing northwest.

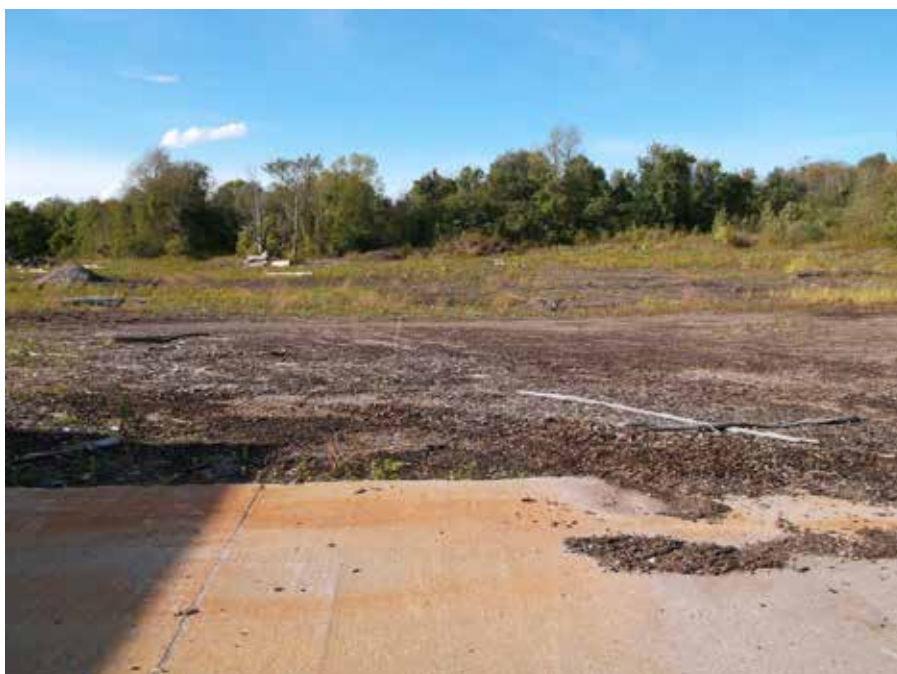
Landfill area, facing west.

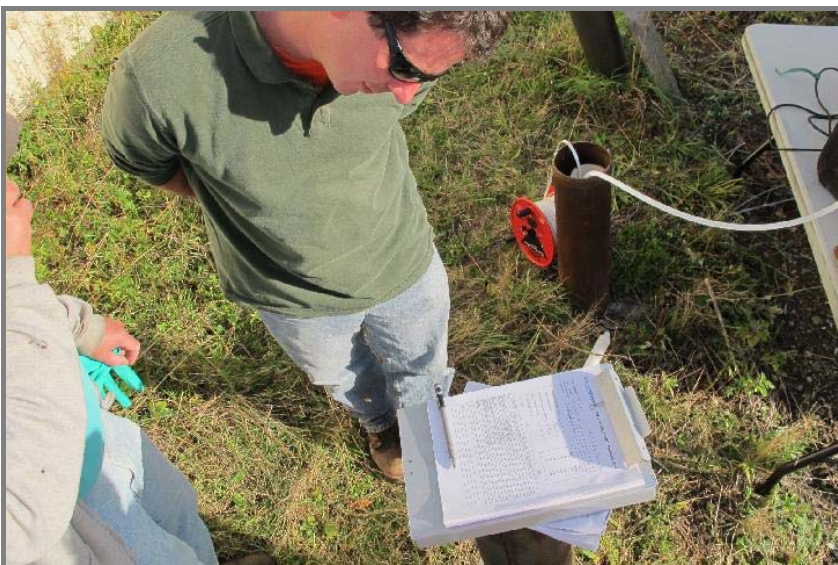
MW-4. Jeremy Wycoff looks at the parameter values of pH, temperature, conductivity, turbidity, etc.

When values do not fluctuate more than 10%, we conclude that native water is flowing from the aquifer through our equipment and it is time to take our samples.

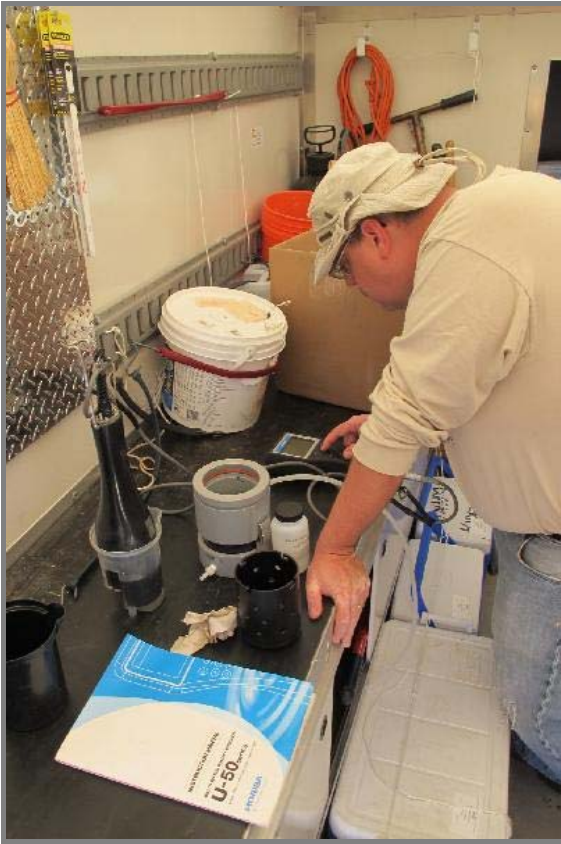
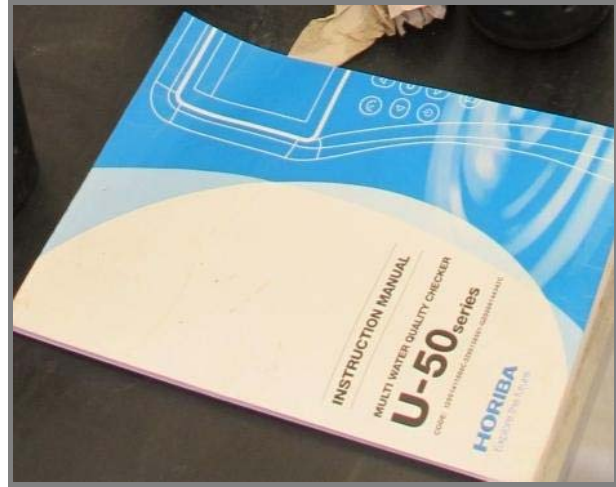
Payson calibrates the Horiba U-50 "cell.

From the equipment manual:

The U-50 Series Multi Water Quality Checker features an integrated control unit and sensors. It is capable of making a maximum of eleven simultaneous measurements for various parameters, and is perfect for use in the field. The U-50 Series is designed with on-site ease-of-use in mind, provides a wide variety of functions, and can be used for water quality measurements and inspections of river water, groundwater, and waste water.

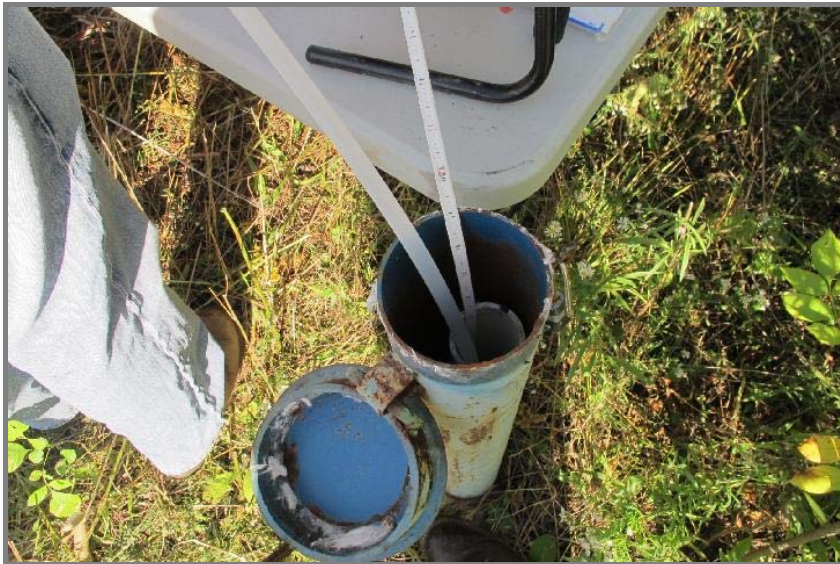
View of MW-7. Coming out of the well are the measuring tape to monitor depth to water and our sampling tubing.

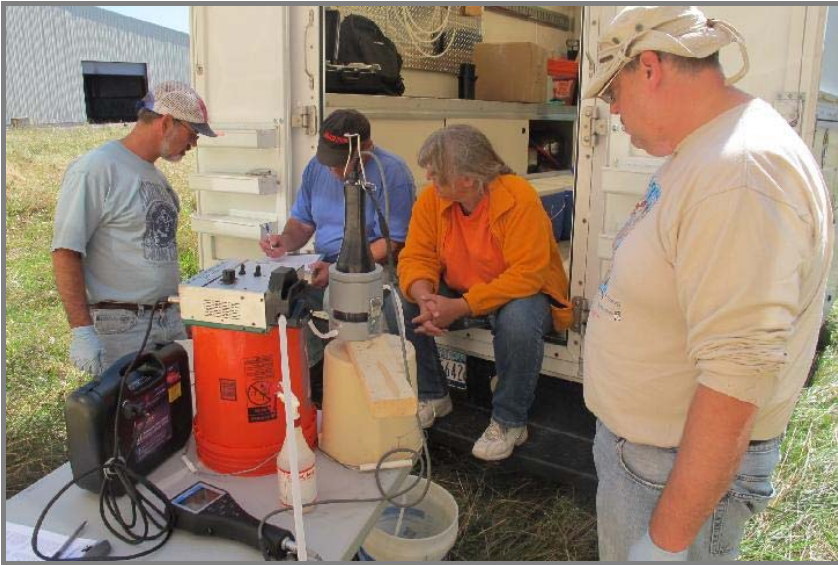
The last well to sample was MW-1 near the apple tree along side of the beige brick building. This well is sampled last because it is heavily contaminated with PCB oil.

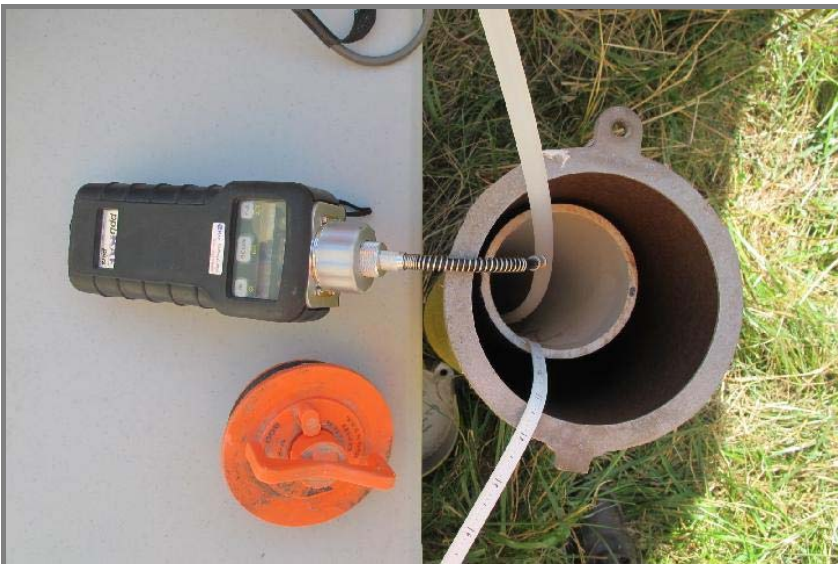
Organic vapors were 1257 ppb measured with the photoionization detector (PID).

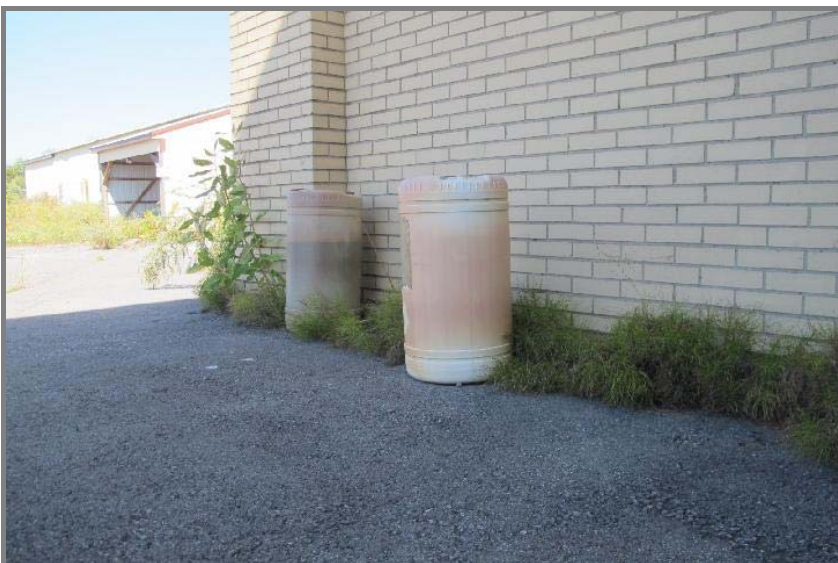
The Great Lakes Veneer Company Inc. left behind waste oil in drums here and here around the derelict facility. Whoever owns this property will be liable for penalties and cleanup costs if it gets spilled.

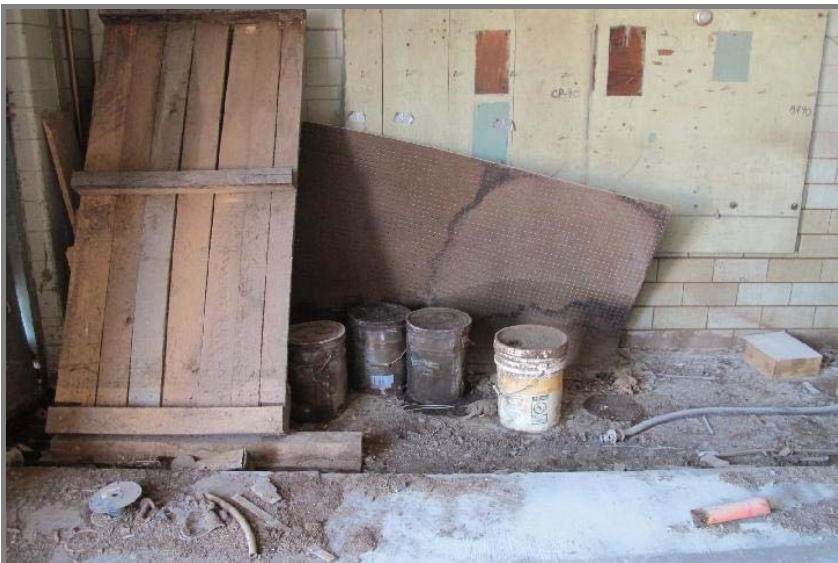
Interior showing waste liquid in containers.

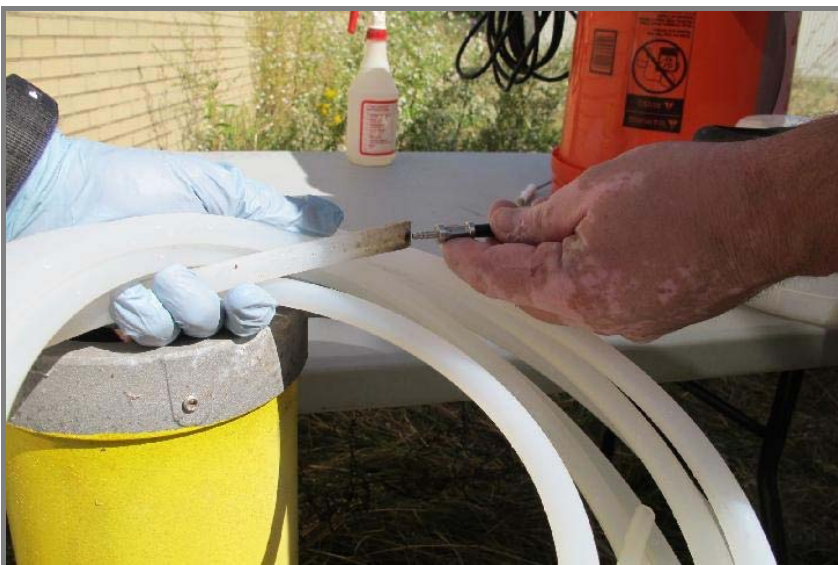
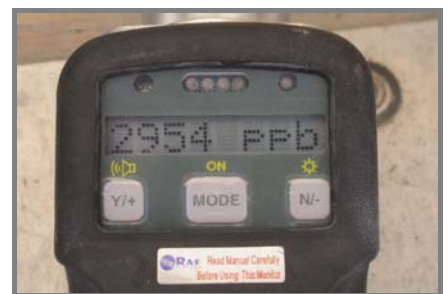
Disposing of the sampling tubing. This well has an oil sheen. The oil is heavier than water and rests at the bottom of the well.
