PERIODIC REVIEW REPORT

Oswego Castings Site

Site Number 7-38-033

June 2017

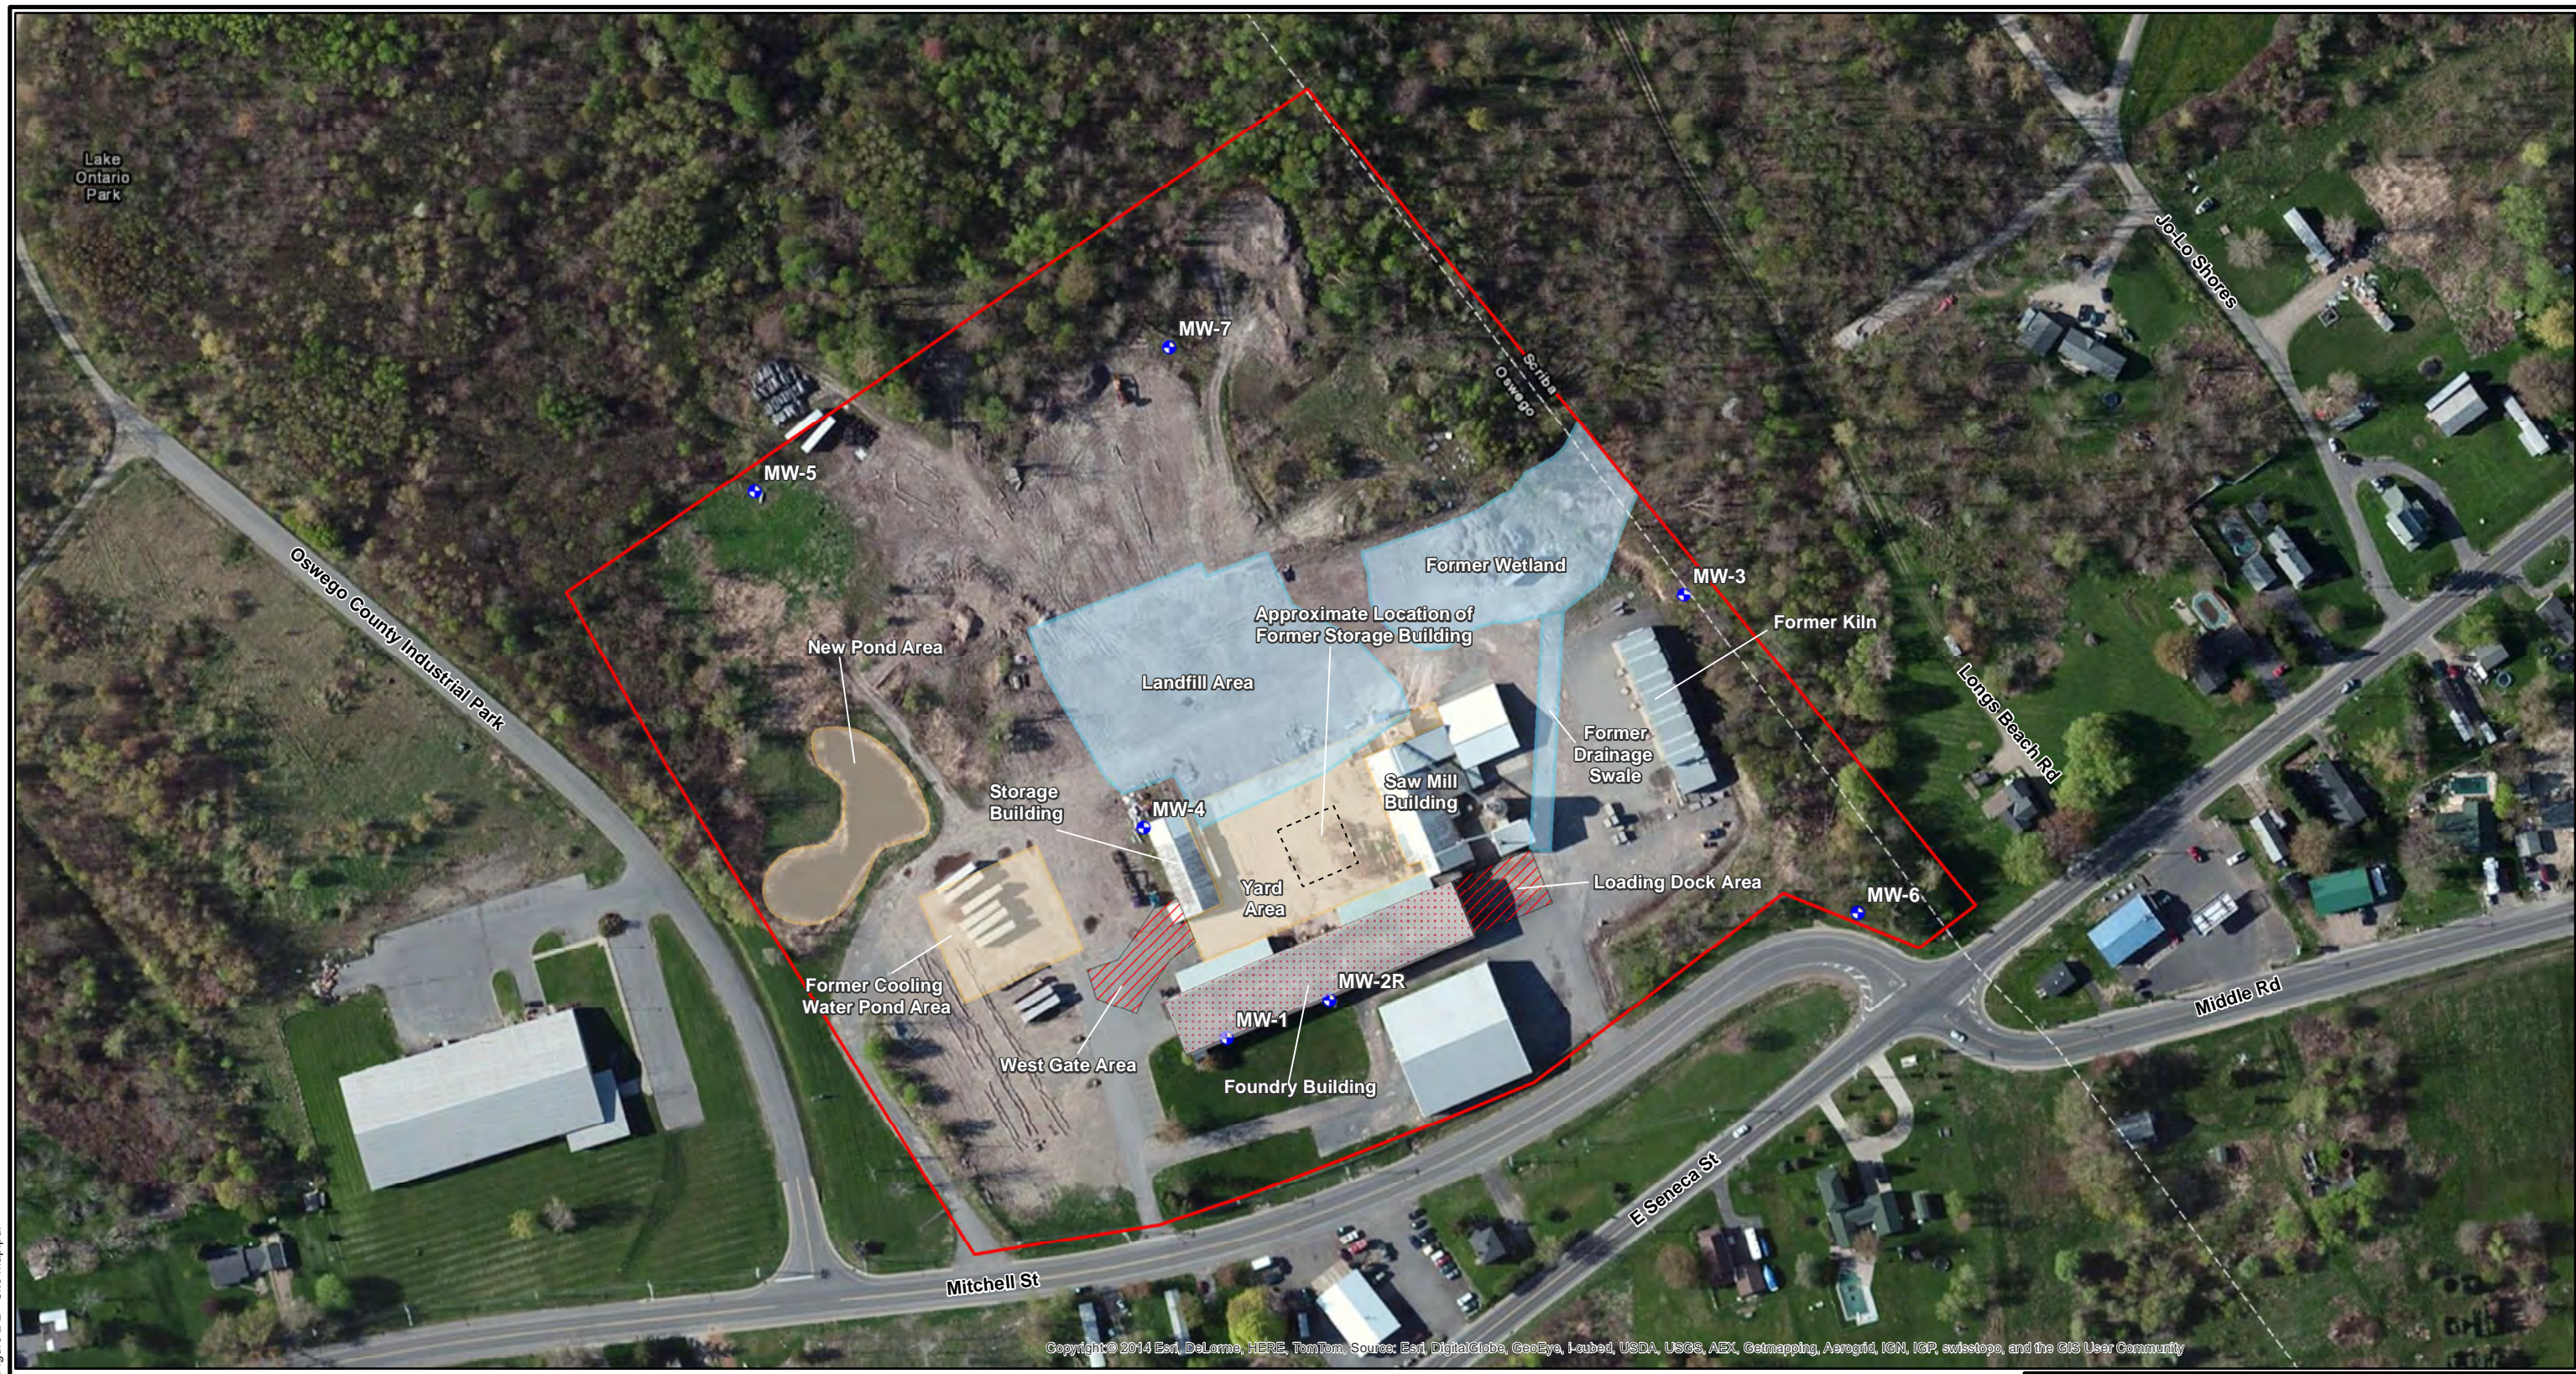
FIGURE
2-2

The selected remedies for the Site were successfully implemented following the guidance provided in each of the ROD documents (NYSDEC 1997 and 2000). Surface soil, subsurface soil, sediment, and foundry wastes containing PCB concentrations greater than 10 ppm were excavated and disposed off-site. Surface soil containing PCB concentrations greater than 1 ppm were excavated to a depth of 12 inches. The excavated material that contained PCB concentrations less than 10 ppm were consolidated and disposed on-site in the former cooling water pond and Landfill. The wastes were then covered with a geotextile and stone barrier layer. PCBs at concentrations greater than 50 ppm remain beneath certain areas of the Sawmill Building slab and beneath the concrete cap in the Yard Area (Figure 2-2) (NYSDEC 2002).

The O&M activities included inspection of the respective landfill, former cooling water pond, and yard area protective covers (Figure 2-2) which are the Engineering Controls (EC) that have been established at the Site. In addition, a general inspection of site features (buildings and grounds) is also completed to assess for potential environmental hazards. An O&M Checklist (Appendix A) was used to document the condition of the ECs during the 2015 and 2016 inspections. Photographs from the 2016 inspection are provided in Appendix B.

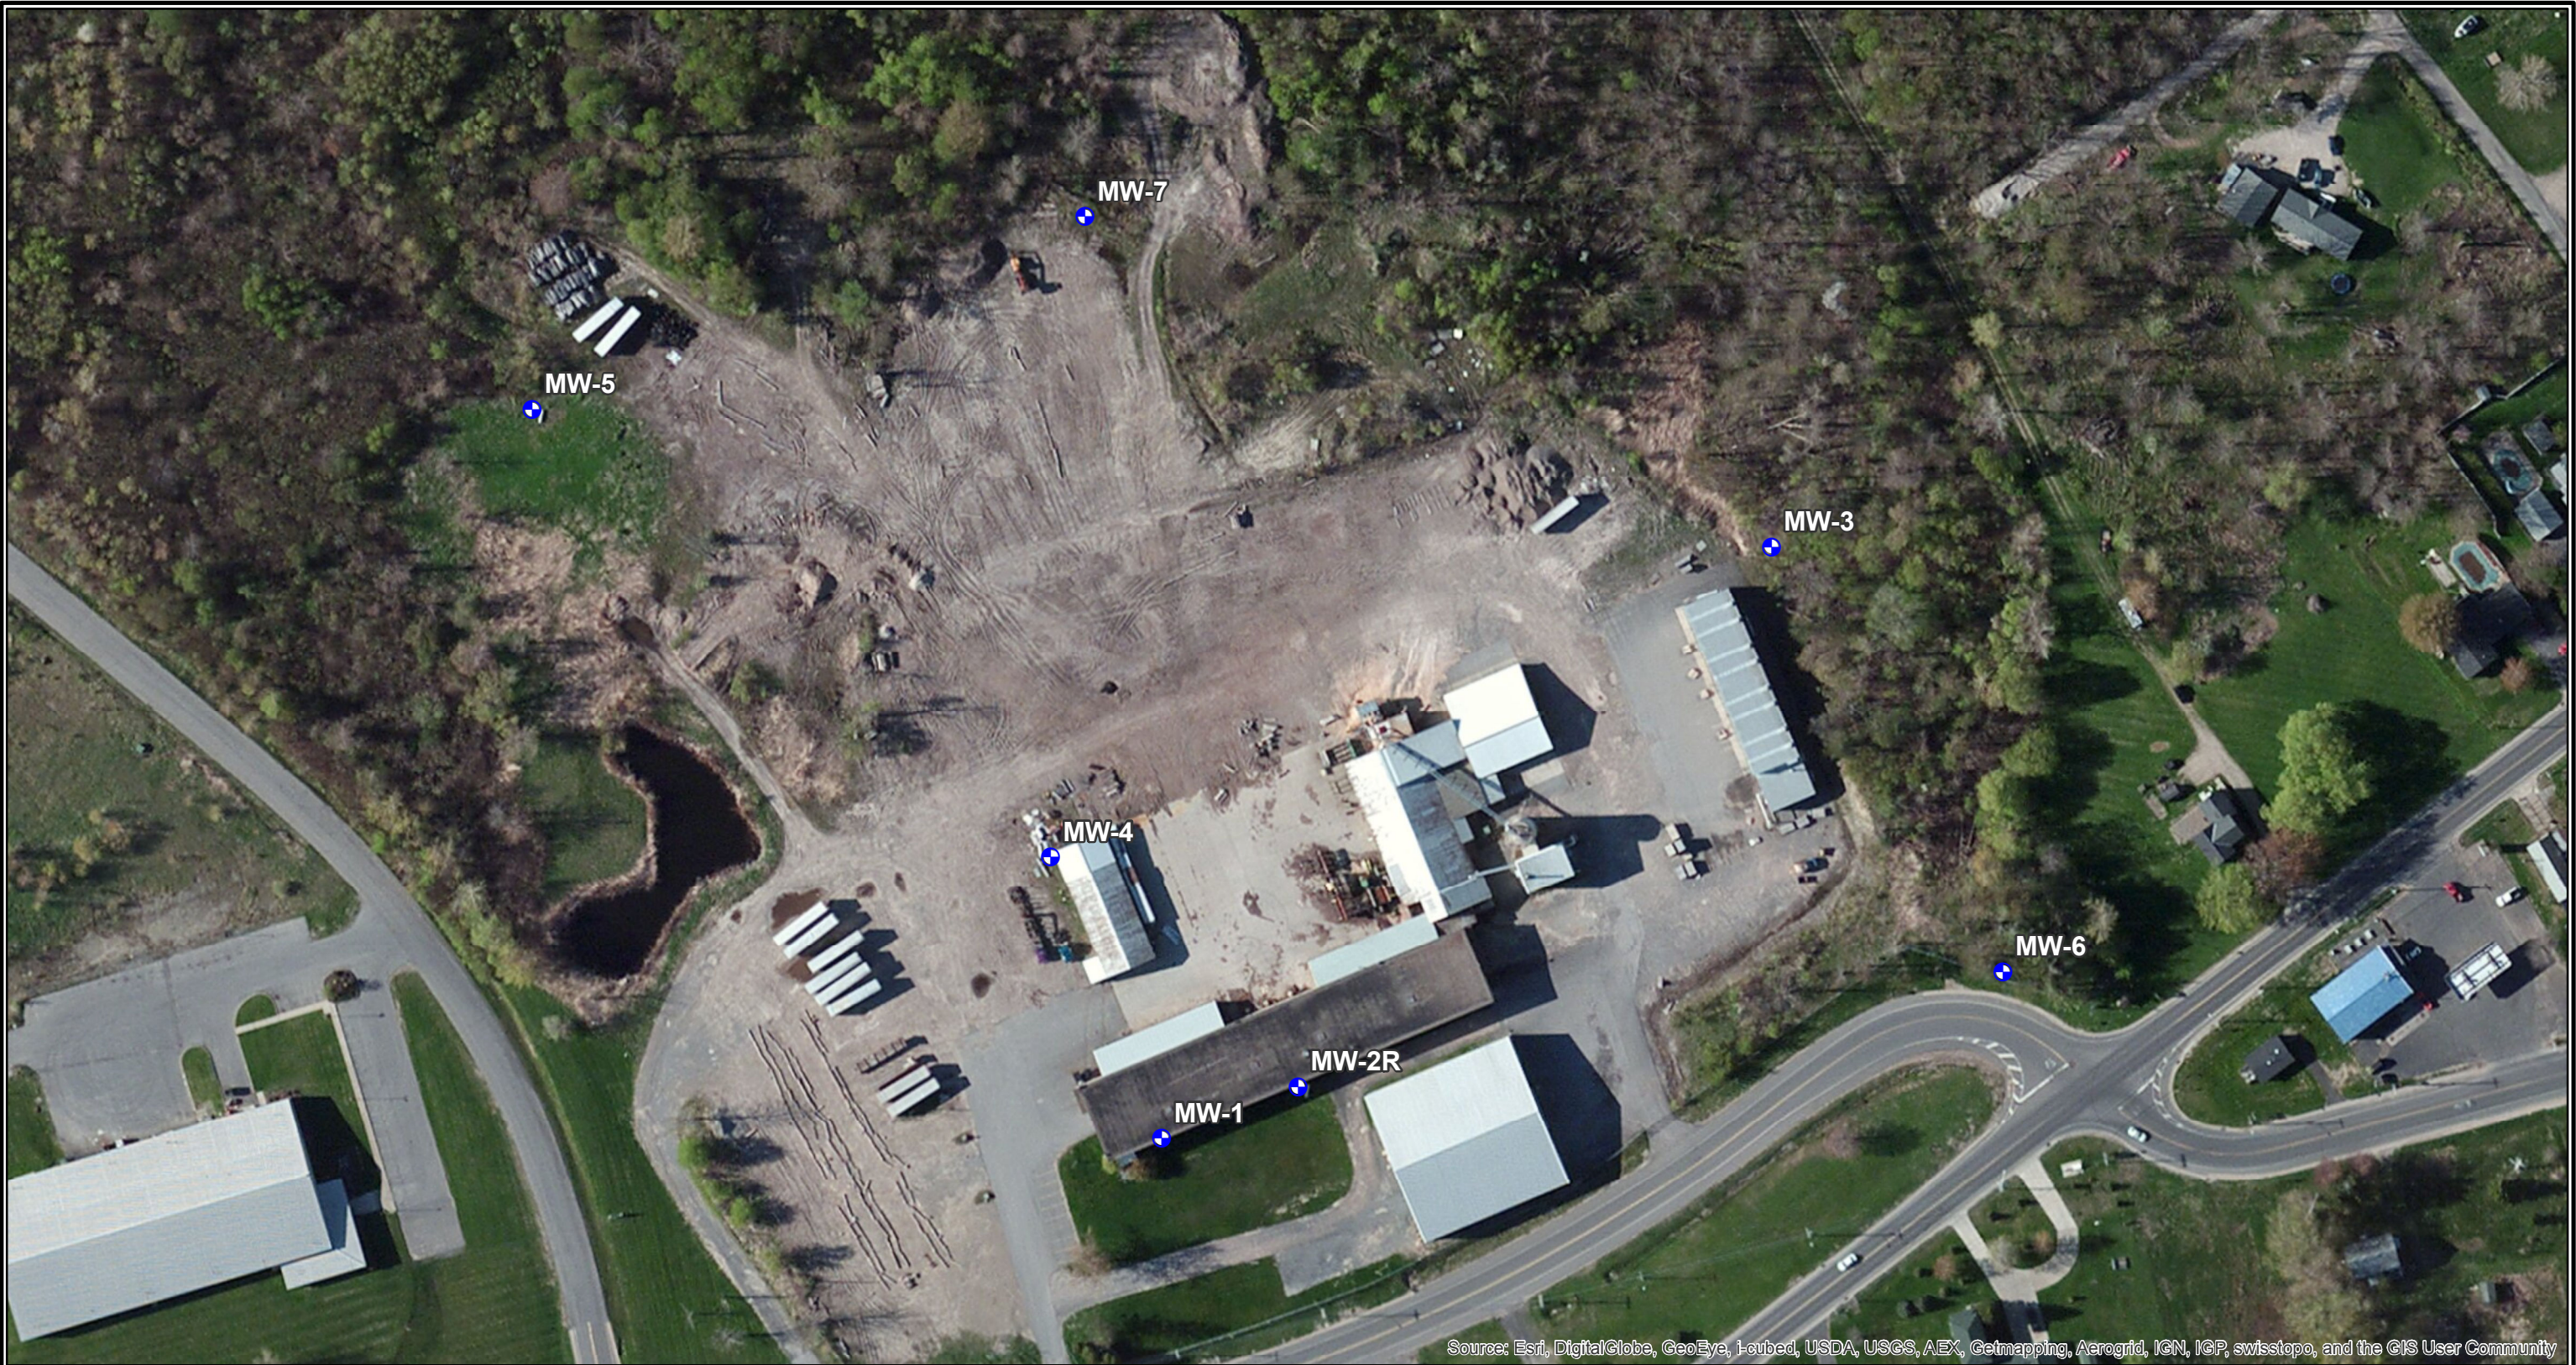
Figure 4-1 Spill Locations

On April 23, 2015, oil spills were identified in two on-site buildings that resulted from deteriorated and/or tipped storage containers. Upon identification of the spills, the incident was reported by Arcadis to the NYSDEC Project Manager and NYSDEC Spills Hotline. The associated NYSDEC Spill Number is 1500821. The Spills Division removed the containers and cleaned the spill areas. According to the NYSDEC Spills Database, the incident was closed on October 22, 2015.

As indicated in Section 2.2, oil spills were identified in two of the on-site buildings during the April 2015 site inspection and reported to the NYSDEC. In 2016, Arcadis inspected and photographed the spill areas following closure of the spill incident. Figure 4-1 shows the locations of the spills and photographs comparing when the spills were identified (April 23, 2015) and during the September 13, 2016 sampling event. As shown in Figure 4-1, the drums and containers of the spilled materials were removed and oil/staining on the floors cleaned. The NYSDEC Spill Record is provided in Appendix C (NYSDEC 2017).

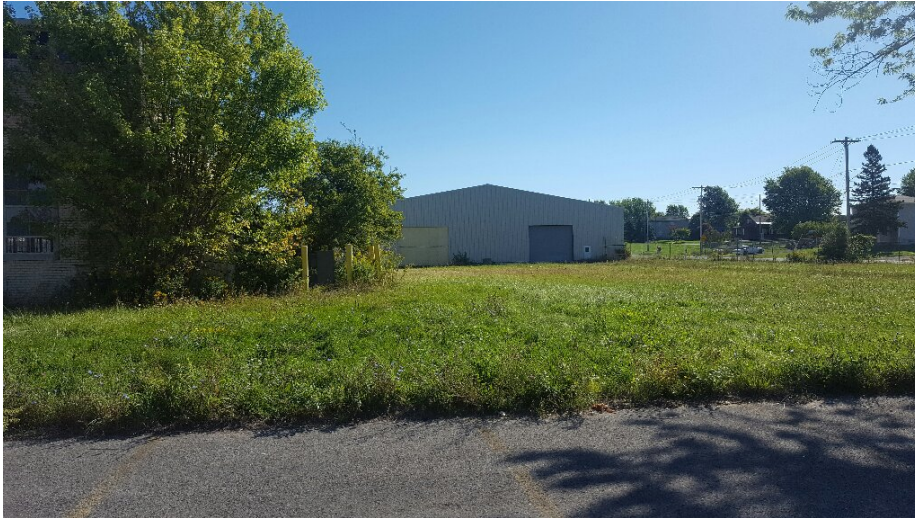
Site facing east

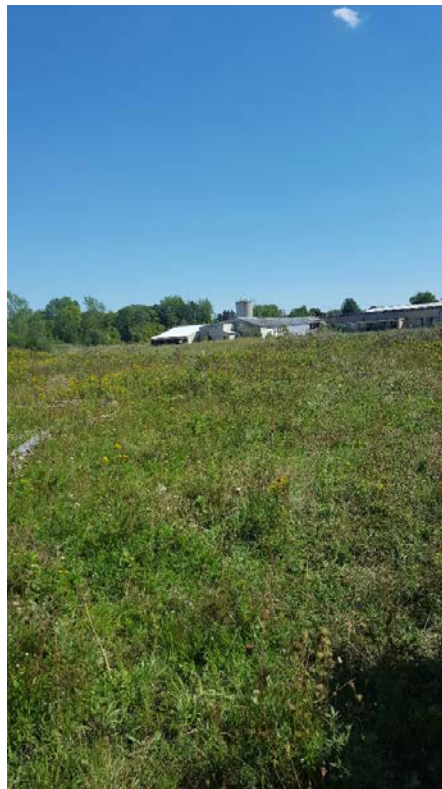
Site facing southeast near MW-5

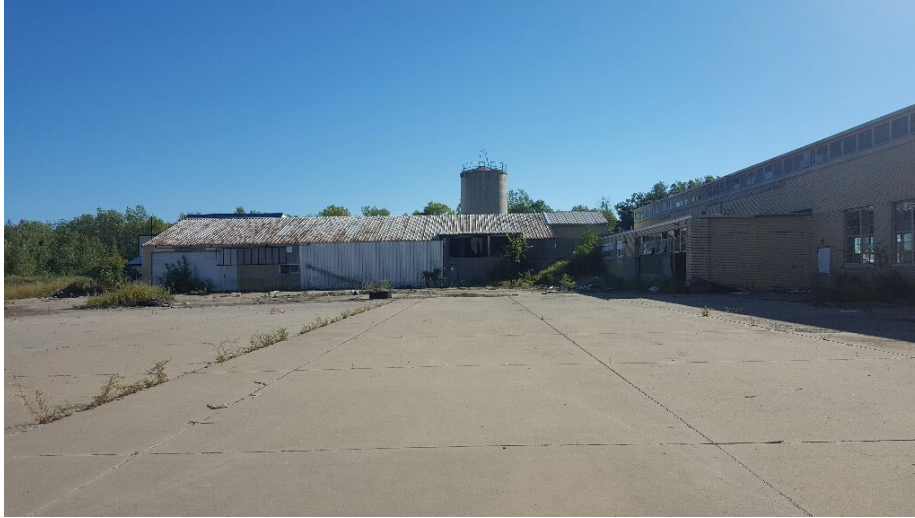
A visual inspection of the concrete cover was performed during each visit to the Site to inspect the integrity of the remedy. As indicated in the April 2015 and September 2016 O&M Checklist (Appendix A), the concrete cap had minor cracks but did not show evidence of settling or other damage. Cracks in the concrete cover were also noted by NYSDEC in the 2002 Remediation Summary Report, but were found to not affect the performance of the remedy (NYSDEC 2002). In addition, as shown in Appendix A and Appendix B, some debris (primarily wood chips and boards) were present on the concrete cap.

Concrete cap in Yard Area, facing east

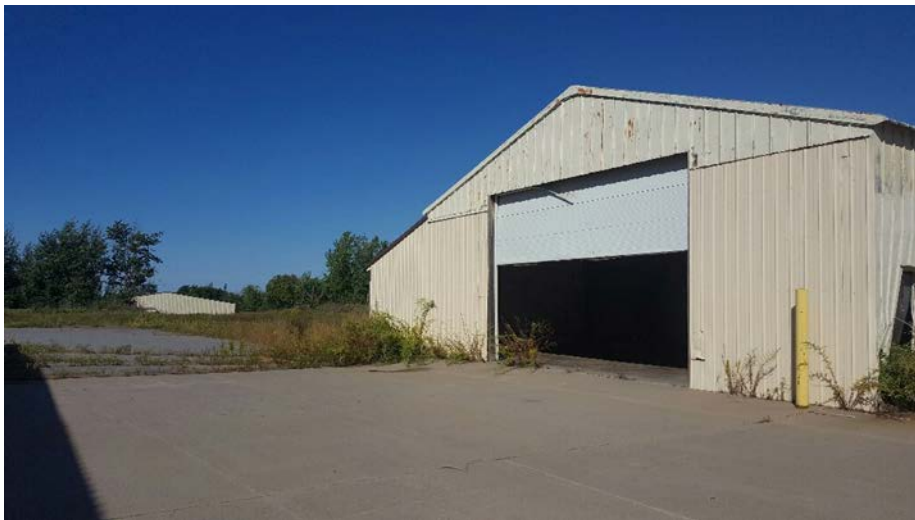
Concrete cap in Yard Area, facing northwest

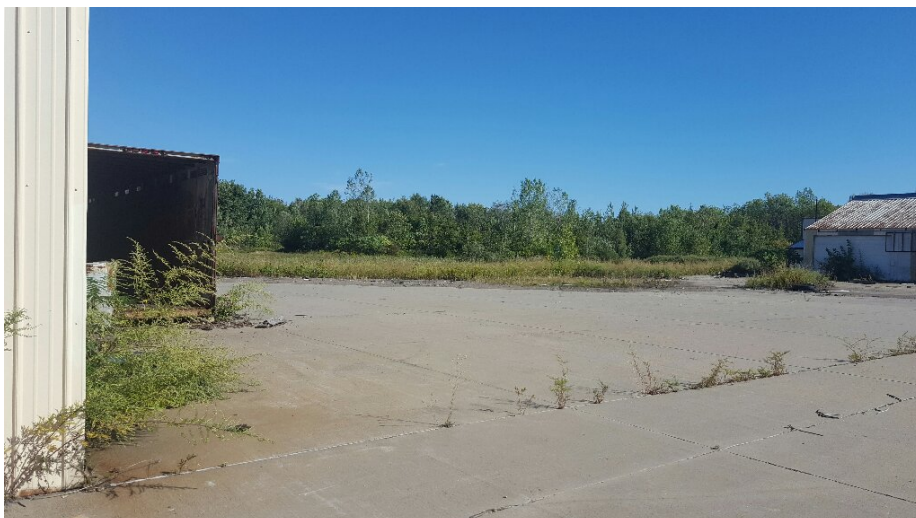
Concrete cap in Yard Area, facing northeast

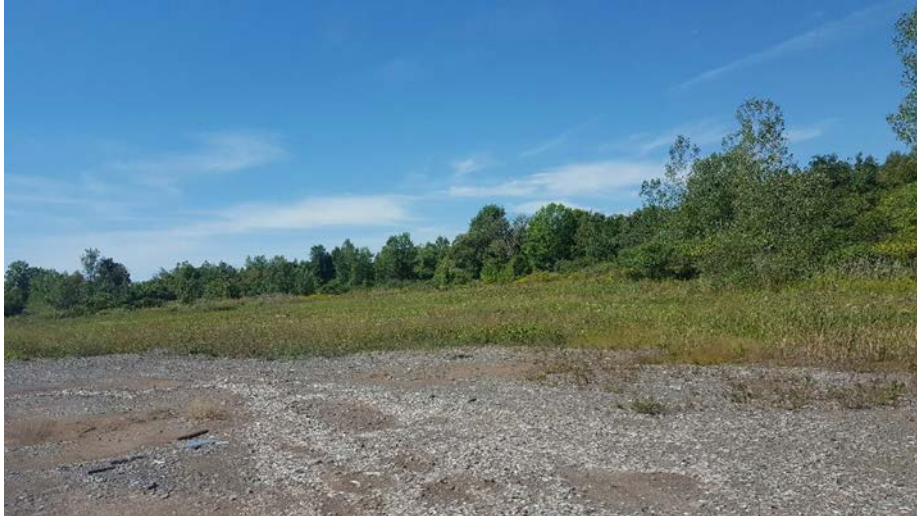
A visual inspection of the landfill was performed during each visit to the Site to assess the landfill cover for erosion, settlement, ponded water, burrowing rodents, and brush or woody vegetation. As shown in the O&M Checklist (Appendix A), during the April 2015 and the September 2016 visit, wood chips, apparently from the former saw mill operation, were covering the landfill area but did not appear to be impacting the performance of the cover. In addition, during the April 2015 visit, the northern area of the cover contained areas of ponded water; however, the inspection was performed following a significant

snow pack melt. Based on previous site inspections by Arcadis, the ponded areas are not likely to be present during the remainder of the year.

Southern edge of Landfill Area - facing northwest

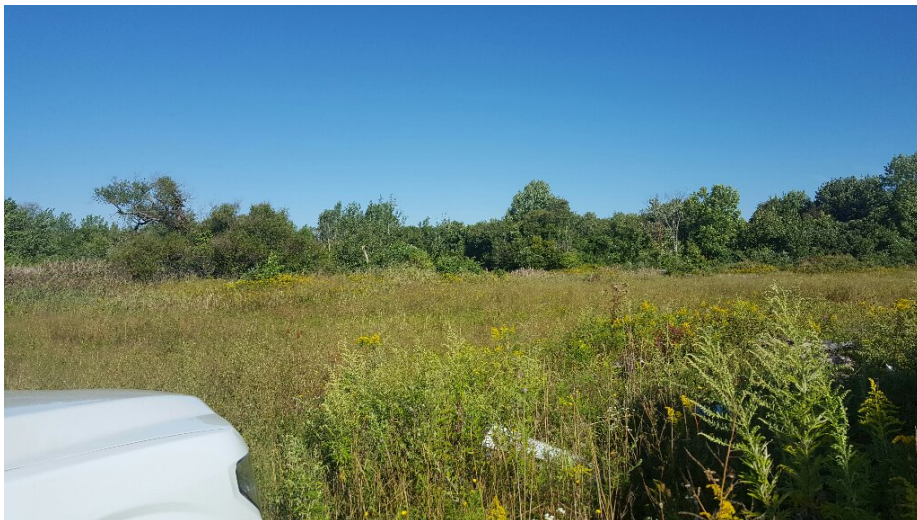
Landfill Area – facing north

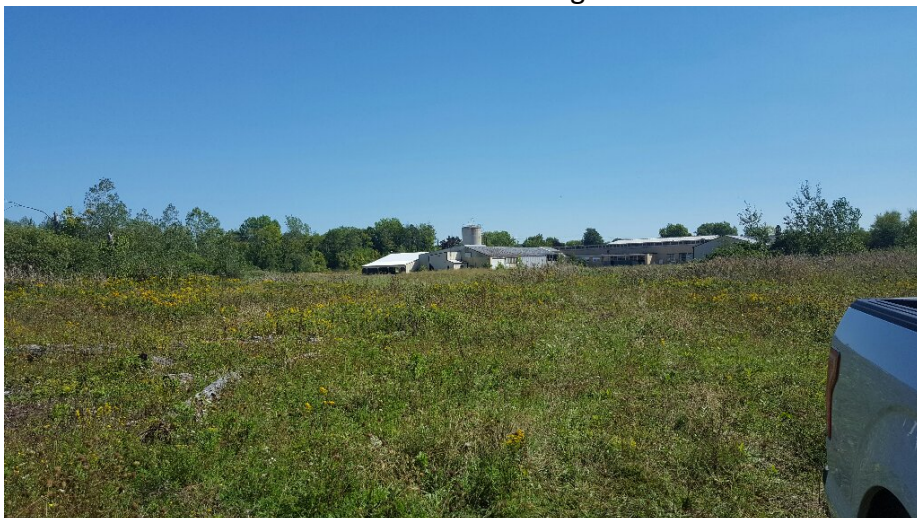
Northern Landfill Area – facing southeast

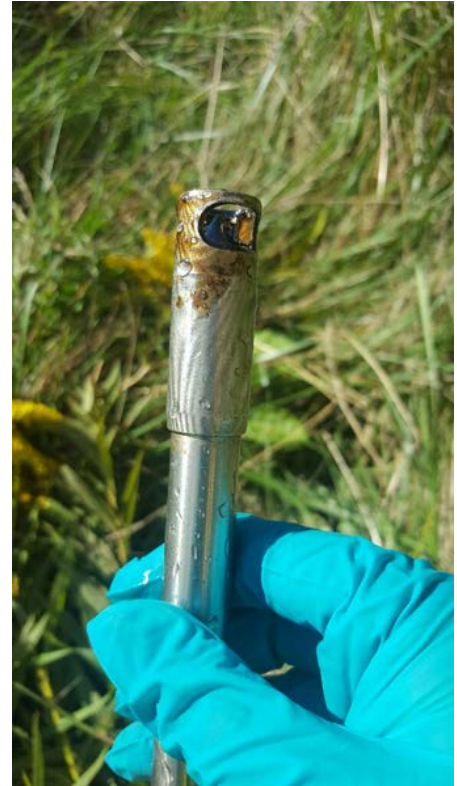
As shown in Appendix E, dense, non-aqueous phase liquid (DNAPL) was observed on the water level probe during the September 2016 monitoring event after measuring the depth to the bottom of groundwater monitoring well MW-1. A photograph showing the DNAPL from MW-1 is also provided in Appendix B. The last detection of DNAPL in this well was during the 2012 groundwater sampling event performed by NYSDEC (NYSDEC, 2012). During the 2012 event, DNAPL was identified on the tip of sample tubing after it was removed from the well. None of the other monitoring wells contained evidence of NAPL during the 2015 or 2016 groundwater monitoring events.

DNAPL from MW-1 on
water level probe (right)

Based on the concentrations of PCBs in groundwater, and the detection of DNAPL in monitoring well MW-1, groundwater monitoring should continue in accordance with the SMP to evaluate the impacts to groundwater from the PCB contamination that remains beneath the protective covers (landfill area, former cooling water pond and yard area) and beneath the sawmill building slab.
