2023 Annual Report Oswego Castings Site (738033) Oswego, New York

Work Assignment No. D009806-34

> September 2024 Version: Final EA Project No. 1602534

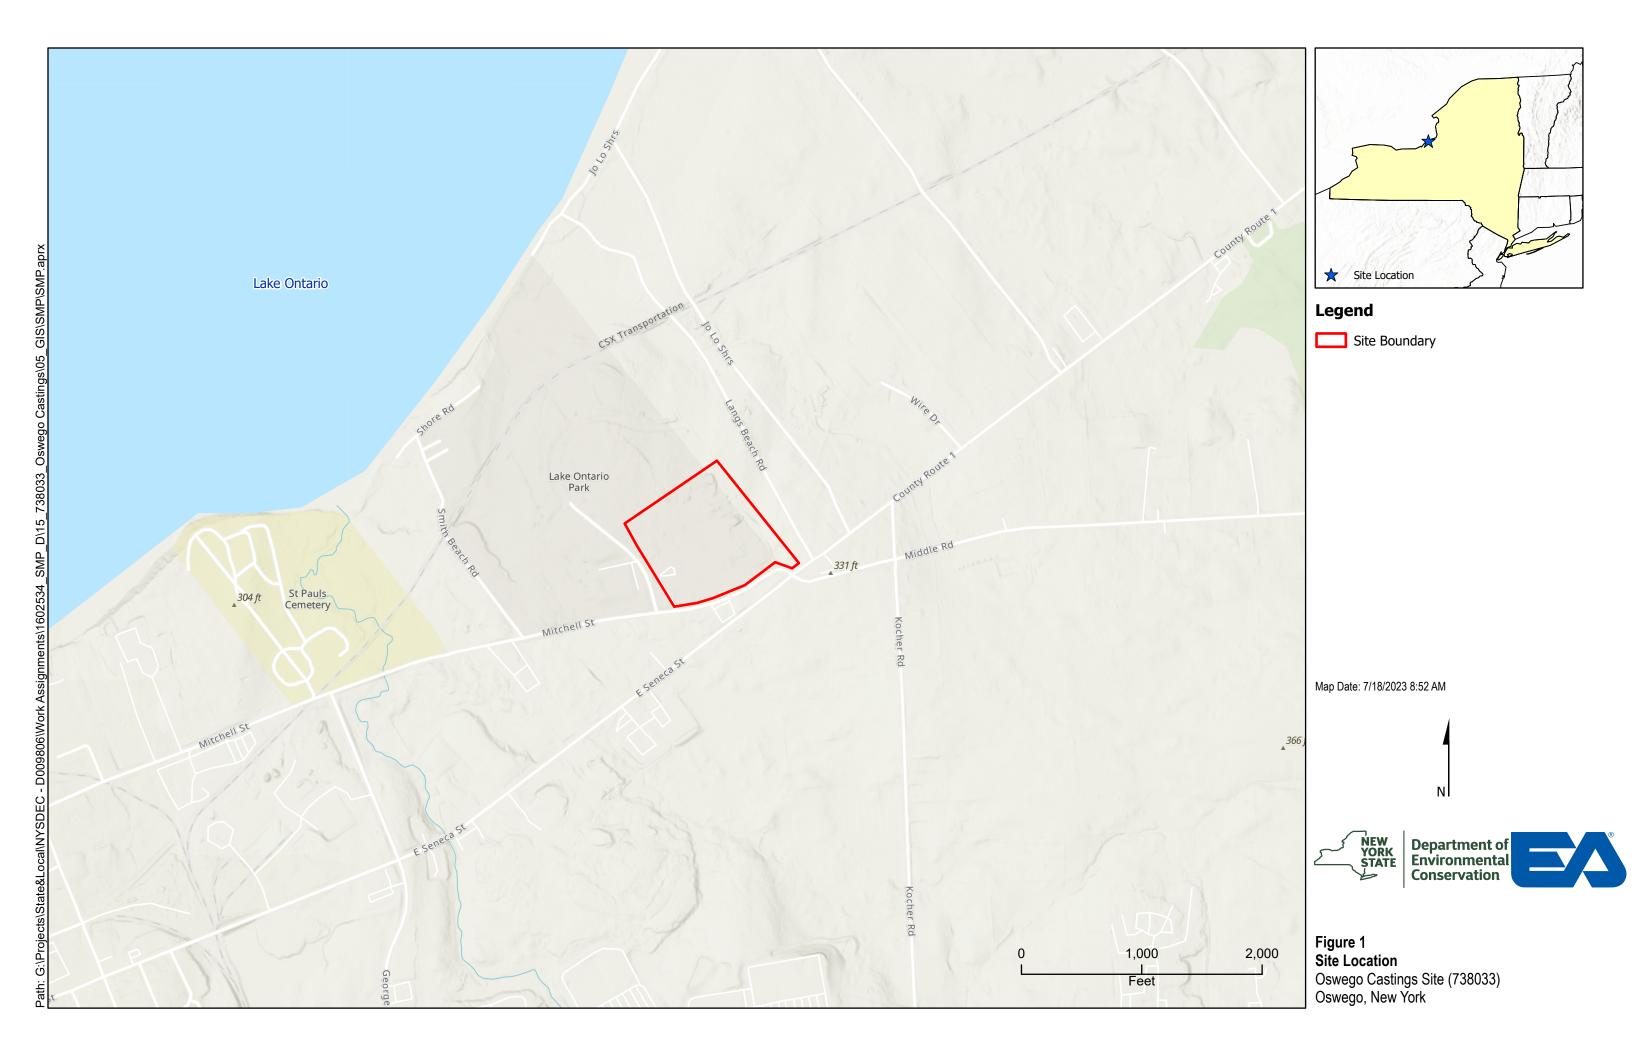
- Figure 1. Site Location
- Figure 2. Site Layout

This Annual Report is a required element for the Oswego Castings Site located in Oswego, New York, hereinafter referred to as the Site (**Figure 1**). The Site is currently in the New York State Inactive Hazardous Waste Disposal Site Remedial Program (Site Number [No.] 738033), which is administered by the New York State Department of Environmental Conservation (NYSDEC). The reporting period for this Annual Report is 1 January 2023 to 31 December 2023.

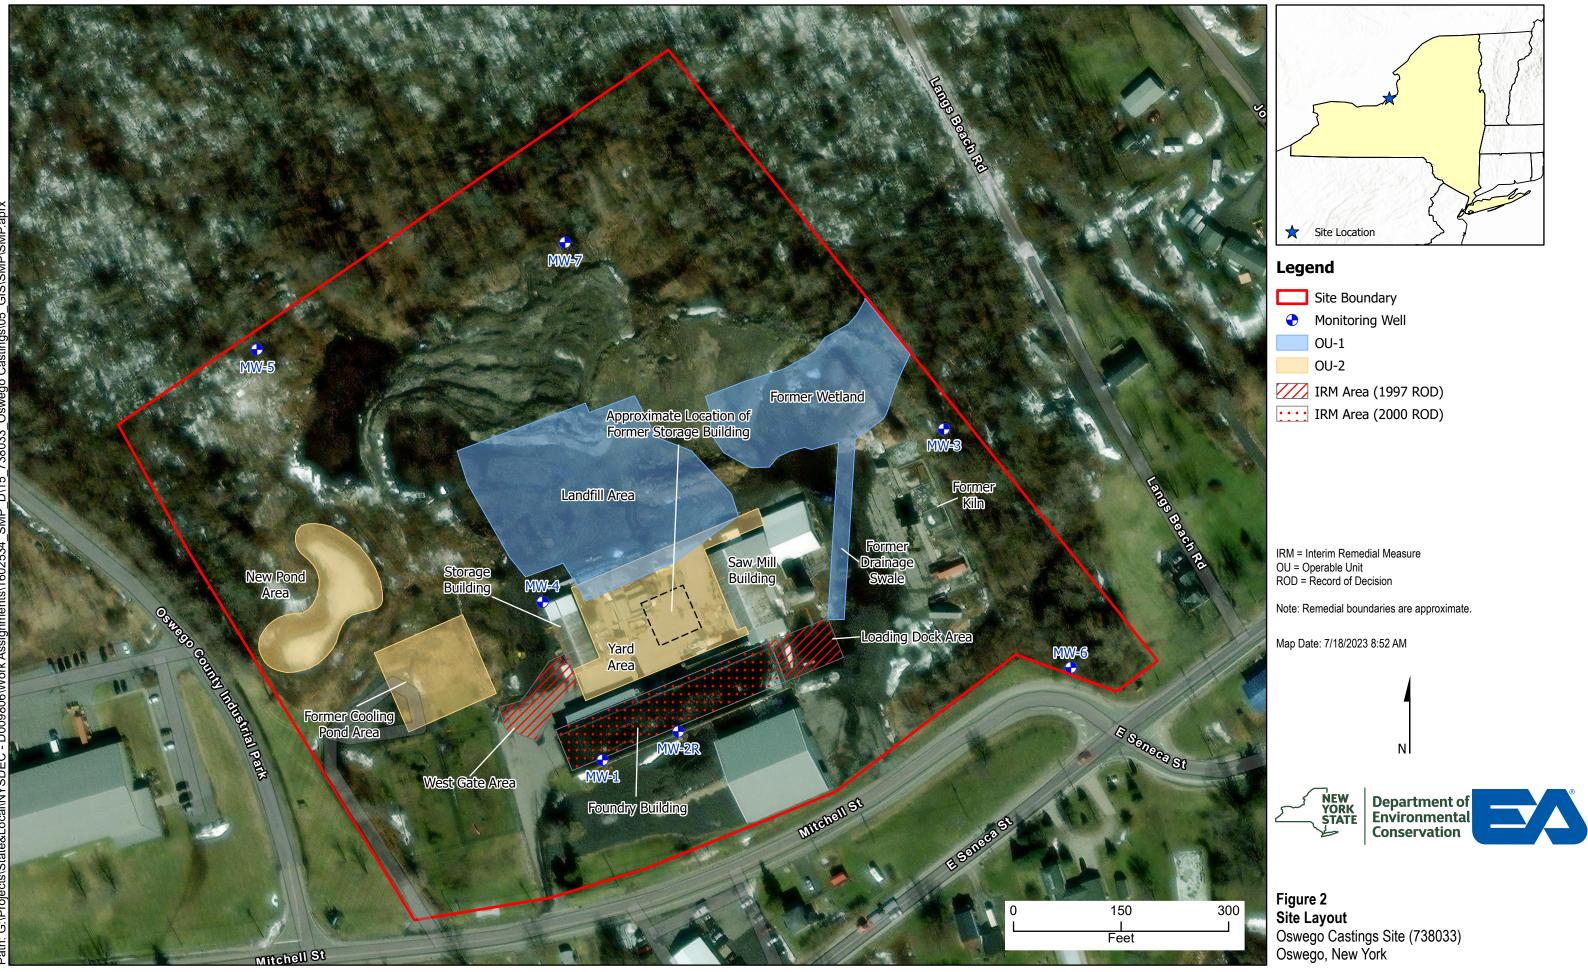
The Site was formerly owned by B and K Metals Inc. (previously Oberdorfer Foundries, Inc.). Oswego Castings Inc., a subsidiary of Oberdorfer Foundries, Inc. operated an aluminum die casting facility on the Site from 1956 to 1986. Polychlorinated biphenyls (PCBs) were detected on the Site in core sands, foundry waste, and wastewater discharged to a process line/septic tank discharge line after the facility closed, during an investigation performed by a prospective buyer. Starting in June 1988, preliminary investigations of the facility were performed by Oberdorfer Foundries, which identified PCBs above the New York State hazardous classification of 50 parts per million. The expected sources of the PCBs include leaks in hydraulic equipment and binders or coatings applied to core sand surfaces. In July 1993, B and K Metals Inc. entered into an Order on Consent with the NYSDEC for a remedial investigation (RI)/Feasibility Study (FS). The RI/FS was conducted between July 1993 and February 1997. A Record of Decision (ROD) was issued for Operable Unit (OU)-1 in 1997 (NYSDEC 1997), and called for excavation of approximately 4,100 cubic yards of soil, sediment, and foundry sand. In addition, the ROD called for removal of the septic tank and placement of crushed stone over the existing on-site landfill. The remedial action for OU-1 immediately followed and included excavation of surface soils, subsurface soils, and foundry wastes, and wetland sediments for offsite disposal; removal of a septic tank and tank contents for off-site disposal, and installation of a soil/crushed stone cover over the landfill area (NYSDEC 1999). A ROD for OU-2 was issued in 2000 (NYSDEC 2000), calling for construction of a concrete pad over the yard area and floor of the sawmill in addition to applying geotextile cover/stone to the former cooling water pond, construction of a new pond, and extending the roof drain from the former cooling water pond to the newly constructed pond. The remedial action for OU-2 was conducted in 2001 and included excavation and consolidation of sediments and soils into the former cooling water pond, installation of a concrete cap over the yard area, excavation of a new pond, and installation of four monitoring wells. As part of the Interim Remedial Measure for the Site, the foundry roof was cleaned to control a PCB source, and PCB impacted soil at the former loading dock was removed (NYSDEC 2002). Site features are shown in **Figure 2**.

In May 2010, the stone buffer for the landfill was regraded and landscape fabric and new stone were applied to the landfill cap. In April 2010, groundwater monitoring well MW-2 was replaced, and three new monitoring wells were installed (MW-5, MW-6, and MW-7). Well locations are presented on **Figure 2**.

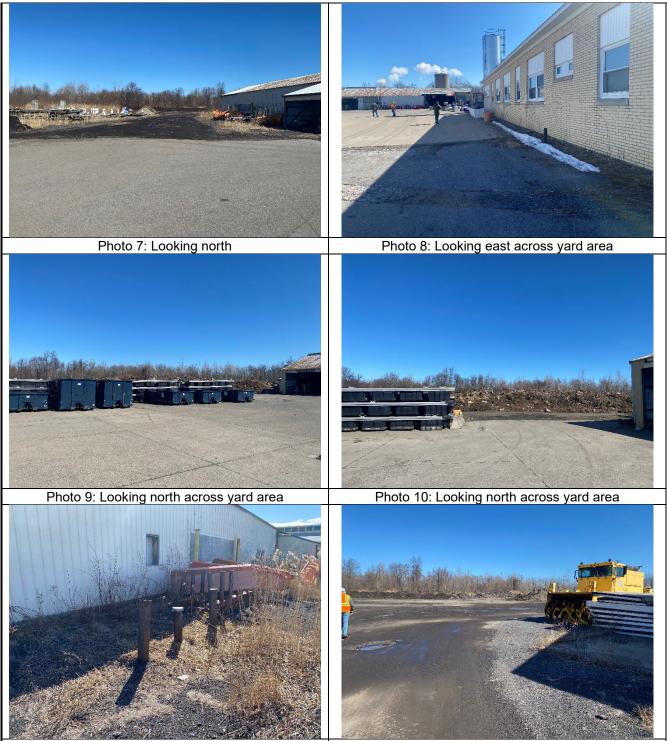
Photo 11: MW-4

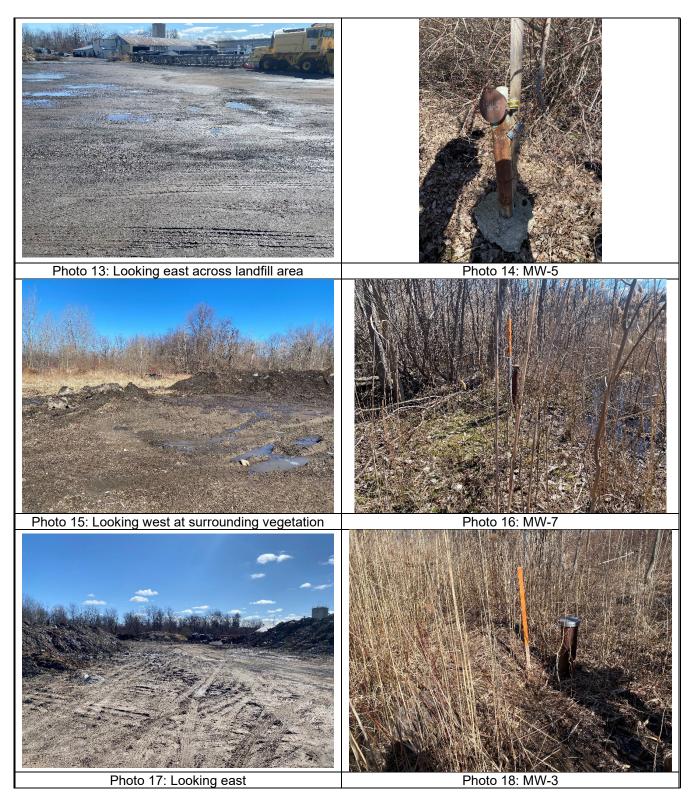
Well ID	DTW	DTB	Notes
MW-1	2.5'	-	<0.01' of NAPL, sheen
MW-2R	2.28	15.73	
MW-3	2.32	17.35	Needs new lock
MW-4	2.79	16.41	
MW-5	4.76	16.89	Needs well repairs
MW-6	6.55	36.86	
MW-7	2.36	16.06	Needs new lock

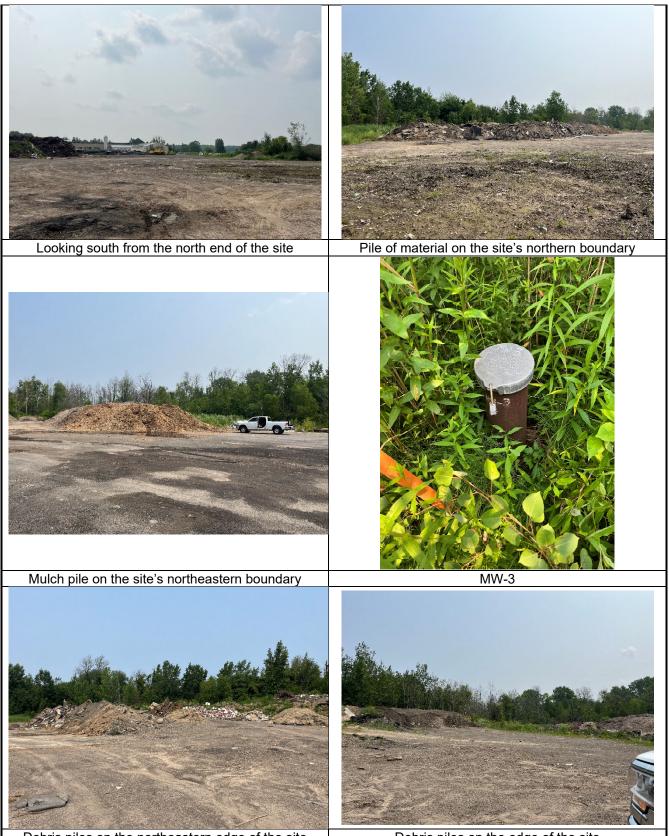
Debris piles on the northeastern edge of the site

Debris piles on the edge of the site

Name	Representing			
Moriah Gilkey	EA			
Project Schedule Comments				
-				
la sur a Davadha a				
Issues Pending				
 Large pile of vegetation debris (20ft high) covering soft cap remedy area. DEC to contact attorneys and Property Owner 				
 Vegetation clearing will need to take place before the next sampling event. 				
Interaction with Public, Property Owners, Media, etc.				
EA observed tenants dumping vegetation debris.				
EA observed tenants dumping vegetation debits.

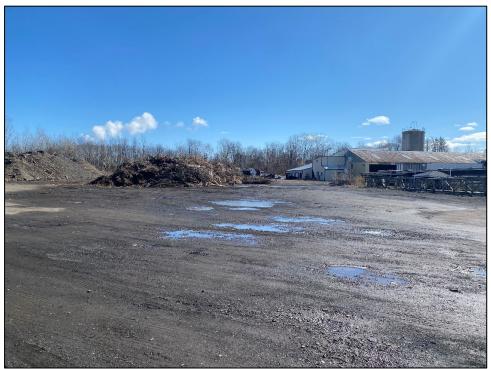
On 20 March 2023, EA and NYSDEC performed a site inspection to assess the conditions of the site and monitoring well network. A large vegetation/debris mound was observed on the soft cap north of the hard cap in the yard area. NYSDEC stated that the property owner was in direct violation, and they would be contacting the owner's attorney to issue a NOV. As discussed previously, NOV was issued on 23 October 2023. EA performed well inspections and gauged the seven existing monitoring wells. The groundwater elevation was between 2.28 and 6.55 ft below

View of Landfill Area on 30 March 2023 Direction: East

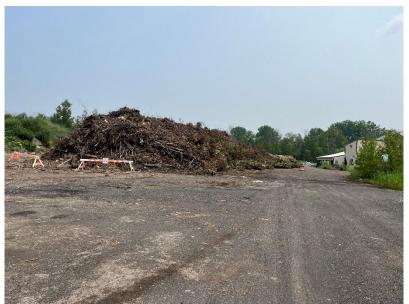
EA performed a site inspection to assess the site conditions and monitor the DNAPL in MW-1 on 17 July 2023. EA was unable to locate MW-5, MW-6, and MW-7 because of thick brush and vegetation. During the site inspection, EA observed that the large pile of vegetation debris was still covering the soft cap remedy area. The size of the vegetation debris pile was approximately 237 ft by 50 ft.

View of Landfill Area on 17 July 2023 Direction: East

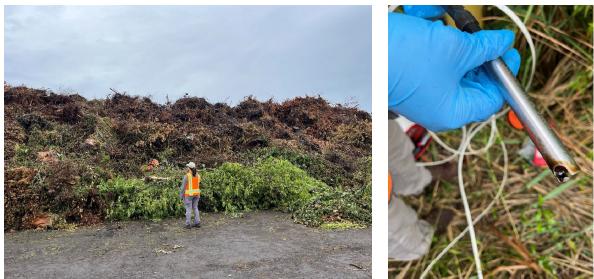
On 10 August 2023, EA performed a site inspection to monitor the DNAPL in MW-1. EA gauged the well. The depth to water was 3.42 ft BTOC, DNAPL was detected at 17.39 ft BTOC, and the depth to the bottom of the well was 17.51 ft BTOC. EA removed the existing absorbent sock and installed a clean absorbent sock at the bottom of the well with small weights. EA also performed a brief site walk to inspect the soft cap and observed the site owner actively dumping landscaping debris on the previously mentioned debris pile located on the soft cap.

View of Landfill Area and Oil Water Interface Probe on 10 August 2023 Direction: North

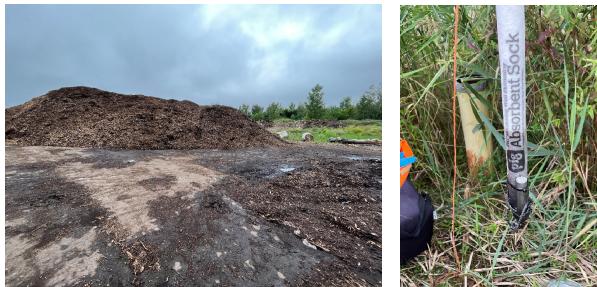
During the site inspection on 11 September 2023, EA removed the absorbent sock out of the well and gauged the DNAPL in MW-1. DNAPL was present on the end of the absorbent sock. The depth to water in the well was 3.72 ft BTOC, and the depth to the bottom of the well was 17.51 ft BTOC. The oil water probe did not indicate that there was DNAPL in the well. EA replaced the absorbent sock at the bottom of the well with small weights. EA performed a brief site walk to inspect the vegetation debris pile on the soft cap. A 'No Dumping' sign was in the road when entering the site. The vegetation debris pile was removed and replaced with a smaller mulch pile in the back portion of the site. The mulch pile measured approximately 161 ft by 72 ft.

View of Landfill Area and Absorbent Sock on 11 September 2023 Direction: Northwest

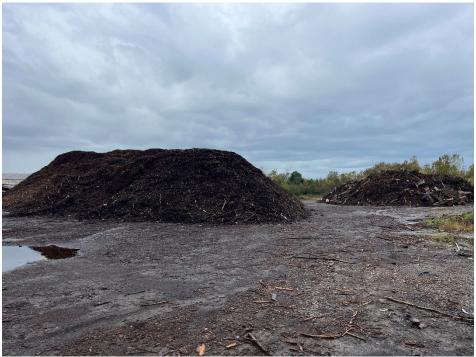
EA conducted a monthly site inspection to gauge MW-1 for DNAPL on 10 October 2023. EA removed the absorbent sock from the well, and DNAPL was present on the absorbent sock. The depth to water was 2.54 ft BTOC, and the depth to the bottom of the well was 17.51 ft BTOC. The oil probe did not indicate that DNAPL was present in the well. EA replaced the absorbent sock at the bottom of the well with small weights. EA performed a brief site walk. The mulch pile from the previous inspection was still present.

View of Landfill Area on 10 October 2023 Direction: West

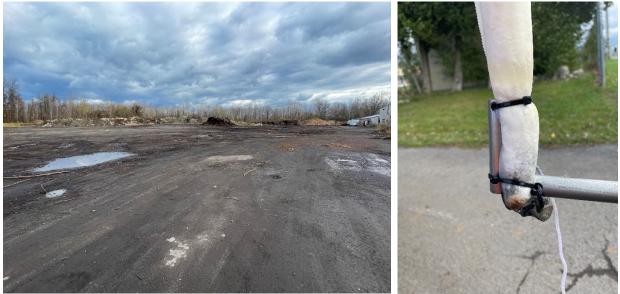
On 10 November 2023, EA performed a site inspection to replace the absorbent sock of MW-1 and gauge the well. EA removed the absorbent sock from the well and observed DNAPL on the absorbent sock. The depth to water was 2.48 ft BTOC. DNAPL was detected at 17.43 ft BTOC, and the depth to the bottom of the well was 17.46 ft BTOC. There was 0.03 ft of DNAPL in the well. EA replaced the absorbent sock at the bottom of the well with small weights. EA conducted a brief site walk and observed that the mulch pile was relocated. There was no brush or mulch present on the soft cap during the inspection.

View of Landfill Area and Absorbent Sock on 10 November 2023 Direction: East

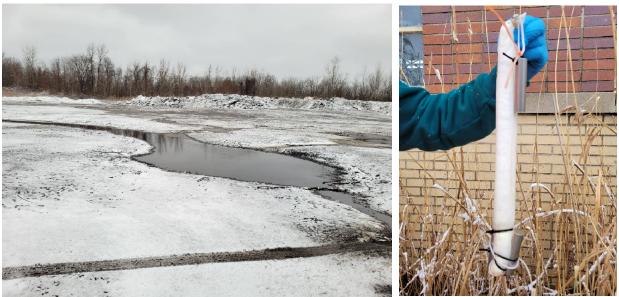
During the site inspection on 18 December 2023, EA removed the absorbent sock from MW-1. There was no DNAPL observed on the absorbent sock. The depth to water in the well was 2.43 ft BTOC, and the depth to bottom was 17.5 ft BTOC. There was no measurable DNAPL; however, there was a trace amount of the product observed on the water level indicator. EA replaced the absorbent sock at the bottom of the well with small weights.

View of Landfill Area and Absorbent Sock on 19 December 2023 Direction: North

EA recommends continuing monthly site inspections and absorbent sock replacements of MW-1 until no product is observed or measured for three consecutive site inspections. Then, subsequent site inspections will be conducted as needed. The next sampling event of the monitoring well network is scheduled for the second quarter of 2024.
