Wetland Delineation Report Fortino Tire Site

DRAFT

October, 2022

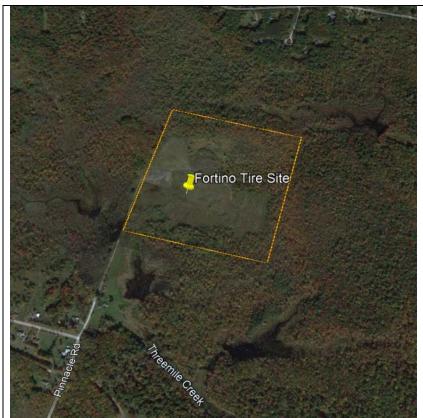
Figure 2. Site Location and Surrounding Environs (2021)

The Site is relatively flat except for the ASR waste pile and municipal landfill which dominate the middle of the Site. Much of the flat portion of the Site is at elevation 474 feet, while the top of the municipal landfill is approximately 508 feet. The slopes of the south and east of the ASR waste pile are generally at a grade of approximately 1:4, while slopes on the northside of the ASR waste pile and municipal landfill are steep. The municipal landfill is covered with upland grasses. The ASR waste area is covered with short upland grass vegetation and some opportunistic tree species. Large swathes of undeveloped woods and wetlands surround the Site (Figure 2).

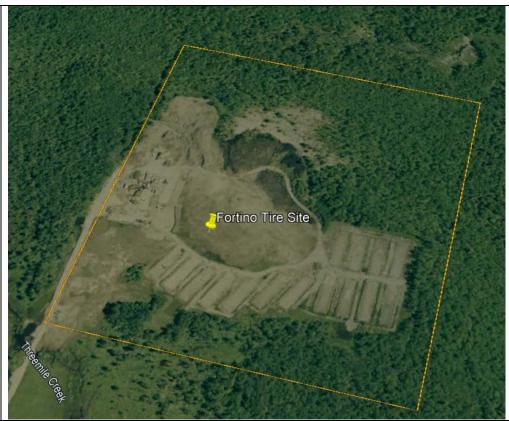
Figure 3. Site Location, circa 2009.

Figure 3 depicts the Site in 2009. In the figure, dedicated work spaces for waste management radiate out from the toe of the ASR slope to the north, east, and along the access road to the south. In these areas, the surfaces were stabilized with compacted soils and stone.

Note the development on Site and the large, disturbed areas and rectangular shaped waste management areas located south and east of the ASR waste pile.

As mentioned previously, and depicted in Figure 3, areas past the toe of slope have been disturbed by past activities (clearing, earthmoving, soil stabilization, temporary road construction, vegetation and tree clearing, etc.). The uplands and much of the wetlands near the ASR waste pile have uneven surfaces, with isolated pits and mounds differing between a couple to as much as eight feet in elevation. Using the sediment criteria for samples placed in the wetlands, if pits and mounds are present, the sample will be targeted to be collected in a pit or deep tire rut that would hold water for a longer period of time.

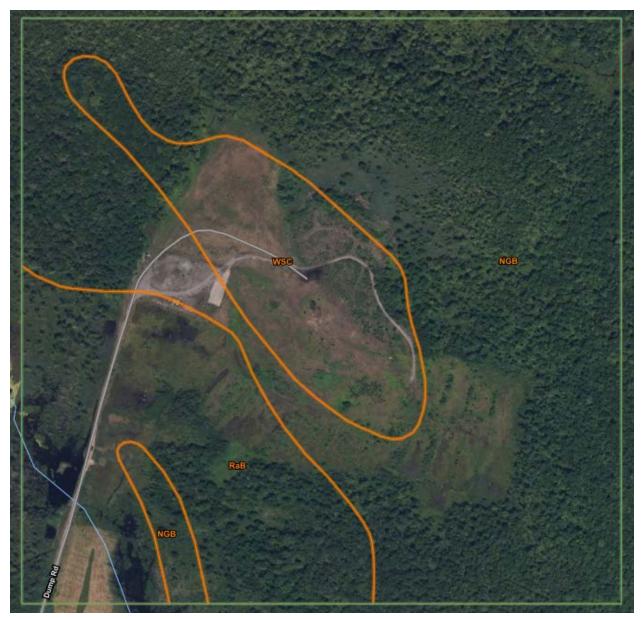
Figure 6. NRCS Soil Survey Map

The USDA Soil Survey mapper was reviewed to identify soils on Site (Figure 6). Three soil types were identified:

- U.S. Geological Survey (USGS) 7.5-minute Topographic Quadrangle Maps (Figure 1);
- U.S. Fish & Wildlife Service (USFWS) National Wetlands Inventory (NWI) Map (Figure 4)
- NYSDEC Freshwater Wetland Maps (Figure 5); and
- USDA Natural Resources Conservation Service's Web Soil Survey Website (Figure 6)

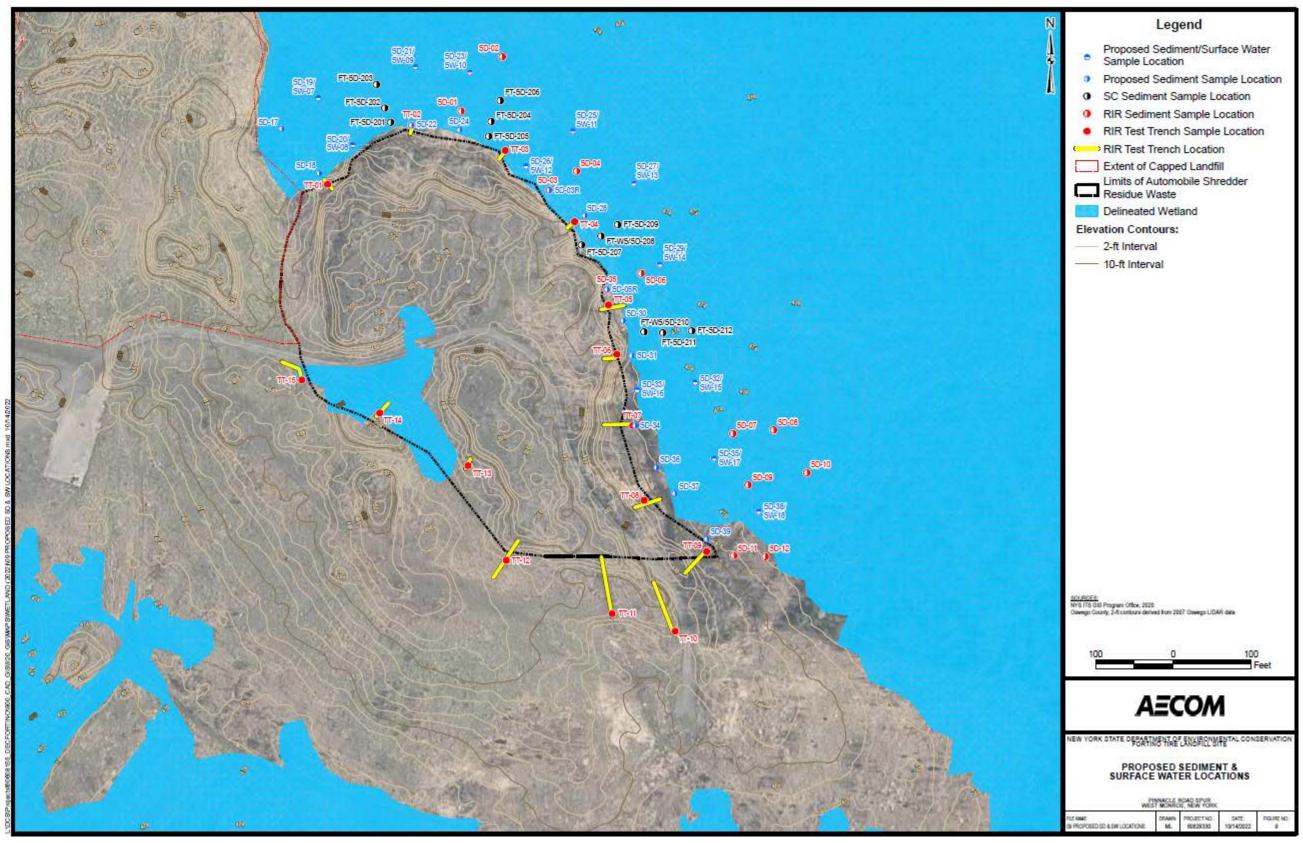
Figure 9 Proposed Sediment Locations

Based on the original sample identification, only a few samples were reclassified from soil to sediment and sediment to soil. Locations for 31 and 32 were changed to sediment as they are located in dense common reed wetlands (Photos 3 and 4 show examples of these areas). Also, location 11 was changed from sediment to soil as it is in an upland area and did not show evidence of or the potential for prolonged inundation.

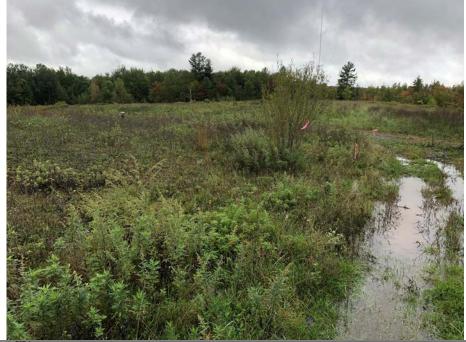
Photo 1

Looking along the upland / wetland line (wetland to right), note the subtle change in elevation and standing water levels in the wetlands and dry conditions of the uplands.

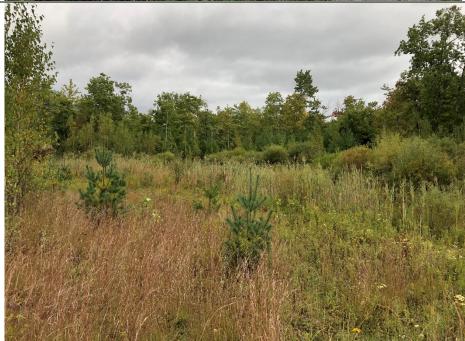
Photo 2

Looking at upland emergent wetland boundary in the eastern portion of the Site. Upland areas (foreground) vegetated with Scotch Pine, broom sedge and Queen Anne's lace; wetlands (background) vegetated with woolgrass, soft rush, cattails, and common reed. The emergent wetlands then meet forested wetlands.

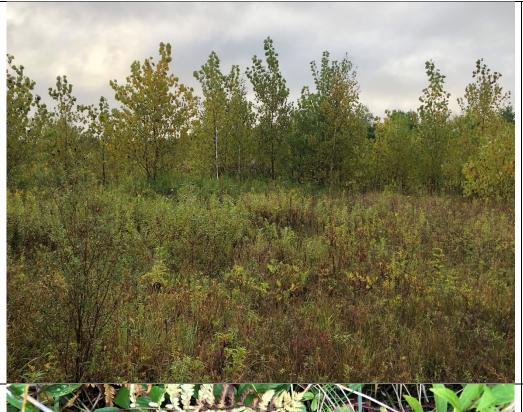
Photo 7

South of the ASR waste pile, within the wetlands, sporadic upland islands are present. These uplands are correlated to what appears to be former work areas as they are often somewhat square or rectangular shaped. Uplands were often dominated with Queen Anne's lace, broom sedge, upland grasses, mugwort, mullein, scotch pine, and aspen, and rosettes of common weeds (e.g., plantain, etc.). Photos 7 and 8 depict upland islands and conditions.

Upland island (location of Monitoring Well MW-122)

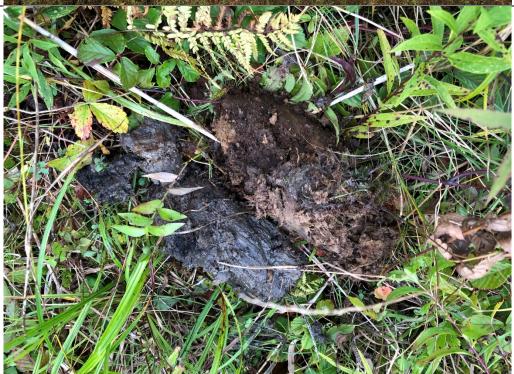
Photo 8

Differences in wetland soils (left) and upland soils (right) observed along the wetland line boundary of the emergent wetlands.

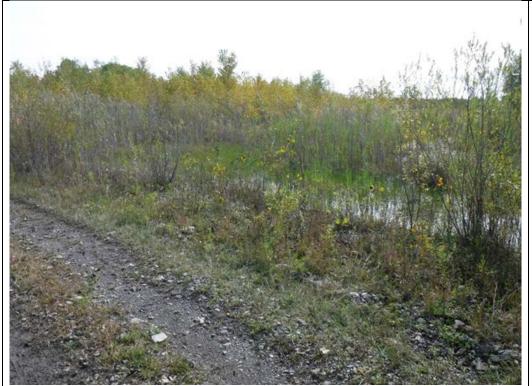
Photo 9

Wetland B is an isolated, non-jurisdictional wetland. The wetland has no hydrologic connection to Three mile Creek or adjacent wetlands (Wetland A). Wetland B is highly disturbed and of low ecological value.

Looking at Wetland B from main access road (foreground) on top of the ASR waste pile.

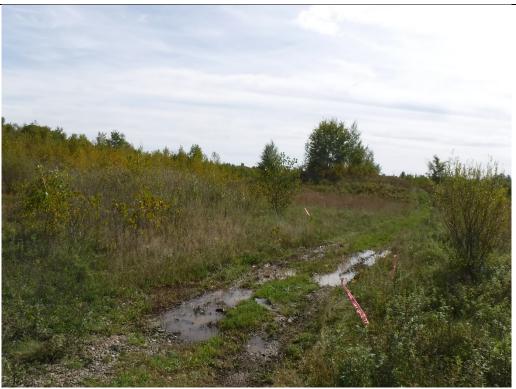
Photo 10

Looking at the south end of Wetland B, note the rutted trackway filled with water.

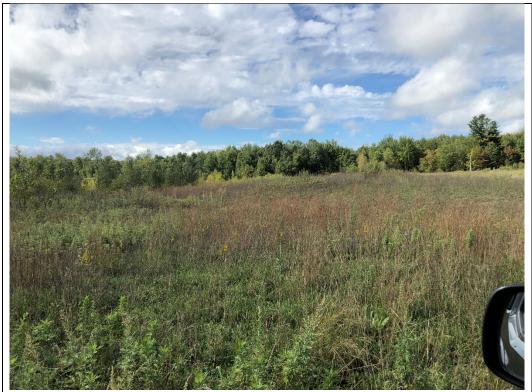
Photo 11
Uplands near
SS-22 and
SS-24.

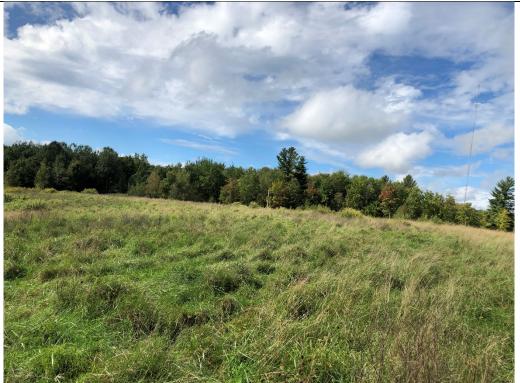
Photo 12
Uplands near SS-26 and SS-28.
