**SITE CHARACTERIZATION REPORT
FOR THE CNY CAR CRUSHERS SITE
(NYSDEC SITE 738048)
HASTINGS, OSWEGO COUNTY, NEW YORK**

SEPTEMBER 2018

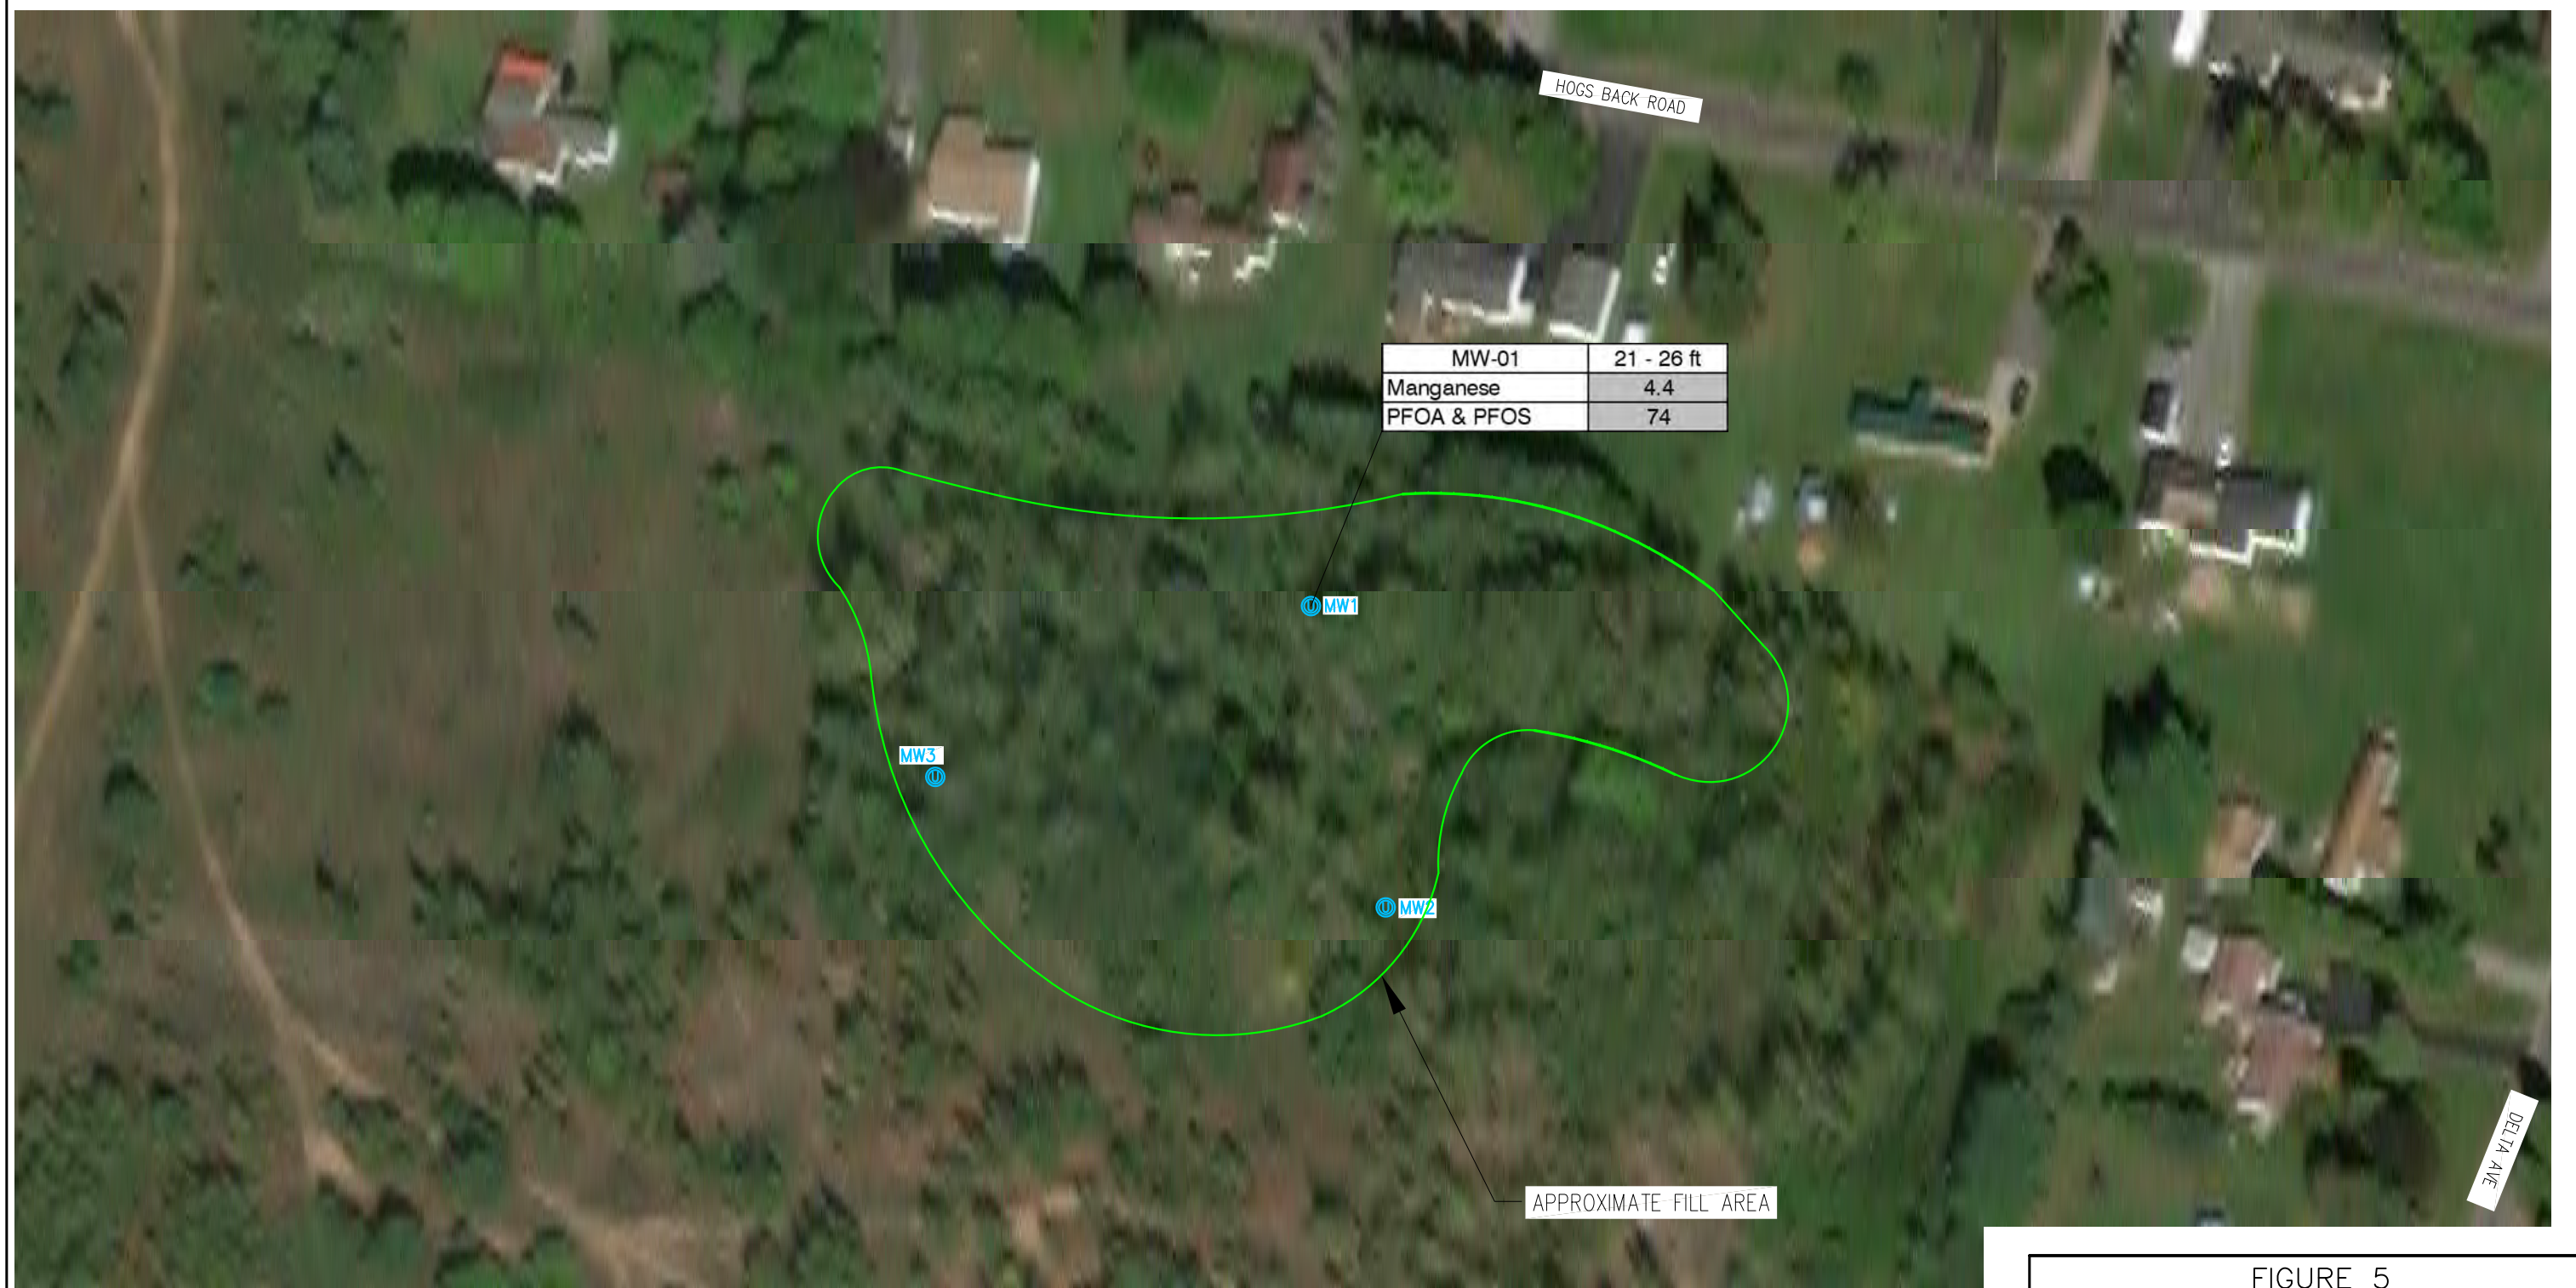
GROUNDWATER SAMPLE RESULTS

As shown in Figure 5, three monitoring wells were installed to assess groundwater quality impacts at the site. Monitoring well locations were selected along the northern property line, close to the nearest residences, and on the southeast and southwest sides of the waste area. The borings for the monitoring wells were drilled with hollow-stem augers. The wells were constructed with 2-inch inside-diameter polyvinyl chloride casing with a 10-foot long, 10-slot screen. Following installation, the monitoring wells were developed to remove material that may have settled in and around the well screen and sand pack. Development water was contained in drums and stored on site for waste characterization. Well construction and development logs are included in Appendix A.

Groundwater samples were analyzed for volatile organic compounds (VOCs), semi-volatile organic compounds (SVOCs), PCBs, TAL metals, and per- and polyfluoroalkyl substances (PFAS). The analytical program used the data quality objectives and quality assurance objectives described in Section 3.2. Groundwater analytical results were compared to New York State groundwater quality standards and guidance values. Table 3 summarizes concentrations of detected organic compounds and metals in groundwater. The concentration of manganese and the combined concentrations of perfluorooctanoic acid (PFOA) and perfluorooctanesulfonic acid (PFOS) in

the sample from MW-1 were the only cases in which NYSDEC Class GA Groundwater standards or guidance values were exceeded. MW-1 is located within the waste mass on the downgradient edge.

The concentration of manganese and the combined concentrations of perfluorooctanoic acid (PFOA) and perfluorooctanesulfonic acid (PFOS) in the sample from MW-1 exceeded the NYSDEC Class GA Groundwater

standards. MW-1 is within the waste mass, downgradient of MW-2 and MW-3. No other exceedances of Class GA standards or guidance values were detected in MW-1, MW-2 or MW-3.

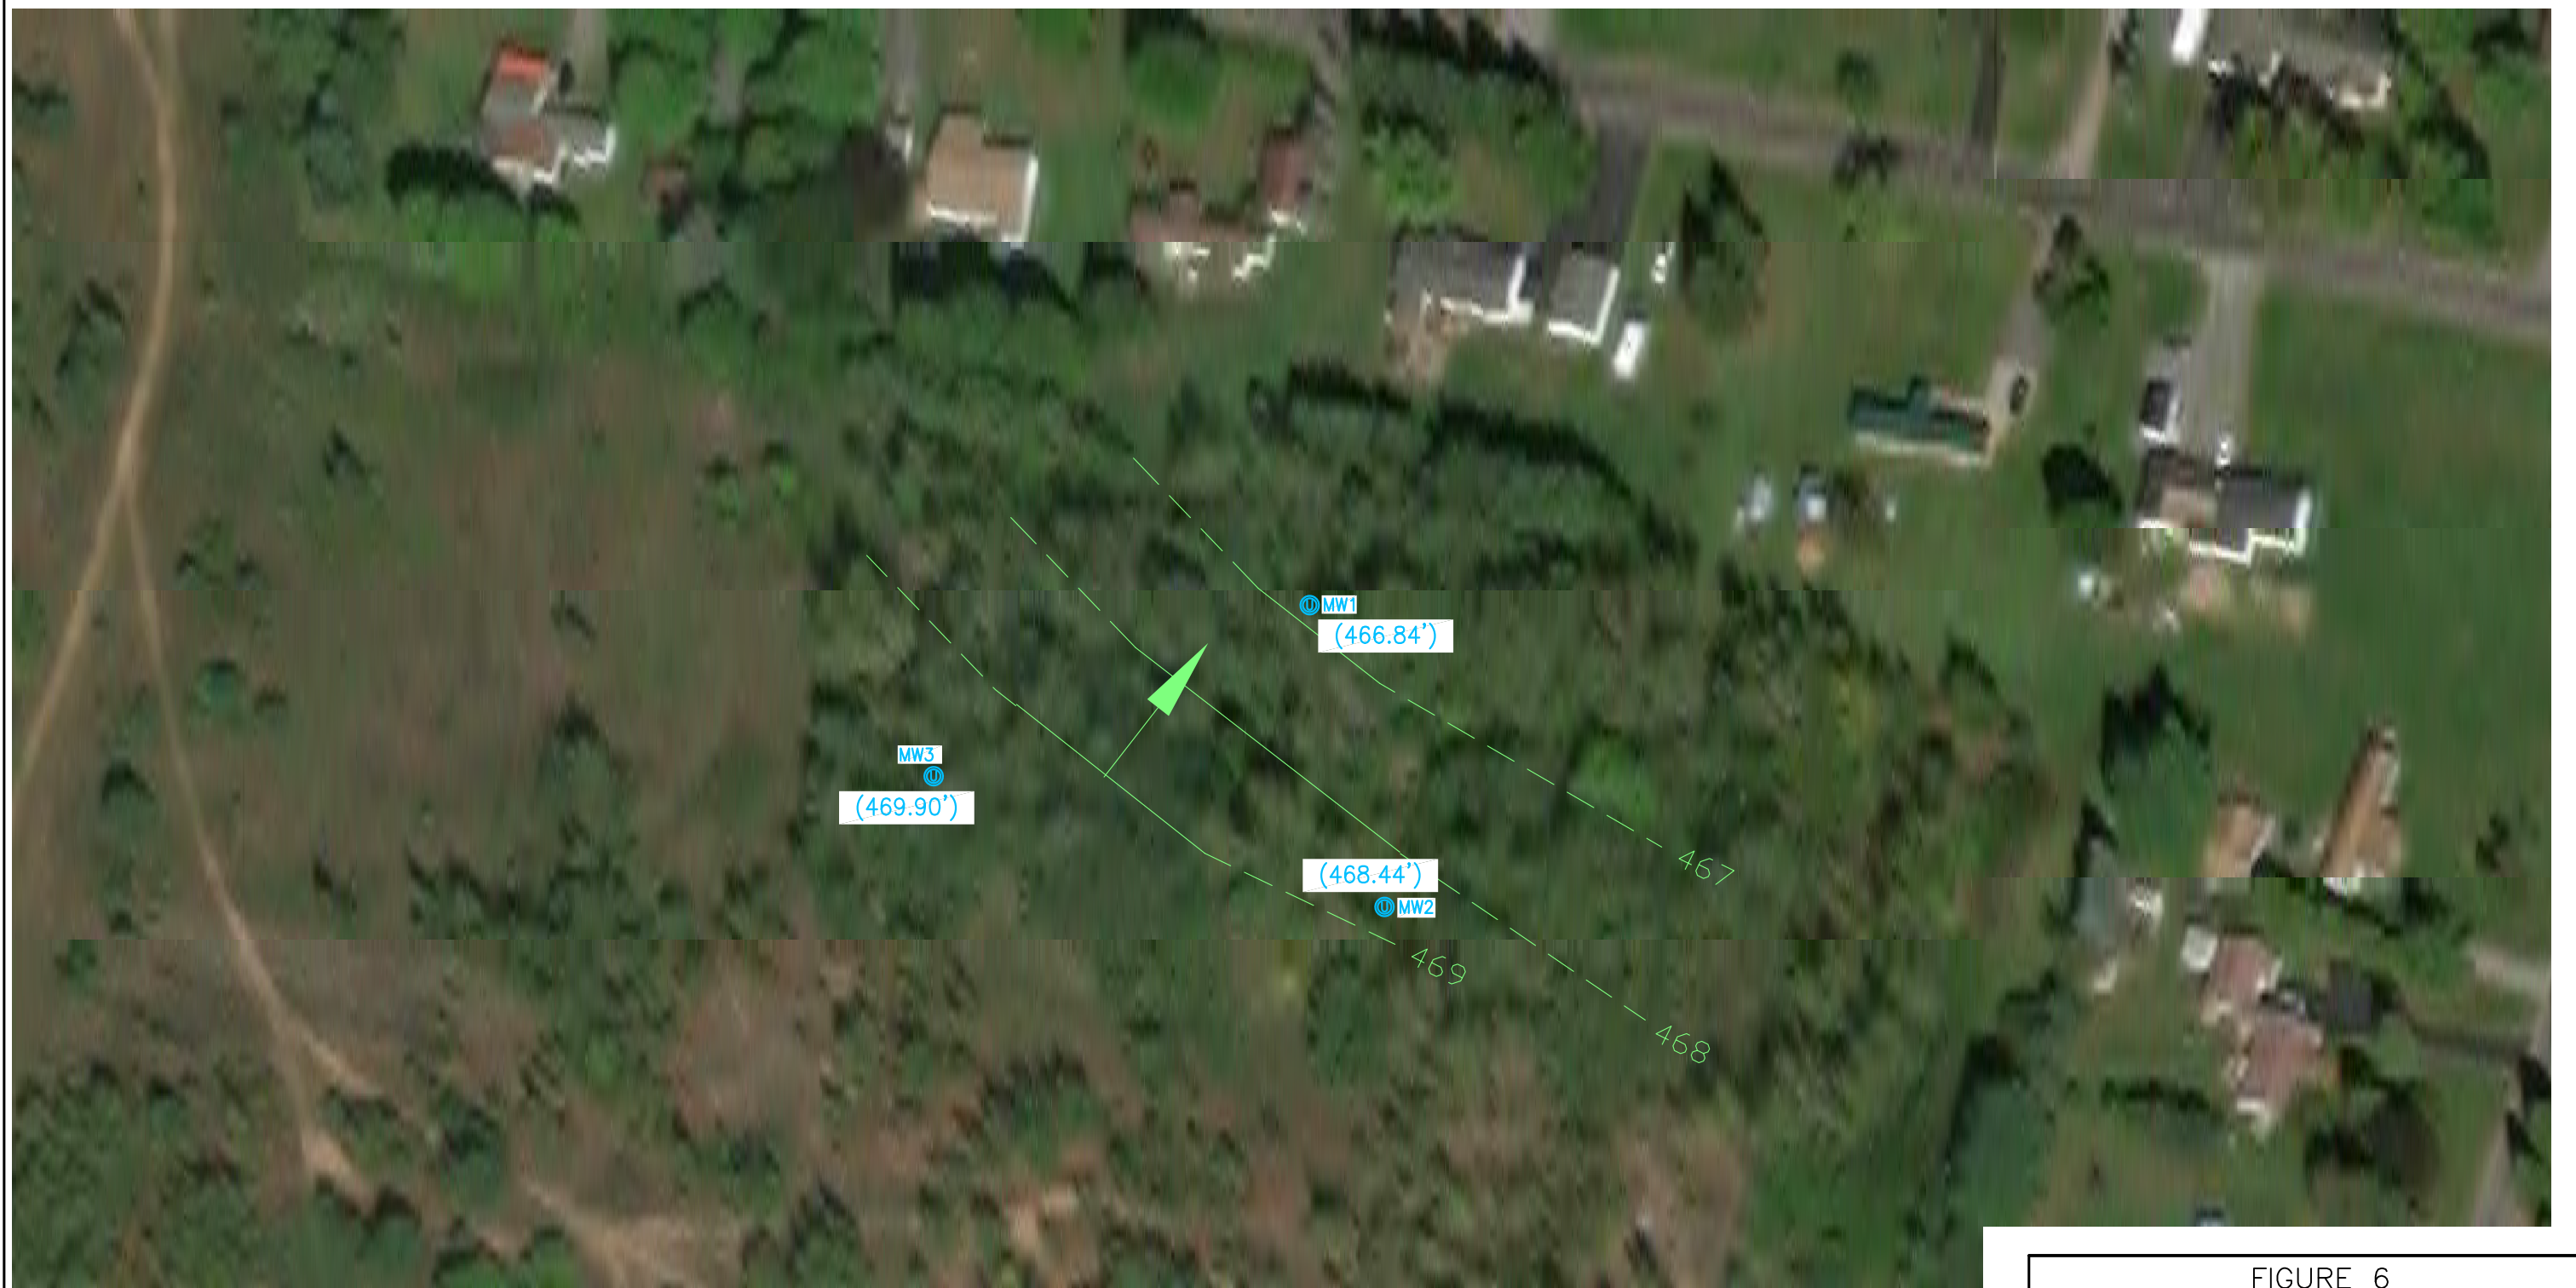
Once well installation and development was complete, the three new monitoring wells were sampled on May 14, 2018, using low-flow sampling techniques. Groundwater sampling logs are included in Appendix B. Prior to sampling, water levels were measured in each well. Those water level depths were converted to elevations and plotted to determine the groundwater flow direction. Figure 6 depicts the groundwater flow pattern for the July 2018 sampling event. Groundwater flow was in a northeasterly direction, toward the residences on Hogsback Road.

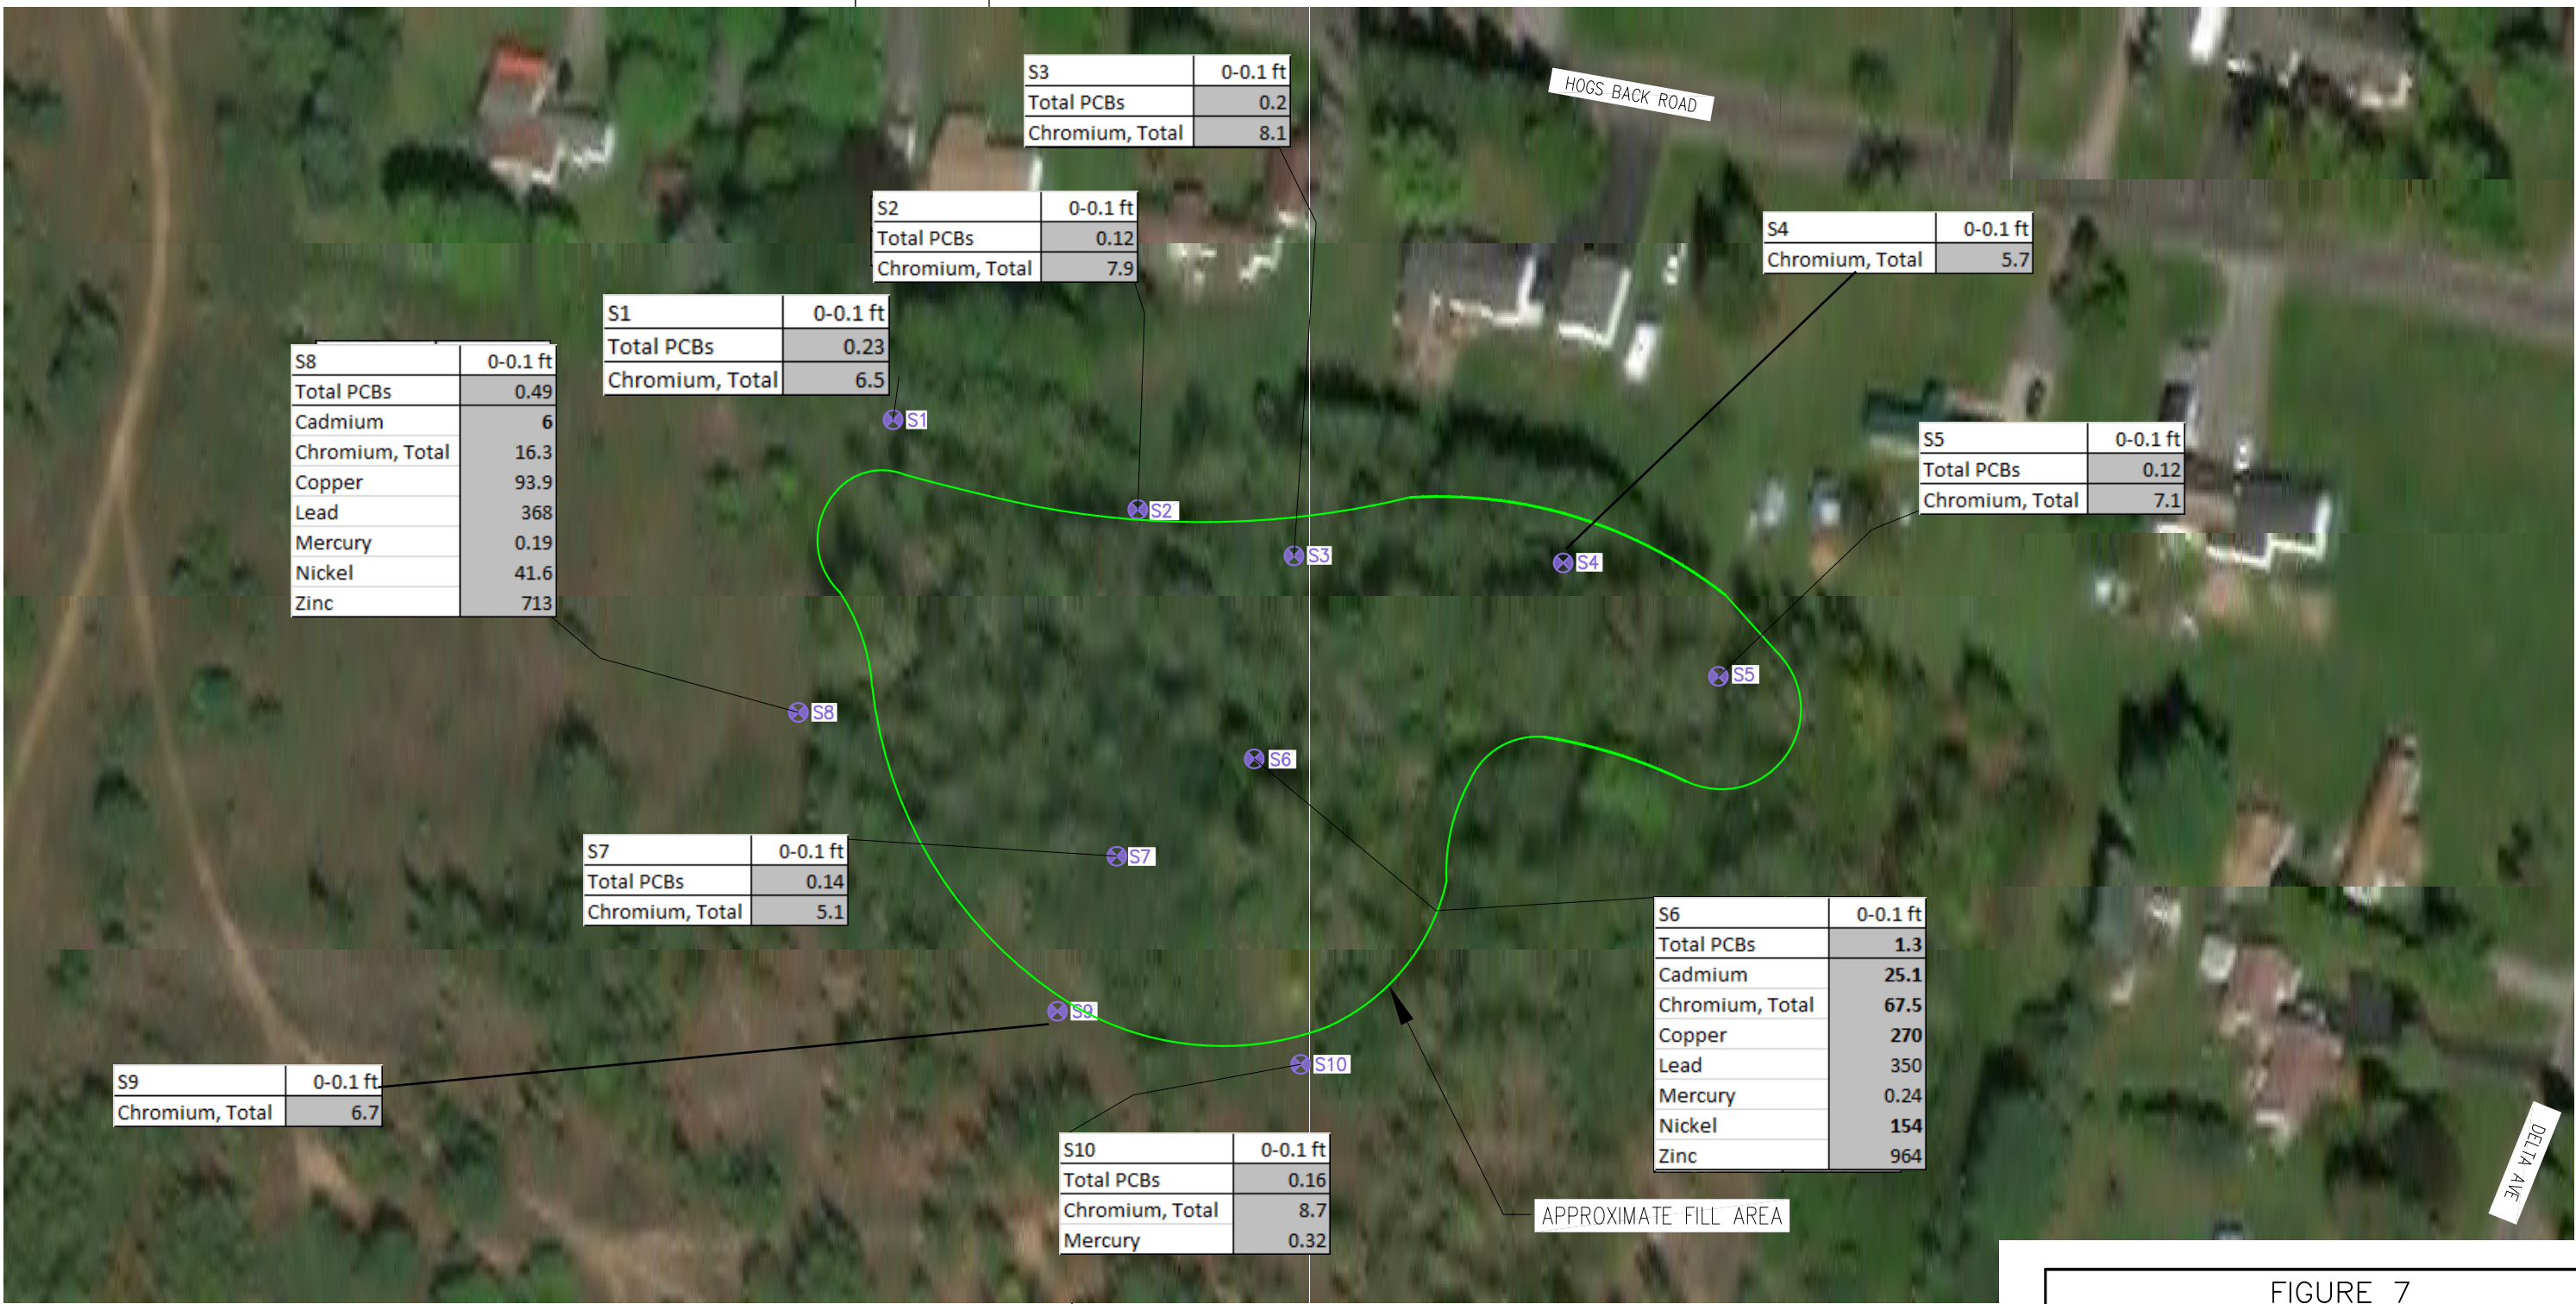
As shown in Figure 7, 10 surface soil samples were collected to assess surface soil quality. The sample locations were selected to characterize the waste mass and surrounding area.

S6 was the only sample with a total PCB concentration that was higher than both the unrestricted and residential use soil quality criteria. Samples S1, S2, S3, S5, S7, S8, and S10 all had total PCB concentrations above the unrestricted use criterion, but all were below the residential use criterion. PCBs were not detected in samples S4 and S9.

S6, S8, and S10 were the only samples with metals concentrations exceeding soil quality criteria. Concentrations of cadmium, chromium, copper, lead, mercury, nickel, and zinc in samples S6 and S8 exceeded the unrestricted and/or residential land use criteria. In S10 the concentration of mercury was above the unrestricted use criterion but below the residential criterion.

All surface soil samples except for S4 and S9 had PCB concentrations above unrestricted or residential use soil quality criteria. Both S4 and S9 are outside the expected waste disposal area; however, they are not the only locations outside the area. S1, S8, and S10 are also outside the expected waste area. S6 and S8 had the highest number of parameters with concentrations above unrestricted or residential use soil quality criteria.
