# **Site Characterization Report**

## **Owego Heat Treat**

### **Inactive Hazardous Waste Disposal Site**

1646 Marshland Road  
Appalachin, Tioga County, New York

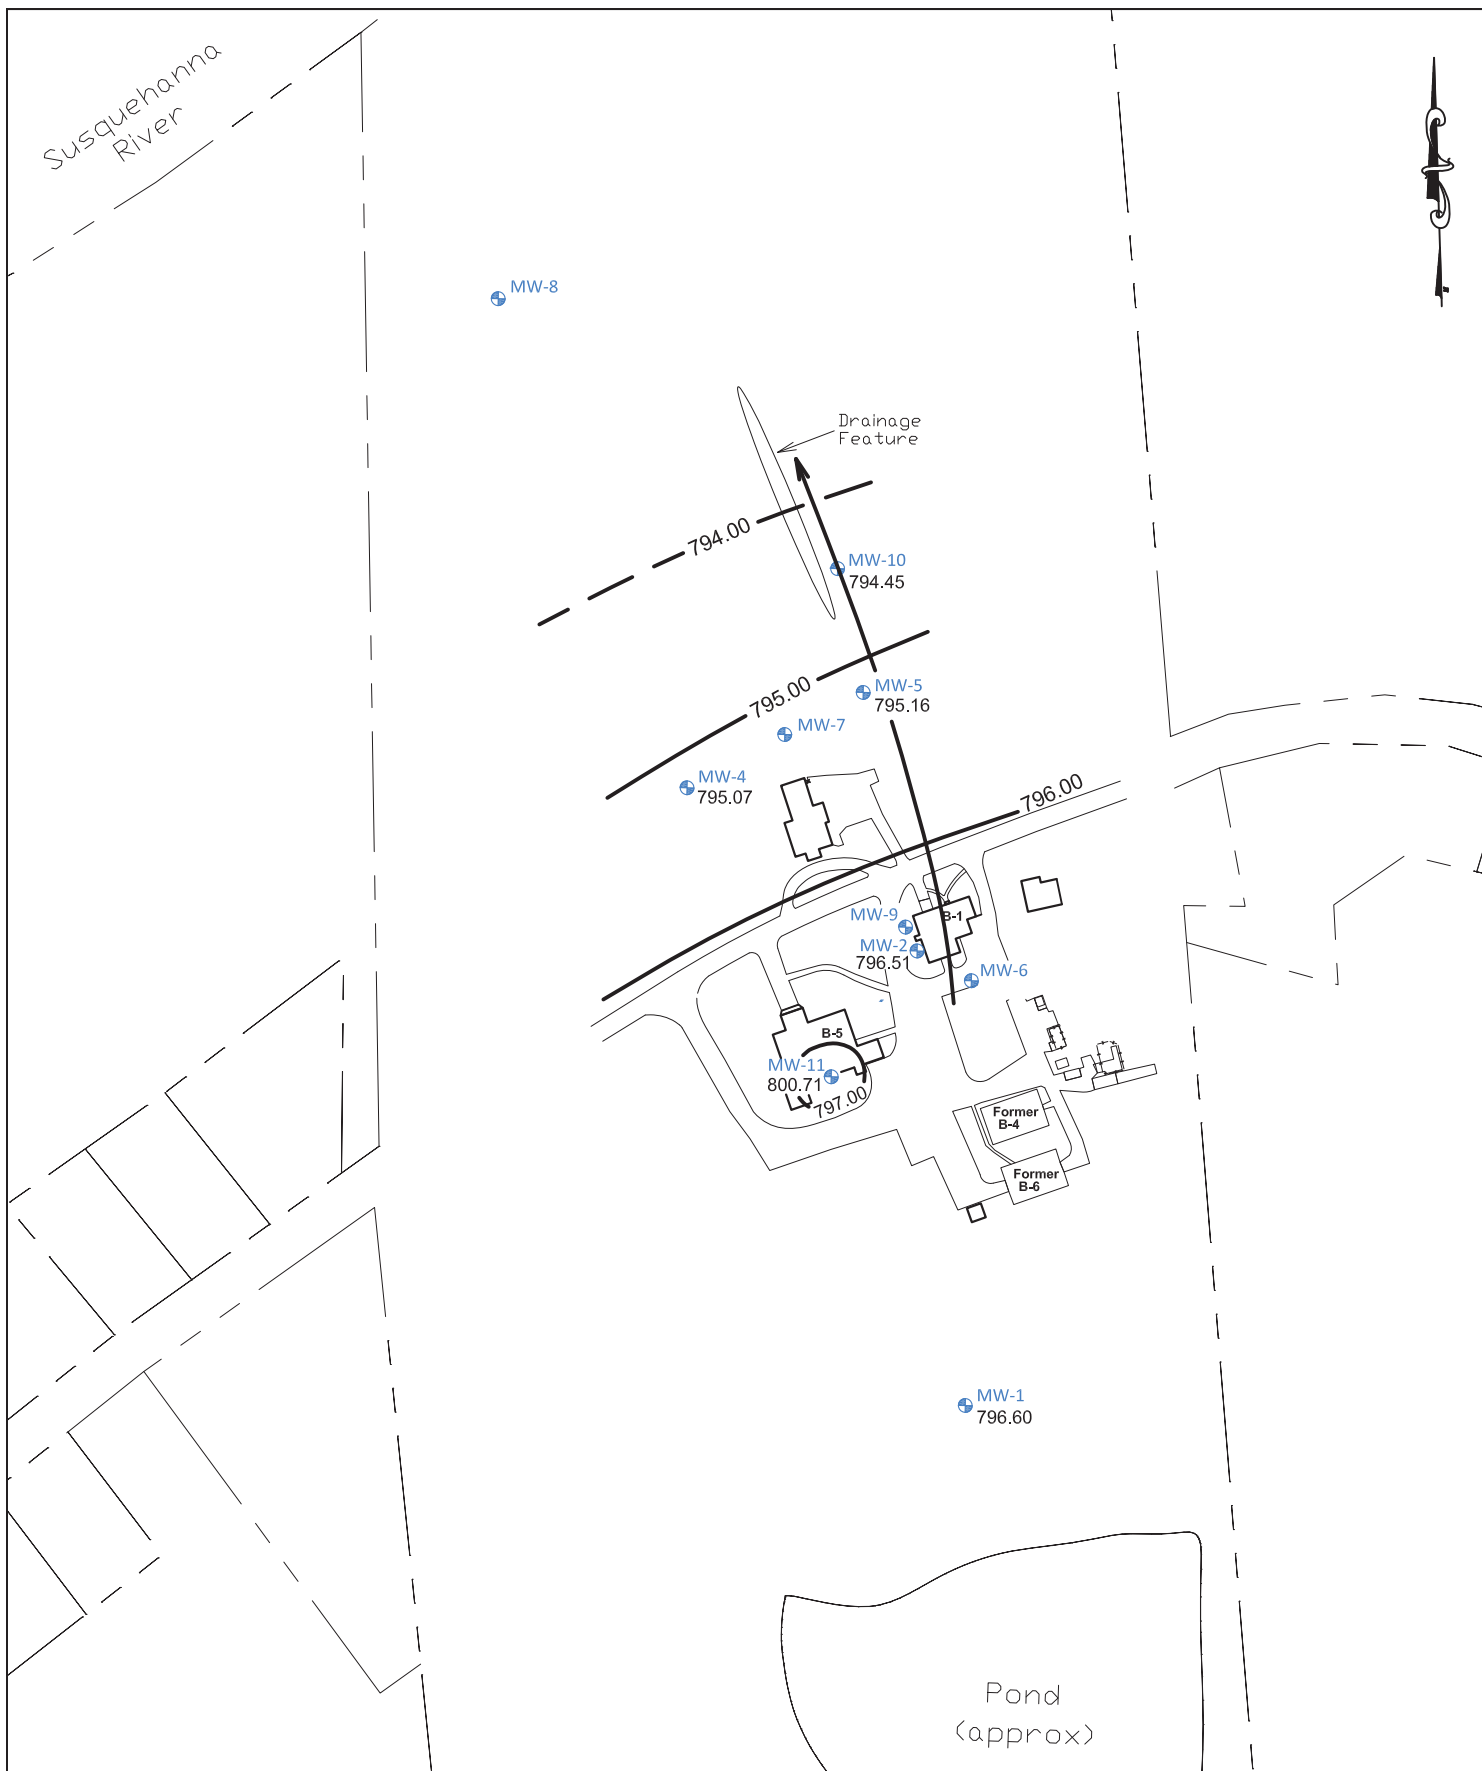
<p>5 McCreahill Road Ballston Spa, NY 12020 p 518.885.5383   f 518.885.5385 info@aztechtech.com   www.aztechtech.com</p> <p>Woman Owned Business</p>	<p><b>SITE:</b> NYSDEC Site # 754011 Owego Heat Treat 1646 Marshland Road Appalachin, New York</p> <p><b>Figure 4A</b></p> <p>DATE: 11-4-2013      Approximate Scale: 1" = 200'</p>	<p><b>Groundwater Contour Map Shallow Wells November 4, 2013</b></p>
---	---	--

important to note that the groundwater elevations recorded on both dates in well MW-11 are approximately 3.0 feet higher than those recorded in the other shallow wells on the site. Aztech believes that these apparently erroneous groundwater elevations are related to the fact that well MW-11, completed at a total depth of 11.9 feet below grade, is considerably shallower than the other shallow wells on the site (completed at approximately 25 feet below grade). The shallow depth of well MW-11 and, its proximity to site building B-2, may reflect a local feature related to the foundation for that building.

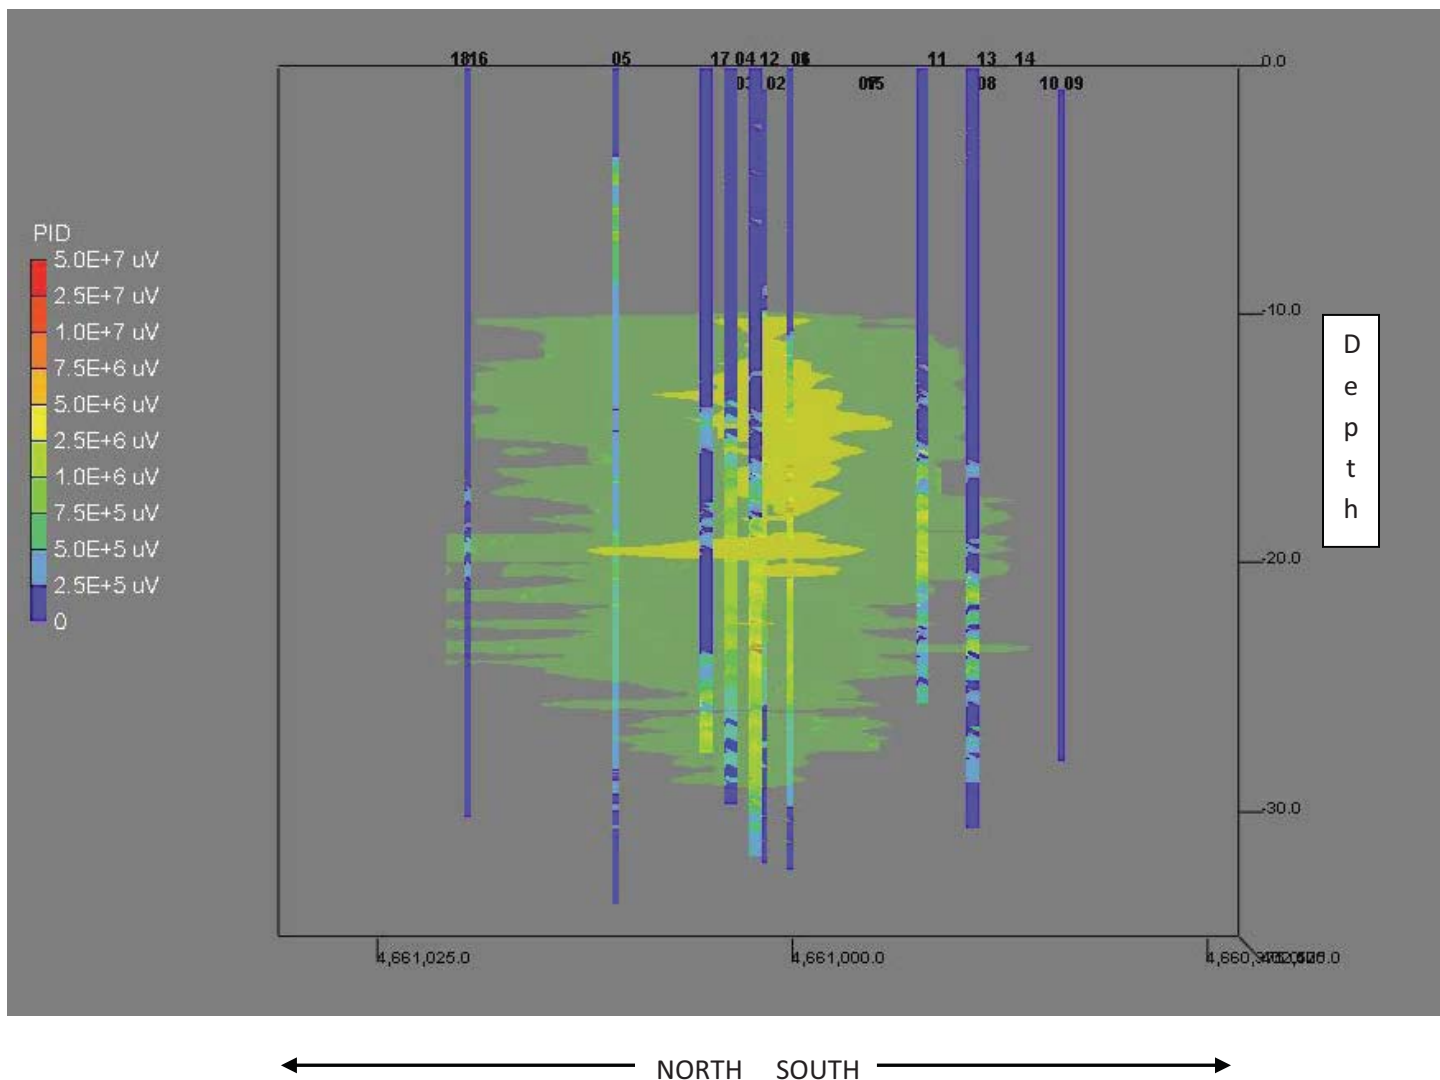
**FIGURE 9**

**North-South  
Transect  
MIP  
Investigation**

The findings of the MIP investigation have identified a central core of VOC impacted source area soil surrounded by a “halo” of less VOC impacted soil. The central core of VOC impacted source area soil appears to be bounded by MIP borehole locations MIP-03, MIP-05, MIP-06 and MIP-07. Based on the fact that soil samples were not obtained to quantify the concentrations of VOCs within the source area, Aztech is recommending that soil borings be advanced within and around the source area as shown on Figure 10. The purpose of the soil borings will be to characterize the composition of soil within and around the source area with respect to soil type and grain size, as well as to screen the soil headspace for total VOC concentration via a photoionization detector. Information gathered via this effort will help to verify the findings of the MIP investigation. Additionally, analytical results of soil samples will help to identify the horizontal and vertical limits of soil quality with respect to the soil cleanup objectives in accordance with NYSDEC policy. Data collected as part of this effort will help in evaluating remedial alternatives within the remedial system optimization process.

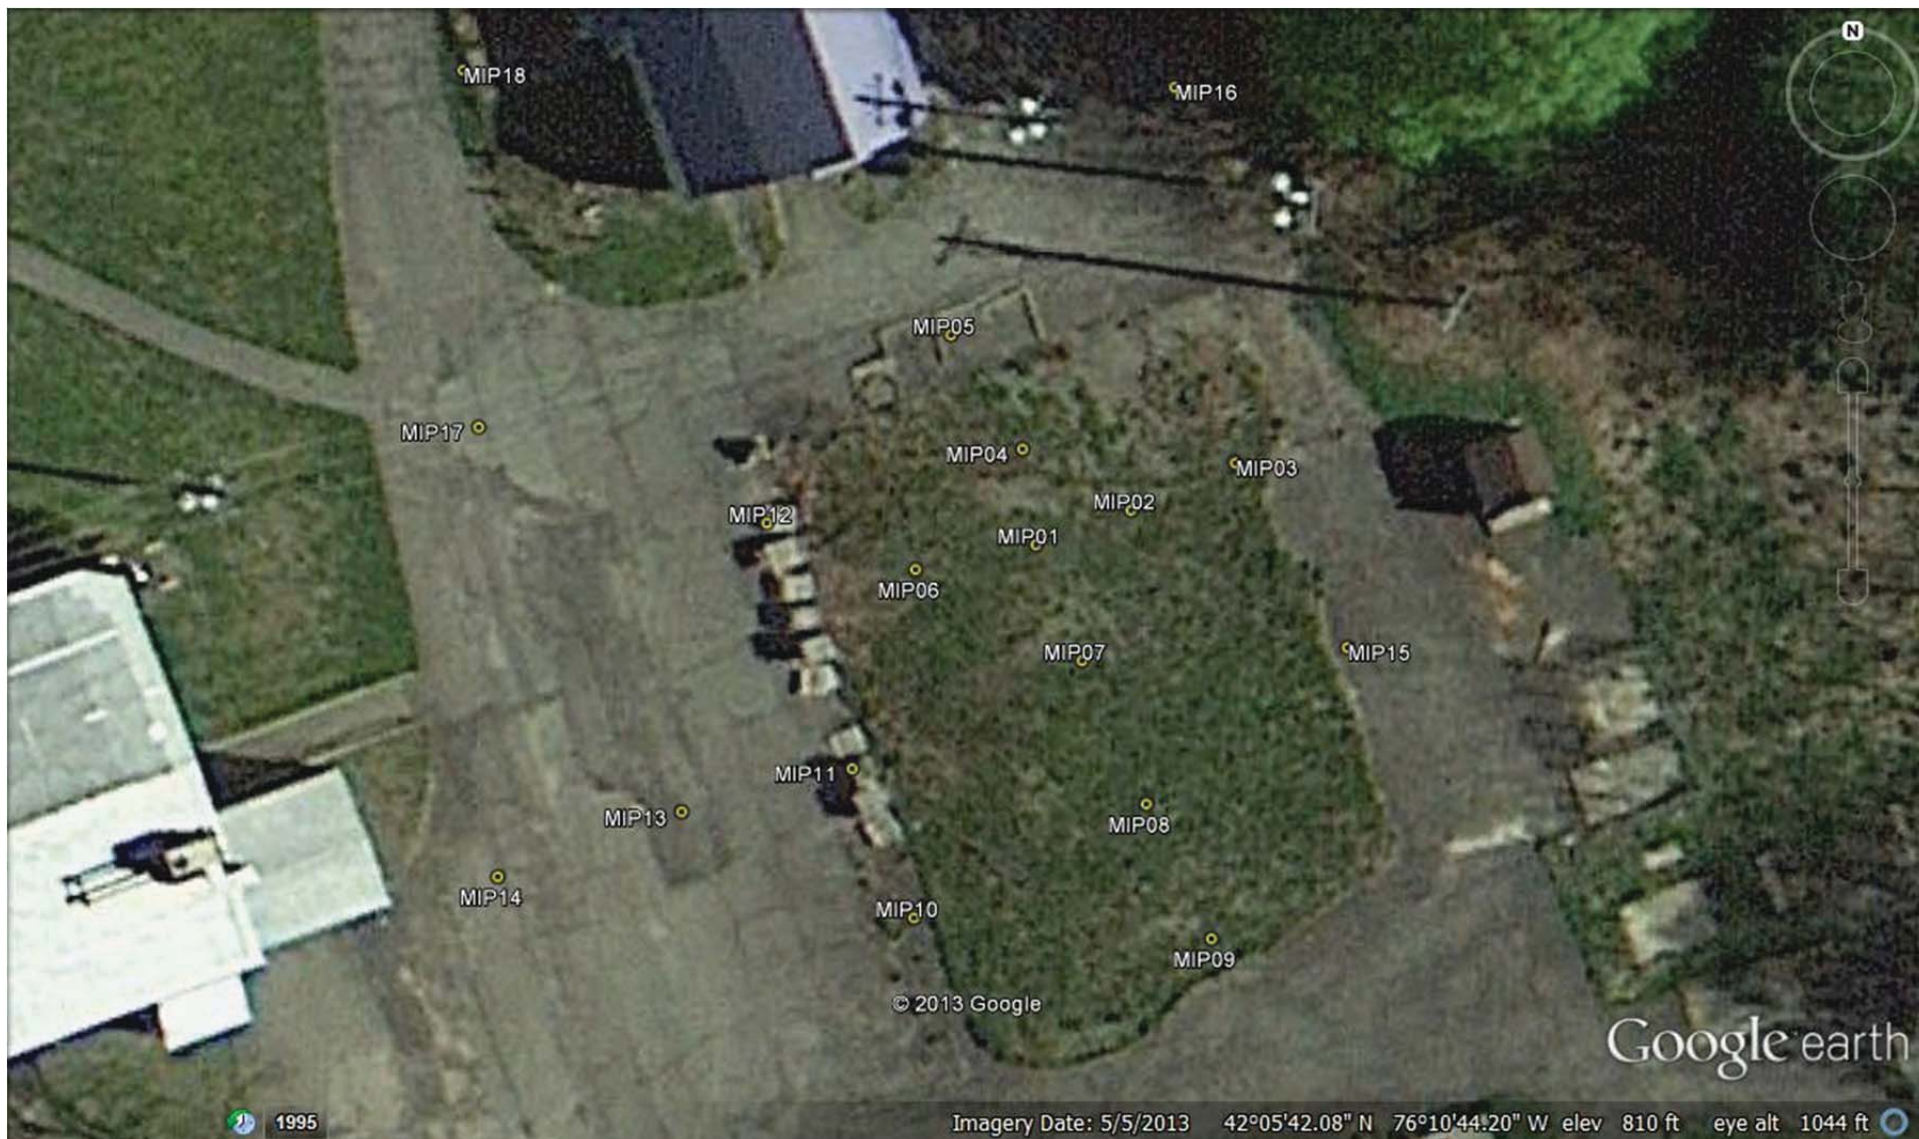
Figure 1 Sitemap and Locations  
July 15<sup>th</sup>, 2013 – July 19<sup>th</sup>, 2013

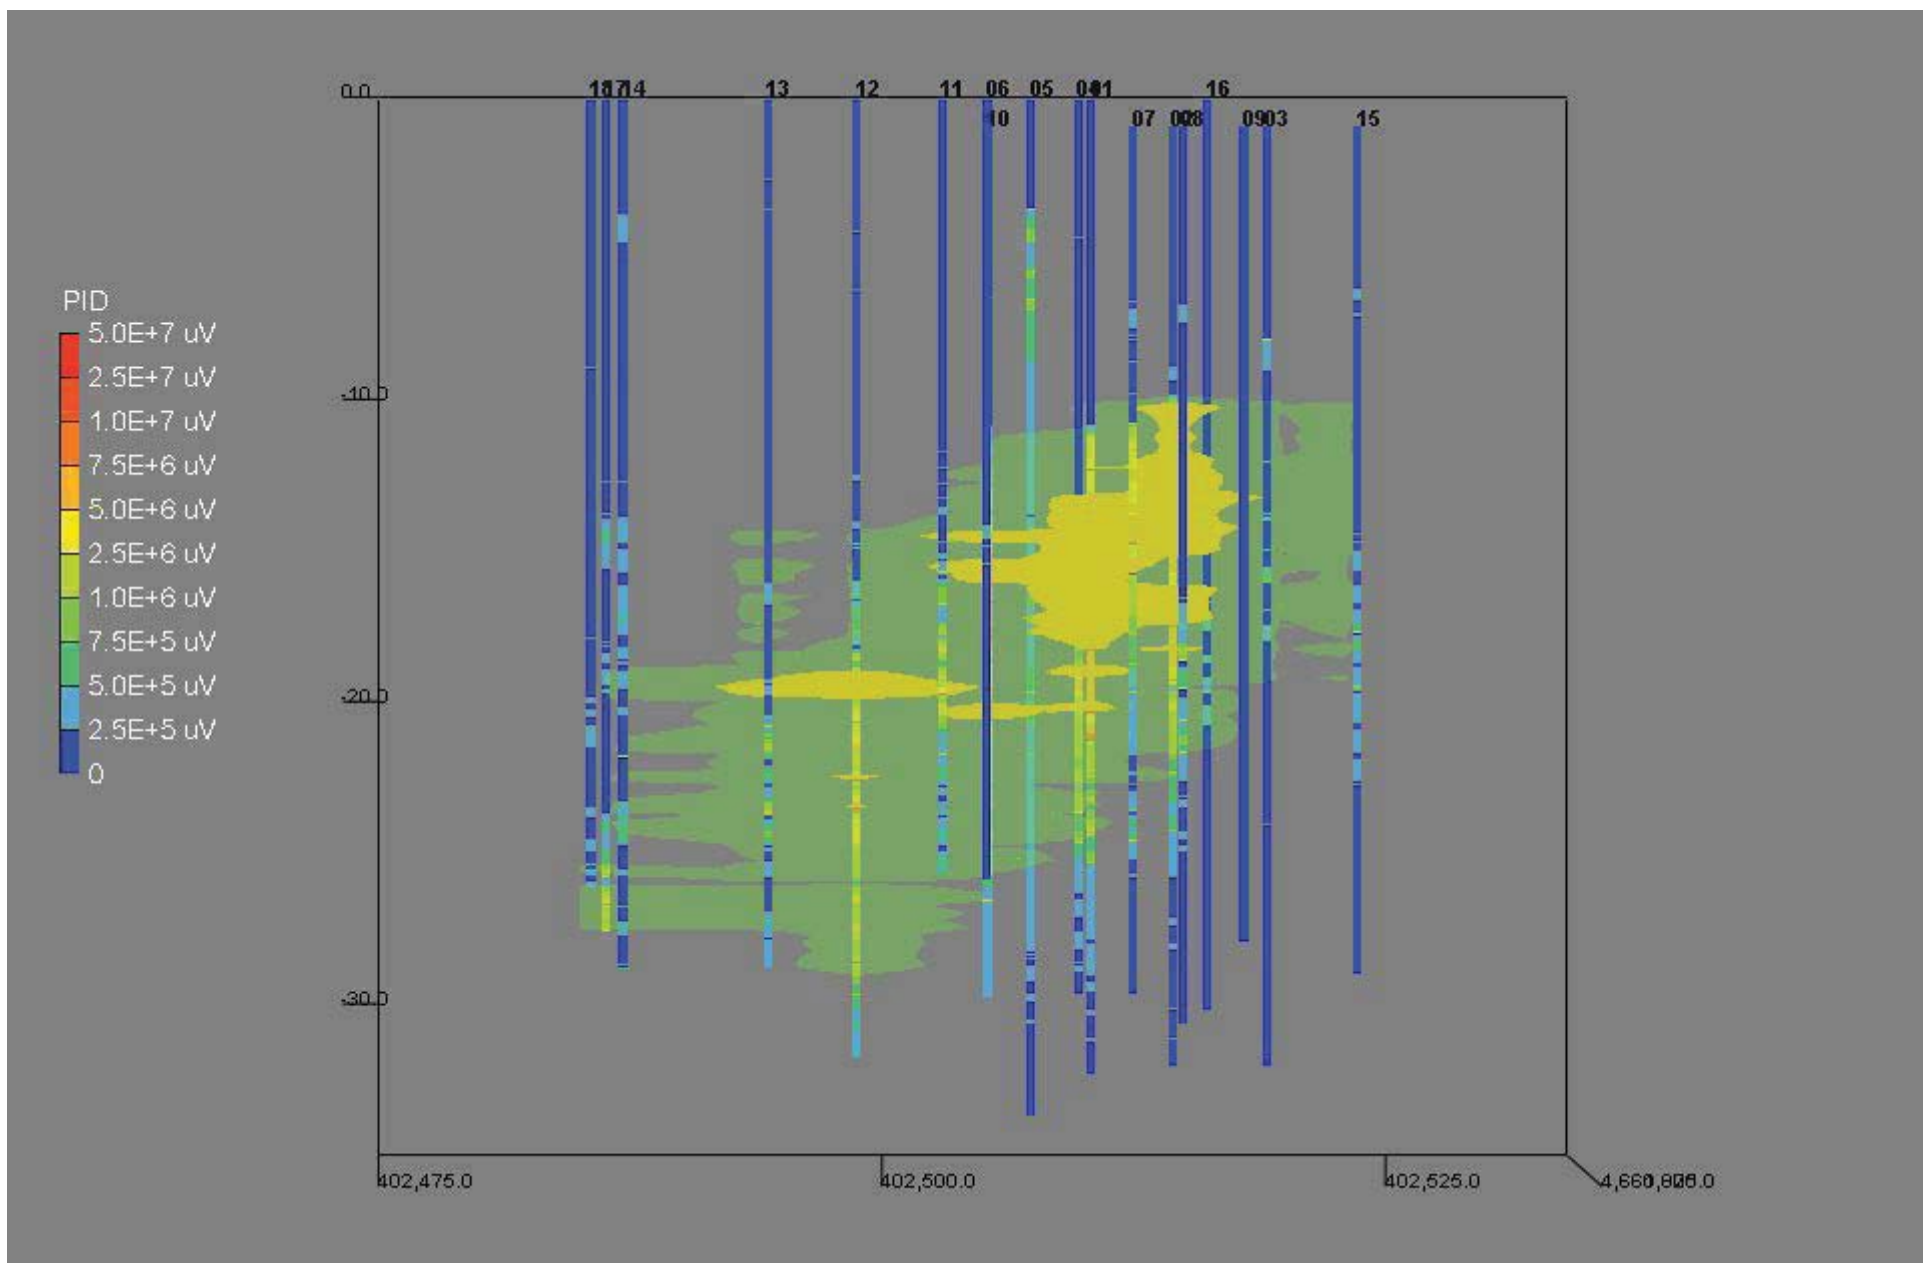
Figure 10 Transect View Looking North, PID Response  $>1.0\text{E}+06\mu\text{V}$  and  $7.5\text{E}+06\mu\text{V}$   
 July 15<sup>th</sup>, 2013 – July 19<sup>th</sup>, 2013
