Re: Summary of Drum Recovery and Soil Sampling Activities
Emerson Power Transmission Facility, Ithaca, New York

Figure 1
Soil Sample Location Plan
Emerson Power Transmission
Ithaca, New York

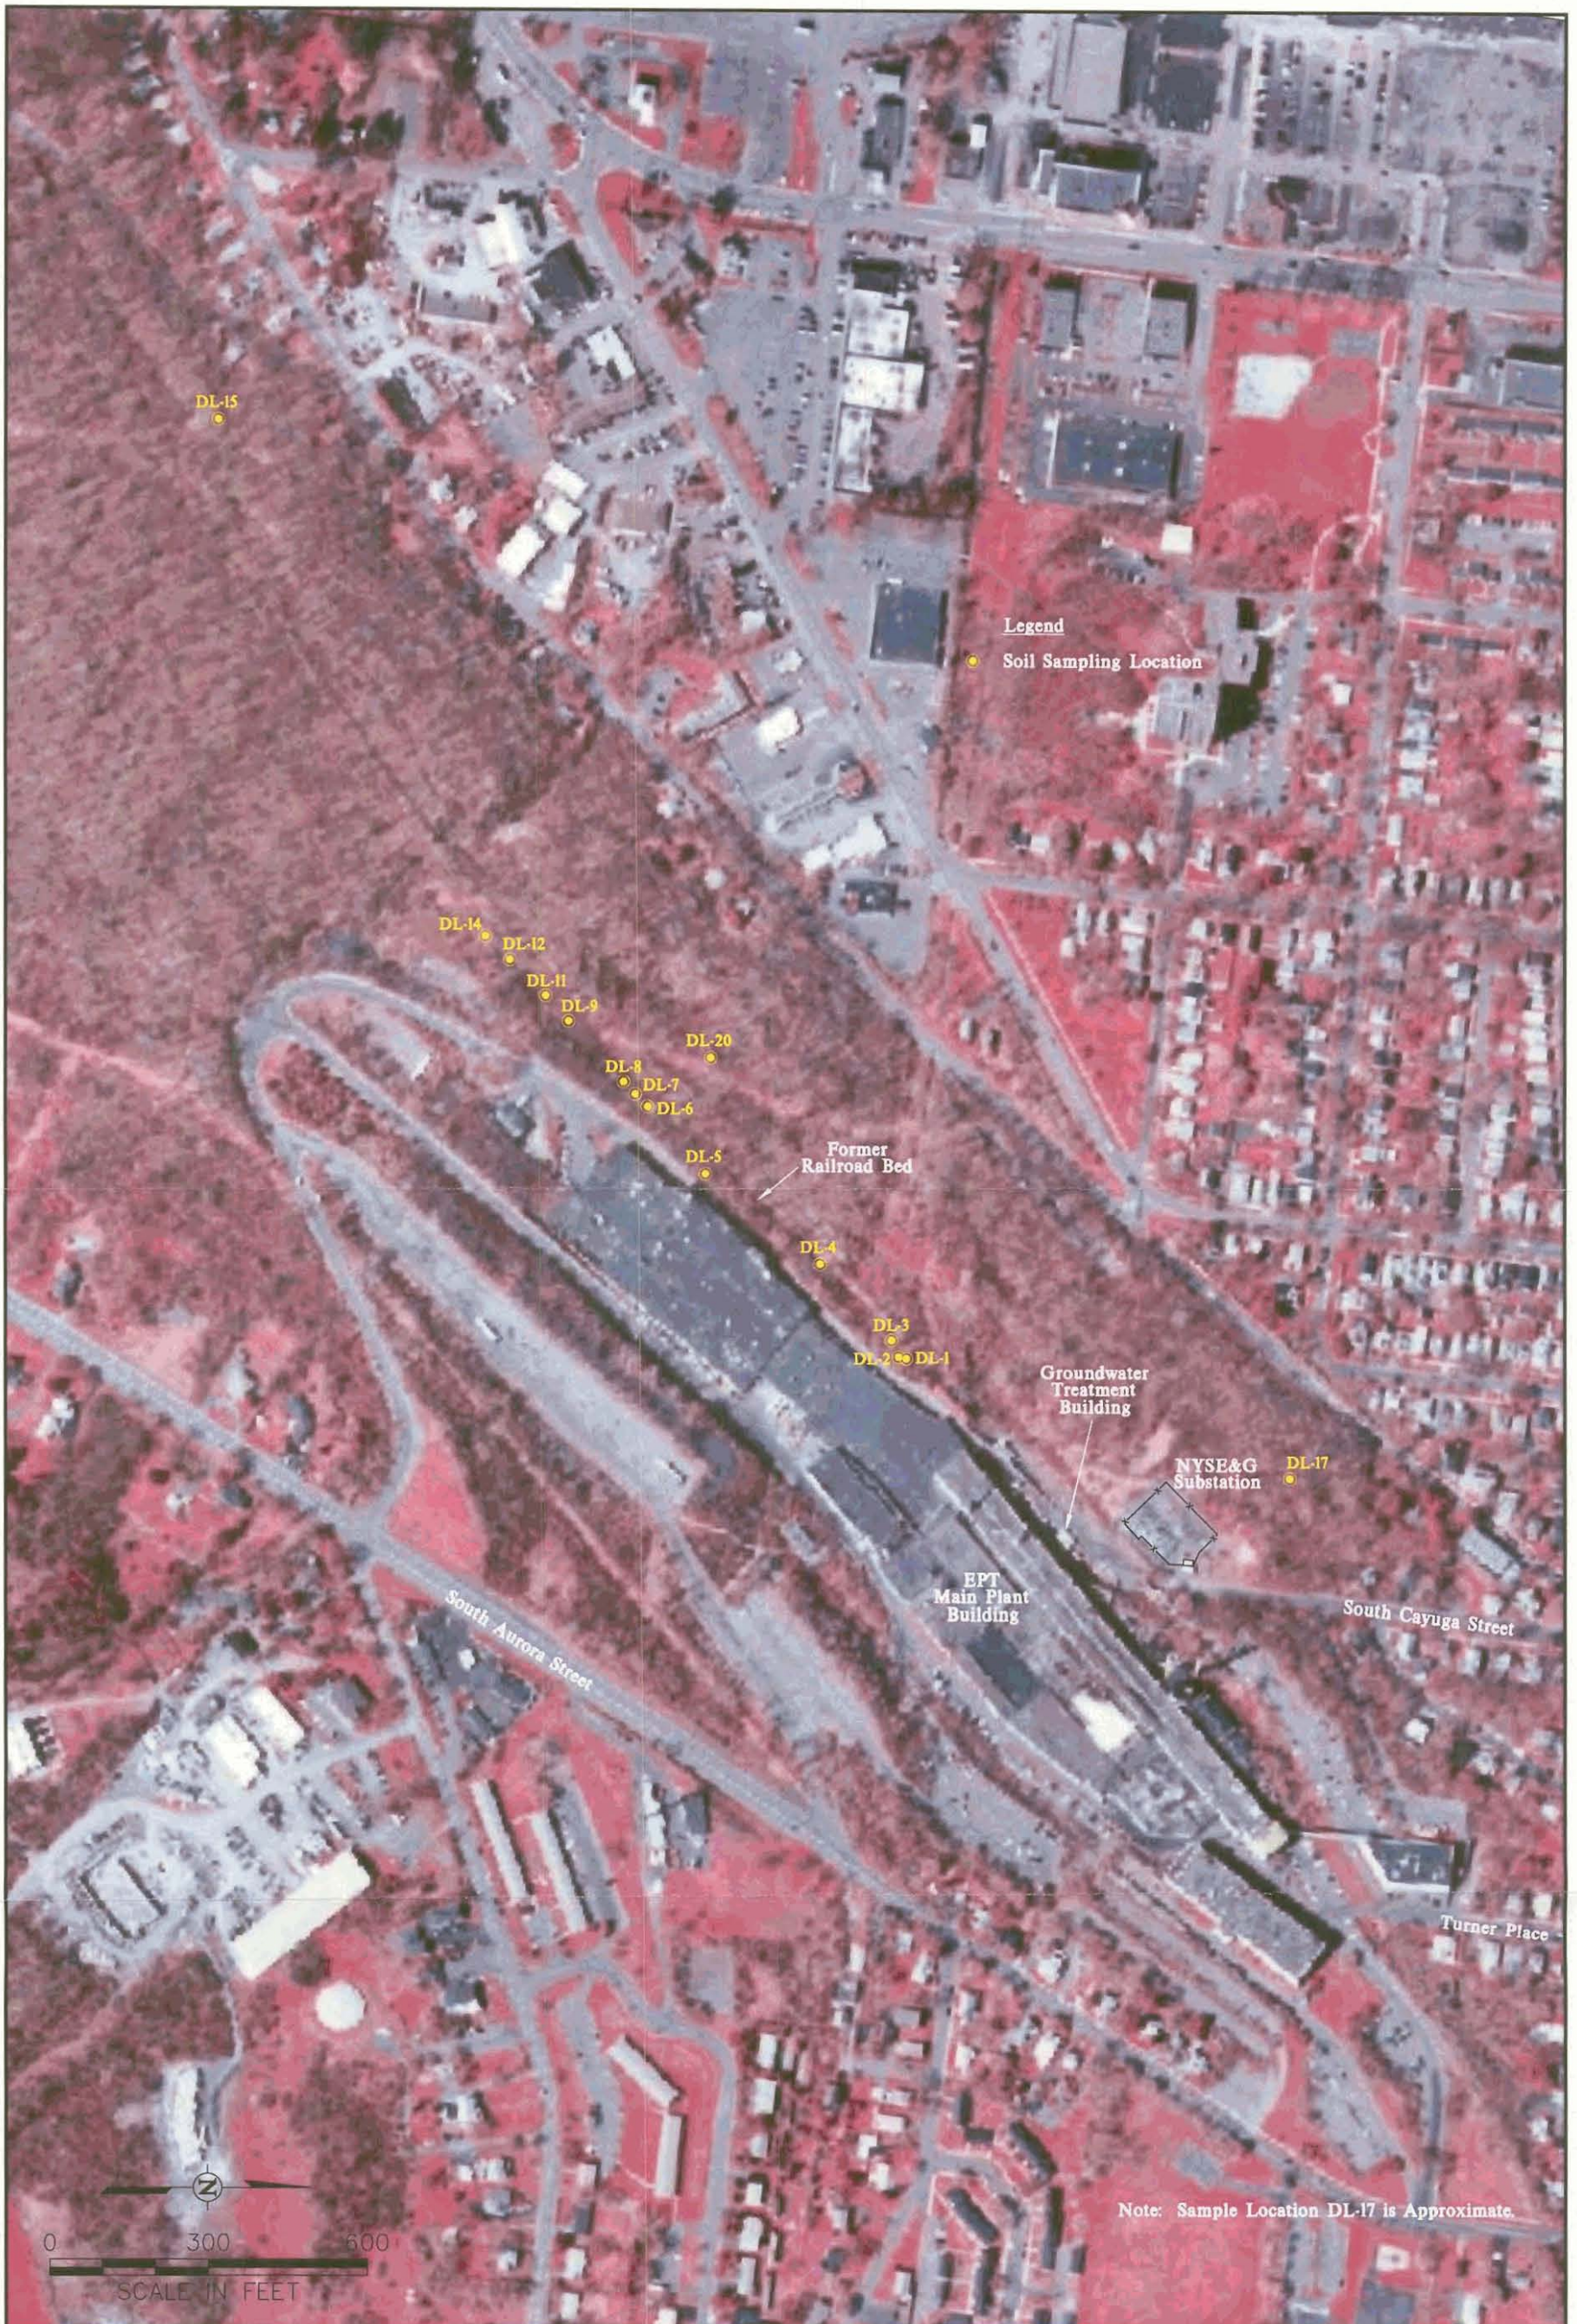
The reconnaissance survey identified drums and containers in 15 separate locations west of the EPT facility. Drum and container locations are designated DL-1, DL-2, DL-4, DL-5 through

DL-9, DL-11, DL-12, DL-14, DL-15, DL-17, and DL-20 on Figure 1. DL-9 initially comprised two locations (DL-9 and DL-10) that were subsequently combined for sampling purposes due to their close proximity. In general, the drums or containers were heavily corroded with numerous holes and no visible markings or labels, except for a container that held grease (DL-5 location). In some cases, only a portion of the drum remained (Enclosure A; see photograph of DL-6). In addition, scrap metal, including drum lids, 5-gallon buckets filled with concrete, culvert pipe, and sections of flue vent, were identified at 5 locations (DL-3, DL-13, DL-16, DL-18, and DL-19). The scrap metal locations were also assigned "DL" numbers during the reconnaissance survey and were marked with survey ribbon. However, with the approval of the New York State Department of Environmental Conservation (NYSDEC), no soil samples were collected at the scrap metal locations for chemical analysis. Therefore, these locations are not shown on Figure 1.

DL-5, DL-6, DL-7, DL-8, DL-9, DL-11, DL-12, DL-14, DL-15, DL-17, and DL-20 on Figure 1. In general, each drum and drum remnant location was selected for soil sampling. However, drum locations DL-9 and DL-10 were in close proximity and, thus, only one soil sample was collected (designated DL-9). No soil samples were collected from the remaining scrap metal locations with approval from the NYSDEC's onsite representative.

Each soil sample location was marked in the field with a wooden stake bearing the drum location number. A surveyor, licensed in the state of New York, was retained to survey the soil sample locations and determine the elevations. The elevations of the ground surface near each sample were surveyed to the nearest 0.01 foot. The horizontal locations were determined to the nearest 0.1 foot. The soil sample locations are shown on Figure 1.
