# **PRELIMINARY SITE ASSESSMENT**

# WORK ASSIGNMENT D004433-9

315 N. MEADOW SITE

ITHACA (C), NY

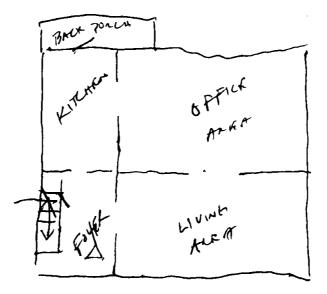
**Basement:**

Draw a plan view sketch of the basement and first floor of the building. Indicate air sampling locations, possible indoor air pollution sources and PID meter readings. If the building does not have a basement, please note.

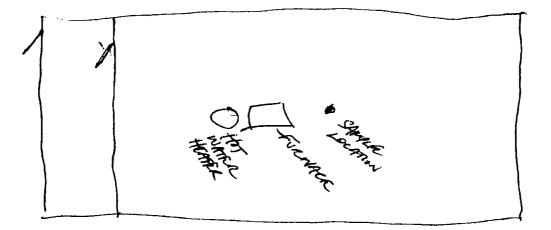
**Basement:**

Draw a plan view sketch of the basement and first floor of the building. Indicate air sampling locations, possible indoor air pollution sources and PID meter readings. If the building does not have a basement, please note.

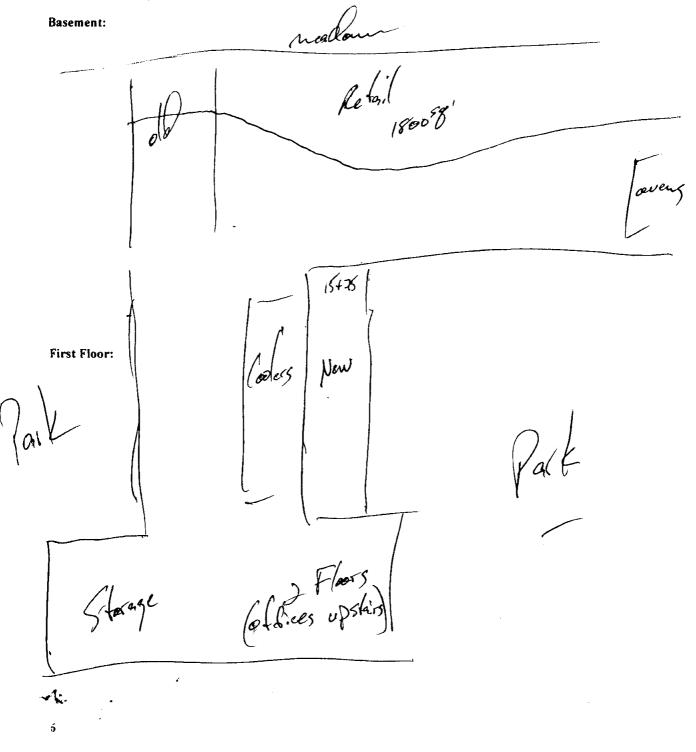
## **10. FLOOR PLANS**

Draw a plan view sketch of the basement and first floor of the building. Indicate air sampling locations, possible indoor air pollution sources and PID meter readings. If the building does not have a basement, please note.
