**Periodic Review Report No. 4  
September 30, 2016 – September 30, 2017  
Clinton West Plaza (755015)**

**Ithaca  
Tompkins County, New York**

October 2017  
Version: DRAFT  
EA Project No. 14907.25

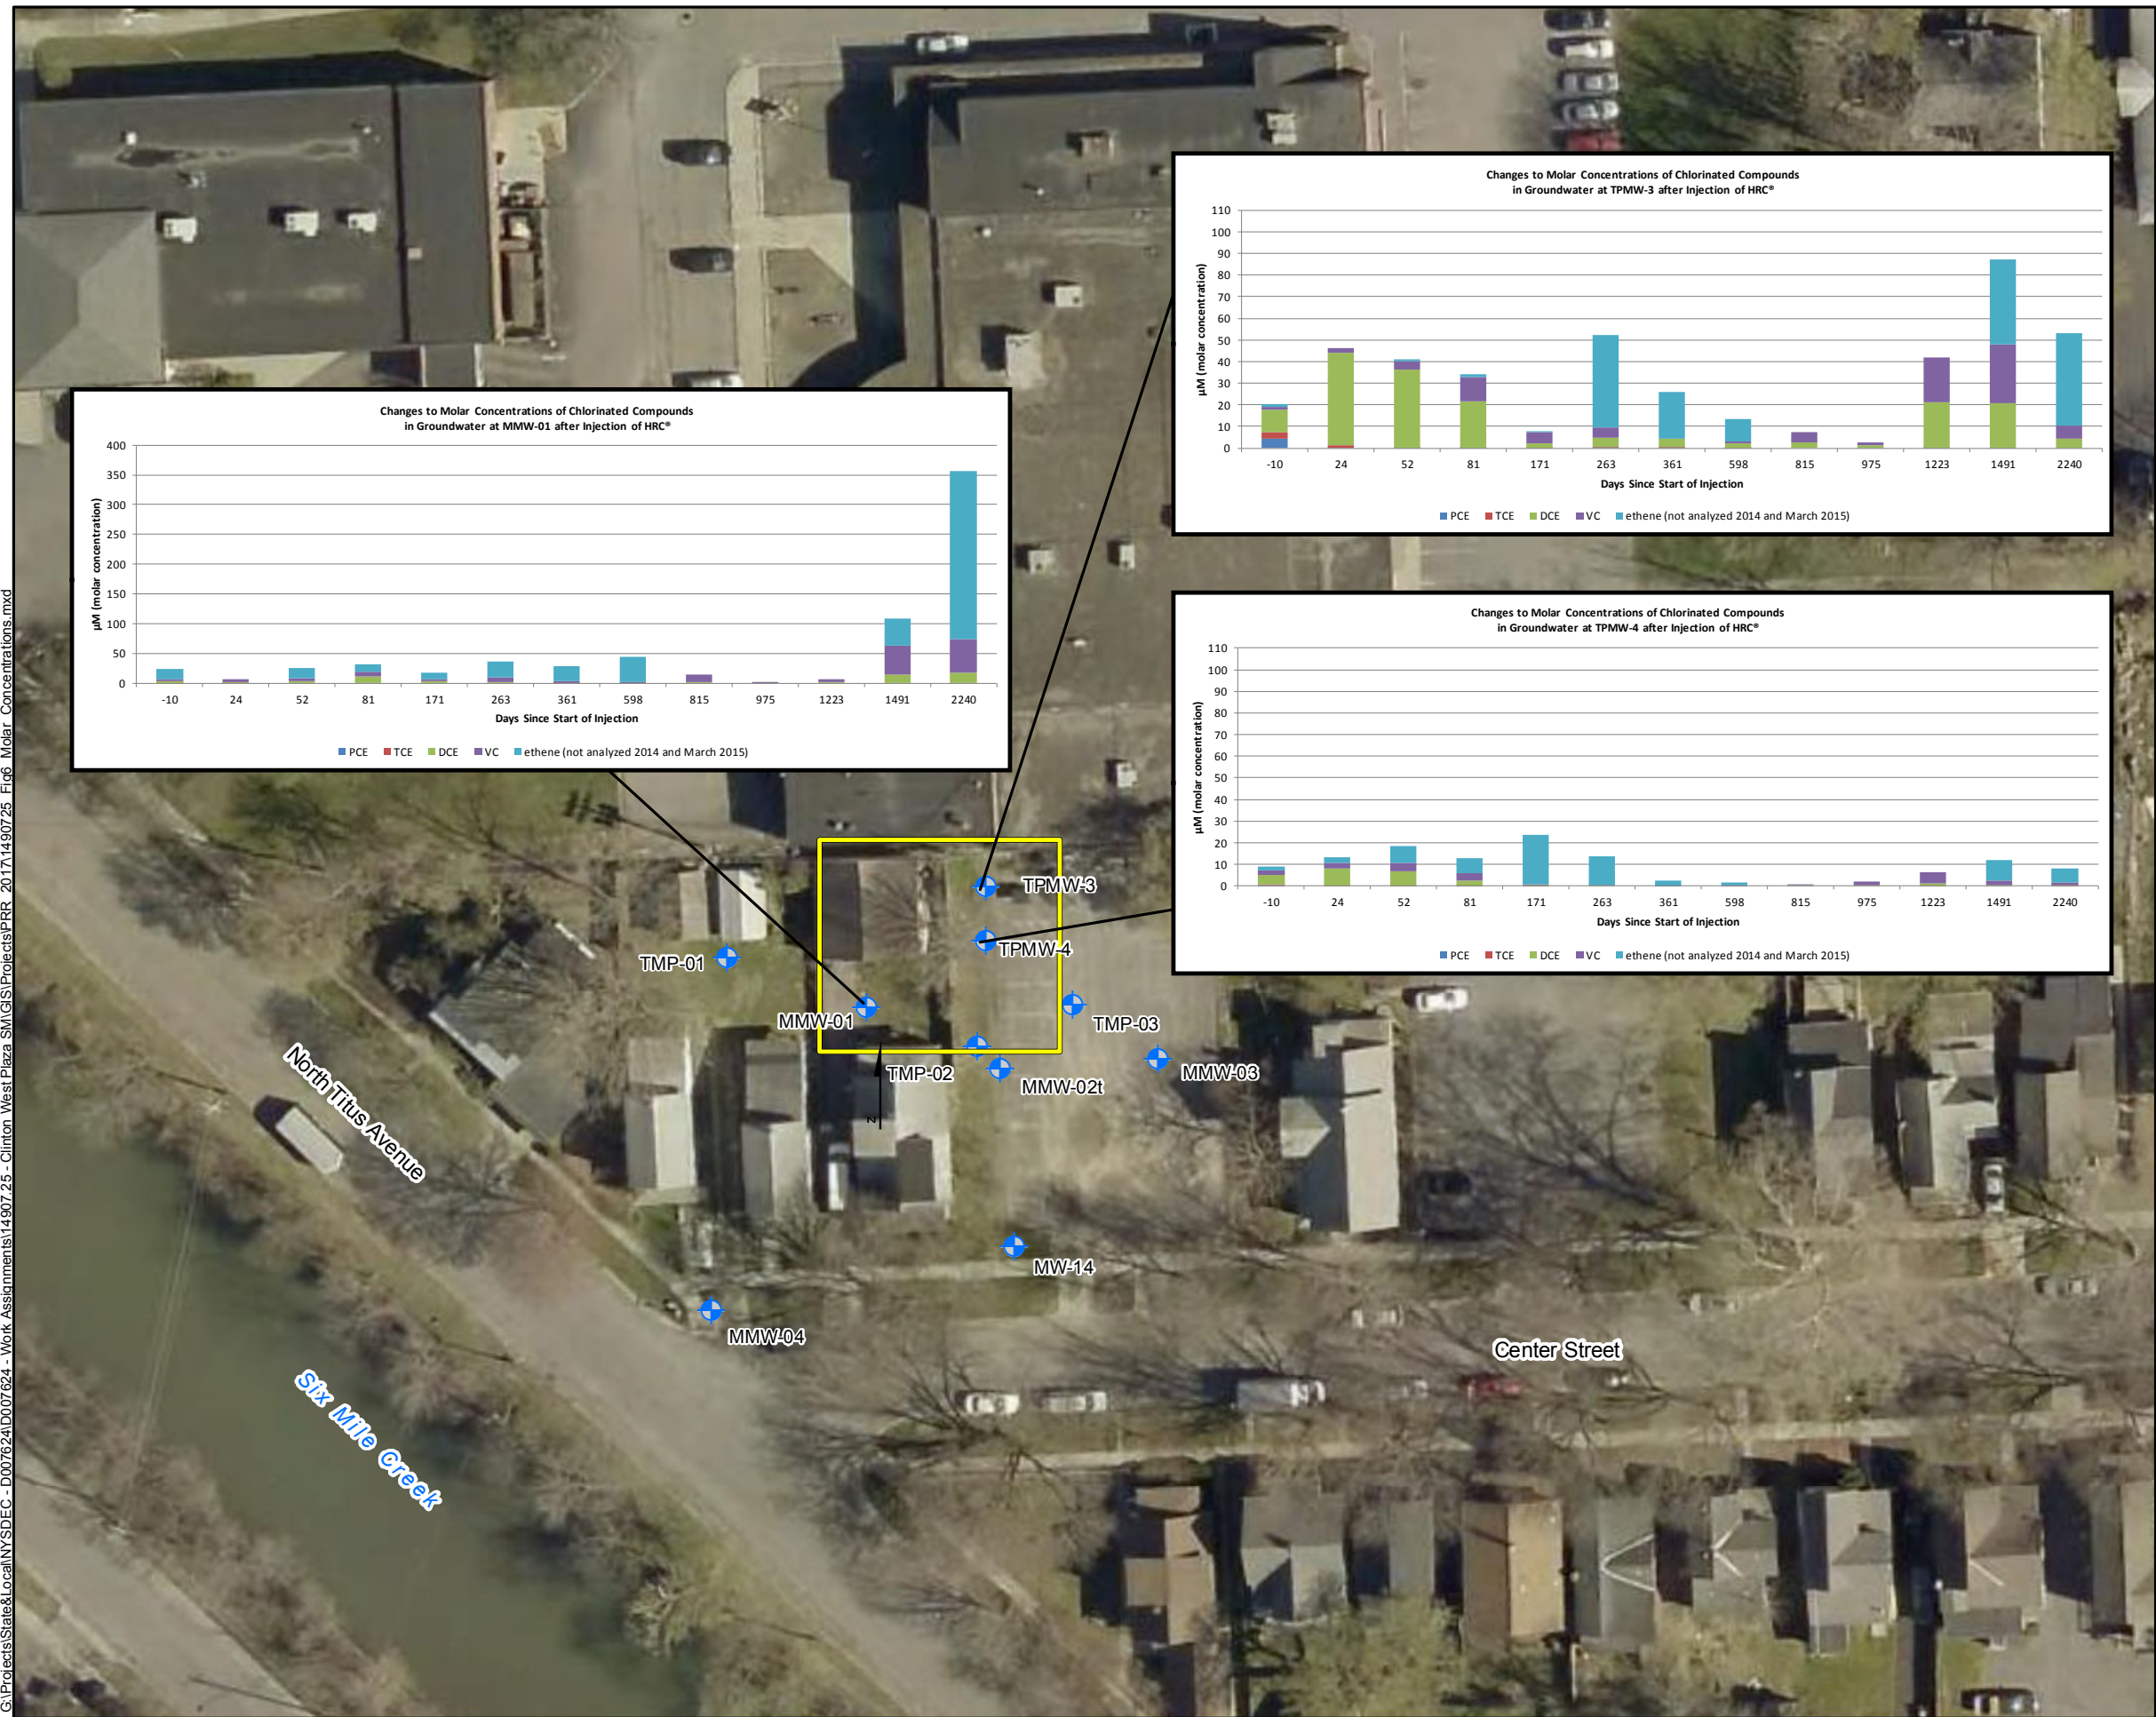
G:\Projects\State&Local\NY\SDC - D007624\DO07624 - Work Assignments\14907.25 - Clinton West Plaza SM\GIS\Projects\PRR\_2017\14907.25 Fig6 Molar Concentrations.mxd

**Figure 6** presents a summary of the molar concentration of total chlorinated ethenes (PCE, TCE, *cis*-1,2-DCE, and VC) at monitoring points (TPMW-3, TPMW-4, and MMW-01) within the targeted treatment zone. Decreases in molar concentration had been observed at each monitoring point through July 2014, which indicated that contaminant mass had been converted to innocuous end products (e.g., ethene). During the 2015 monitoring period it was observed that total molar concentrations (predominantly *cis*-1,2-DCE and VC) increased at TPMW-03 and MMW-01. This trend continued in 2016, although molar concentrations decreased at TPMW-03 compared to 2015, but remains greater than the high from 2011 through 2014.
