## NOTICE OF VIOLATION (NOV)

Re: Petroleum Bulk Storage (PBS) Program Site Inspection - 6 NYCRR Part 613  
PBS# 8-444944 - LAMB FARMS INC  
3962 BATAVIA ELBA TOWNLINE ROAD  
Oakfield, NY 14125

**New York State Department of Environmental Conservation**  
**Petroleum Bulk Storage (PBS) Inspection Form**

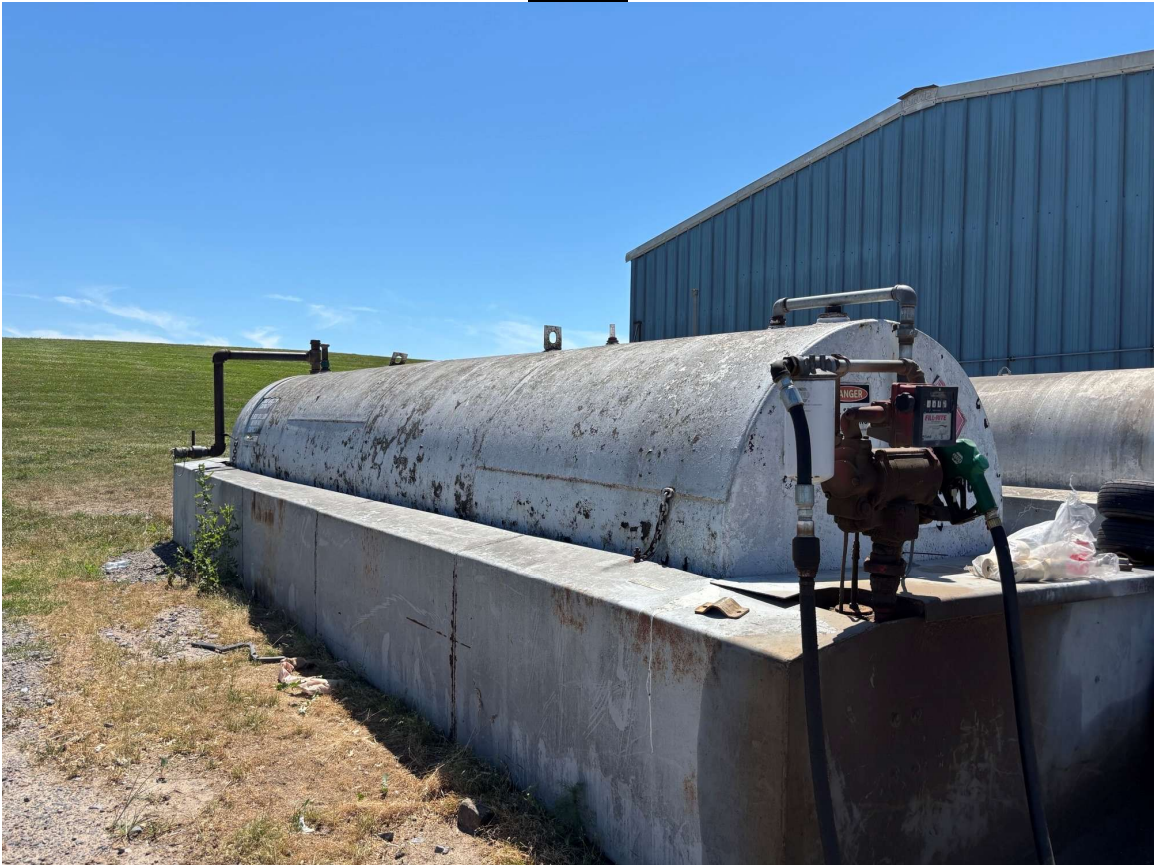
SCF – Surface coating is faded or no longer covers the entire AST exterior [SP4/SP5]

Tank 006 – 4,000 gallon diesel tank. Areas of loose / peeling paint observed.

*Within 30 calendar days after the date of the NOV, re-coat the tank exterior and submit a photograph showing the coated exterior.*

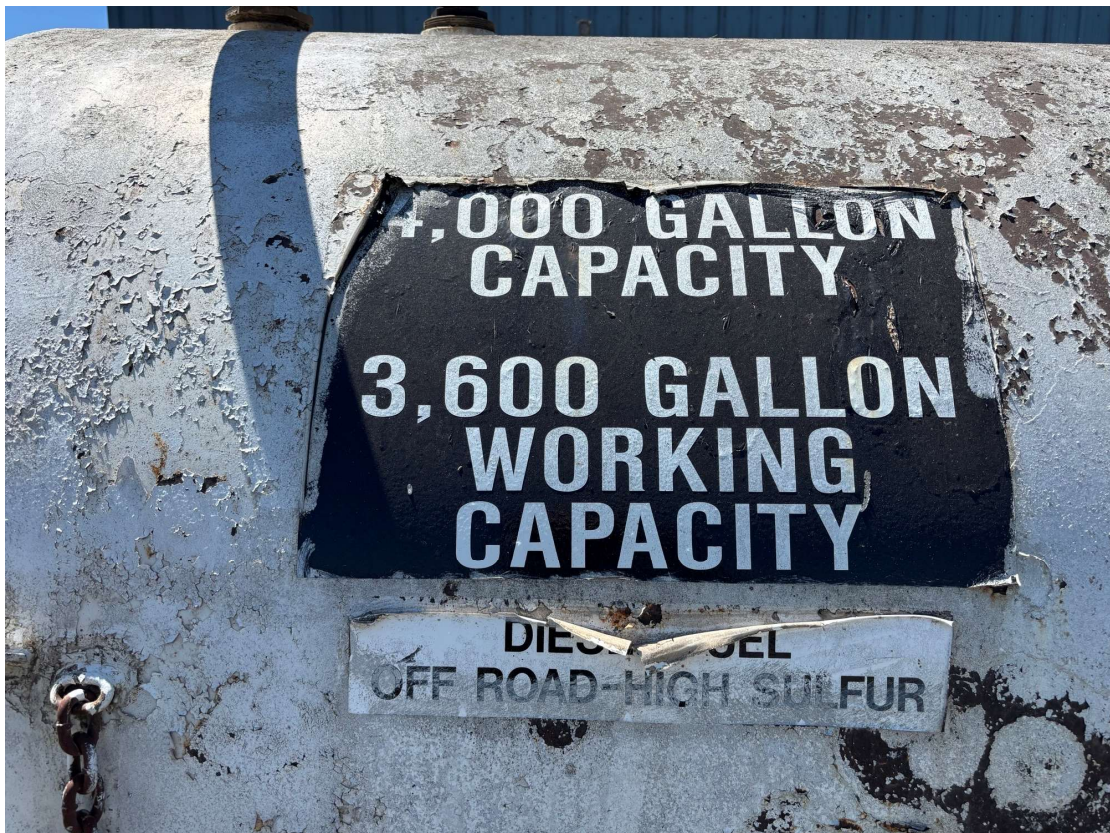
Tank 006 labeling. Note: Tank # is on end of tank.

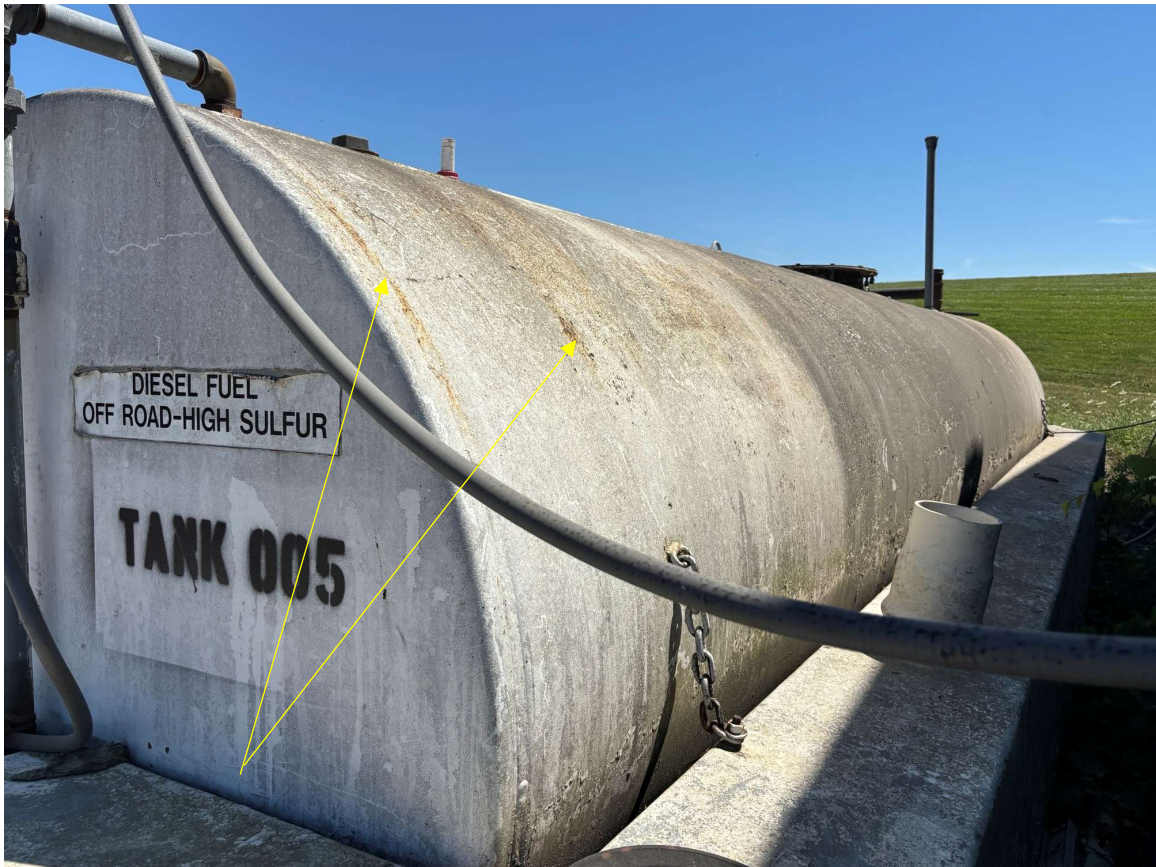
SCF – Surface coating is faded or no longer covers the entire AST exterior [SP4/SP5]

Tank 005 – Areas of corrosion observed.

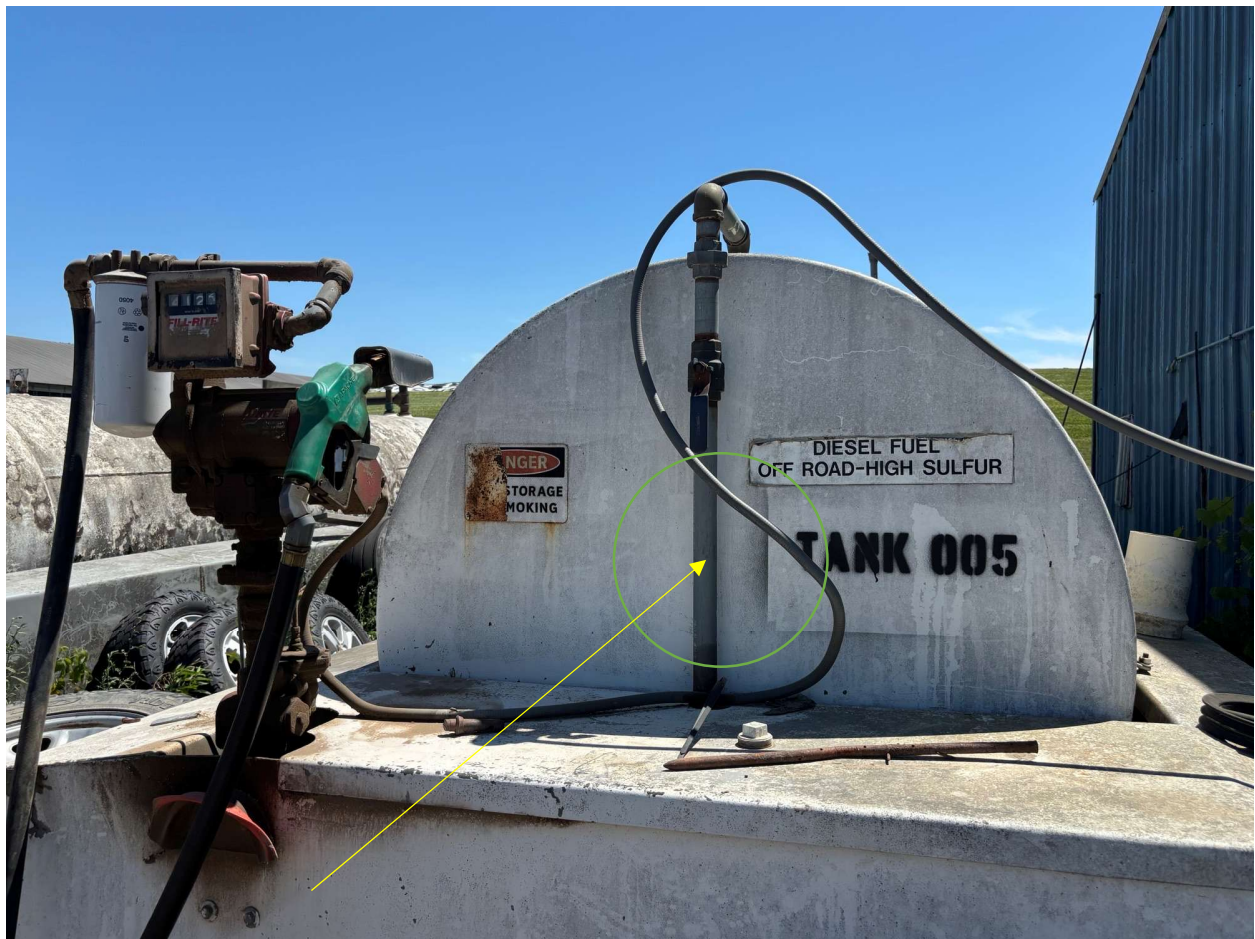
**No solenoid/anti-siphon valve – [613-4.1(b)(6)(ii)].** The piping/dispenser is not equipped with the required solenoid valve/anti-siphon valve. A motor fuel dispenser at an elevation below the top of the associated tank, must be equipped with a solenoid/anti-siphon valve – adjacent to and downstream of the operating valve – so that petroleum cannot flow by gravity from the tank system in case of piping/dispenser hose failure.

No solenoid (anti-siphon) valve immediately downgradient of the operational valve.

*Within 30 calendar days after the date of the NOV, install (and submit documentation of) a solenoid valve/anti-siphon valve.*
