NEW YORK STATE DEPARTMENT OF ENVIRONMENTAL CONSERVATION
 DIVISION OF ENVIRONMENTAL REMEDIATION
Site Classification Report

Site Code: 808006	Site Name: Townley Hill Road Dump Site
City: Catlin	Town: Catlin
Region: 8	County: Chemung
Current Classification: 02	Proposed Classification: 04
Estimated Size (acres): 11.29	Disposal Area: Landfill
Significant Threat: Previously	Site Type:
Priority ranking Score: 260	Project Manager: Zachary Russo

PRE-REMEDATION SITE CONDITIONS
 TOWNLEY HILL ROAD DUMP SITE
 TOWN OF CATLIN, NEW YORK
 PREPARED FOR
CBS CORPORATION
 PITTSBURGH, PENNSYLVANIA

EXCAVATION AND MATERIAL REMOVAL AS-BUILT AREAS TOWNLEY HILL ROAD DUMP SITE TOWN OF CATLIN, NEW YORK PREPARED FOR CBS CORPORATION PITTSBURGH, PENNSYLVANIA	
	AUTOCAD FILE NUMBER: 01304E51	
DRAWN BY: <i>D.J. Martino</i> CHECKED BY: <i>R.P. HRENKO</i> APPROVED BY: <i>A.E. PROCTOR</i>	DATE: 1-22-14 DATE: 8-6-14 DATE: 8-6-14	FIGURE NUMBER 3

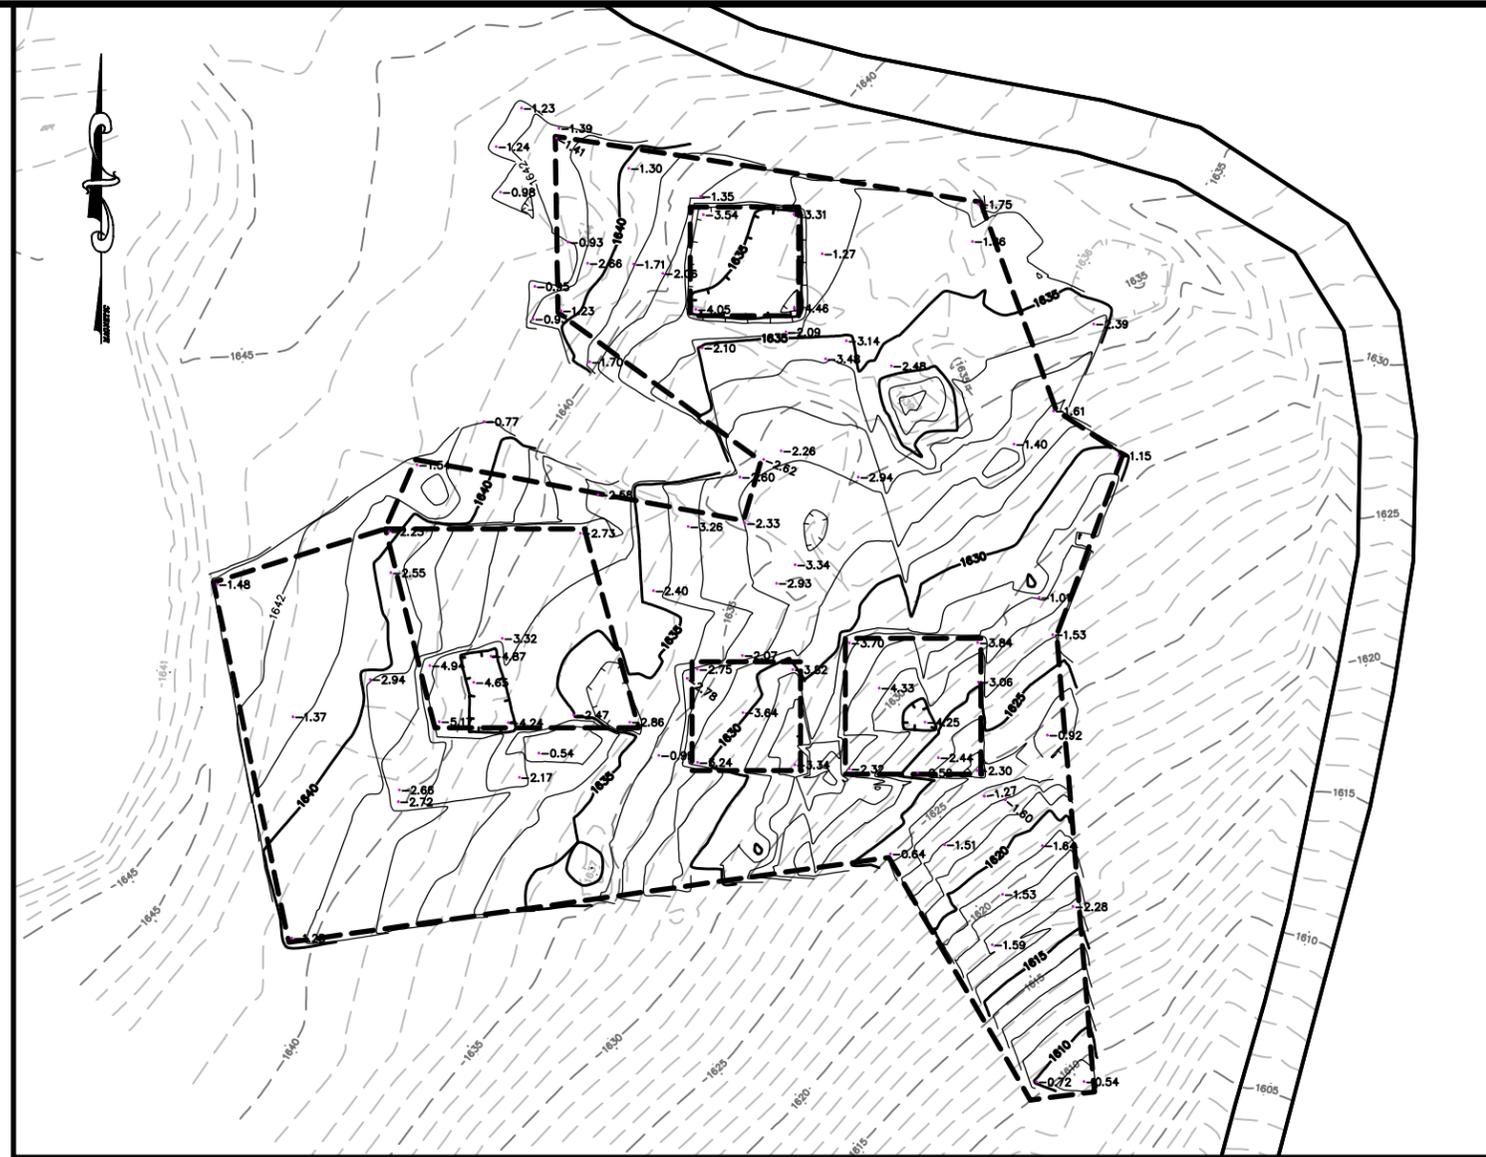
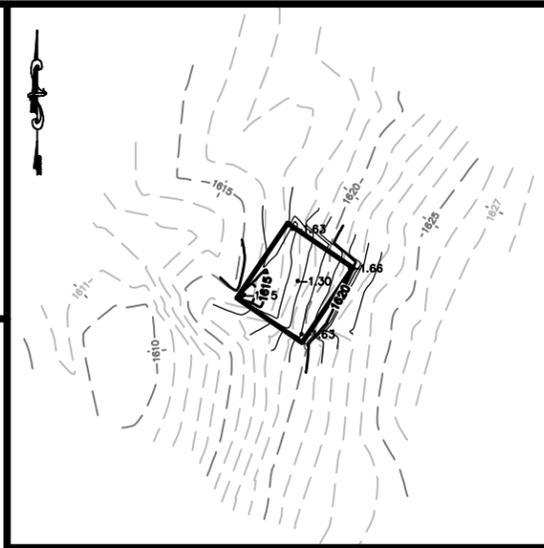
TEST PIT TP-3
1" = 20'

TEST PIT TP-7/16
1" = 20'

TEST PIT TP-5
1" = 20'

FORMER DRUM DISPOSAL AREA
1" = 20'

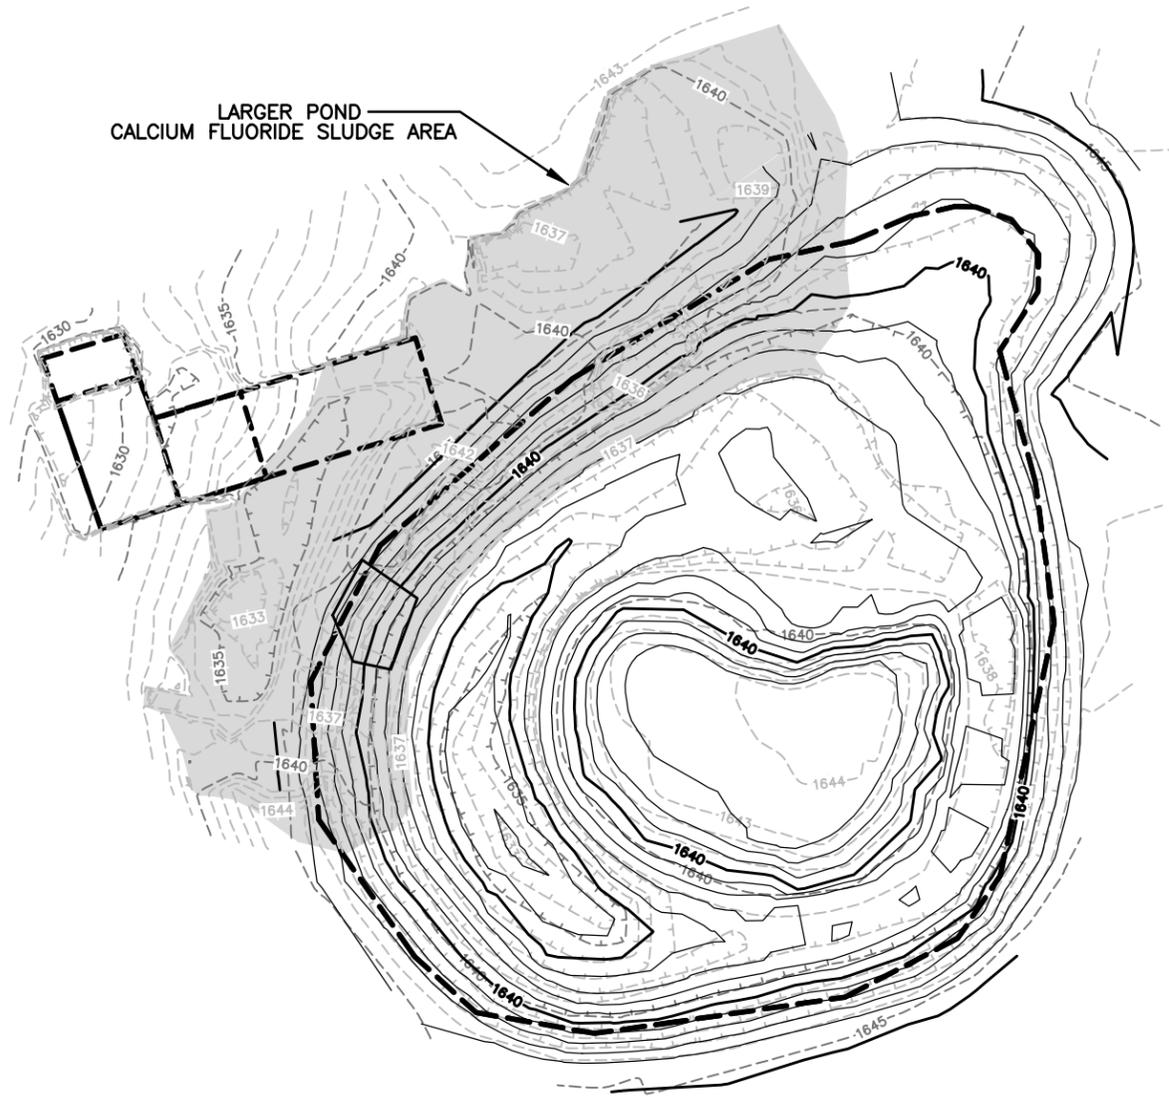
LARGER POND
1" = 20'

SMALLER POND
1" = 10'
