## **SITE MANAGEMENT PLAN**

Kentucky Avenue Wellfield Superfund Site  
Operable Unit 4 – Koppers Pond  
Horseheads, New York

August 2022

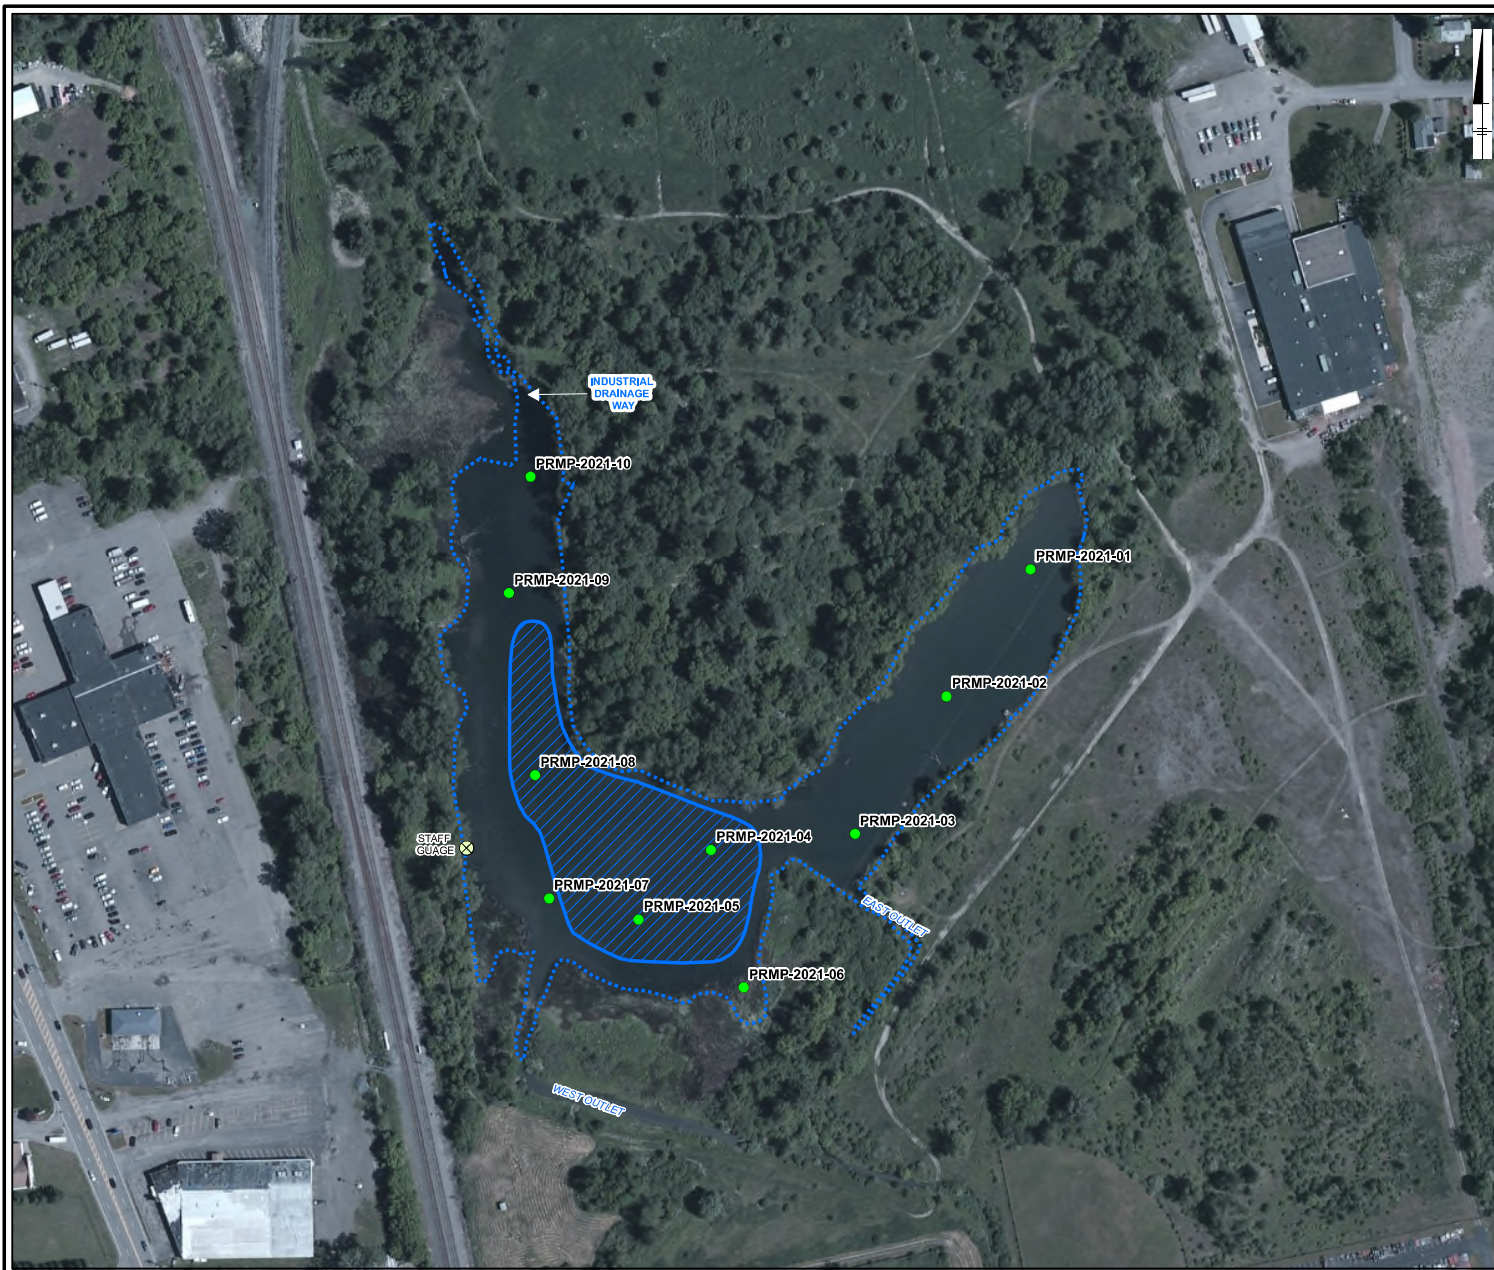
- LEGEND:**
- POST-CONSTRUCTION/RESTORATION MONITORING LOCATION
  - ⊗ STAFF GAUGE
  - REMEDIAL LIMITS AND WETLAND A
  - HISTORICAL AVERAGE WATER CONDITIONS (SEE NOTE 2)
  - WETLAND A HISTORIC LOW WATER CONDITIONS (SEE NOTE 2)

As part of the post-construction monitoring, the vegetation and general site condition will be evaluated during the post-construction/restoration phase in accordance with the general methods noted below and will be conducted for up to 2 years (i.e., Years 1 through 2) following completion of restoration in “Year 0”. Ten permanent monitoring locations have been established for the monitoring period and are demarcated with a PVC pipe or green metal fence post. The monitoring locations are presented on Figure 2.

time of the delineation but is known to have a highly variable hydrology depending precipitation and stormwater flows and persistent vegetation that tolerates a drier hydrologic regime is present on the site. The method of delineation utilized accounts for the highly variable hydrology of the project area. The wetland boundary coincides with the historical average water conditions limit and closely followed the topographic contour of the former Koppers Pond basin. Wetland A received hydrologic inflow from stormwater runoff drainage feature on the northwest end of the basin. Wetland A drained in a southeast direction from two constructed ditches. The limits of Wetland A are shown on Figure 2.
