Annual Periodic Review Report Baseline Event through Q4

Madison Avenue Former MGP Site
Elmira, New York
NYSDEC Site Number: 808018

September 2014
Revised February 2015

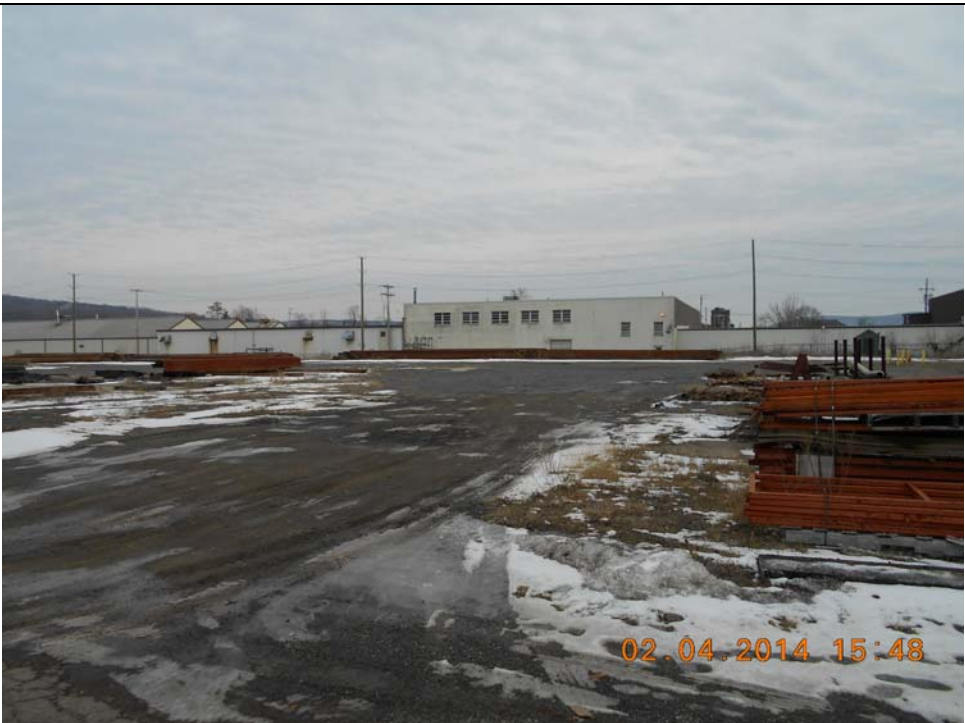
PHOTOGRAPHER: NJB	
DATE: 02/04/14	
DIRECTION: SE	
COMMENT: Picture showing stone coverage over former manufactured gas plant (MGP). Photo indicates cover in good condition; no repair required.

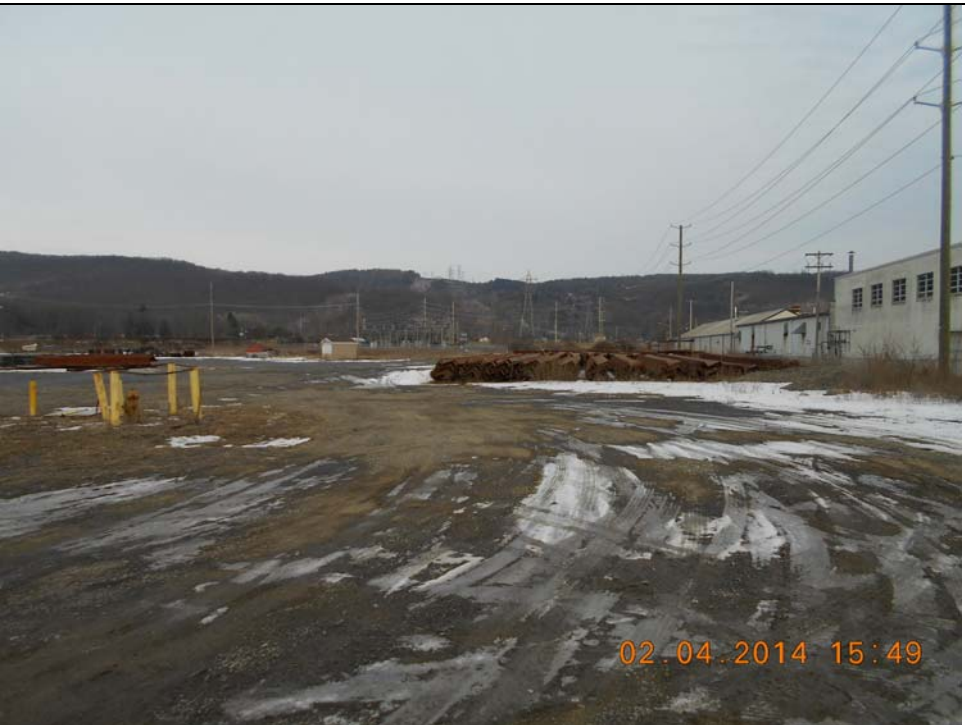
PHOTOGRAPHER: NJB	
DATE: 02/04/14	
DIRECTION: E	
COMMENT: Picture showing stone coverage over former MGP. Photo indicates cover in good condition; no repair required.

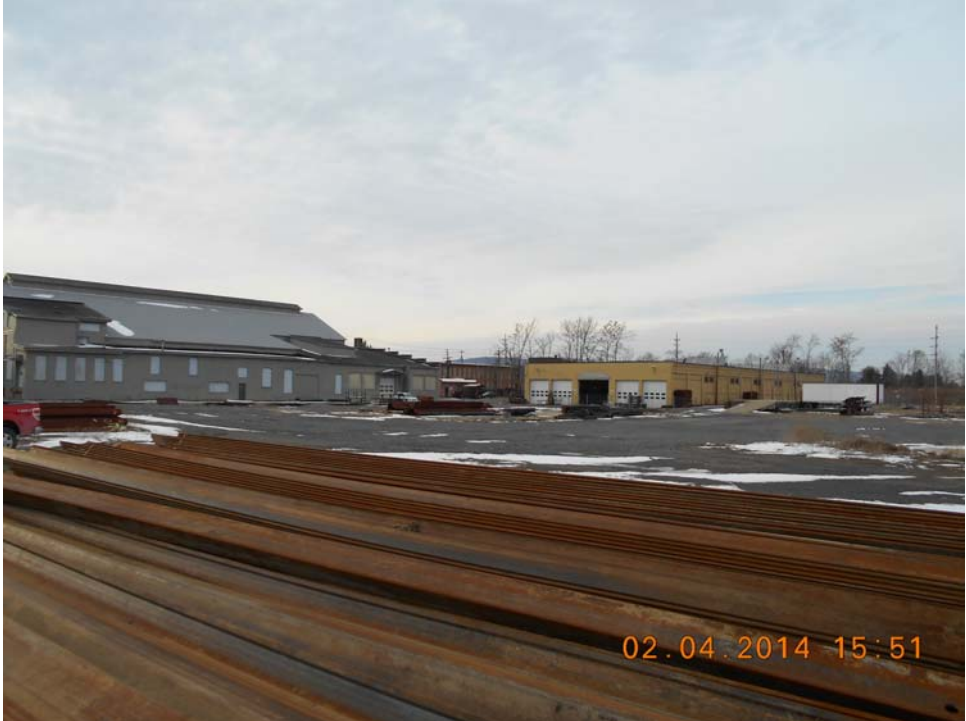
PHOTOGRAPHER: NJB	
DATE: 02/04/14	
DIRECTION: NW	
COMMENT: Picture showing stone coverage over former MGP. Photo indicates cover in good condition; no repair required. Area in foreground used for staging of steel sheetpile.

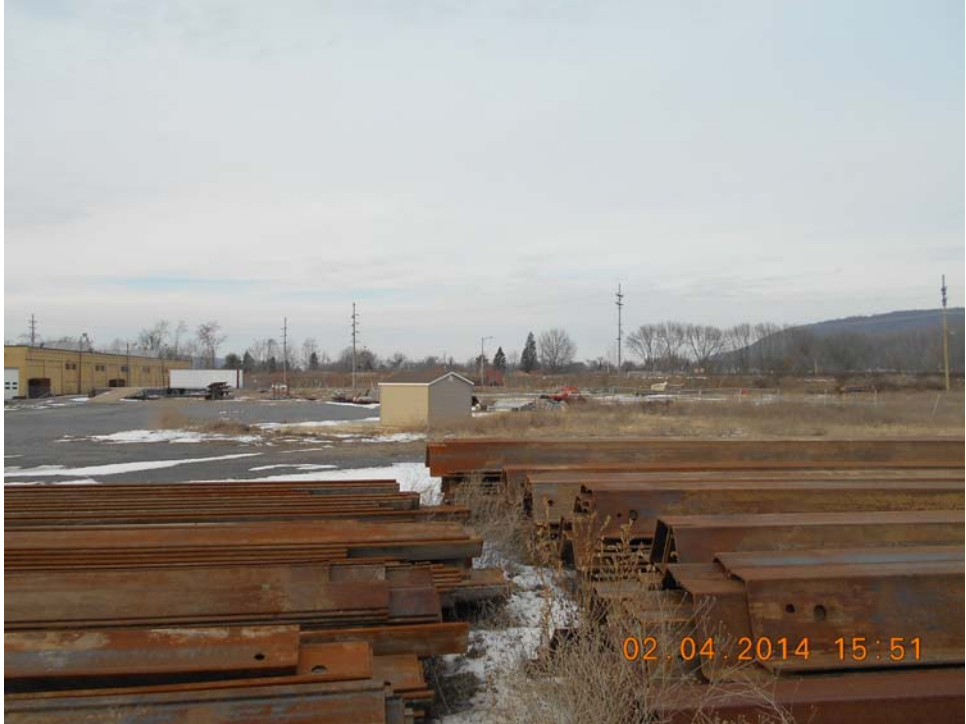
PHOTOGRAPHER: NJB	
DATE: 02/04/14	
DIRECTION: N	
COMMENT: Picture showing stone coverage over former MGP property. Staged steel sheet piles in foreground; storage shed in center of picture. Photo indicates cover in good condition; no repair required.

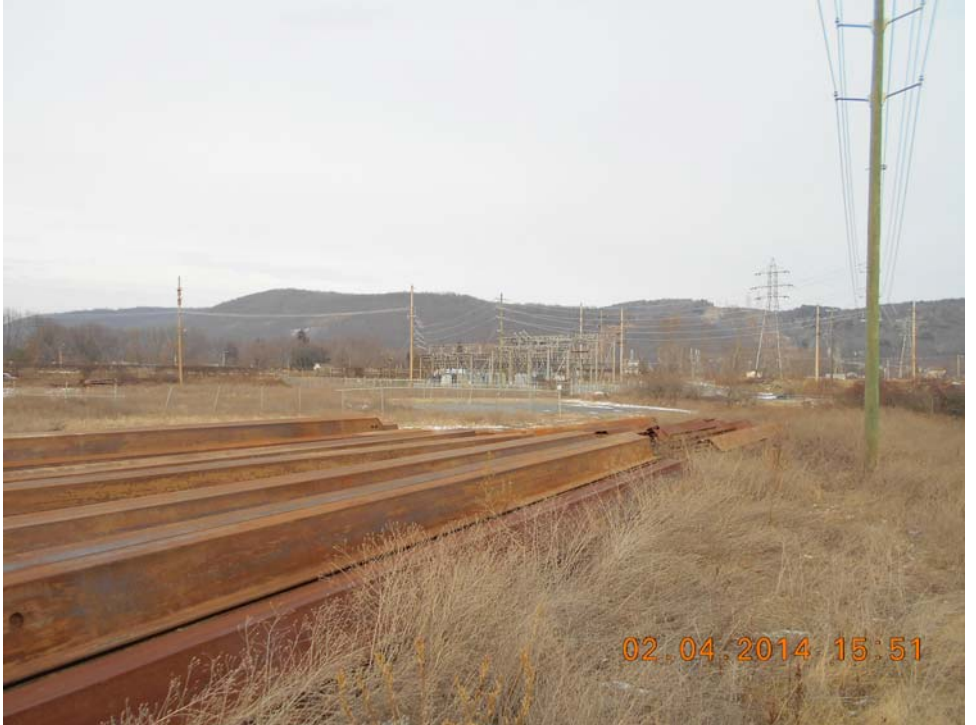
PHOTOGRAPHER: NJB	
DATE: 02/04/14	
DIRECTION: NE	
COMMENT: Picture showing stone and vegetation coverage over PCB IRM removal areas (1997) and purifier waste removal area (2011). Photo indicates cover in good condition; no repair required. Area used for staging of steel sheet piles.

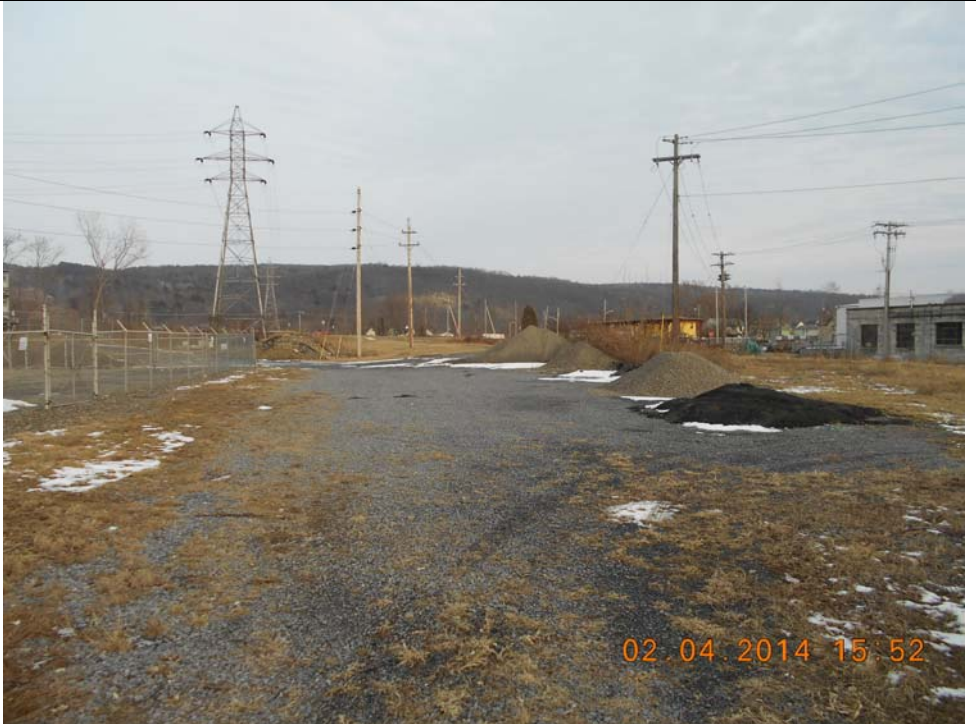
PHOTOGRAPHER: NJB	
DATE: 02/04/14	
DIRECTION: E	
COMMENT: Picture showing stone coverage and stock piled materials over ISS areas. Coverage appears in good condition, no repairs required.

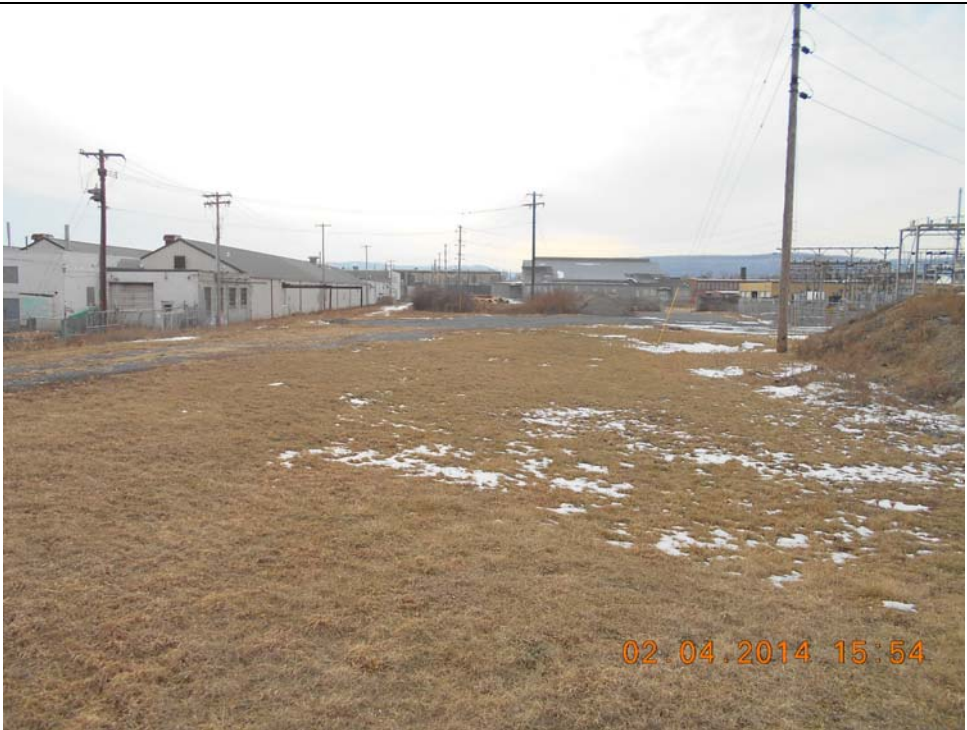
PHOTOGRAPHER: NJB	
DATE: 02/04/14	
DIRECTION: SW	
COMMENT: Picture showing grass area and stone coverage over ISS area, purifier waste IRM removal area (2004), and purifier waste removal area (2011). Photo indicates cover is in good condition; no repairs required.

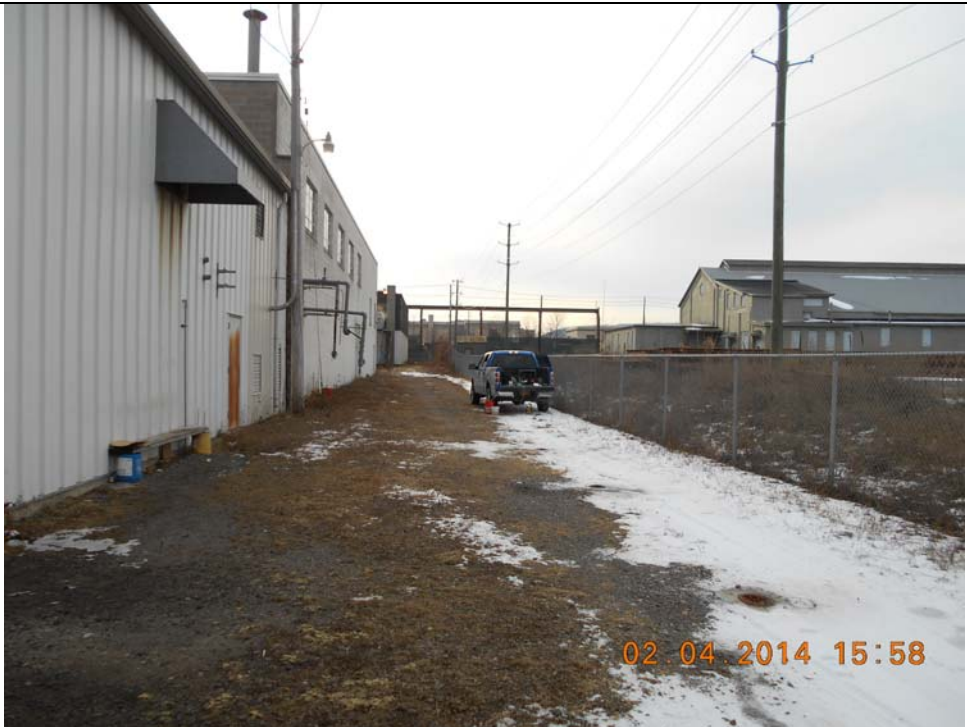
PHOTOGRAPHER: NJB	
DATE: 02/04/14	
DIRECTION: WSW	
COMMENT: Picture showing groundwater treatment system area. Photo indicates property is in good condition; no repairs required.

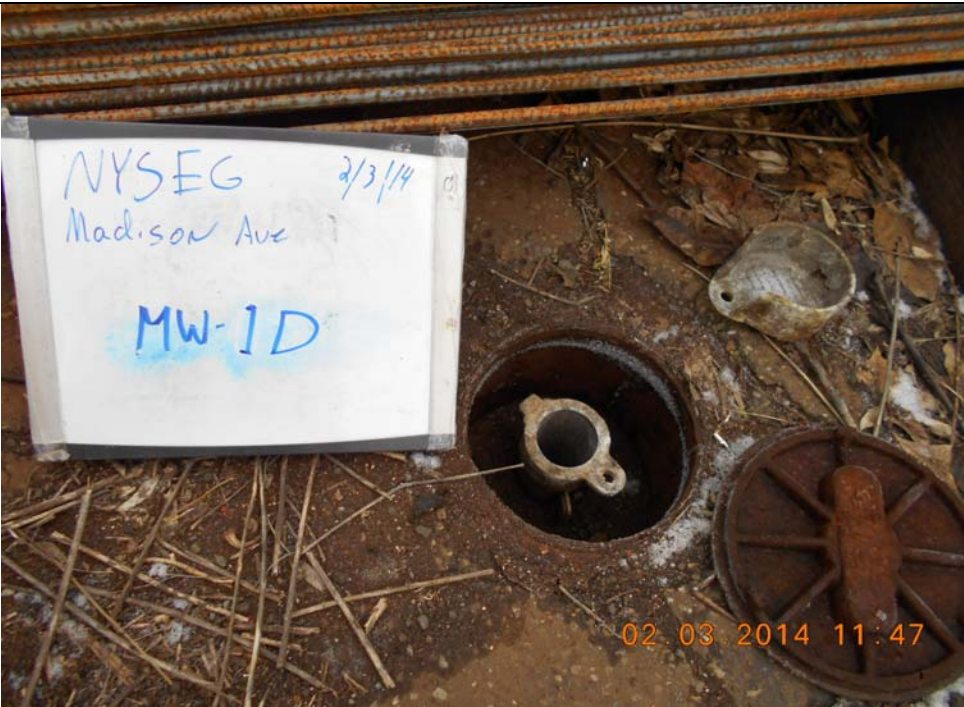
PHOTOGRAPHER: RDC	
DATE: 02/03/2014	
DIRECTION: facing N	
COMMENT: Photograph showing MW-1D. Well is in good condition with cap and competent cover.

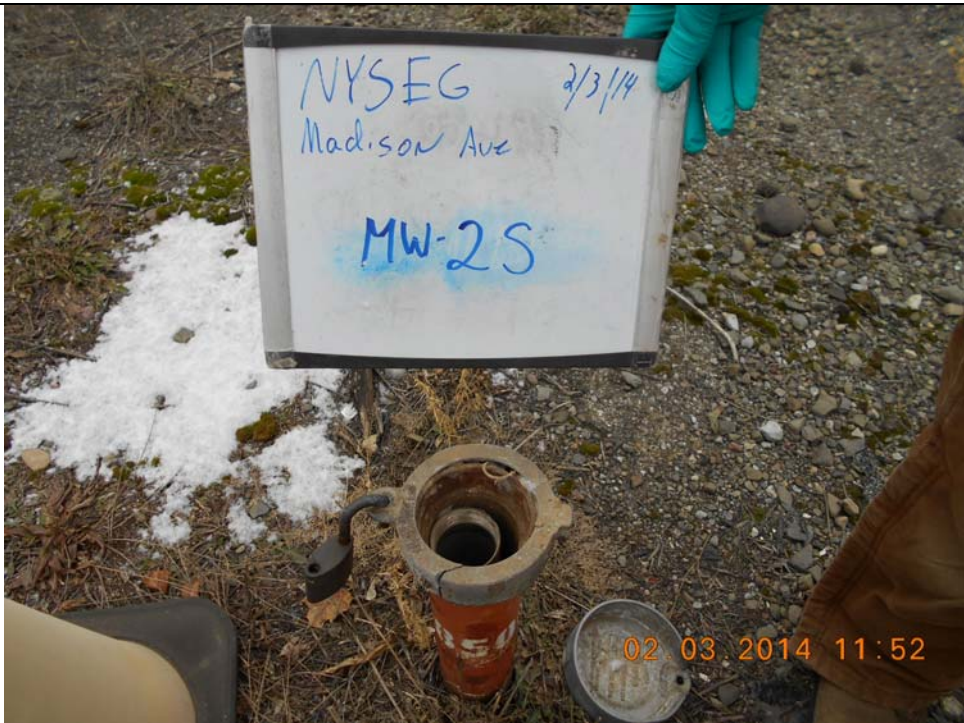
PHOTOGRAPHER: RDC	
DATE: 02/03/2014	
DIRECTION: facing E	
COMMENT: Photograph showing MW-2S. Cap mounting rig is cracked but competent. Well is in good condition with locking cap.

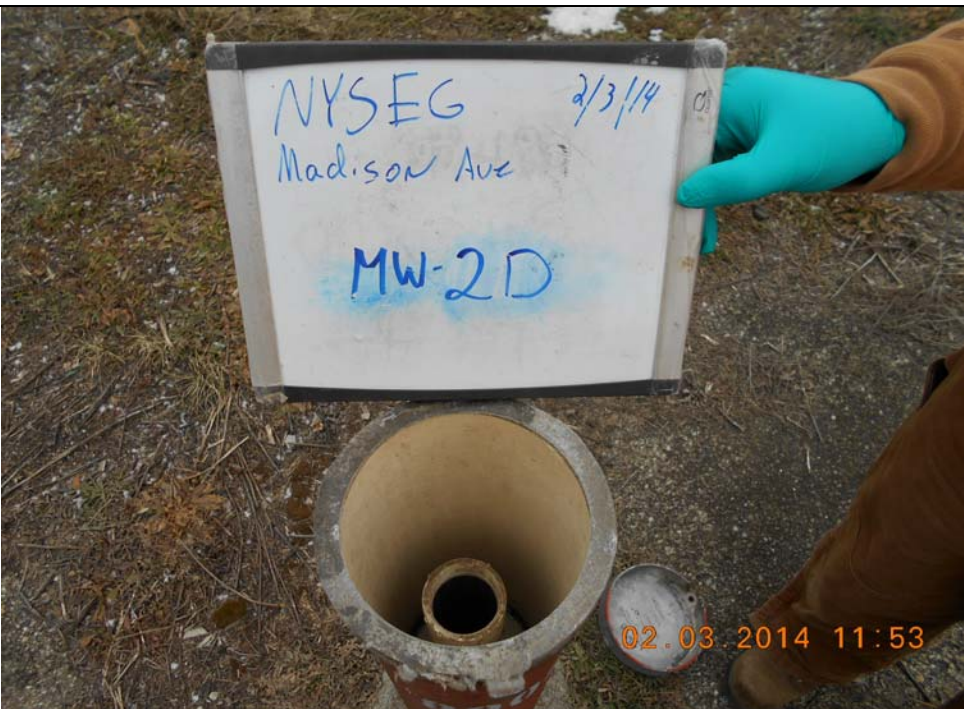
PHOTOGRAPHER: RDC	
DATE: 02/03/2014	
DIRECTION: facing E	
COMMENT: Photograph showing MW-2D. Well is in good condition with locking cap.

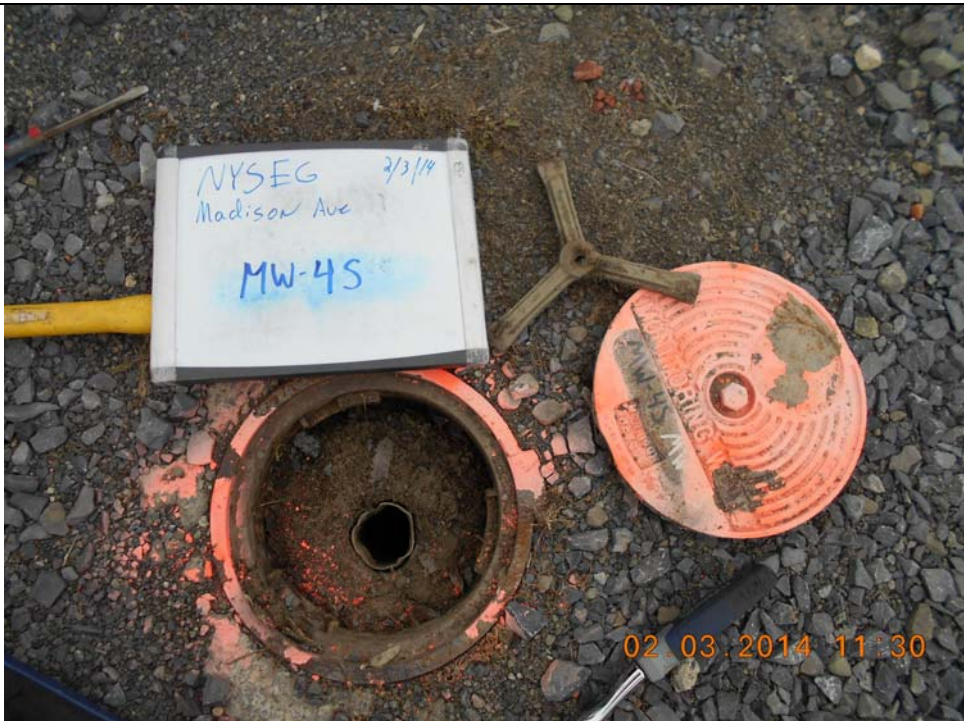
PHOTOGRAPHER: RDC	
DATE: 02/03/2014	
DIRECTION: facing W	
COMMENT: Photograph showing MW-4S. Well is in poor condition and requires repair; riser needs to be cut down to make room for locking well plug. Well cover is competent.

Location ID	Observed Deficiency	Action(s) Completed/Recommended
MW-4S	Appears road box has settled or was run over by heavy equipment resulting in a crushed riser section (at the very top). Currently no locking well cap can fit under the road box lid.	Requires crushed portion of well riser to be removed (cut), a locking well cap and resurvey.
MW-6S	Missing locking well cap.	Requires new aluminum locking cap.
MW-9S	Locking tabs are broken on road box such that lid cannot be secured.	Requires new road box, surface completion and re-survey.
MW-9D	Appears rod box has settled or has been run over such that the riser is too high for the lid to be secured.	Requires new road box, surface completion and resurvey.
AW-2	The concrete surface completion has deteriorated and crumbled to pieces.	Requires new concrete surface completion.
AW-11	The steel lid of road box is broken and cracked.	Requires new steel lid for road box.

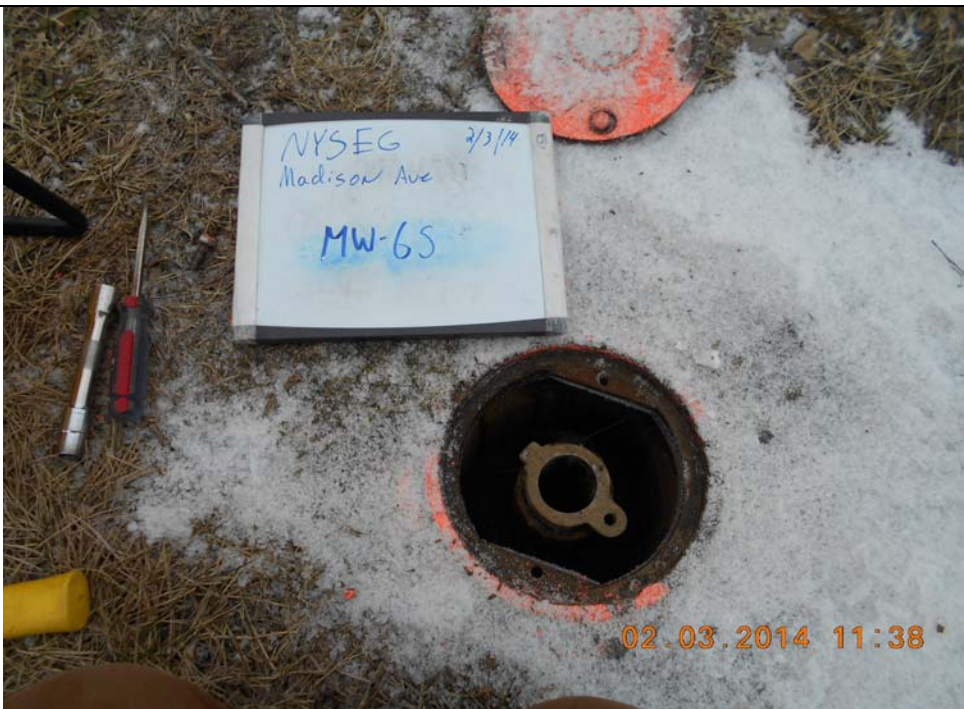
PHOTOGRAPHER: NJB	
DATE: 02/03/2014	
DIRECTION: facing S	
COMMENT: Photograph showing MW-6S. Well is in good condition, but requires a locking cap. Well cover is competent.

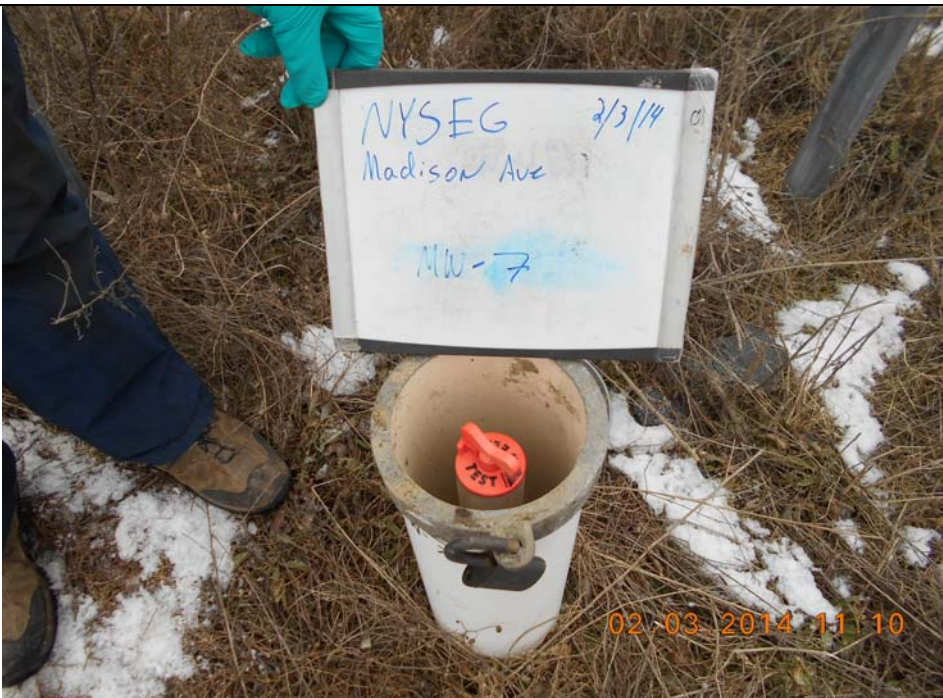
PHOTOGRAPHER: NJB	
DATE: 02/03/2014	
DIRECTION: facing N	
COMMENT: Photograph showing MW-7. Well is in good condition. Well has well plug and locking well cover.

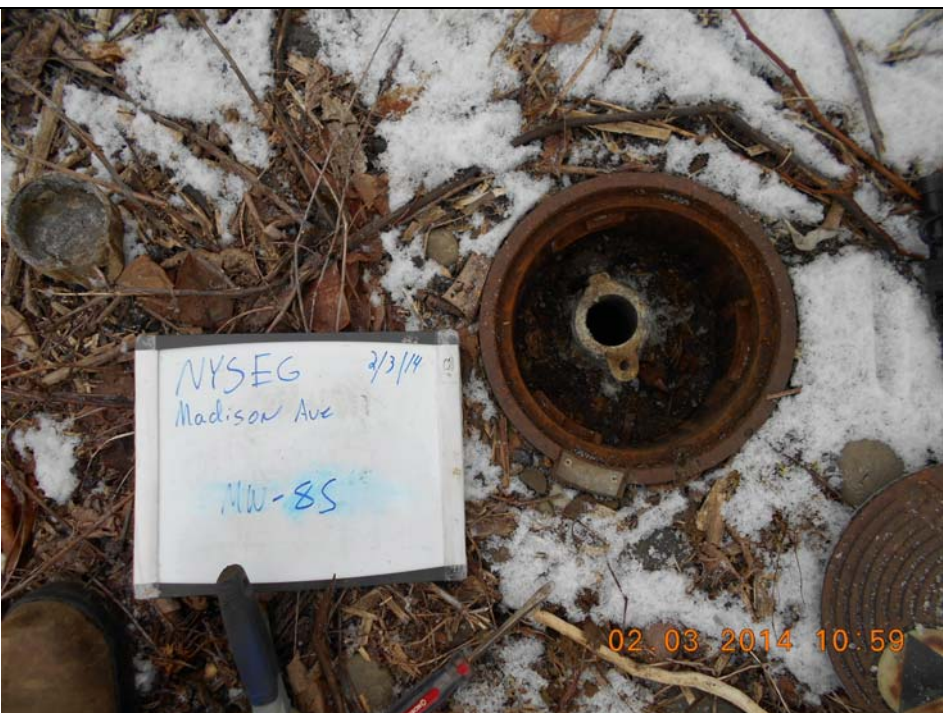
PHOTOGRAPHER: NJB	
DATE: 02/03/2014	
DIRECTION: facing S	
COMMENT: Photograph of MW-8S. Well is in good condition with locking well cap and competent cover.

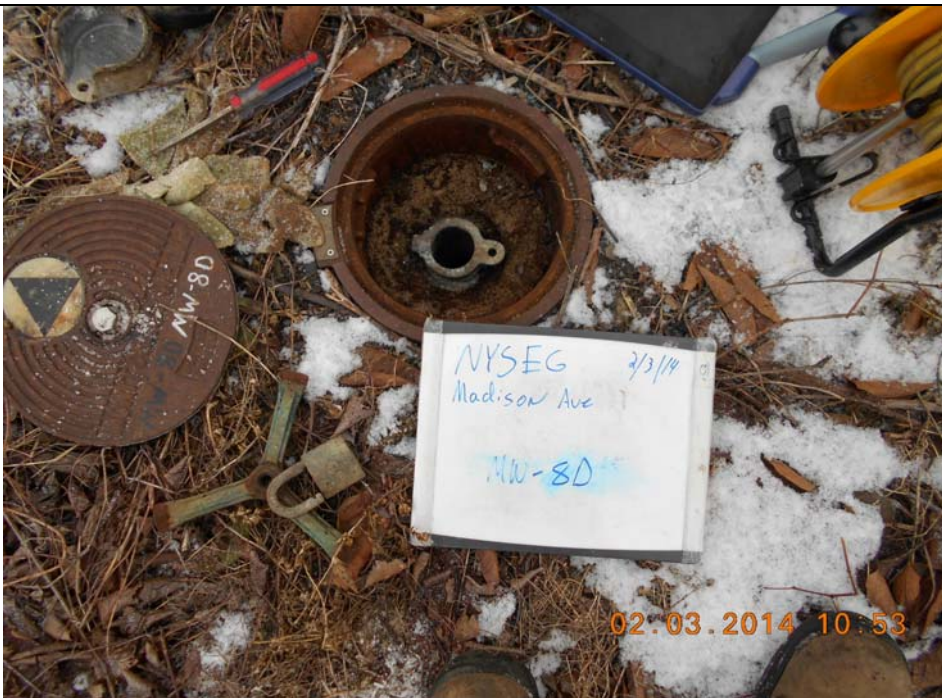
PHOTOGRAPHER: NJB	
DATE: 02/03/2014	
DIRECTION: facing S	
COMMENT: Photograph showing MW-8D. Well is in good condition with locking well cap and competent cover.

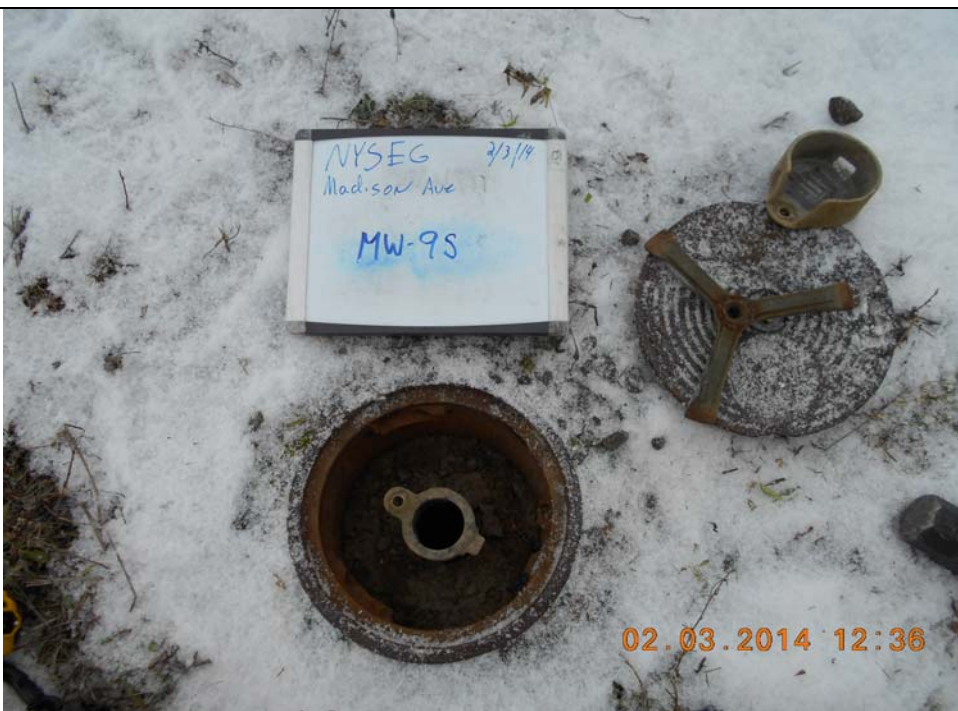
PHOTOGRAPHER: RDC	
DATE: 02/03/2014	
DIRECTION: facing S	
COMMENT: Photograph showing MW-9S. Tabs on road box are broken; well requires new road box set in concrete.

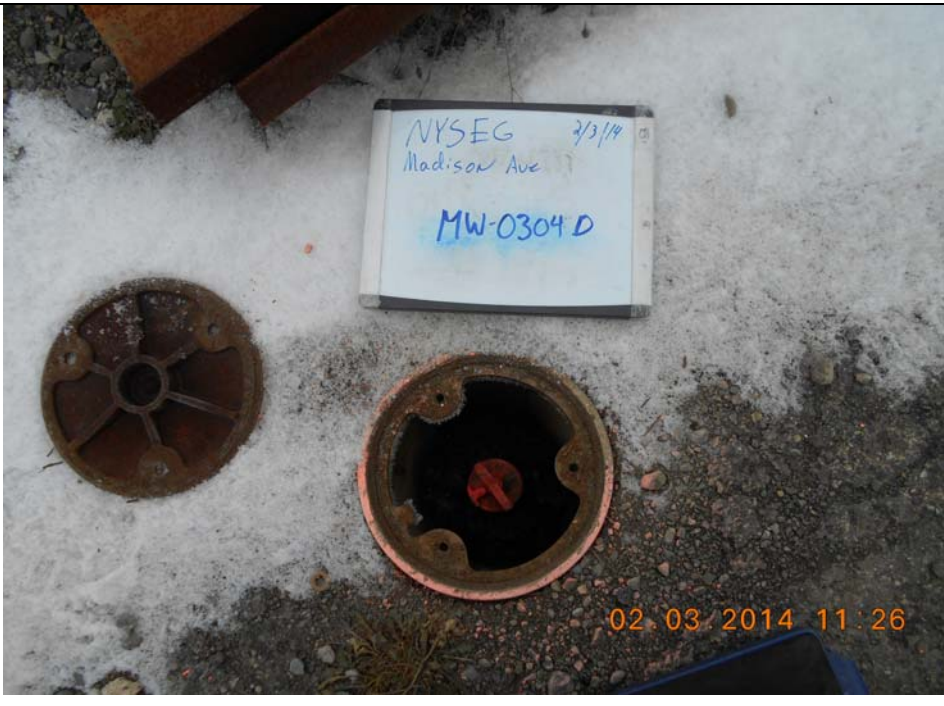
PHOTOGRAPHER: RDC	
DATE: 02/03/2014	
DIRECTION: facing W	
COMMENT: Photograph showing MW-0304D. Well is in good condition with well and competent cover.

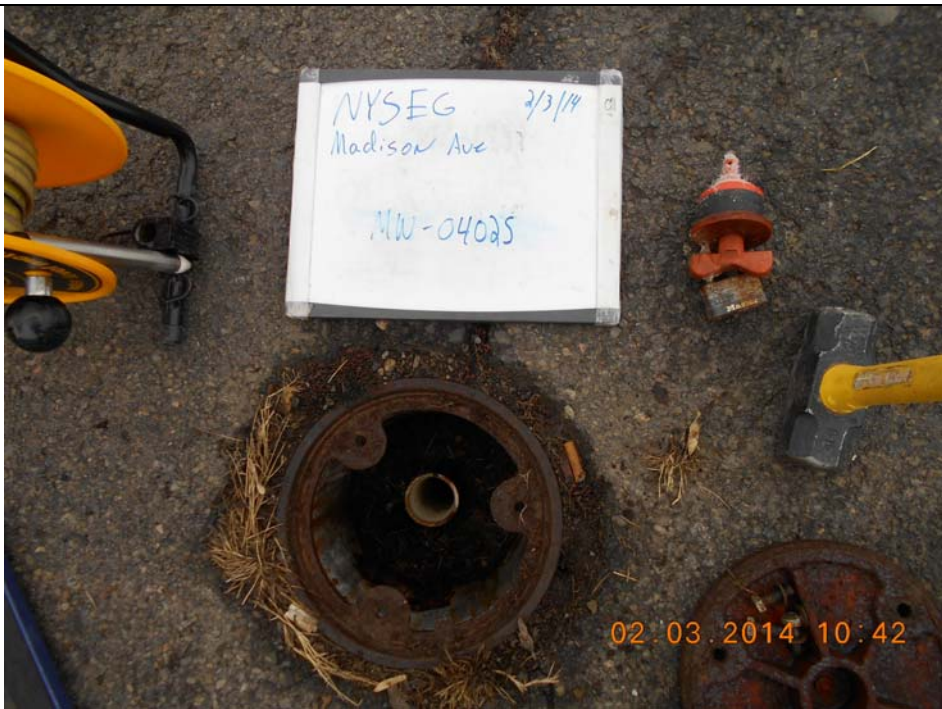
PHOTOGRAPHER: NJB	
DATE: 02/03/2014	
DIRECTION: facing E	
COMMENT: Photograph showing MW-0402S. Well is in good condition with locking well plug and competent cover.

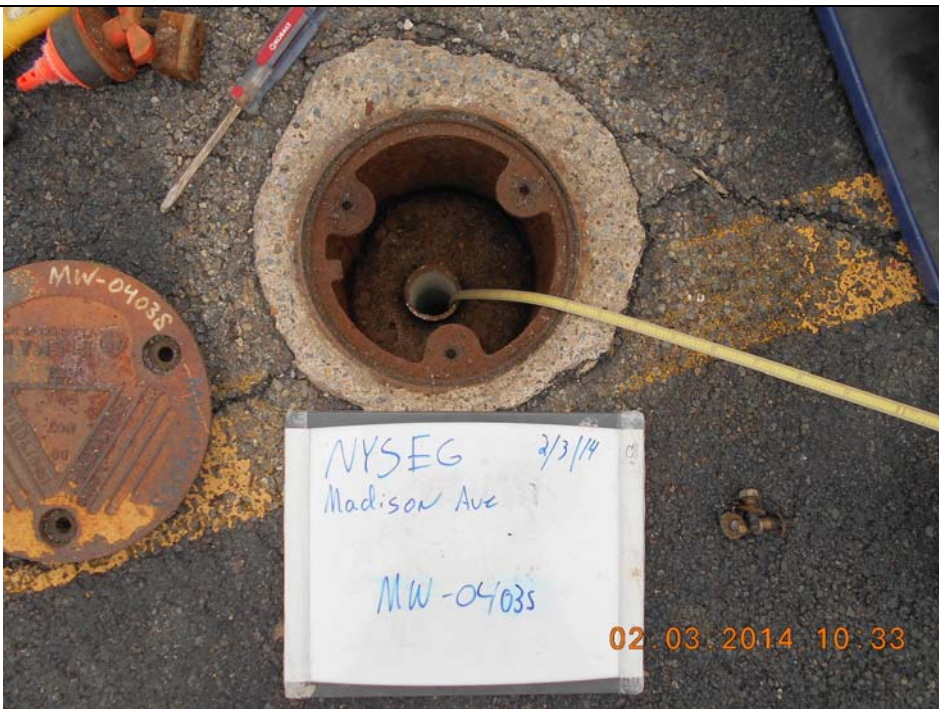
PHOTOGRAPHER: NJB	
DATE: 02/03/2014	
DIRECTION: facing W	
COMMENT: Photograph showing MW-0403S. Well is in good condition with locking well plug and competent cover.

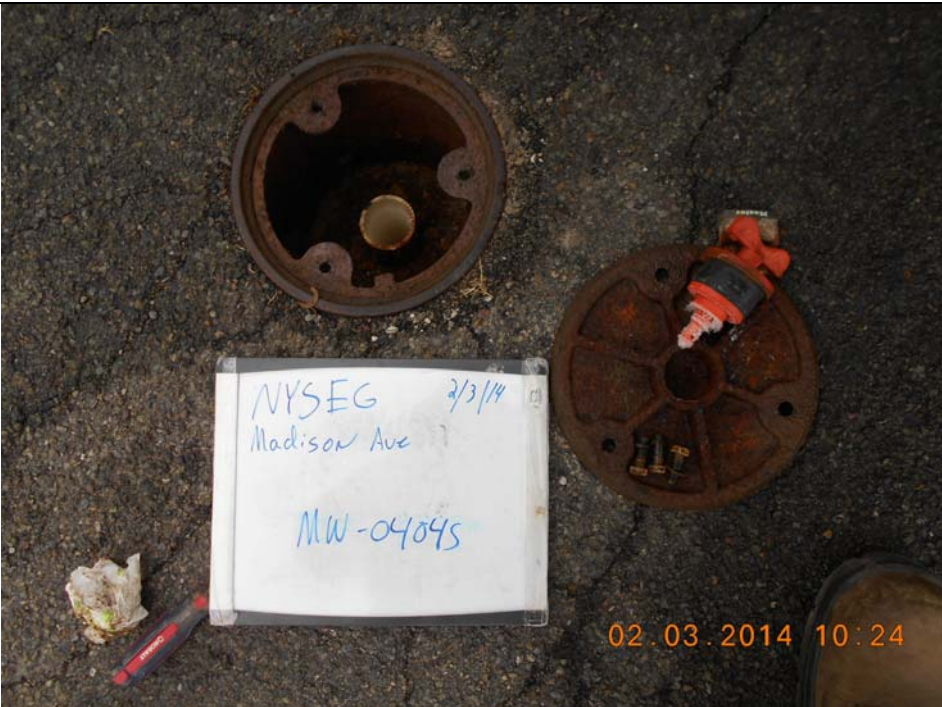
PHOTOGRAPHER: NJB	
DATE: 02/03/2014	
DIRECTION: facing E	
COMMENT: Photograph showing MW-0404S. Well is in good condition with locking well plug and competent cover.

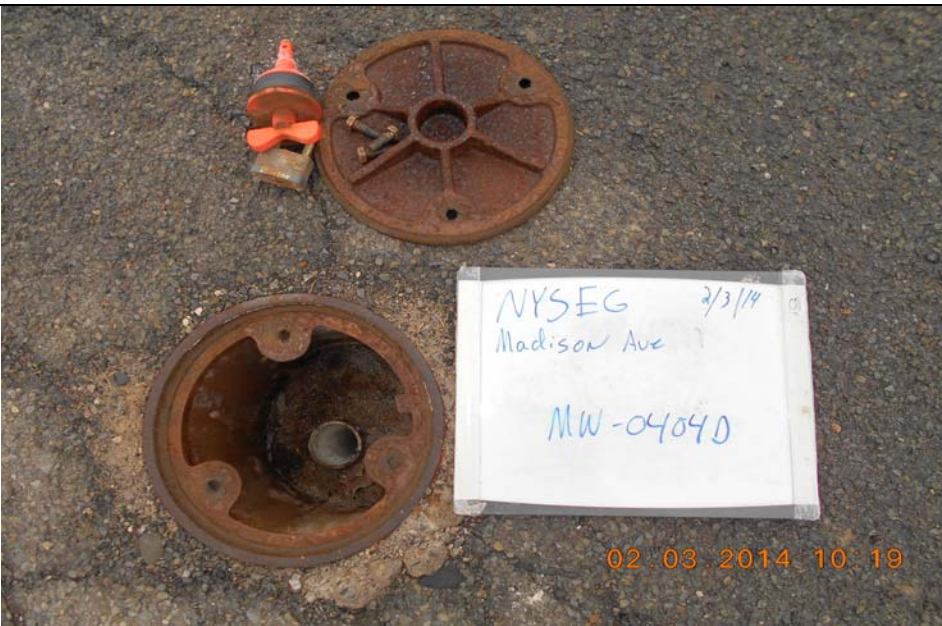
PHOTOGRAPHER: NJB	
DATE: 02/03/2014	
DIRECTION: facing E	
COMMENT: Photograph of MW-0404D. Well is in good condition with locking well plug and competent cover.

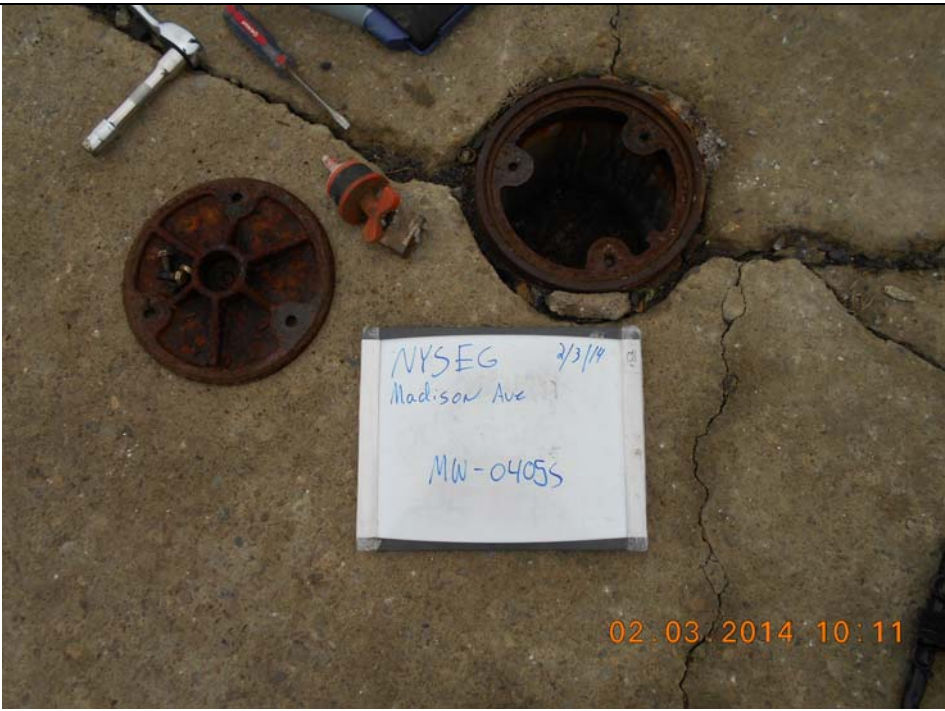
PHOTOGRAPHER: NJB	
DATE: 02/03/2014	
DIRECTION: facing E	
COMMENT: Photograph of MW-0405S. Well is in good condition with locking well plug and competent cover. Surrounding concrete flags are cracked, but road box is secure.

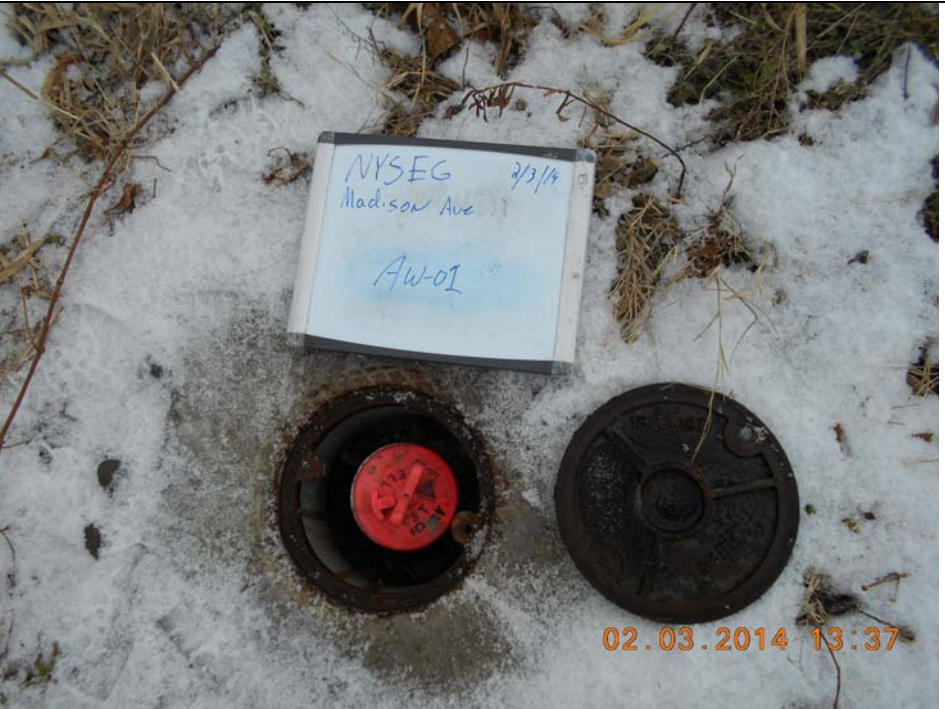
PHOTOGRAPHER: RDC	
DATE: 02/03/2014	
DIRECTION: facing N	
COMMENT: Photograph showing AW-01. Well and stainless steel canister/assembly is in good condition. Well has well plug and competent cover.

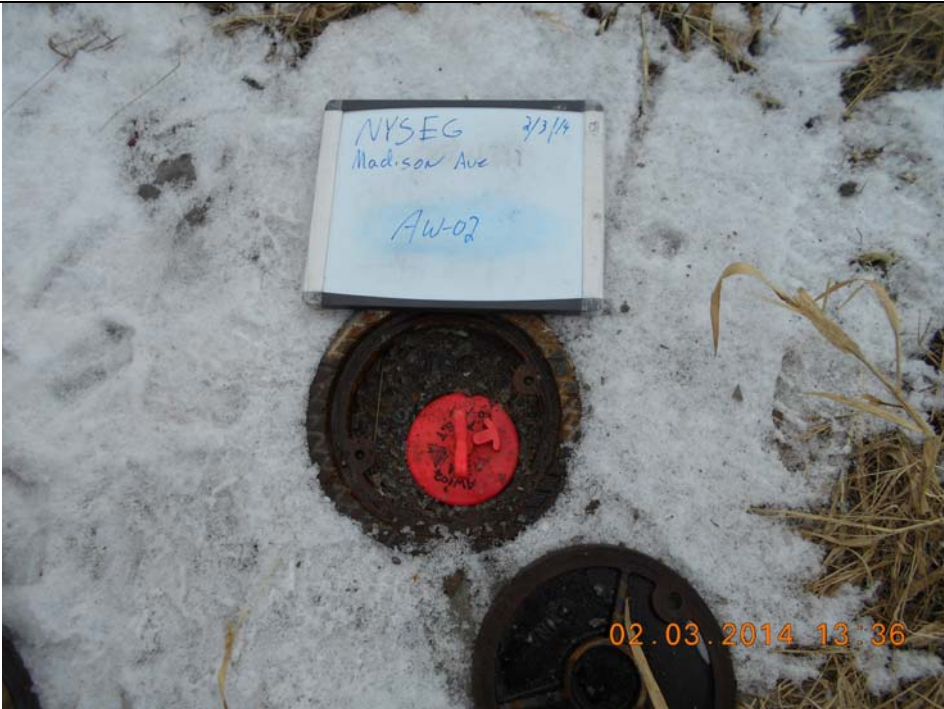
PHOTOGRAPHER: RDC	
DATE: 02/03/2014	
DIRECTION: facing N	
COMMENT: Photograph showing AW-02. Well and stainless steel canister/assembly is in good condition. Well has well plug and competent cover. Concrete at surface completion is brittle and degrading; needs to be replaced.

As presented in **Section 5.3**, repairs to two AWs are recommended

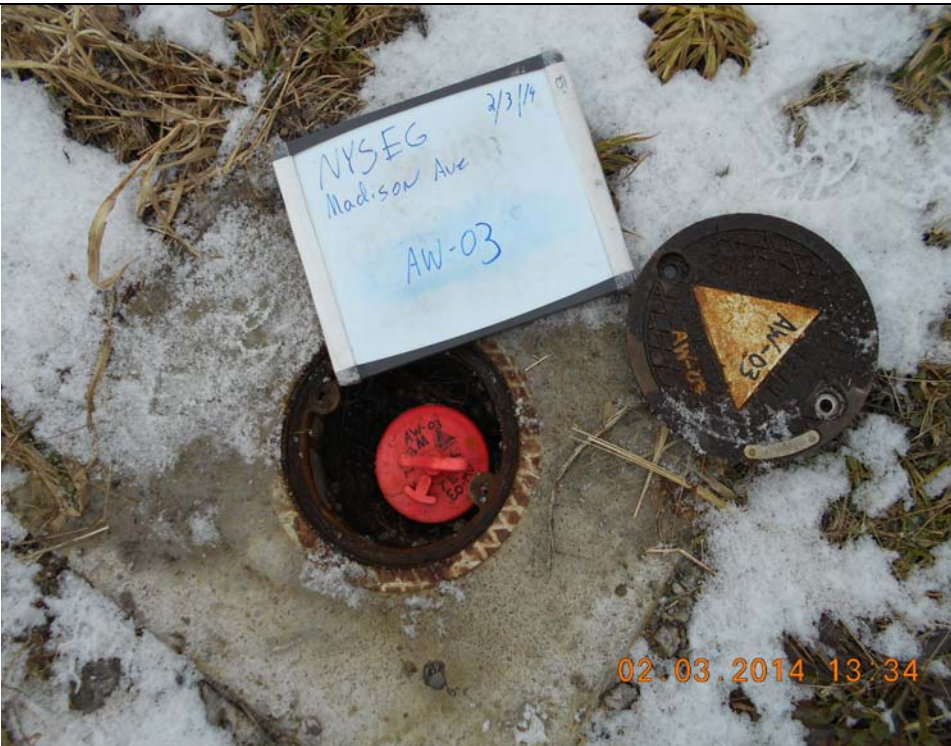
PHOTOGRAPHER: NJB	
DATE: 02/03/2014	
DIRECTION: facing N	
COMMENT: Photograph showing AW-03. Well and stainless steel canister/assembly is in good condition. Well has well plug and competent cover.

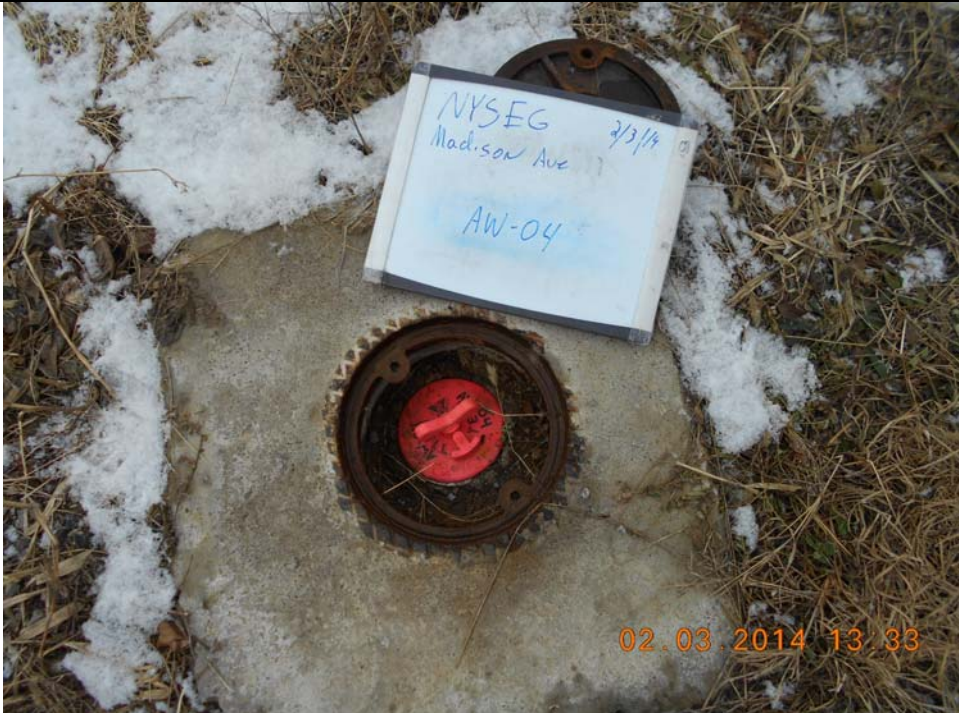
PHOTOGRAPHER: NJB	
DATE: 02/03/2014	
DIRECTION: facing N	
COMMENT: Photograph showing AW-04. Well and stainless steel canister/assembly is in good condition. Well has well plug and competent cover.

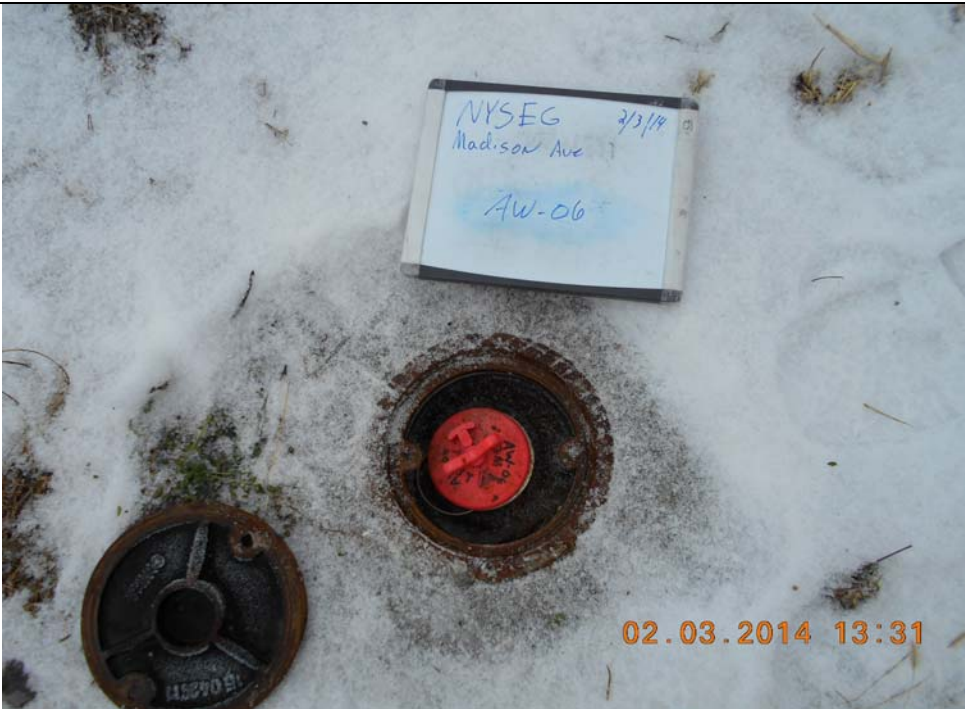
PHOTOGRAPHER: NJB	
DATE: 02/03/2014	
DIRECTION: facing N	
COMMENT: Photograph showing AW-06. Well and stainless steel canister/assembly is in good condition. Well has well plug and competent cover.

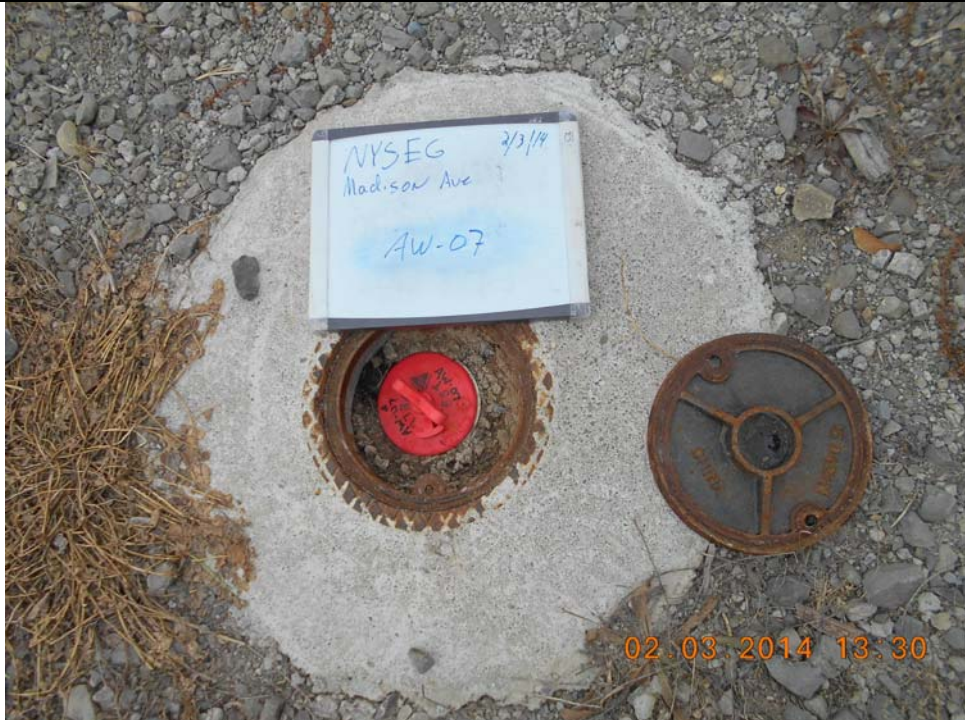
PHOTOGRAPHER: NJB	
DATE: 02/03/2014	
DIRECTION: facing N	
COMMENT: Photograph showing AW-07. Well and stainless steel canister/assembly is in good condition. Well has well plug and competent cover.

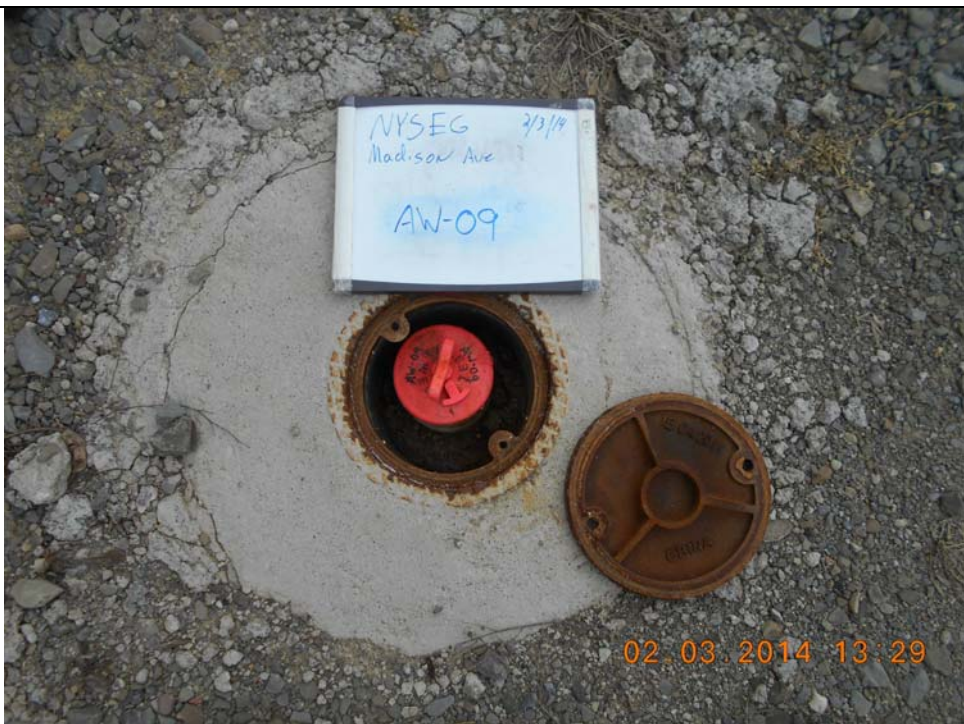
PHOTOGRAPHER: RDC	
DATE: 02/03/2014	
DIRECTION: facing N	
COMMENT: Photograph showing AW-09. Well and stainless steel canister/assembly is in good condition. Well has well plug and competent cover.

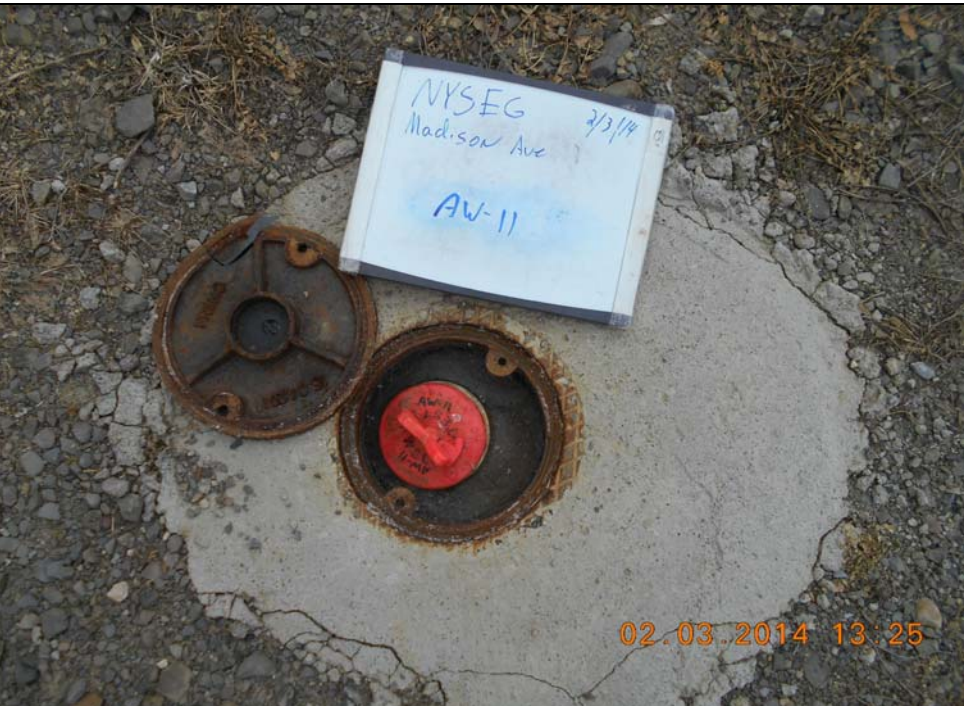
PHOTOGRAPHER: RDC	
DATE: 02/03/2014	
DIRECTION: facing N	
COMMENT: Photograph showing AW-11. Well and stainless steel canister/assembly is in good condition. Well has well plug. Well cover is cracked and broken and requires replacement.
