Annual Periodic Review Report Baseline Event through Q4

Madison Avenue Former MGP Site
Elmira, New York
NYSDEC Site Number: 808018

September 2014
Revised February 2015

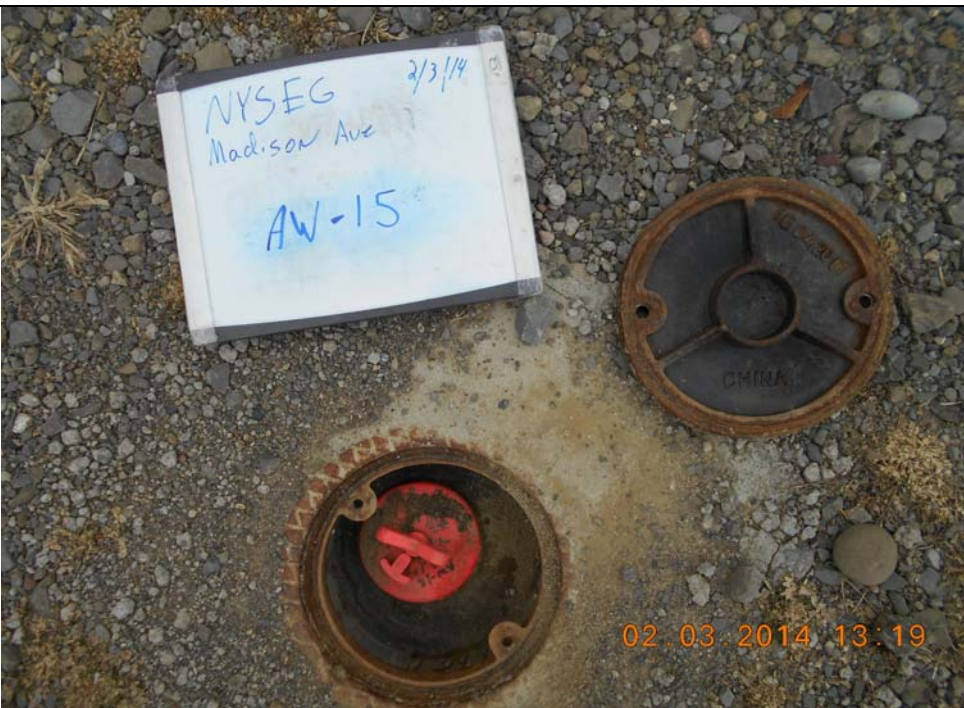
PHOTOGRAPHER: RDC	
DATE: 02/03/2014	
DIRECTION: facing N	
COMMENT: Photograph showing AW-15. Well and stainless steel canister/assembly is in good condition. Well has well plug and competent cover.

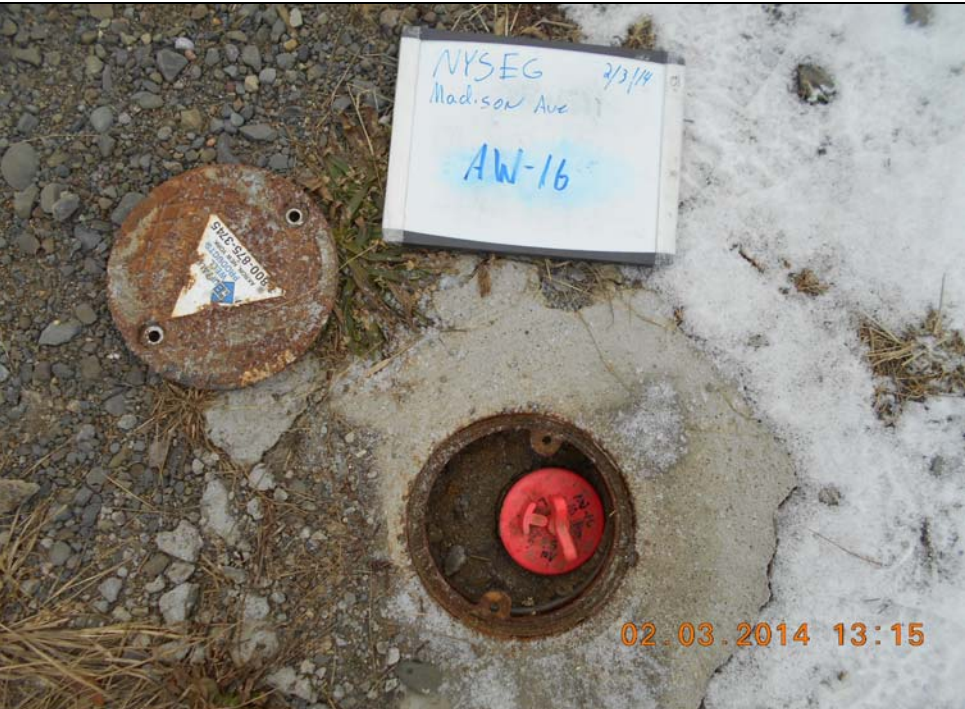
PHOTOGRAPHER: RDC	
DATE: 02/03/2014	
DIRECTION: facing N	
COMMENT: Photograph showing AW-16. Well and stainless steel canister/assembly is in good condition. Well has well plug and competent cover.

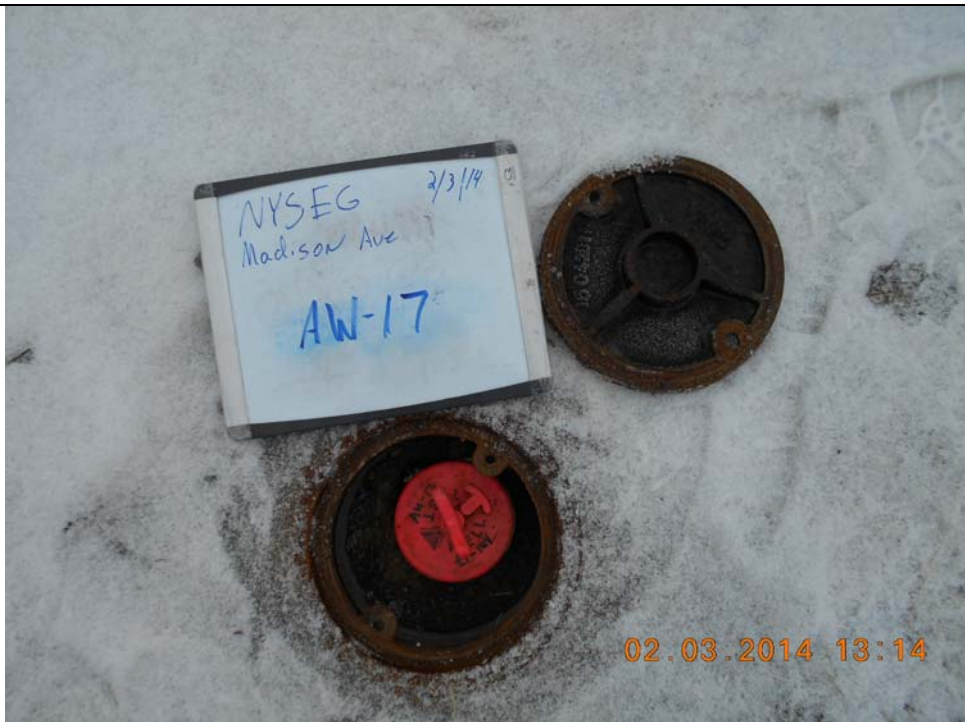
PHOTOGRAPHER: RDC	
DATE: 02/03/2014	
DIRECTION: facing N	
COMMENT: Photograph showing AW-17. Well and stainless steel canister/assembly is in good condition. Well has well plug and competent cover.

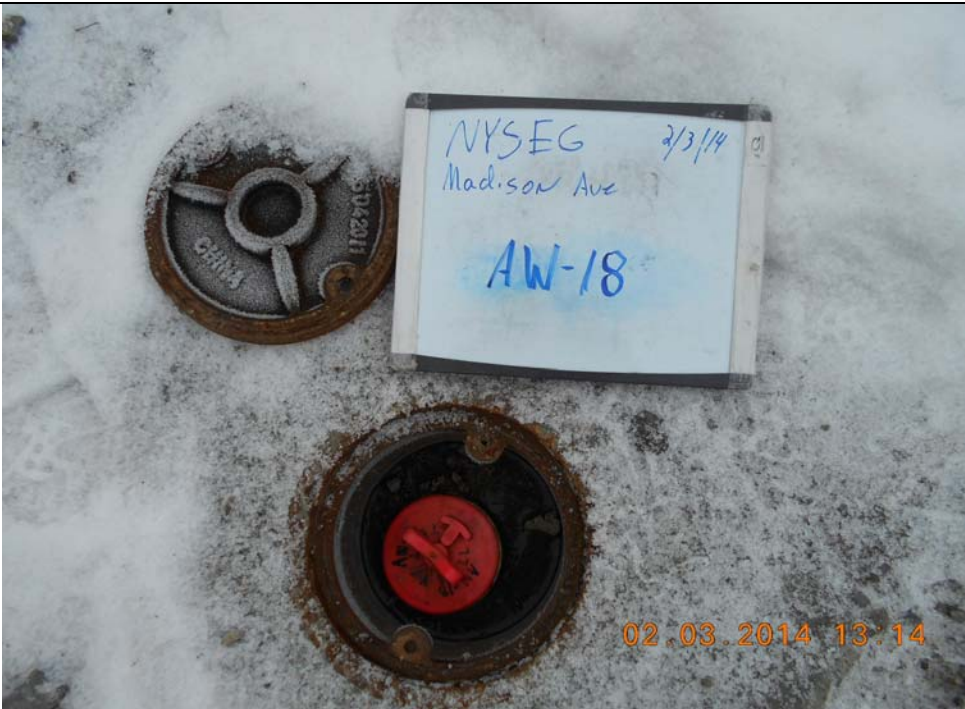
PHOTOGRAPHER: RDC	
DATE: 02/03/2014	
DIRECTION: facing N	
COMMENT: Photograph showing AW-18. Well and stainless steel canister/assembly is in good condition. Well has well plug and competent cover.

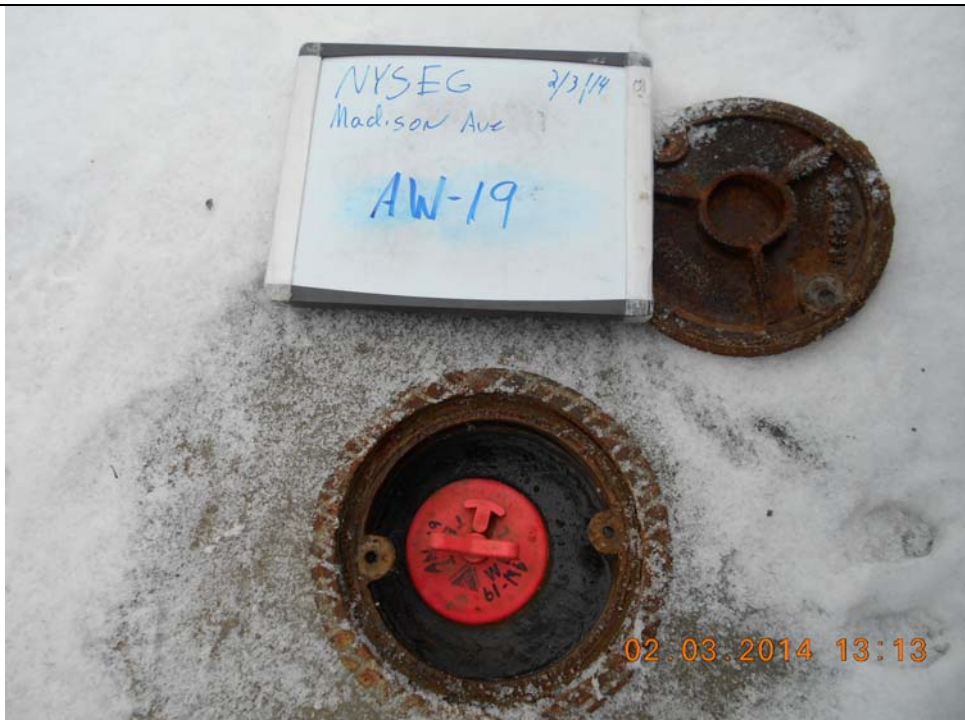
PHOTOGRAPHER: RDC	
DATE: 02/03/2014	
DIRECTION: facing N	
COMMENT: Photograph showing AW-19. Well and stainless steel canister/assembly is in good condition. Well has well plug and competent cover.

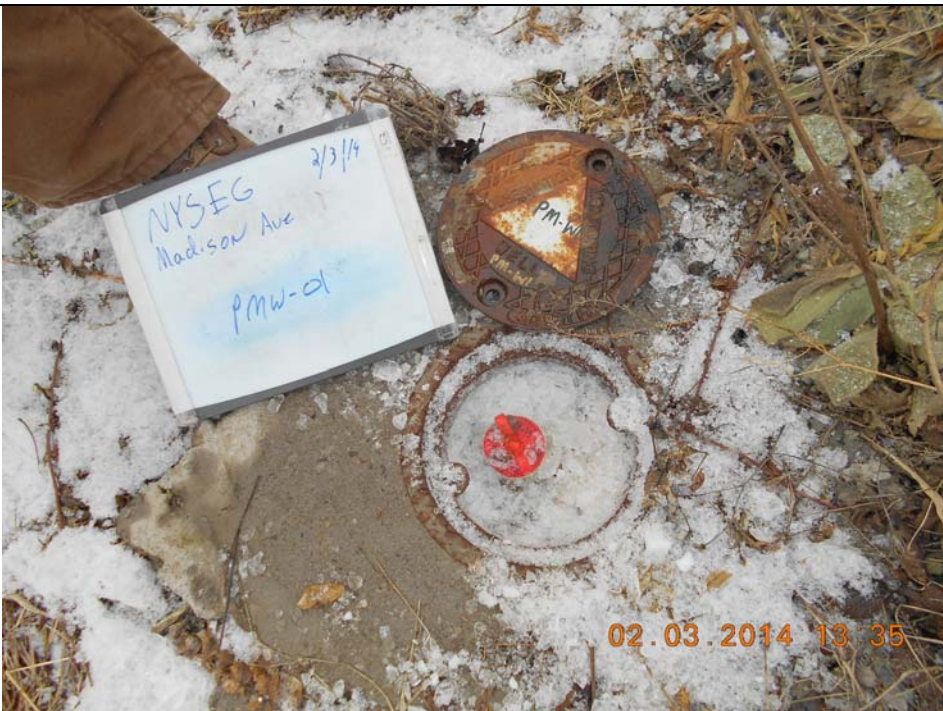
PHOTOGRAPHER: RDC	
DATE: 02/03/2014	
DIRECTION: facing N	
COMMENT: Photograph showing PMW-01. Well is in good condition with well plug and competent cover.

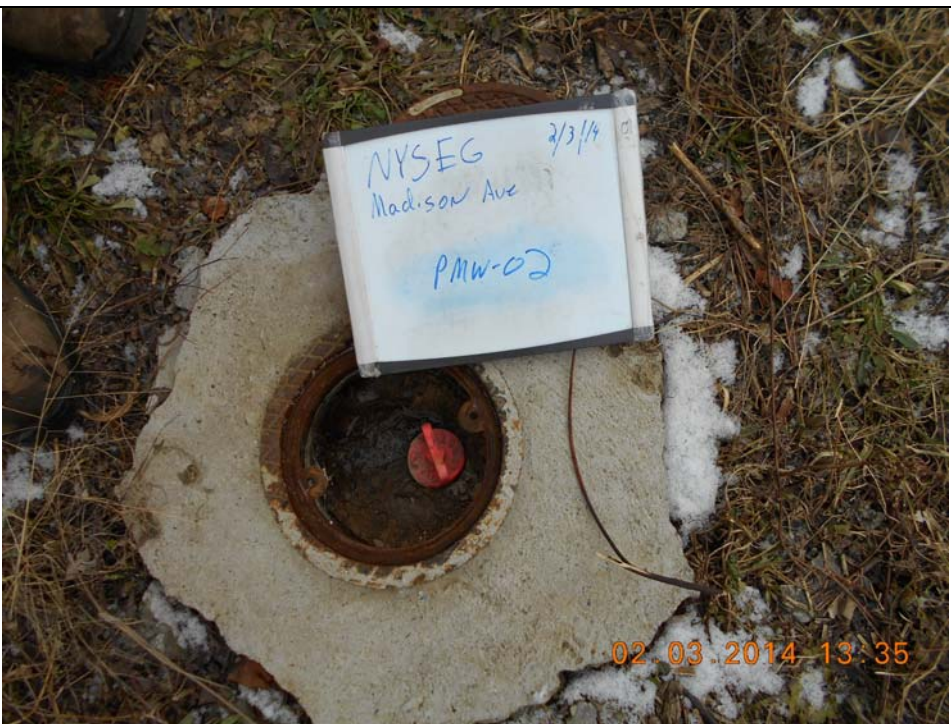
The surface completion at PMW-2 was observed to be deteriorated and the surrounding ground surface settled. The higher groundwater elevation at PMW-2 may be the result of surface water infiltration due to a complete failure of its surface completion. The surface completion at PMW-2 is scheduled to be repaired during the August 2014 semi-annual site visit.).

PHOTOGRAPHER: RDC	
DATE: 02/03/2014	
DIRECTION: facing N	
COMMENT: Photograph showing PMW-02. Ground around surface completion has settled. New surface completion (concrete apron and road box) is required.

As presented in **Section 5.3**, repairs to one PMW is recommended.

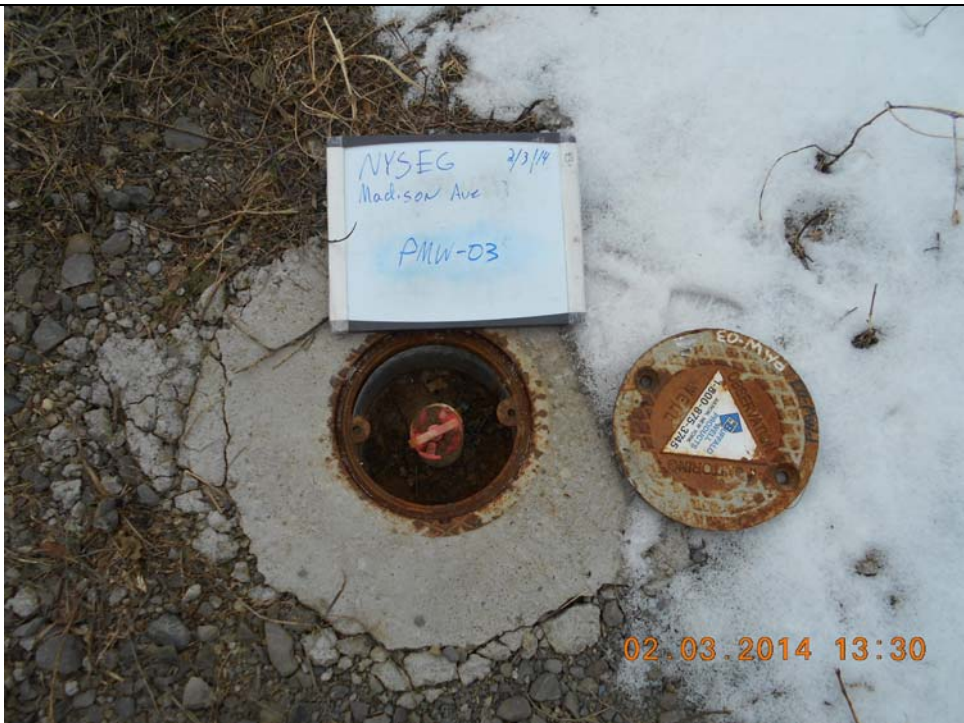
PHOTOGRAPHER: NJB	
DATE: 02/03/2014	
DIRECTION: facing N	
COMMENT: Photograph showing PMW-03. Well is in good condition with well plug and competent cover.

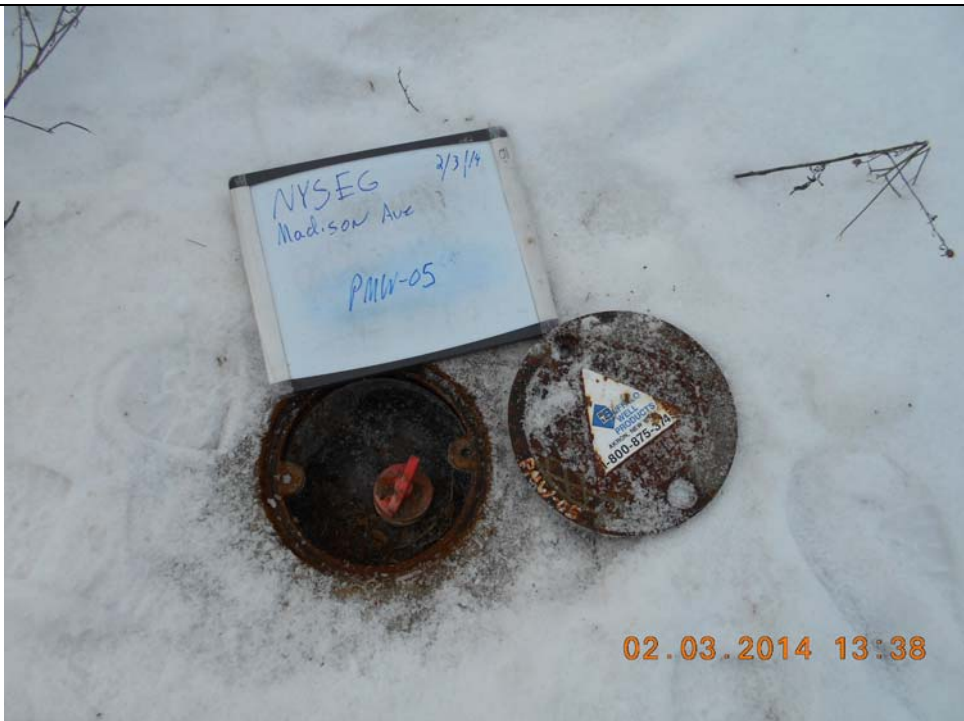
PHOTOGRAPHER: RDC	
DATE: 02/03/2014	
DIRECTION: facing N	
COMMENT: Photograph showing PMW-05. Well is in good condition with well plug and competent cover.

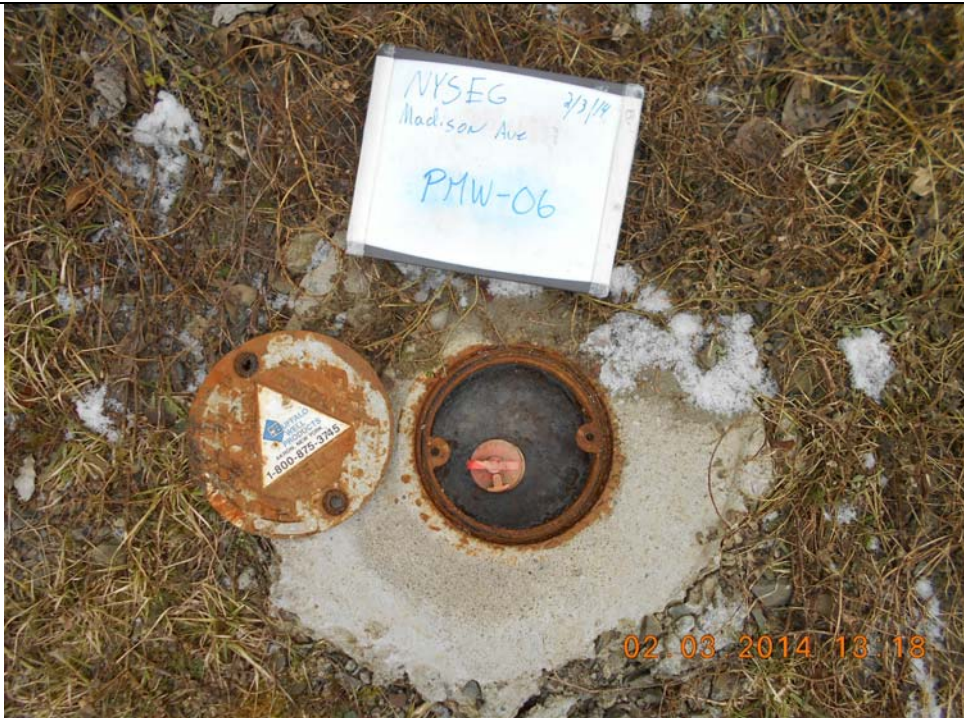
PHOTOGRAPHER: RDC	
DATE: 02/03/2014	
DIRECTION: facing N	
COMMENT: Photograph showing PMW-06. Well is in good condition with well plug and competent cover.

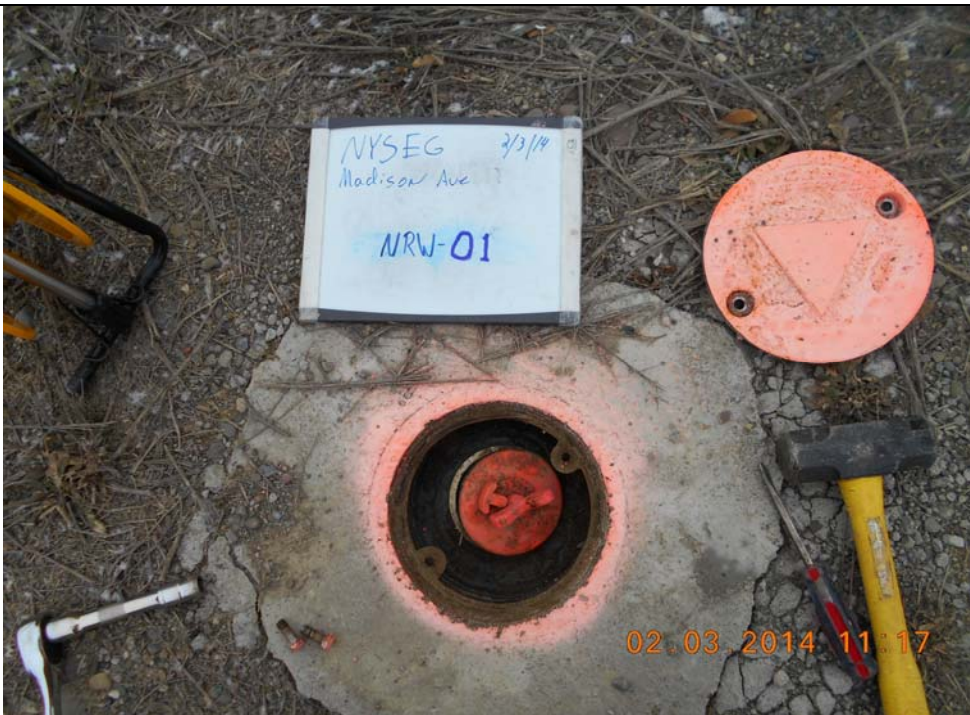
PHOTOGRAPHER: RDC	
DATE: 02/03/2014	
DIRECTION: facing N	
COMMENT: Photograph showing NRW-01. Well is in good condition with well plug and competent cover. Riser needs to be cut down to provide adequate room for well plug.

As presented in **Section 5.3**, repairs to one NRW is recommended.

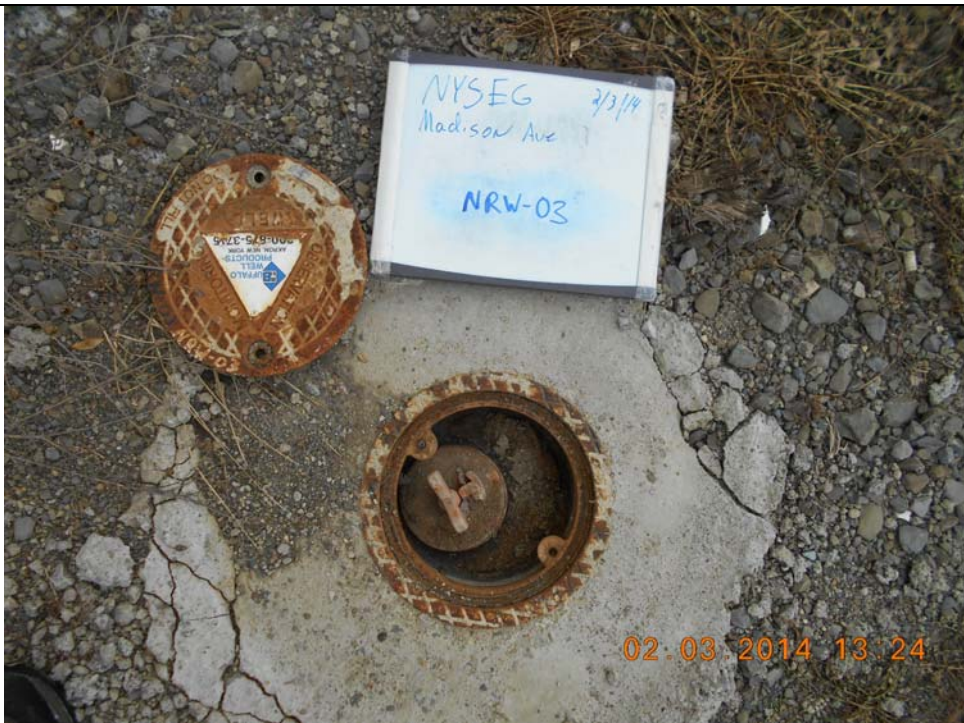
PHOTOGRAPHER: RDC	
DATE: 02/03/2014	
DIRECTION: facing N	
COMMENT: Photograph showing NRW-03. Well is in good condition with well plug and competent cover.

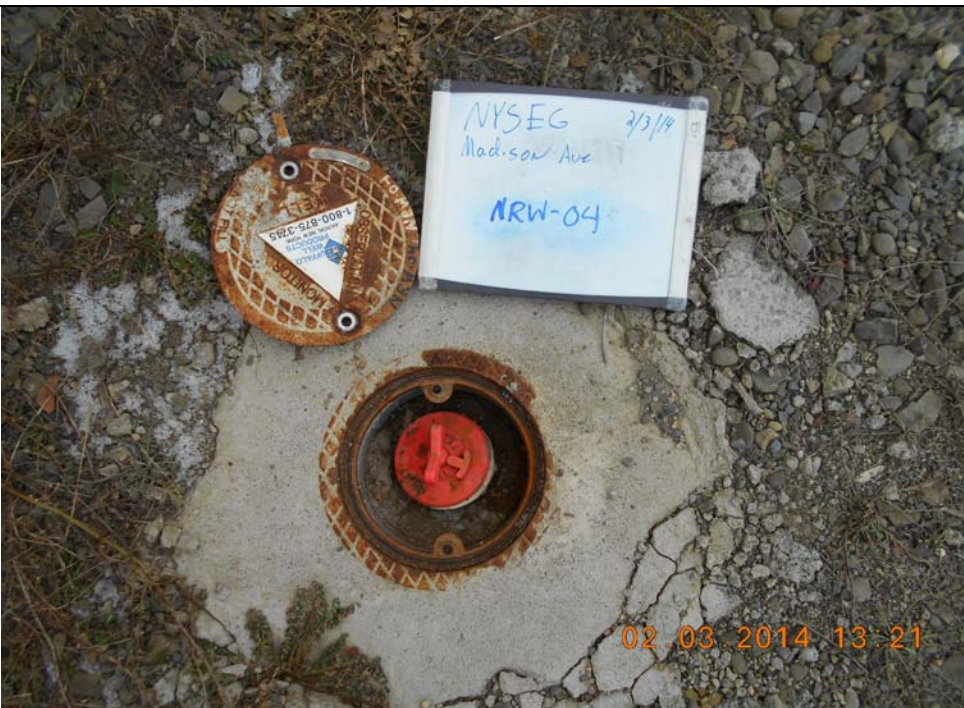
PHOTOGRAPHER: RDC	
DATE: 02/03/2014	
DIRECTION: facing N	
COMMENT: Photograph showing NRW-04. Well is in good condition with well plug and competent cover.

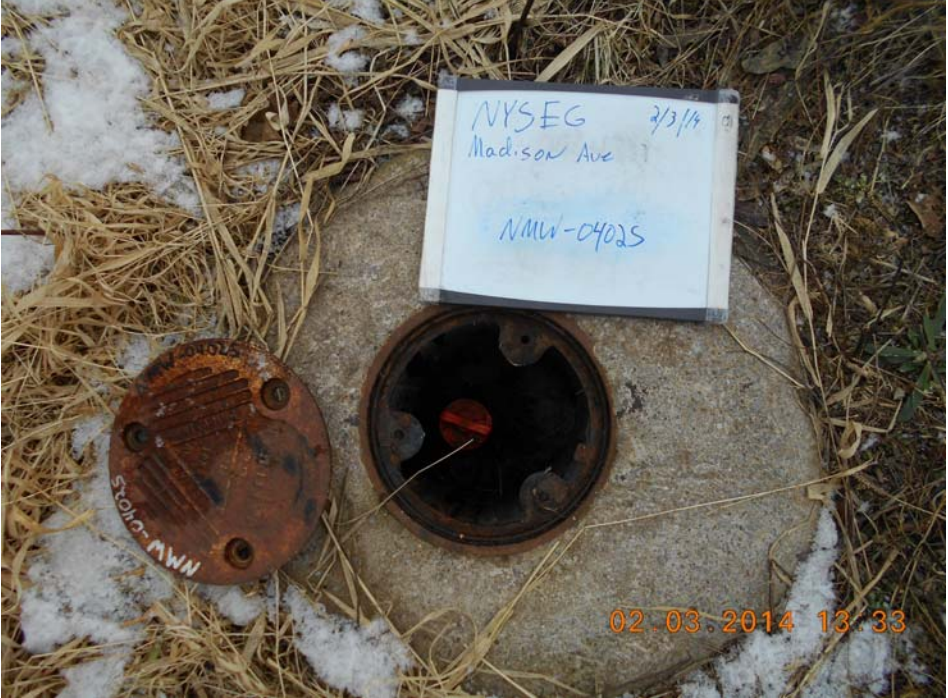
PHOTOGRAPHER: NJB	
DATE: 02/03/2014	
DIRECTION: facing N	
COMMENT: Photograph showing NMW-0402S. Well is in good condition with well plug and competent cover.
