ANNUAL PERIODIC REVIEW REPORT (Q17 THROUGH Q20)

Madison Avenue Former MGP Site
Elmira, New York
NYSDEC Site Number: 808018

April 27, 2018

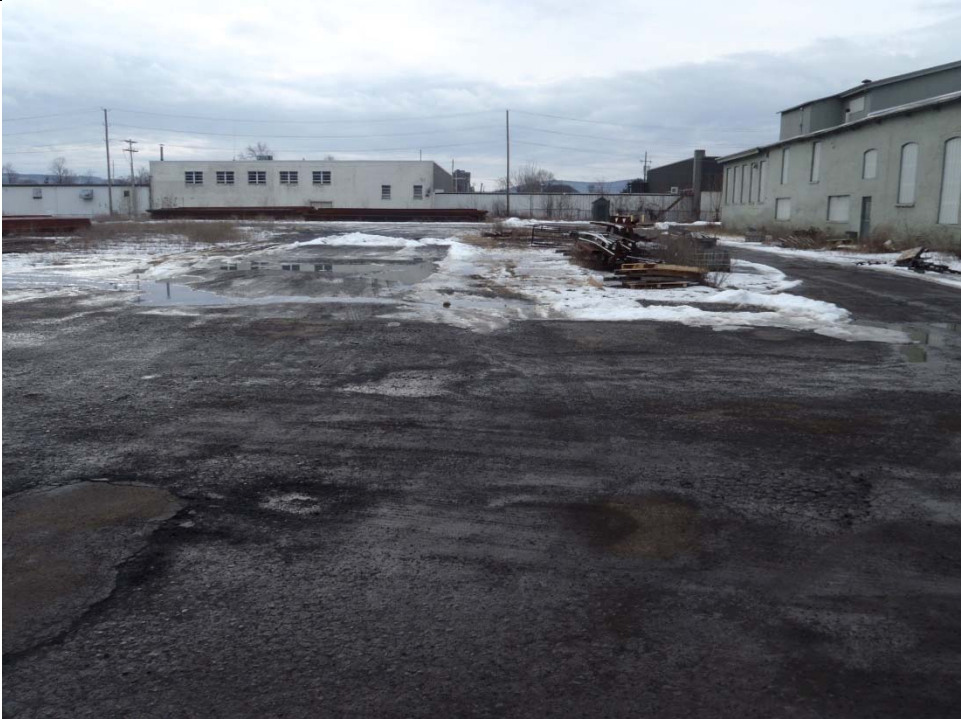
CLIENT: NYSEG	SITE NAME: Madison Avenue Former MGP Site
PROJECT#: B0013134.0001	SITE LOCATION: Elmira, New York
PHOTOGRAPH #: 1

PHOTOGRAPHER: NJB	
DATE: 02/12/18	
DIRECTION: SE	
COMMENT: Picture showing stone parking area over former manufactured gas plant (MGP) area. Photo indicates cover is in good condition; no repair is needed.

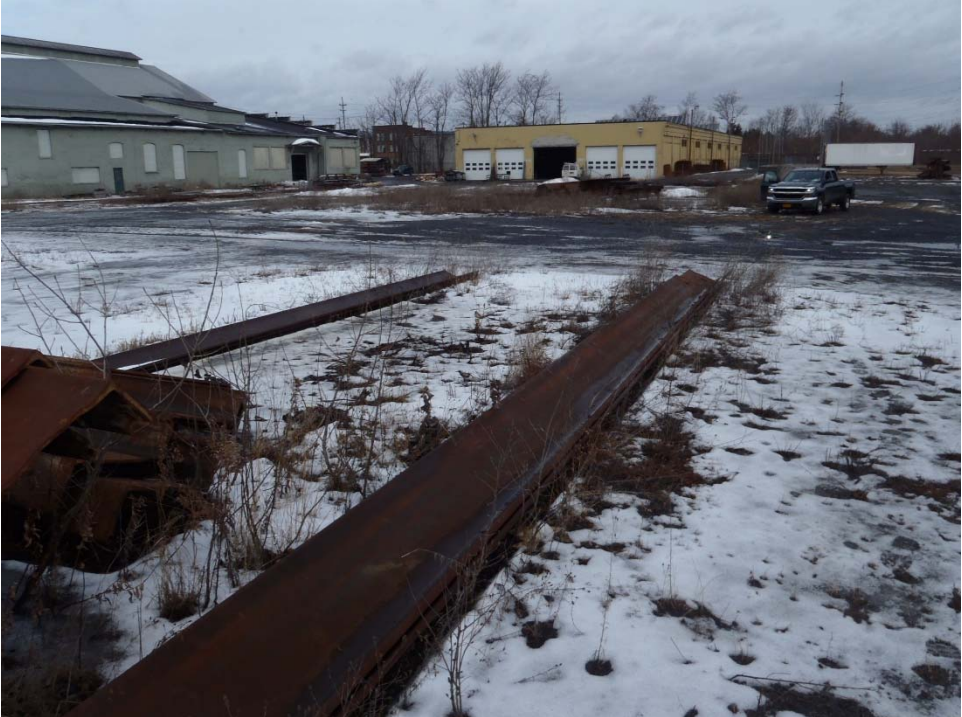
CLIENT: NYSEG	SITE NAME: Madison Avenue Former MGP Site
PROJECT#: B0013134.0001	SITE LOCATION: Elmira, New York
PHOTOGRAPH #: 3

PHOTOGRAPHER: NJB	
DATE: 02/12/18	
DIRECTION: NW	
COMMENT: Picture showing stone parking area over former MGP. Photo indicates cover is in good condition; no repair is needed. Area currently used for material staging.

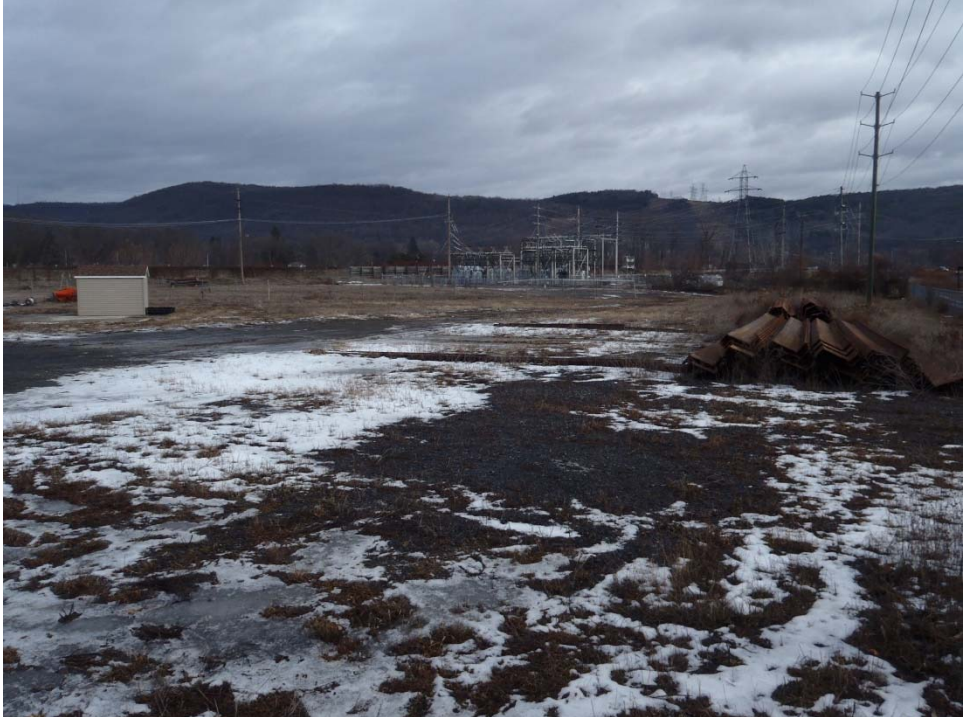
CLIENT: NYSEG	SITE NAME: Madison Avenue Former MGP Site
PROJECT#: B0013134.0001	SITE LOCATION: Elmira, New York
PHOTOGRAPH #: 5

PHOTOGRAPHER: NJB	
DATE: 02/12/18	
DIRECTION: NE	
COMMENT: Picture showing stone and vegetation coverage over PCB IRM removal areas (1997) and purifier waste removal area (2011). Photo indicates cover is in good condition; no repair is needed. Area currently used for material staging

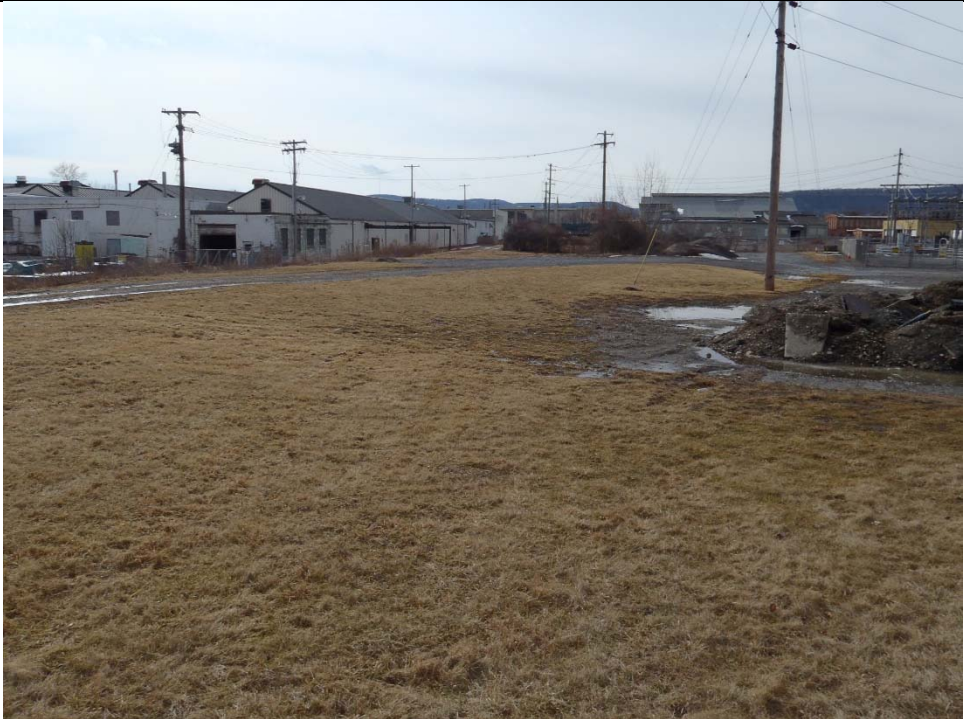
CLIENT: NYSEG	SITE NAME: Madison Avenue Former MGP Site
PROJECT#: B0013134.0001	SITE LOCATION: Elmira, New York
PHOTOGRAPH #: 7

PHOTOGRAPHER: NJB	
DATE: 02/12/18	
DIRECTION: SW	
COMMENT: Picture showing grass area and stone coverage over ISS area, purifier waste IRM removal area (2004) and purifier waste removal area (2011). Photo indicates cover is in good condition; no repair is needed.

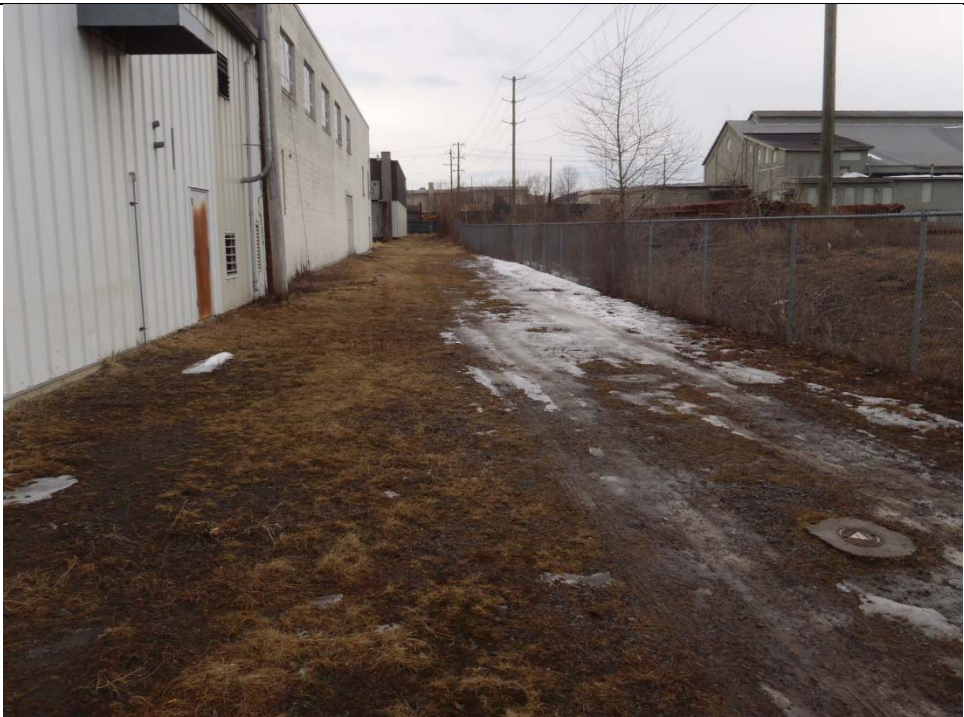
CLIENT: NYSEG	SITE NAME: Madison Avenue Former MGP Site
PROJECT#: B0013134.0001	SITE LOCATION: Elmira, New York
PHOTOGRAPH #: 8

PHOTOGRAPHER: NJB	
DATE: 02/12/18	
DIRECTION: WSW	
COMMENT: Picture showing treatment system area. Photo indicates cover is in good condition; no repair is needed.

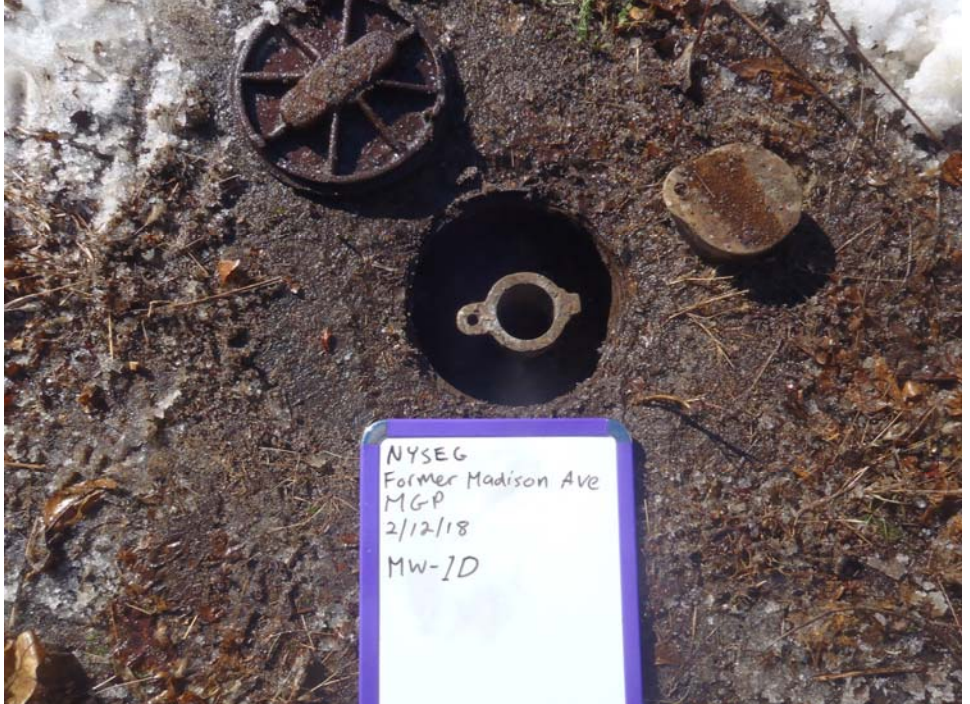
CLIENT: NYSEG	SITE NAME: Madison Avenue Former MGP Site
PROJECT#: B0013134.0001	SITE LOCATION: Elmira, New York
WELL ID: MW-1D

PHOTOGRAPHER: NJB	
DATE: 02/12/18	
DIRECTION: NA	
COMMENT: Photograph showing MW-1D. Well is in good condition with cap and competent cover.

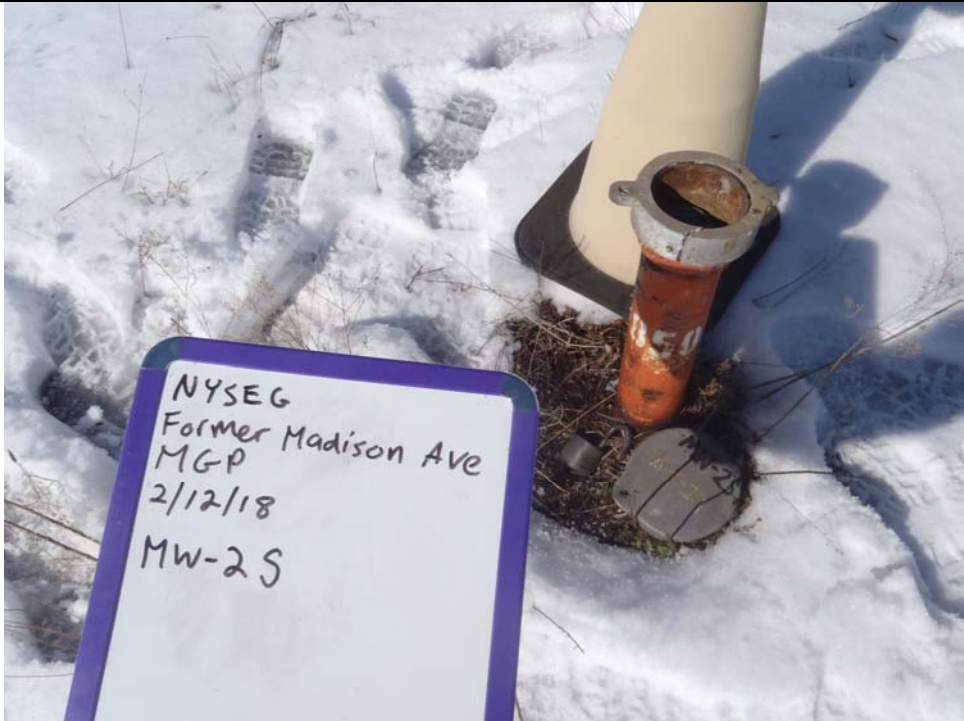
CLIENT: NYSEG	SITE NAME: Madison Avenue Former MGP Site
PROJECT#: B0013134.0001	SITE LOCATION: Elmira, New York
WELL ID: MW-2S

PHOTOGRAPHER: NJB	
DATE: 02/12/18	
DIRECTION: NA	
COMMENT: Photograph showing MW-2S. Cap mounting rig is cracked but competent. Well is in good condition with locking cap.

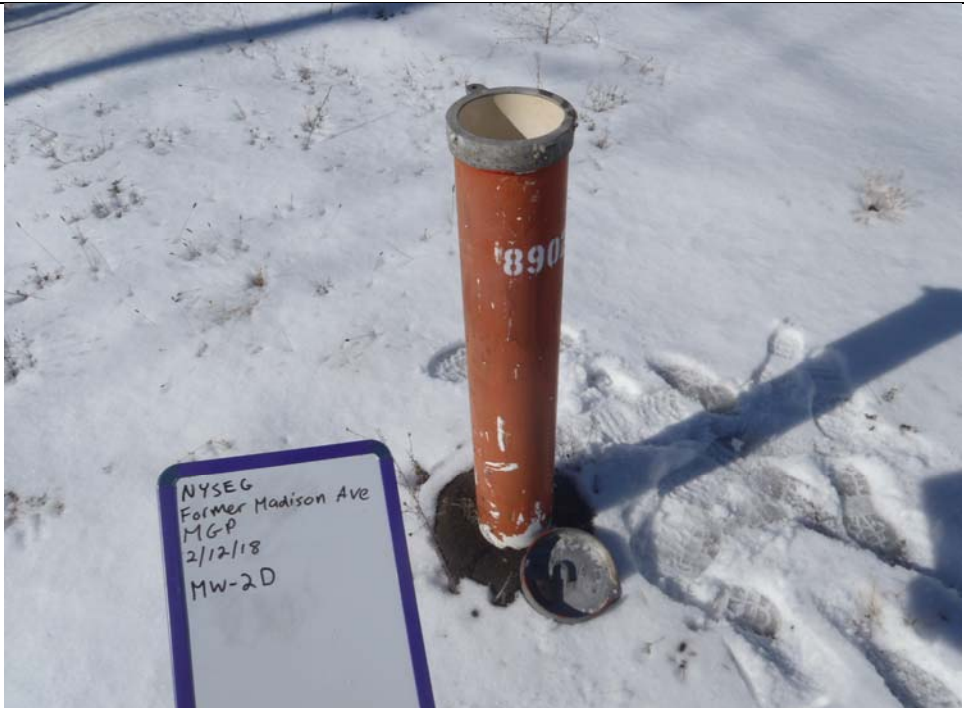
CLIENT: NYSEG	SITE NAME: Madison Avenue Former MGP Site
PROJECT#: B0013134.0001	SITE LOCATION: Elmira, New York
WELL ID: MW-2D

PHOTOGRAPHER: NJB	
DATE: 02/12/18	
DIRECTION: NA	
COMMENT: Photograph showing MW-2D. Well is in good condition with locking cap.

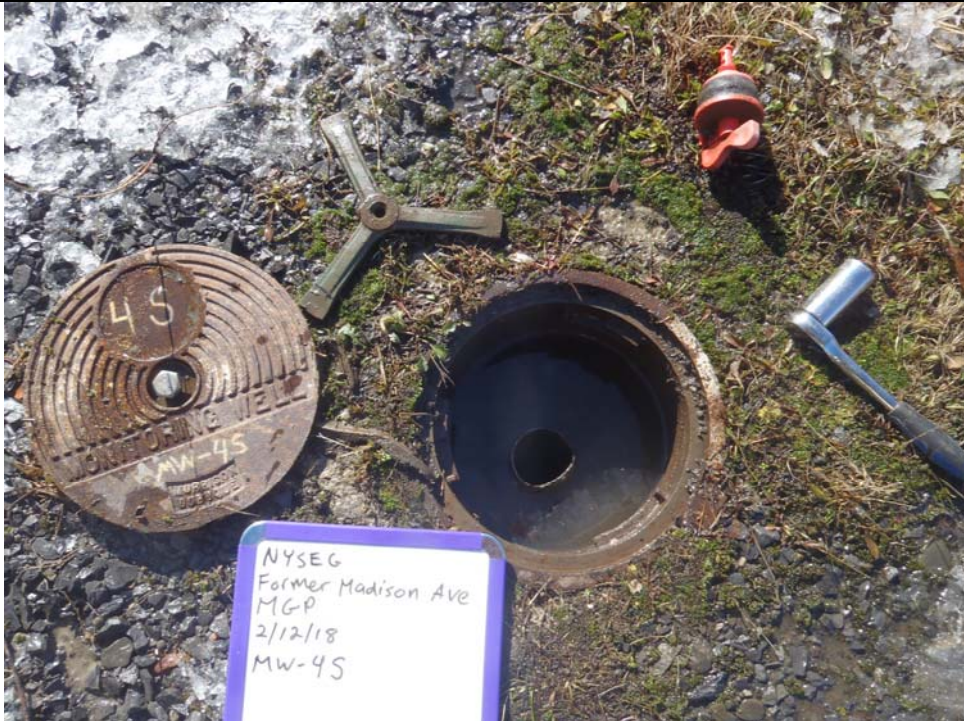
CLIENT: NYSEG	SITE NAME: Madison Avenue Former MGP Site
PROJECT#: B0013134.0001	SITE LOCATION: Elmira, New York
WELL ID: MW-4S

PHOTOGRAPHER: NJB	
DATE: 02/12/18	
DIRECTION: NA	
COMMENT: Photograph showing MW-4S. Well is in good condition with locking cap and competent cover.

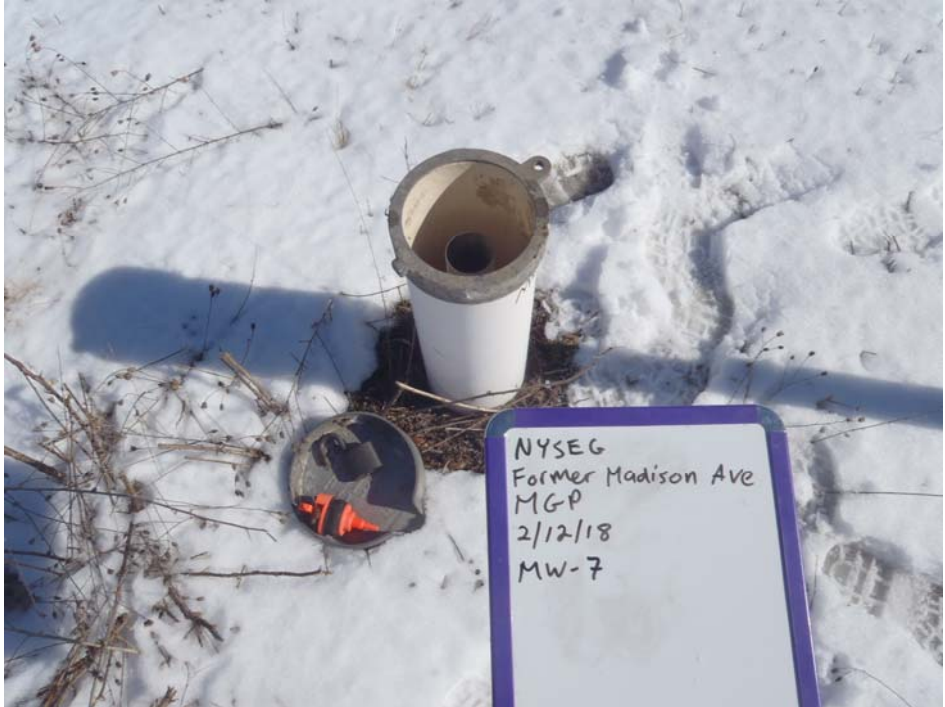
CLIENT: NYSEG	SITE NAME: Madison Avenue Former MGP Site
PROJECT#: B0013134.0001	SITE LOCATION: Elmira, New York
WELL ID: MW-7

PHOTOGRAPHER: NJB	
DATE: 02/12/18	
DIRECTION: NA	
COMMENT: Photograph showing MW-7. Well is in good condition. Well has well plug and locking well cover.

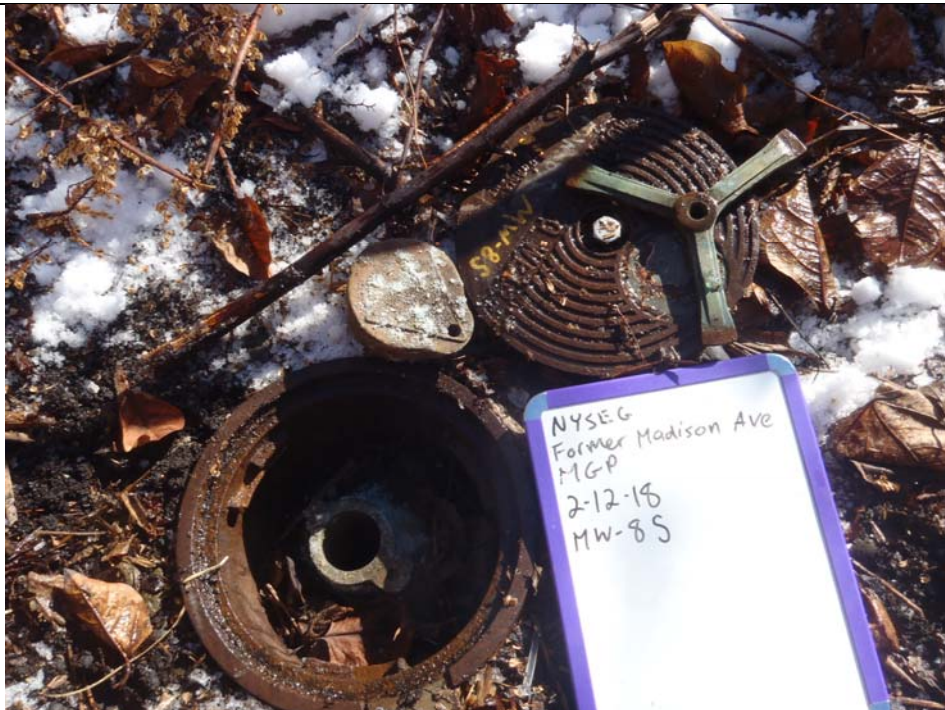
CLIENT: NYSEG	SITE NAME: Madison Avenue Former MGP Site
PROJECT#: B0013134.0001	SITE LOCATION: Elmira, New York
WELL ID: MW-8S

PHOTOGRAPHER: NJB	
DATE: 02/12/18	
DIRECTION: NA	
COMMENT: Photograph of MW-8S. Well is in good condition with locking well cap and competent cover.

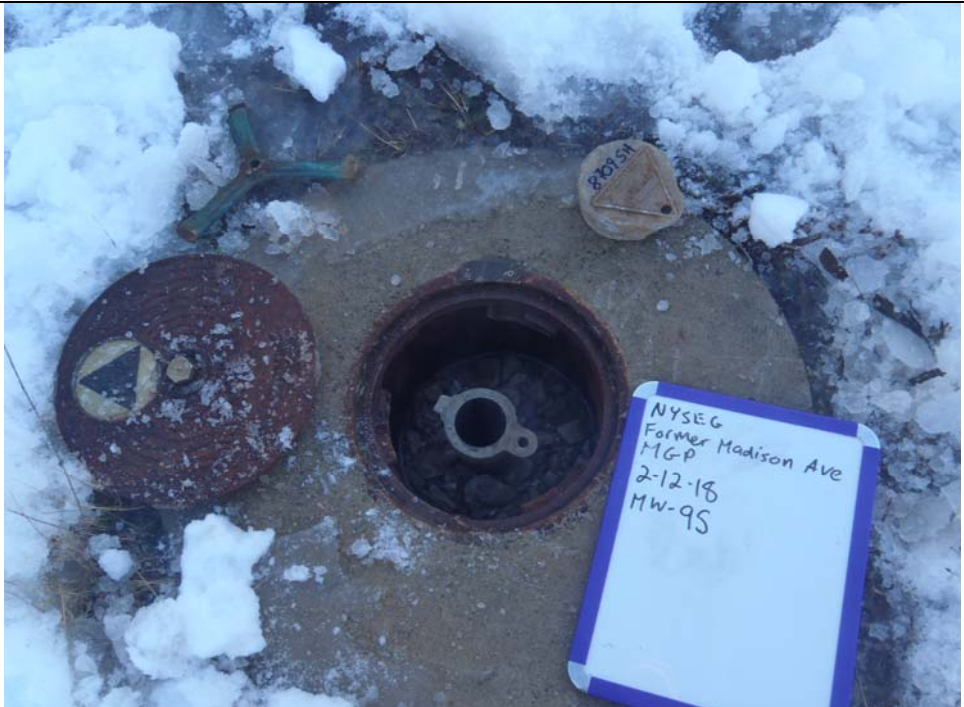
CLIENT: NYSEG	SITE NAME: Madison Avenue Former MGP Site
PROJECT#: B0013134.0001	SITE LOCATION: Elmira, New York
WELL ID: MW-9S

PHOTOGRAPHER: NJB	
DATE: 02/12/18	
DIRECTION: NA	
COMMENT: Photograph showing MW-9S. Well is in good condition with locking well cap and competent cover.

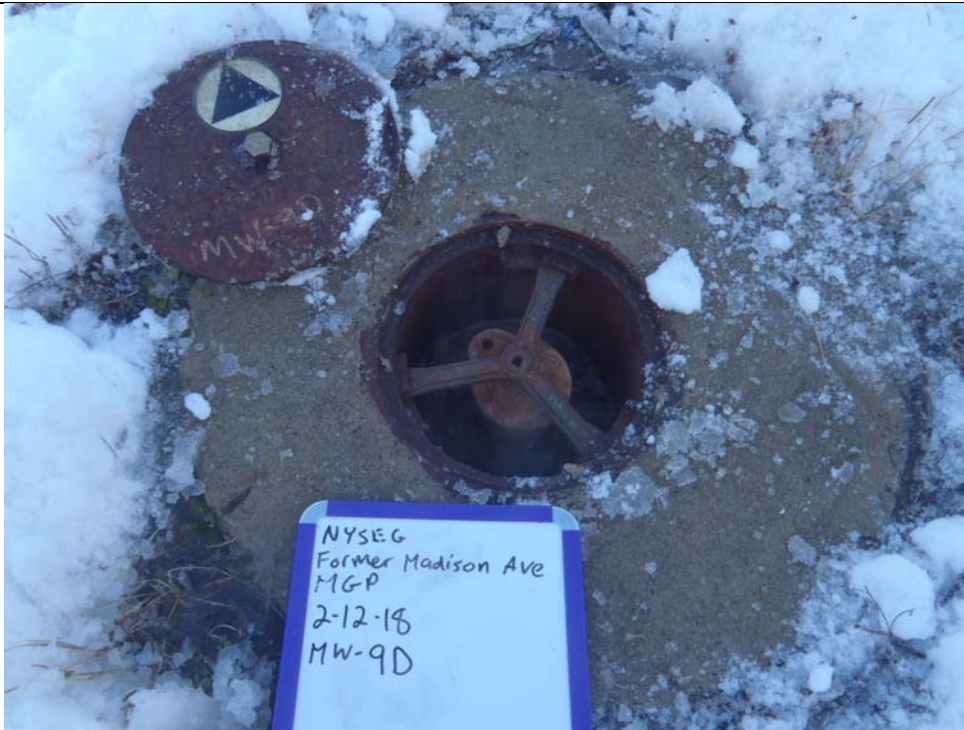
PHOTOGRAPHER: NJB	
DATE: 02/12/18	
DIRECTION: NA	
COMMENT: Photograph showing MW-9D. Well is in good condition with locking well cap and competent cover.

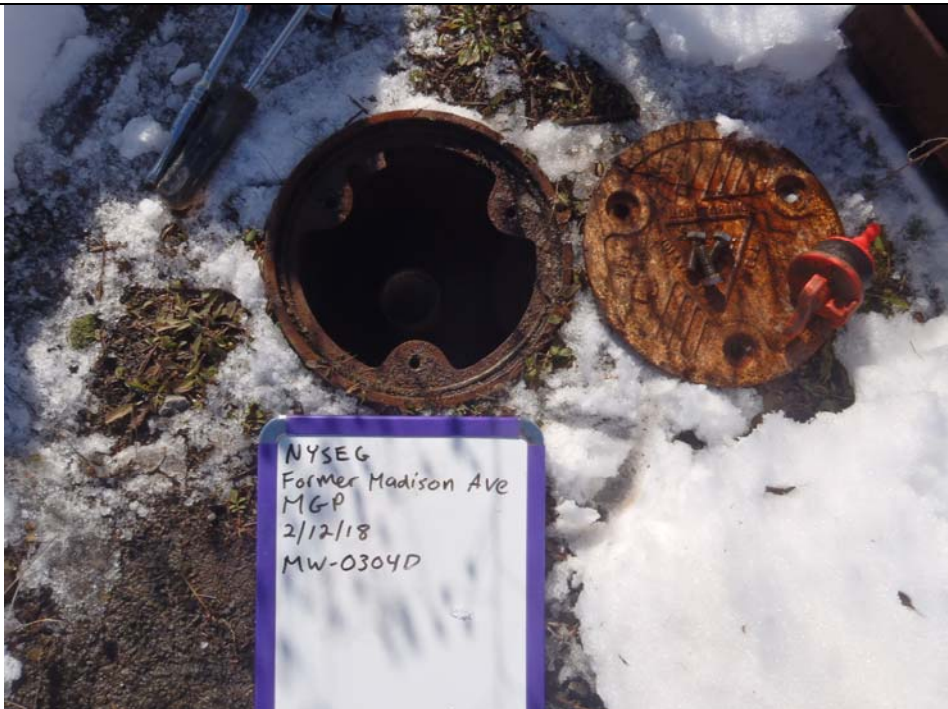
PHOTOGRAPHER: NJB	
DATE: 02/12/18	
DIRECTION: NA	
COMMENT: Photograph showing MW-0304D. Well is in good condition with well and competent cover.

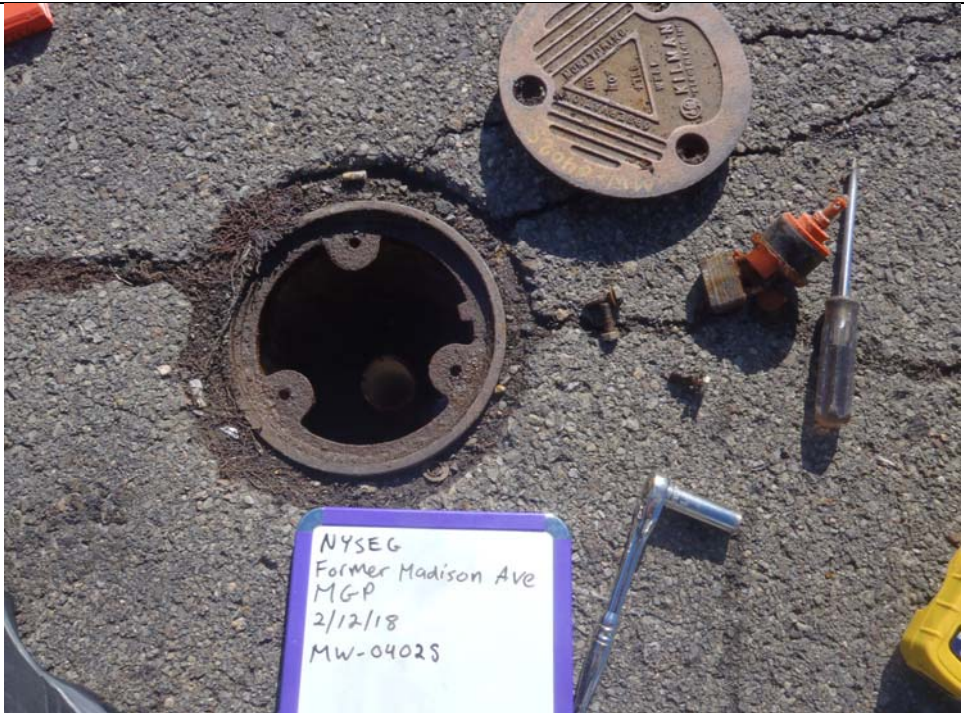
PHOTOGRAPHER: NJB	
DATE: 02/12/18	
DIRECTION: NA	
COMMENT: Photograph showing MW-0402S. Well is in good condition with locking well plug and competent cover.

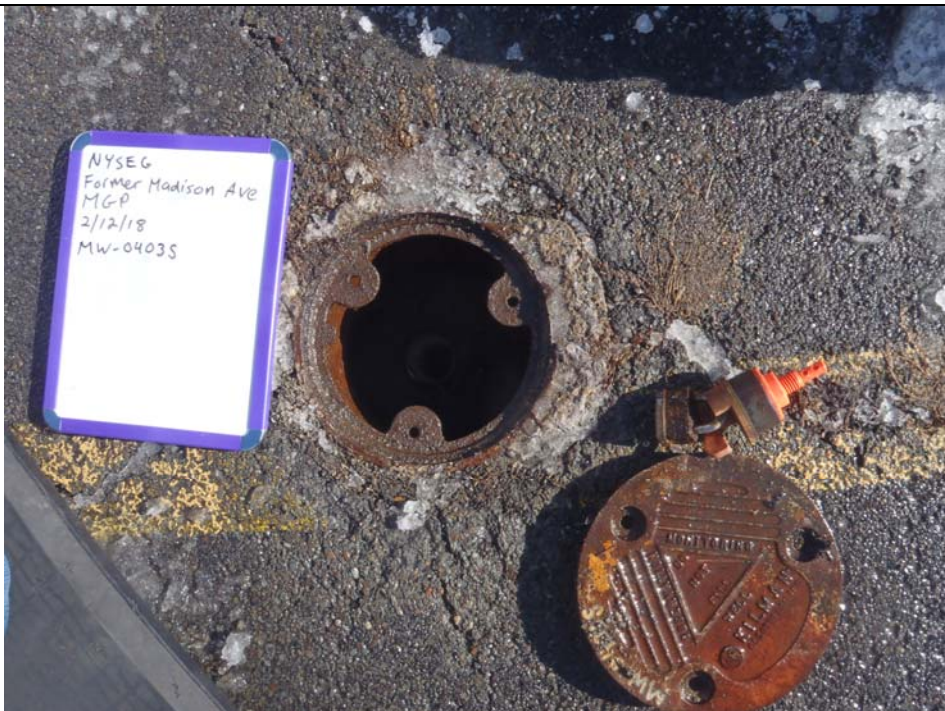
PHOTOGRAPHER: NJB	
DATE: 02/12/18	
DIRECTION: NA	
COMMENT: Photograph showing MW-0403S. Well is in good condition with locking well plug and competent cover.

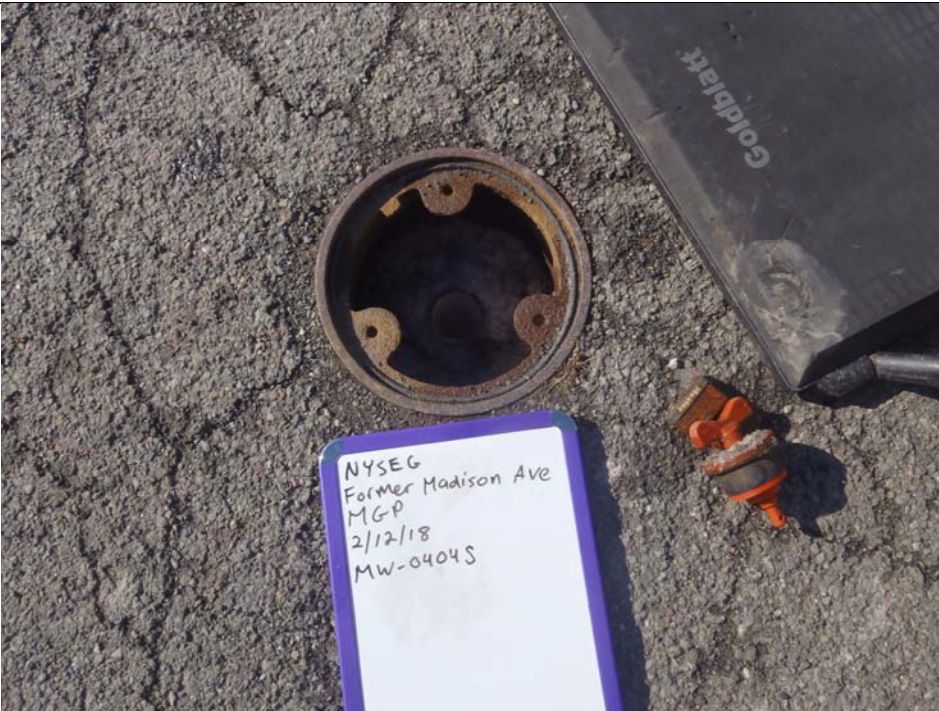
Visual inspection of the treatment system wells was conducted during the annual site visit (Q20). Only one deficiency was noted; the well road box lid was missing on monitoring well MW-0404S and requires replacement/repair.

PHOTOGRAPHER: NJB	
DATE: 02/12/18	
DIRECTION: NA	
COMMENT: Photograph showing MW-0404S. Well is in good condition with locking well plug and competent cover. Bolted well lid was observed missing during the Annual Site Inspection. The lid will be replaced.

In addition, photographic documentation of the condition of each well associated with the site, including protective covers, locking devices, and overall integrity of the wells is also provided as **Appendix E**. The only deficiency noted was that the road box lid was missing from MW-0404S and requires replacement.

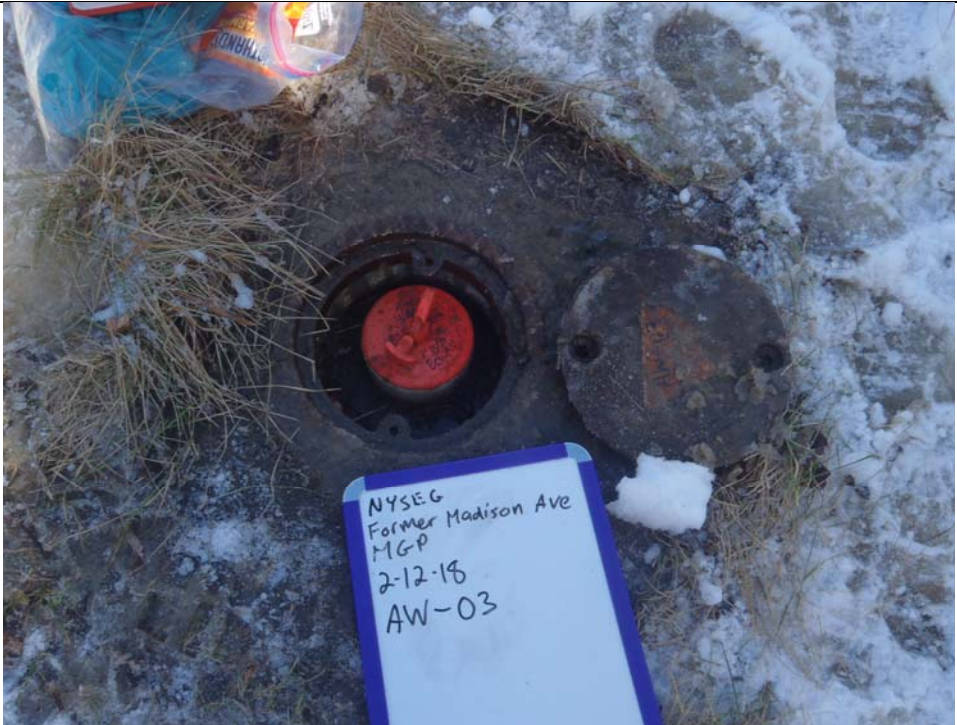
PHOTOGRAPHER: NJB	
DATE: 02/12/18	
DIRECTION: NA	
COMMENT: Photograph showing AW-03. Well and stainless-steel canister/assembly is in good condition. Well has well plug and competent cover.

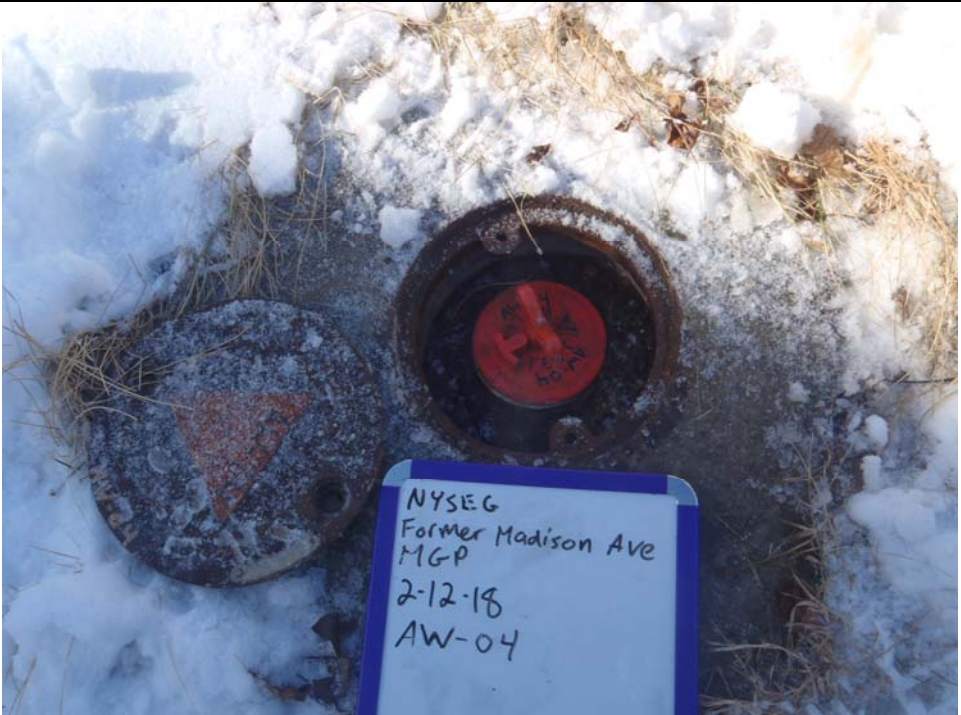
PHOTOGRAPHER: NJB	
DATE: 02/12/18	
DIRECTION: NA	
COMMENT: Photograph showing AW-4. Well and stainless-steel canister/assembly is in good condition. Well has well plug and competent cover.

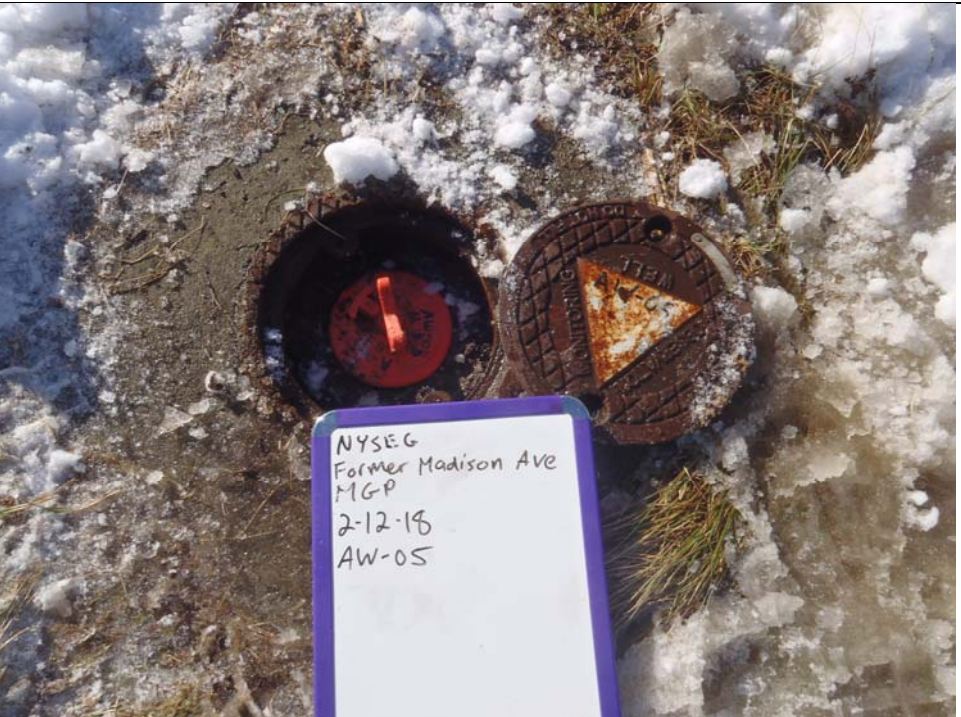
PHOTOGRAPHER: NJB	
DATE: 02/12/18	
DIRECTION: NA	
COMMENT: Photograph showing AW-05 Well and stainless – steel canister/assembly is in good condition. Well has well and competent cover.

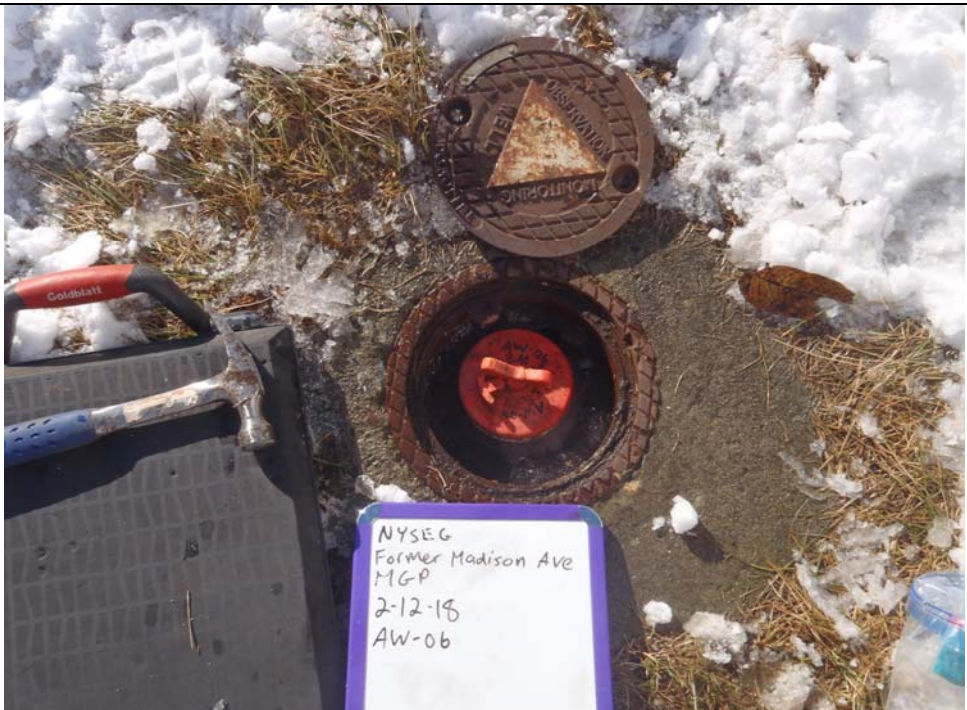
PHOTOGRAPHER: NJB	
DATE: 02/12/18	
DIRECTION: NA	
COMMENT: Photograph showing AW-6. Well and stainless-steel canister/assembly is in good condition. Well has well plug and competent cover.

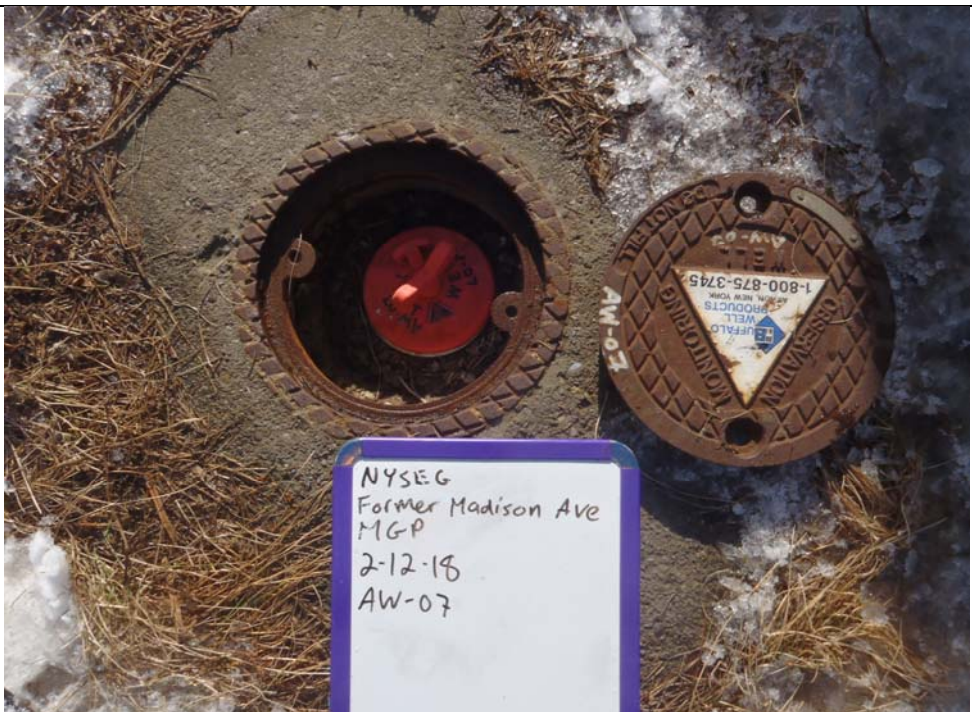
PHOTOGRAPHER: NJB	
DATE: 02/12/18	
DIRECTION: NA	
COMMENT: Photograph showing AW-7. Well and stainless-steel canister/assembly is in good condition. Well has well plug and competent cover.

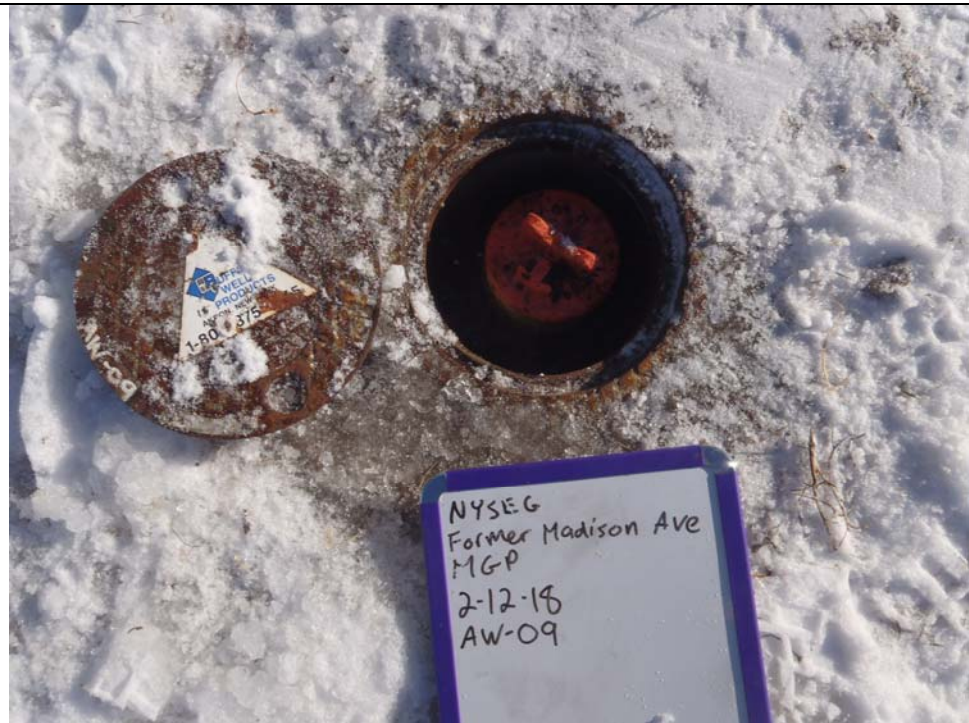
PHOTOGRAPHER: NJB	
DATE: 02/12/18	
DIRECTION: NA	
COMMENT: Photograph showing AW-9. Well and stainless-steel canister/assembly is in good condition. Well has well plug and competent cover.

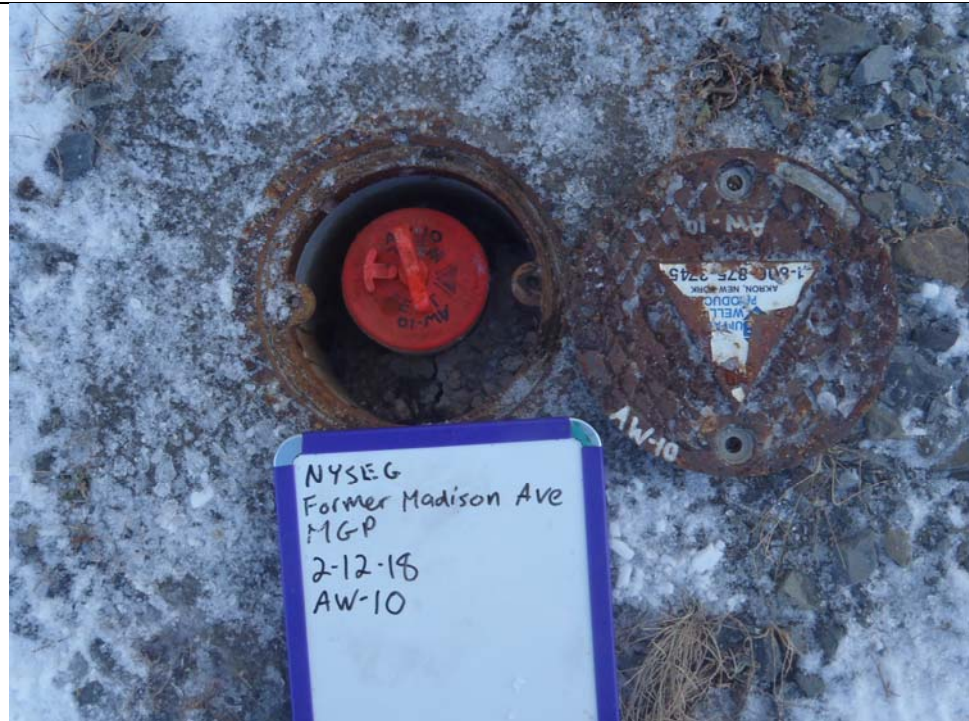
PHOTOGRAPHER: NJB	
DATE: 02/12/18	
DIRECTION: NA	
COMMENT: Photograph showing AW-10. Well and stainless-steel canister/assembly is in good condition. Well has well plug and competent cover.

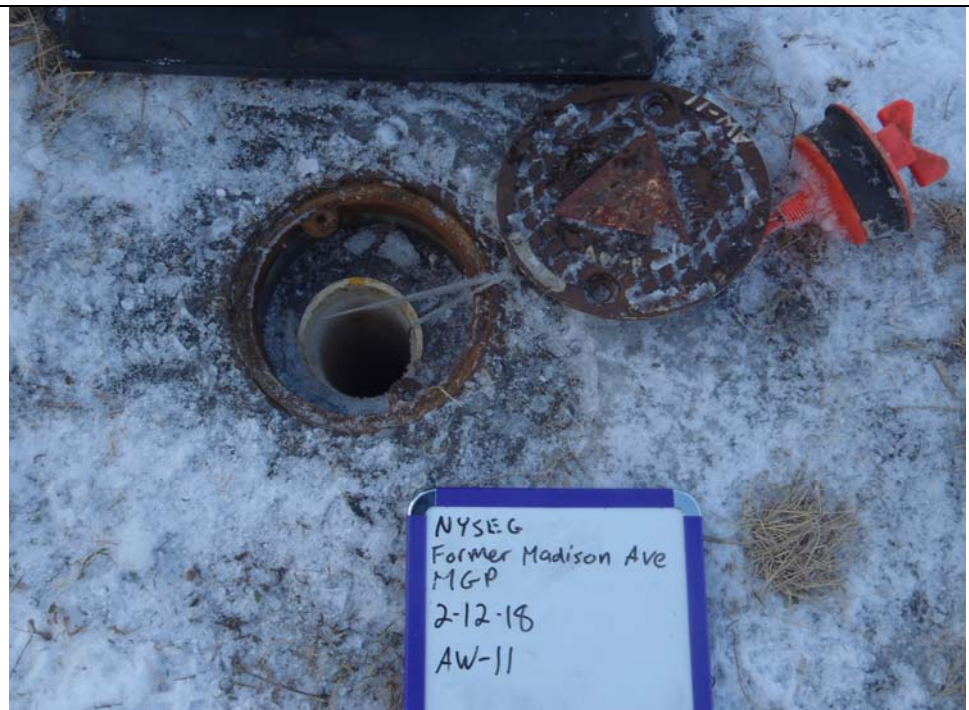
PHOTOGRAPHER: NJB	
DATE: 02/12/18	
DIRECTION: NA	
COMMENT: Photograph showing AW-11. Well and stainless-steel canister/assembly is in good condition. Well has well plug and competent cover.

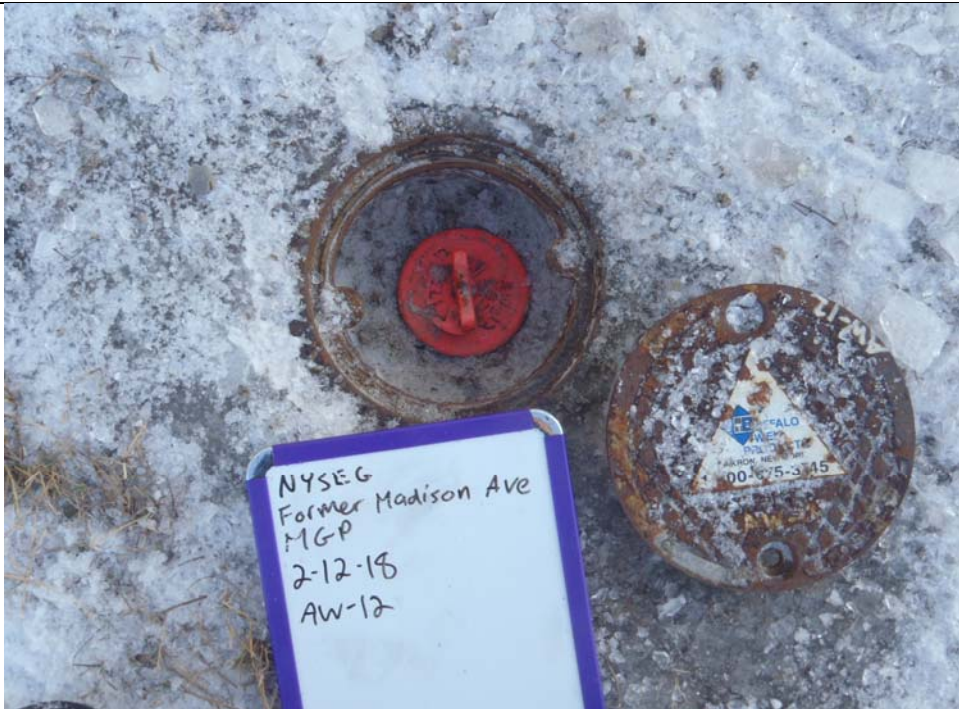
PHOTOGRAPHER: NJB	
DATE: 02/12/18	
DIRECTION: NA	
COMMENT: Photograph showing AW-12. Well and stainless-steel canister/assembly is in good condition. Well has well plug and competent cover.

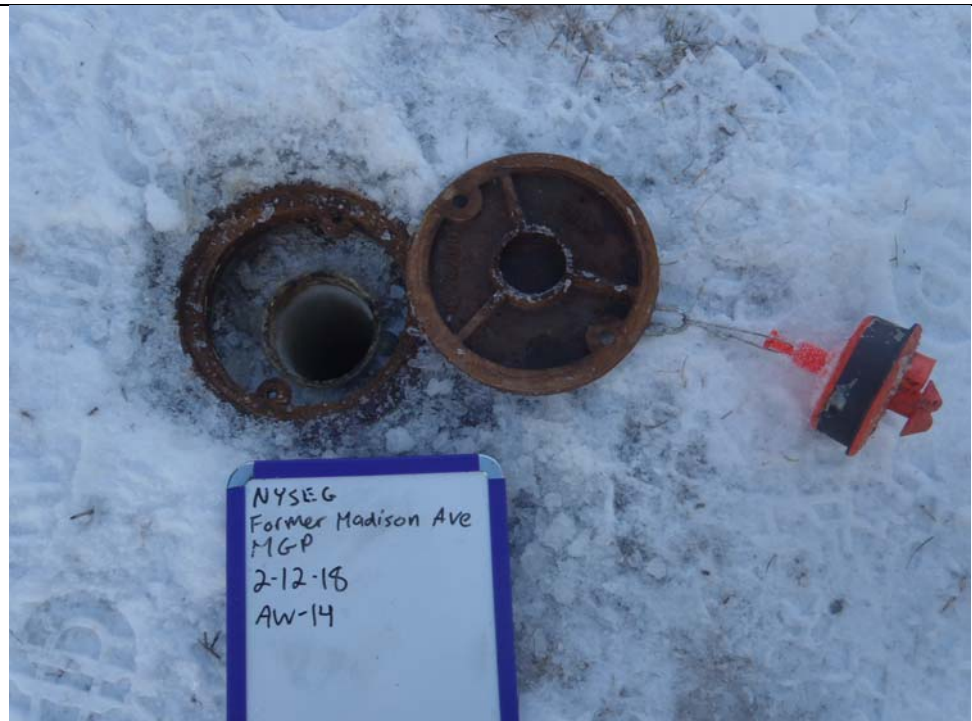
PHOTOGRAPHER: NJB	
DATE: 02/12/18	
DIRECTION: NA	
COMMENT: Photograph showing AW-14. Well and stainless-steel canister/assembly is in good condition. Well has well plug and competent cover.

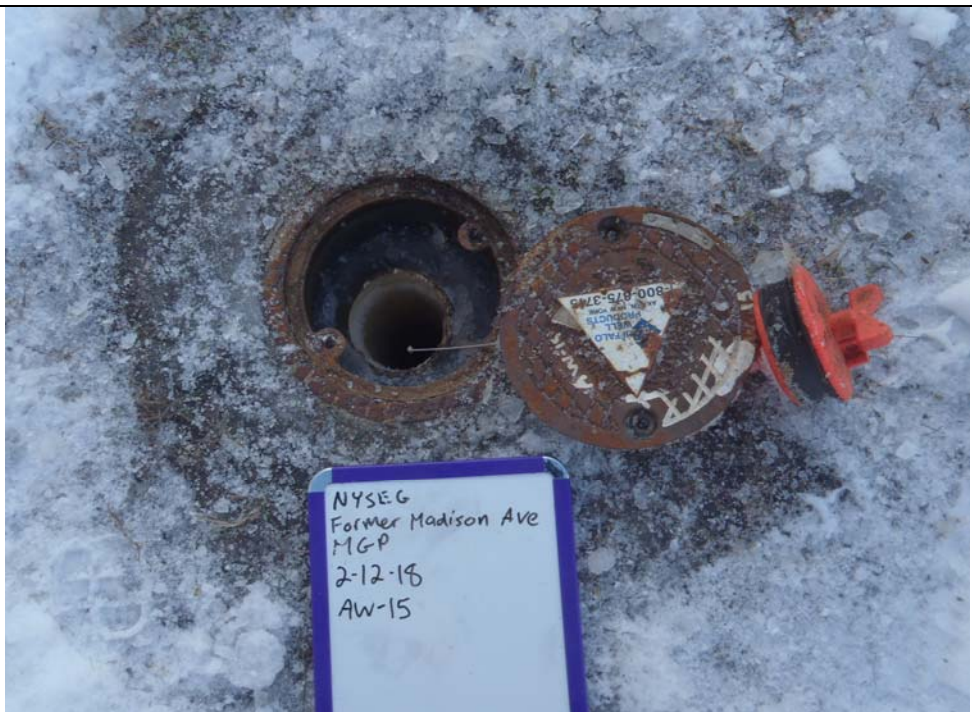
PHOTOGRAPHER: NJB	
DATE: 02/12/18	
DIRECTION: NA	
COMMENT: Photograph showing AW-15. Well and stainless-steel canister/assembly is in good condition. Well has well plug and competent cover.

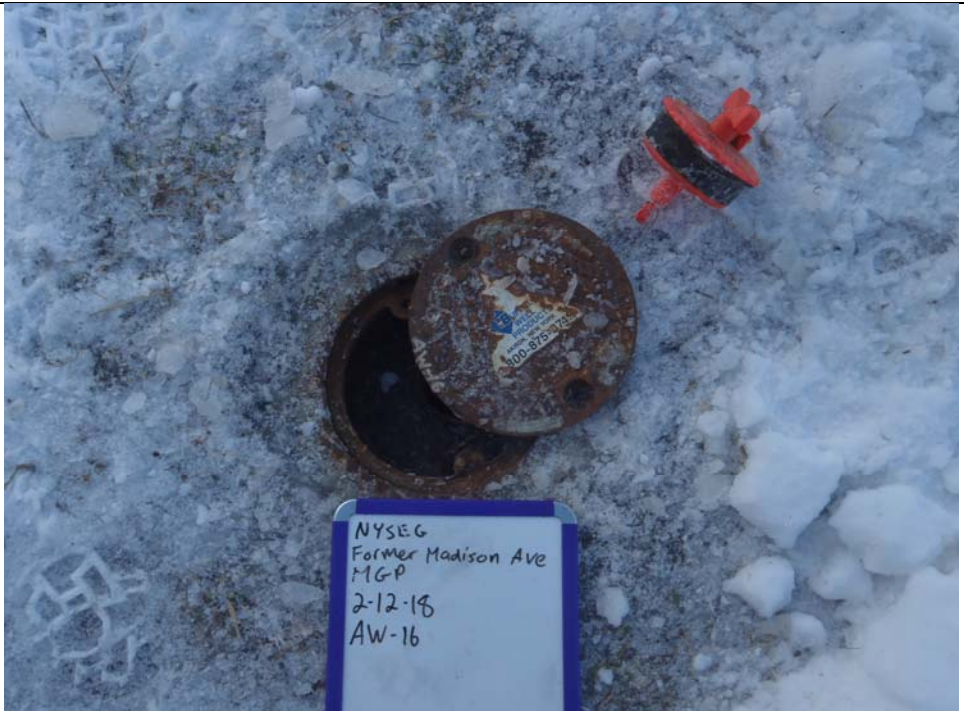
PHOTOGRAPHER: NJB	
DATE: 02/12/18	
DIRECTION: NA	
COMMENT: Photograph showing AW-16. Well and stainless-steel canister/assembly is in good condition. Well has well plug and competent cover.

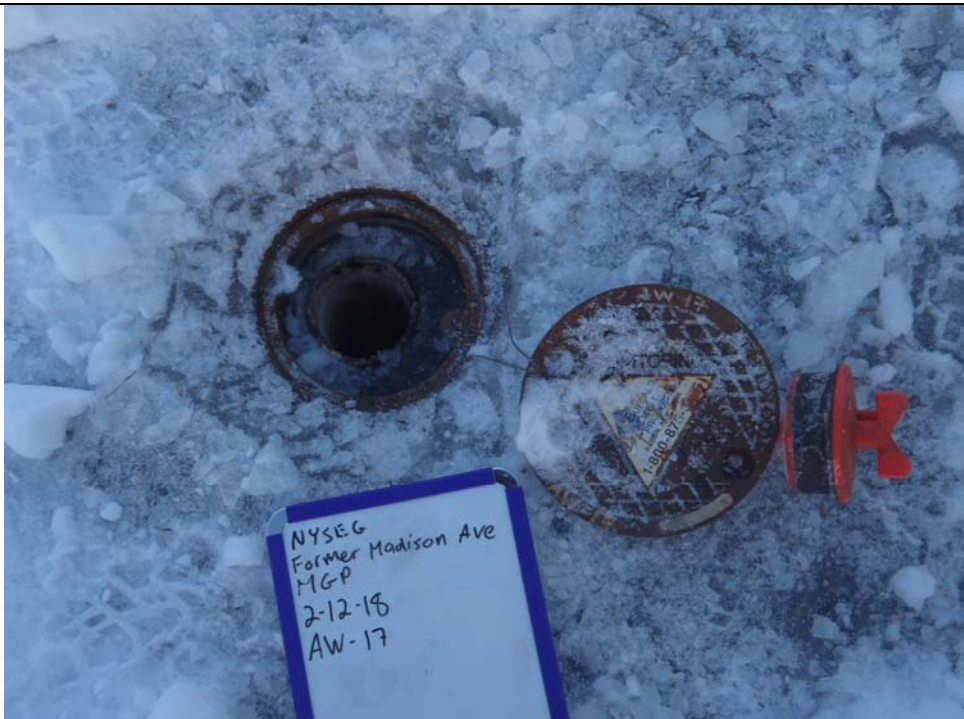
PHOTOGRAPHER: NJB	
DATE: 02/12/18	
DIRECTION: NA	
COMMENT: Photograph showing AW-17. Well and stainless-steel canister/assembly is in good condition. Well has well plug and competent cover.
