ANNUAL PERIODIC REVIEW REPORT (Q17 THROUGH Q20)

Madison Avenue Former MGP Site
Elmira, New York
NYSDEC Site Number: 808018

April 27, 2018

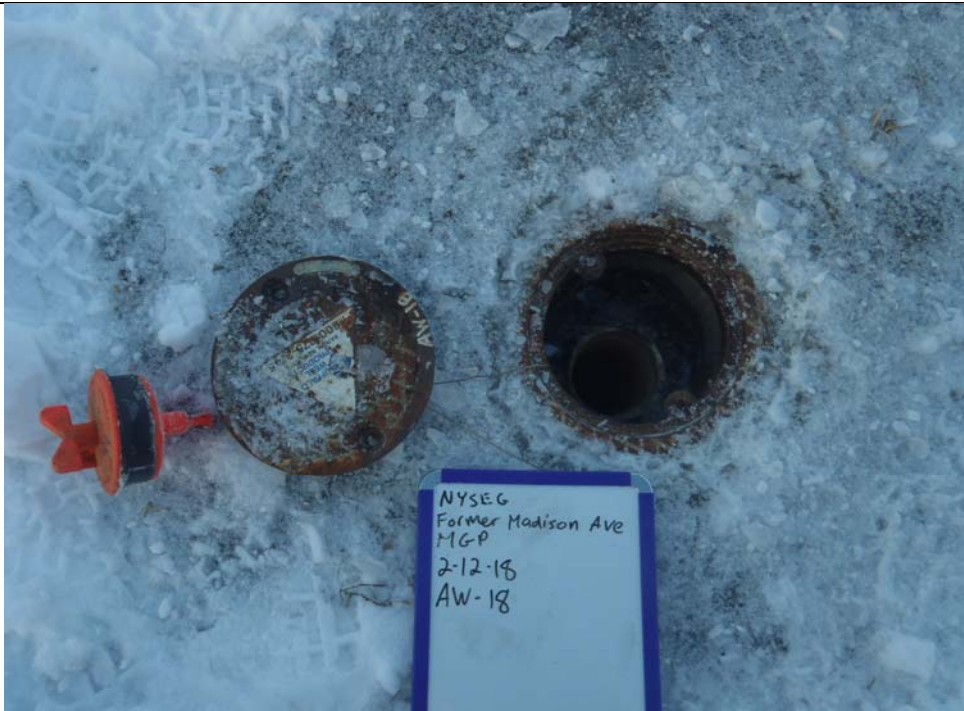
PHOTOGRAPHER: NJB	
DATE: 02/12/18	
DIRECTION: NA	
COMMENT: Photograph showing AW-18. Well and stainless-steel canister/assembly is in good condition. Well has well plug and competent cover.

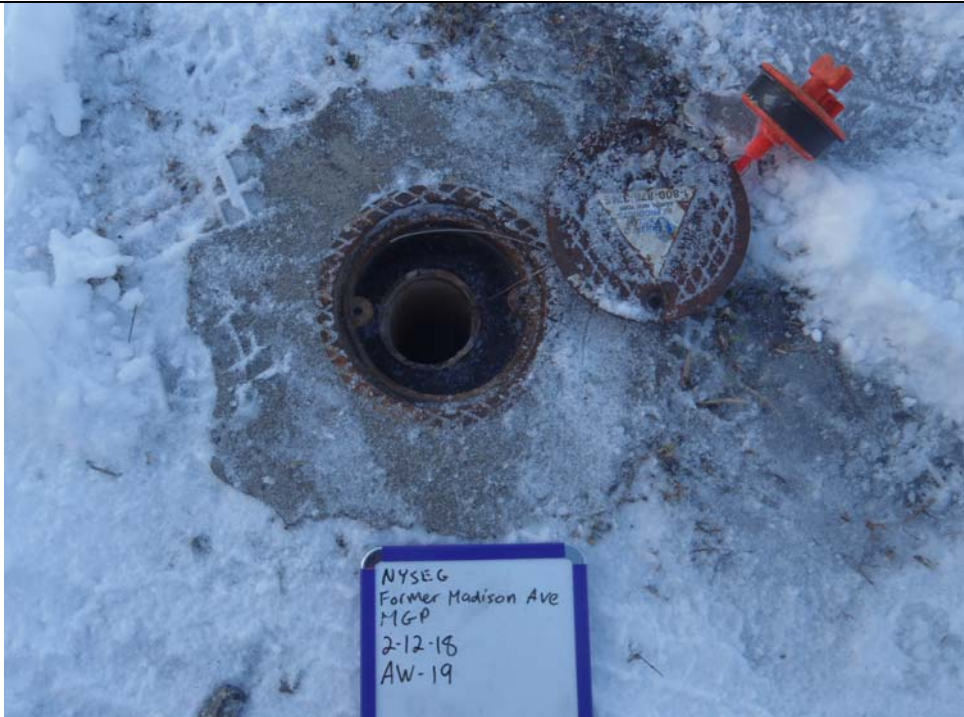
PHOTOGRAPHER: NJB	
DATE: 02/12/18	
DIRECTION: NA	
COMMENT: Photograph showing AW-19. Well and stainless-steel canister/assembly is in good condition. Well has well plug and competent cover.

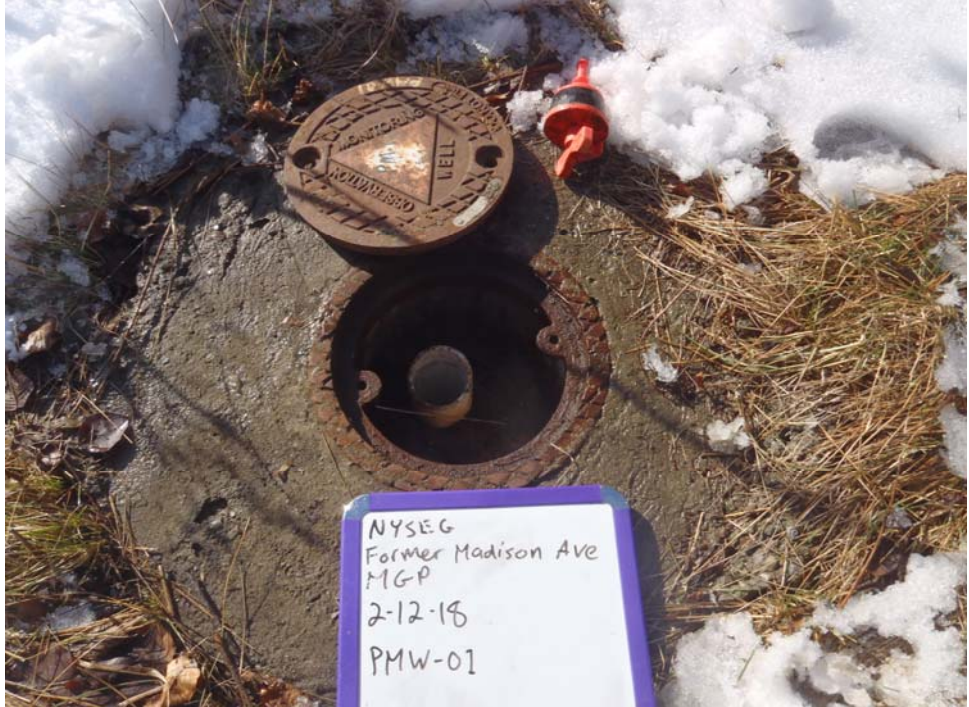
PHOTOGRAPHER: NJB	
DATE: 02/12/18	
DIRECTION: NA	
COMMENT: Photograph showing PMW-1. Well is in good condition with well plug and competent cover.

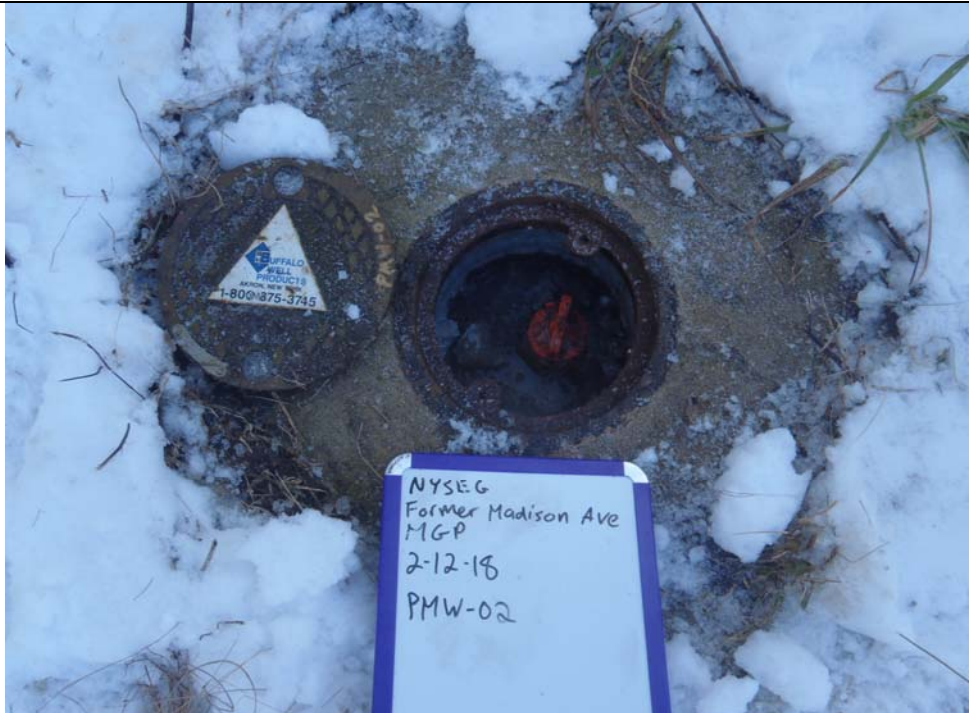
PHOTOGRAPHER: NJB	
DATE: 02/12/18	
DIRECTION: NA	
COMMENT: Photograph showing PMW-2. Well is in good condition with well plug and competent cover.

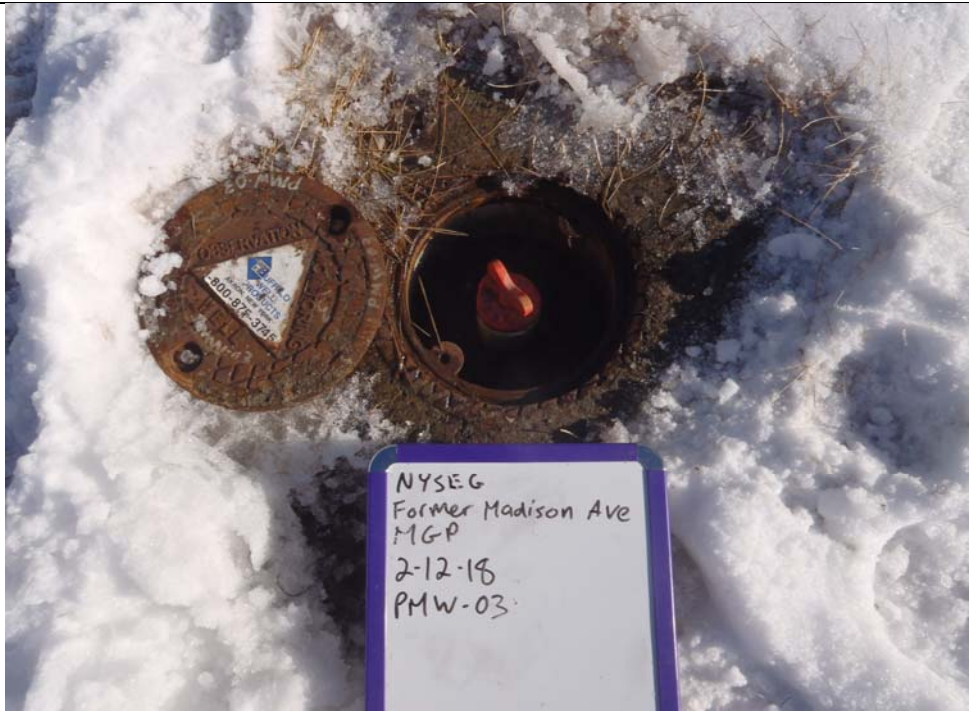
PHOTOGRAPHER: NJB	
DATE: 02/12/18	
DIRECTION: NA	
COMMENT: Photograph is showing well PMW-03. Well is in good condition with well and competent cover.

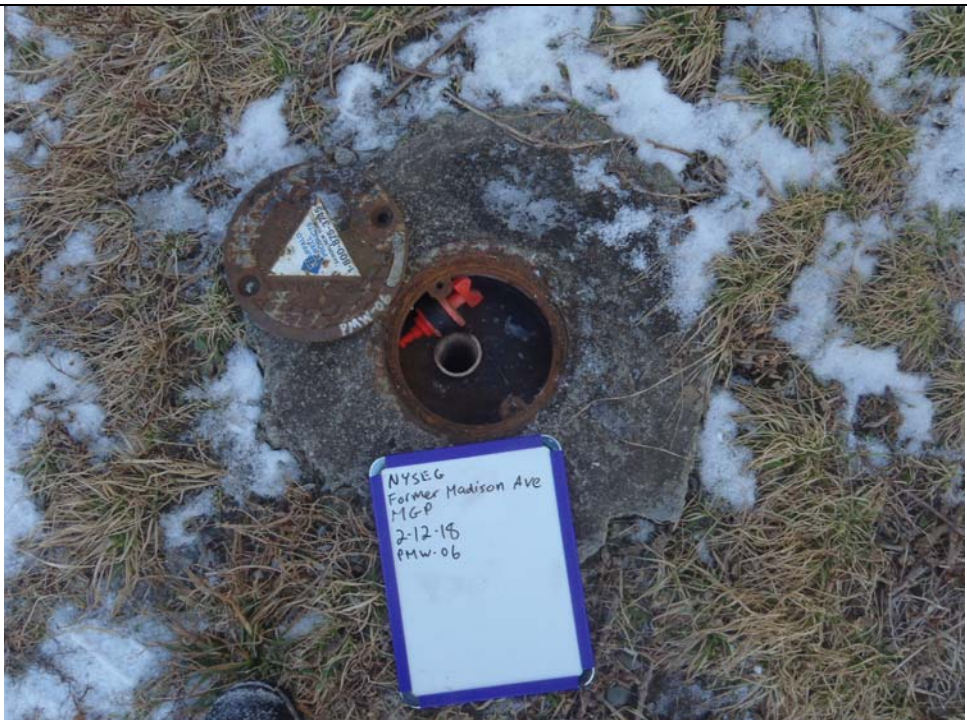
PHOTOGRAPHER: NJB	
DATE: 02/12/18	
DIRECTION: NA	
COMMENT: Photograph showing PMW-6. Well is in good condition with well plug and competent cover.

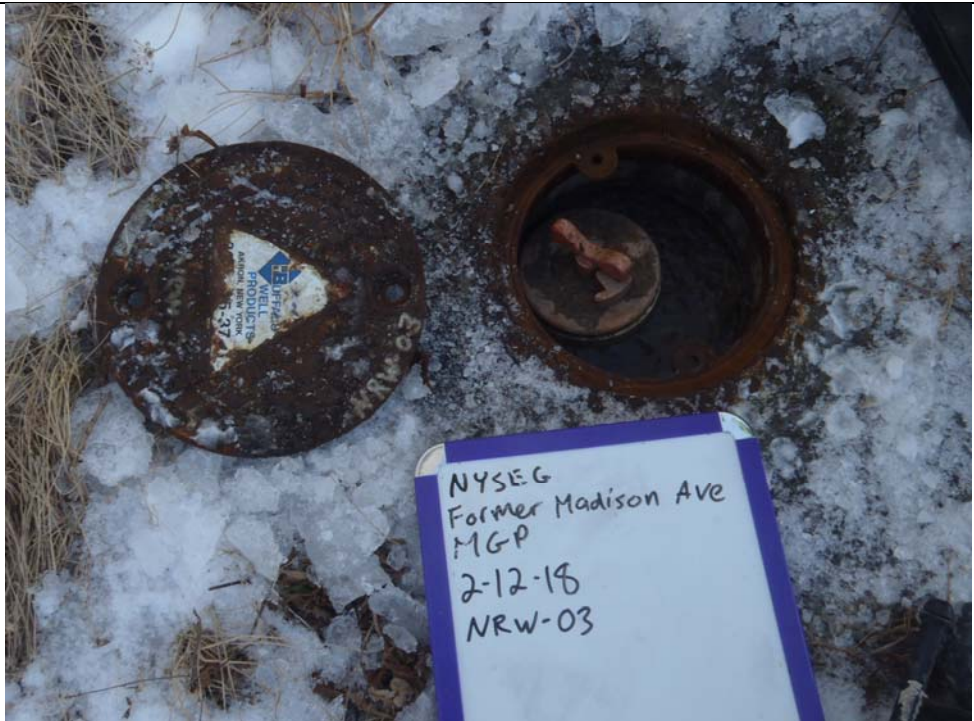
PHOTOGRAPHER: NJB	
DATE: 02/12/18	
DIRECTION: NA	
COMMENT: Photograph showing NRW-3. Well is in good condition with the plug and competent cover.

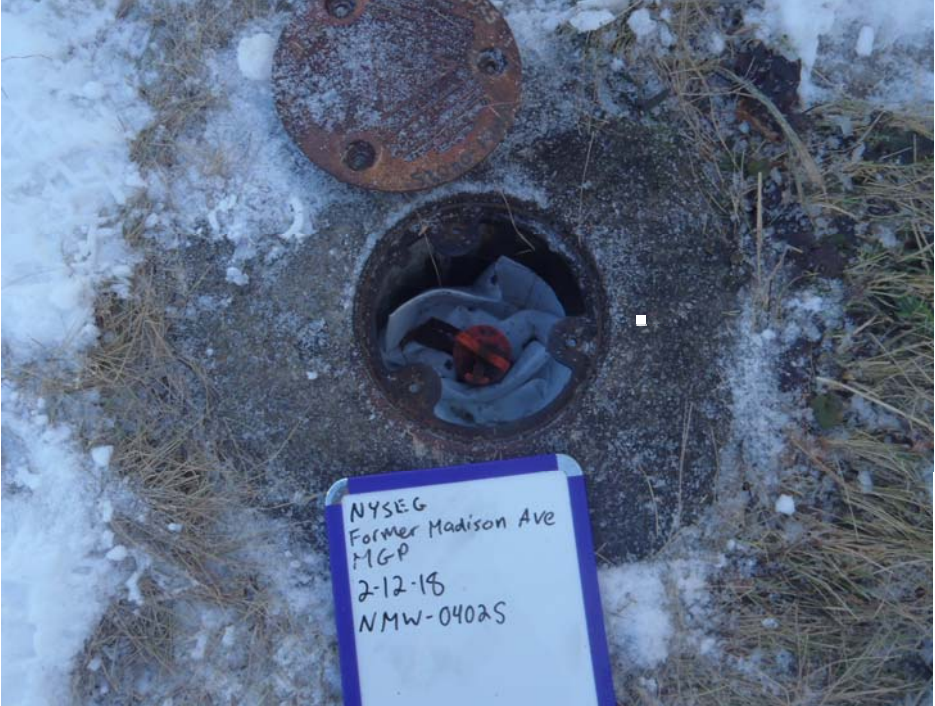
PHOTOGRAPHER: NJB	
DATE: 02/12/18	
DIRECTION: NA	
COMMENT: Photograph showing NMW-0402S. Well is in good condition with the plug and competent cover.
