ANNUAL PERIODIC REVIEW REPORT (Q21 THROUGH Q24)

Madison Avenue Former MGP Site
Elmira, New York
NYSDEC Site Number: 808018

April 2019

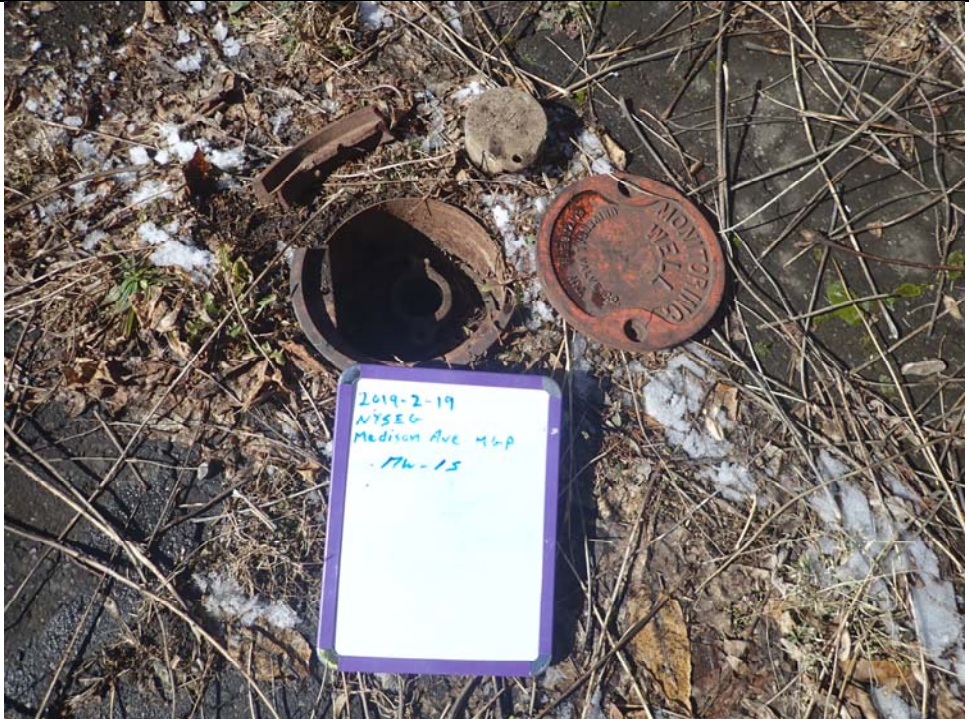
CLIENT: NYSEG	SITE NAME: Madison Avenue Former MGP Site
PROJECT#: B0013134.0001	SITE LOCATION: Elmira, New York
WELL ID: MW-1S

PHOTOGRAPHER: NJB	
DATE: 02/19/19	
DIRECTION: NA	
COMMENT: Photograph showing MW-1S. Well is in good condition with cap and competent cover.

- MW-1S, MW-6S, MW-0402S, MW-0403S, MW-0404D, and MW-0405S: To properly secure the road box cover, the bolt holes for the road box lid should be re-tapped and the bolts replaced.
- MW-1S: The road box and apron are deteriorated/destroyed and should be replaced.

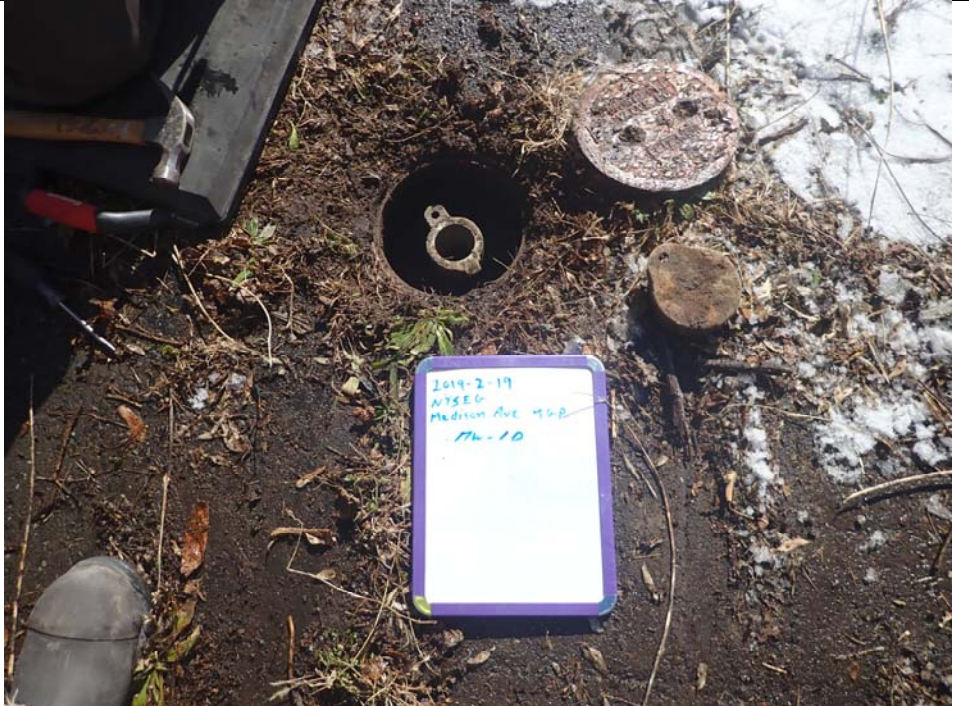
CLIENT: NYSEG	SITE NAME: Madison Avenue Former MGP Site
PROJECT#: B0013134.0001	SITE LOCATION: Elmira, New York
WELL ID: MW-1D

PHOTOGRAPHER: NJB	
DATE: 02/19/19	
DIRECTION: NA	
COMMENT: Photograph showing MW-1D. Well is in good condition with cap and competent cover.

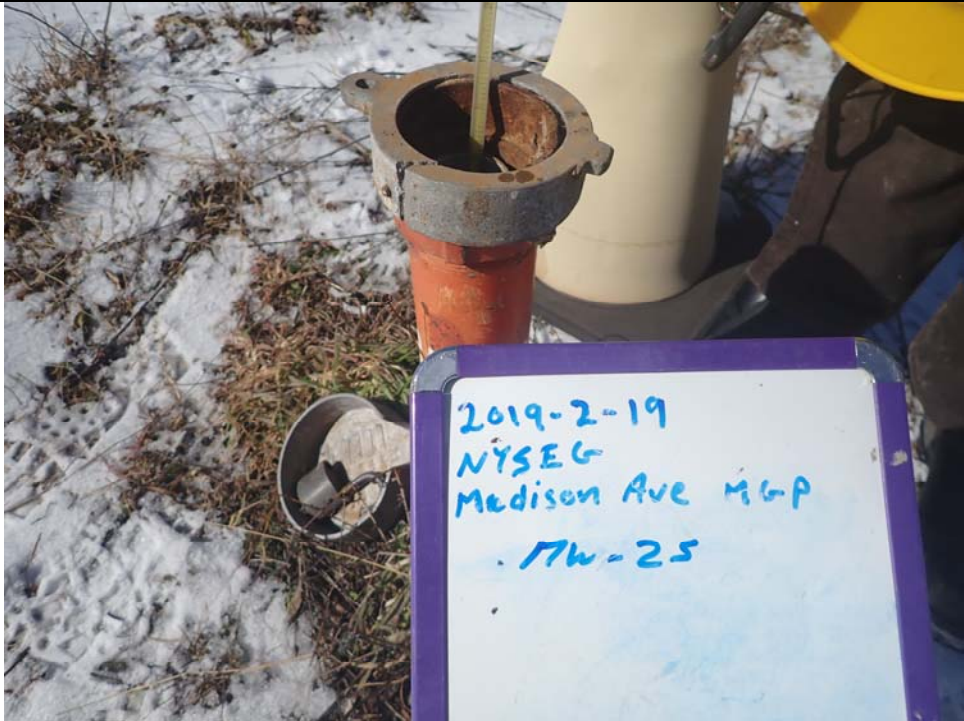
CLIENT: NYSEG	SITE NAME: Madison Avenue Former MGP Site
PROJECT#: B0013134.0001	SITE LOCATION: Elmira, New York
WELL ID: MW-2S

PHOTOGRAPHER: NJB	
DATE: 02/19/19	
DIRECTION: NA	
COMMENT: Photograph showing MW-2S. Cap mounting rig is cracked but competent. Well is in good condition with locking cap.

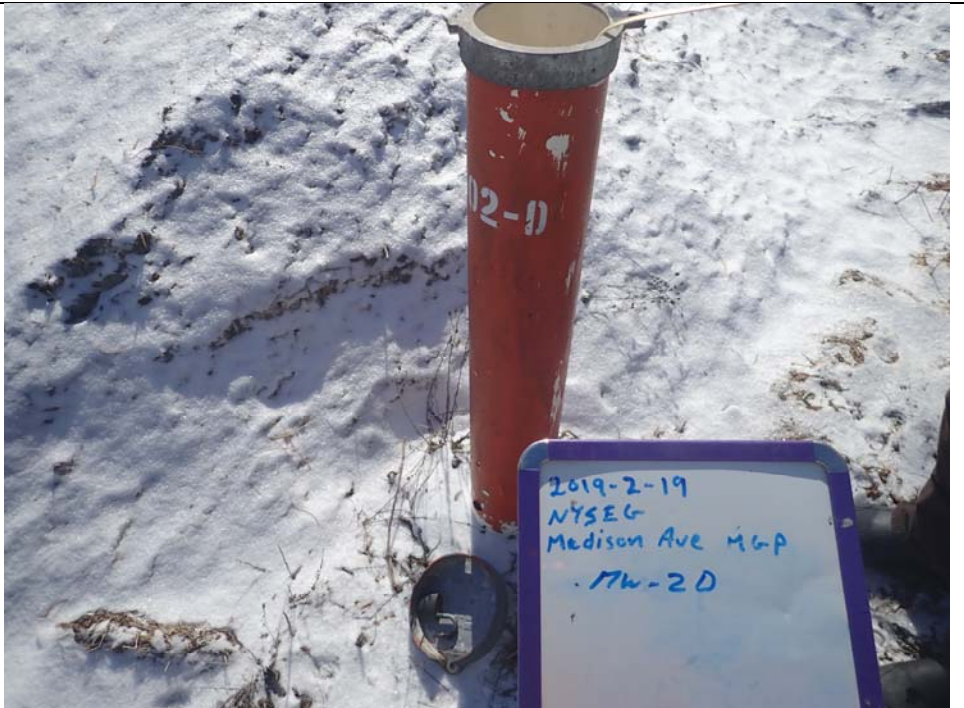
CLIENT: NYSEG	SITE NAME: Madison Avenue Former MGP Site
PROJECT#: B0013134.0001	SITE LOCATION: Elmira, New York
WELL ID: MW-2D

PHOTOGRAPHER: NJB	
DATE: 02/19/19	
DIRECTION: NA	
COMMENT: Photograph showing MW-2D. Well is in good condition with locking cap.

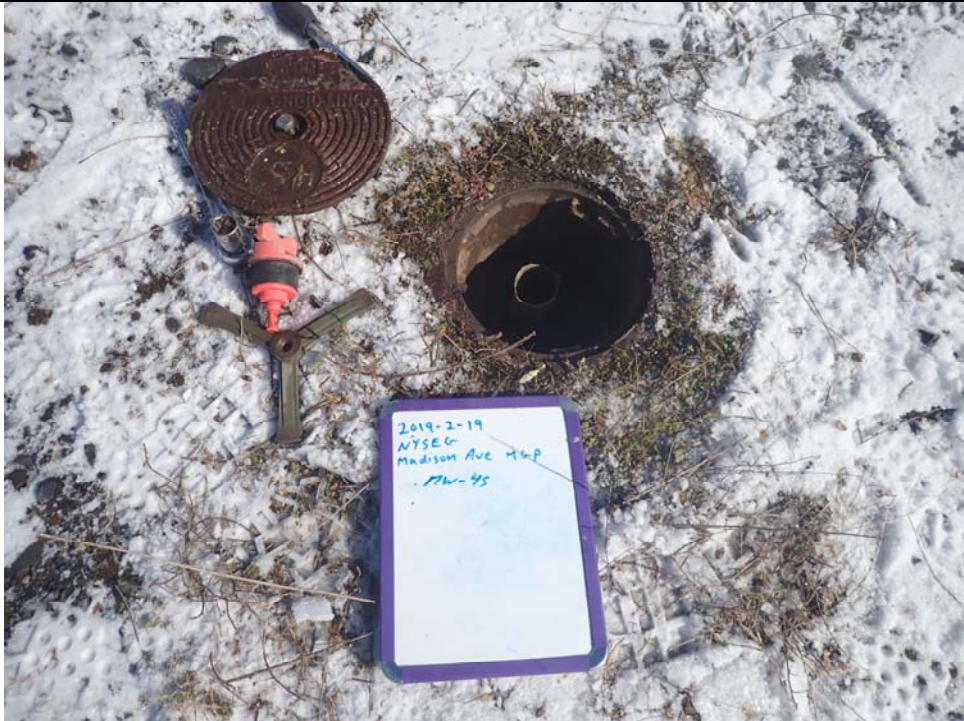
CLIENT: NYSEG	SITE NAME: Madison Avenue Former MGP Site
PROJECT#: B0013134.0001	SITE LOCATION: Elmira, New York
WELL ID: MW-4S

PHOTOGRAPHER: NJB	
DATE: 02/19/19	
DIRECTION: NA	
COMMENT: Photograph showing MW-4S. Well is in good condition with locking cap and competent cover.

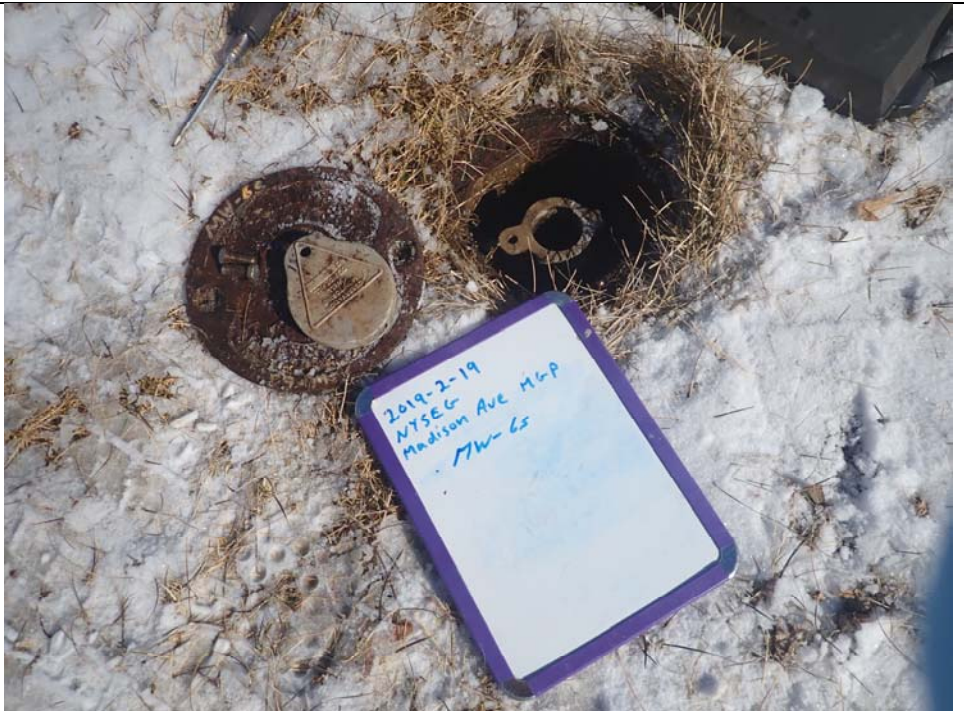
CLIENT: NYSEG	SITE NAME: Madison Avenue Former MGP Site
PROJECT#: B0013134.0001	SITE LOCATION: Elmira, New York
WELL ID: MW-6S

PHOTOGRAPHER: NJB	
DATE: 02/19/19	
DIRECTION: NA	
COMMENT: Photograph showing MW-6S. Well is in good condition with locking cap and competent cover.

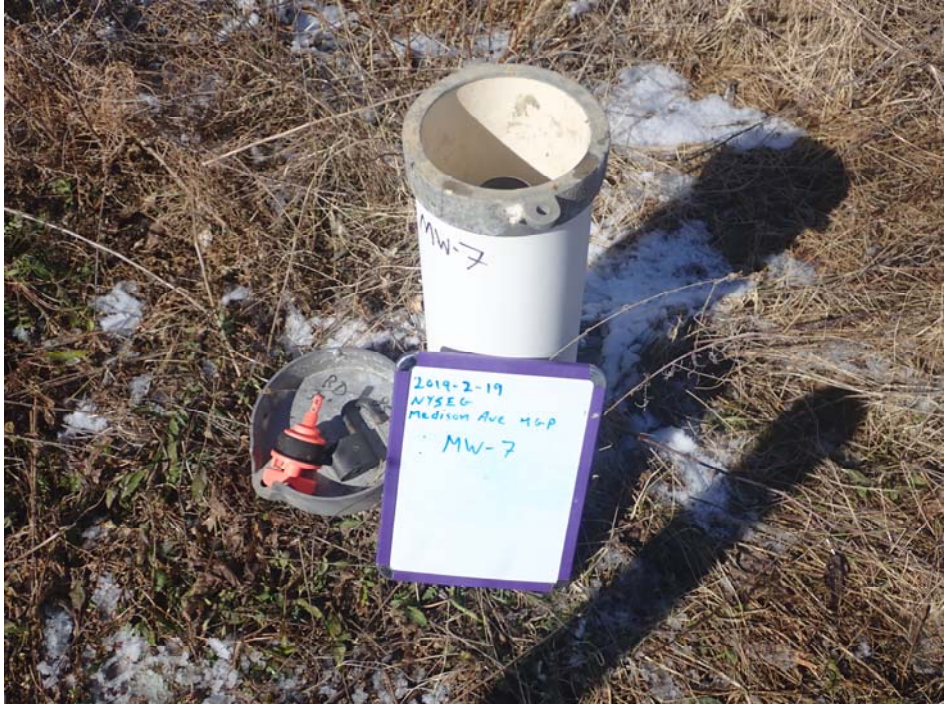
CLIENT: NYSEG	SITE NAME: Madison Avenue Former MGP Site
PROJECT#: B0013134.0001	SITE LOCATION: Elmira, New York
WELL ID: MW-7

PHOTOGRAPHER: NJB	
DATE: 02/19/109	
DIRECTION: NA	
COMMENT: Photograph showing MW-7. Well is in good condition. Well has well plug and locking well cover.

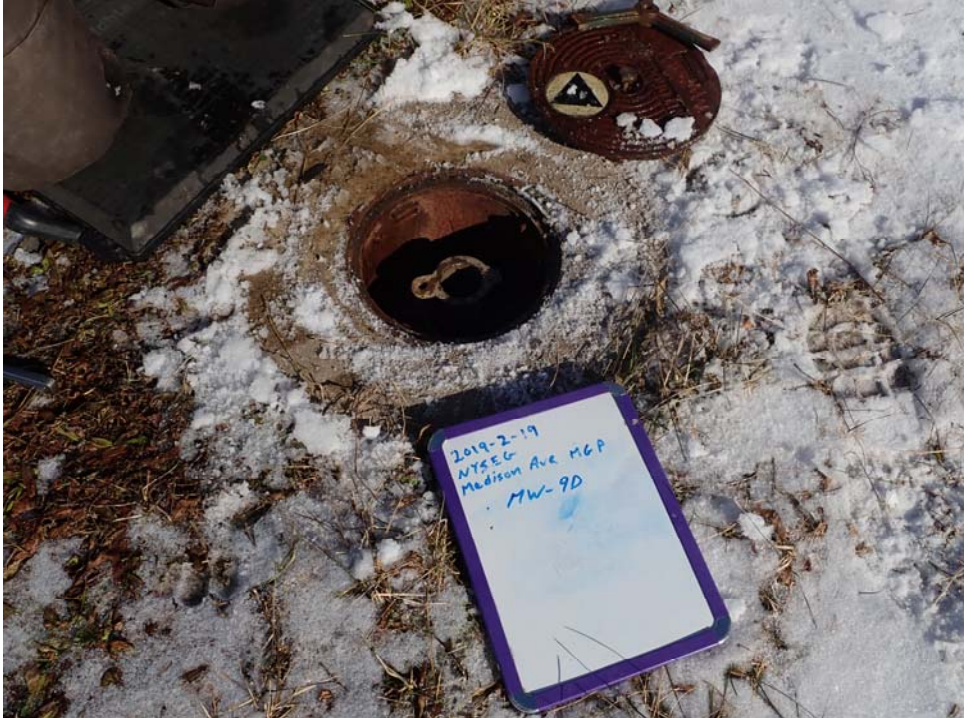
CLIENT: NYSEG	SITE NAME: Madison Avenue Former MGP Site
PROJECT#: B0013134.0001	SITE LOCATION: Elmira, New York
WELL ID: MW-9D

PHOTOGRAPHER: NJB	
DATE: 02/19/19	
DIRECTION: NA	
COMMENT: Photograph showing MW-9D. Well is in good condition with locking well cap and competent cover.

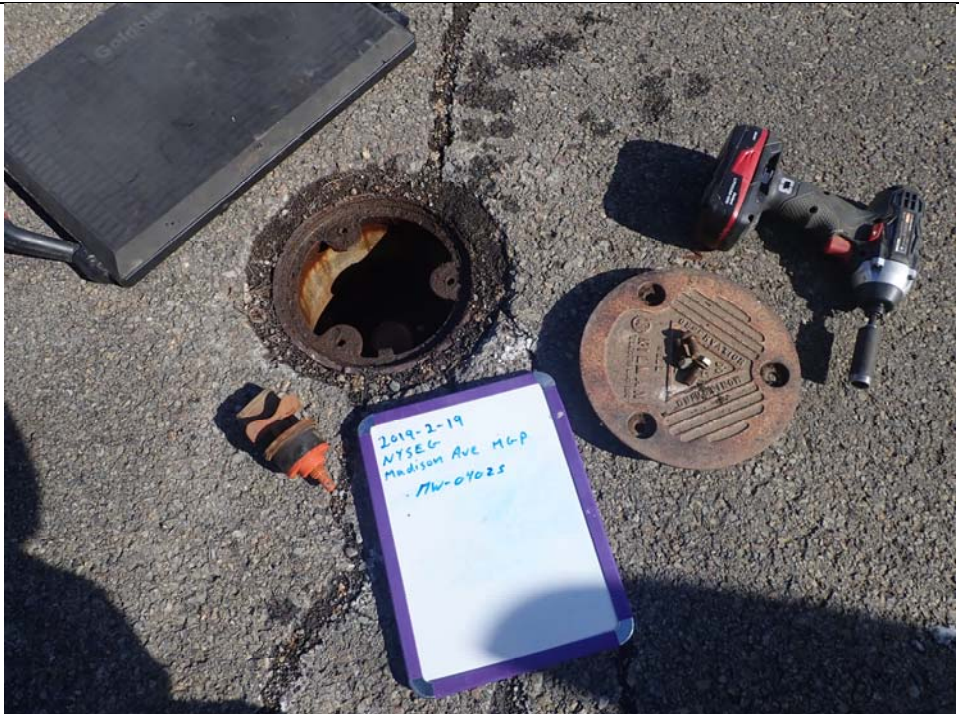
PHOTOGRAPHER: NJB	
DATE: 02/19/19	
DIRECTION: NA	
COMMENT: Photograph showing MW-0402S. Well is in good condition with locking well plug and competent cover.

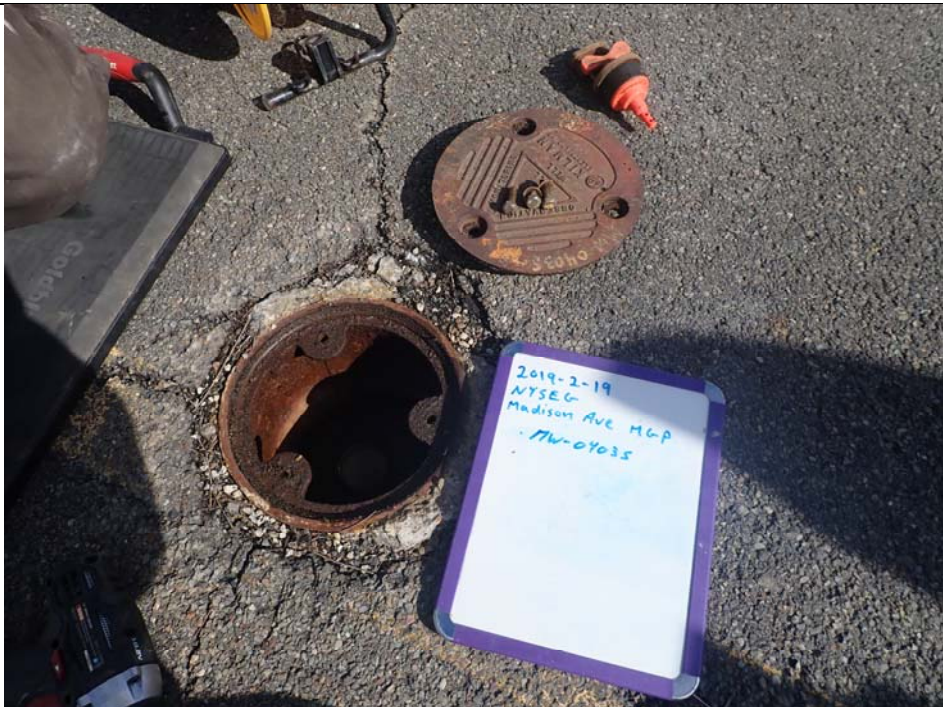
PHOTOGRAPHER: NJB	
DATE: 02/19/19	
DIRECTION: NA	
COMMENT: Photograph showing MW-0403S. Well is in good condition with locking well plug and competent cover.

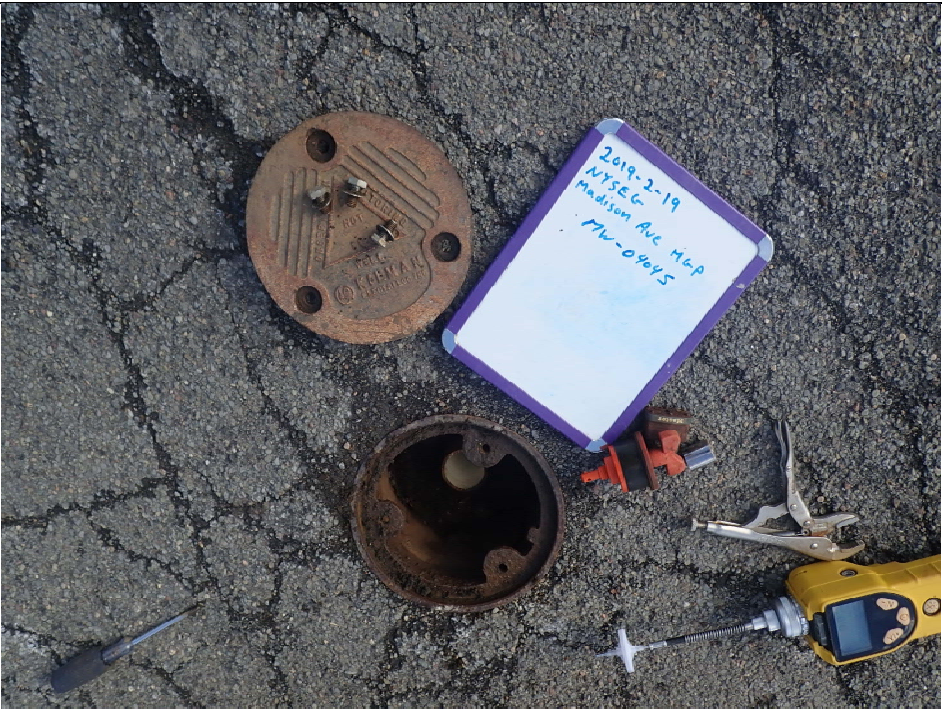
PHOTOGRAPHER: NJB	
DATE: 02/19/19	
DIRECTION: NA	
COMMENT: Photograph showing MW-0404S. Well is in good condition with locking well plug and competent cover. Bolted well lid was observed missing during the Annual Site Inspection. The lid will be replaced.

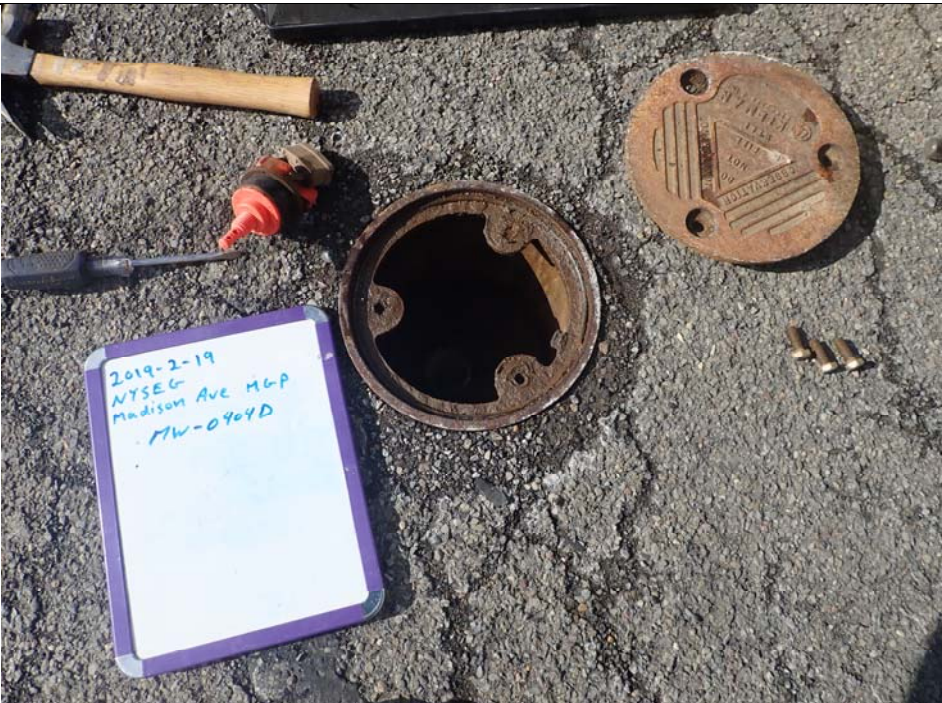
PHOTOGRAPHER: NJB	
DATE: 02/19/19	
DIRECTION: NA	
COMMENT: Photograph of MW-0404D. Well is in good condition with locking well plug and competent cover.

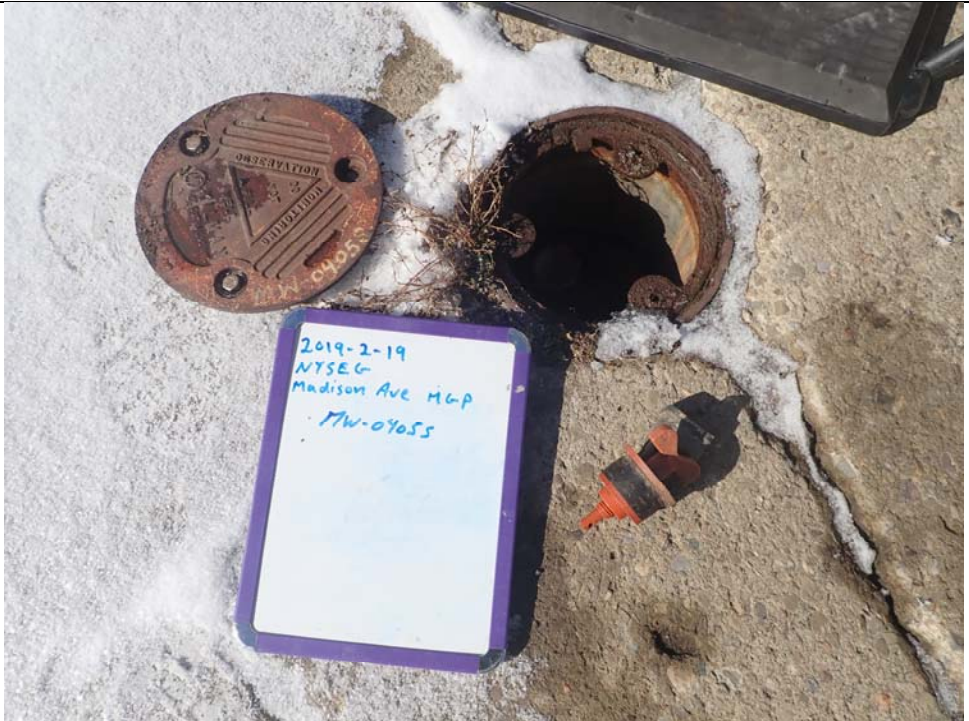
PHOTOGRAPHER: NJB	
DATE: 02/19/19	
DIRECTION: NA	
COMMENT: Photograph of MW-0405S. Well is in good condition with locking well plug and competent cover. Surrounding concrete flags are cracked, but road box is secure.

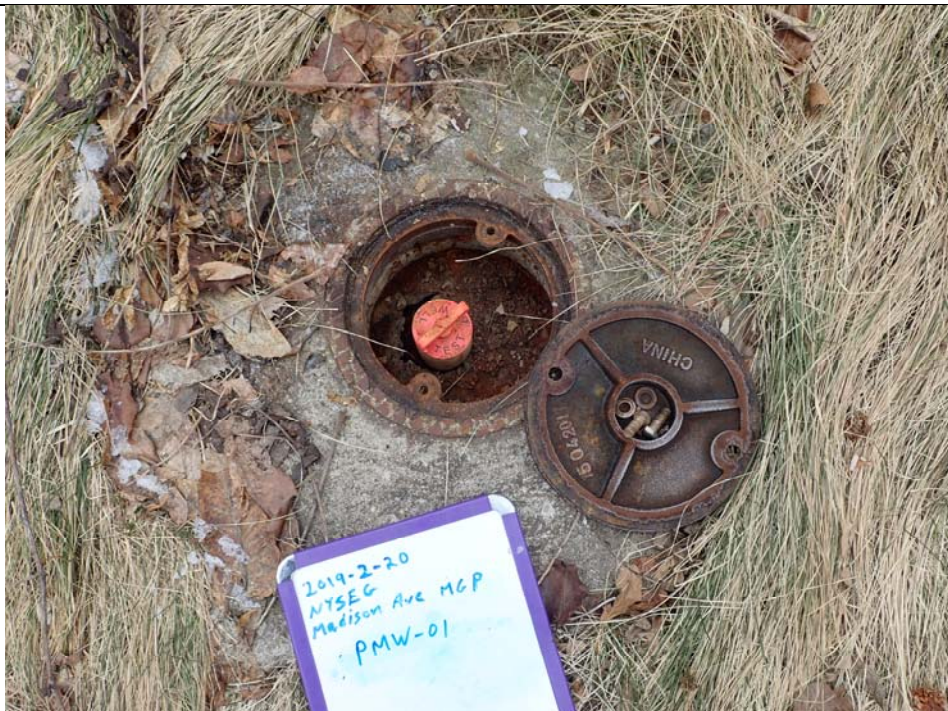
PHOTOGRAPHER: NJB	
DATE: 02/20/19	
DIRECTION: NA	
COMMENT: Photograph showing PMW-1. Well is in good condition with well plug and competent cover, however well road box has settled since installation. During the February 2019 site visit, the PVC riser was cut shorter and the well measuring point was resurveyed.

- Risers were cut down at PMW-01, PMW-03, and PMW-04. Due to heaving of the wells and/or sinking of the road boxes, the lids on the road boxes for each of the three PMWs could not be properly secured. To preserve the integrity of the well, the 2-inch riser was cut down within the road box, and the top of casings were re-surveyed along with MW-2S during the Q24 site visit. Note that these repairs were completed towards the end of the site visit, after gauging of the site wells were completed; therefore, the top of casing elevations presented in **Table 2** did not require revision for this report – the revised top of casing elevations will be reflected in the next gauging event.

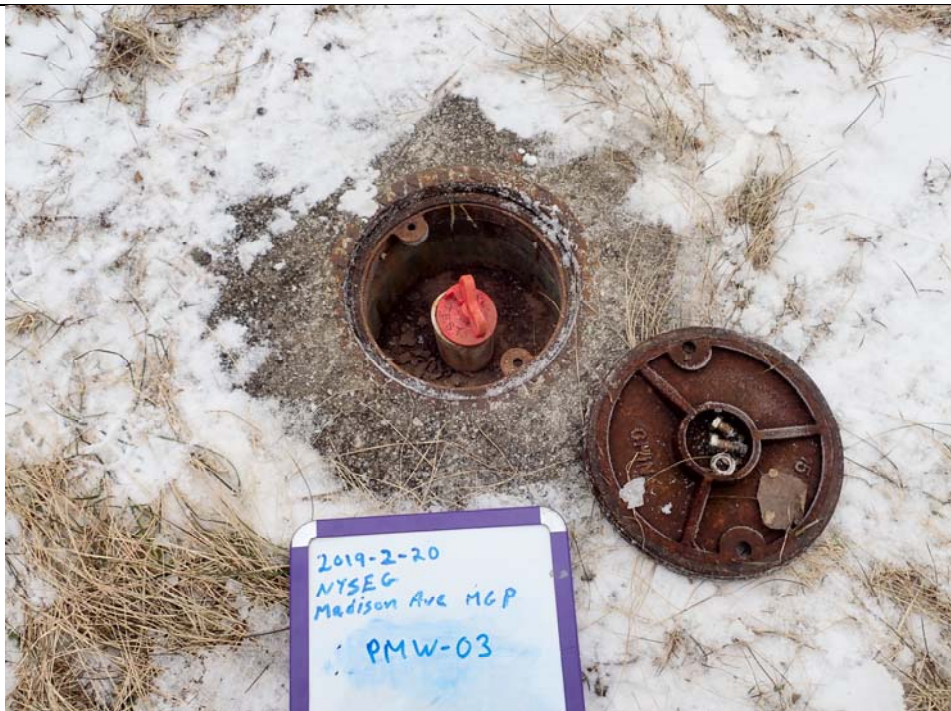
PHOTOGRAPHER: NJB	
DATE: 02/20/19	
DIRECTION: NA	
COMMENT: Photograph is showing well PMW-03. Well is in good condition with well plug and competent cover, however well road box has settled since installation. During the February 2019 site visit, the PVC riser was cut shorter and the well measuring point was resurveyed.
