Re: 2019 and 2020 Annual Periodic Review Reports Response Letter  
Madison Avenue Former MGP Site, Elmira  
Site #808018

RE: **Annual Periodic Review Report (Q25  
through Q28) (revised)**  
Madison Avenue Former MGP Site  
Site # 808018  
Elmira, Chemung County

NYSEG  
MADISON AVENUE FORMER MGP SITE  
ANNUAL PERIODIC REVIEW REPORT

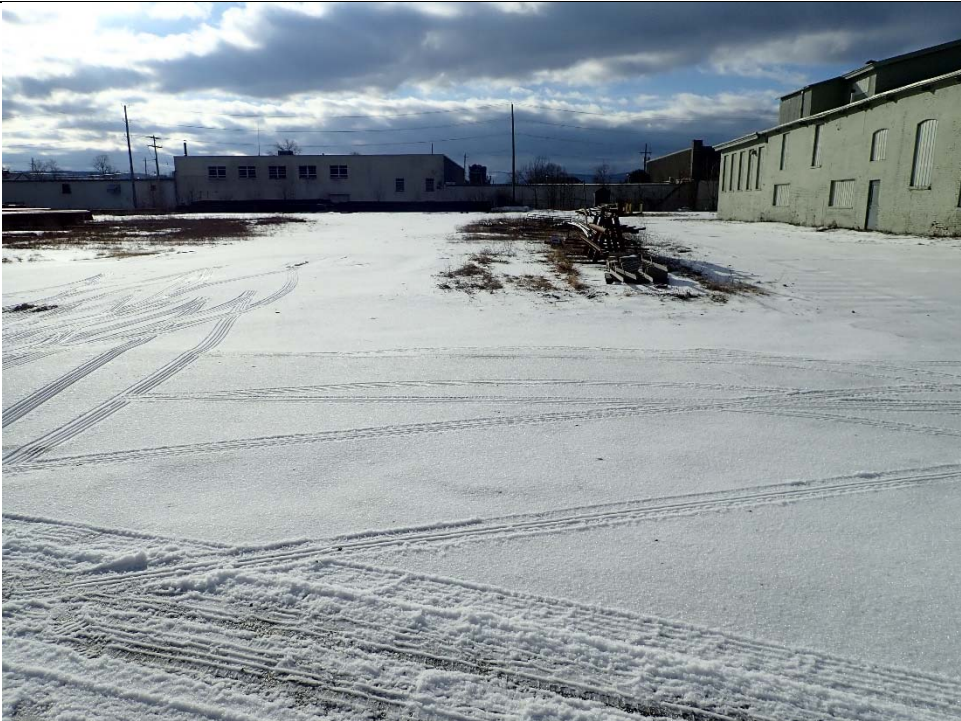
<b>PHOTOGRAPHER:</b> NJB	
<b>DATE:</b> 02/21/19	
<b>DIRECTION:</b> SE	
<b>COMMENT:</b> Picture showing (snow covered) stone parking area over former manufactured gas plant (MGP) area. Photo indicates cover is in good condition; no repair is needed.

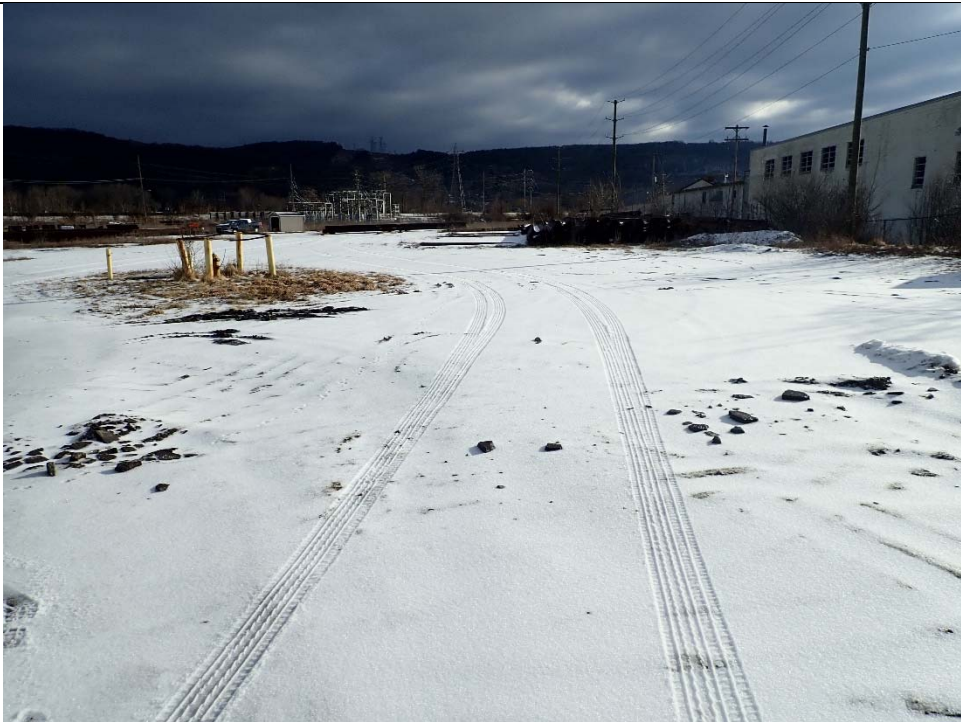
<b>PHOTOGRAPHER:</b> NJB	
<b>DATE:</b> 02/21/19	
<b>DIRECTION:</b> E	
<b>COMMENT:</b> Picture showing (snow covered) stone parking area over former MGP. Photo indicates cover is in good condition; no repair is needed.

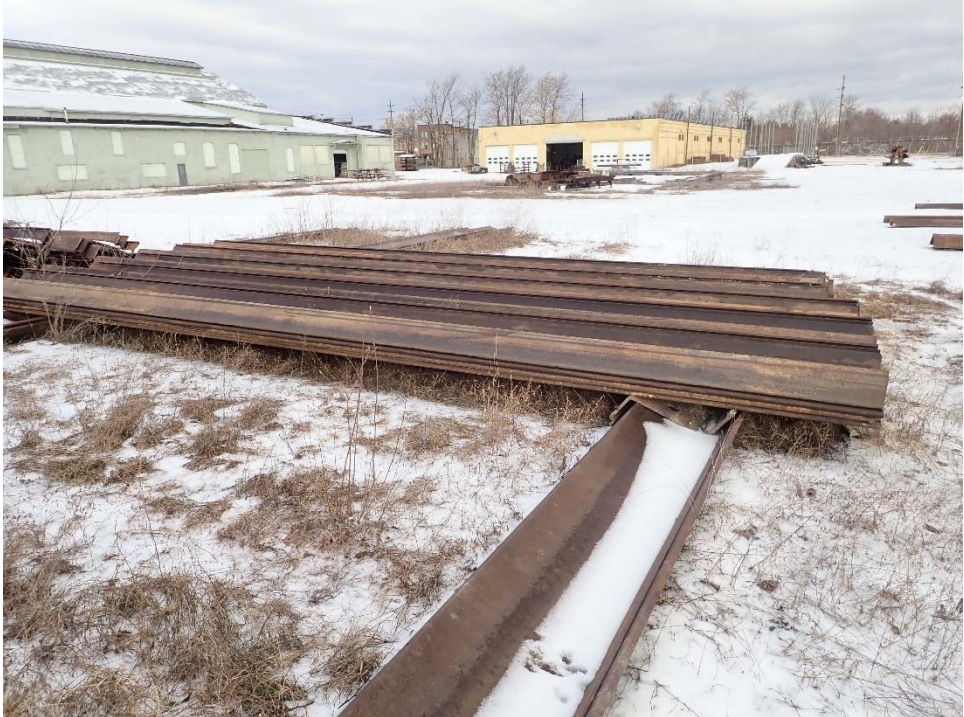
<b>PHOTOGRAPHER:</b> NJB	
<b>DATE:</b> 02/21/19	
<b>DIRECTION:</b> NW	
<b>COMMENT:</b> Picture showing (snow covered) stone parking area over former MGP. Photo indicates cover is in good condition; no repair is needed. Area currently used for material staging.

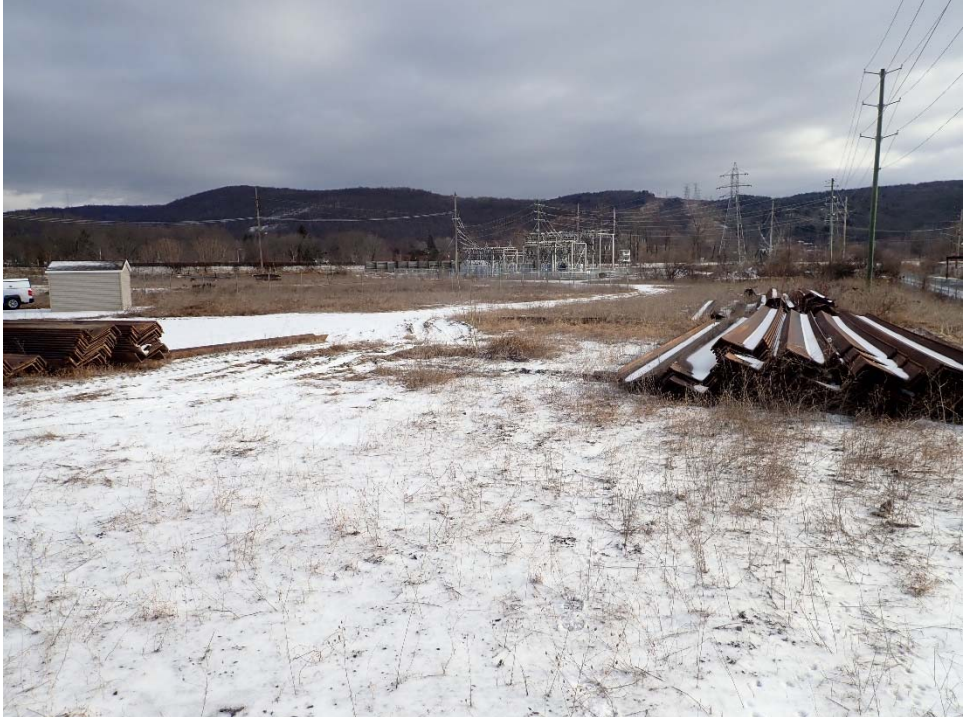
<b>PHOTOGRAPHER: NJB</b>	
<b>DATE: 02/21/19</b>	
<b>DIRECTION: NE</b>	
<b>COMMENT:</b> Picture showing stone and vegetation coverage over PCB IRM removal areas (1997) and purifier waste removal area (2011). Photo indicates cover is in good condition; no repair is needed. Area currently used for material staging

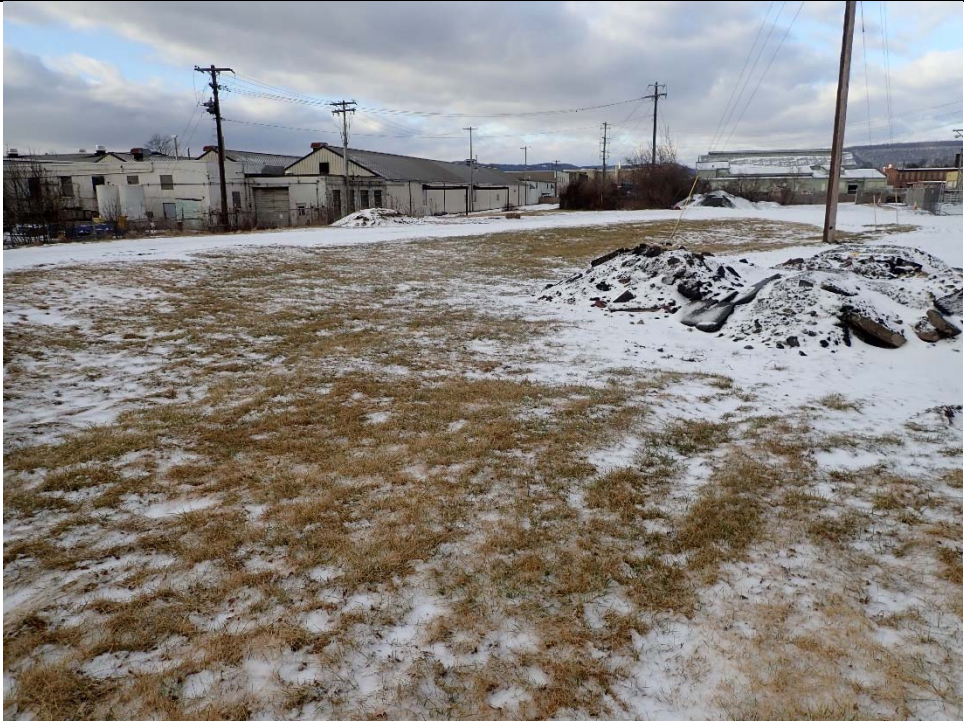
<b>PHOTOGRAPHER:</b> NJB	
<b>DATE:</b> 02/21/19	
<b>DIRECTION:</b> SW	
<b>COMMENT:</b> Picture showing grass area and stone coverage over ISS area, purifier waste IRM removal area (2004) and purifier waste removal area (2011). Photo indicates cover is in good condition; no repair is needed.

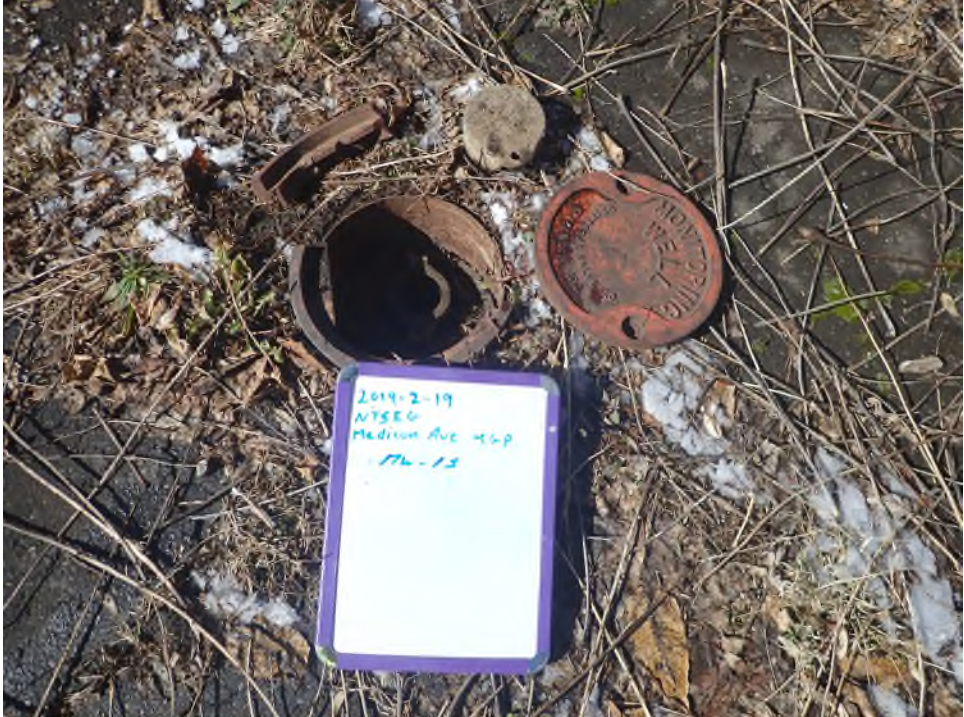
<b>PHOTOGRAPHER: NJB</b>	
<b>DATE: 02/19/19</b>	
<b>DIRECTION: NA</b>	
<b>COMMENT:</b> Photograph showing MW-1S. Well surface completion requires repair/replacement.

- MW-1S, MW-6S, MW-0402S, MW-0403S, MW-0404D, and MW-0405S: To properly secure the road box cover, the bolt holes for the road box lid should be re-tapped and the bolts replaced.
- MW-1S: The road box and apron are deteriorated/destroyed and should be replaced.

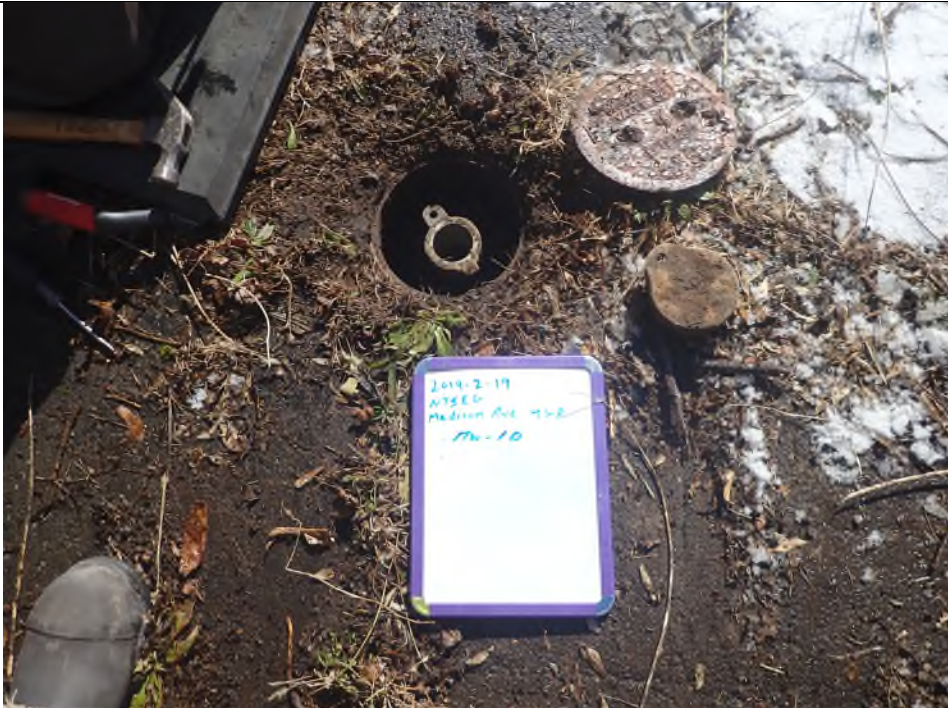
<b>PHOTOGRAPHER: NJB</b>	
<b>DATE: 02/19/19</b>	
<b>DIRECTION: NA</b>	
<b>COMMENT:</b> Photograph showing MW-1D. Well is in good condition with cap and competent cover.

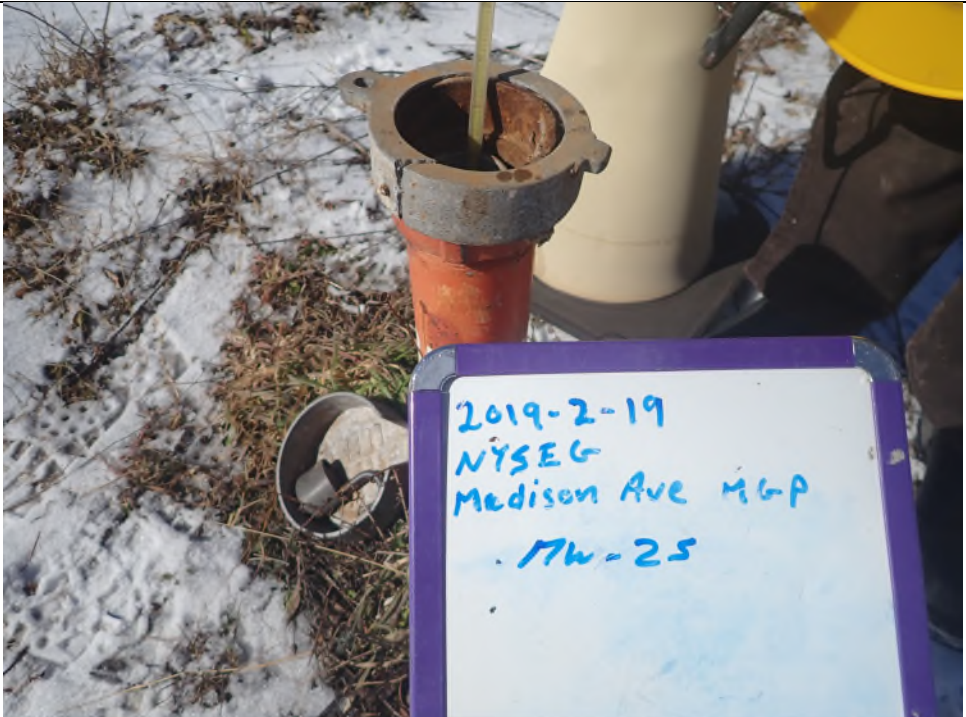
<b>PHOTOGRAPHER:</b> NJB	
<b>DATE:</b> 02/19/19	
<b>DIRECTION:</b> NA	
<b>COMMENT:</b> Photograph showing MW-2S. Cap mounting rig is cracked but competent. Well is in good condition with locking cap.

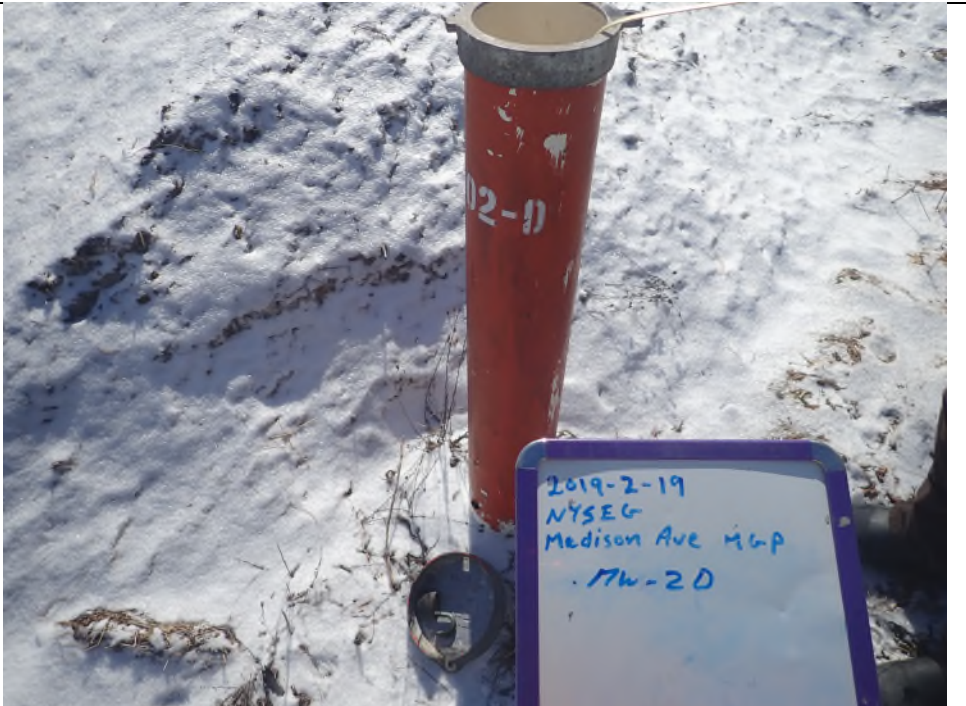
<b>PHOTOGRAPHER:</b> NJB	
<b>DATE:</b> 02/19/19	
<b>DIRECTION:</b> NA	
<b>COMMENT:</b> Photograph showing MW-2D. Well is in good condition with locking cap.

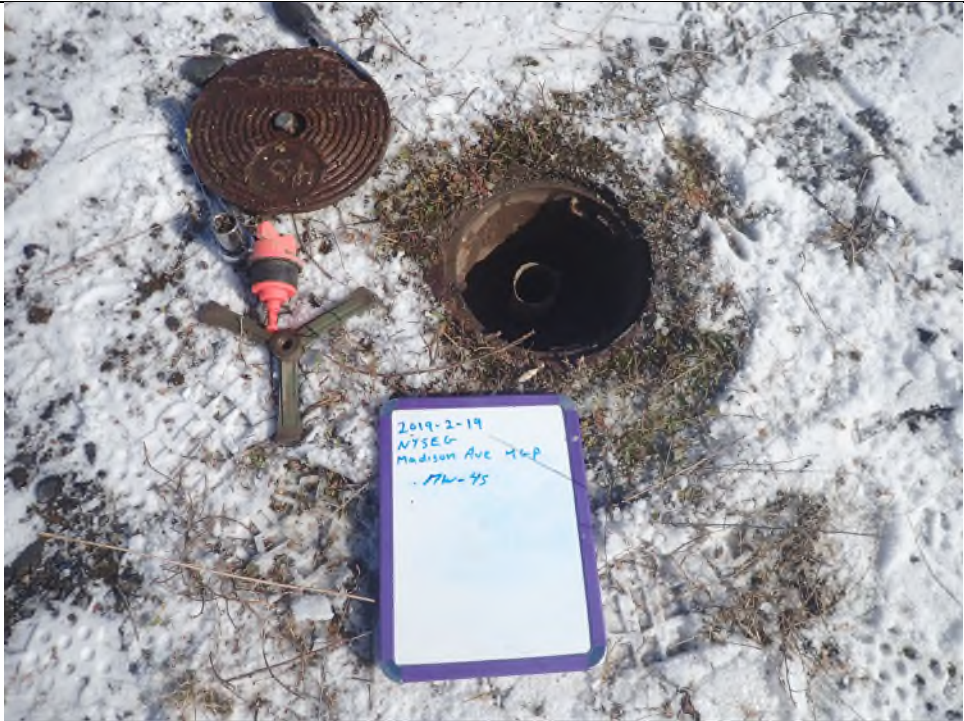
<b>PHOTOGRAPHER:</b> NJB	
<b>DATE:</b> 02/19/19	
<b>DIRECTION:</b> NA	
<b>COMMENT:</b> Photograph showing MW-4S. Well is in good condition with locking cap and competent cover.

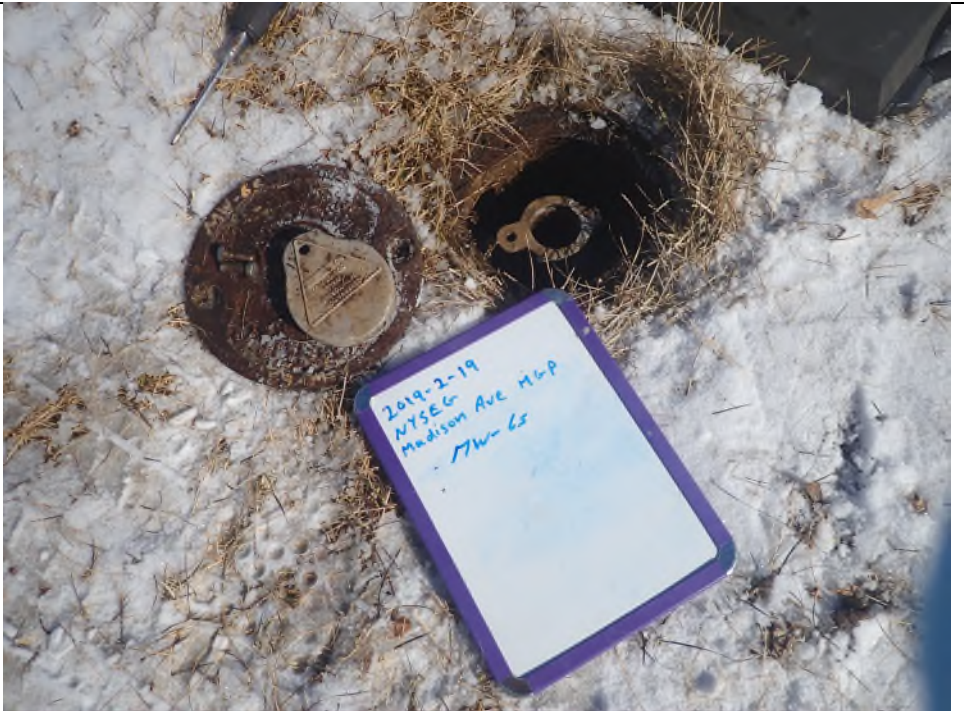
<b>PHOTOGRAPHER:</b> NJB	
<b>DATE:</b> 02/19/19	
<b>DIRECTION:</b> NA	
<b>COMMENT:</b> Photograph showing MW-6S. Well is in good condition with locking cap and competent cover.

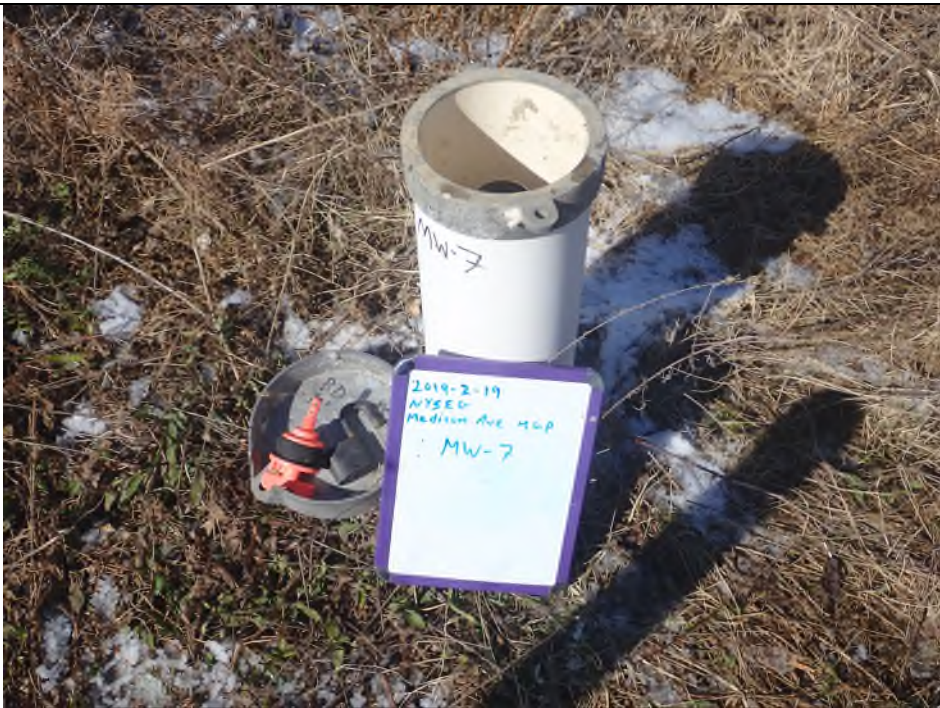
<b>PHOTOGRAPHER: NJB</b>	
<b>DATE: 02/19/19</b>	
<b>DIRECTION: NA</b>	
<b>COMMENT:</b> Photograph showing MW-7. Well is in good condition. Well has well plug and locking well cover.

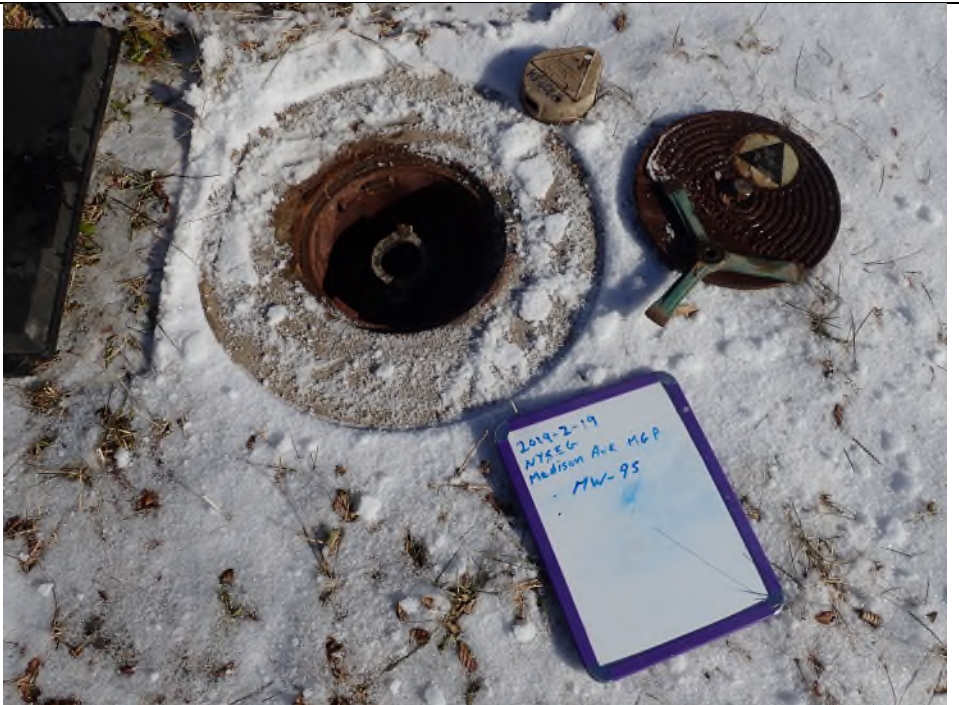
<b>PHOTOGRAPHER:</b> NJB	
<b>DATE:</b> 02/19/19	
<b>DIRECTION:</b> NA	
<b>COMMENT:</b> Photograph showing MW-9S. Well is in good condition with locking well cap and competent cover.

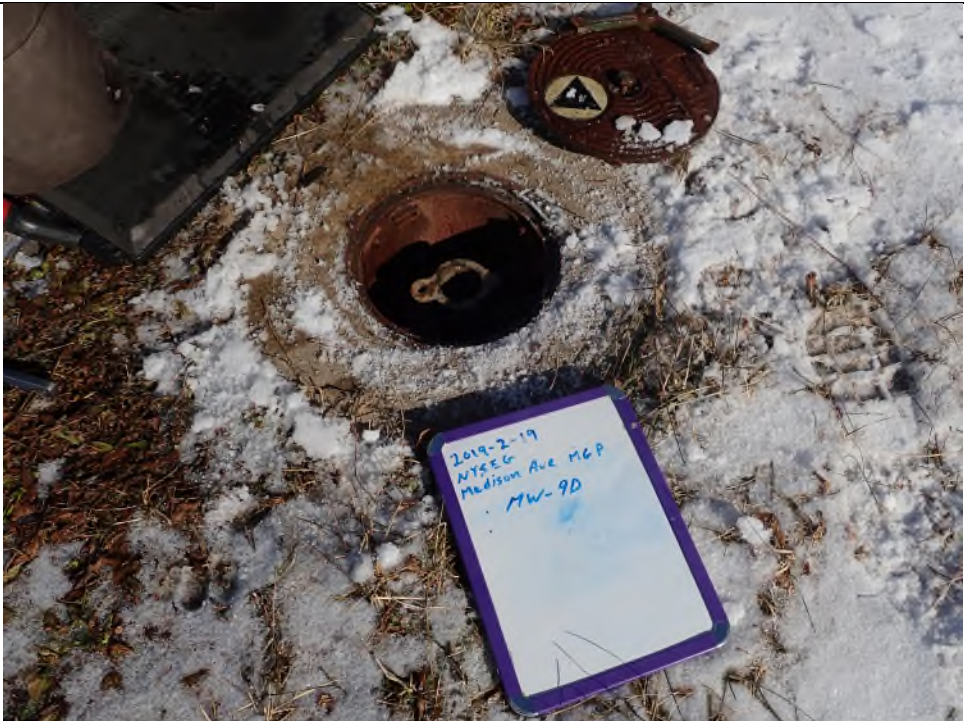
<b>PHOTOGRAPHER:</b> NJB	
<b>DATE:</b> 02/19/19	
<b>DIRECTION:</b> NA	
<b>COMMENT:</b> Photograph showing MW-9D. Well is in good condition with locking well cap and competent cover.

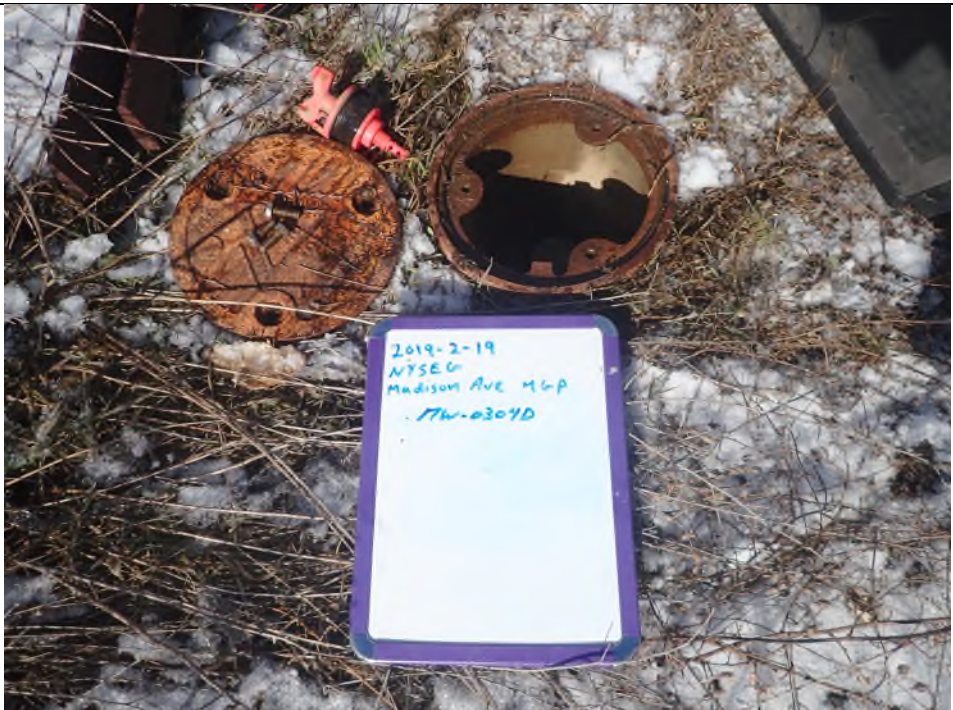
<b>PHOTOGRAPHER:</b> NJB	
<b>DATE:</b> 02/19/19	
<b>DIRECTION:</b> NA	
<b>COMMENT:</b> Photograph showing MW-0304D. Well is in good condition with well and competent cover.

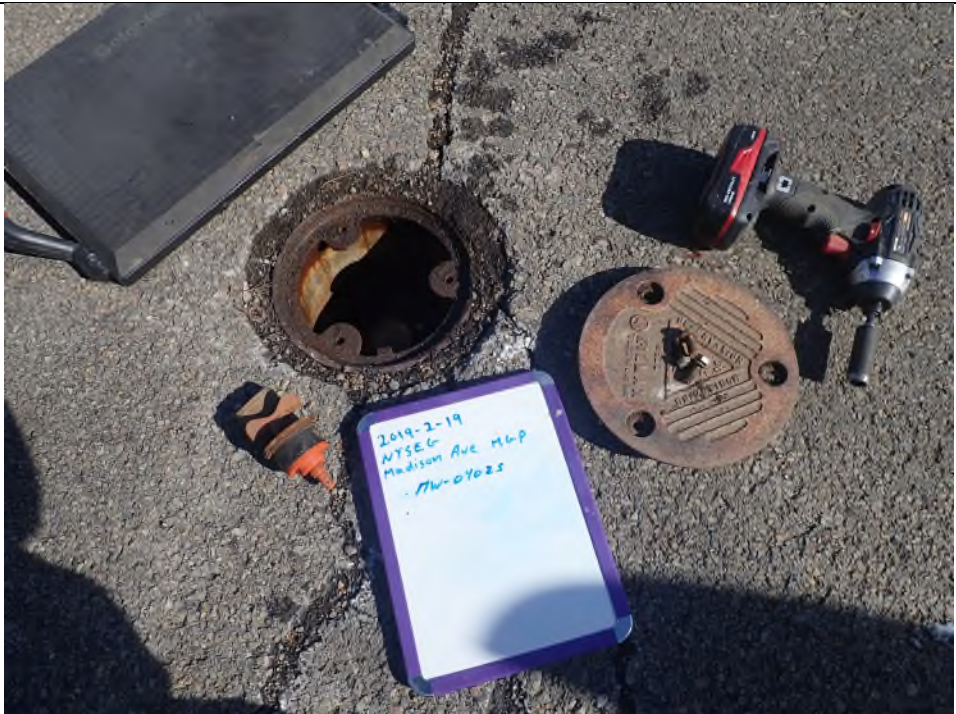
<b>PHOTOGRAPHER:</b> NJB	
<b>DATE:</b> 02/19/19	
<b>DIRECTION:</b> NA	
<b>COMMENT:</b> Photograph showing MW-0402S. Well is in good condition with locking well plug and competent cover.

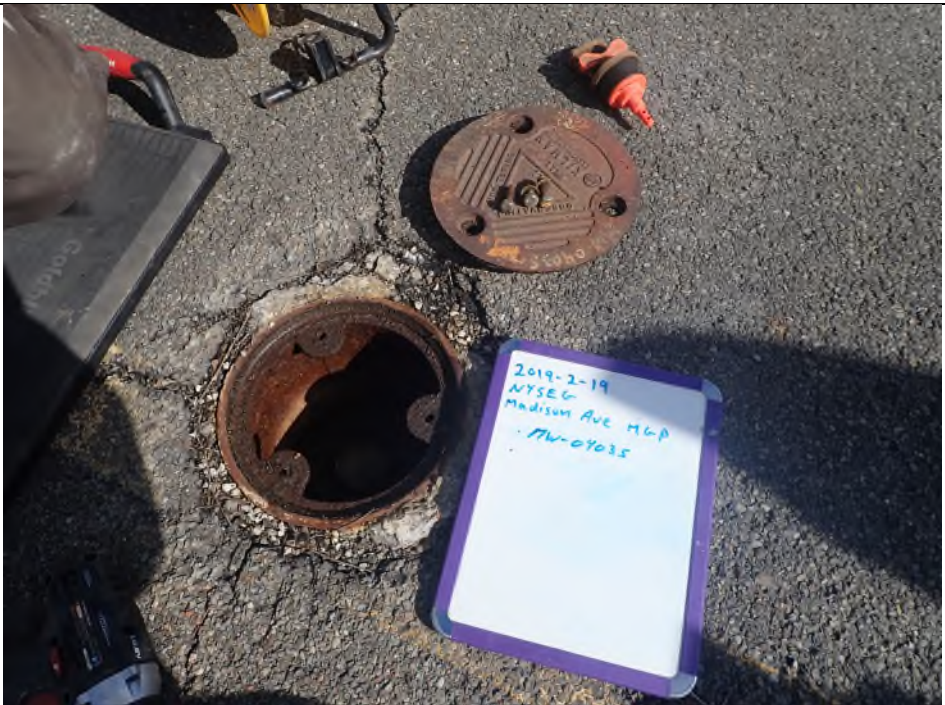
<b>PHOTOGRAPHER:</b> NJB	
<b>DATE:</b> 02/19/19	
<b>DIRECTION:</b> NA	
<b>COMMENT:</b> Photograph showing MW-0403S. Well is in good condition with locking well plug and competent cover.

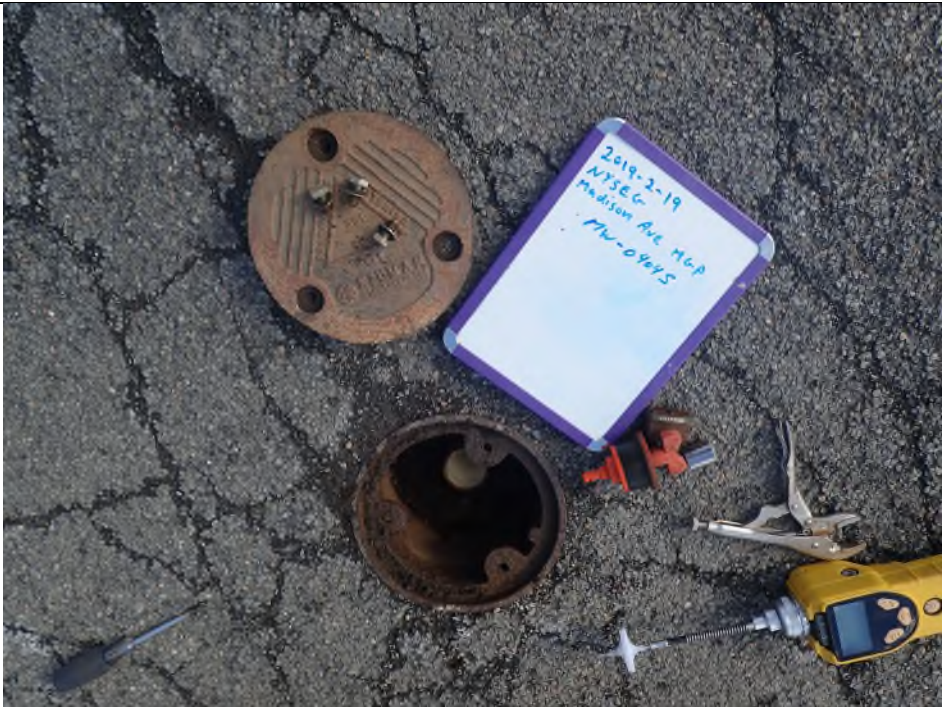
<b>PHOTOGRAPHER:</b> NJB	
<b>DATE:</b> 02/19/19	
<b>DIRECTION:</b> NA	
<b>COMMENT:</b> Photograph showing MW-0404S. Well is in good condition with locking well plug and competent cover. Bolted well lid was observed missing during the Annual Site Inspection. The lid will be replaced.

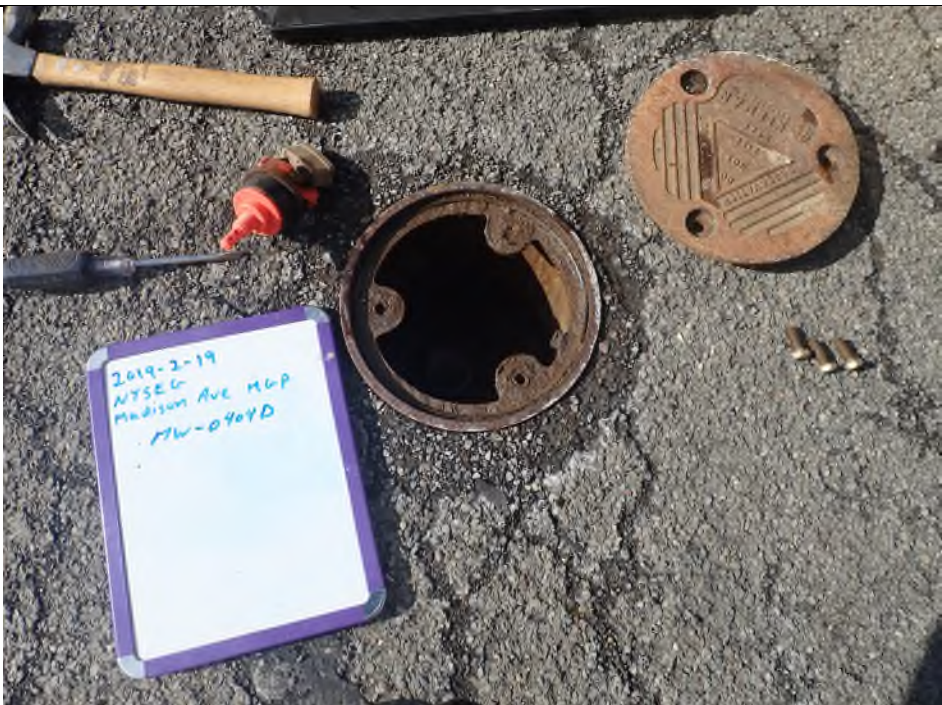
<b>PHOTOGRAPHER:</b> NJB	
<b>DATE:</b> 02/19/19	
<b>DIRECTION:</b> NA	
<b>COMMENT:</b> Photograph of MW-0404D. Well is in good condition with locking well plug and competent cover.

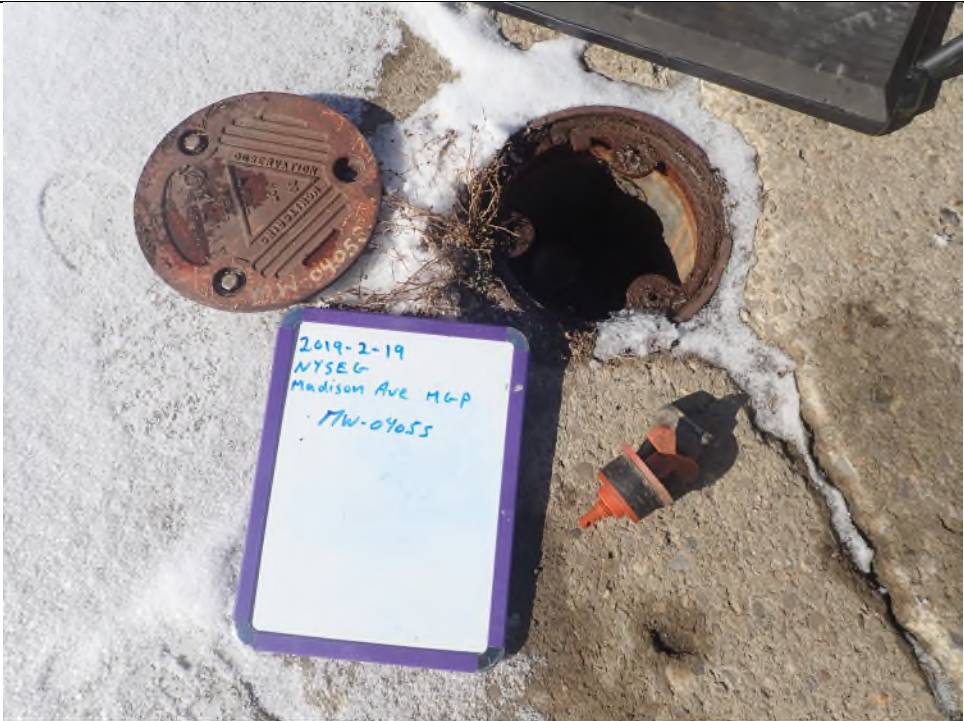
<b>PHOTOGRAPHER: NJB</b>	
<b>DATE: 02/19/19</b>	
<b>DIRECTION: NA</b>	
<b>COMMENT:</b> Photograph of MW-0405S. Well is in good condition with locking well plug and competent cover. Surrounding concrete flags are cracked, but road box is secure.

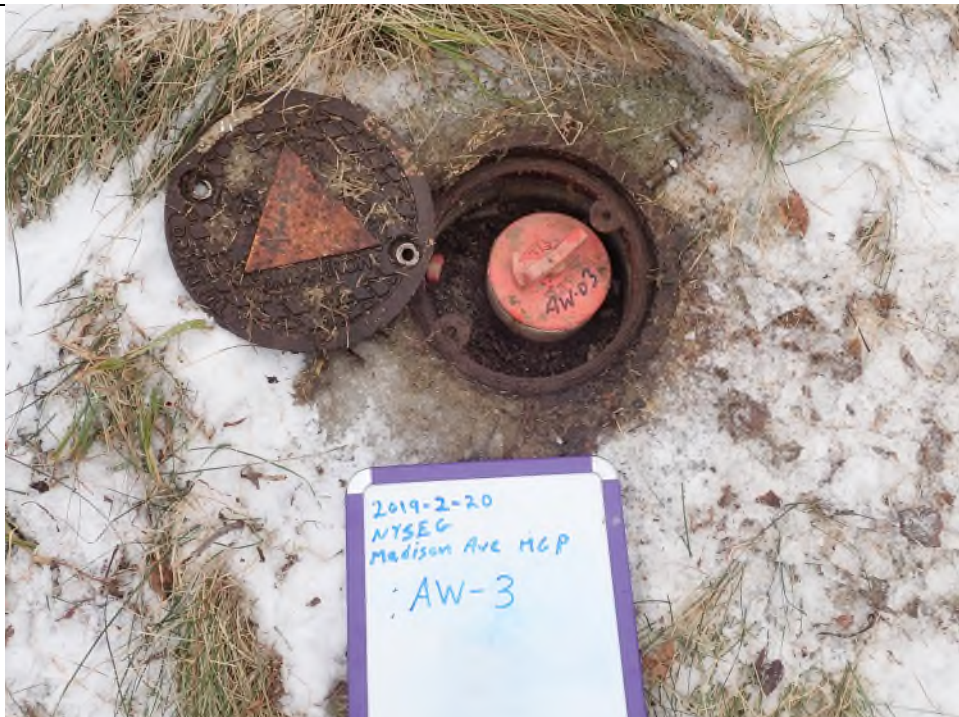
<b>CLIENT: NYSEG</b>	<b>SITE NAME: Madison Avenue Former MGP Site</b>
<b>PROJECT#:</b> B0013134.0001	<b>SITE LOCATION: Elmira, New York</b>
<b>WELL ID: AW-3</b>

<b>PHOTOGRAPHER: NJB</b>	
<b>DATE: 02/20/19</b>	
<b>DIRECTION: NA</b>	
<b>COMMENT:</b> Photograph showing AW-03. Well and stainless-steel canister/assembly is in good condition. Well has well plug and competent cover.

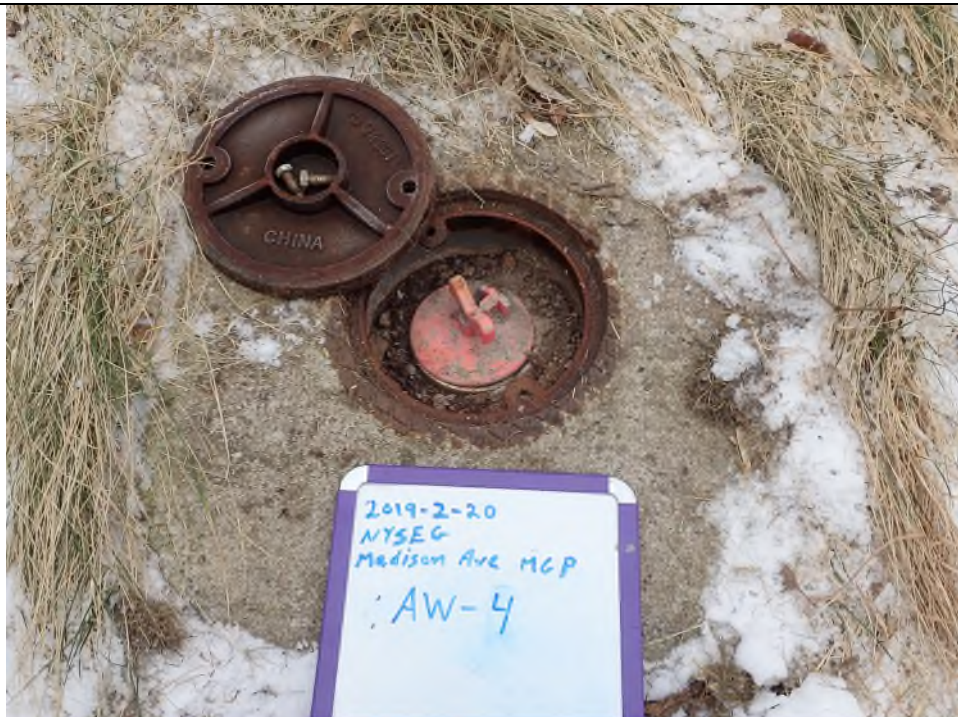
<b>CLIENT: NYSEG</b>	<b>SITE NAME: Madison Avenue Former MGP Site</b>
<b>PROJECT#:</b> B0013134.0001	<b>SITE LOCATION: Elmira, New York</b>
<b>WELL ID: AW-4</b>

<b>PHOTOGRAPHER: NJB</b>	
<b>DATE: 02/20/19</b>	
<b>DIRECTION: NA</b>	
<b>COMMENT:</b> Photograph showing AW-4. Well and stainless-steel canister/assembly is in good condition. Well has well plug and competent cover.

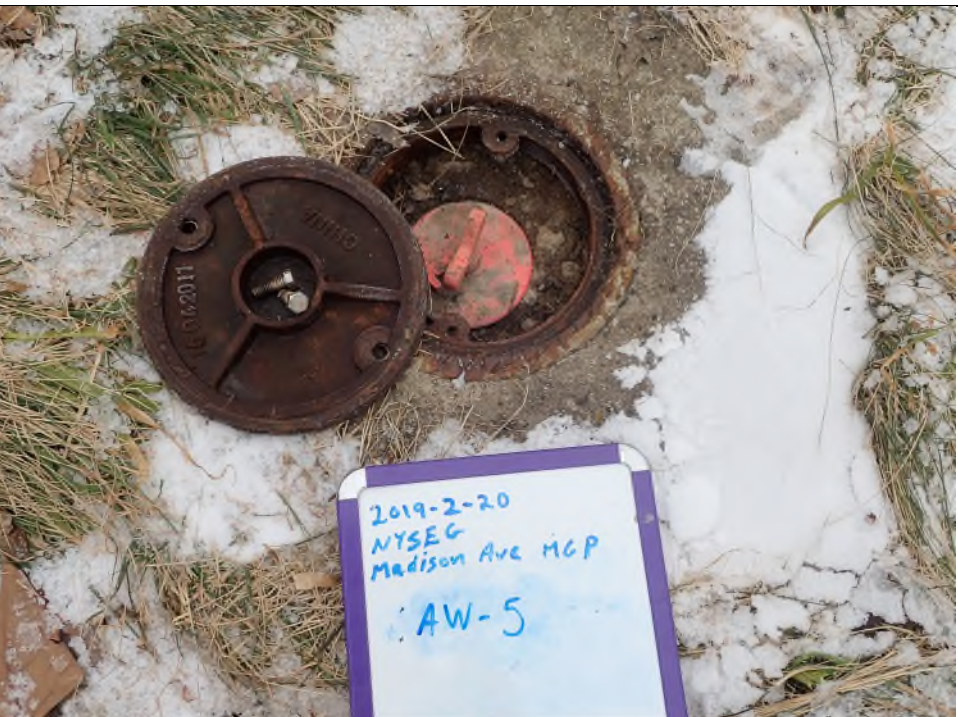
<b>CLIENT: NYSEG</b>	<b>SITE NAME: Madison Avenue Former MGP Site</b>
<b>PROJECT#:</b> B0013134.0001	<b>SITE LOCATION: Elmira, New York</b>
<b>WELL ID: AW-5</b>

<b>PHOTOGRAPHER: NJB</b>	
<b>DATE: 02/20/19</b>	
<b>DIRECTION: NA</b>	
<b>COMMENT:</b> Photograph showing AW-05 Well and stainless – steel canister/assembly is in good condition. Well has well and competent cover.

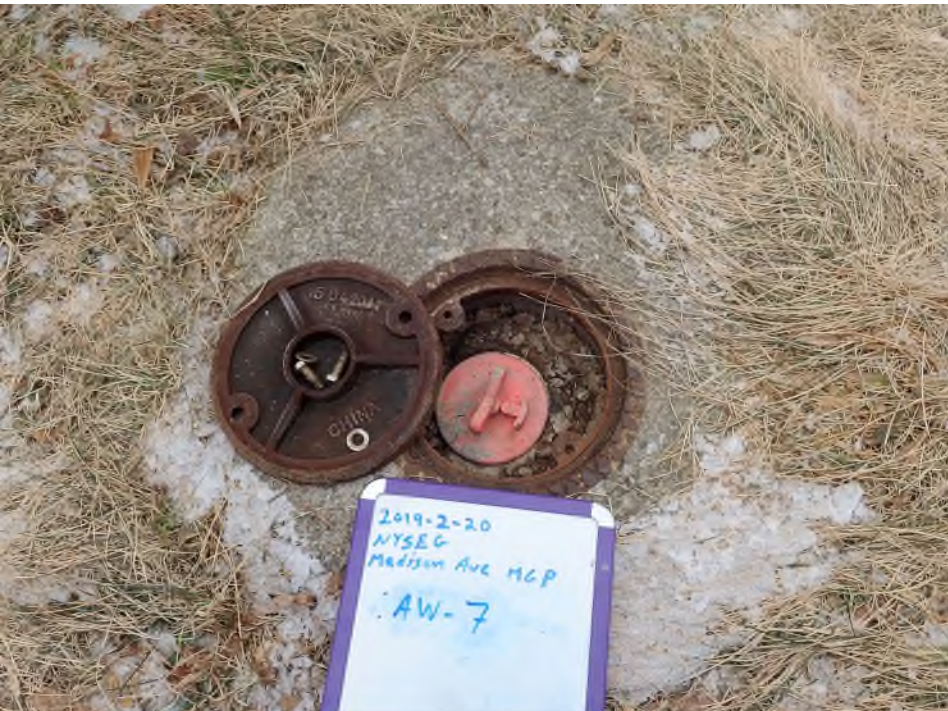
<b>CLIENT:</b> NYSEG	<b>SITE NAME:</b> Madison Avenue Former MGP Site
<b>PROJECT#:</b> B0013134.0001	<b>SITE LOCATION:</b> Elmira, New York
<b>WELL ID:</b> AW-7

<b>PHOTOGRAPHER:</b> NJB	
<b>DATE:</b> 02/20/19	
<b>DIRECTION:</b> NA	
<b>COMMENT:</b> Photograph showing AW-7. Well and stainless-steel canister/assembly is in good condition. Well has well plug and competent cover.

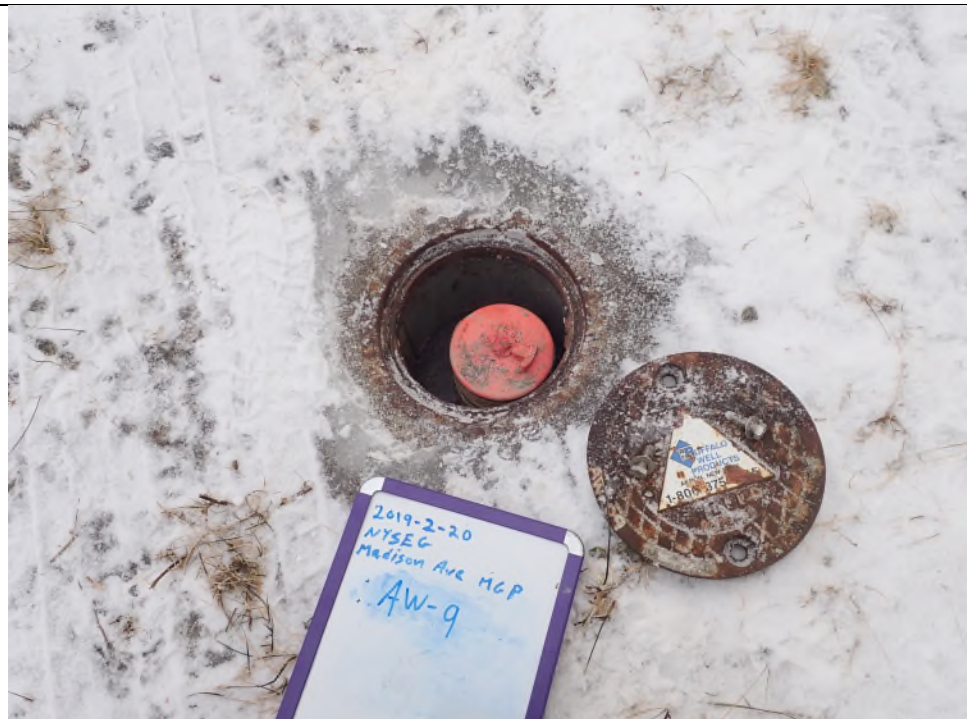
<b>CLIENT:</b> NYSEG	<b>SITE NAME:</b> Madison Avenue Former MGP Site
<b>PROJECT#:</b> B0013134.0001	<b>SITE LOCATION:</b> Elmira, New York
<b>WELL ID:</b> AW-9

<b>PHOTOGRAPHER:</b> NJB	
<b>DATE:</b> 02/20/19	
<b>DIRECTION:</b> NA	
<b>COMMENT:</b> Photograph showing AW-9. Well and stainless-steel canister/assembly is in good condition. Well has well plug and competent cover.

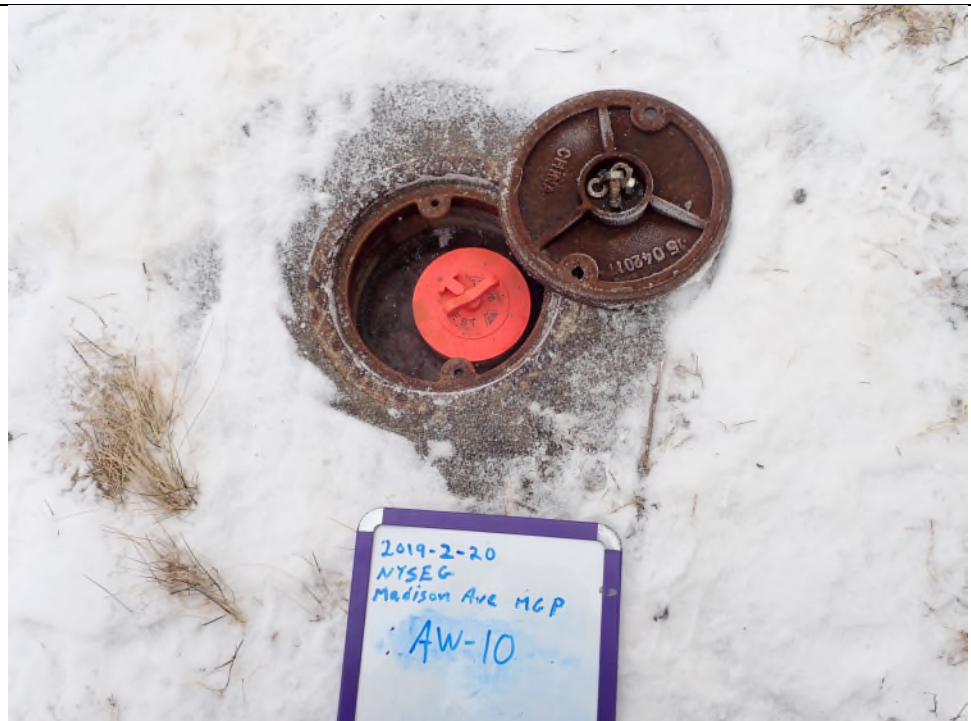
<b>CLIENT: NYSEG</b>	<b>SITE NAME: Madison Avenue Former MGP Site</b>
<b>PROJECT#:</b> B0013134.0001	<b>SITE LOCATION: Elmira, New York</b>
<b>WELL ID: AW-10</b>

<b>PHOTOGRAPHER: NJB</b>	
<b>DATE: 02/20/19</b>	
<b>DIRECTION: NA</b>	
<b>COMMENT:</b> Photograph showing AW-10. Well and stainless-steel canister/assembly is in good condition. Well has well plug and competent cover.

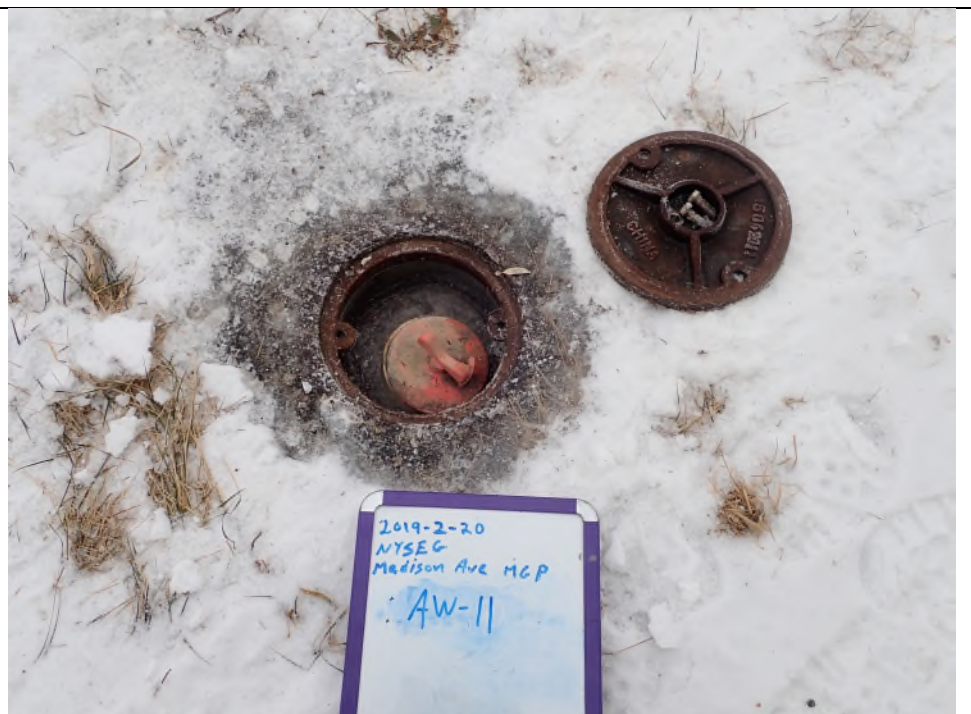
<b>CLIENT: NYSEG</b>	<b>SITE NAME: Madison Avenue Former MGP Site</b>
<b>PROJECT#:</b> B0013134.0001	<b>SITE LOCATION: Elmira, New York</b>
<b>WELL ID: AW-11</b>

<b>PHOTOGRAPHER: NJB</b>	
<b>DATE: 02/20/19</b>	
<b>DIRECTION: NA</b>	
<b>COMMENT:</b> Photograph showing AW-11. Well and stainless-steel canister/assembly is in good condition. Well has well plug and competent cover.

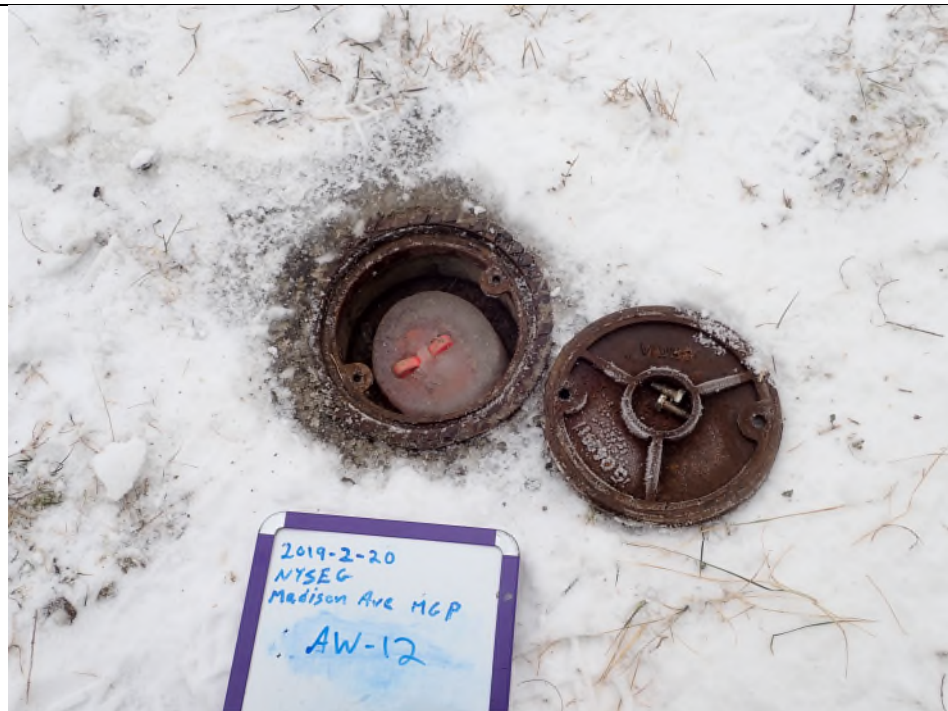
<b>CLIENT: NYSEG</b>	<b>SITE NAME: Madison Avenue Former MGP Site</b>
<b>PROJECT#:</b> B0013134.0001	<b>SITE LOCATION: Elmira, New York</b>
<b>WELL ID: AW-12</b>

<b>PHOTOGRAPHER: NJB</b>	
<b>DATE: 02/20/19</b>	
<b>DIRECTION: NA</b>	
<b>COMMENT:</b> Photograph showing AW-12. Well and stainless-steel canister/assembly is in good condition. Well has well plug and competent cover.

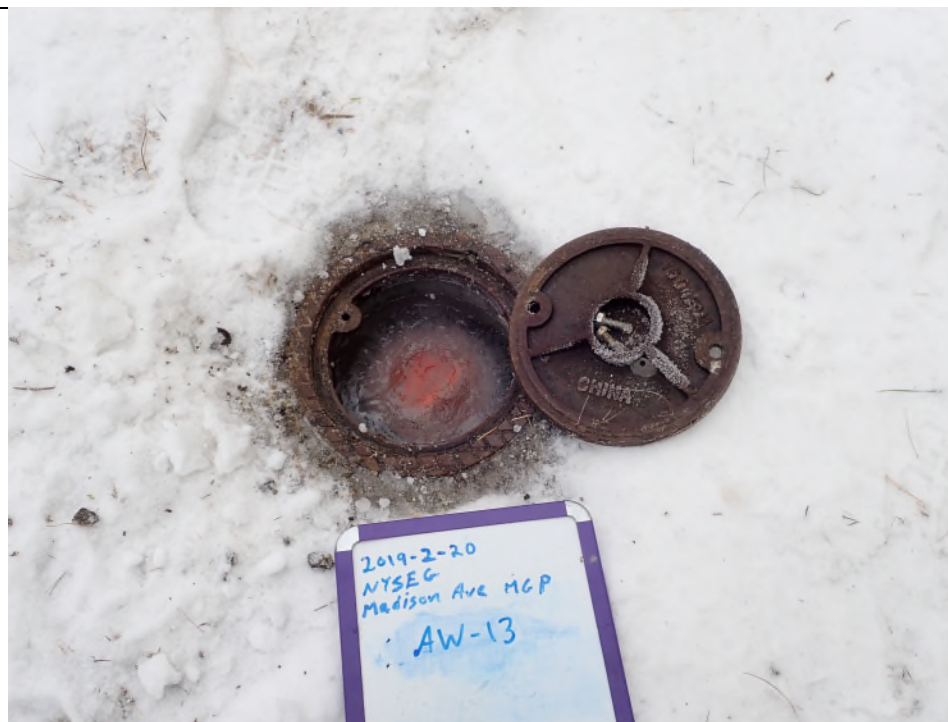
<b>CLIENT: NYSEG</b>	<b>SITE NAME: Madison Avenue Former MGP Site</b>
<b>PROJECT#:</b> B0013134.0001	<b>SITE LOCATION: Elmira, New York</b>
<b>WELL ID: AW-13</b>

<b>PHOTOGRAPHER: NJB</b>	
<b>DATE: 02/20/19</b>	
<b>DIRECTION: NA</b>	
<b>COMMENT:</b> Photograph showing AW-13. Well and stainless-steel canister/assembly is in good condition. Well has well plug and competent cover.

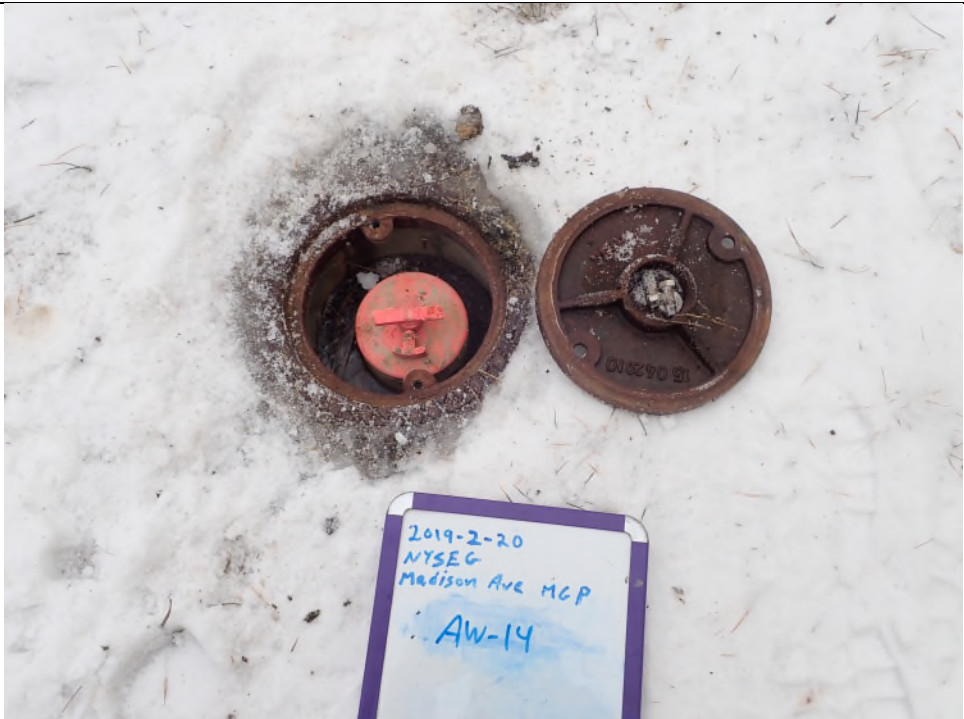
<b>CLIENT:</b> NYSEG	<b>SITE NAME:</b> Madison Avenue Former MGP Site
<b>PROJECT#:</b> B0013134.0001	<b>SITE LOCATION:</b> Elmira, New York
<b>WELL ID:</b> AW-14

<b>PHOTOGRAPHER:</b> NJB	
<b>DATE:</b> 02/20/19	
<b>DIRECTION:</b> NA	
<b>COMMENT:</b> Photograph showing AW-14. Well and stainless-steel canister/assembly is in good condition. Well has well plug and competent cover.
