Re: 2019 and 2020 Annual Periodic Review Reports Response Letter  
Madison Avenue Former MGP Site, Elmira  
Site #808018

RE: **Annual Periodic Review Report (Q25  
through Q28) (revised)**  
Madison Avenue Former MGP Site  
Site # 808018  
Elmira, Chemung County

NYSEG  
MADISON AVENUE FORMER MGP SITE  
ANNUAL PERIODIC REVIEW REPORT

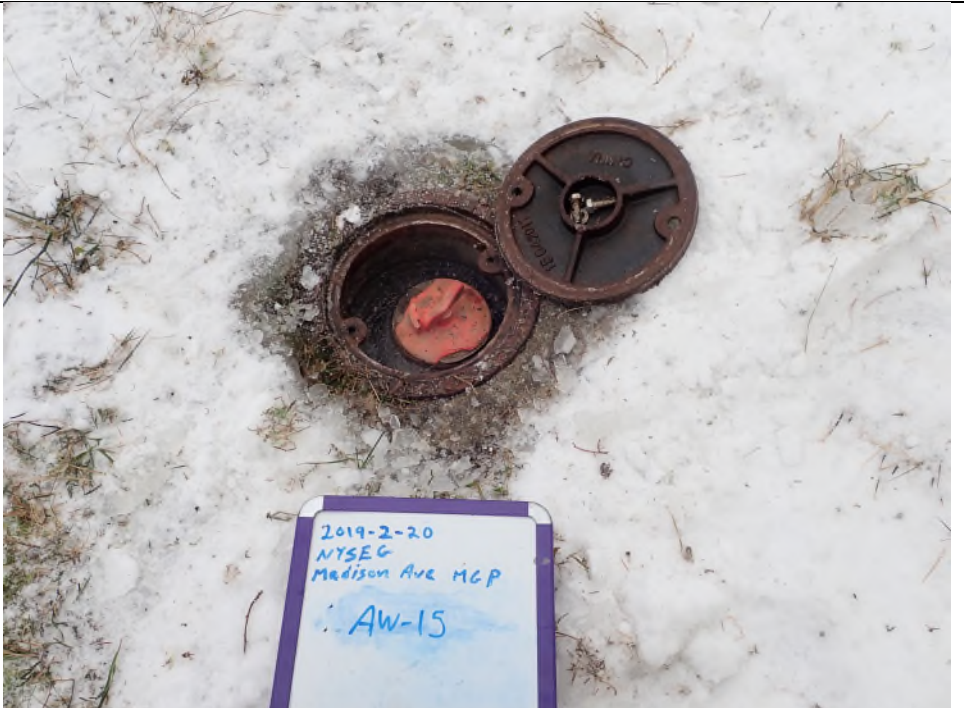
<b>CLIENT:</b> NYSEG	<b>SITE NAME:</b> Madison Avenue Former MGP Site
<b>PROJECT#:</b> B0013134.0001	<b>SITE LOCATION:</b> Elmira, New York
<b>WELL ID:</b> AW-15

<b>PHOTOGRAPHER:</b> NJB	
<b>DATE:</b> 02/20/19	
<b>DIRECTION:</b> NA	
<b>COMMENT:</b> Photograph showing AW-15. Well and stainless-steel canister/assembly is in good condition. Well has well plug and competent cover.

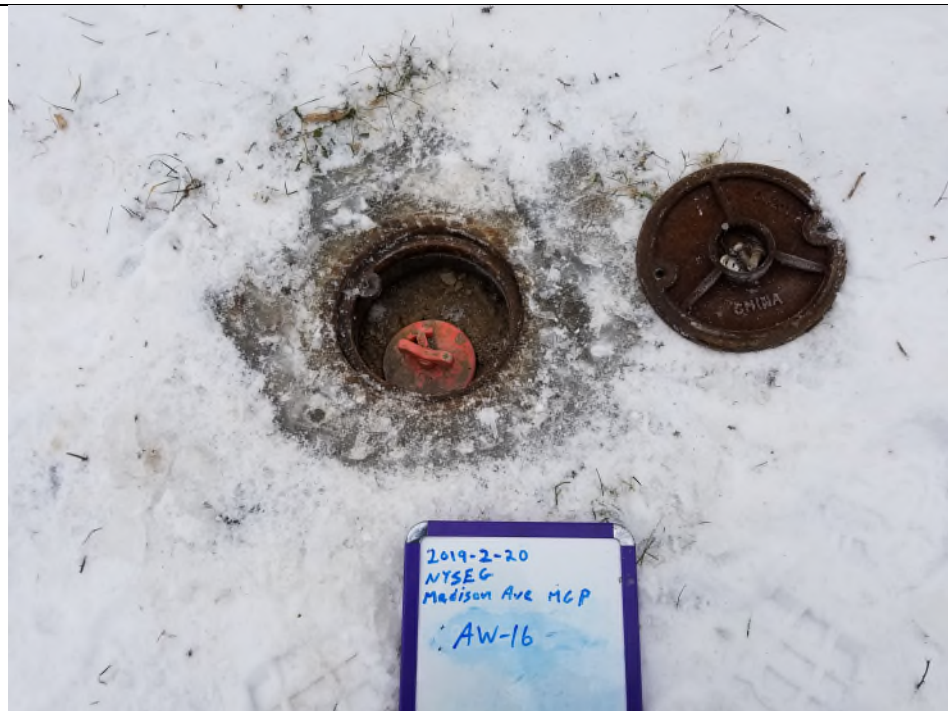
<b>CLIENT:</b> NYSEG	<b>SITE NAME:</b> Madison Avenue Former MGP Site
<b>PROJECT#:</b> B0013134.0001	<b>SITE LOCATION:</b> Elmira, New York
<b>WELL ID:</b> AW-16

<b>PHOTOGRAPHER:</b> NJB	
<b>DATE:</b> 02/20/19	
<b>DIRECTION:</b> NA	
<b>COMMENT:</b> Photograph showing AW-16. Well and stainless-steel canister/assembly is in good condition. Well has well plug and competent cover.

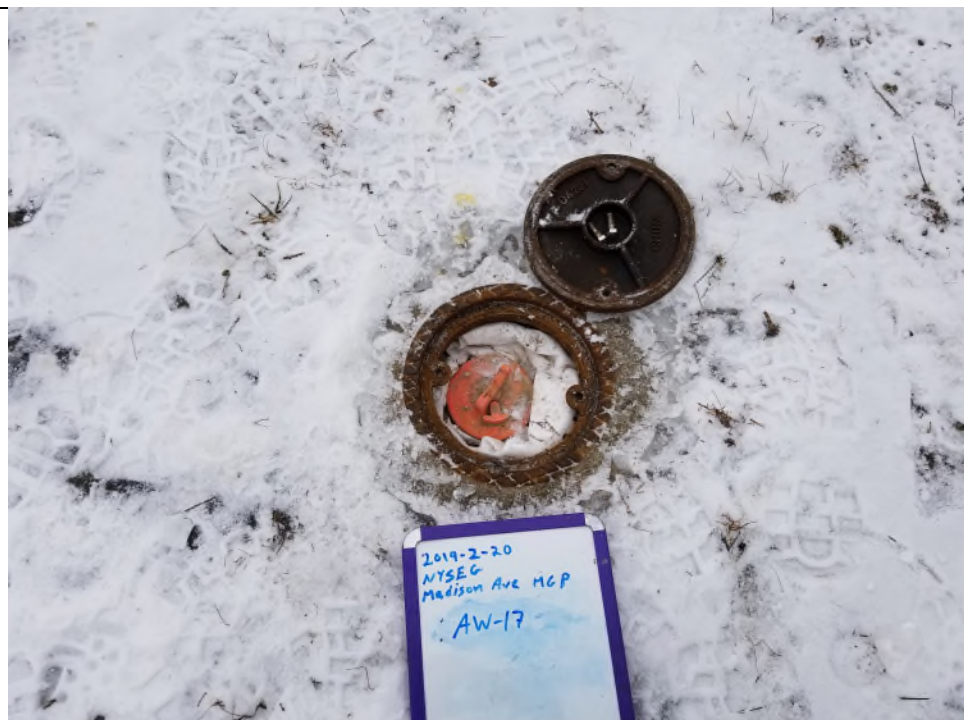
Based on visual inspection, no repairs to AW-17 are required.

<b>PHOTOGRAPHER:</b> NJB	
<b>DATE:</b> 02/20/19	
<b>DIRECTION:</b> NA	
<b>COMMENT:</b> Photograph showing AW-17. Well and stainless-steel canister/assembly is in good condition. Well has well plug and competent cover.

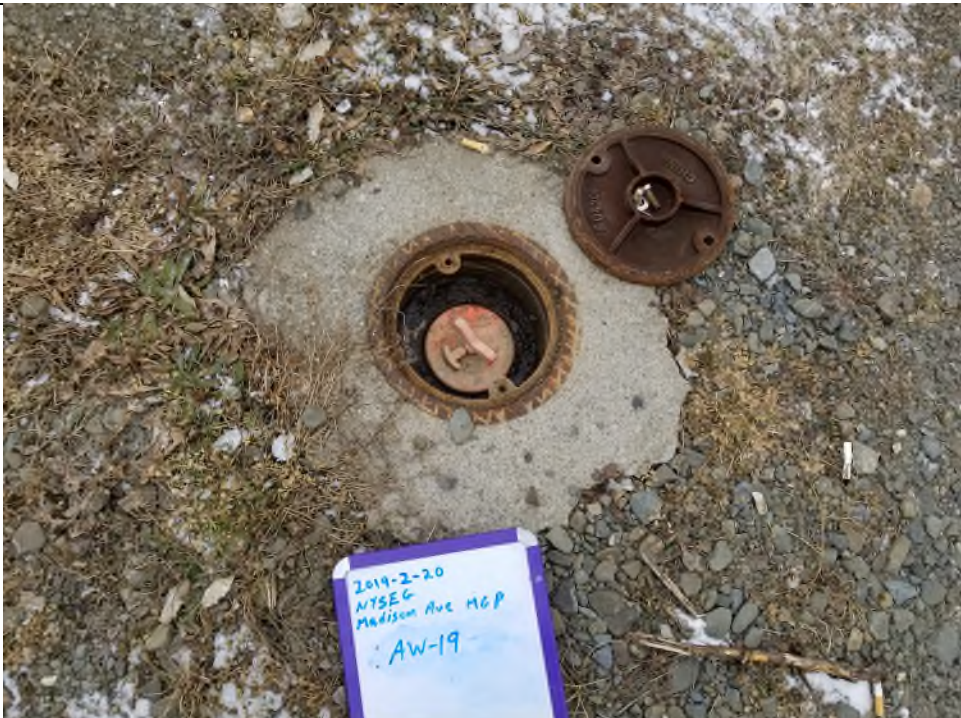
<b>CLIENT:</b> NYSEG	<b>SITE NAME:</b> Madison Avenue Former MGP Site
<b>PROJECT#:</b> B0013134.0001	<b>SITE LOCATION:</b> Elmira, New York
<b>WELL ID:</b> AW-19

<b>PHOTOGRAPHER:</b> NJB	
<b>DATE:</b> 02/20/19	
<b>DIRECTION:</b> NA	
<b>COMMENT:</b> Photograph showing AW-19. Well and stainless-steel canister/assembly is in good condition. Well has well plug and competent cover.

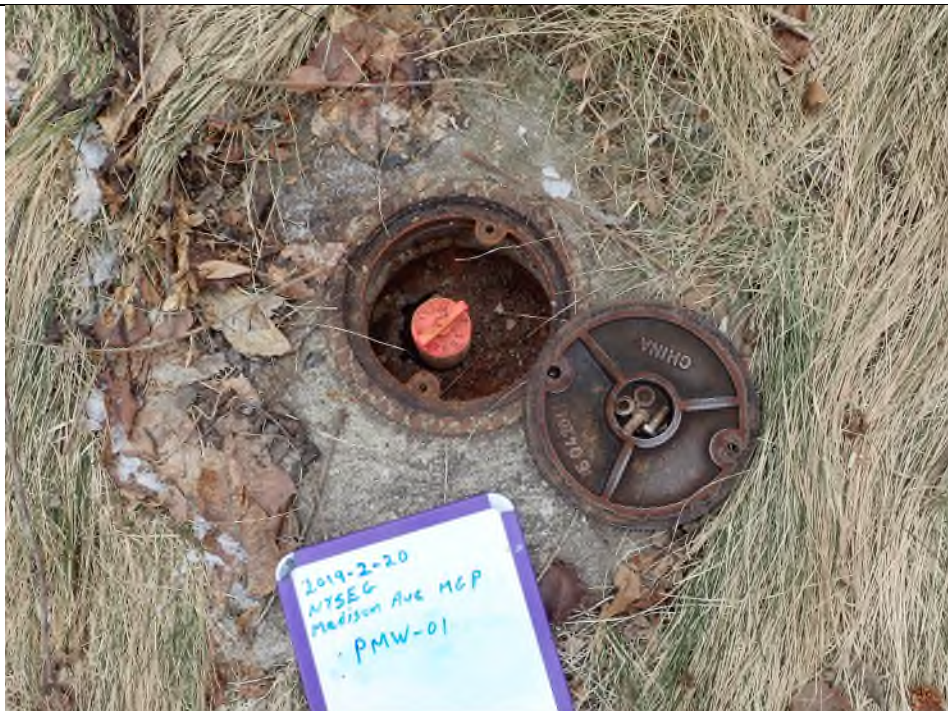
<b>PHOTOGRAPHER: NJB</b>	
<b>DATE: 02/20/19</b>	
<b>DIRECTION: NA</b>	
<b>COMMENT:</b> Photograph showing PMW-1. Well is in good condition with well plug and competent cover, however well road box has settled since installation. During the February 2019 site visit, the PVC riser was cut shorter and the well measuring point was resurveyed.

- Risers were cut down at PMW-01, PMW-03, and PMW-04. Due to heaving of the wells and/or sinking of the road boxes, the lids on the road boxes for each of the three PMWs could not be properly secured. To preserve the integrity of the well, the 2-inch riser was cut down within the road box, and the top of casings were re-surveyed along with MW-2S during the Q24 site visit. Note that these repairs were completed towards the end of the site visit, after gauging of the site wells were completed; therefore, the top of casing elevations presented in **Table 2** did not require revision for this report – the revised top of casing elevations will be reflected in the next gauging event.

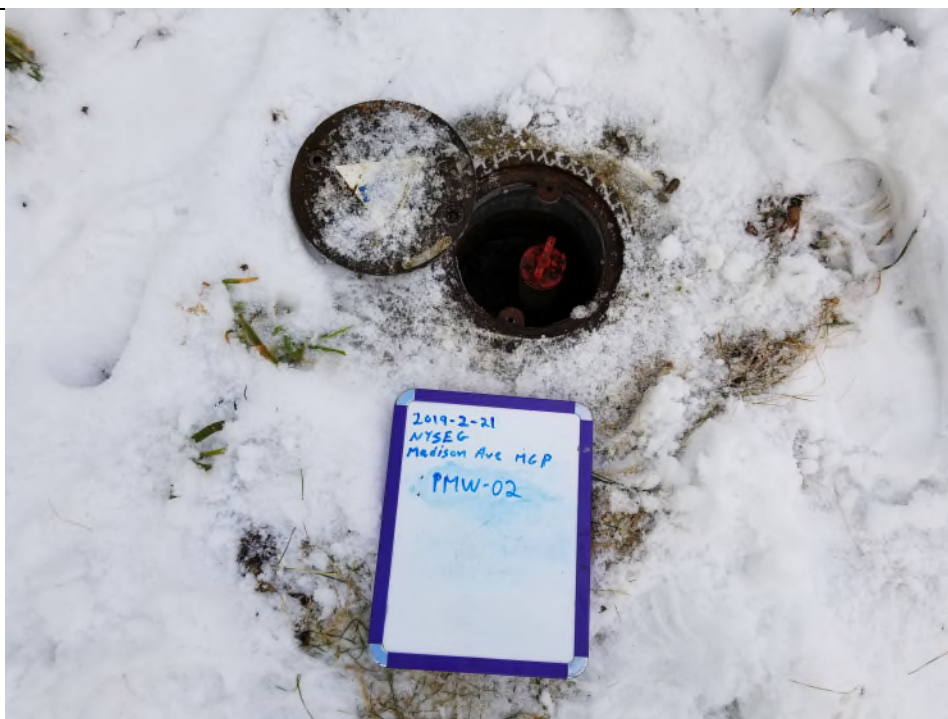
<b>CLIENT: NYSEG</b>	<b>SITE NAME: Madison Avenue Former MGP Site</b>
<b>PROJECT#:</b> B0013134.0001	<b>SITE LOCATION: Elmira, New York</b>
<b>WELL ID: PMW-2</b>

<b>PHOTOGRAPHER: NJB</b>	
<b>DATE: 02/21/19</b>	
<b>DIRECTION: NA</b>	
<b>COMMENT:</b> Photograph showing PMW-2. Well is in good condition with well plug and competent cover.

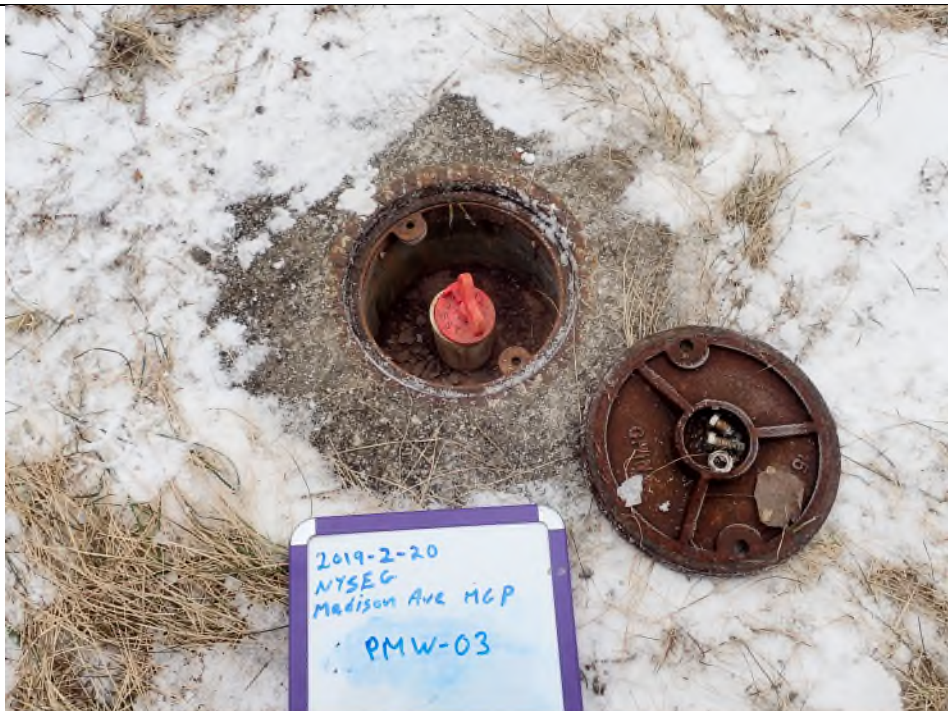
<b>PHOTOGRAPHER:</b> NJB	
<b>DATE:</b> 02/20/19	
<b>DIRECTION:</b> NA	
<b>COMMENT:</b> Photograph is showing well PMW-03. Well is in good condition with well plug and competent cover, however well road box has settled since installation. During the February 2019 site visit, the PVC riser was cut shorter and the well measuring point was resurveyed.

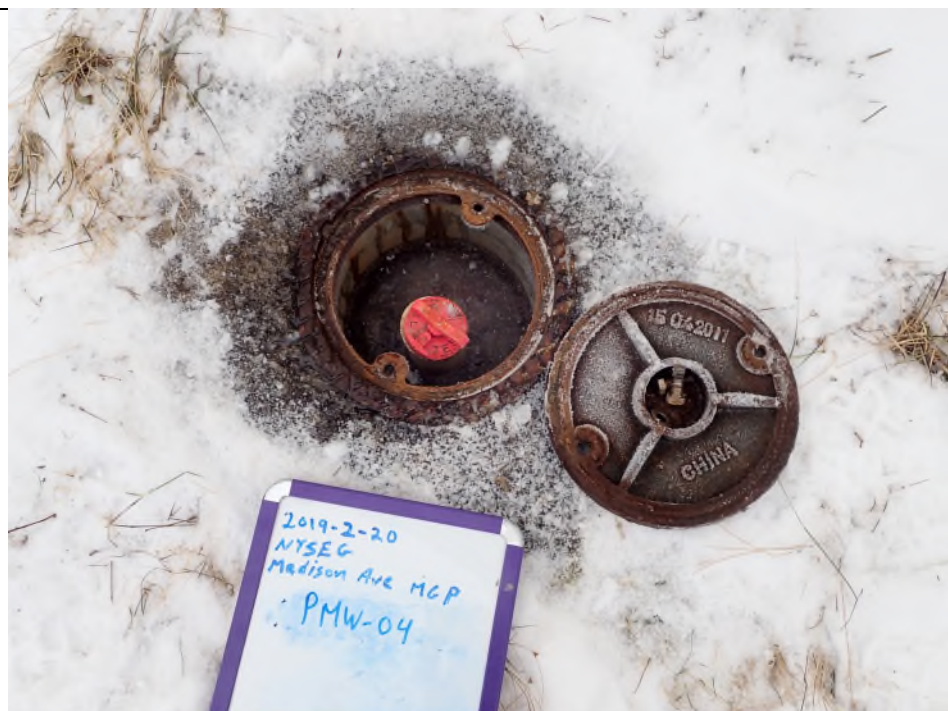
<b>PHOTOGRAPHER:</b> NJB	
<b>DATE:</b> 02/20/19	
<b>DIRECTION:</b> NA	
<b>COMMENT:</b> Photograph showing PMW-4. Well is in good condition with well plug and competent cover, however well road box has settled since installation. During the February 2019 site visit, the PVC riser was cut shorter and the well measuring point was resurveyed.

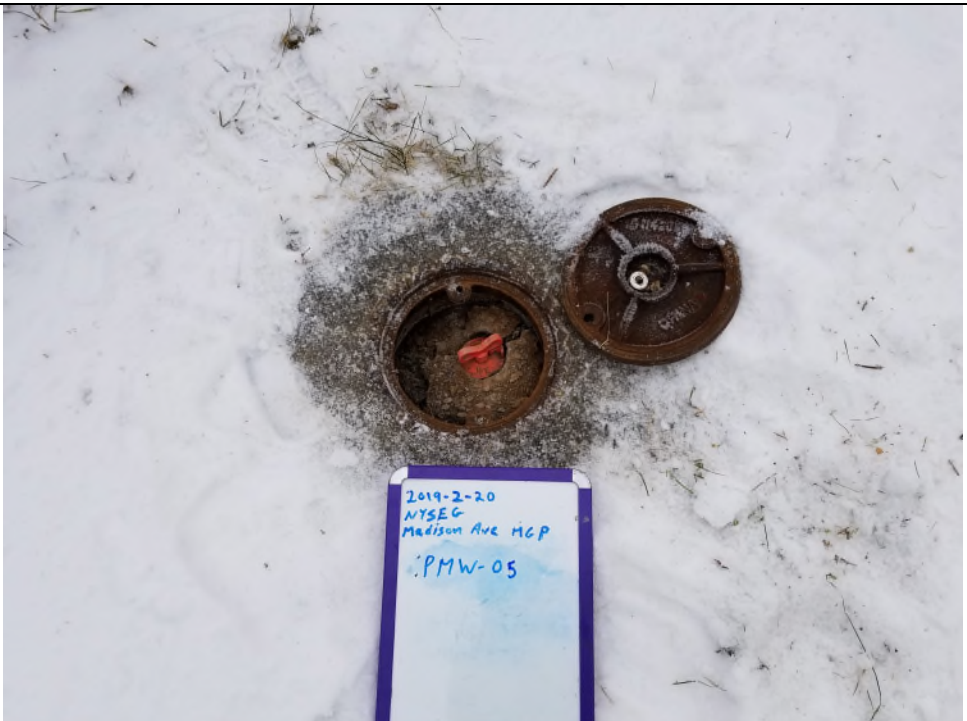
<b>CLIENT: NYSEG</b>	<b>SITE NAME: Madison Avenue Former MGP Site</b>
<b>PROJECT#:</b> B0013134.0001	<b>SITE LOCATION: Elmira, New York</b>
<b>WELL ID: PMW-5</b>

<b>PHOTOGRAPHER: NJB</b>	
<b>DATE: 02/20/19</b>	
<b>DIRECTION: NA</b>	
<b>COMMENT:</b> Photograph showing PMW-5. Well is in good condition with well plug and competent cover.

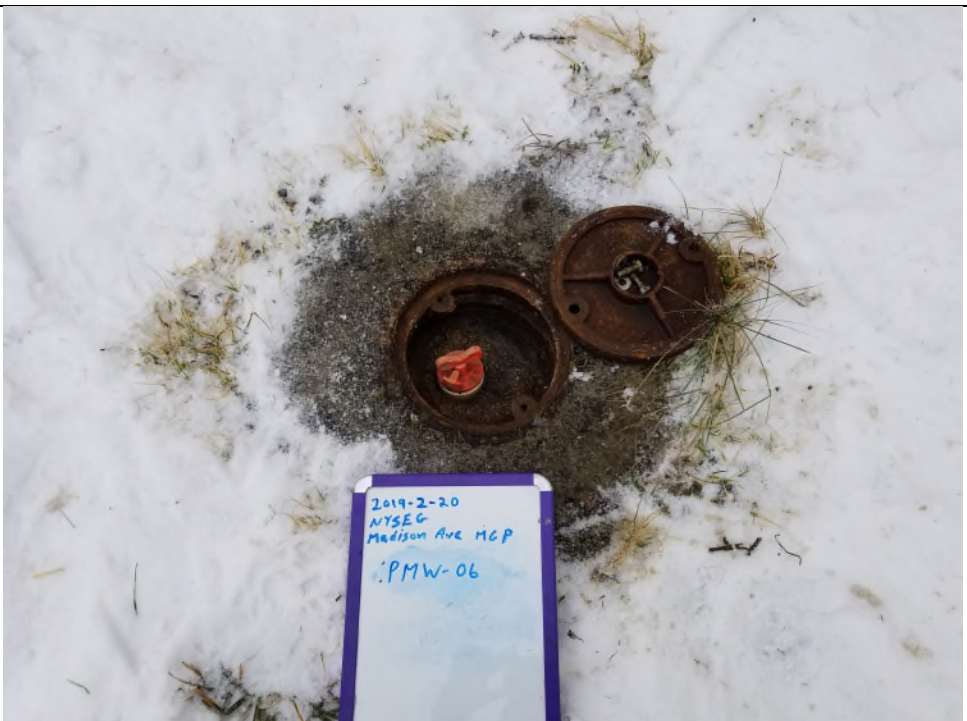
<b>CLIENT: NYSEG</b>	<b>SITE NAME: Madison Avenue Former MGP Site</b>
<b>PROJECT#:</b> B0013134.0001	<b>SITE LOCATION: Elmira, New York</b>
<b>WELL ID: PMW-6</b>

<b>PHOTOGRAPHER: NJB</b>	
<b>DATE: 02/20/19</b>	
<b>DIRECTION: NA</b>	
<b>COMMENT:</b> Photograph showing PMW-6. Well is in good condition with well plug and competent cover.

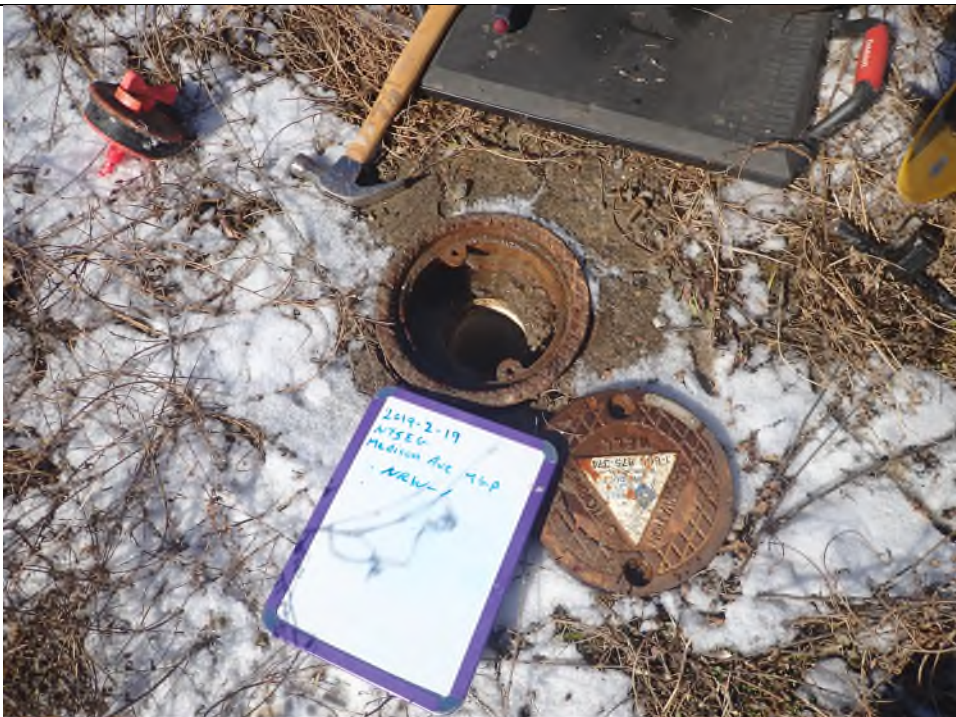
<b>CLIENT:</b> NYSEG	<b>SITE NAME:</b> Madison Avenue Former MGP Site
<b>PROJECT#:</b> B0013134.0001	<b>SITE LOCATION:</b> Elmira, New York
<b>WELL ID:</b> NRW-1

<b>PHOTOGRAPHER:</b> NJB	
<b>DATE:</b> 02/19/19	
<b>DIRECTION:</b> NA	
<b>COMMENT:</b> Photograph showing NRW-1. Well is in good condition with well plug and competent cover.

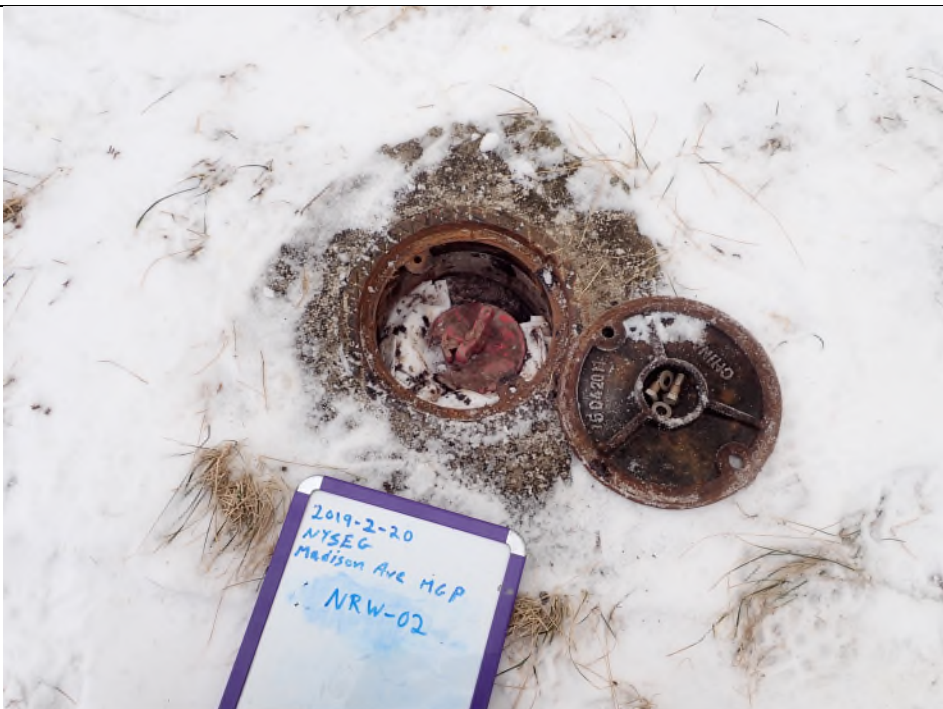
<b>CLIENT:</b> NYSEG	<b>SITE NAME:</b> Madison Avenue Former MGP Site
<b>PROJECT#:</b> B0013134.0001	<b>SITE LOCATION:</b> Elmira, New York
<b>WELL ID:</b> NRW-2

<b>PHOTOGRAPHER:</b> NJB	
<b>DATE:</b> 02/20/19	
<b>DIRECTION:</b> NA	
<b>COMMENT:</b> Photograph showing NRW-2. Well is in good condition with the well plug and competent cover.

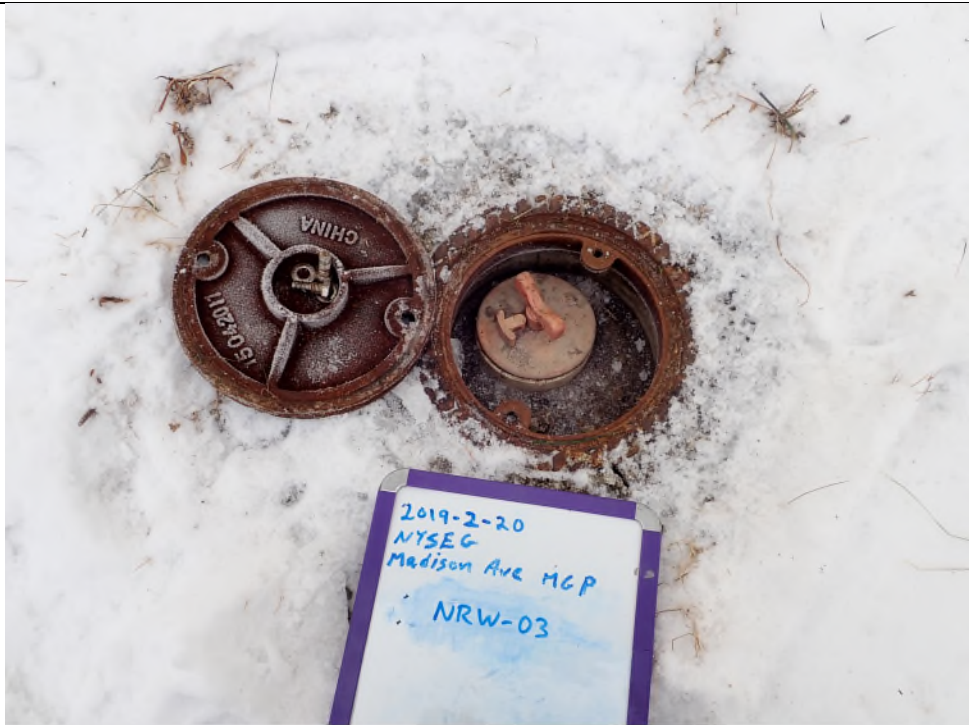
<b>CLIENT:</b> NYSEG	<b>SITE NAME:</b> Madison Avenue Former MGP Site
<b>PROJECT#:</b> B0013134.0001	<b>SITE LOCATION:</b> Elmira, New York
<b>WELL ID:</b> NRW-3

<b>PHOTOGRAPHER:</b> NJB	
<b>DATE:</b> 02/20/19	
<b>DIRECTION:</b> NA	
<b>COMMENT:</b> Photograph showing NRW-3. Well is in good condition with the plug and competent cover.

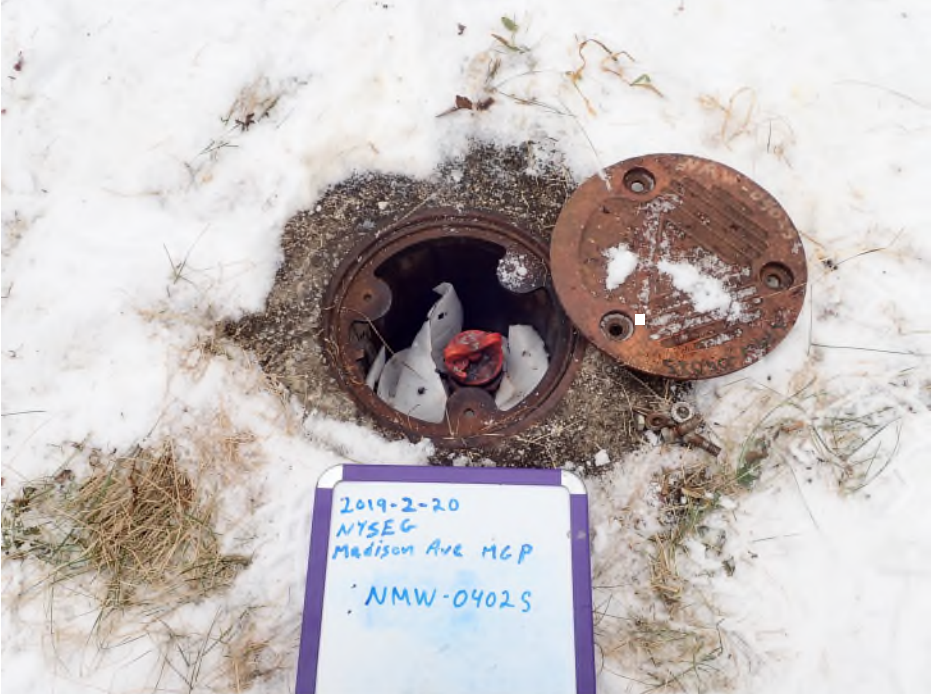
<b>CLIENT: NYSEG</b>	<b>SITE NAME: Madison Avenue Former MGP Site</b>
<b>PROJECT#:</b> B0013134.0001	<b>SITE LOCATION: Elmira, New York</b>
<b>WELL ID: NMW-0402S</b>

<b>PHOTOGRAPHER: NJB</b>	
<b>DATE: 02/20/19</b>	
<b>DIRECTION: NA</b>	
<b>COMMENT:</b> Photograph showing NMW-0402S. Well is in good condition with the plug and competent cover.
