Re: 2019 and 2020 Annual Periodic Review Reports Response Letter  
Madison Avenue Former MGP Site, Elmira  
Site #808018

RE: **Annual Periodic Review Report (Q25  
through Q28) (revised)**  
Madison Avenue Former MGP Site  
Site # 808018  
Elmira, Chemung County

April 2020, Revised August 2020

## ANNUAL PERIODIC REVIEW REPORT (Q25 THROUGH Q28)

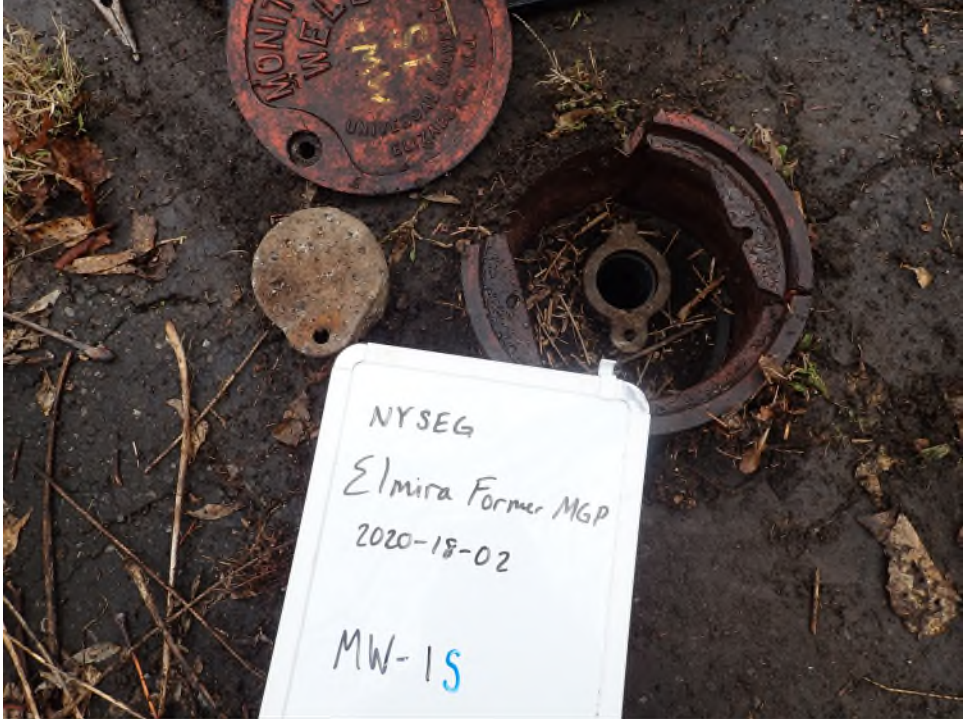
| <b>WELL ID:</b> MW-1S | |

- The road box and apron around MW-1S and MW-1D are deteriorated/destroyed and should be replaced.

The road boxes and aprons around MW-1S and MW-1D are deteriorated/destroyed and should be replaced. Repairs should be completed during the August 2020 site visit.

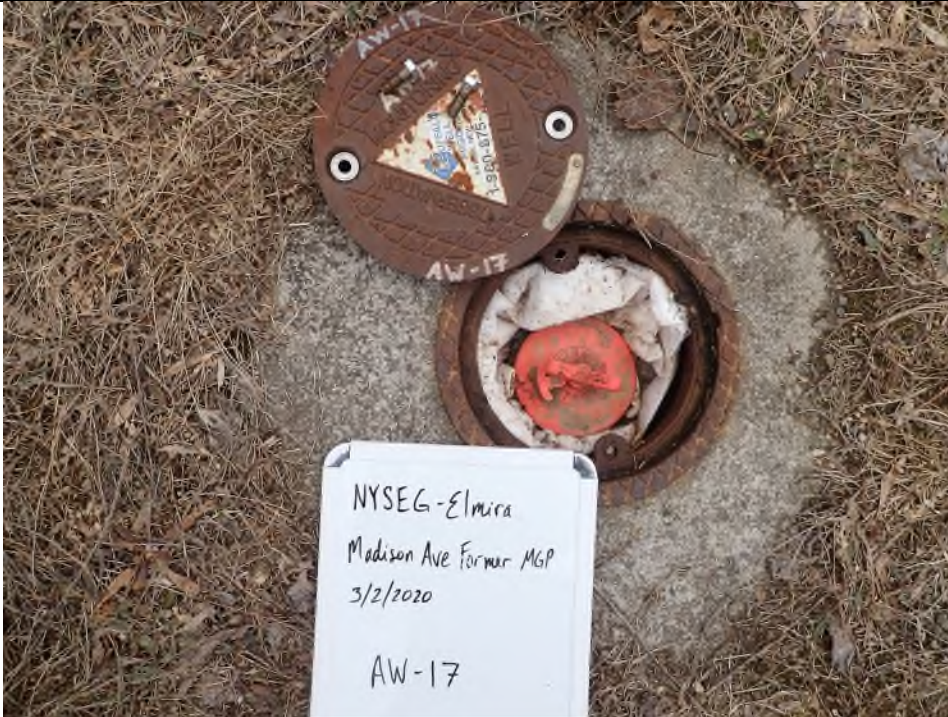
| <b>WELL ID: AW-17</b> | |

- Sediments were removed from AW-17 by manual bailing on August 14, 2019 during the Q26 semi-annual site visit.
- Bolt holes for the road box lids were re-tapped and the bolts replaced at 6 wells, including:
