Former Sperry Remington Site Elmira, New York

<b>Study Area Historical Topographic Maps: 1895 and 1953</b>	
Former Sperry Remington Site Elmira, New York	
<b>Geosyntec</b> consultants	<b>Figure</b> 5
Columbia, MD	November 2018

**Lead Analytical Results in Sediment (0 to 2 ft bsi)**  
**Comparisons to Soil Cleanup Objectives**  
Former Sperry Remington Site Elmira, New York

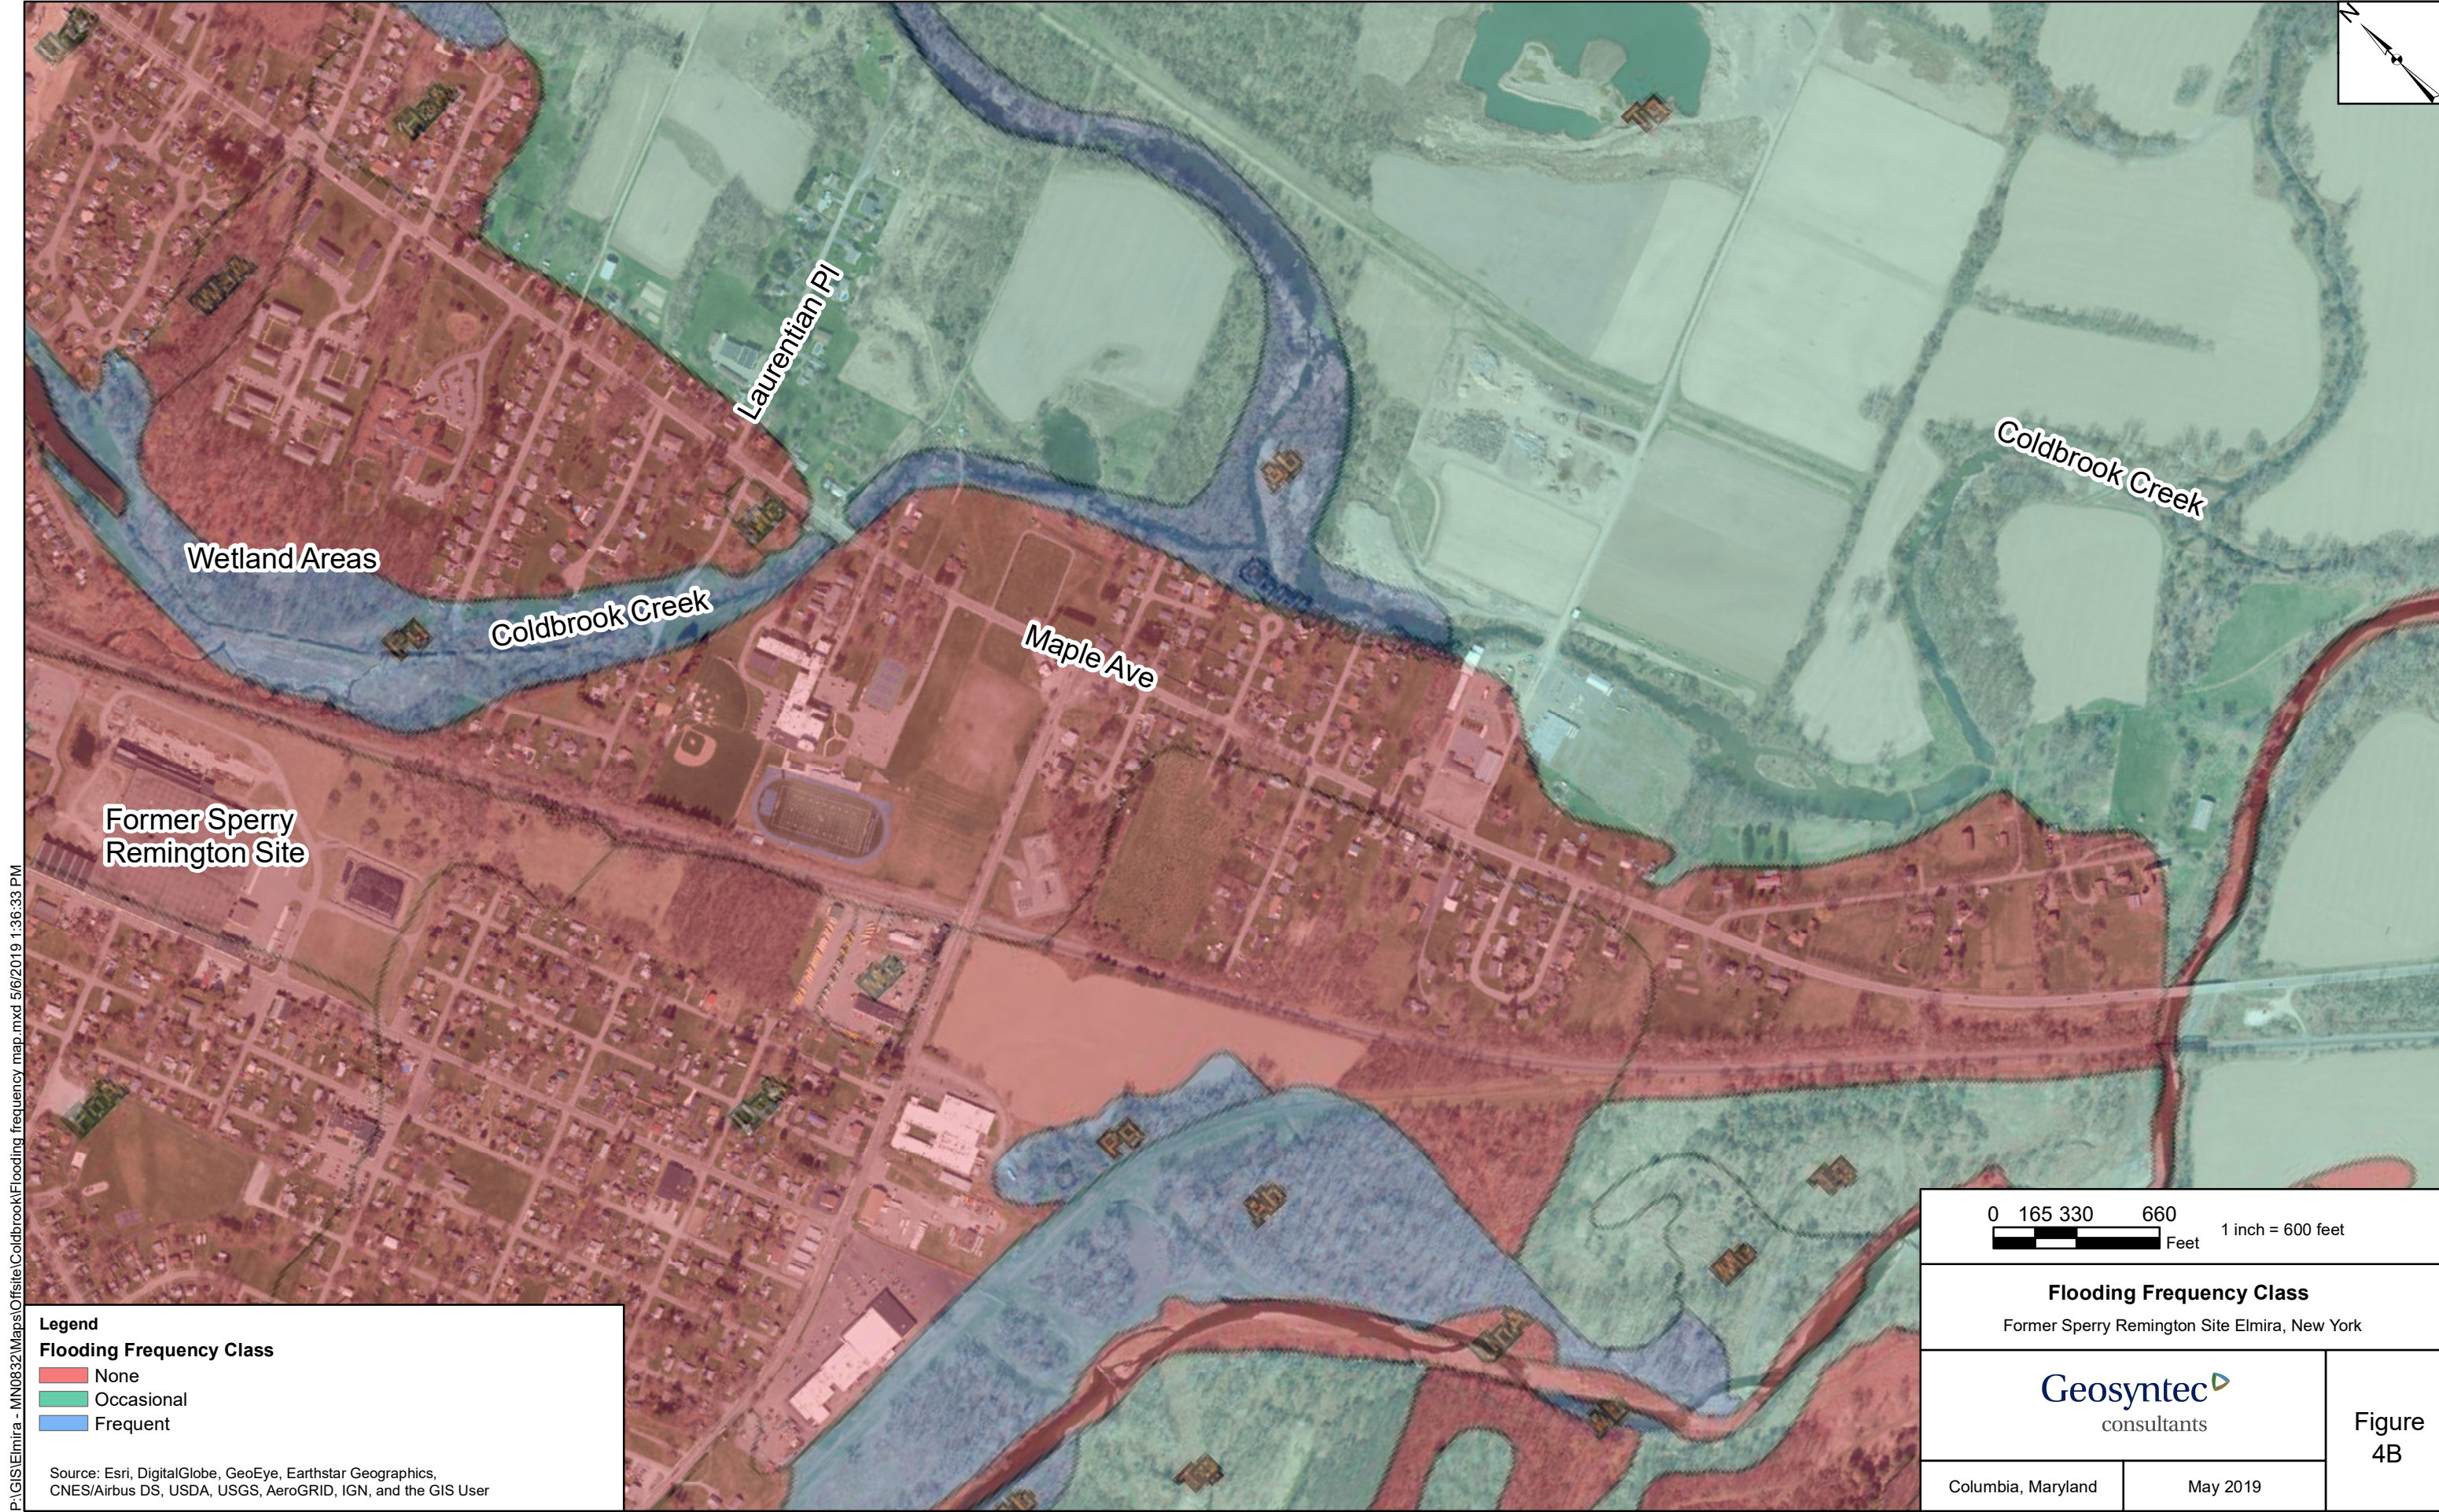
Figure 4B

**Flooding Frequency Class**

None

Occasional

Frequent

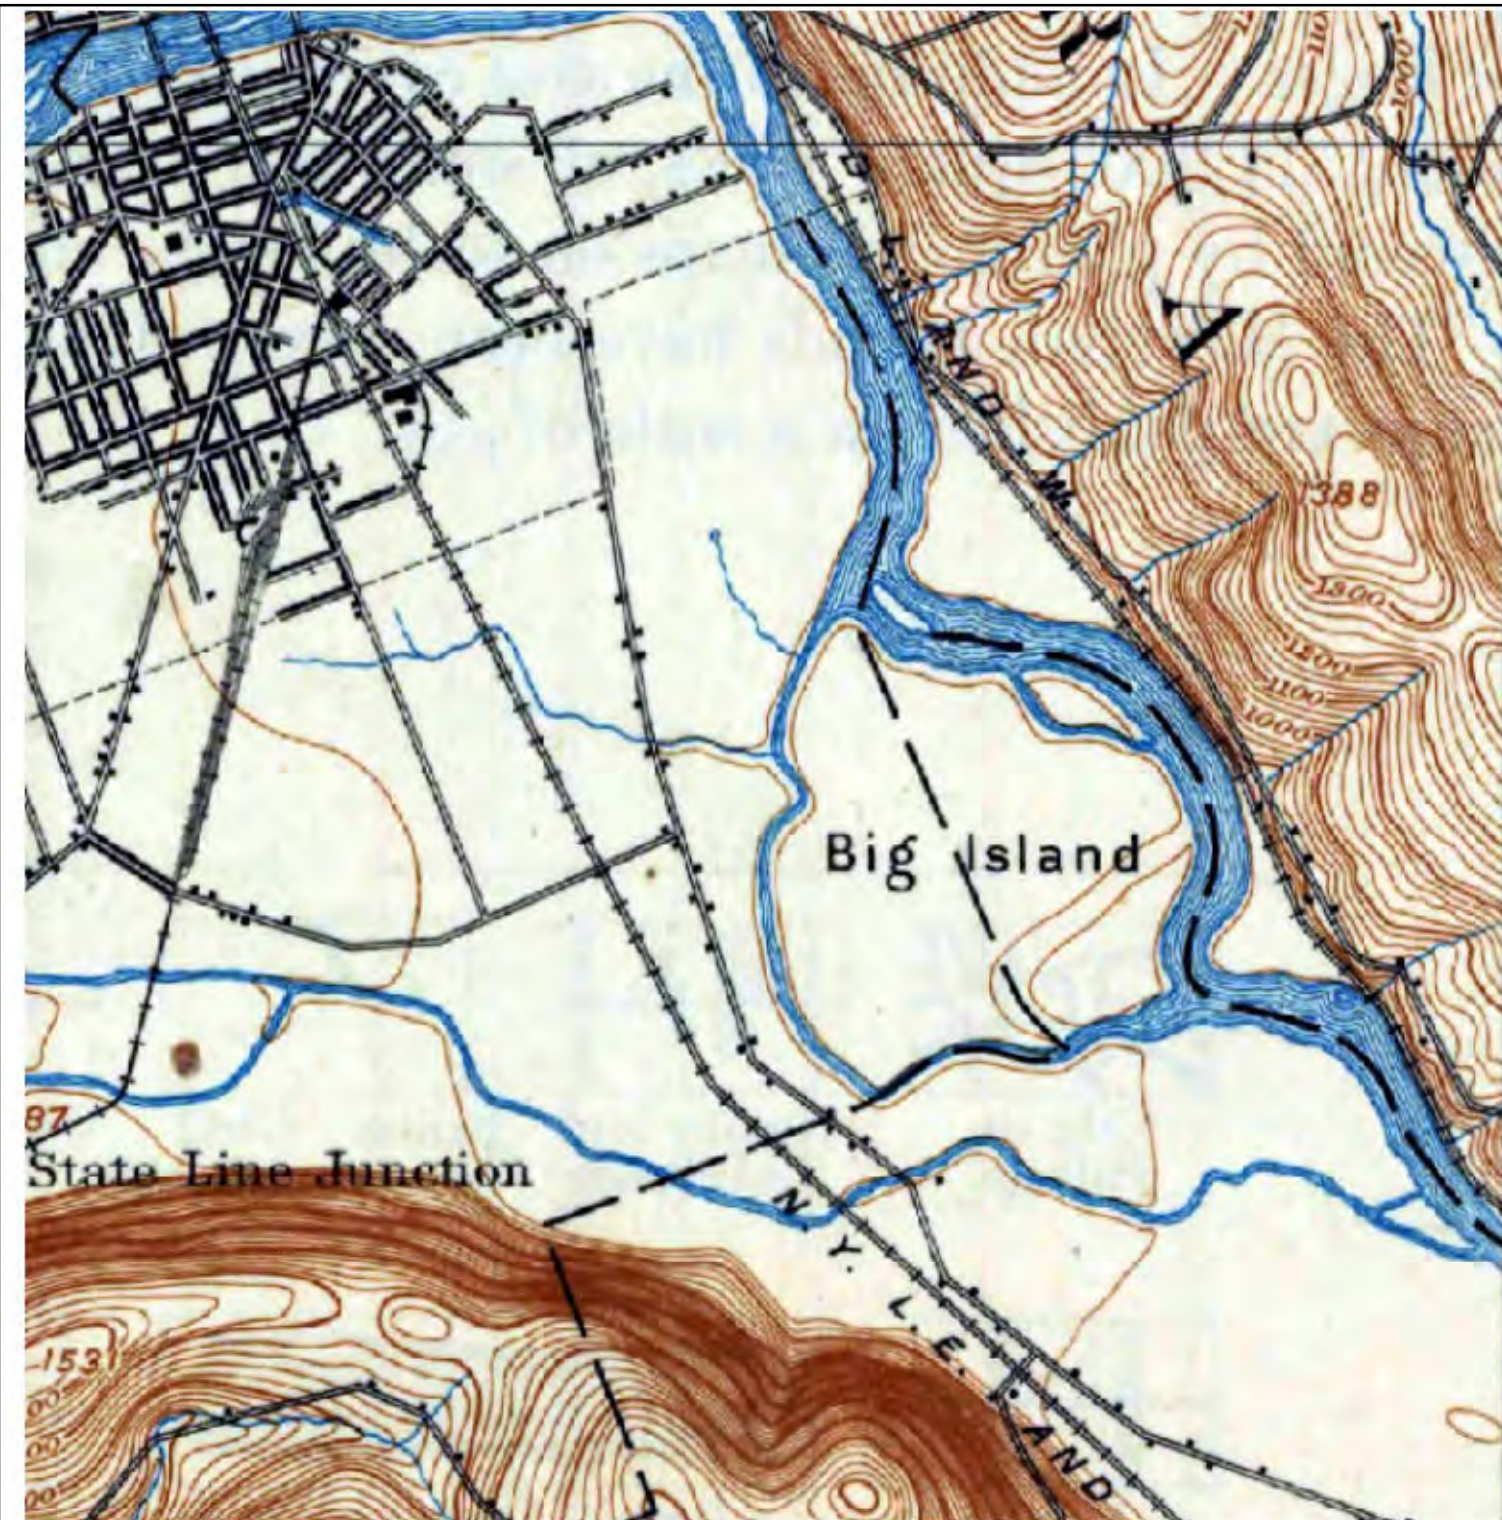
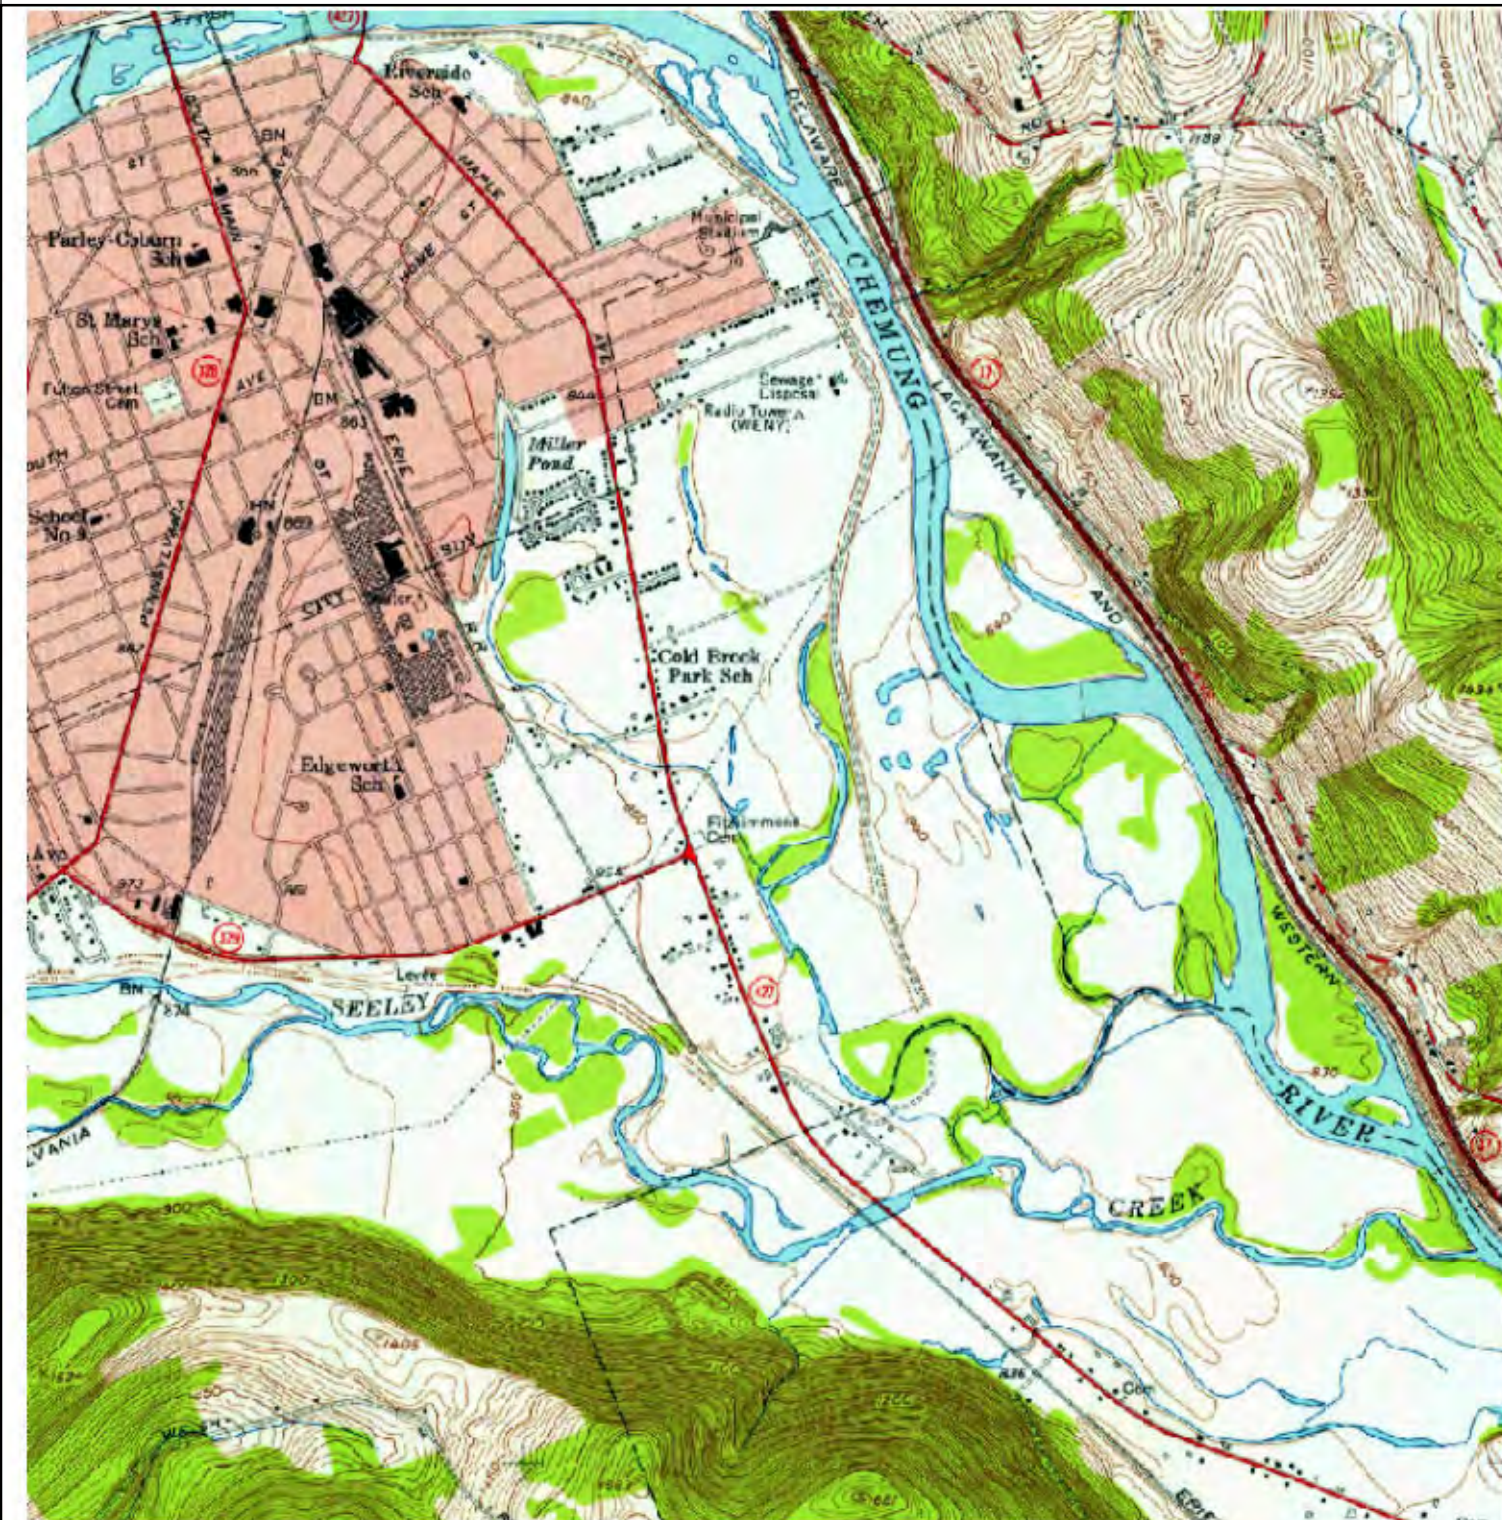
Historical Topographic Map - 1895

Historical Topographic Map - 1953

Sources:  
U.S. Geological Survey, 1895, USGS 1:62500-scale Quadrangle for Elmira, NY 1895: U.S. Geological Survey.  
U.S. Geological Survey, 1953, USGS 1:24000-scale Quadrangle for Elmira, NY 1953: U.S. Geological Survey.

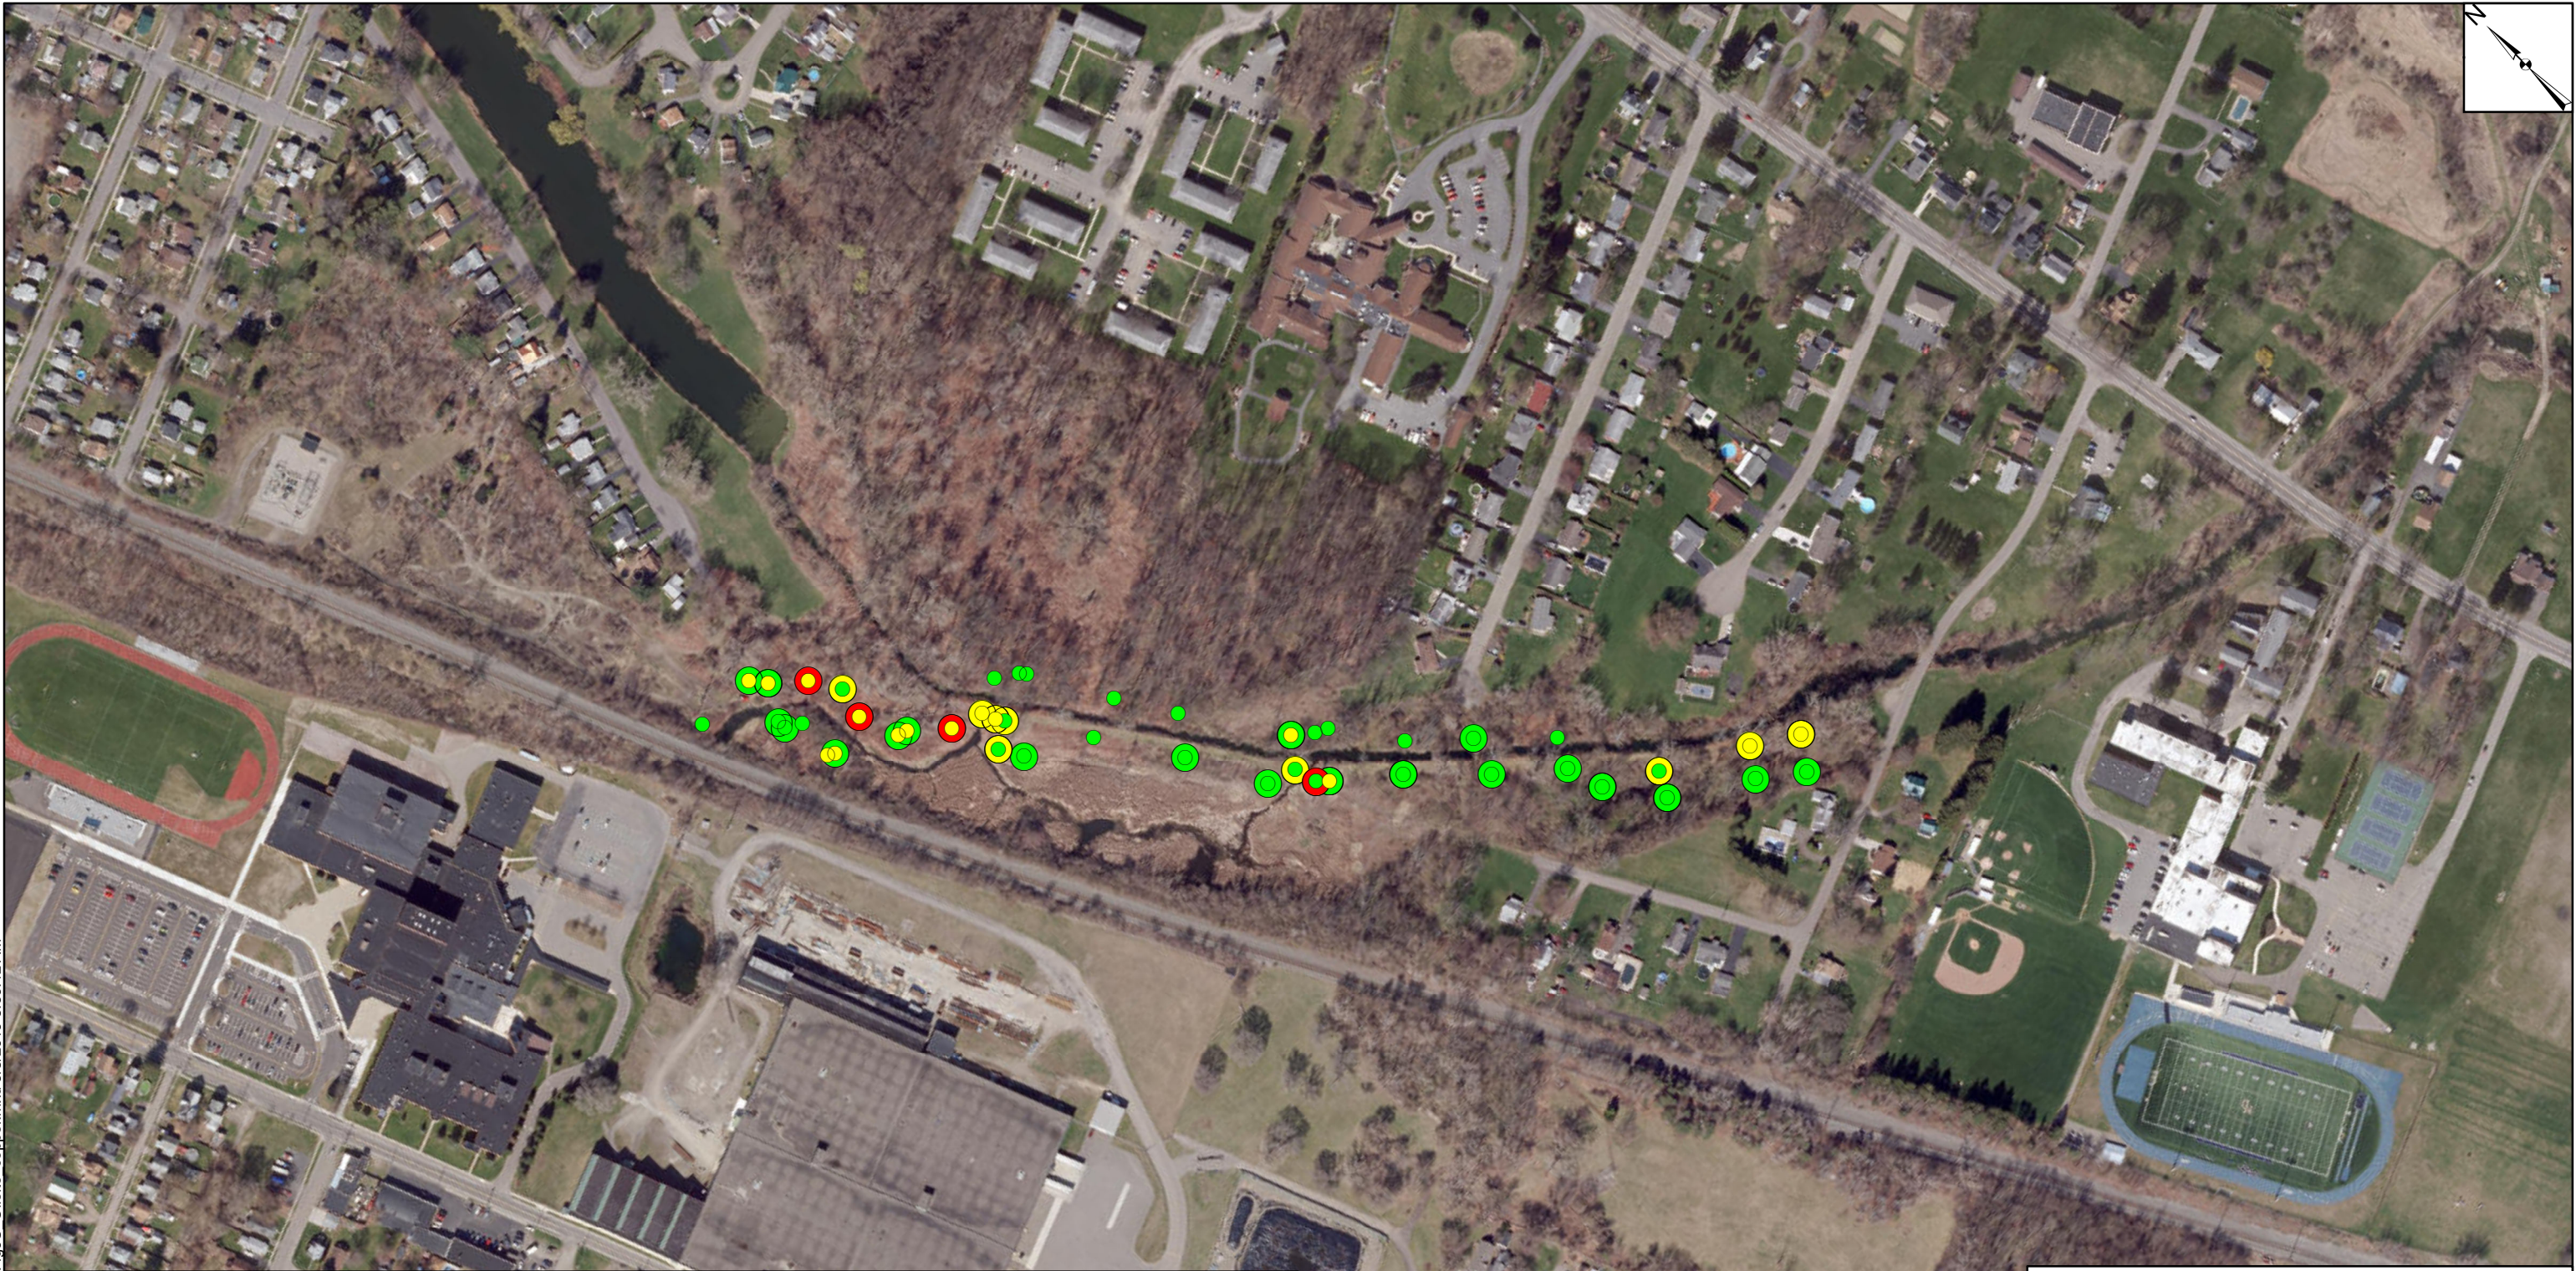
**9C**

**Copper in Soil (mg/kg) 0-0.5 ft bgs**

- Below Unrestricted Use SCO (<50 mg/kg)
- Below Residential Use SCO (50-270 mg/kg)
- Above Residential Use SCO (>270 mg/kg)

**Copper in Soil (mg/kg) >0.5 ft bgs**

The ecological copper SCO is 50 mg/kg (i.e., unrestricted SCO exceedances are also ecological SCO exceedances)

**Copper Analytical Results in Soil (0 to 3 ft bgs)**

**Comparisons to Soil Cleanup Objectives**

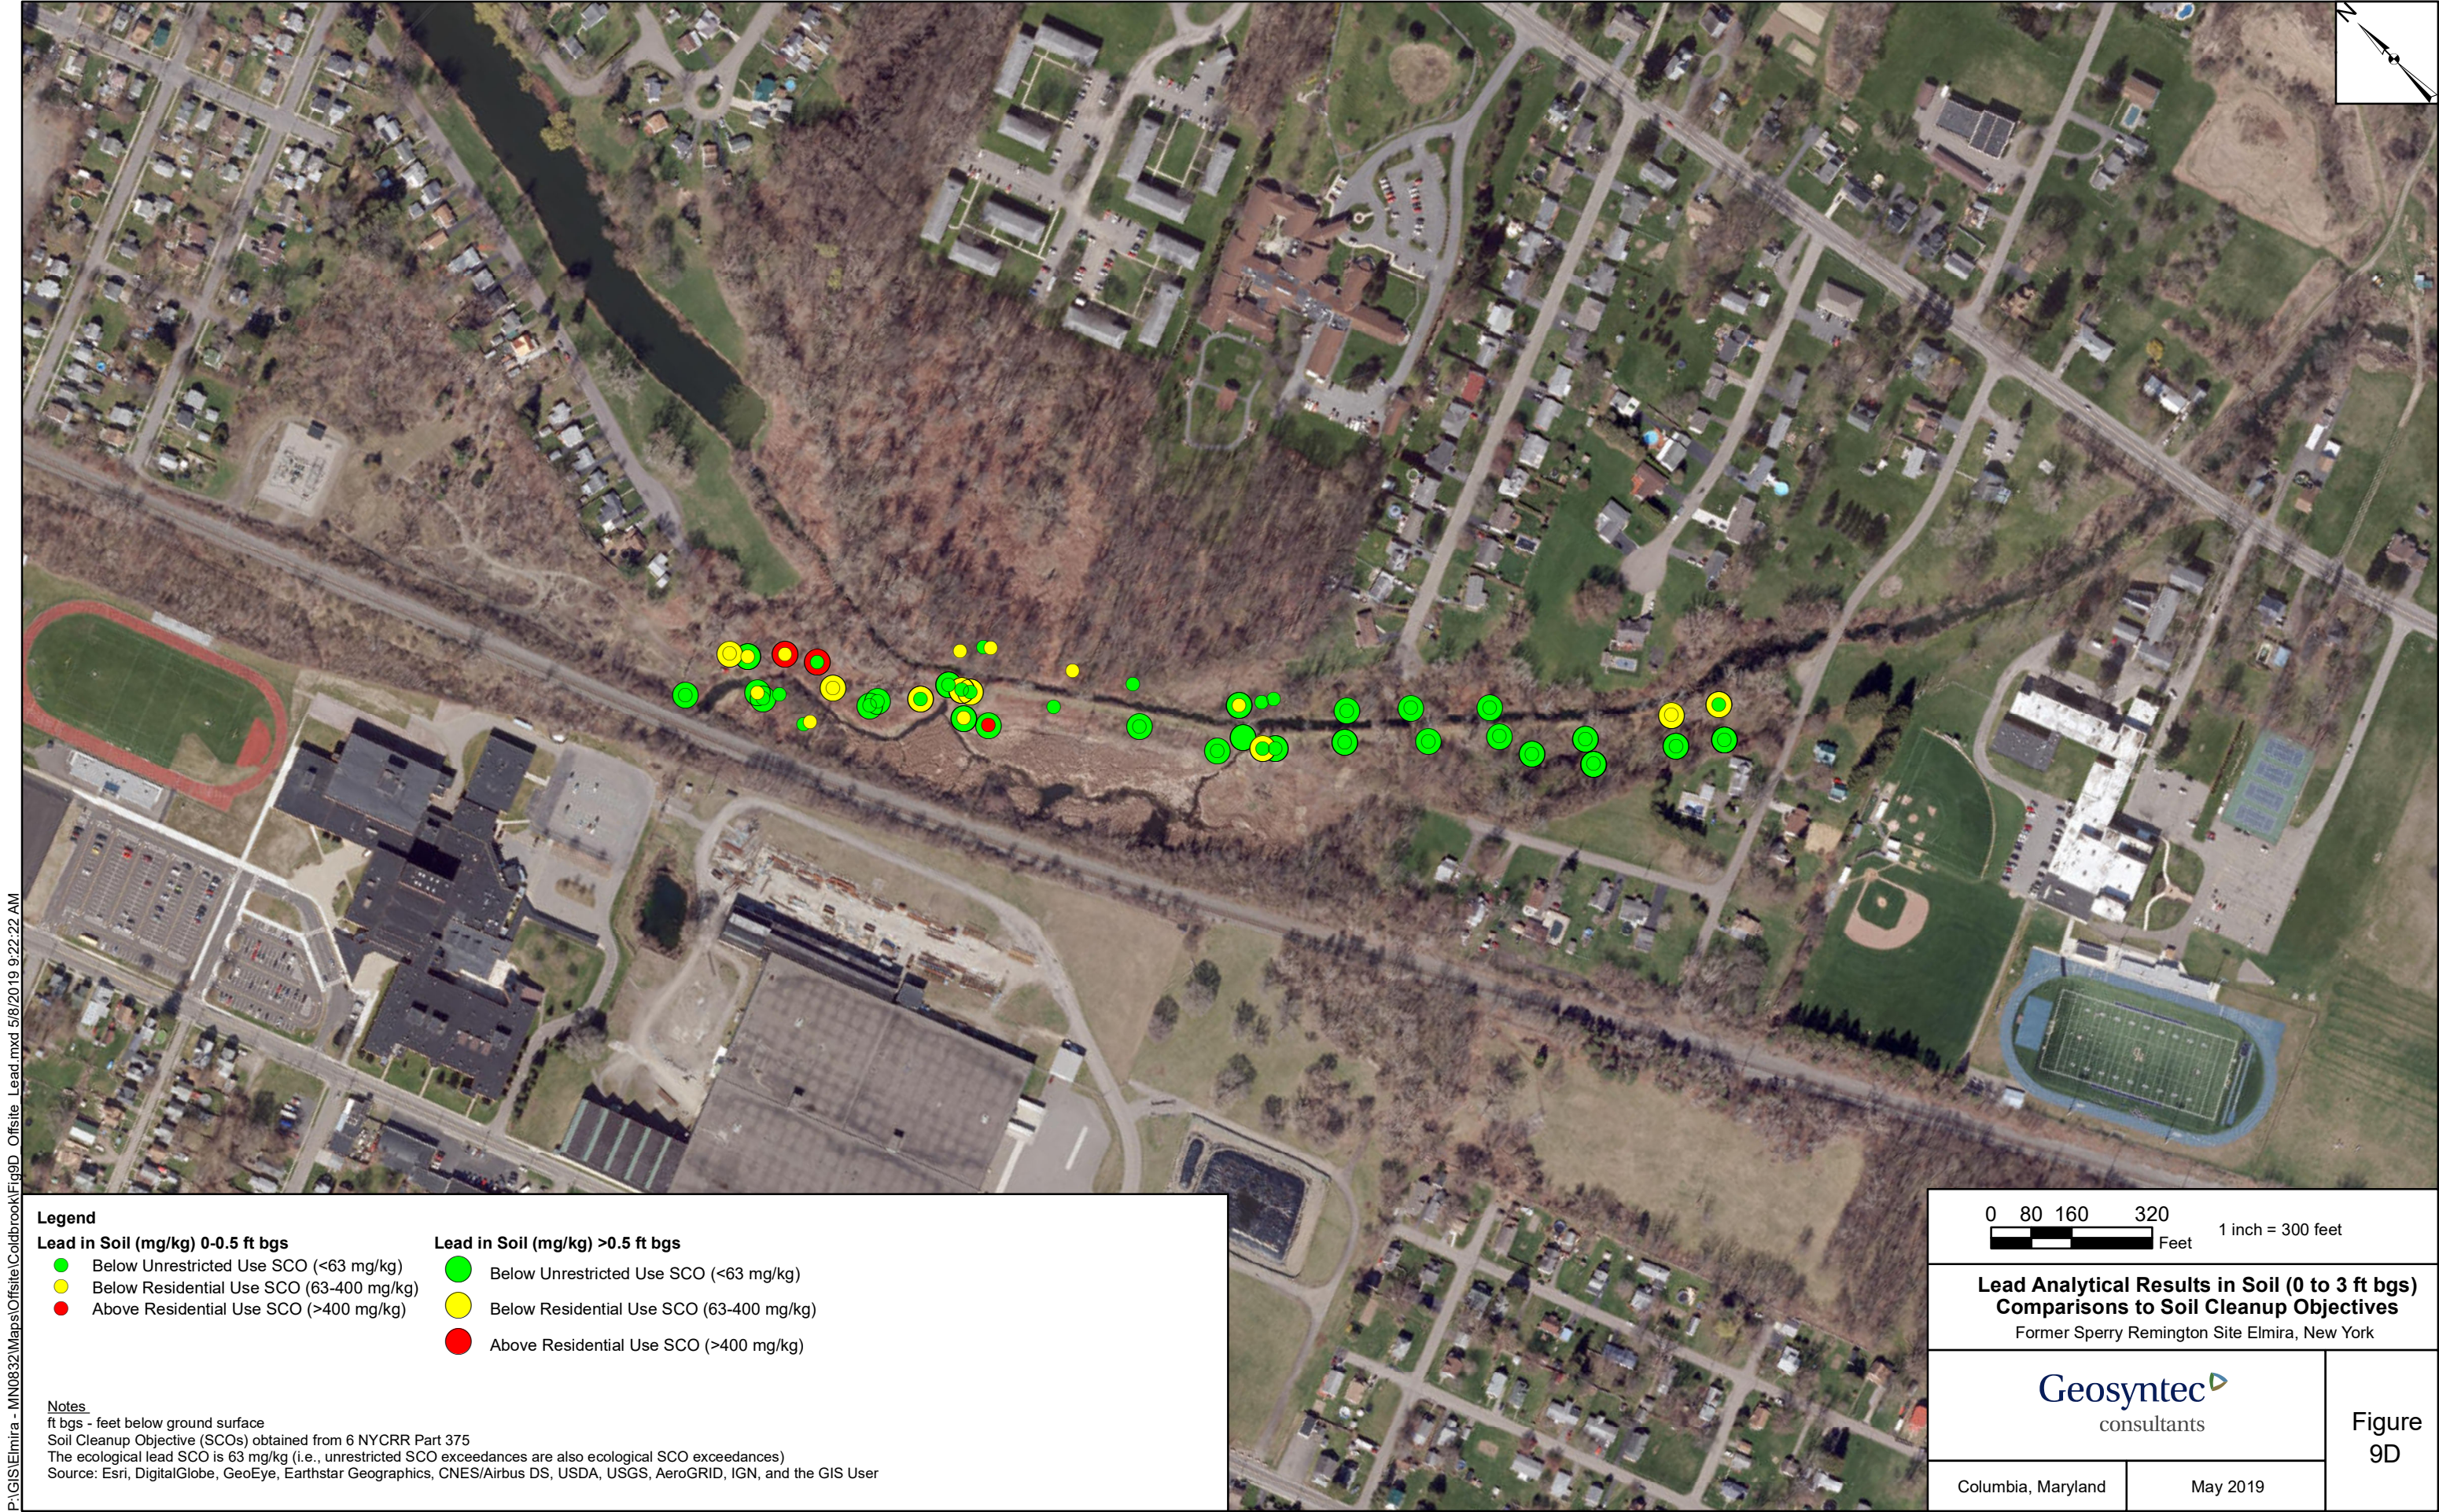
Figure  
9D

**Lead in Soil (mg/kg) 0-0.5 ft bgs**

- Below Unrestricted Use SCO (<63 mg/kg)
- Below Residential Use SCO (63-400 mg/kg)
- Above Residential Use SCO (>400 mg/kg)

**Lead in Soil (mg/kg) >0.5 ft bgs**

ft bgs - feet below ground surface  
Soil Cleanup Objective (SCOs) obtained from 6 NYCRR Part 375  
The ecological lead SCO is 63 mg/kg (i.e., unrestricted SCO exceedances are also ecological SCO exceedances)  
Source: Esri, DigitalGlobe, GeoEye, Earthstar Geographics, CNES/Airbus DS, USDA, USGS, AeroGRID, IGN, and the GIS User

**Lead Analytical Results in Soil (0 to 3 ft bgs)  
Comparisons to Soil Cleanup Objectives**  
Former Sperry Remington Site Elmira, New York

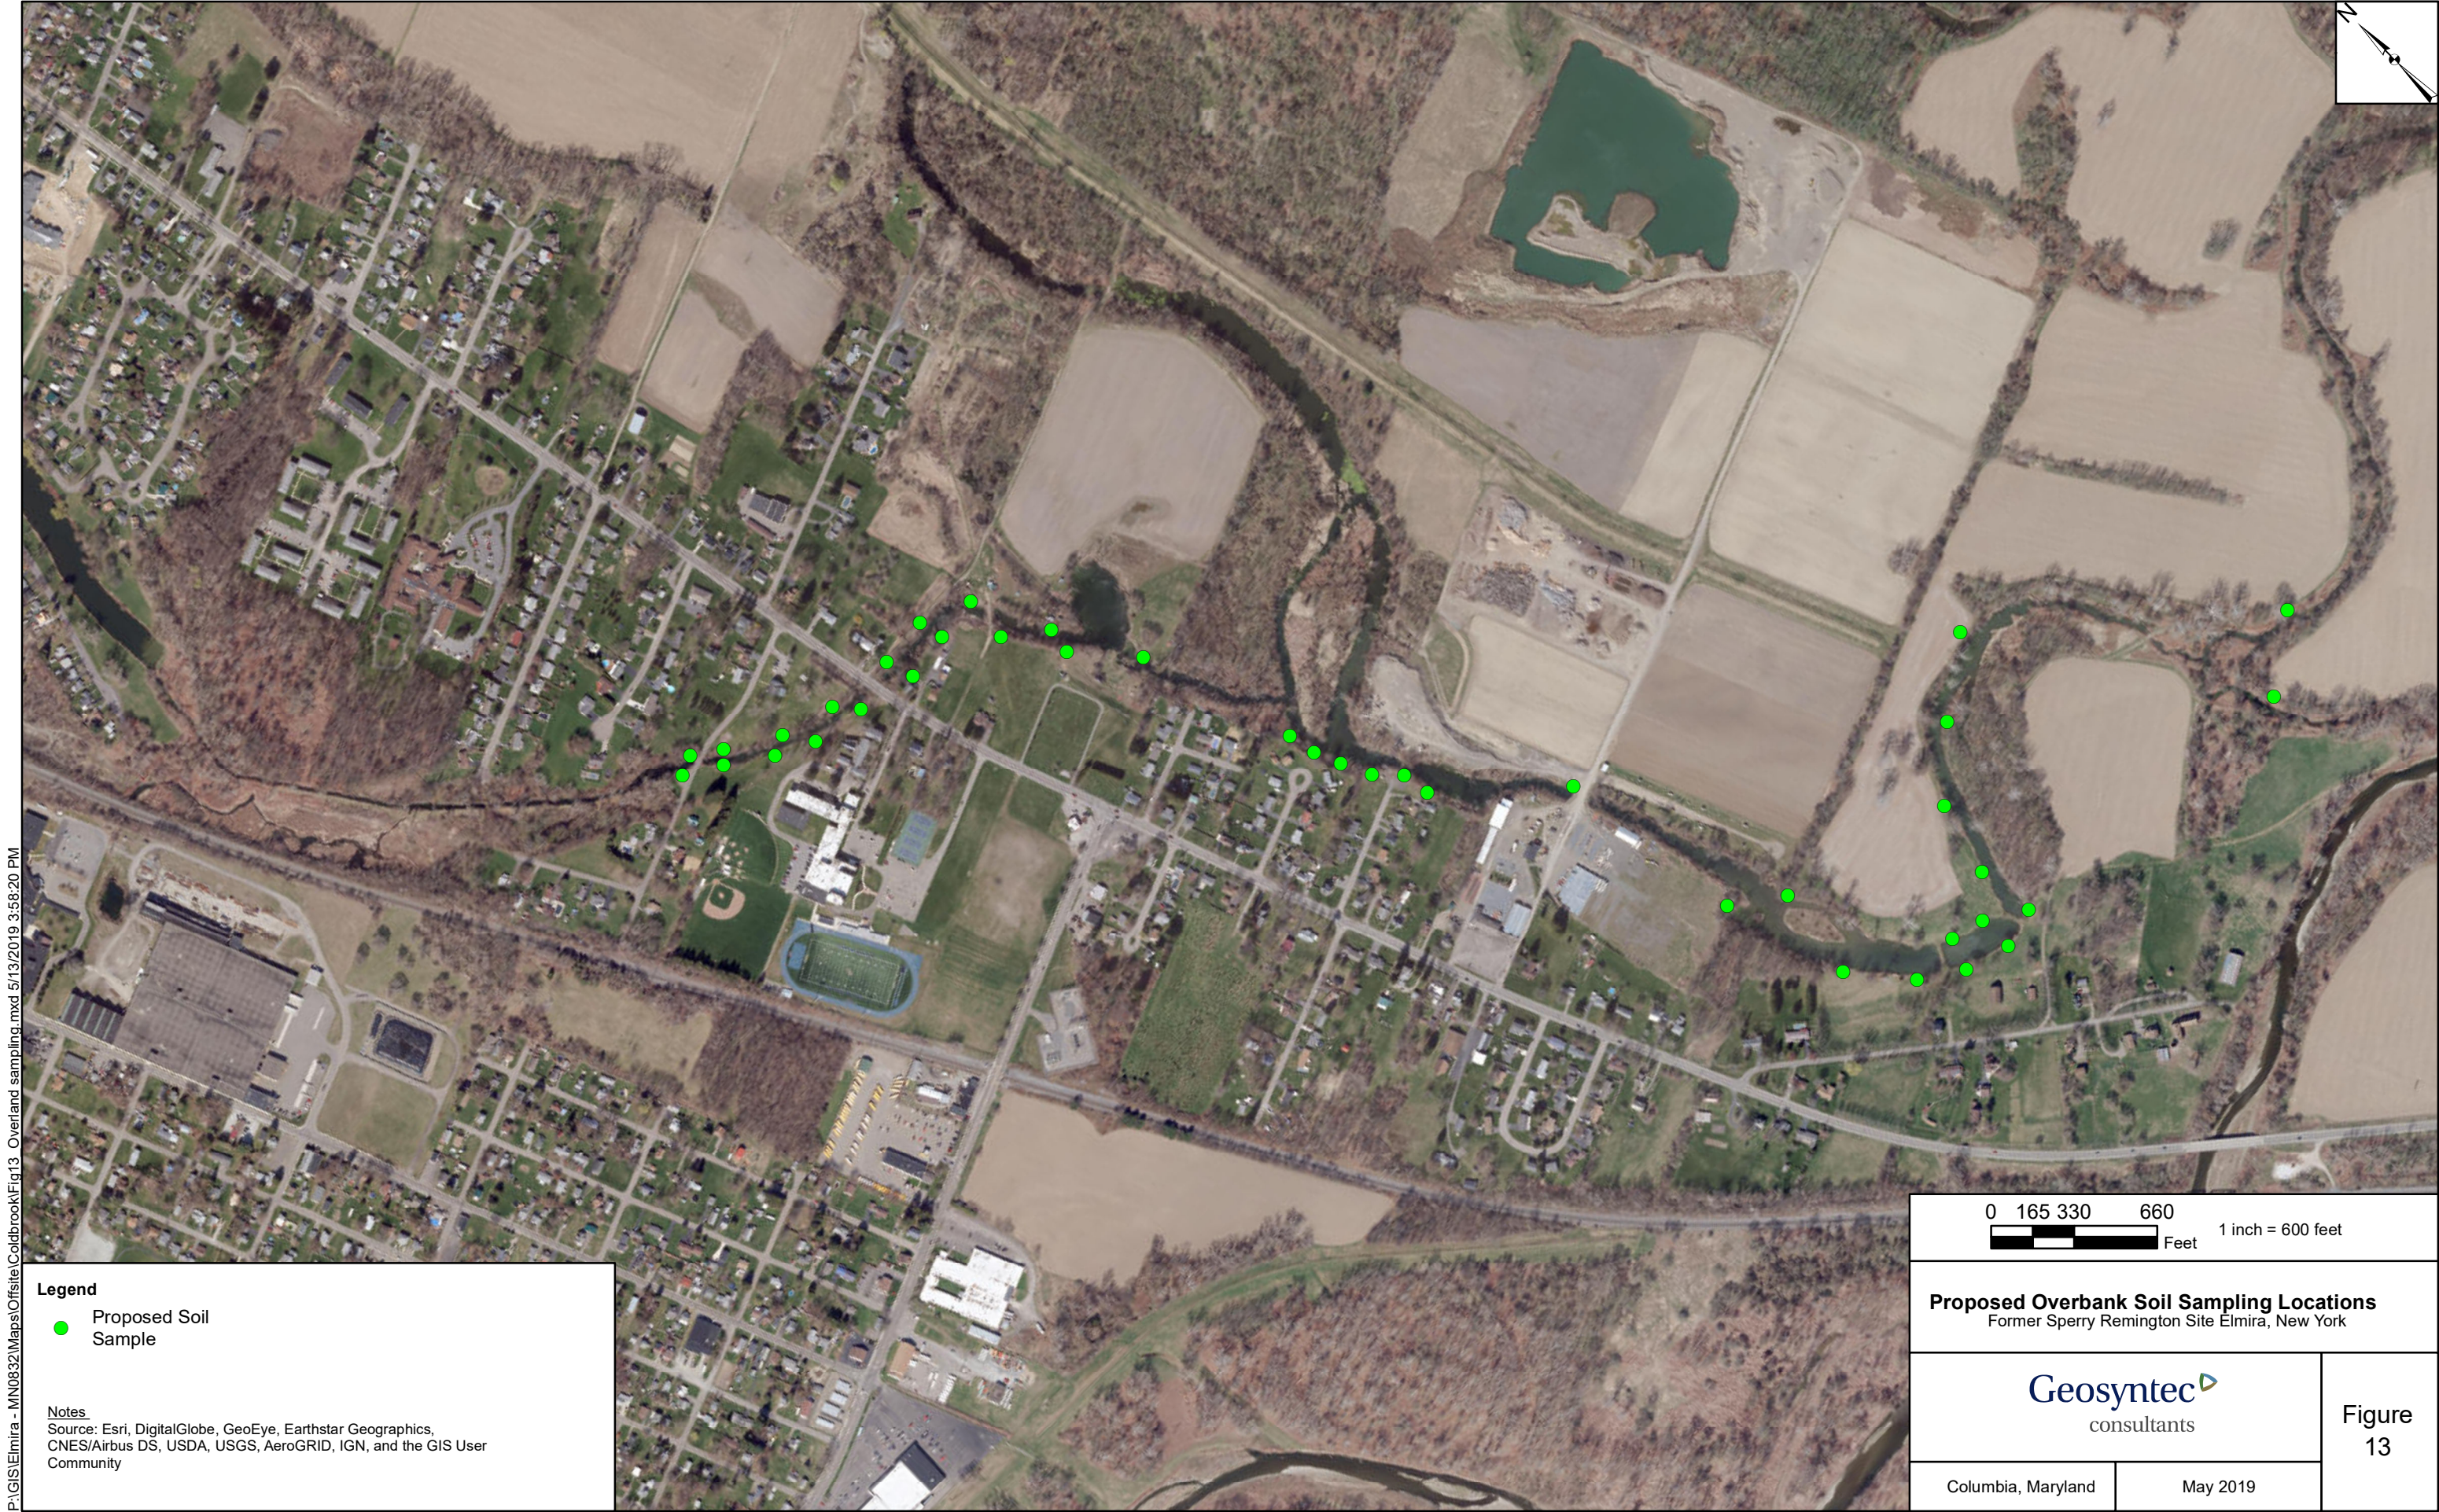
Figure  
13

- Proposed Soil Sample

**Proposed Overbank Soil Sampling Locations**  
Former Sperry Remington Site Elmira, New York
