FINAL REPORT
CORRECTIVE ACTION PRIOR TO LOSS OF
INTERIM STATUS INSPECTION
INDUSTRIAL SERVICE CORPORATION
ELMIRA, NEW YORK

EPA I.D. NO. NYD002221430

March 1989

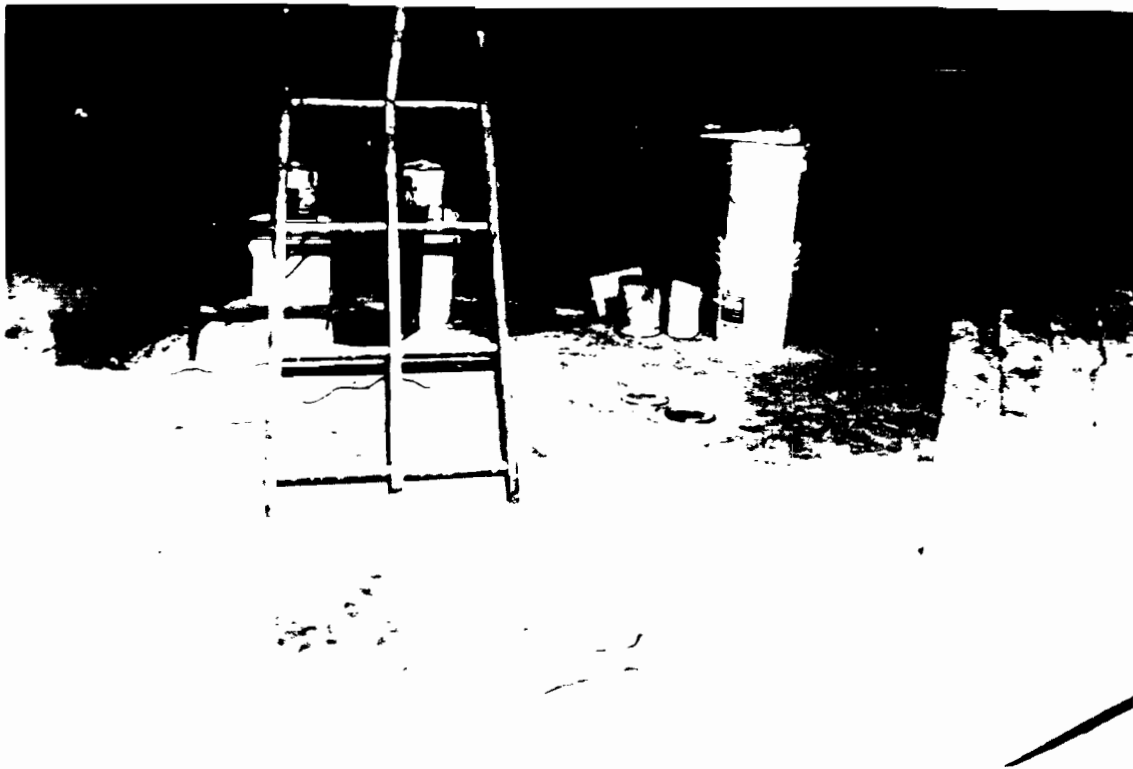
At the time of the inspection, the Drum Storage Area was not in use. The floor appeared clean and the concrete was in good condition.

- 1.1 Location of the former Drum Storage Area. The paint supplies in the photograph were being used in this area at the time of the inspection.

Industrial Services submitted modifications to an approved closure plan in August of 1988. The closure plan states that the floor of the Drum Storage Area will be tested for cadmium, complexed cyanide and lead (Refs. 11 and 13).

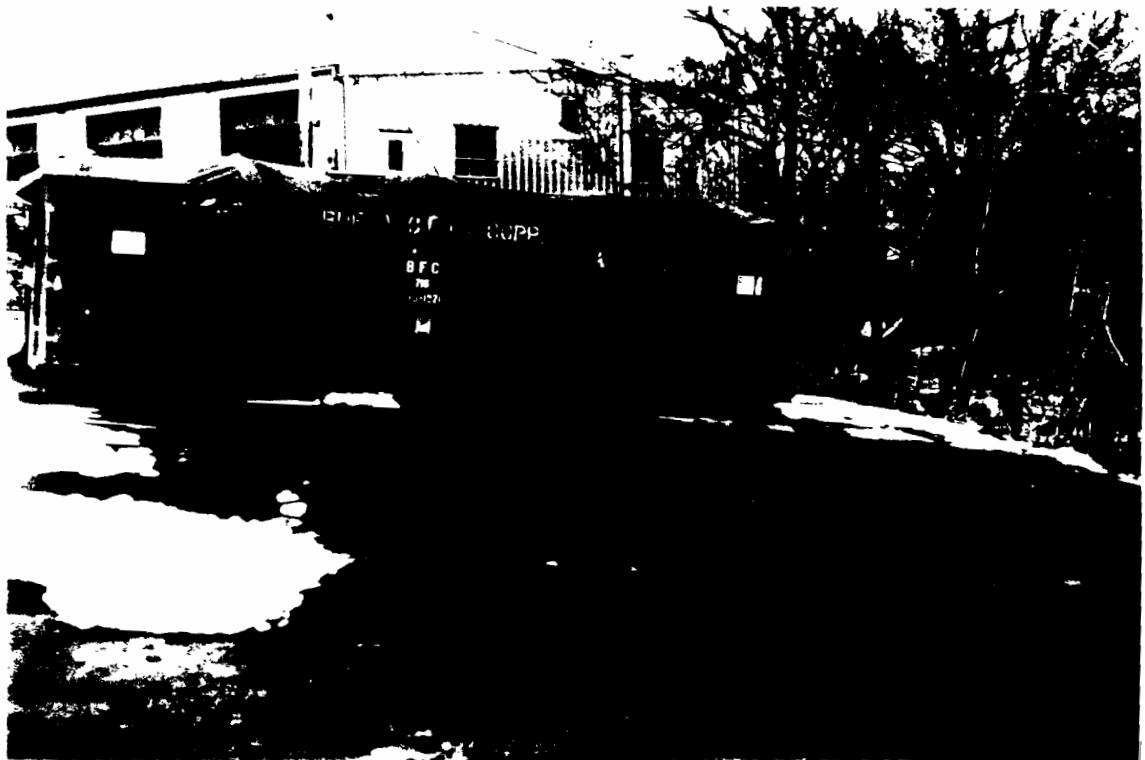
There are no known or suspected releases from this unit. The Roll-Off Box is covered with a tarp and stored on an asphalt paved area.

3.1, 4.1 The Roll-Off Box stores wastewater treatment sludge prior to shipment off site for disposal.

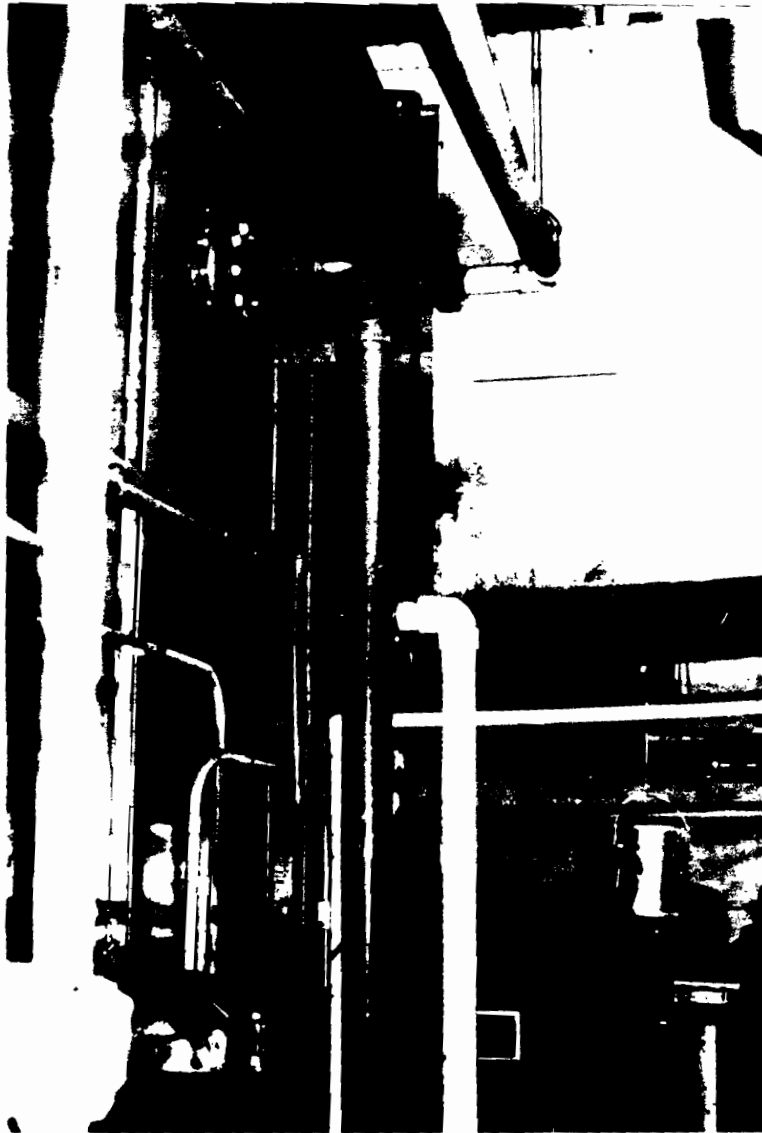
The wastewater from the Electrochemical Cells is discharged to the Degassing Tank (SWMU 12). The Degassing Tank removes hydrogen gas from the wastewater and vents it to the atmosphere. The Degassing Tank discharges wastewater to the Clarifier (SWMU 13) where an anionic polymer is added to aid in settling the metal hydroxides. The Clarifier is separated into a flocculation chamber and a clarifying section. Effluent from the Clarifier overflows to the Secondary Sump (SWMU 16) prior to discharge to the local POTW. The

- 12.1 The Degassing Tank is used to remove hydrogen gas after wastewater passes through the Electrochemical Cells (SWMU 11). Note the Clarifier (SWMU 13) in the foreground and the Cyanide Oxidation Unit (SWMU 9) in the background.

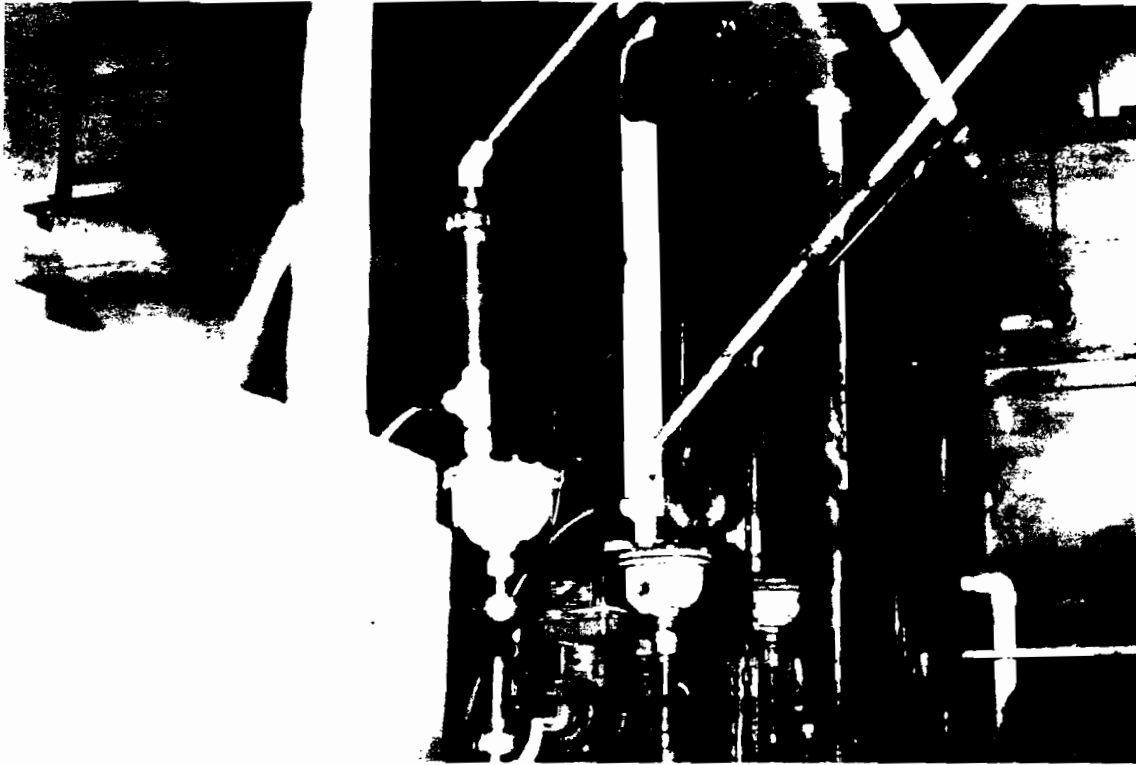
13.1 The Clarifier is the large tank in the middle of the photograph. The Degassing Tank (SWMU 12) is visible behind the Clarifier.
