22 April 2021

**Subject: Revised Site Characterization Work Plan Addendum #4  
Former Scott Technologies Site (#p808049)  
1051 South Main Street, City of Elmira, Chemung County, NY**

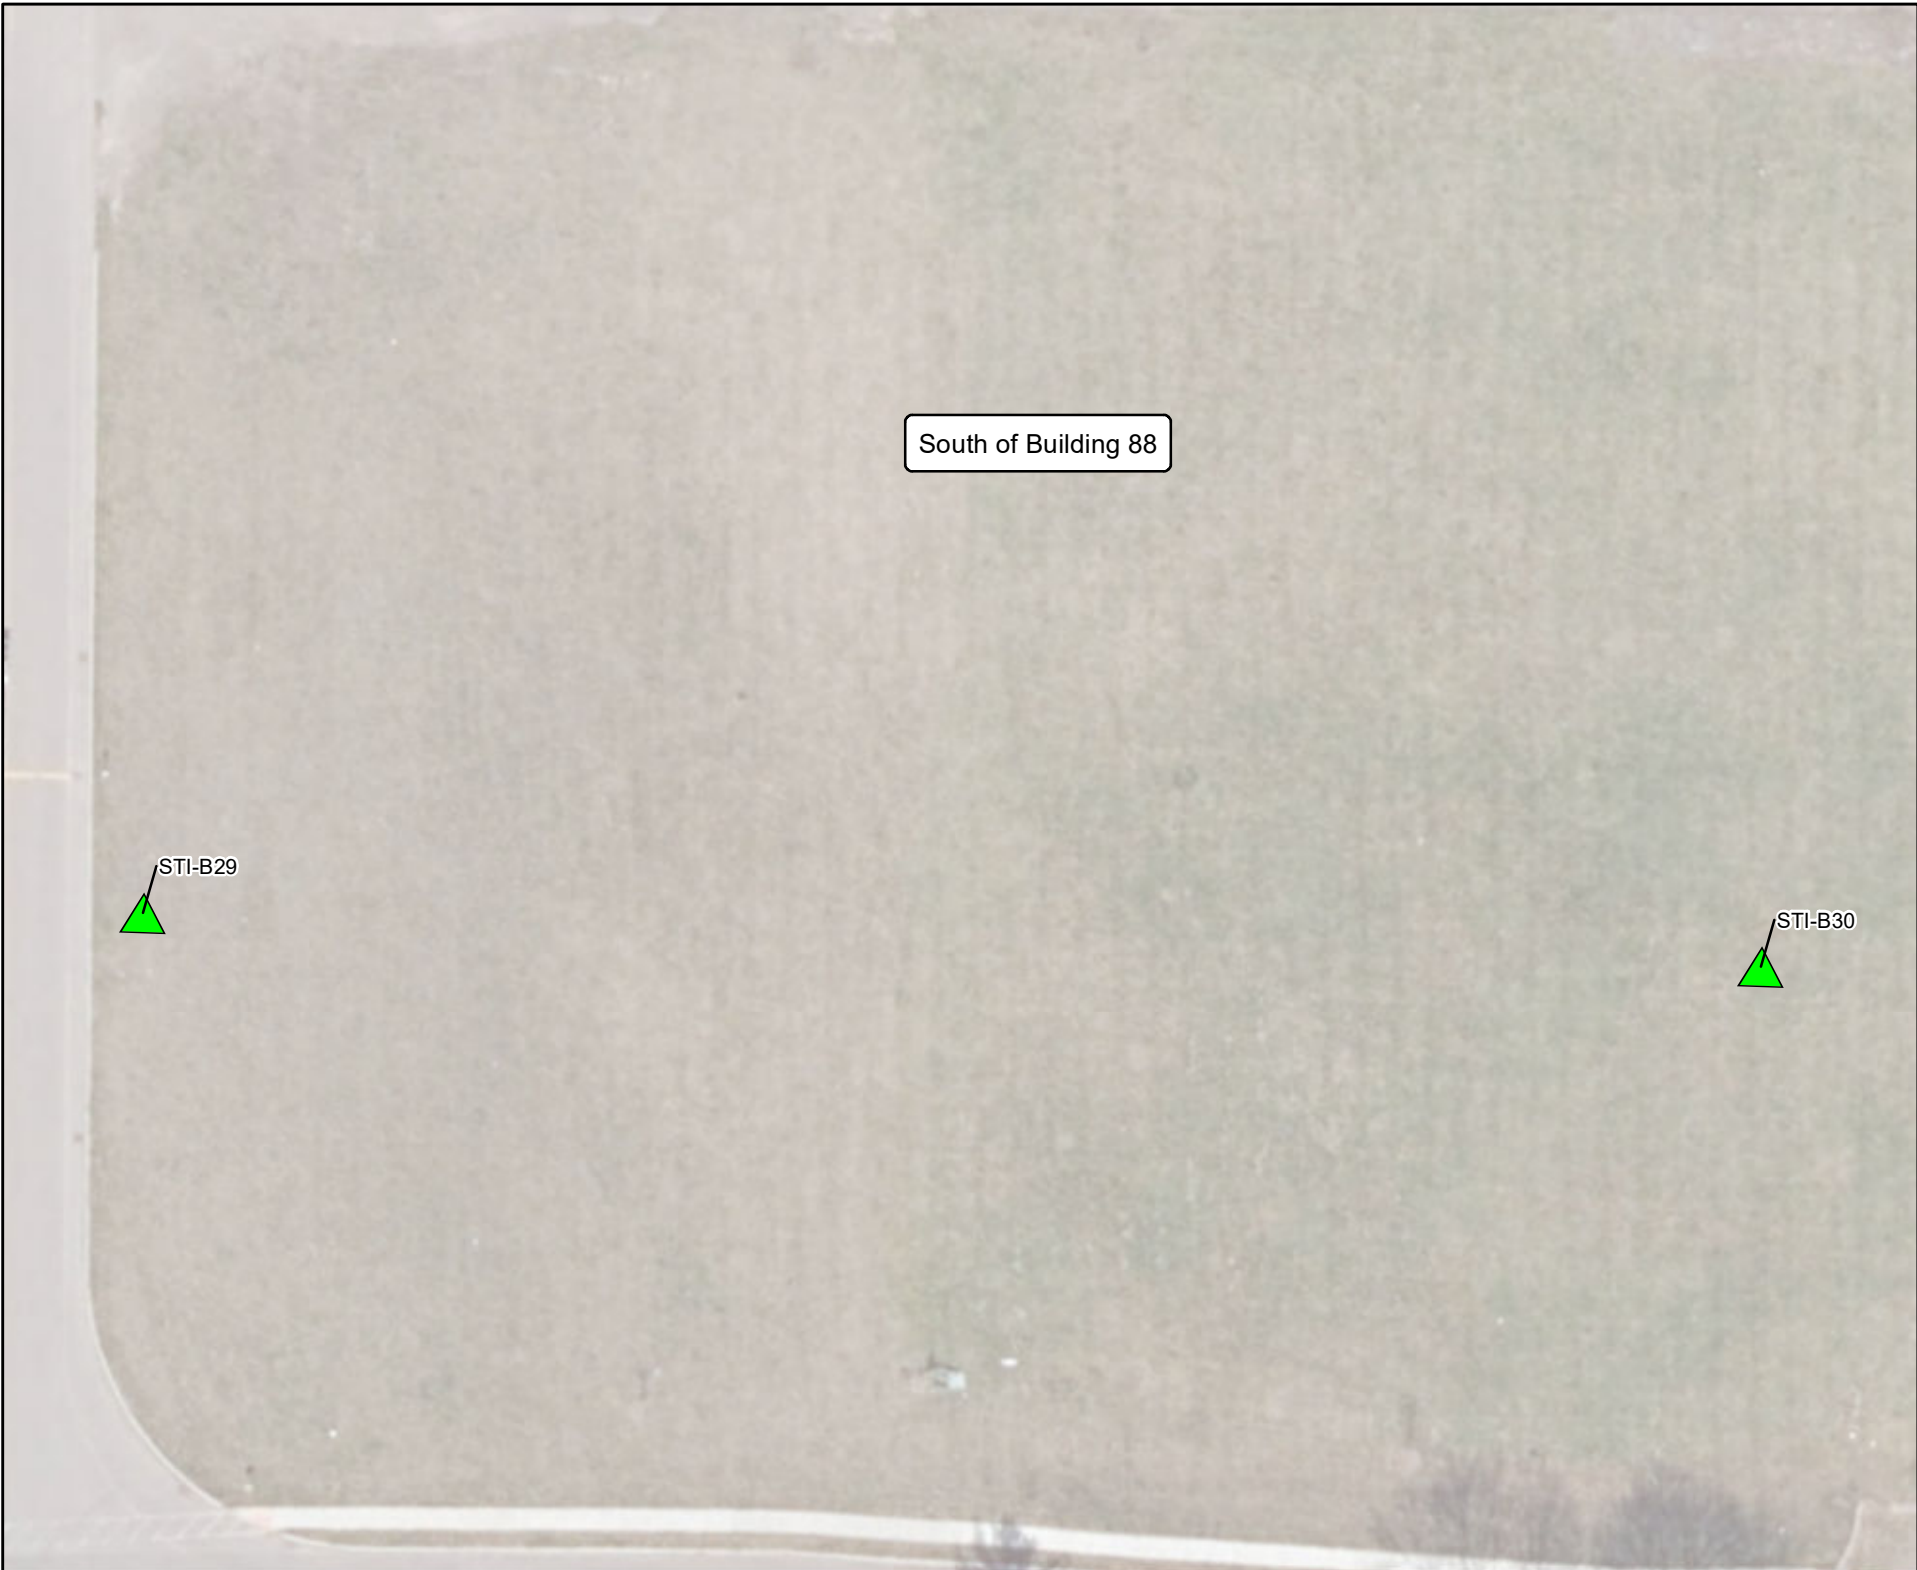
**Figure  
2A-2**

**PCB Exceedances**

Does Not Exceed Residential Screening Criteria

**PCBs – South of Building 88  
(0-0.5 ft bgs)**

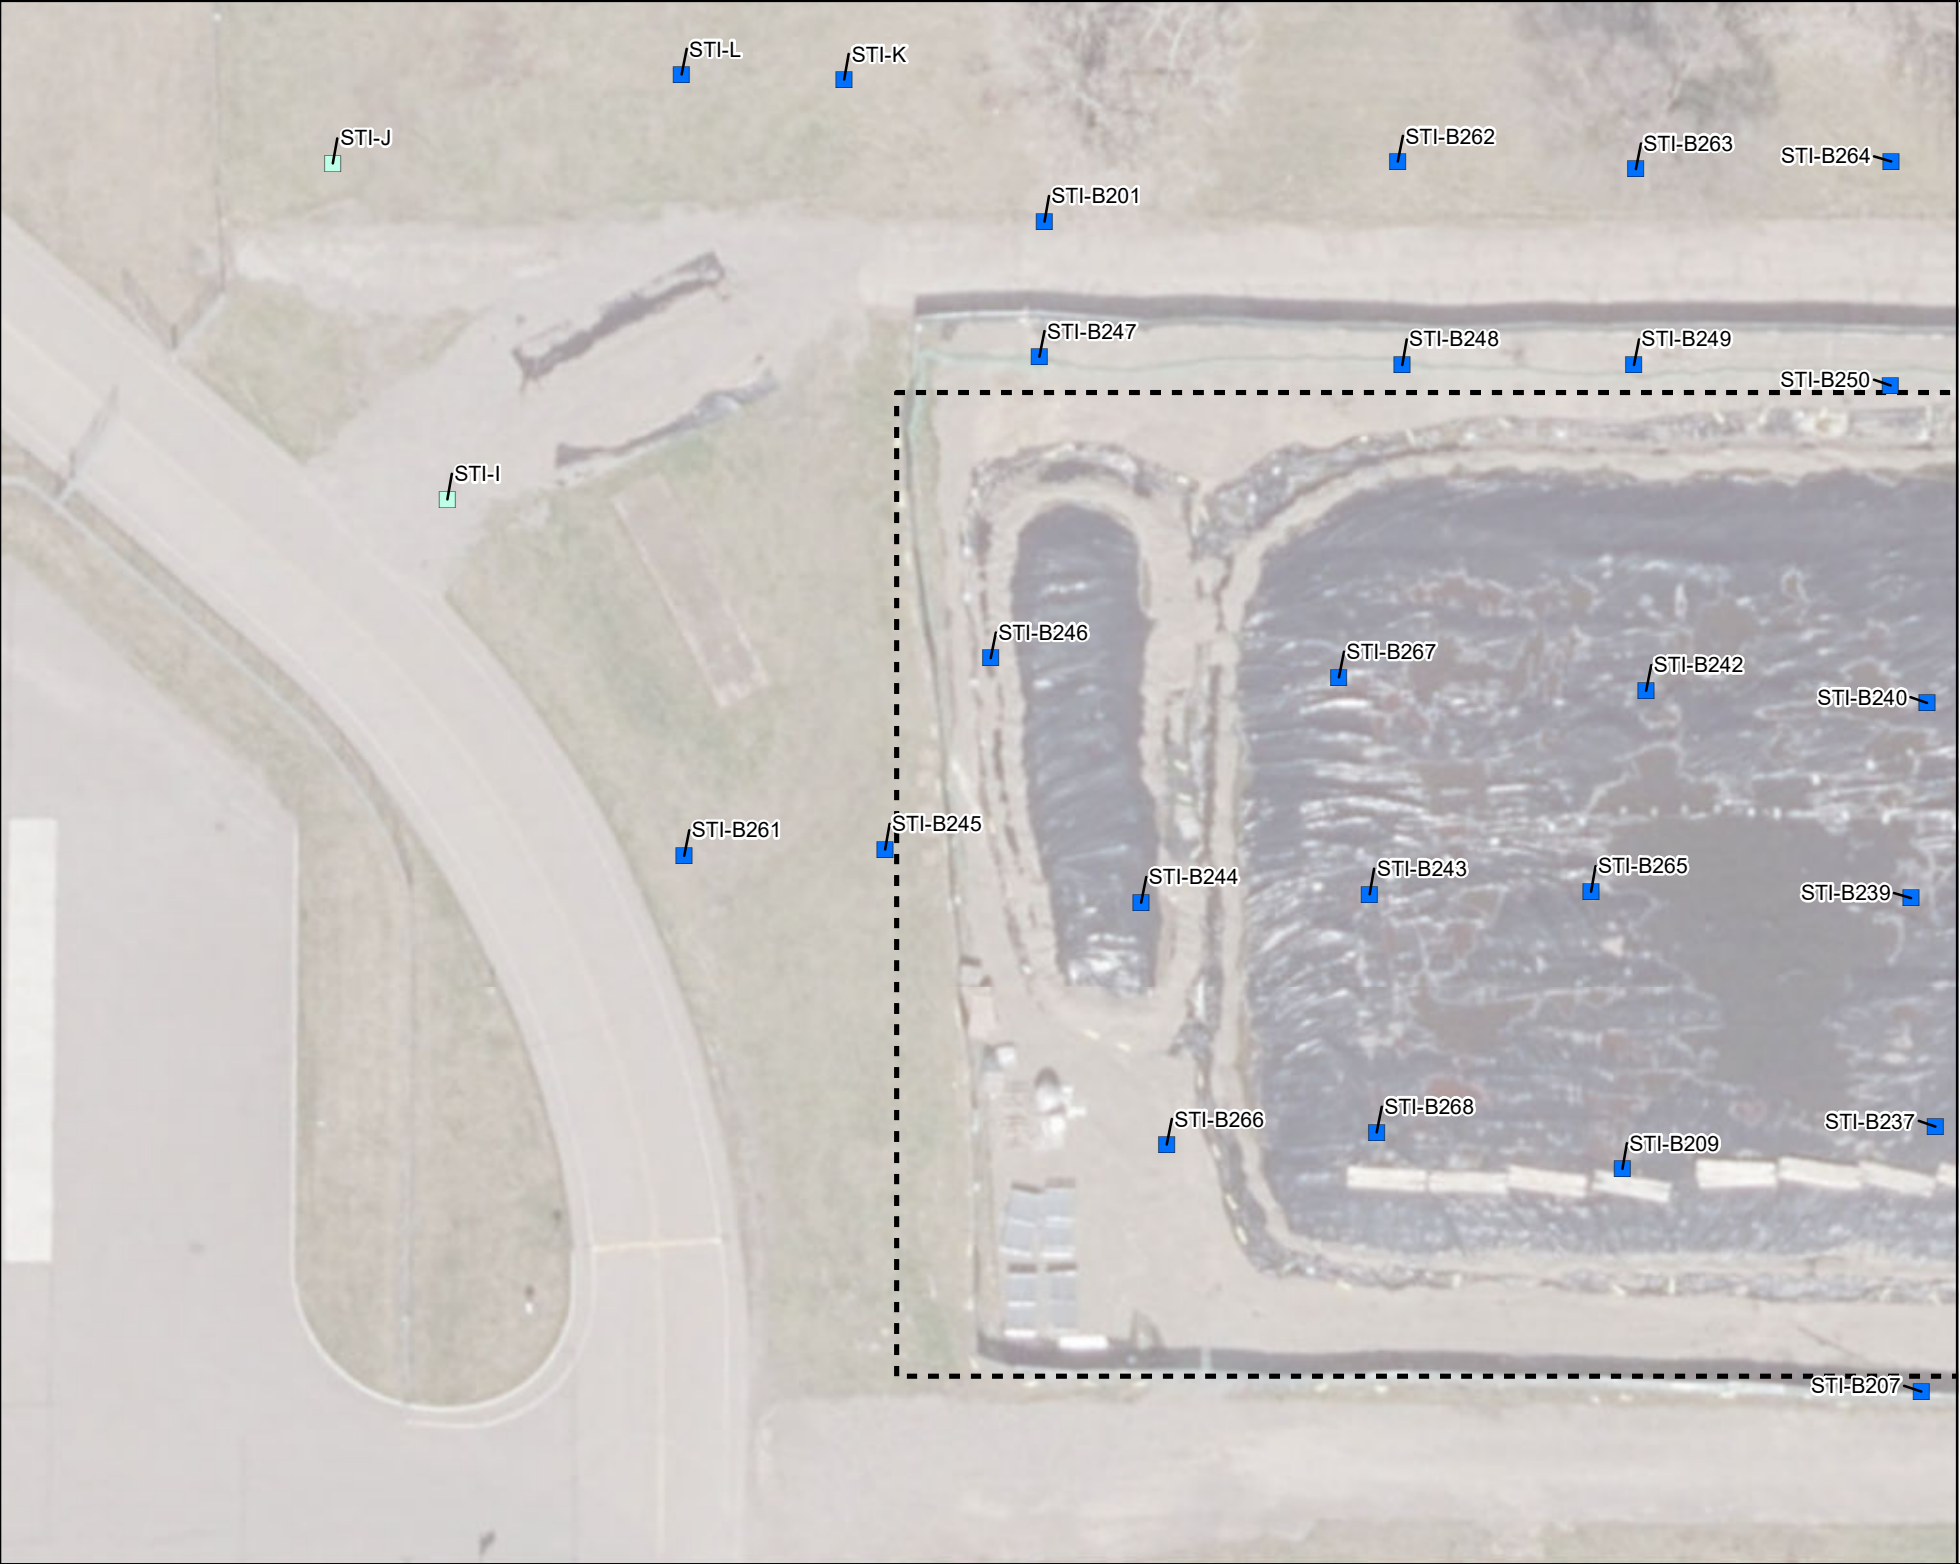
| | SVOCs – South of Building 88<br>(1-2 ft bgs) | | |

- Vertical delineation of COPC exceedances in surface soil within the footprint of the decommissioned MSA (**Figures 3A-1/B-2/C-2/C-3 and 4A-1/B-2/C-2/C-3**);
