## LAPP INSULATOR SITE

### INDOOR AIR MONITORING REPORT SEPTEMBER 2019

LAPP INSULATOR  
LEROY (T)

SITE NO. 819017  
GENESEE COUNTY, NY

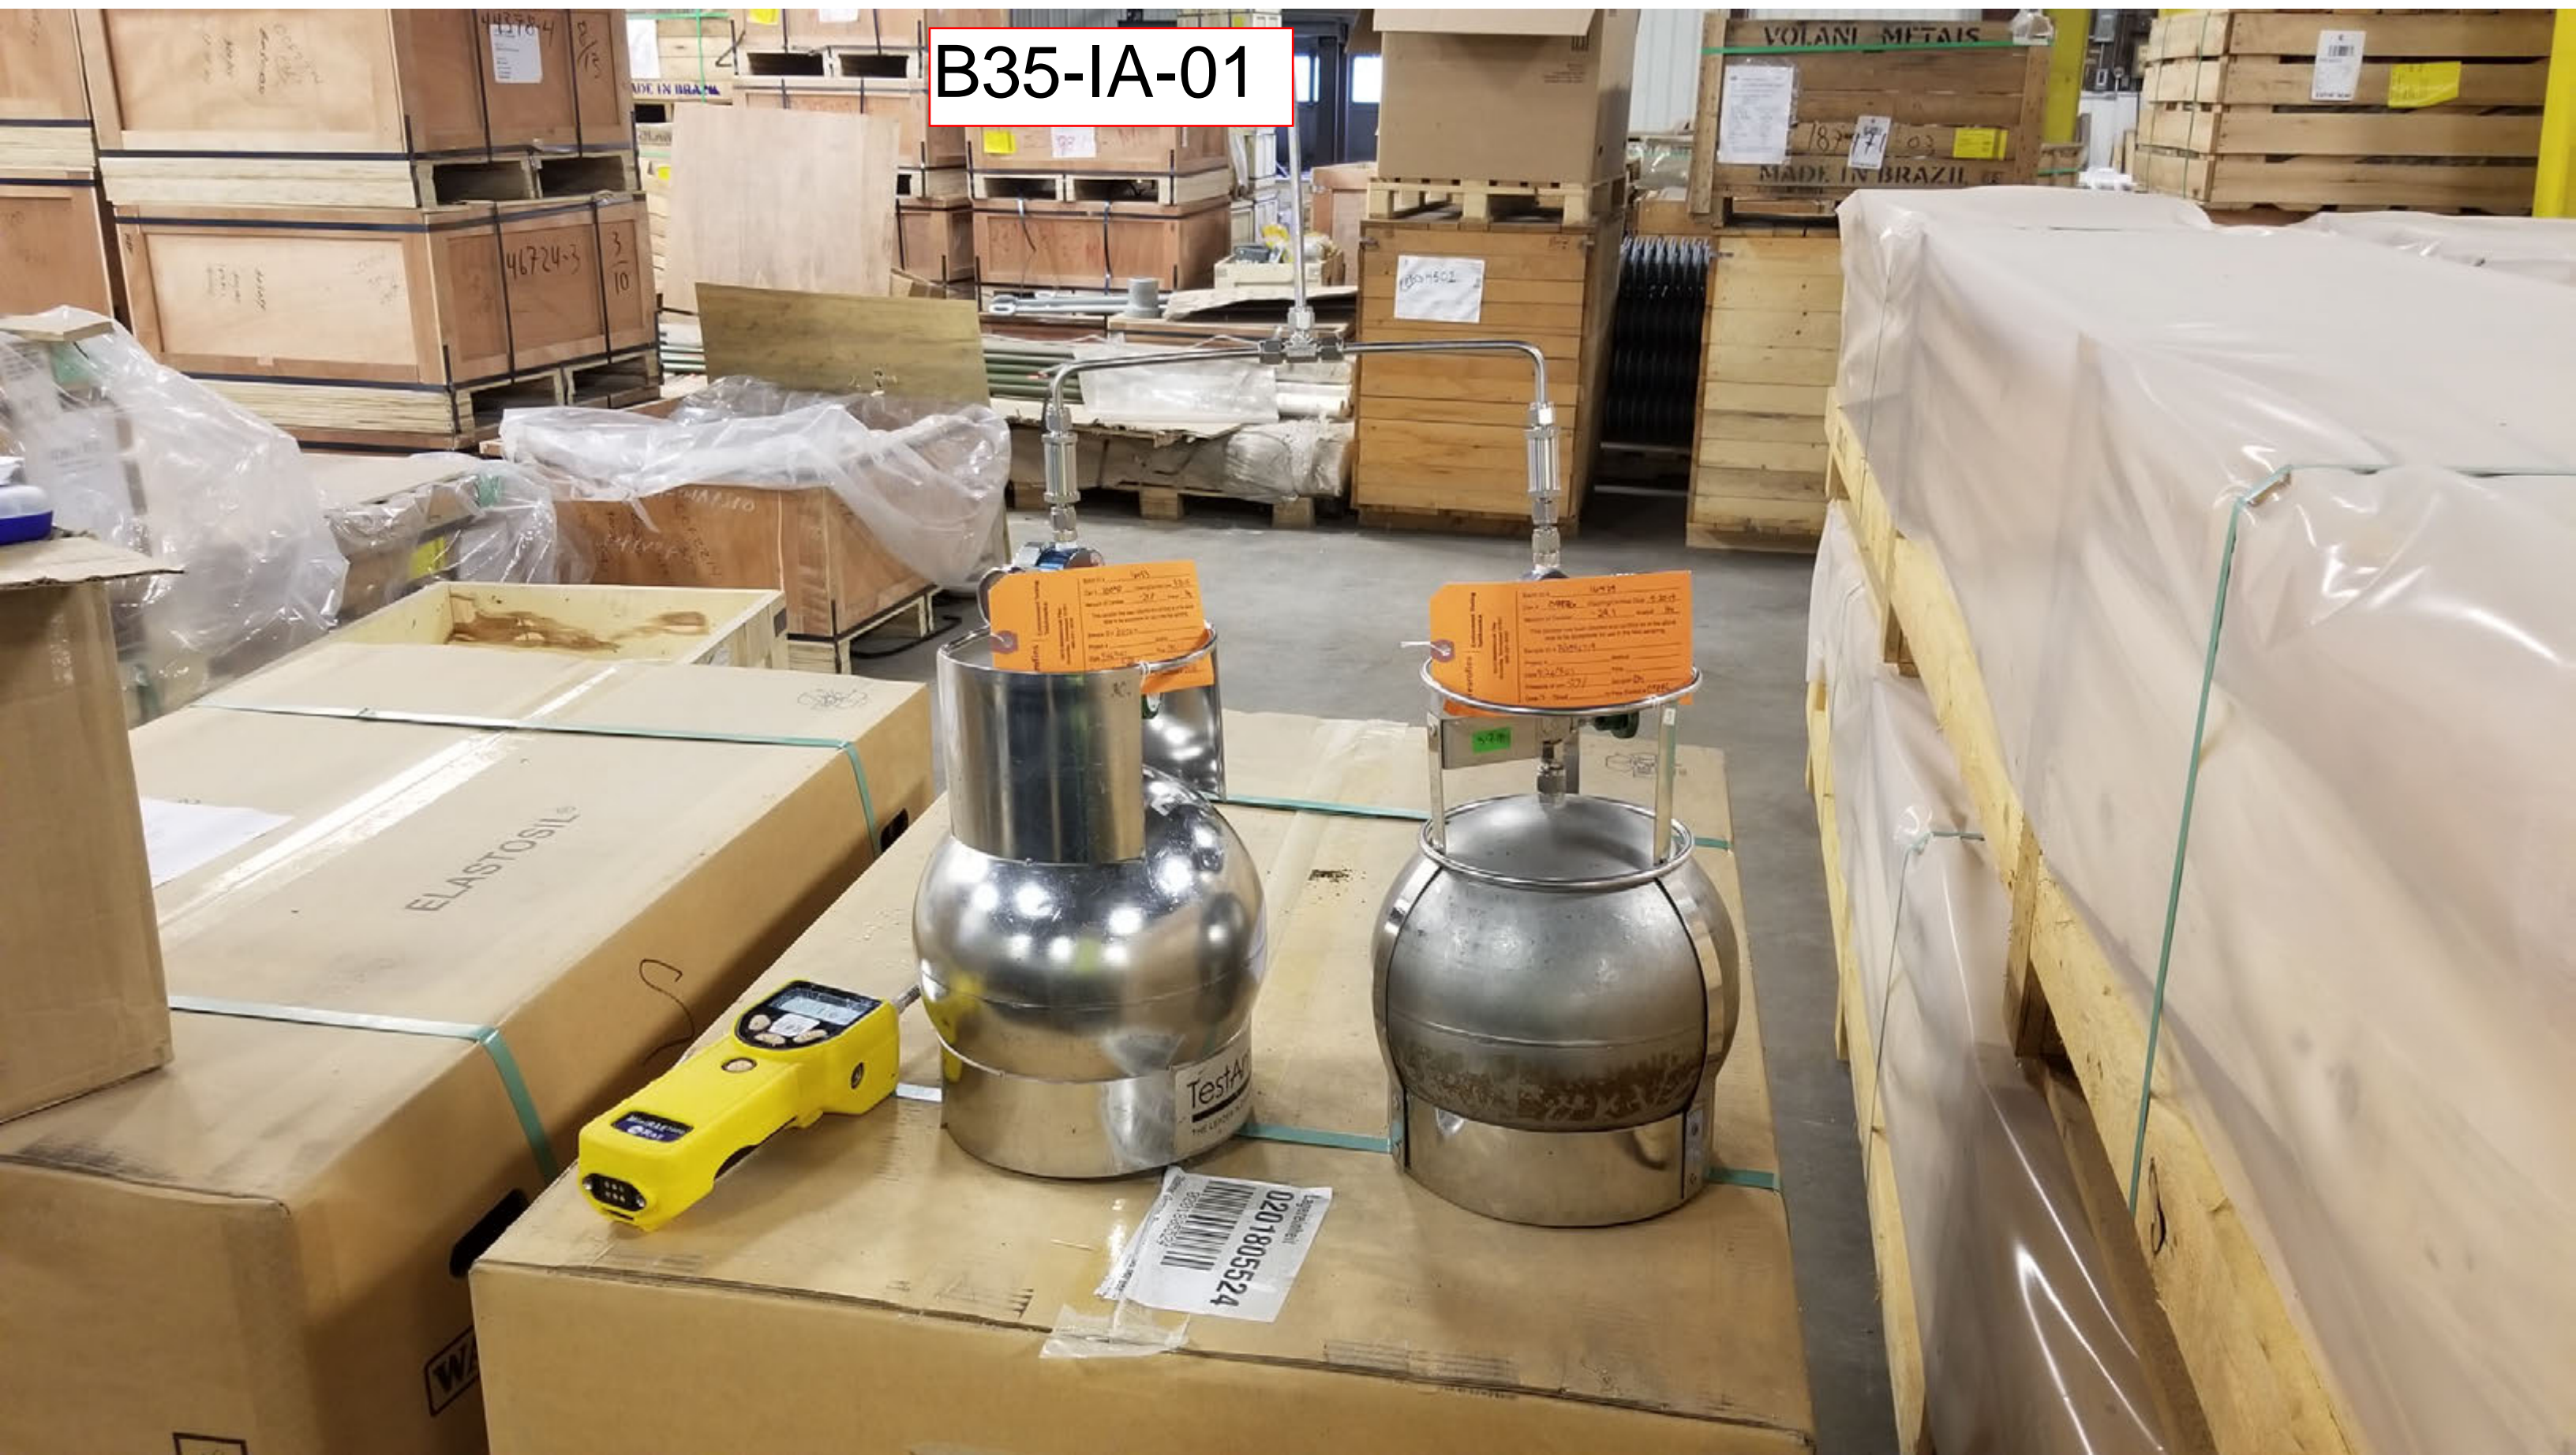
It should be noted that the results for sample B35-IA-01 were rejected in its entirety because the laboratory determined that the Summa canister contained residue from a previous use, rendering the data unusable. A field duplicate (FD 092719) was collected at location B35-IA-01, therefore only the field duplicate results are used for this location.

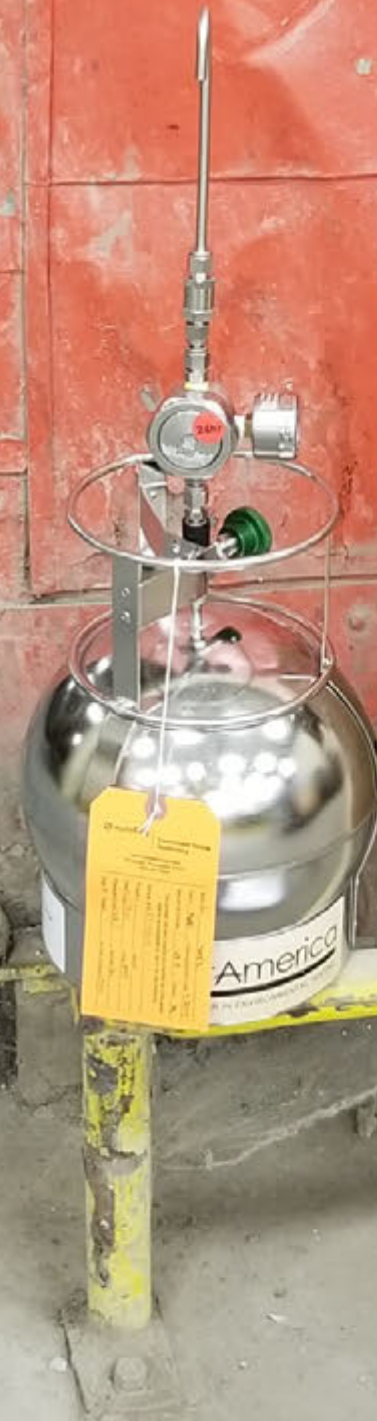
B37-IA-01

The Building B-37 product inventory was updated during the September 2019 monitoring event. During the June 2019 monitoring event, three waste oil drums were observed near the location of sample

B-37-IA-01; these drums were not present during the September 2019 monitoring event. Because of an elevated methylene chloride concentration observed in sampling B-37-IA-01 during the June 2019 monitoring event, NYSDEC requested that URS enlarge the search area for the product inventory. URS examined a nearby painting room, where methylene chloride may be commonly used. There were several cabinets containing various paints and mineral spirits in this room, but there were no PID readings observed. The background PID reading was also 0 ppm in this area. No other potential sources of methylene chloride, or any other VOCs, were identified near this sample location.

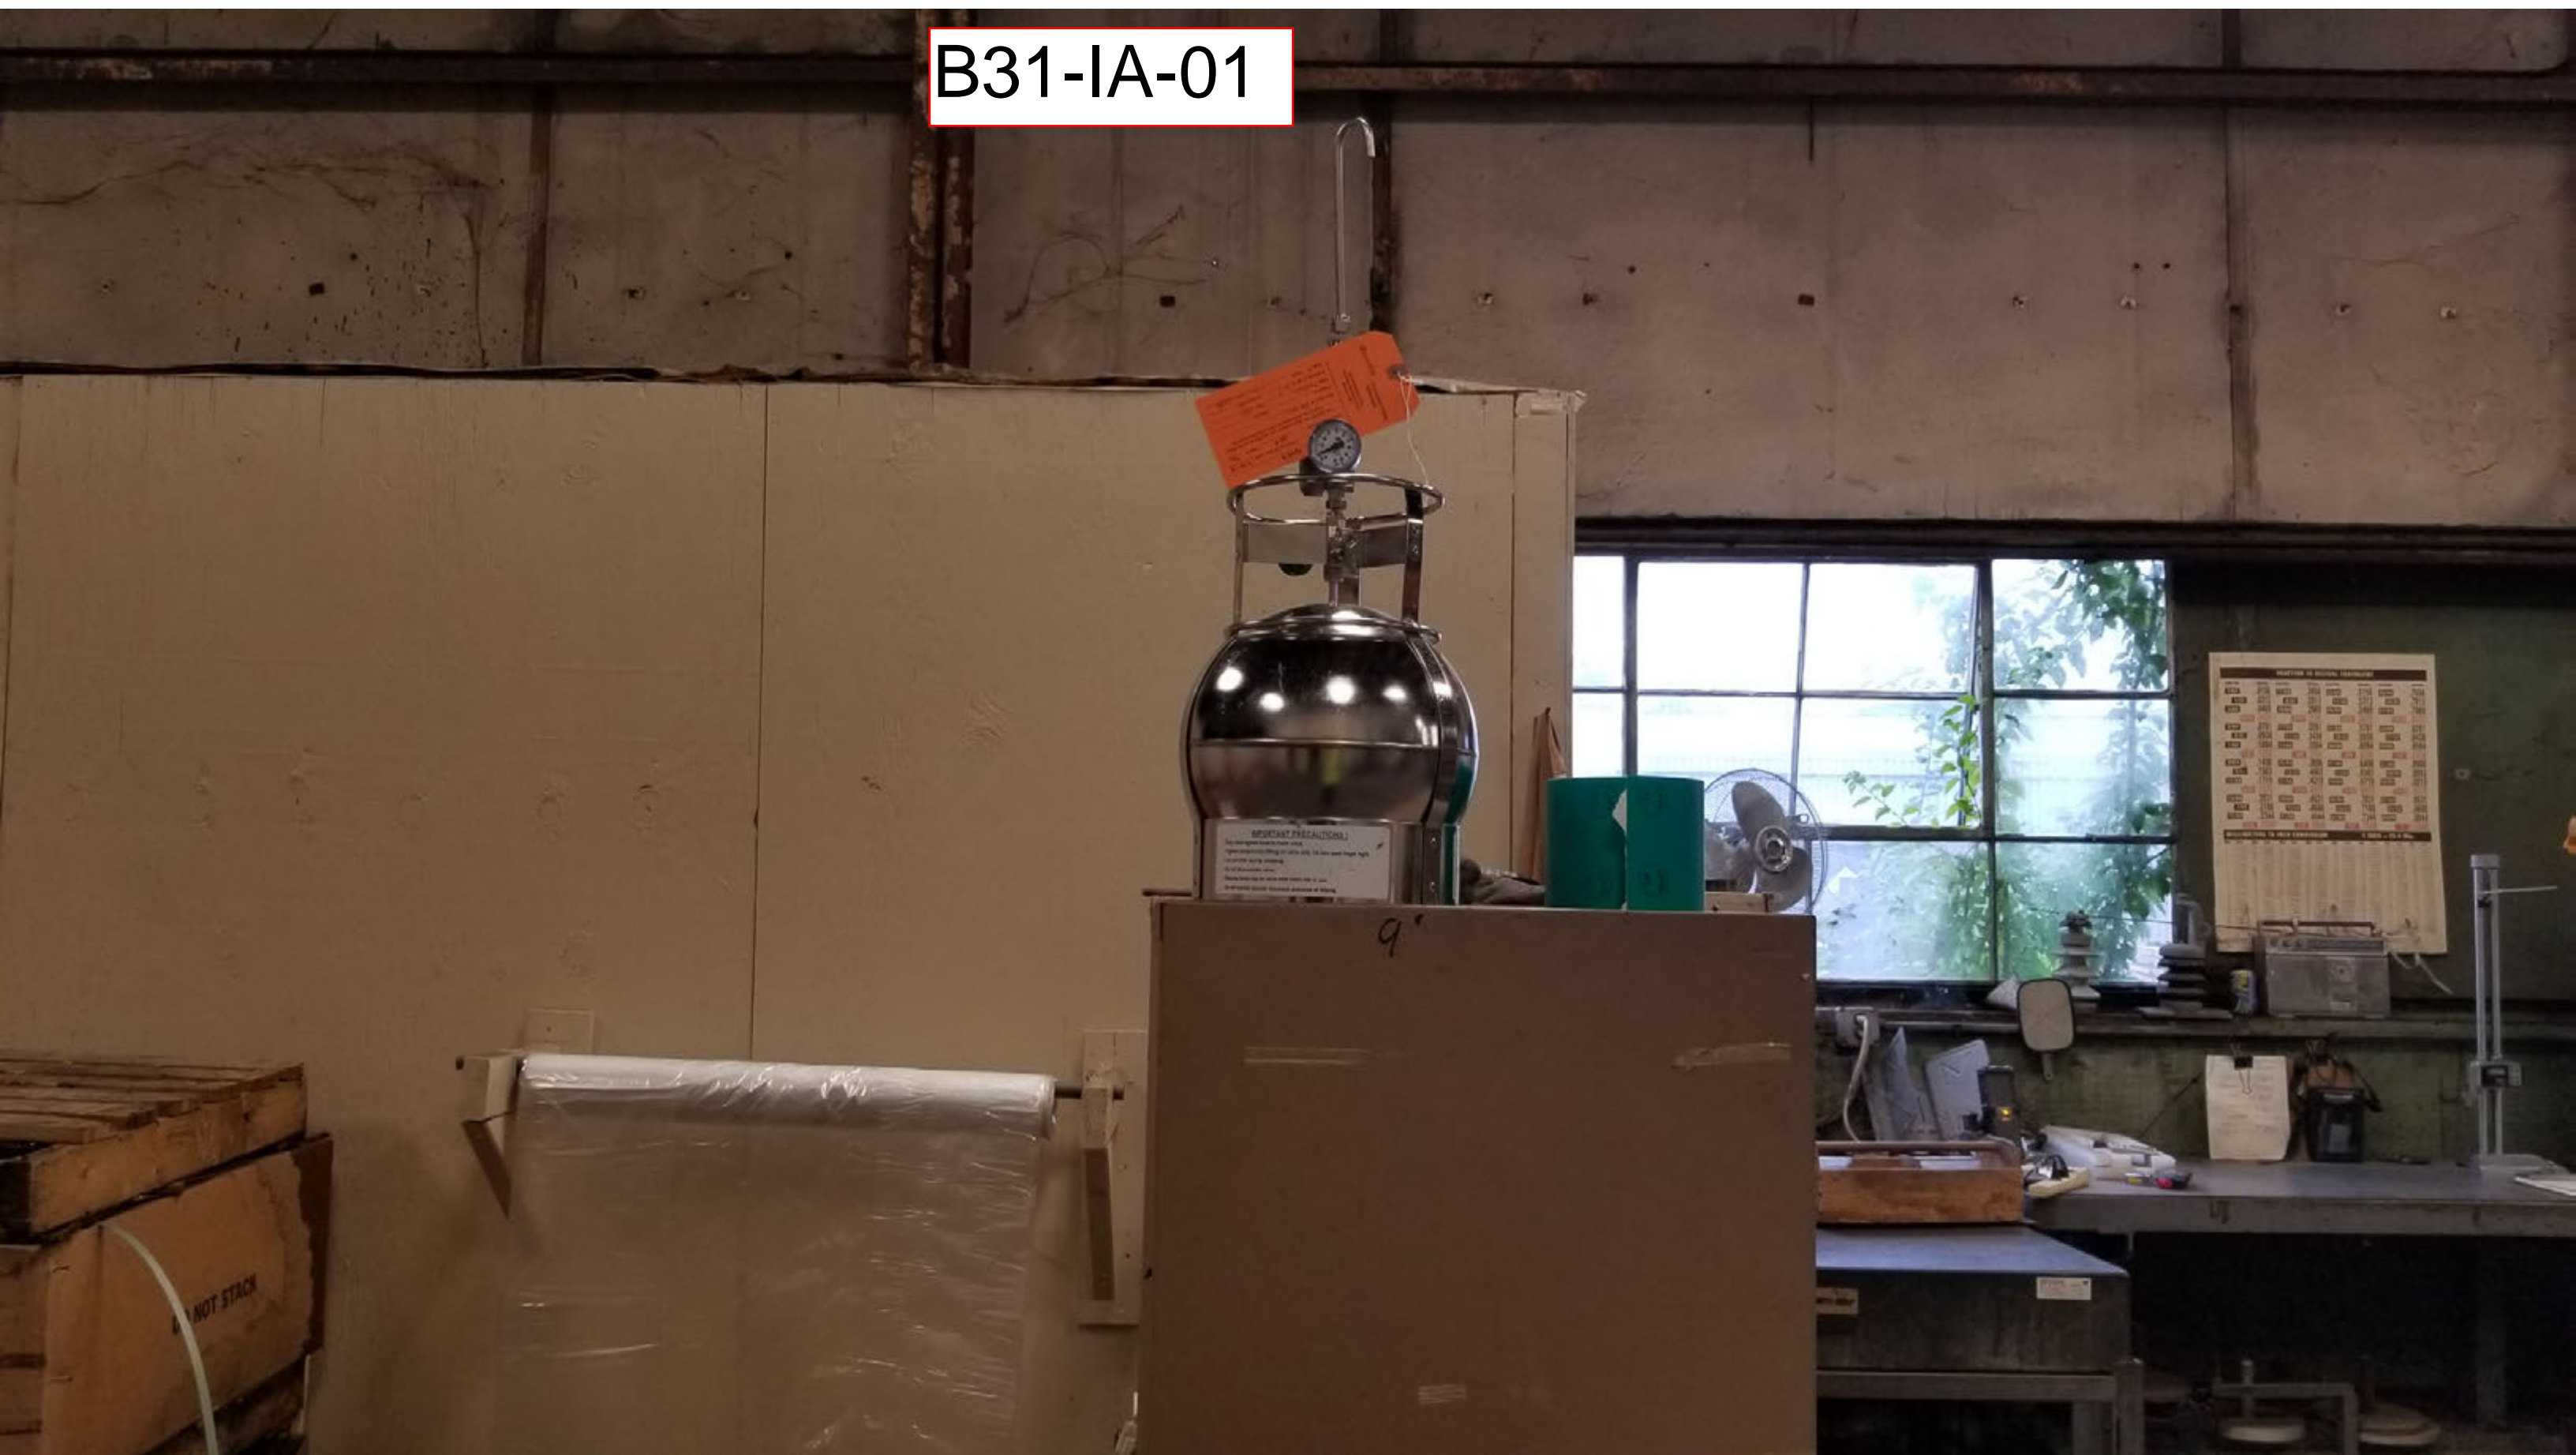
B31-IA-01

During the September 2019 monitoring event, the inventory for the workshop area of Building B-31 (where sample B-31-IA-01 is collected) was updated. The background PID reading was 0 ppm. In addition to the chemicals observed during the June 2019 monitoring event (spray paints, lubricants and paint stripper with PID readings of 3 ppm or less), paint stripper, PlioBond, and enamel were observed. The maximum PID reading observed was the PlioBond at 4 ppm. PlioBond does not contain chlorinated VOCs according to the Safety Data Sheet (included in Appendix A).

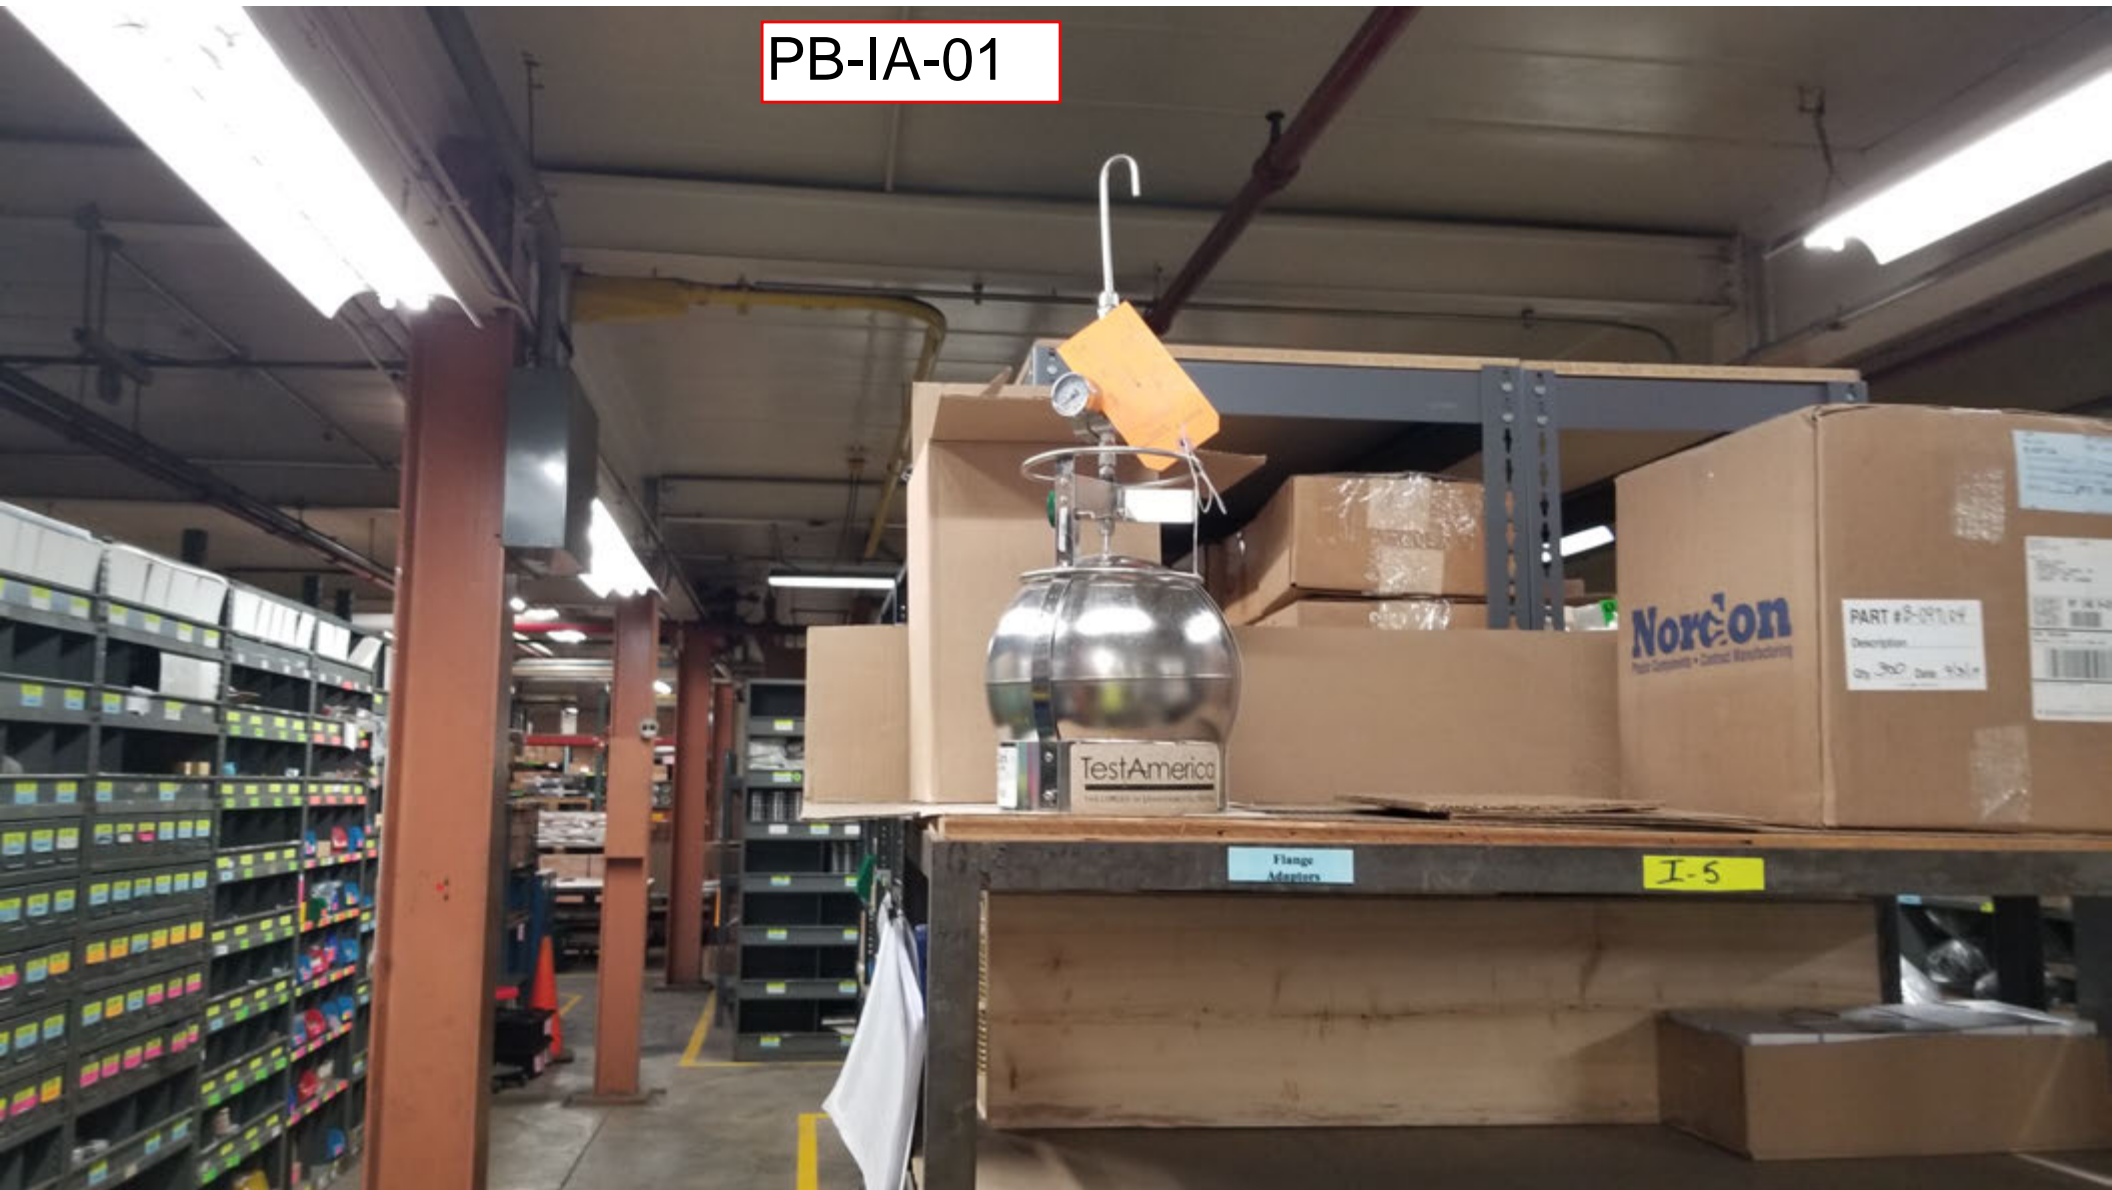
PB-IA-01

- Sample location PB-IA-01: Background PID reading was 3 ppm. There were no products observed near this sampling location. This area sees occasional forklift traffic.

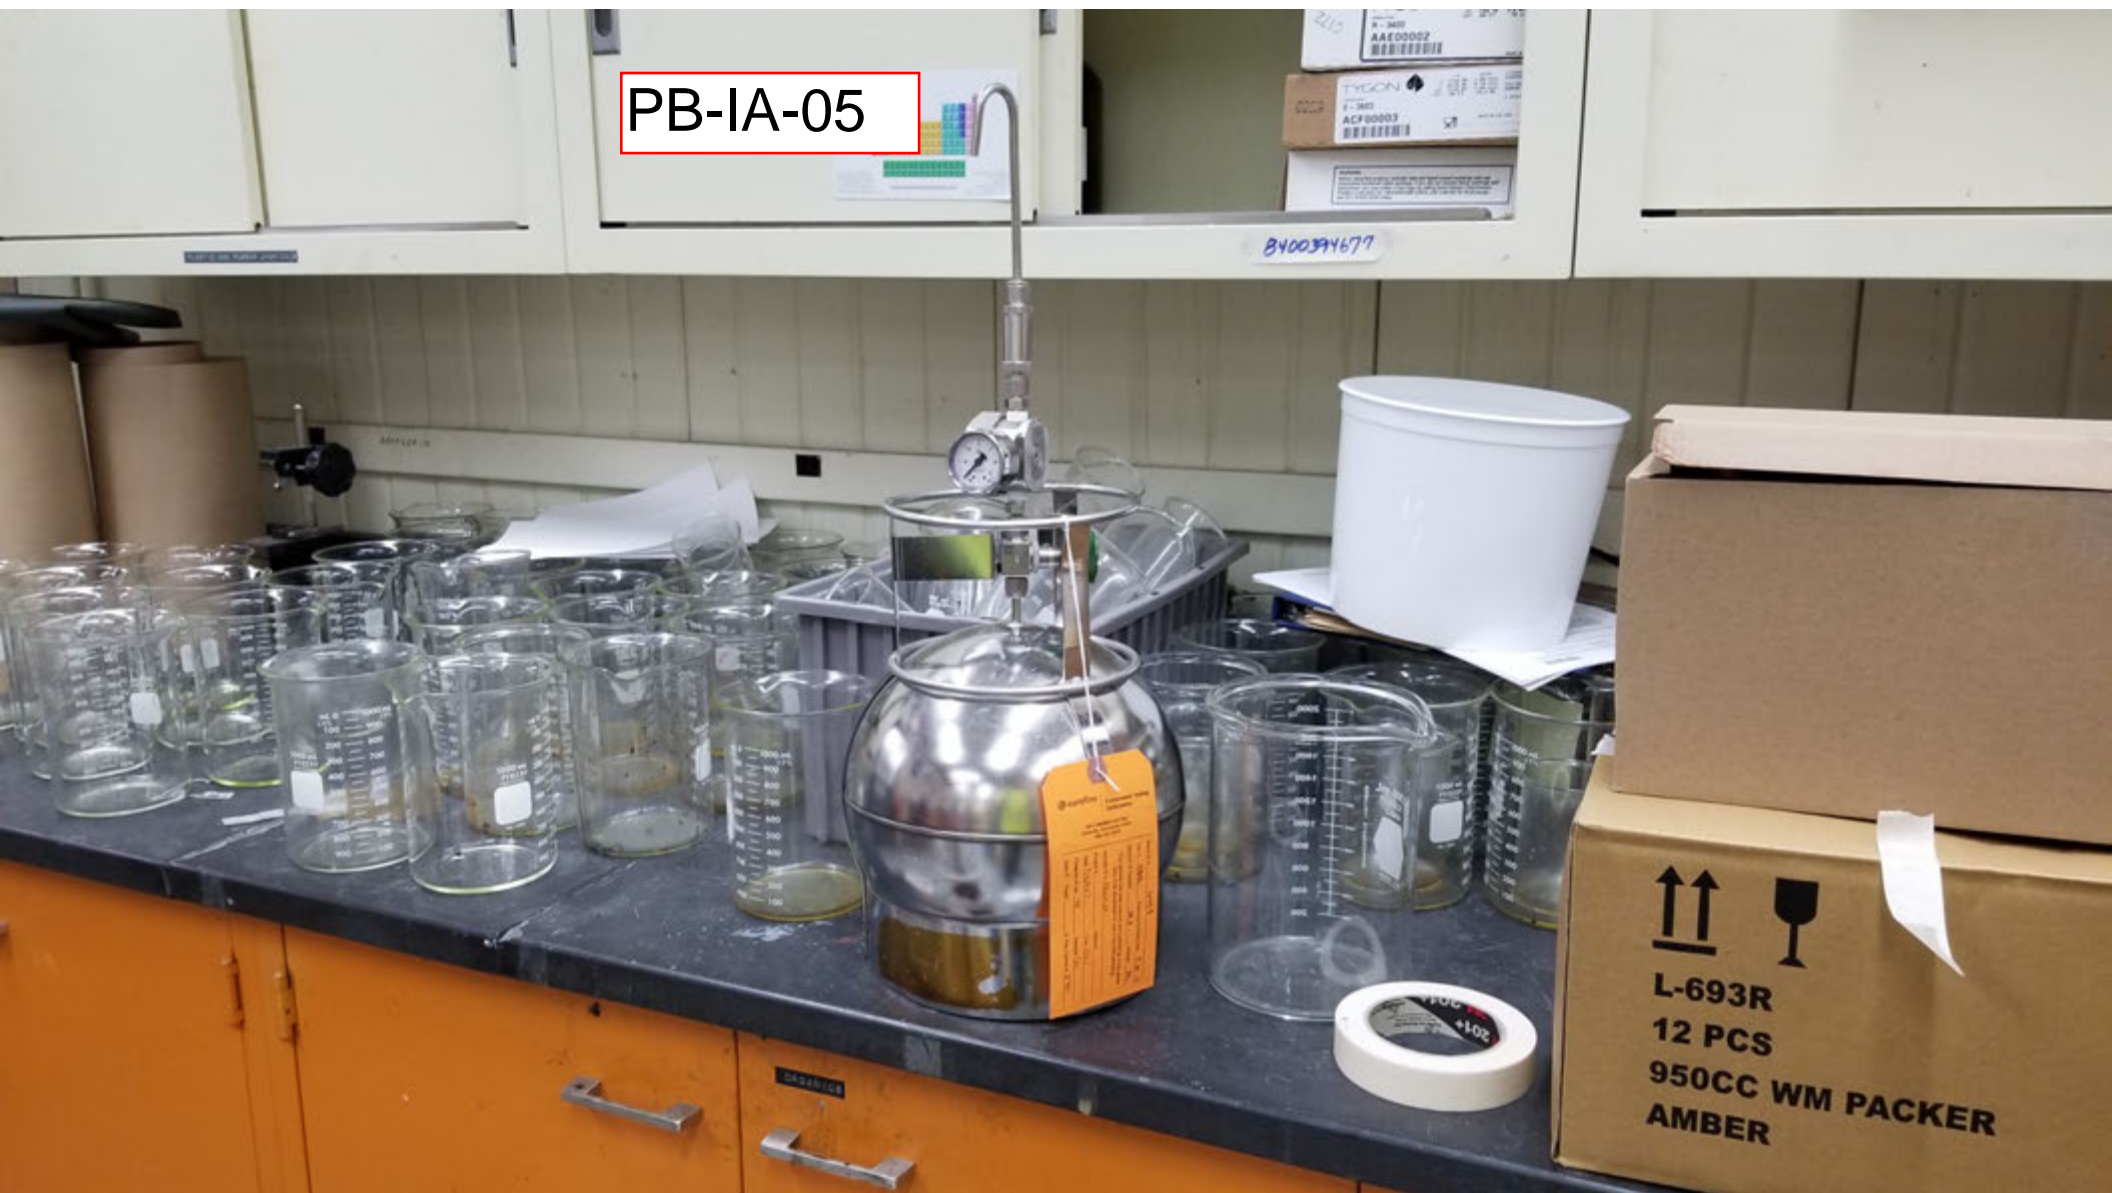
PB-IA-05

- Sample location PB-IA-05: During the September 2019 monitoring event, the background PID reading was 0 ppm in the polymer laboratory of the PCore Building (Sample location PB-IA-05). There are certain products stored inside a flammables cabinet in the laboratory that are known to exhibit high PID readings; PCore personnel typically remove these products prior to the sampling. However, for the September 2019 monitoring event, these products were not removed. There were no PID readings observed in or around the flammable's cabinet during the September 2019 monitoring event. The product inventory was revisited in the laboratory, and there were no notable changes to the product inventory (the contents of the flammables cabinet have not changed since the cabinet was last inventoried in February 2019). It should be noted that a sump pit in the floor of the laboratory, which was exposed to bare subsoil, was sealed during the construction of the SSD system in this location in May 2019.
