Periodic Review Report

Enarc-O Machine Products Site NYSDEC Site No. 826011

B0672-023-001

**ENARC-O MACHINE PRODUCTS, INC. SITE
LIMA, NEW YORK**

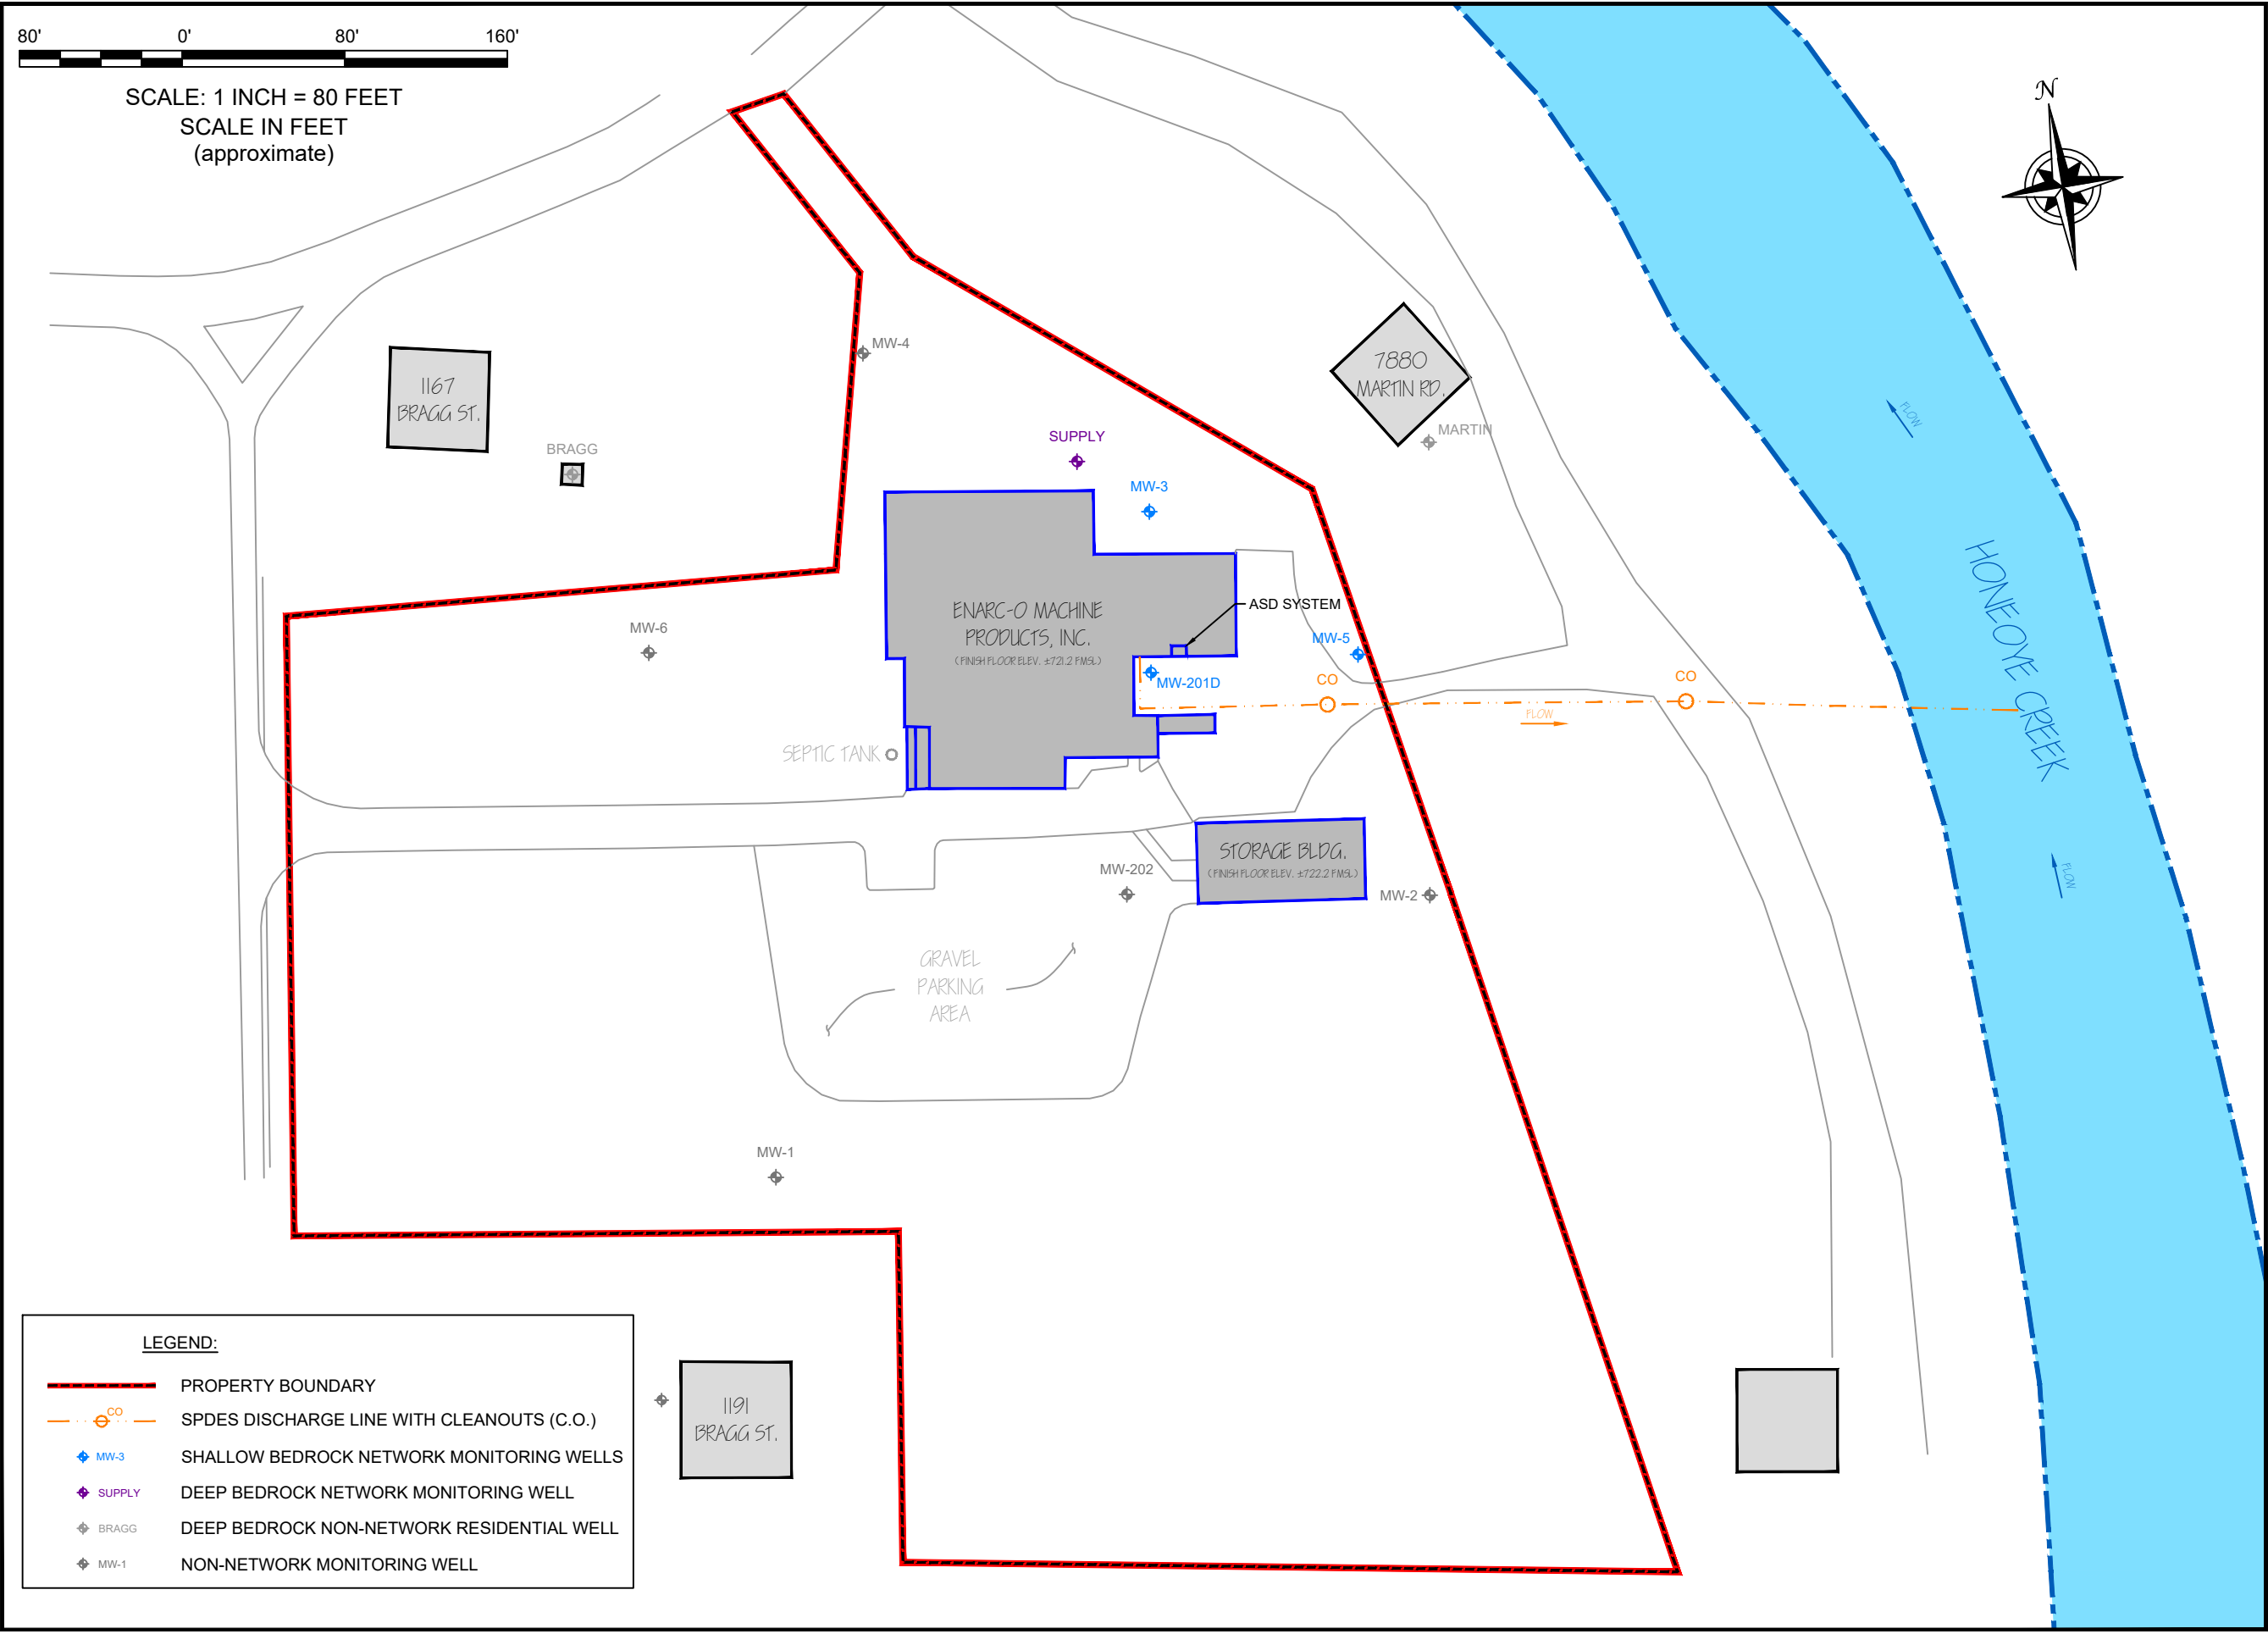
FIGURE 2

SITE PLAN

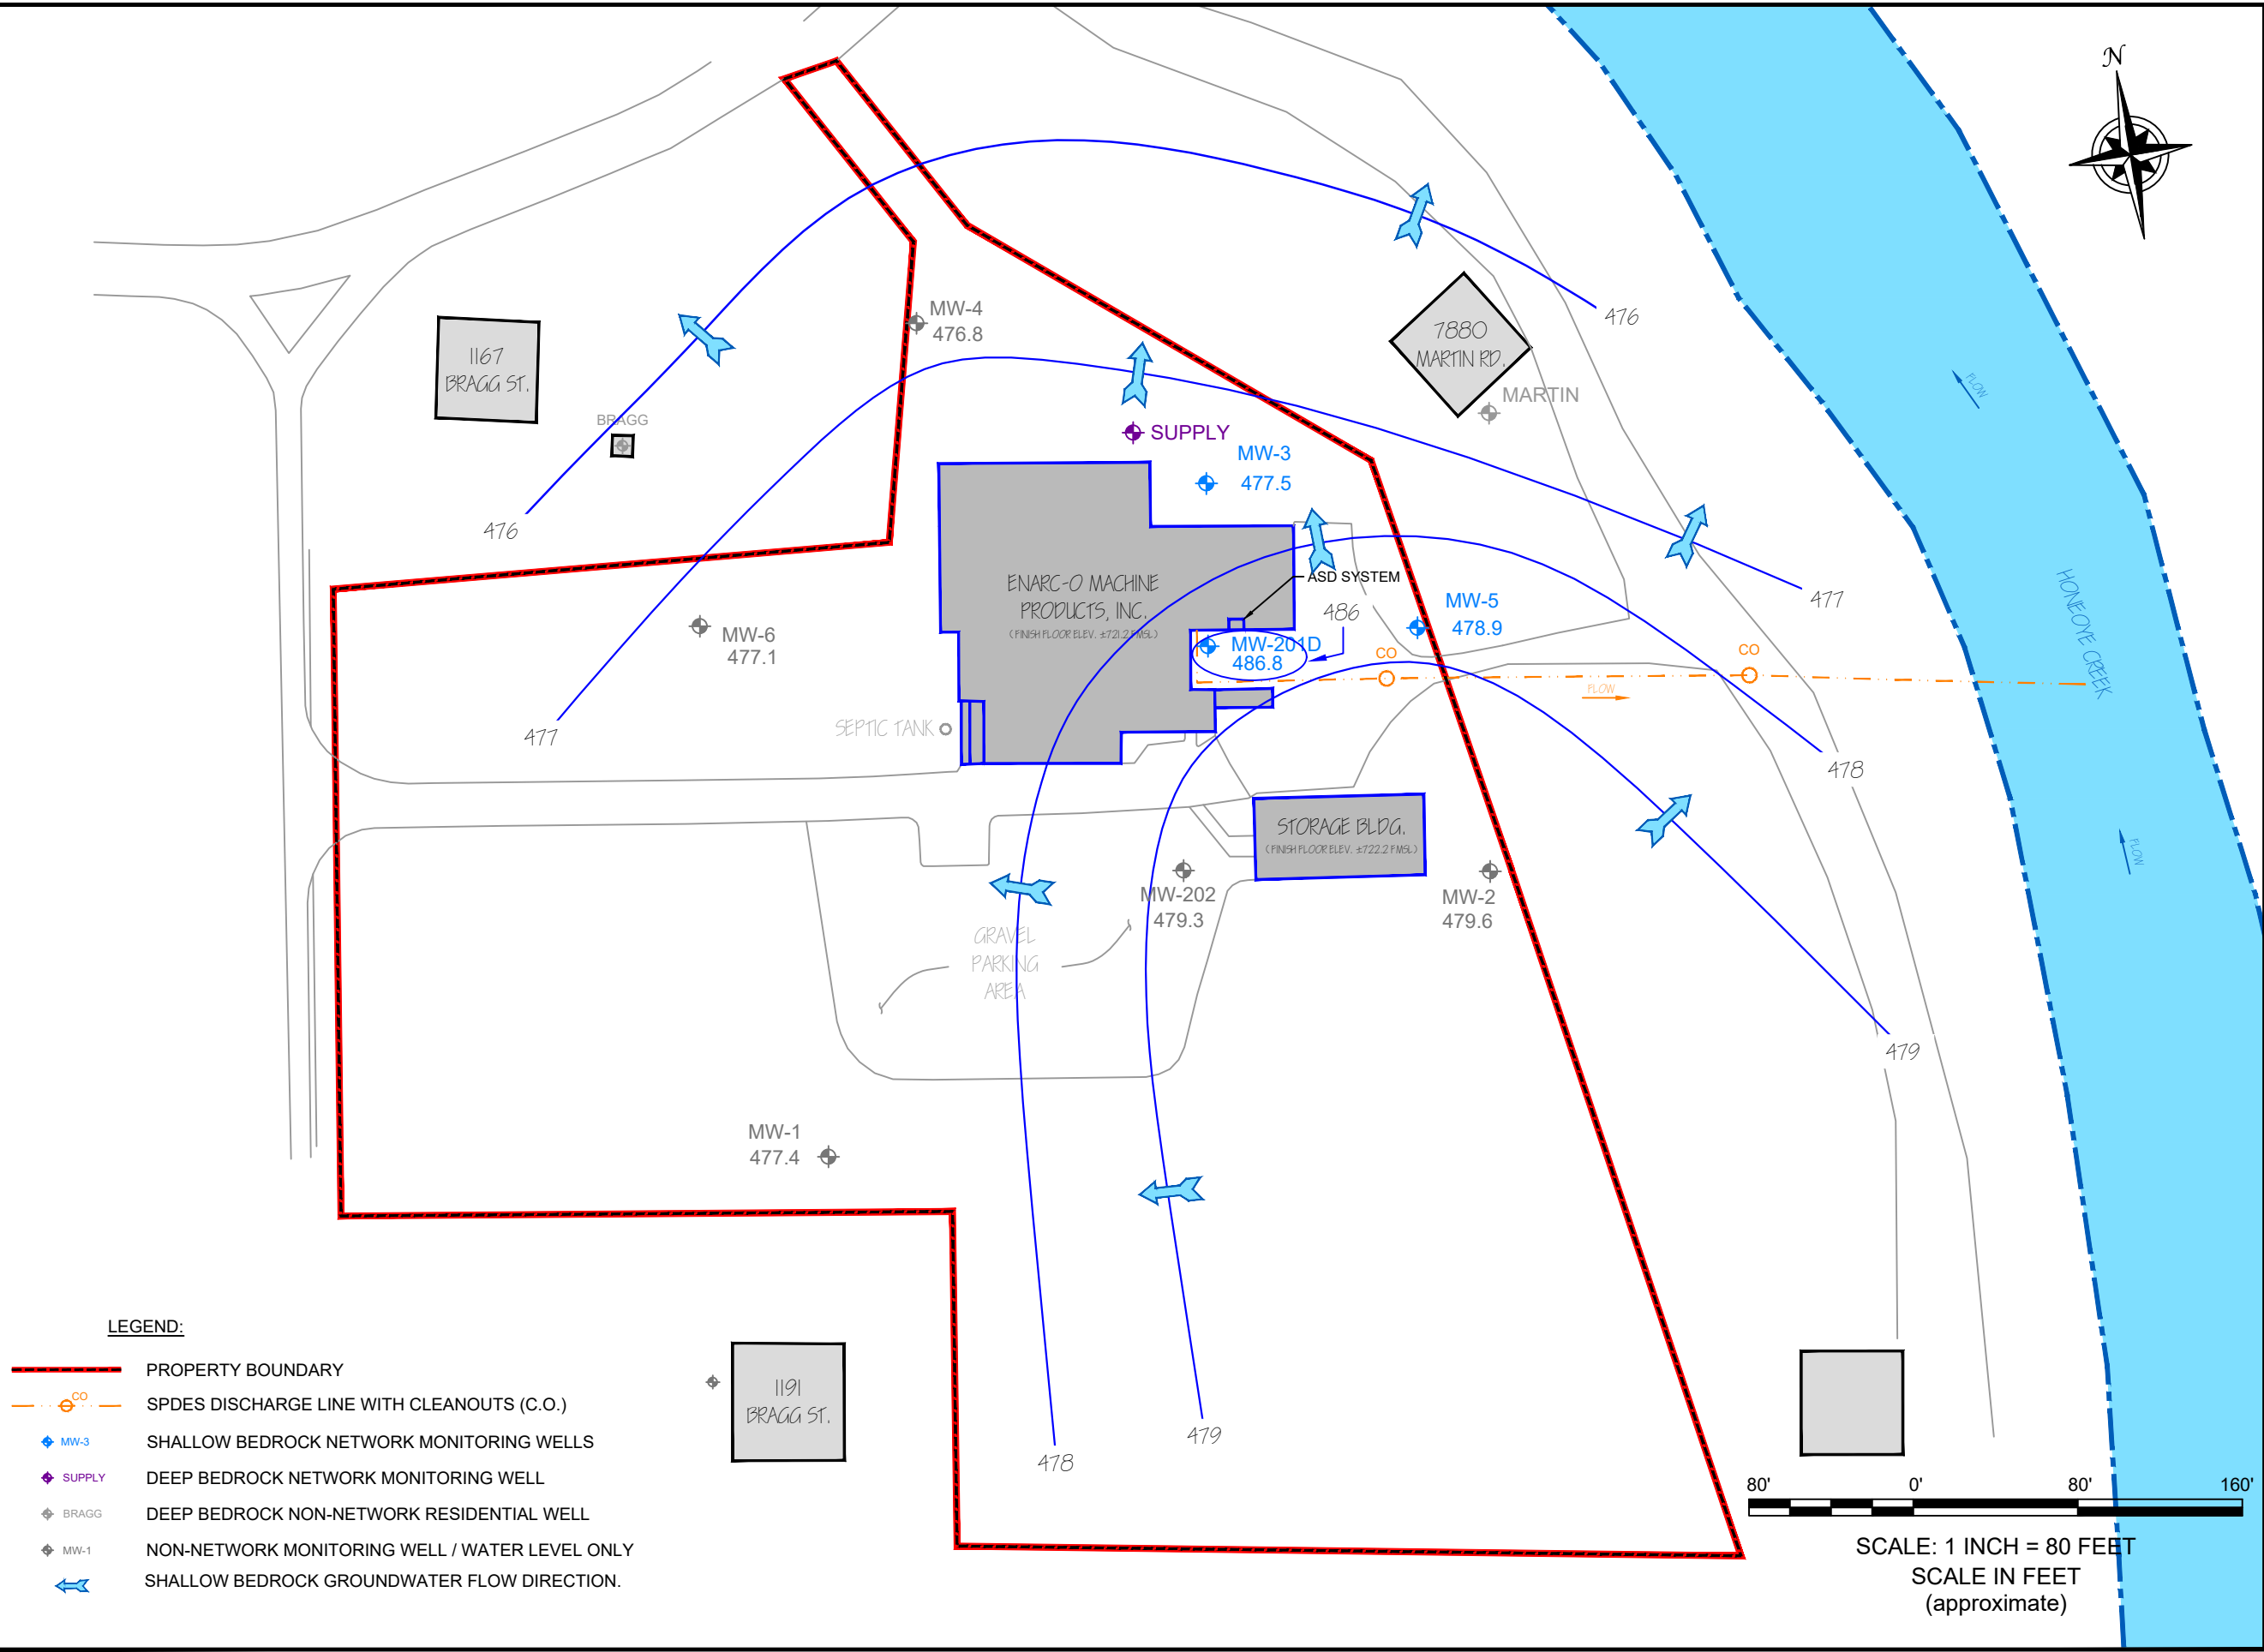
SITE PLAN AND SHALLOW BEDROCK ISOPOTENTIAL MAP

POST-REMEDIATION GROUNDWATER MONITORING (MAY 2021)

Isopotential maps developed following the May 2021 and the September 2022 monitoring events and are presented as Figure 1 (May 2021) & (September 2022) respectively. As indicated, groundwater flow is generally to the north and to the west. A localized component toward Honeoye Creek on the east side of the site was observed during the May 2021 and September 2022 monitoring events.

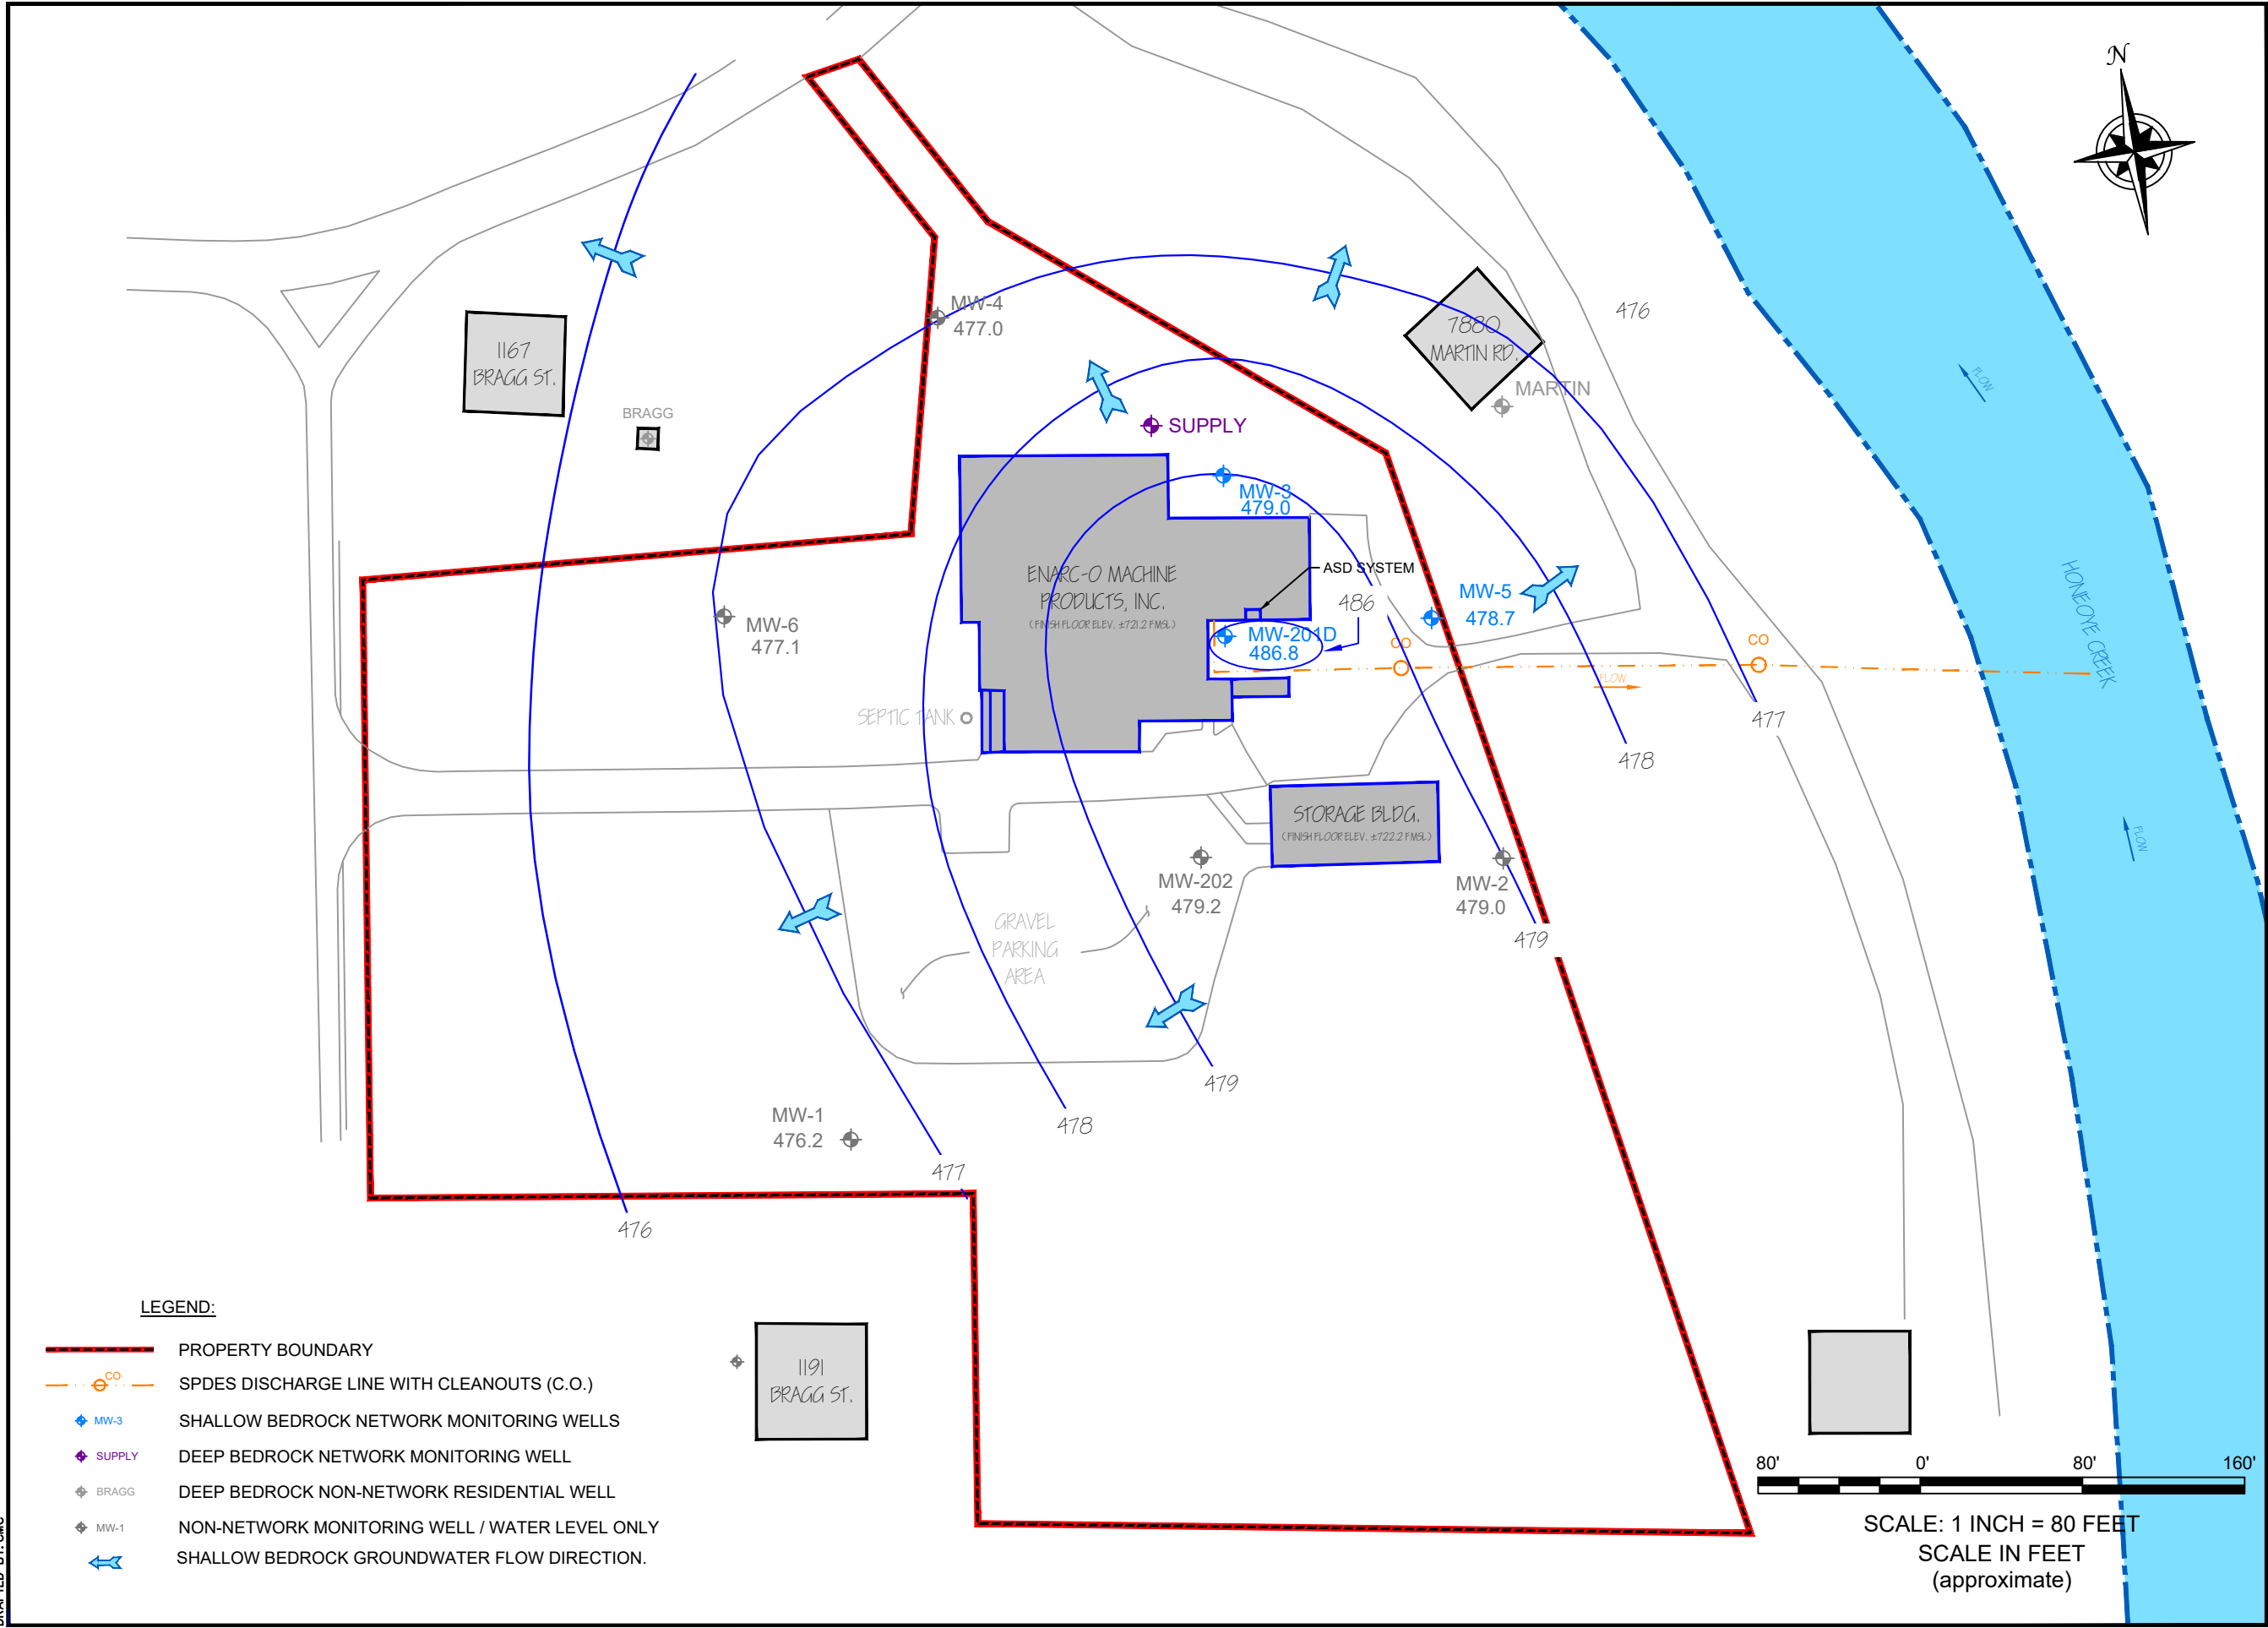
FIGURE 1

SITE PLAN AND SHALLOW BEDROCK ISOPOTENTIAL MAP

POST-REMEDIATION GROUNDWATER MONITORING (SEPTEMBER 2022)

Water level data collected from the former Supply Well are not employed for development of the isopotential maps as they are not indicative of shallow bedrock groundwater flow. The Supply Well, with a total depth of 185 feet below ground surface (fbgs) and a water level generally below 80.0 fbgs, reflects the deeper groundwater aquifer. In addition an artificial mound has been historically observed at MW-201D and is thought to be caused from unconsolidated structural fill materials that were used to backfill the remedial excavation that was located in this area of the site. As such the water level collected from MW-201D is reflective of the trapped water.

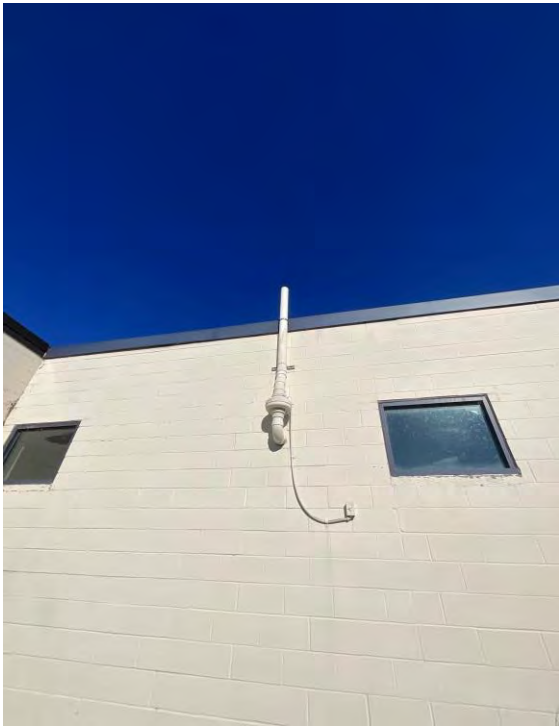
Client Name: Alco Manufacturing Corp		Site Location: Enarc-O- Plant Site- Lima, NY	Project No.: B0672-023-001
Photo No. 2	Date 02/14/23

Direction Photo Taken: North			
Description: ASD Exhaust Fan and piping.

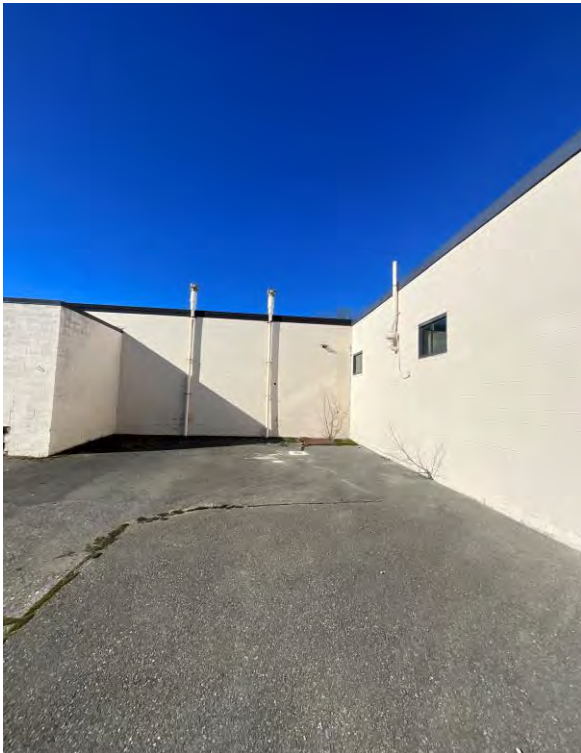
Photo No. 3	Date 02/14/23

Direction Photo Taken: Northwest		
Description: Asphalt cover and passive vents.

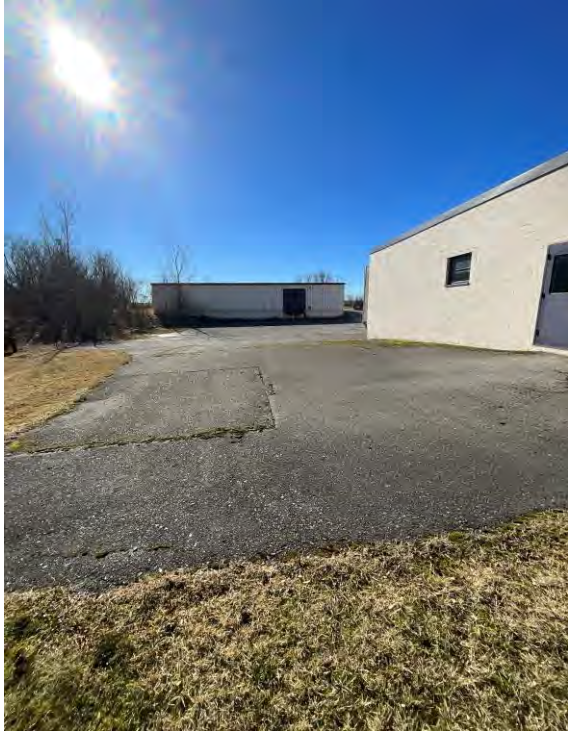
Client Name: Alco Manufacturing Corp		Site Location: Enarc-O- Plant Site- Lima, NY	Project No.: B0672-023-001
Photo No. 4	Date 02/14/23

Direction Photo Taken: East			
Description: ASD Exhaust Fan and piping.

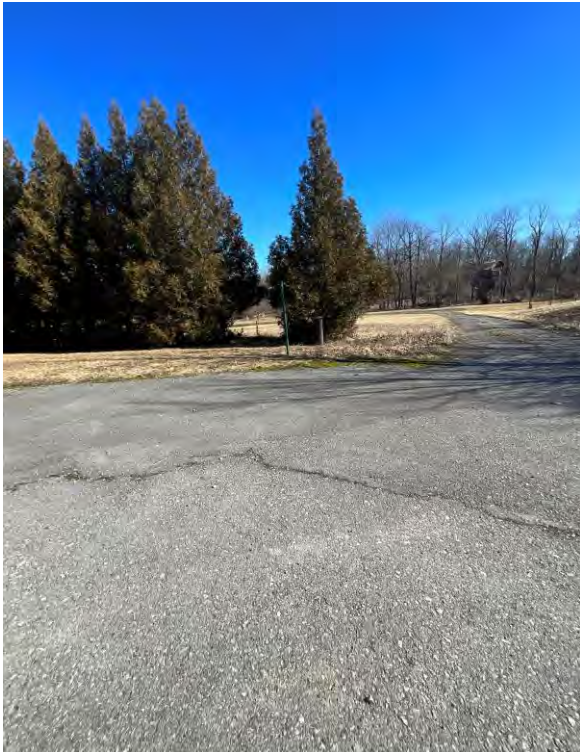
Photo No. 5	Date 02/14/23

Direction Photo Taken: South		
Description: Asphalt cover

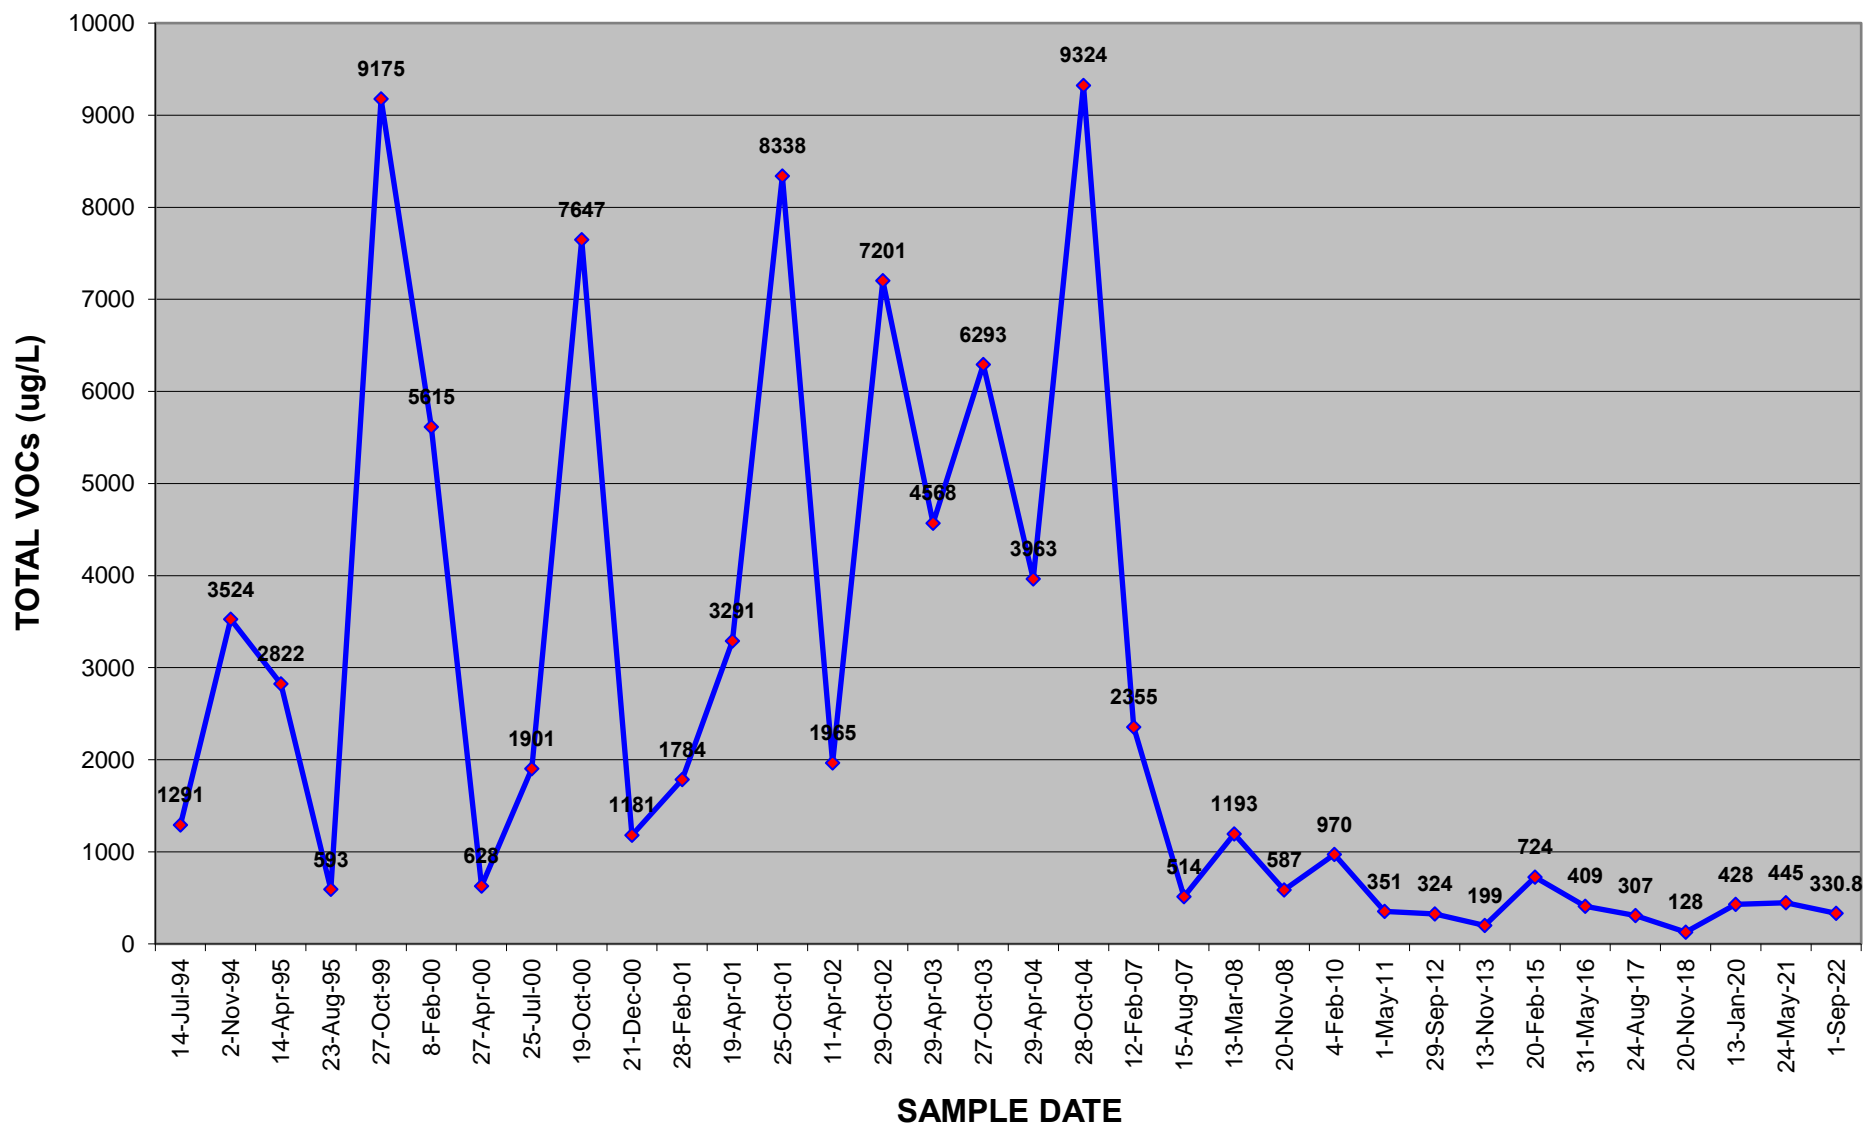
HISTORIC ANALYTICAL RESULTS MW-3

Moreover, Wells MW-3, MW-5 and the Supply Well, which monitor groundwater outside of the source area, have yielded total VOC levels below 1 part per million (ppm) over the past 5-year period covered by this Periodic Review Report. This indicates that attenuation processes are continuing to minimize offsite environmental impact.

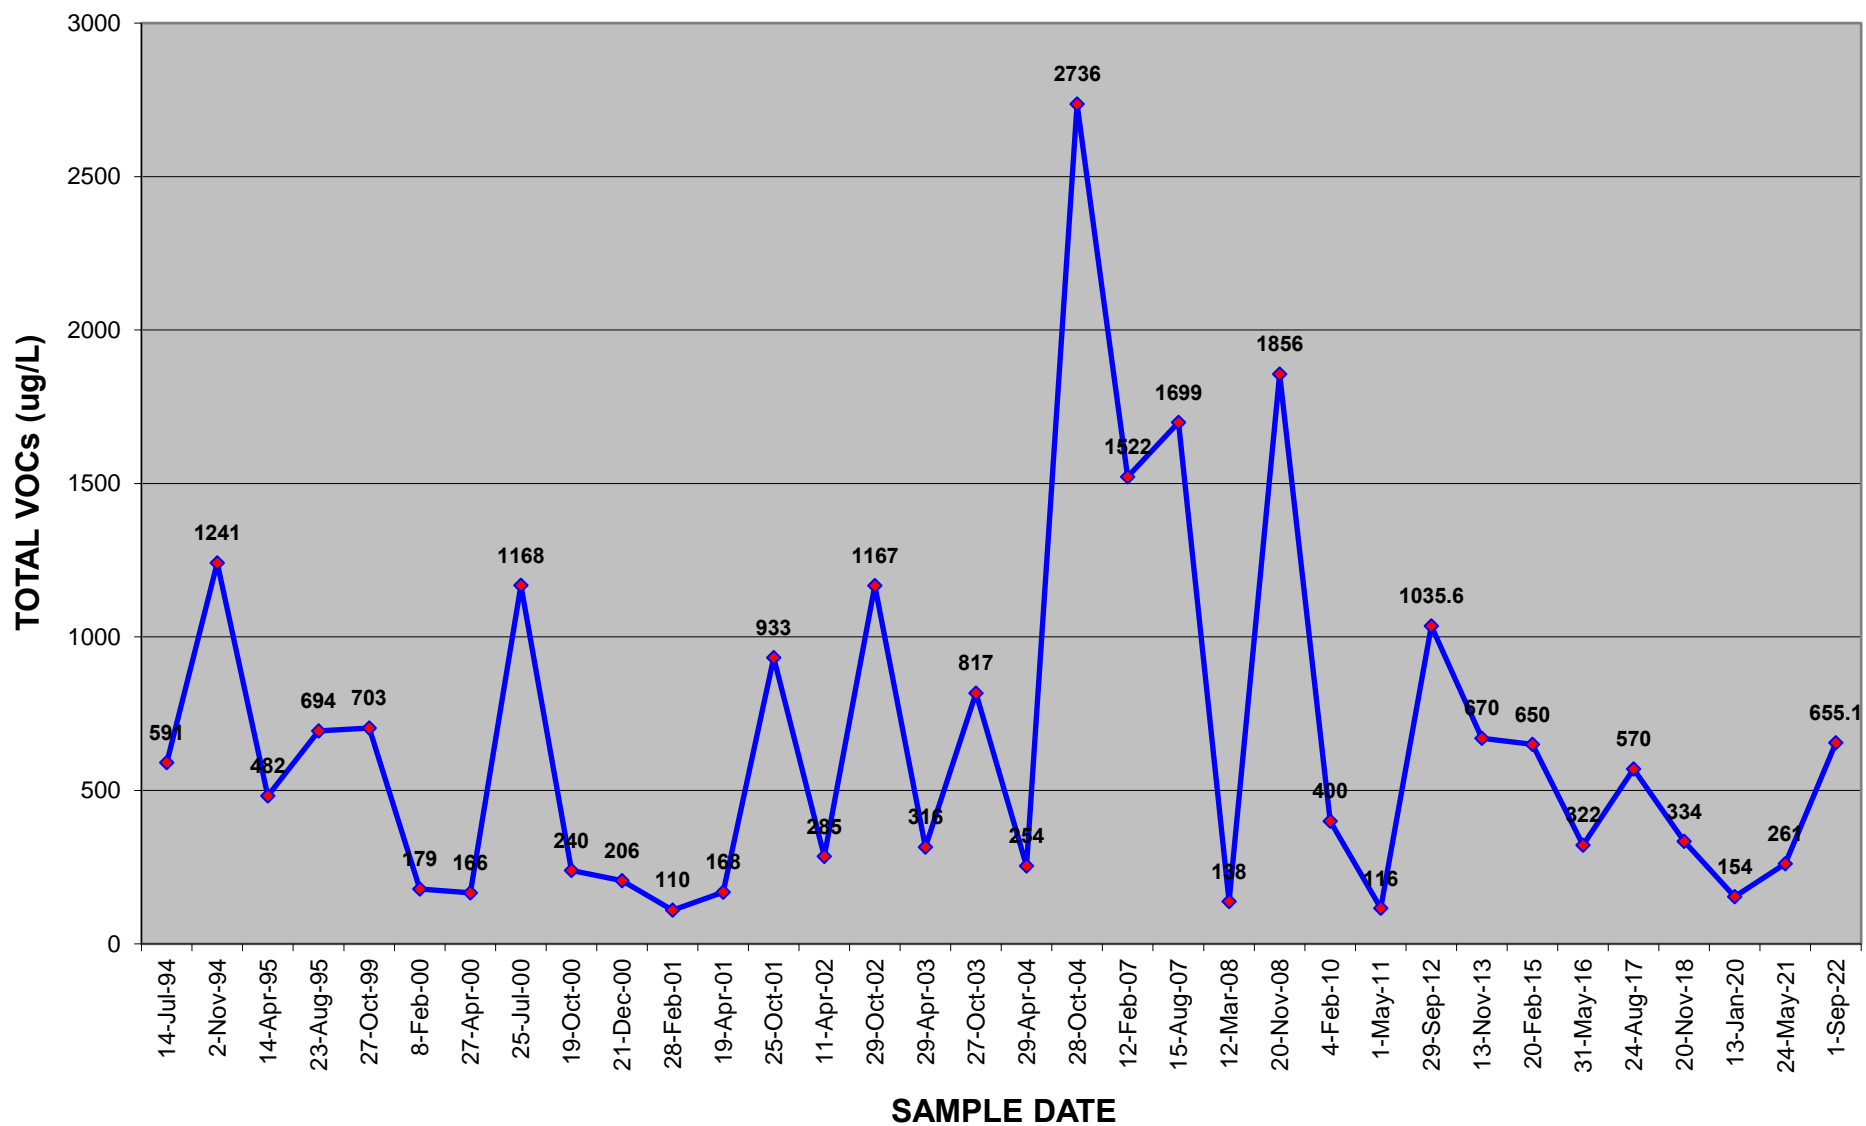
HISTORIC ANALYTICAL RESULTS MW-5

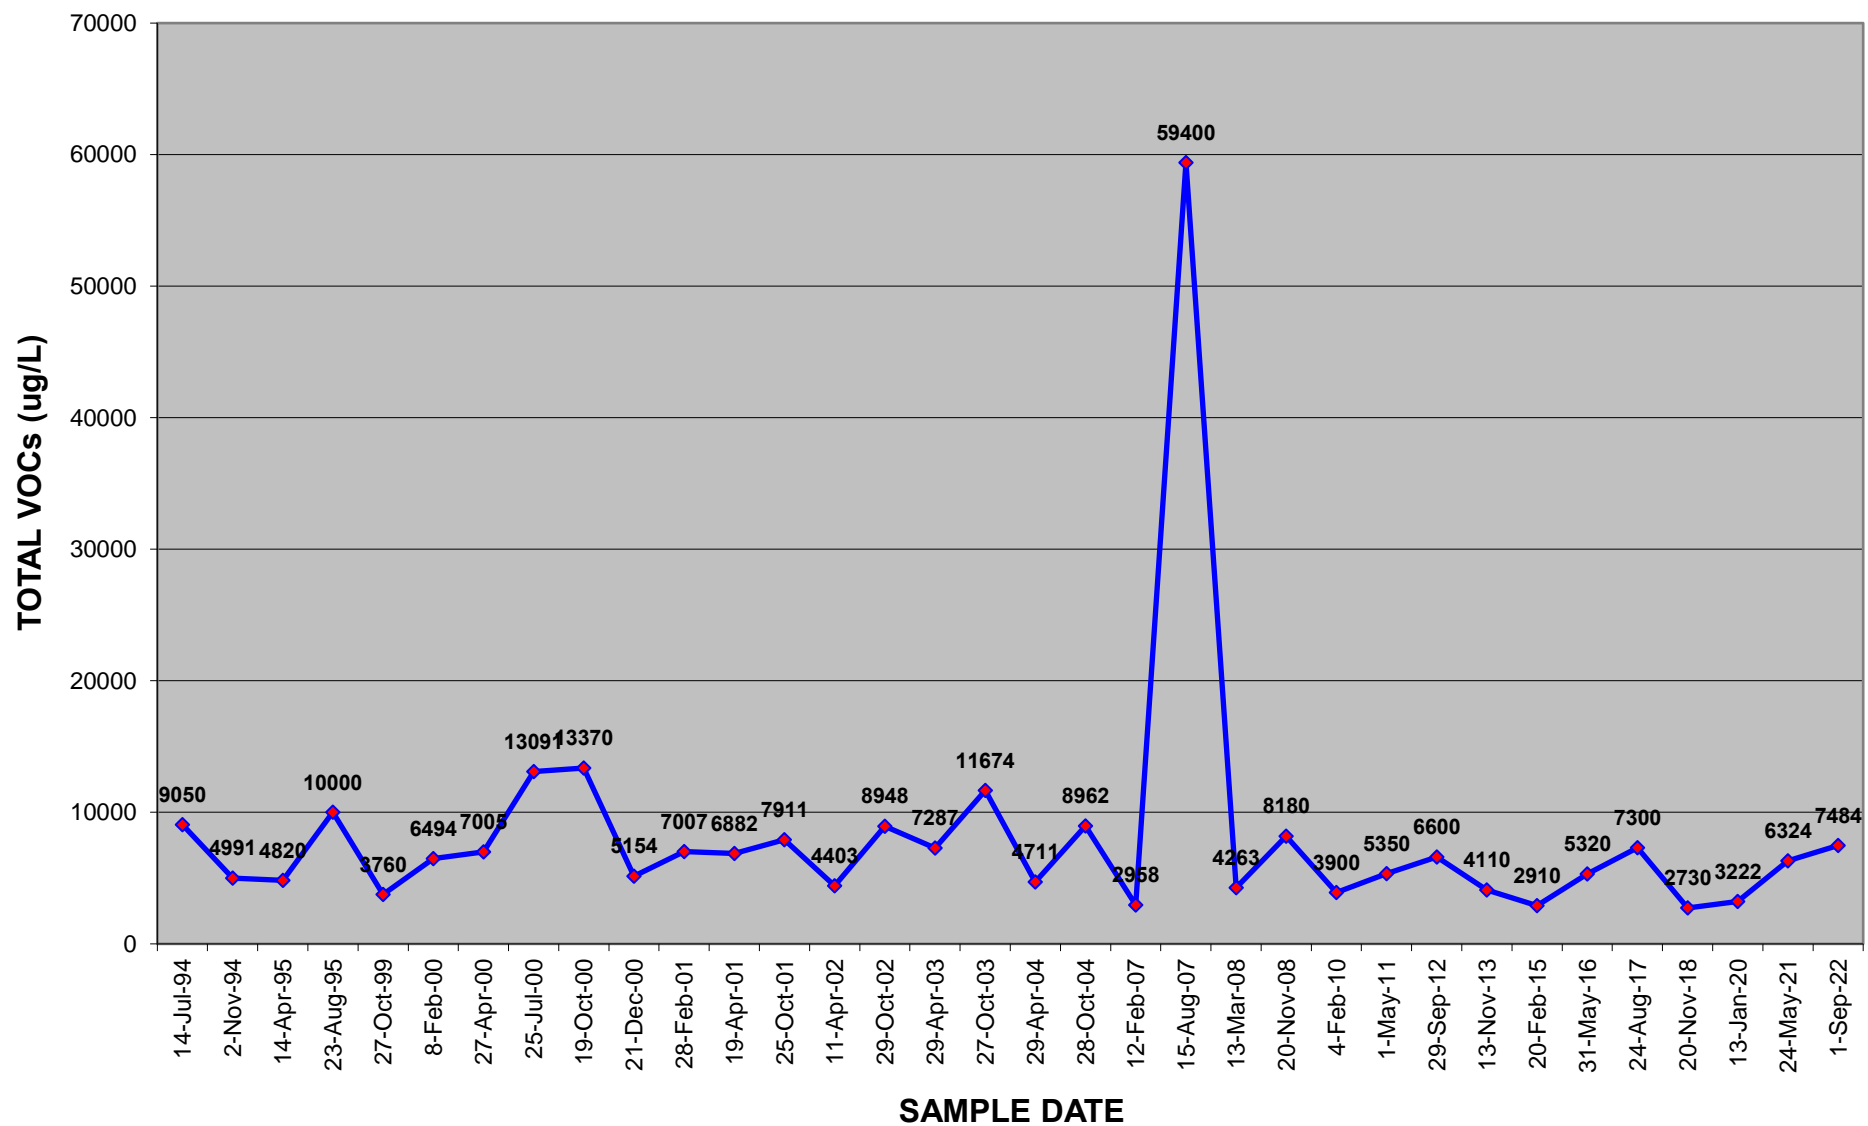
HISTORIC ANALYTICAL RESULTS MW-201D

Historic groundwater monitoring results are presented in tabular and graphical form in Appendix C of this report. In general, the results show that the chlorinated VOC (cVOC) concentrations measured at these locations have stabilized and remain well below historic highs. In addition, floating product has not been identified in any of the monitoring wells since the excavation of additional source soil was performed in 2005.

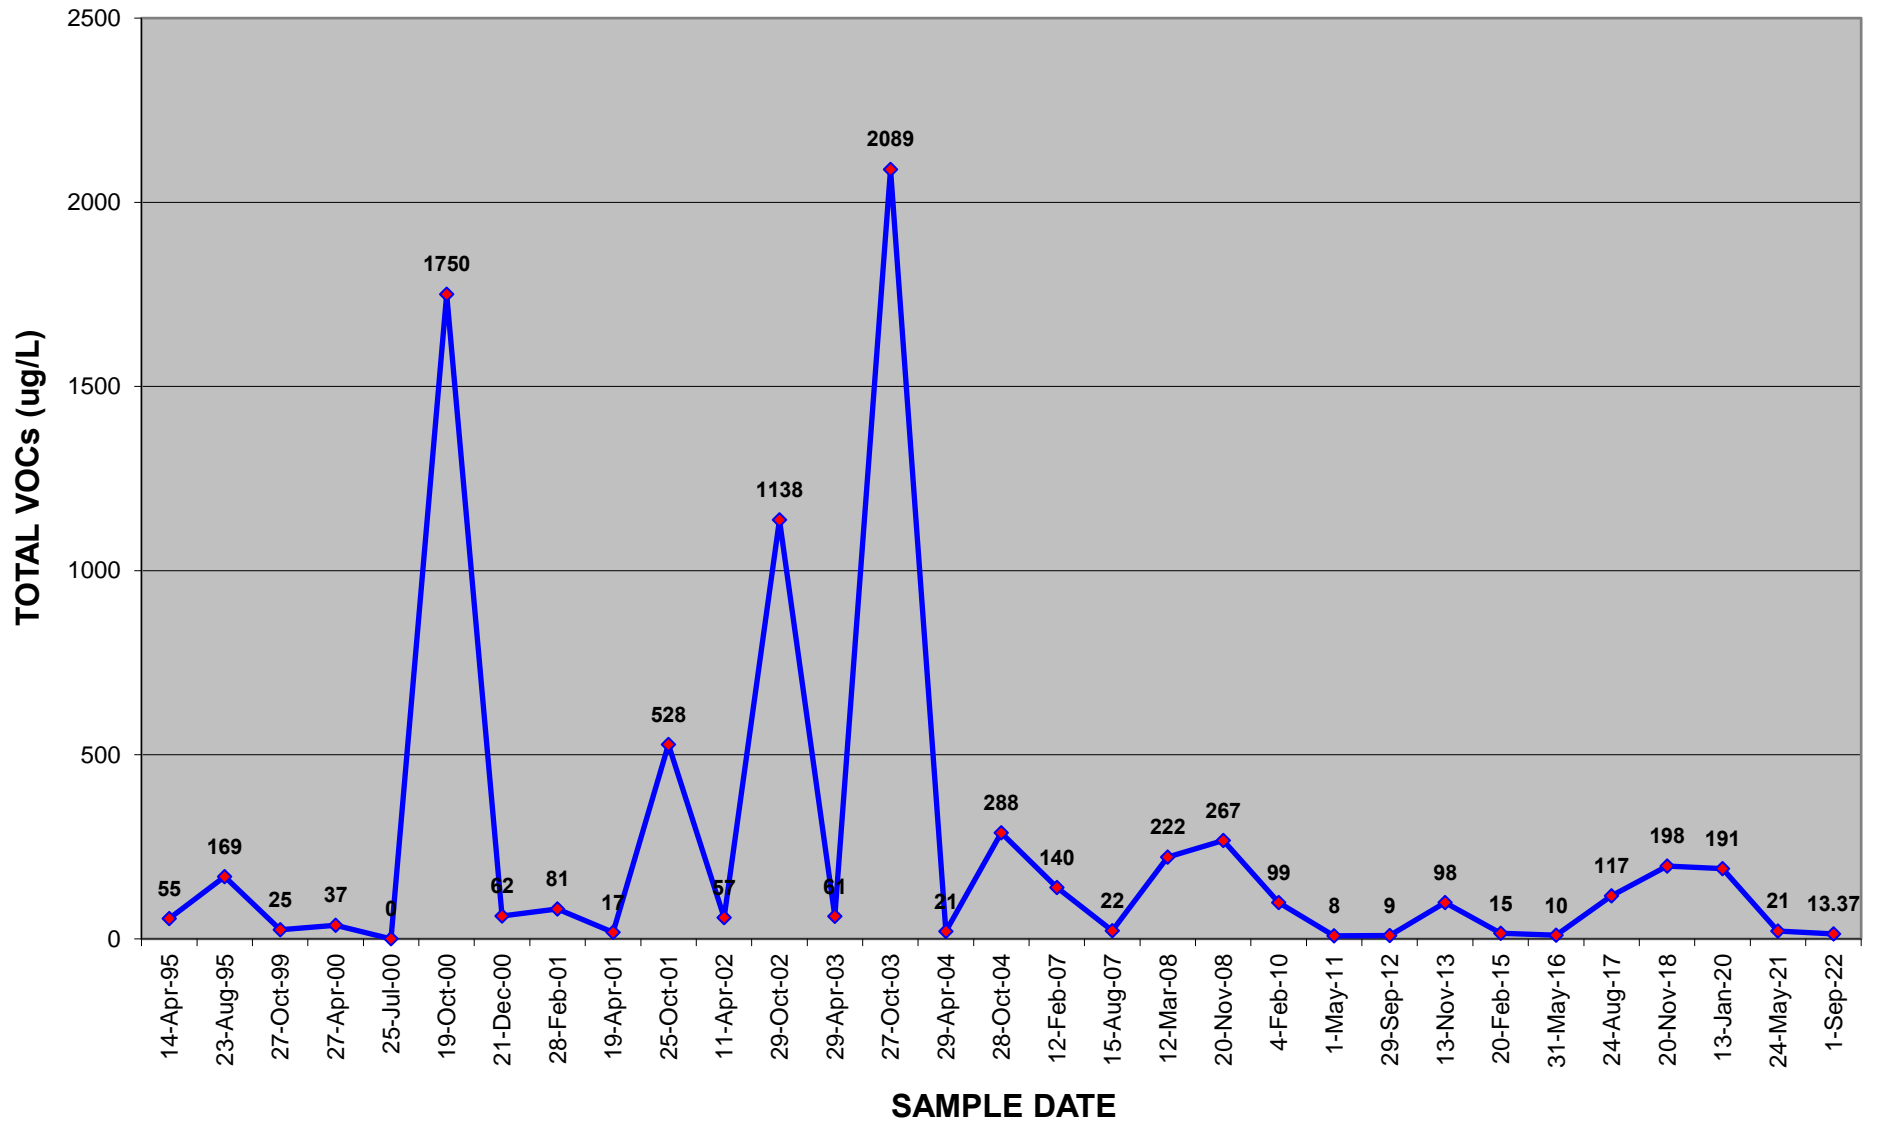
HISTORIC ANALYTICAL RESULTS SUPPLY WELL
