Re: Dearcop Farm, Site #8-28-016
W.A. #D002625-14
Interim Remedial Measure (IRM) Final Report

Ecology and Environment Engineering, P.C., (E & E) is pleased to submit six copies of this final report summarizing the field activities associated with the Interim Remedial Measure (IRM) at the Dearcop Farm Site in Gates, New York (NYSDEC Site No. 8-28-016). Additional copies were also provided to Todd Caffoe in the NYSDEC Region 8 office, David Napier of NYSDOH, and Joe Albert of the Monroe County Health Department. The IRM activities were carried out by Griffin Industrial Services, Inc. (GIS) of New Woodstock, New York. E & E subcontracted GIS under the NYSDEC Standby Contract and oversaw all phases of their work.

**Pre/ Post Construction
Documentation Photographs**

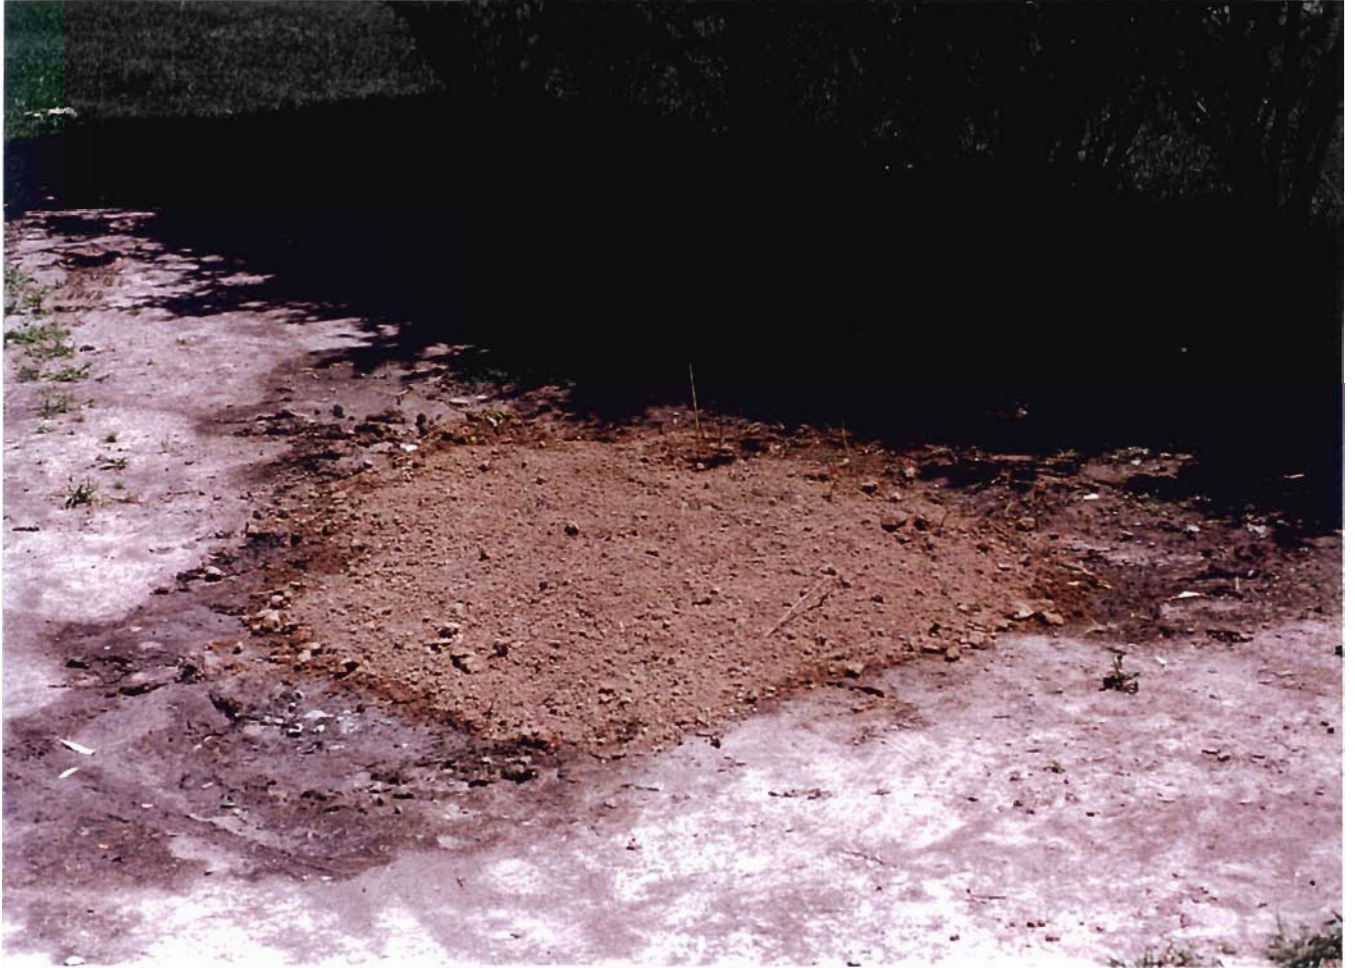
DEARCOP SITE 129 - AFTER

#129 where the excavation was in an area being used as a driveway. Areas beyond the excavation limits were repaired with topsoil and seed.

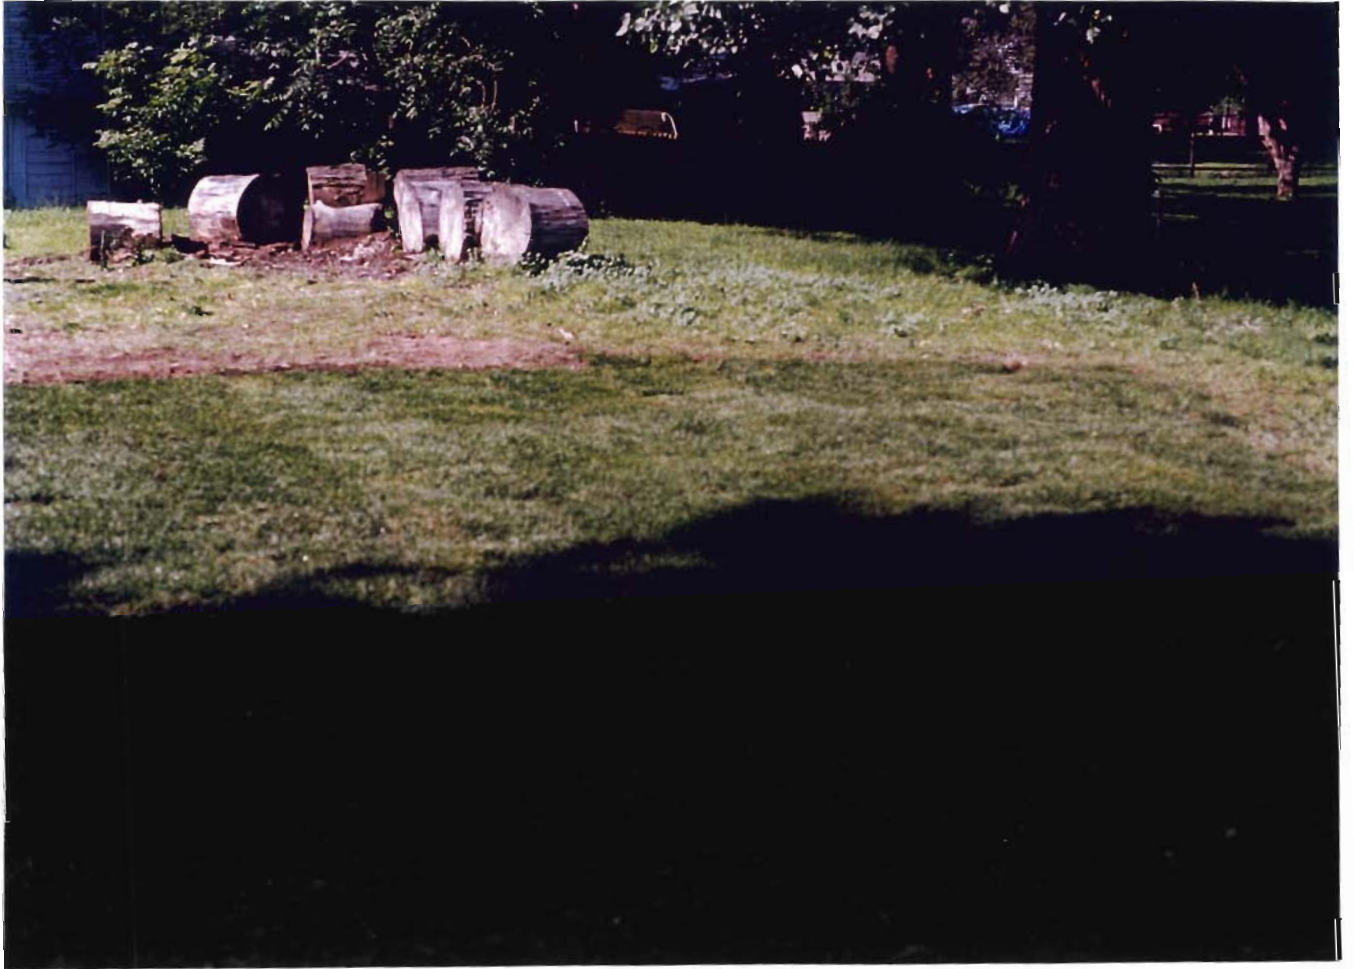
DEARCOP SITE 206 - AFTER

GIS was directed to repair the disturbed areas at #206 on August 16, 1996 due to a complaint received by the landowner that the sod had died. Upon re-inspection by E & E, GIS was directed to re-grade #206 with topsoil and over-seed the excavation area.

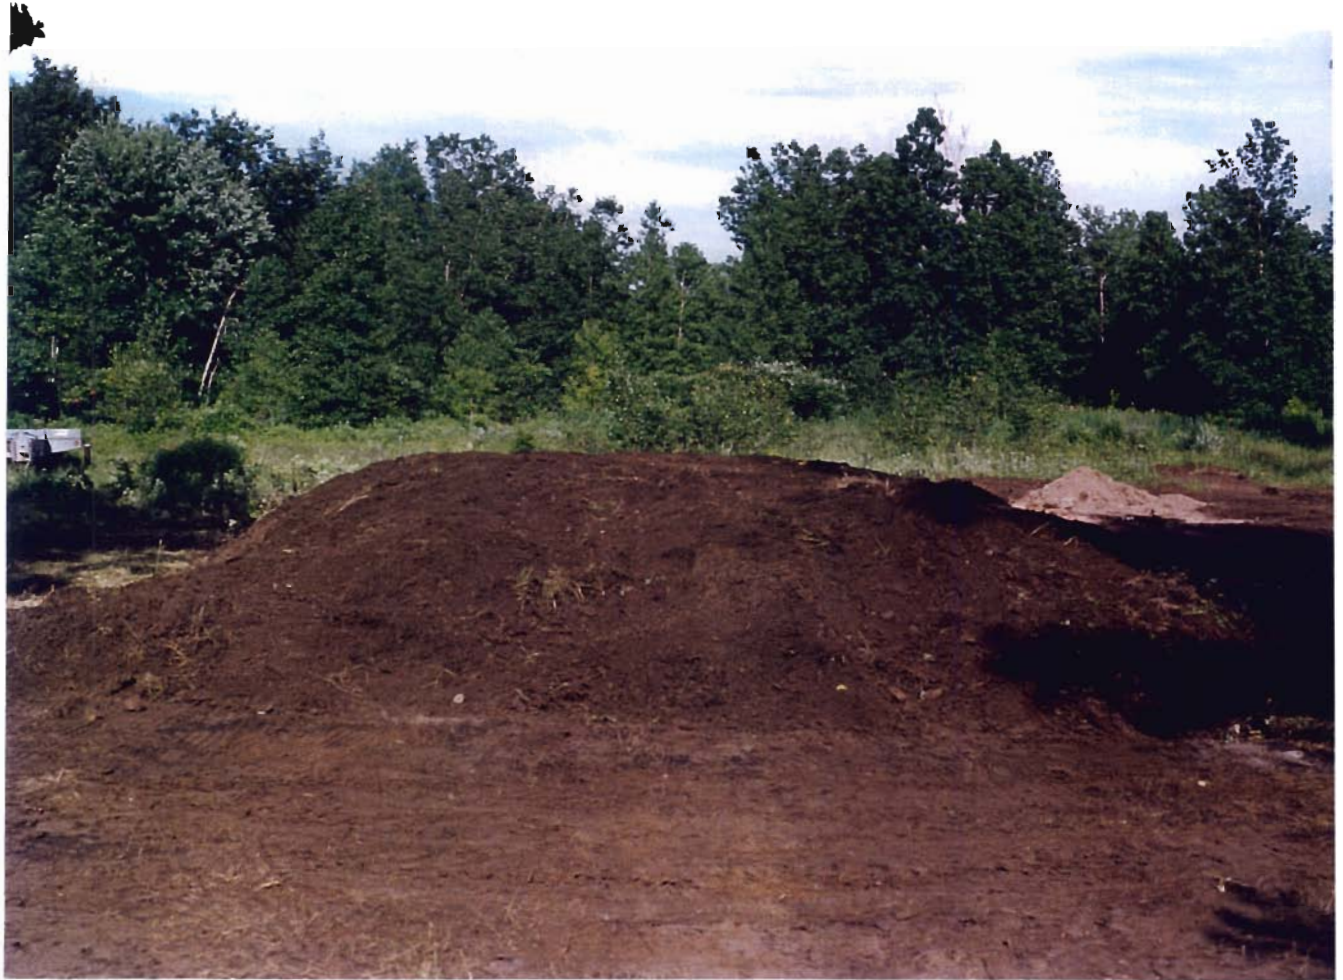
DEARCOP STOCKPILE - AFTER

40-mil LDPE liner was substituted for the stockpile in place of 40-mil HDPE specified.

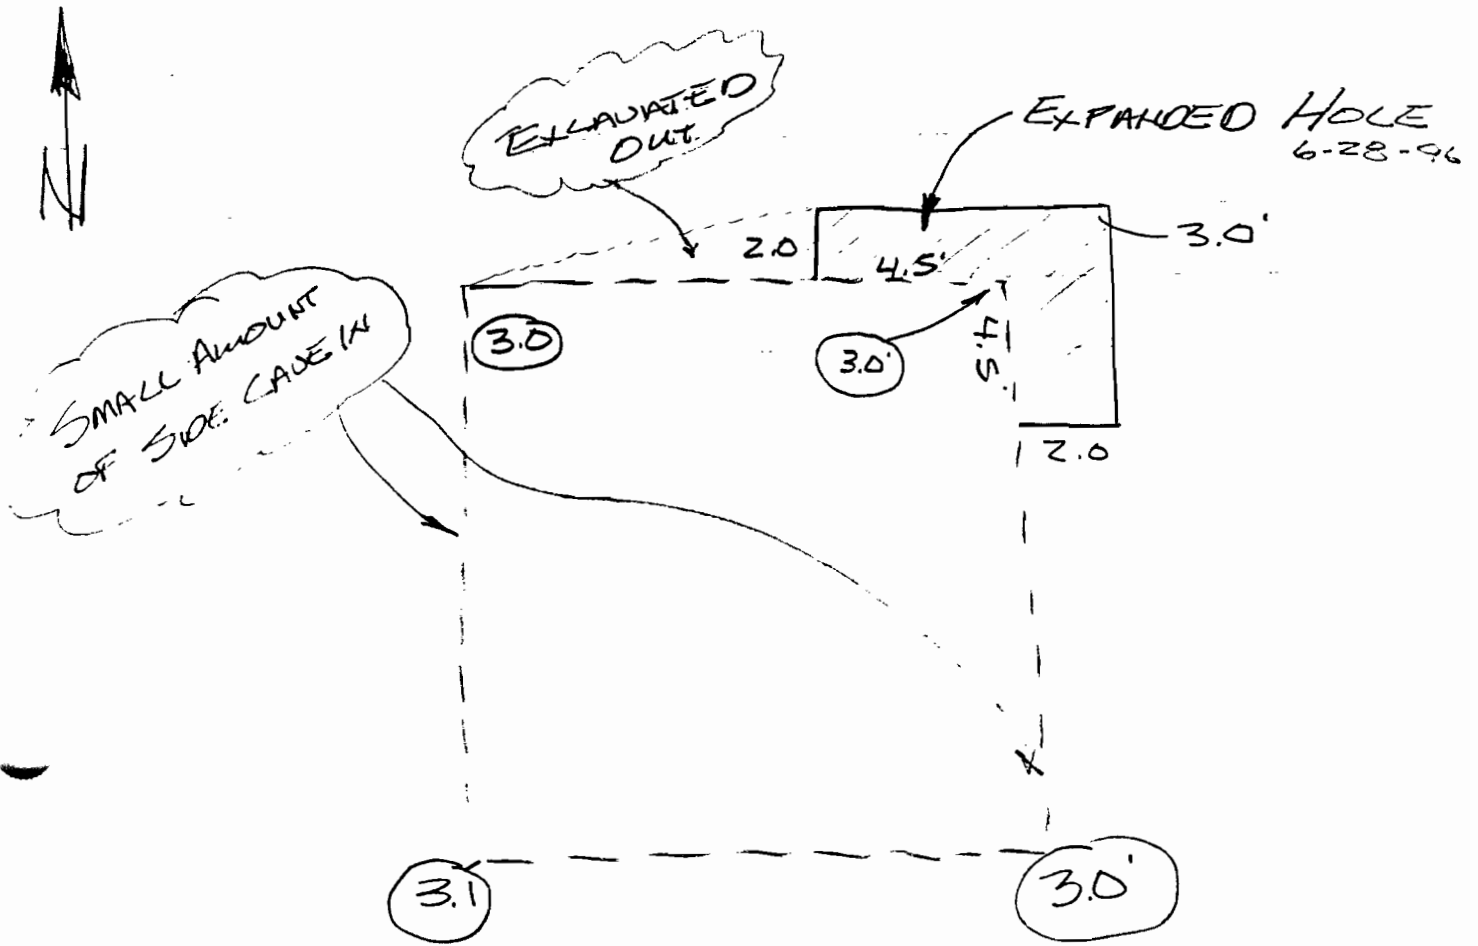
HOUSE # 206

NO WATER IN HOLE
