**WELL INSTALLATION AND COMPLETION REPORT
HORIZONTAL EXTRACTION WELL HW-1
ARCH CHEMICALS, INC.
SITE NO. 828018a**

MACTEC E & G (PC)

March 2023

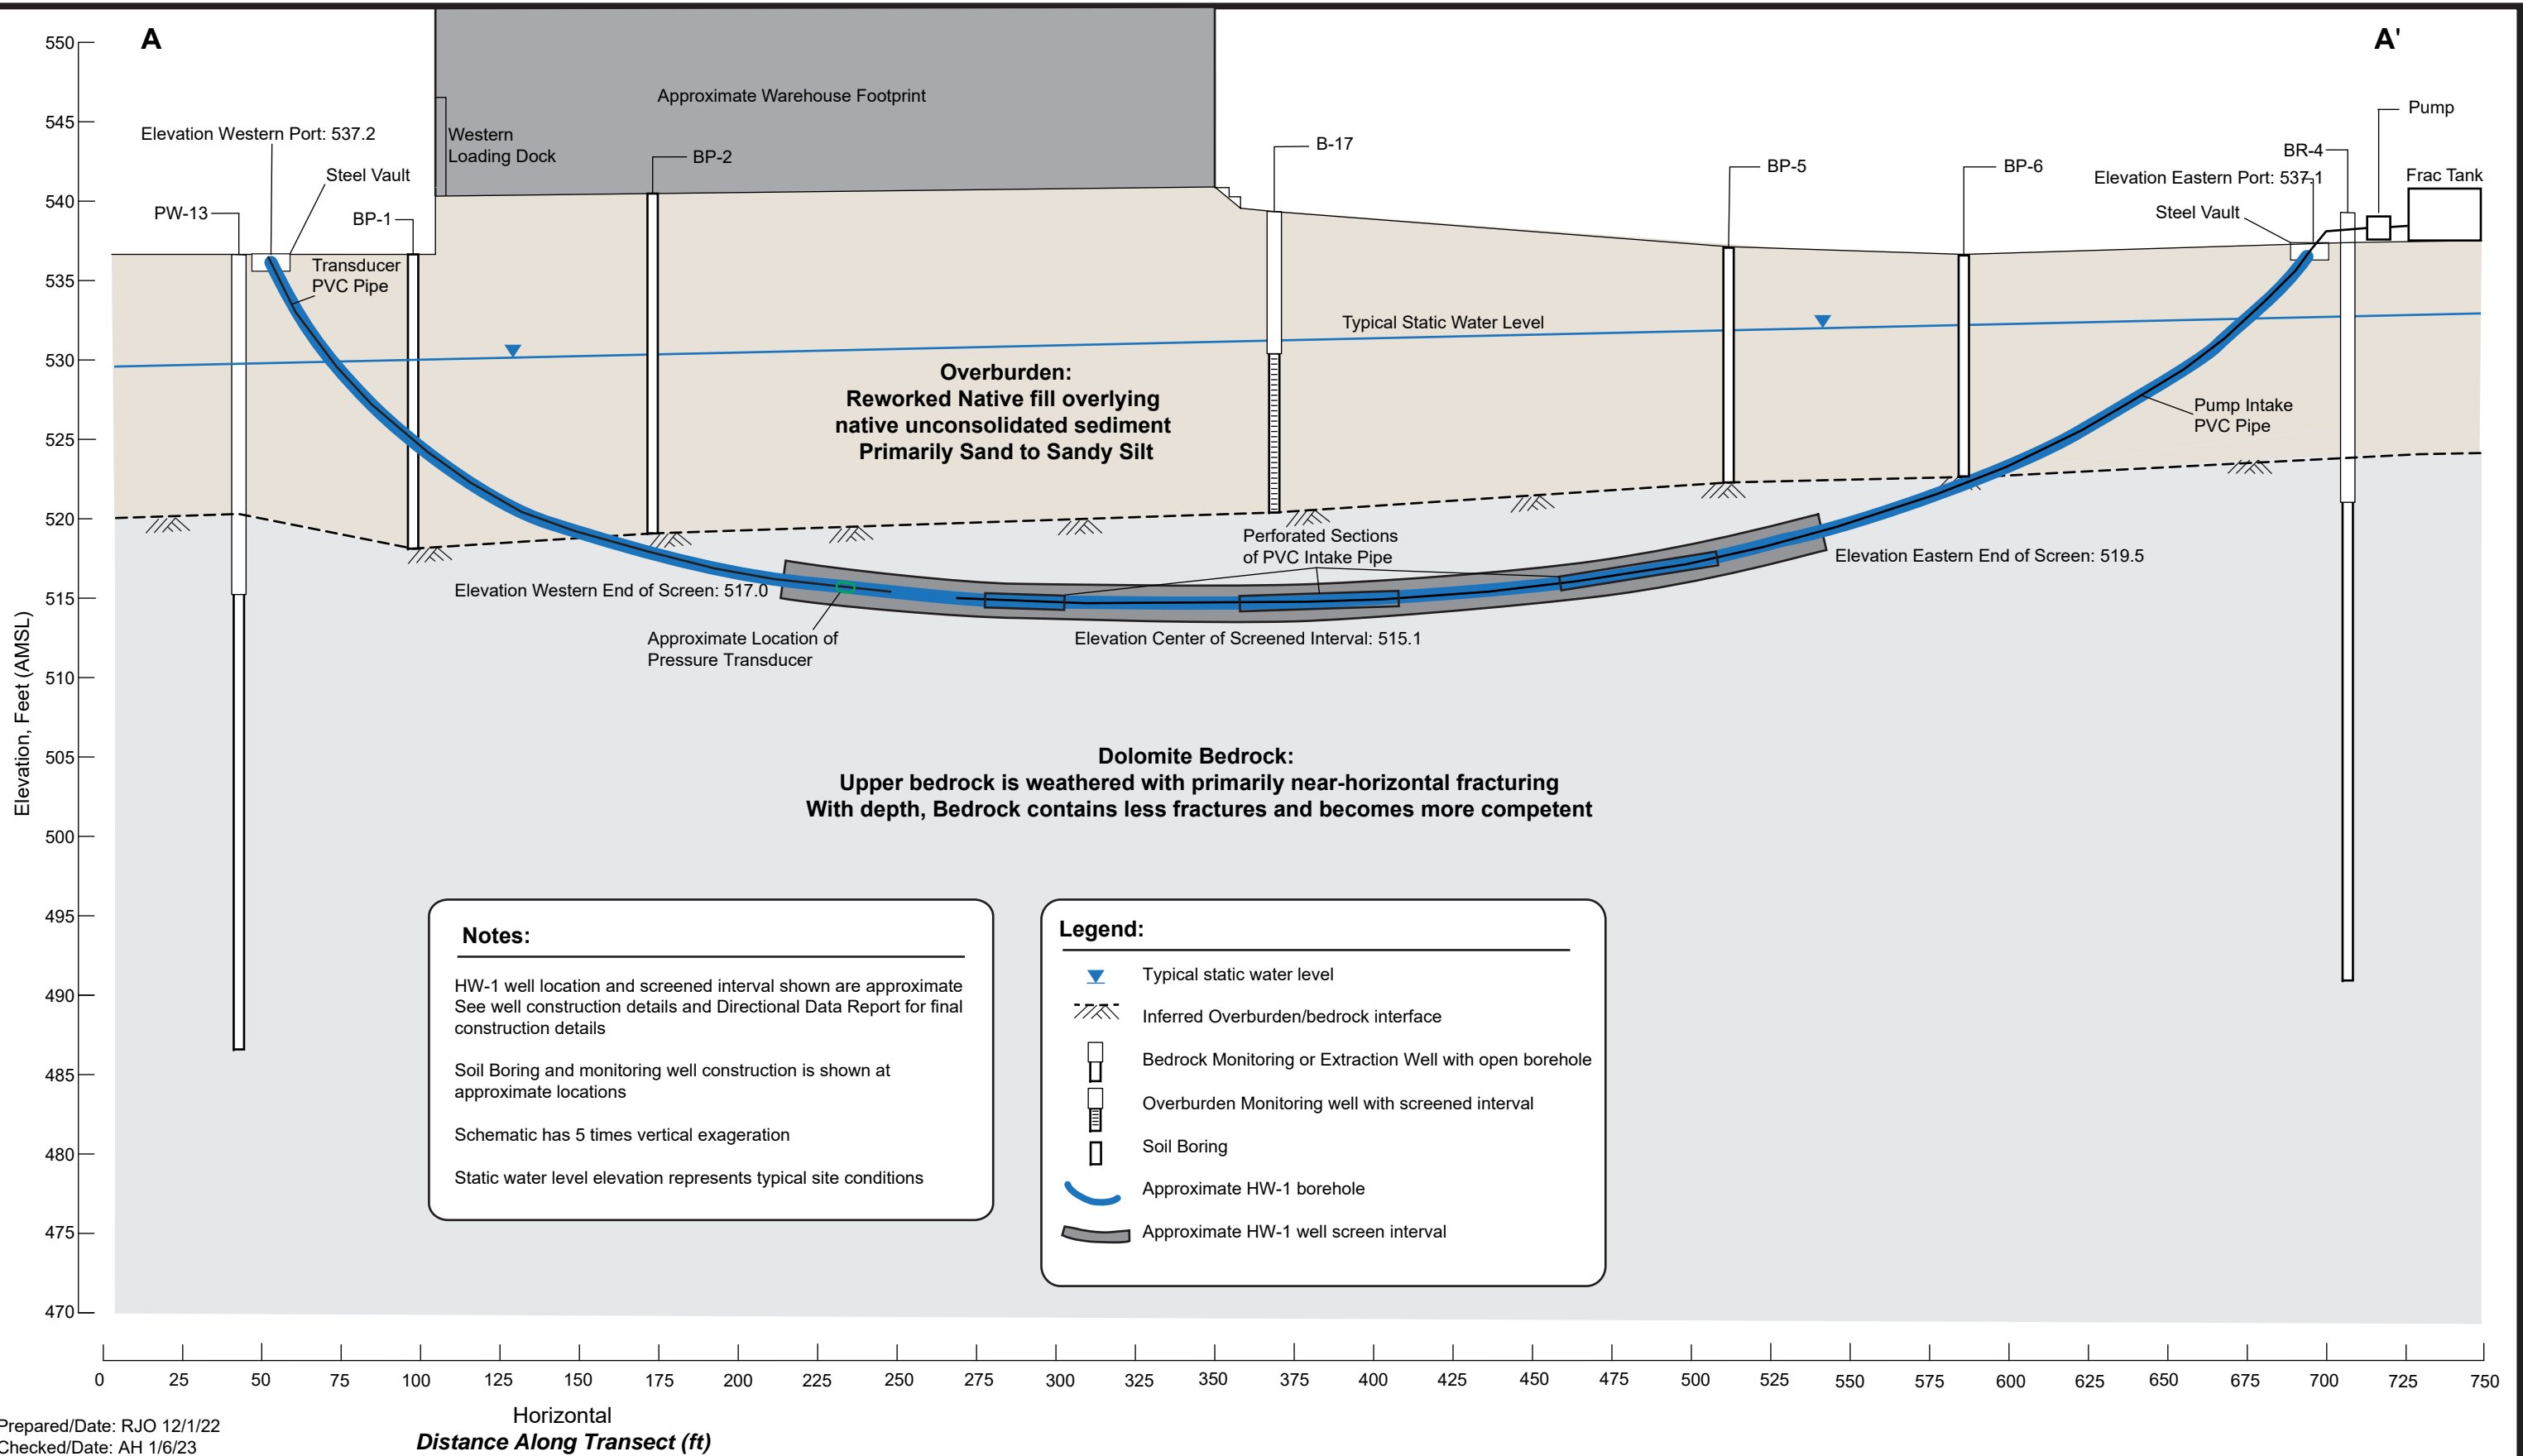
Figure 5: HW-1 Pumping Test Setup
Horizontal Extraction Well HW-1 Installation and Completion Report
January 2023

The VRT was completed on December 15th, 2021. The test was completed using portable, gasoline powered centrifugal (transfer) pumps. Initially, a transfer pump with a two-inch intake was used however, to obtain pumping rates greater than 25 gpm, a larger transfer pump with a three-inch intake was used. An approximate 450 foot long, 1.5inch diameter PVC intake pipe was installed from the eastern port of HW-1 with three separate, five-to-ten-foot perforated intervals along the length of the screen. The perforated intervals were designed to draw water from each third of the well screen. The perforations were sized and spaced to approximate a 0.030" screen slot size to exceed the 0.020" screen slot size of the borehole well screen. The western end of the intake pipe was capped to ensure water was drawn from the perforated intervals. The eastern end of the intake pipe was plumbed to a centrifugal pump staged near the port hole for HW-1. The discharge from the pump was contained within an on-site frac tank staged near the eastern port.

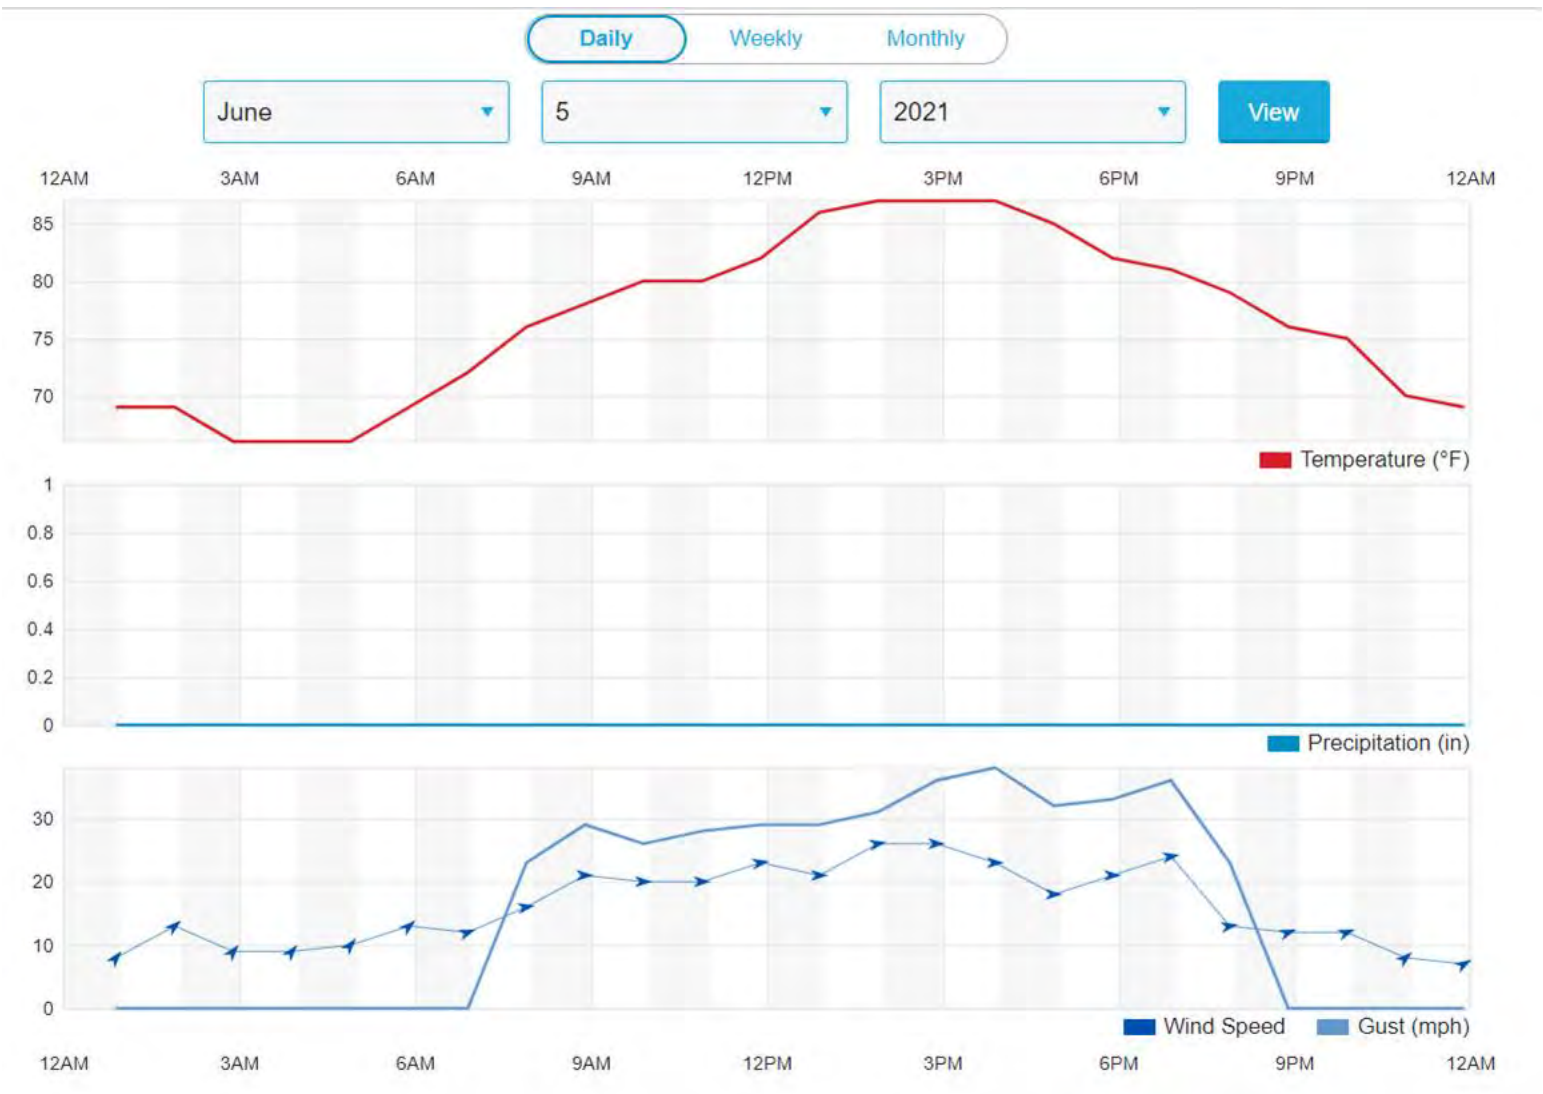
ARCH Chemical HW-1 Dust Monitoring - 6/05/21

The CAMP was set up and run from 0830 – 1730. No exceedances of dust action limits were noted. Down wind PID and work area PID did not register readings through out the day. Attached is a graph of the upwind and downwind dust monitors. Down wind was positioned to the North of the drilling area, up wind was positioned in the South of the drilling area. It should be noted that the majority of dust readings were likely directly associated with traffic on the road and not from drilling activities.

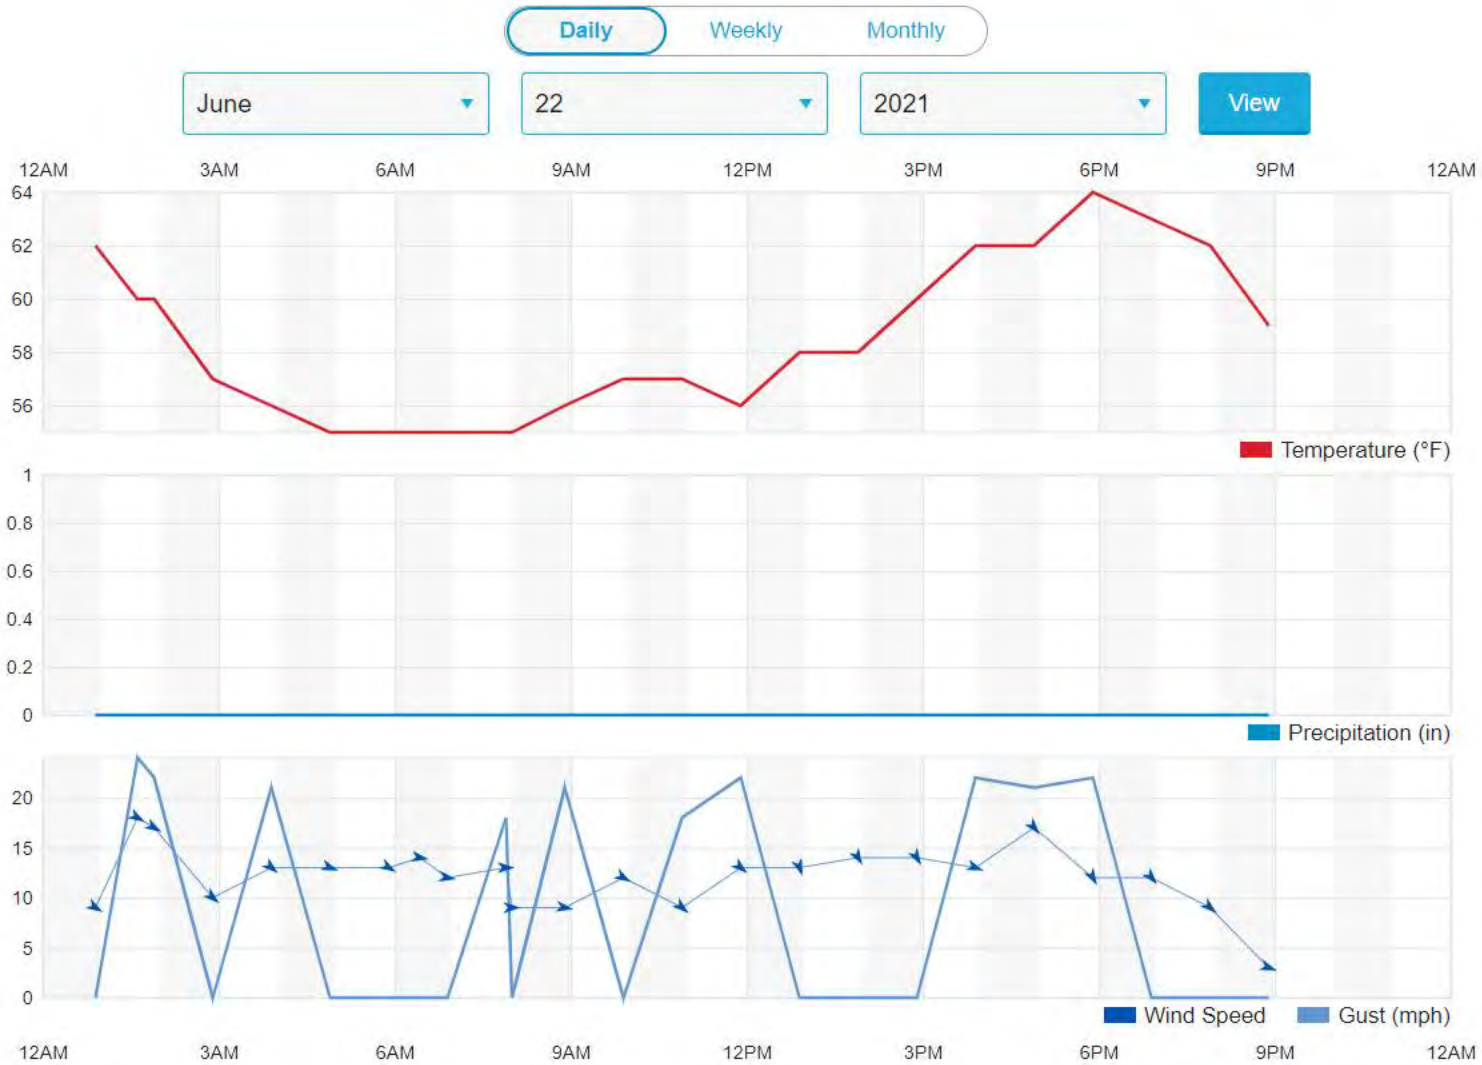
062221

The CAMP was set up and run from 0700 – 1835. Downwind PID and work area PID did not register readings throughout the day. The PID picked up low level 0.1 ppm at the mud recycler while drilling today, otherwise all readings were non detect. Attached is a graph of the upwind and downwind dust monitors. Downwind was positioned to the North East of the drilling area, up wind was positioned in the South West of the drilling area. The wind today was generally from the north west through the day. Wind speed picked up in the afternoon and some dust clouds were observed from the unpaved areas of the site moving into the work area. No dust was observed to be generated from drilling activities. Note the down wind location was down today between 9 am and 10 am because of a power connection issue. This was resolved and monitoring continued through out the day.

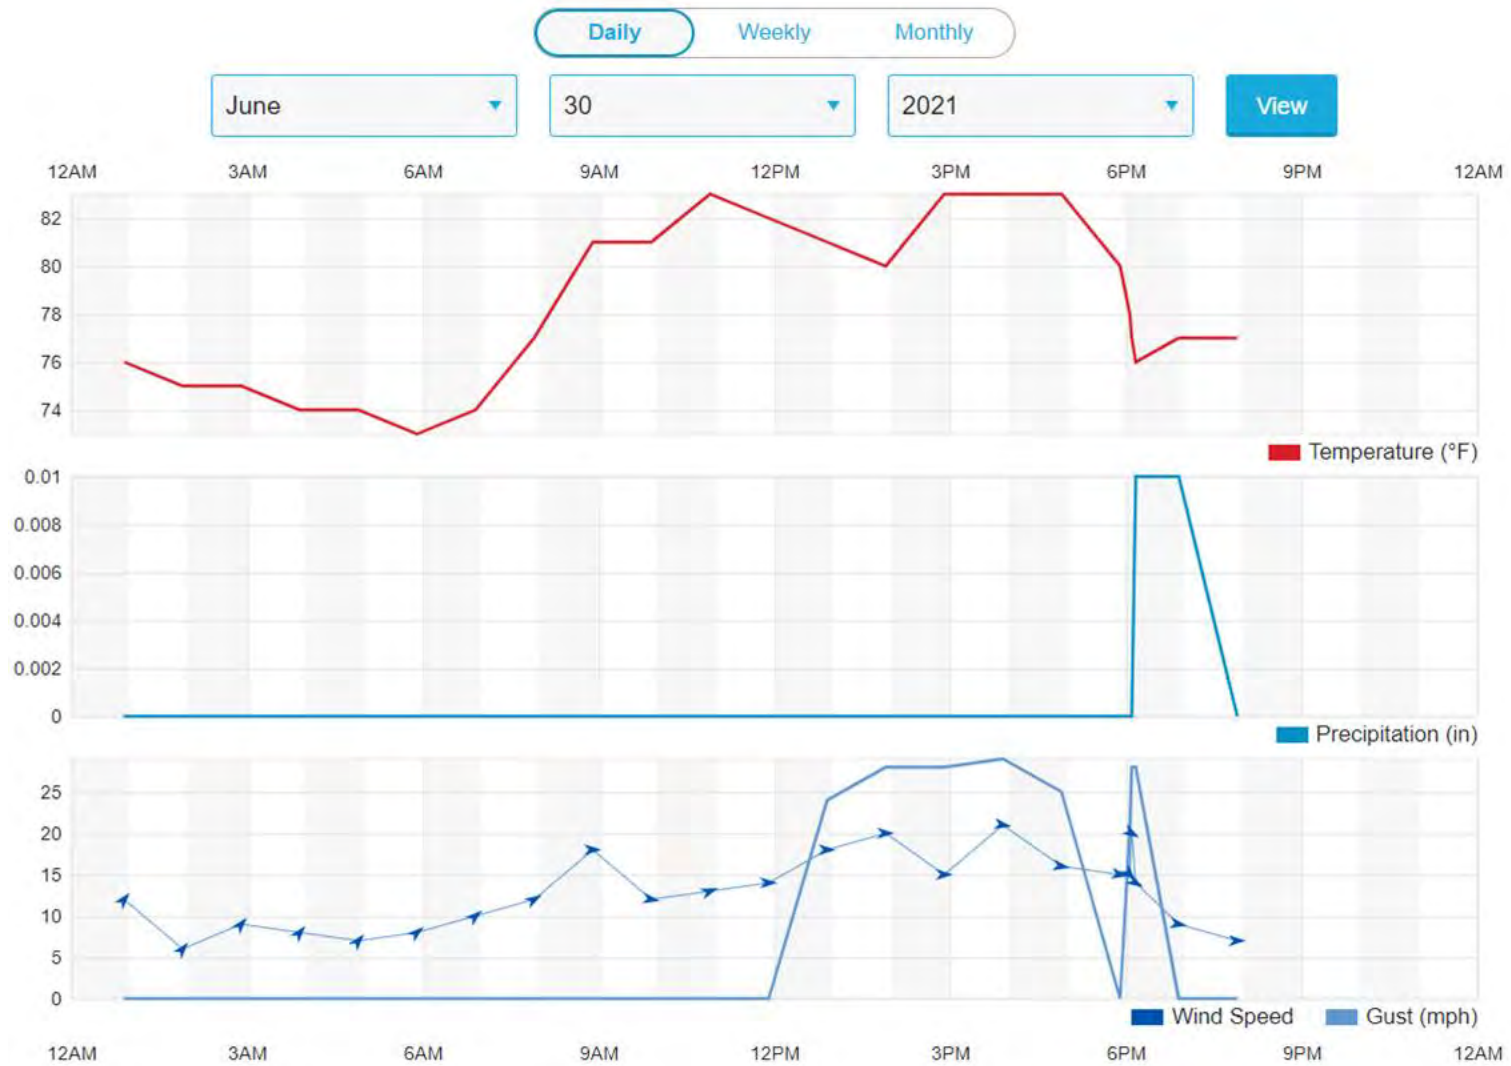
HW-1 06/30/21

The CAMP was operated throughout the day and dust clouds could be observed moving across the site moving from South West to North East. No dust was generated by drilling activities. PIDs were used to continuously monitoring for vapors at the mud recycling plant and both entry pits. Highest concentrations observed was 1.5 ppm at the mud recycling plant. Graph of dust is attached for reference.

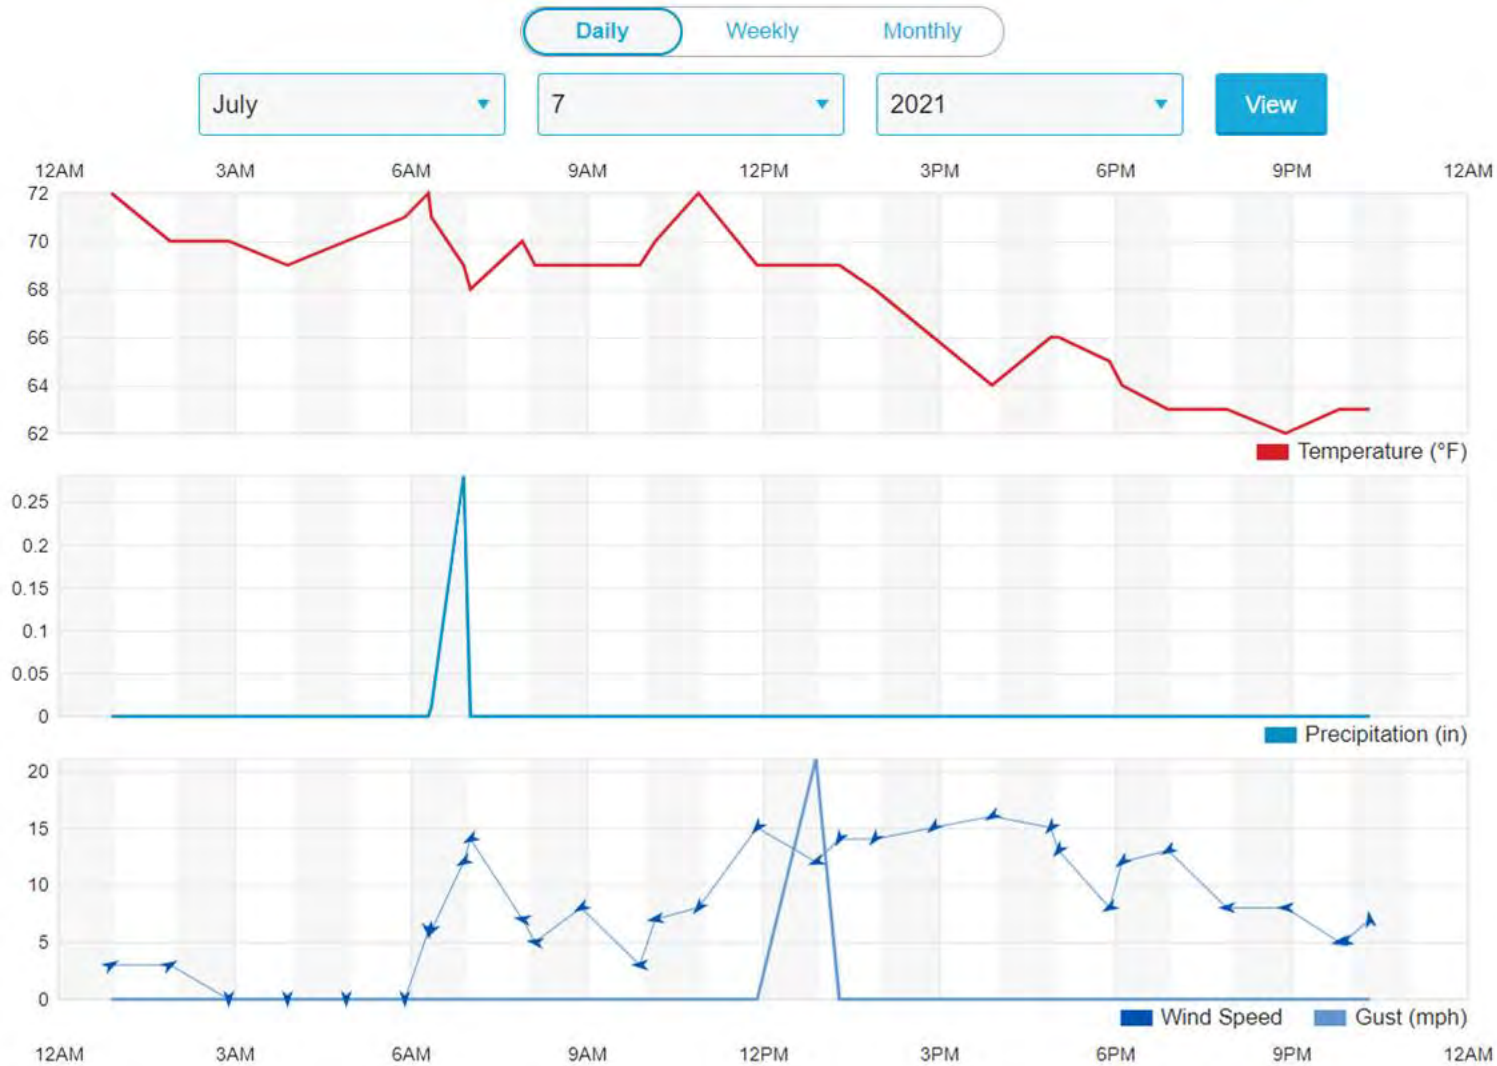
The CAMP was activated throughout the day with continuous monitoring for vapors at the mud pit and mud recycling plant. The highest observed readings at the mud recycling plant was 1.0 ppm in the breathing space and 3.5 ppm directly over the recycling tank. No elevated readings were observed at the mud pit. Dust monitors were active starting at 10:30 after passing showers during the morning. A graph of the upwind and downwind results are attached. Wind was predominantly from the NE – SW (weather data below). It should be noted that the dust monitoring located down wind of the drilling plant identified elevated levels while the mud plant was in operation. However, downwind PM-10 particulate levels not in exceedance of 0.15 mg/m³ of the up wind monitoring station.

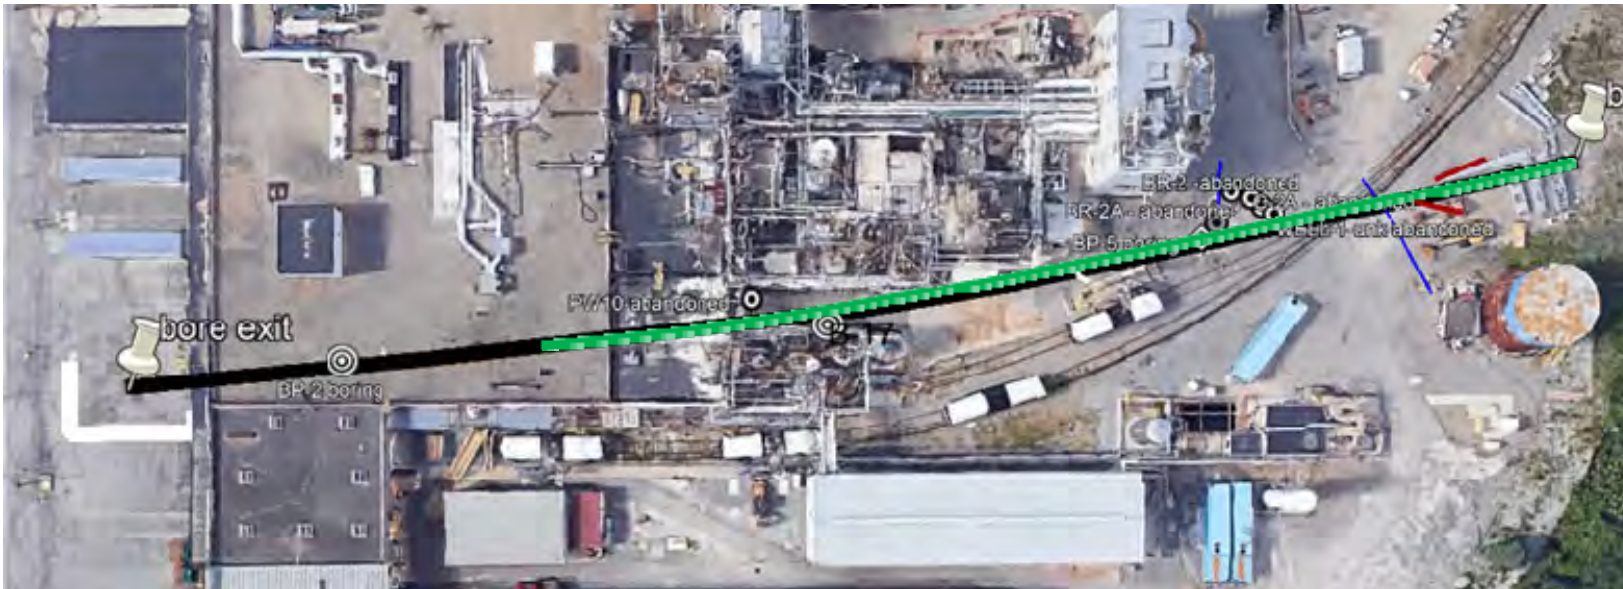
Please see the attached filed reports for 7/26. The reaming pass continued towards the west exit pit for a total of ~100 feet of progress. Drill mud returns are being discharged into both the entry and exit pits of the borehole requiring Ellingson to recover mud from the exit pit using the vac trailer and water truck and move it back to the mud recycling plant. Reaming progress is represented by the green line below.

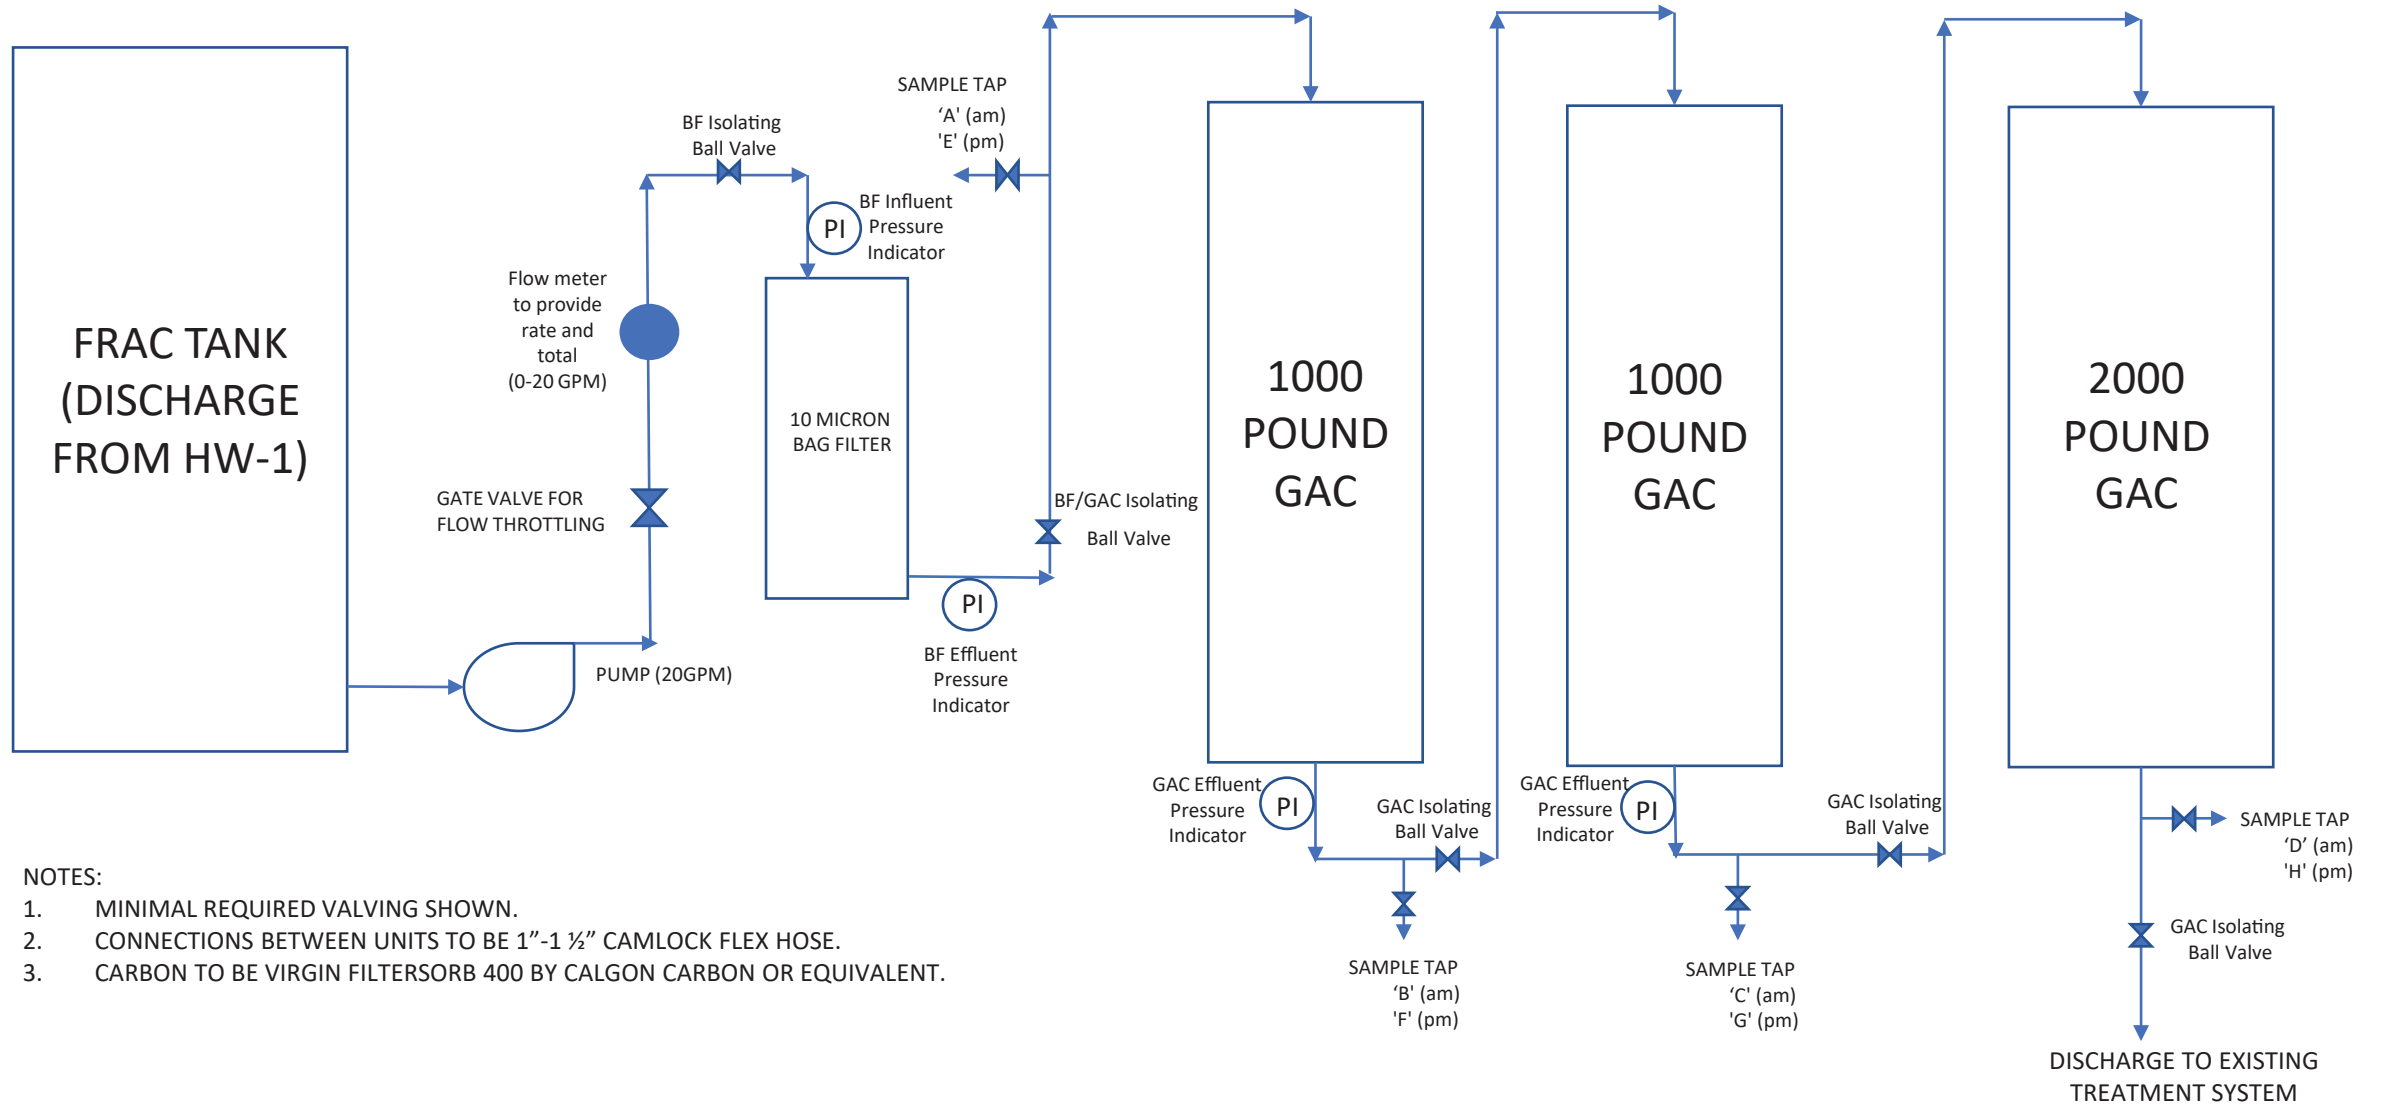
ARCH GAC FLOW SCHEMATIC

1. MINIMAL REQUIRED VALVING SHOWN.
2. CONNECTIONS BETWEEN UNITS TO BE 1"-1 1/2" CAMLOCK FLEX HOSE.
3. CARBON TO BE VIRGIN FILTERSORB 400 BY CALGON CARBON OR EQUIVALENT.

The test results from the CRT effluent show treatment of discharge water using GAC remains as an option for long term operation for HW-1. However, given the concentrations and expected usage rates, a pilot test treatment operation is recommended for a period of at least 2 months. This pilot test would be planned to monitor longer term usage rates for GAC as well monitor the effects on the VOC and chloropyridine plumes with periodic groundwater sampling. It's recommended that the six operating extraction wells be shut down during the pilot test period while HW-1 is operating.
