**Period Review Report
Golden Road Disposal Site
NYSDEC Site Number 828021
Town of Chili, Monroe County, New York**

March 2024
Version: FINAL
EA Project No. 1602523.07

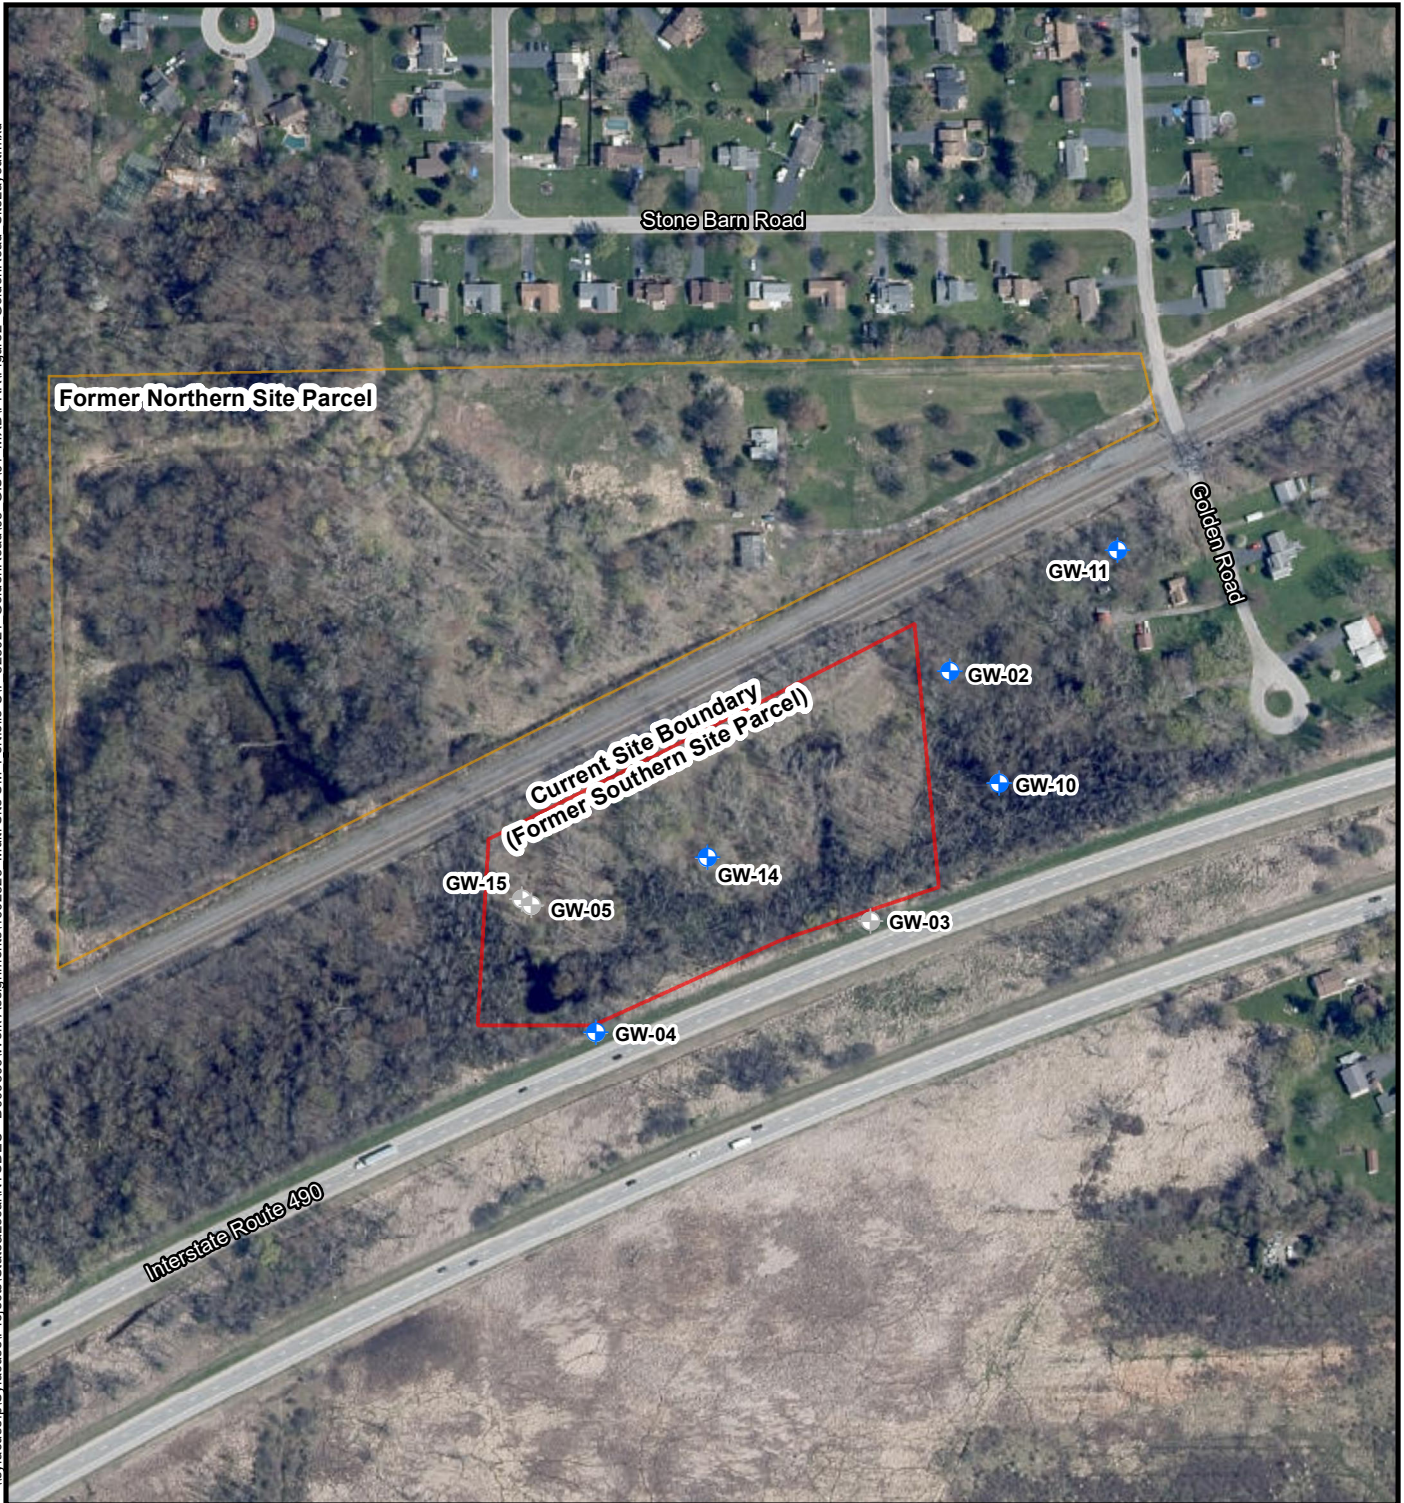
Figure 2
SITE LAYOUT
Golden Road Disposal Site (828021)
Rochester, New York

Formerly, the Site also included a 12-acre northern parcel located to the north of the current Site boundaries (**Figure 2**). The north parcel is generally flat with building structures. It was bounded by residences to the north and east, railroad tracks to the south, and a wooded area to the west. This parcel was remediated previously and removed from the site description after the ROD (NYSDEC 2002) found that no consequential amounts of hazardous waste were identified on the north parcel. Therefore, the north parcel is not included in this PRR.

A map of the site layout and monitoring wells is presented on **Figure 2**. Daily field reports, field logs, and Site Inspection Reports are provided in **Appendix B, C, and D**, respectively.

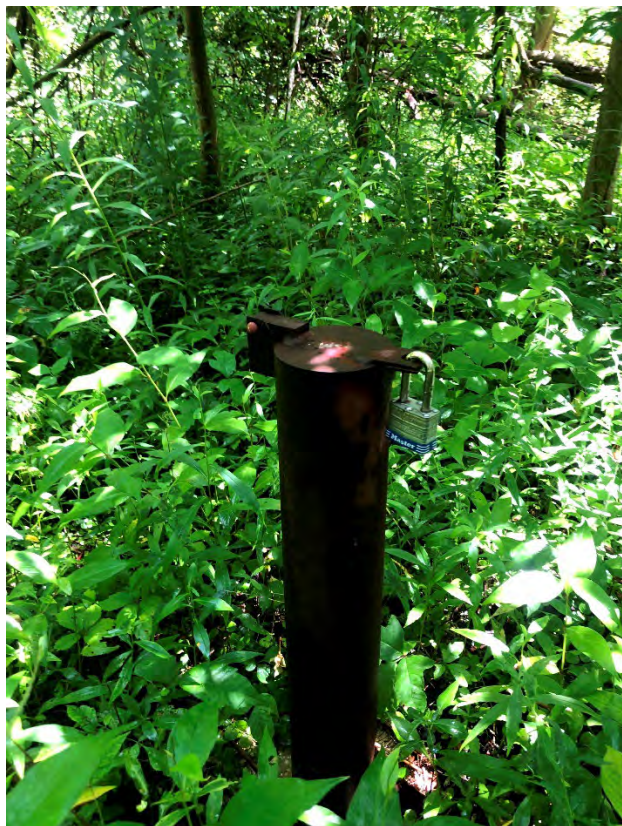
Looking West down the access road	Approximate location of GW-14, which could not be found

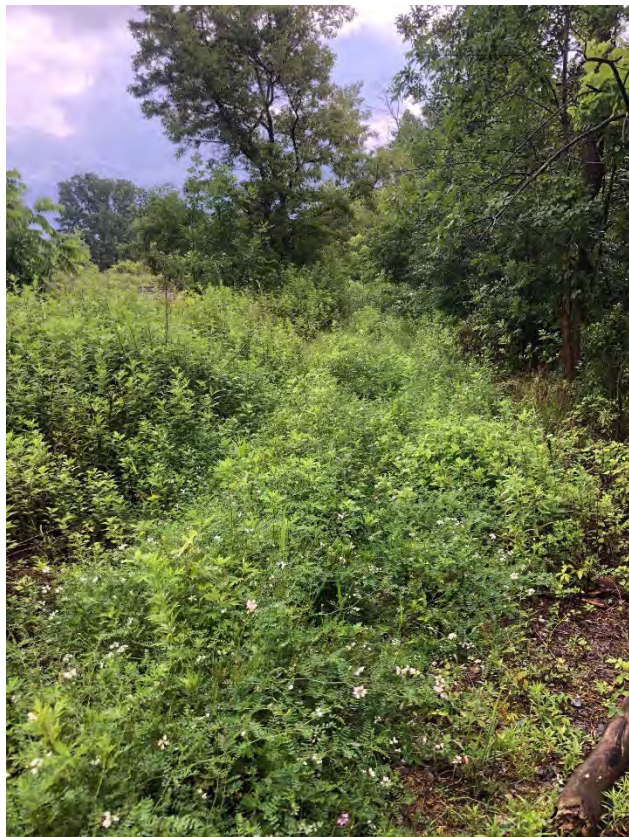
Approximate location of GW-10, which couldn't be found

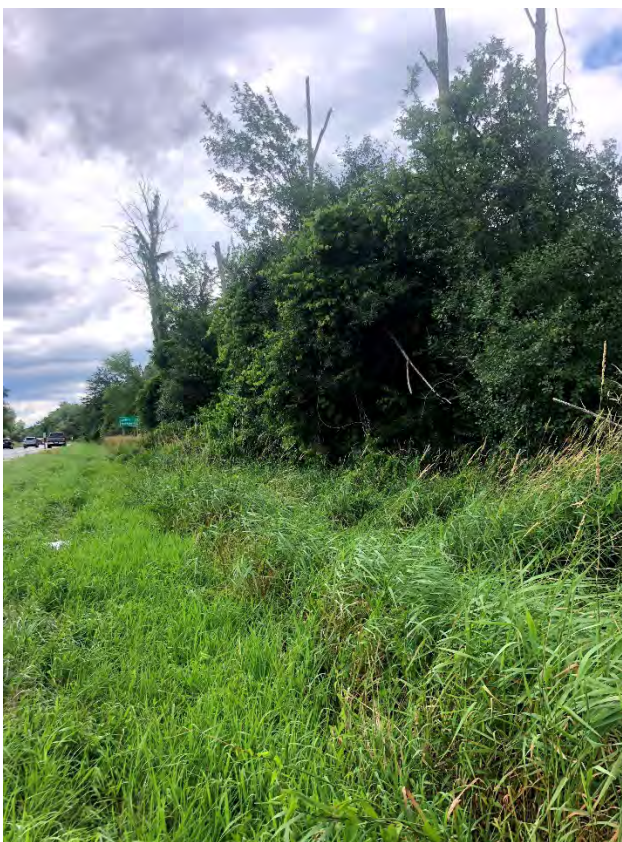
Looking East down access road with approximate location of GW-11 to right side of photo in brush, which couldn't be located.

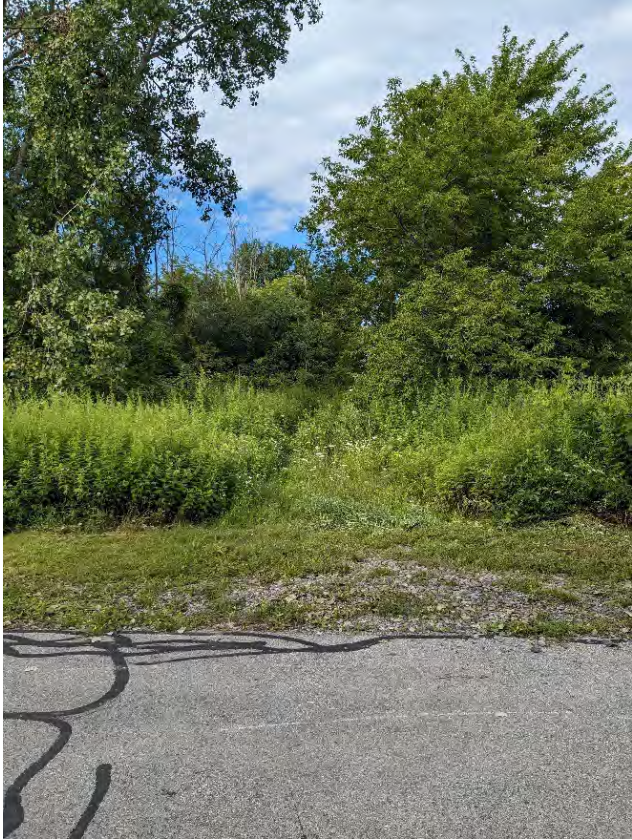
Access road (looking WSW from Golden Rd).	Overgrowth along access road (facing WSW).

Lots of trash/ waste on site. The site is extremely overgrown with vegetations and there are several obstructions such as fallen trees and metal scraps in the brush. The access road is usable on foot, but a vehicle would have a hard time. GW-10, GW-15 and GW-03 are damaged.

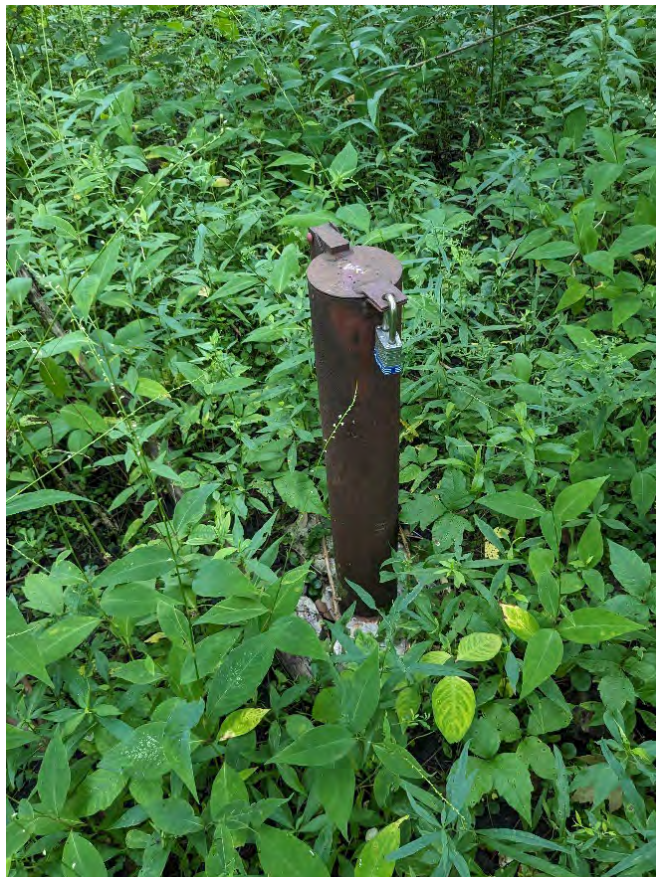
Approximate location of GW-10, which couldn't be found

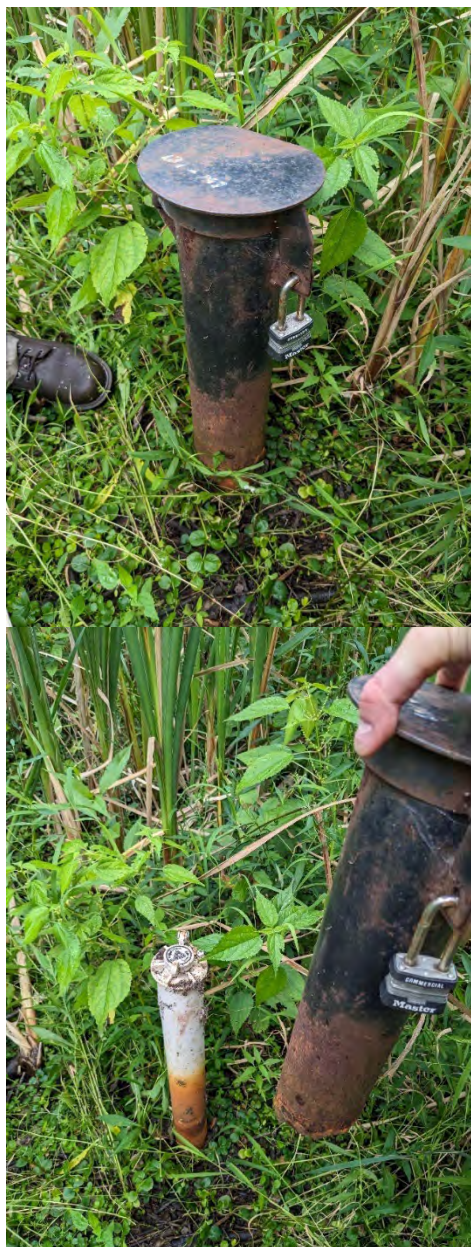
GW-10

(1110) EA locates GW-10. Steel casing
is damaged. → can be removed
from around PUC.

- An evaluation of remaining contamination in surface soil and surface sediment should be performed. Surface soil and surface sediment samples may be collected as part of the evaluation to confirm current conditions. Based on the results of this evaluation, the site may potentially be delisted or reclassified from Class 4 to Class C (Completed).
- Abandonment of site monitoring wells (including those that are damaged).

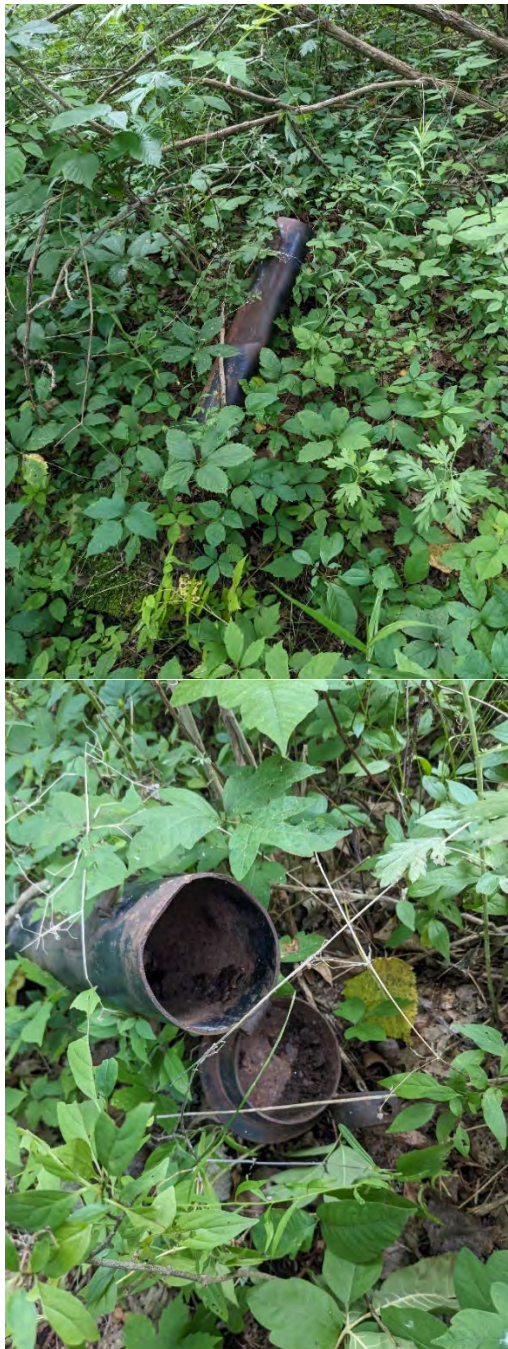
(1210) EA locates GW-15 → damaged
casing, bent horizontal to ground.
EA unable to locate GW-05
which should have been adjacent
to GW-15.

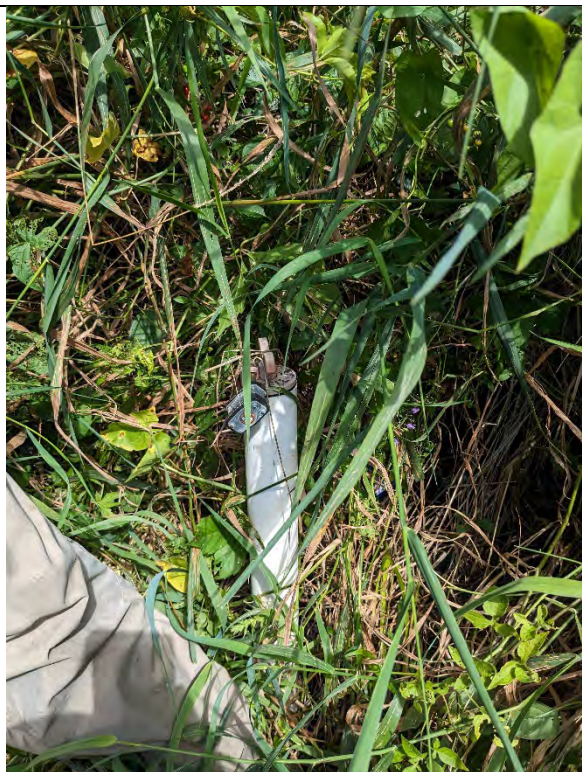
4 Groundwater Monitoring Well Conditions			
Well Casings	<input checked="" type="checkbox"/>	<input checked="" type="checkbox"/>	GW-10 + GW-15 need repairs
Well Locks	<input checked="" type="checkbox"/>	<input type="checkbox"/>	
5 Wetlands			
General Conditions	<input checked="" type="checkbox"/>	<input type="checkbox"/>	
Vegetation	<input checked="" type="checkbox"/>	<input type="checkbox"/>	
Water Levels	<input checked="" type="checkbox"/>	<input type="checkbox"/>	
6 Others (list)			
GW-11 = Found, GW-2 = Found, GW-10 = Found - casing is removable			
GW-14 = Found, GW-15 = Found - damaged (on side), GW-04 = Found, no casing			
GW-03 = Found, damaged casing

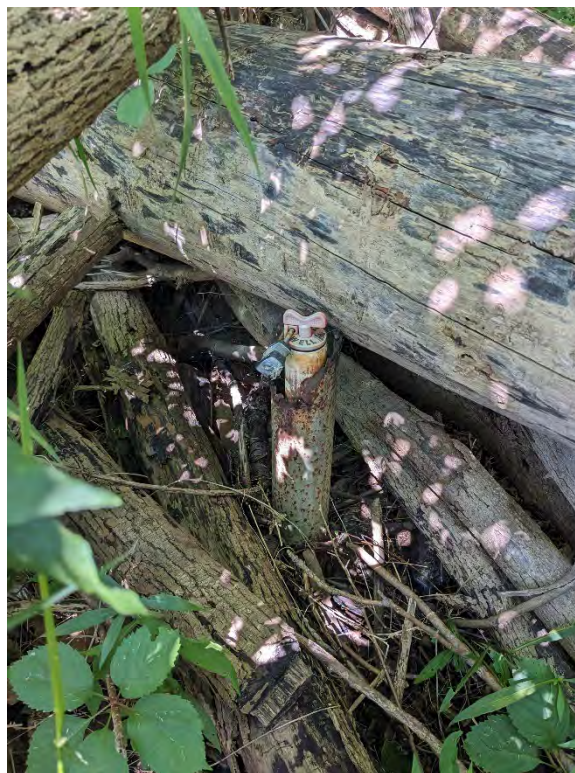
(1320) EA locates GW-03 (broken casing)

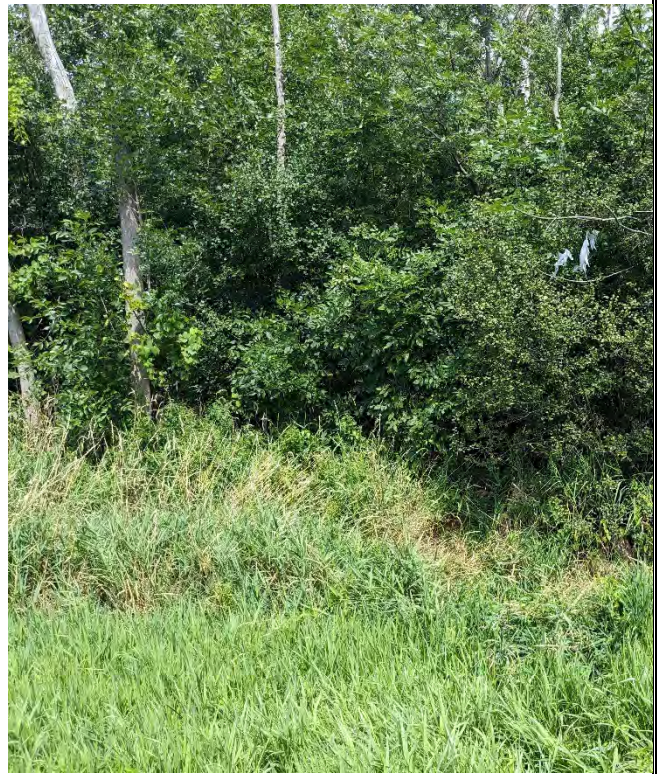
Location of GW-03 from the road.
