CONSTRUCTION CERTIFICATION REPORT

REMEDICATION OF THE  
SWEDEN 3-CHAPMAN SITE  
#8-28-040A

New York State Department of Environmental Conservation  
Region 8  
6274 East Avon-Lima Road  
Avon, New York 14414

July 2000

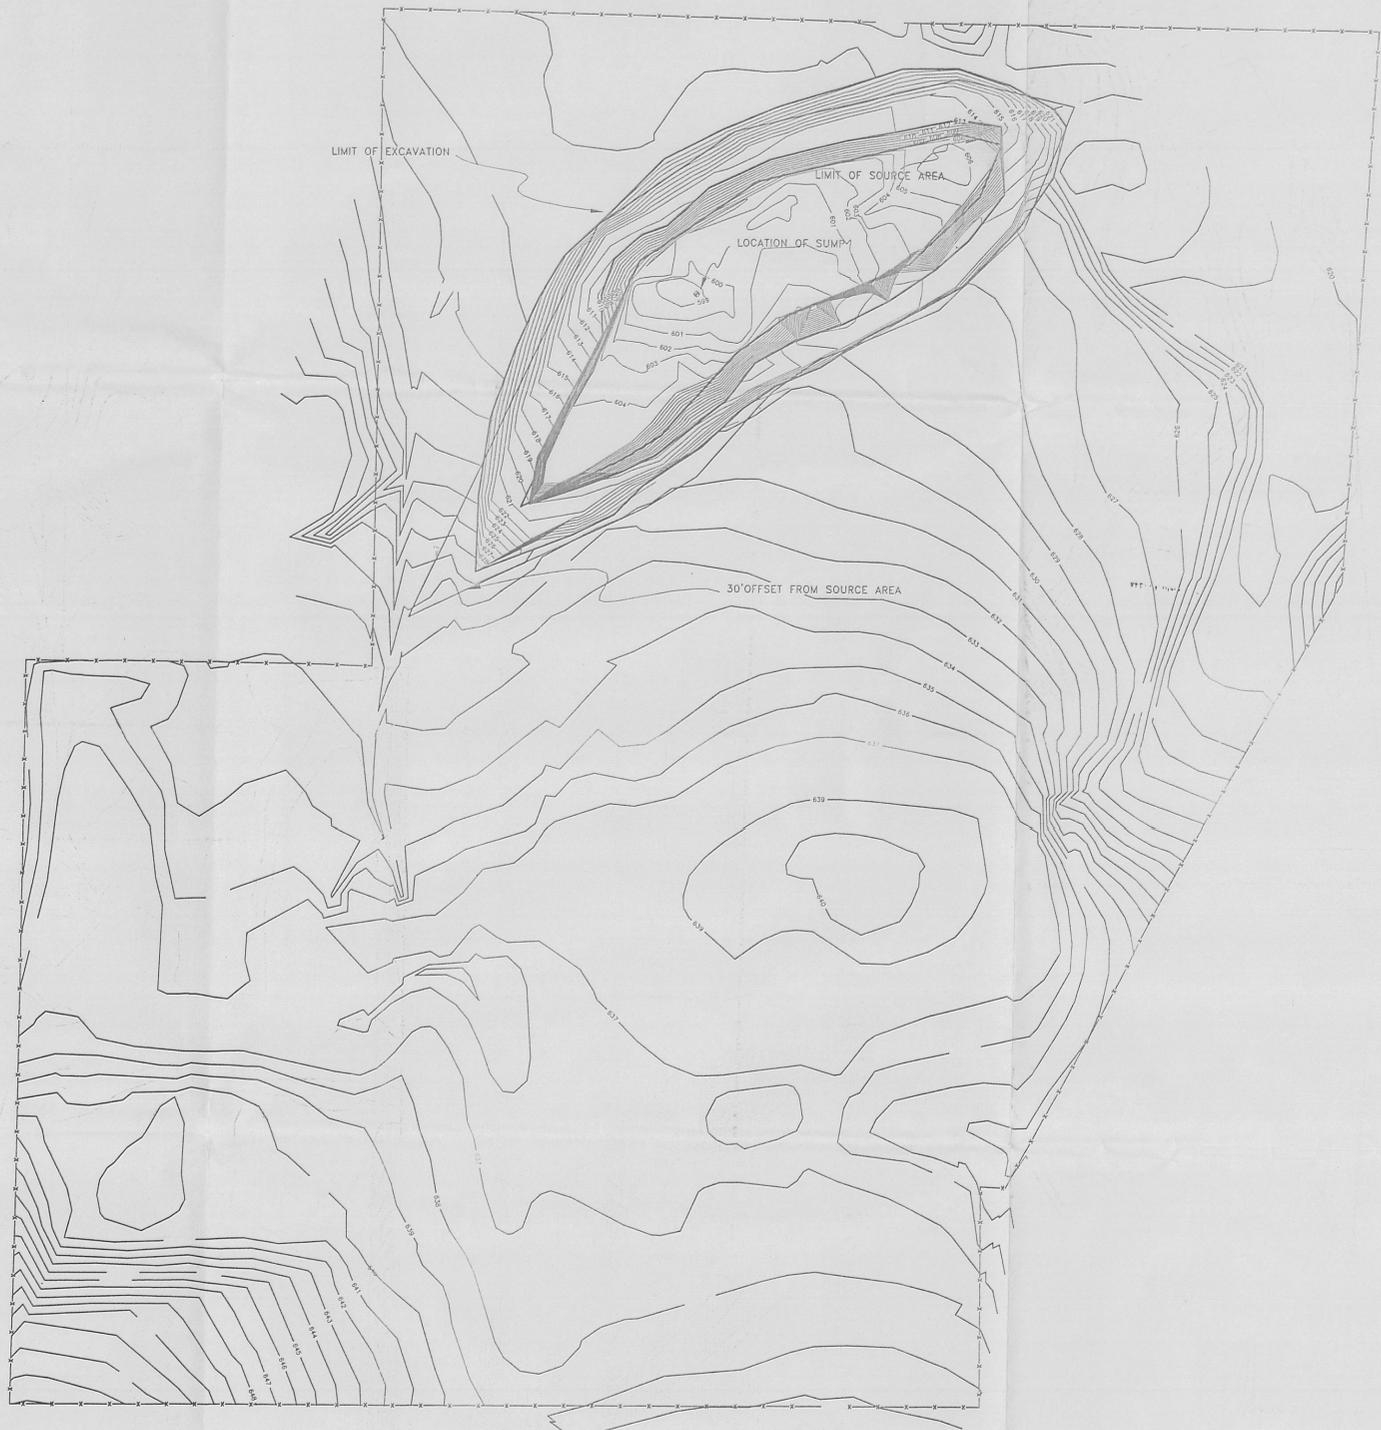
02-18-1999 Volume Report: Total fill removed around source area  
Lower left grid corner: 666571.59, 1153191.54  
Upper right grid corner: 666981.59, 1153511.54  
X grid resolution: 41, Y grid resolution: 32  
X grid cell size: 10.00, Y grid cell size: 10.00  
Cut volume: 247927 cubic ft, 9182 cubic yards

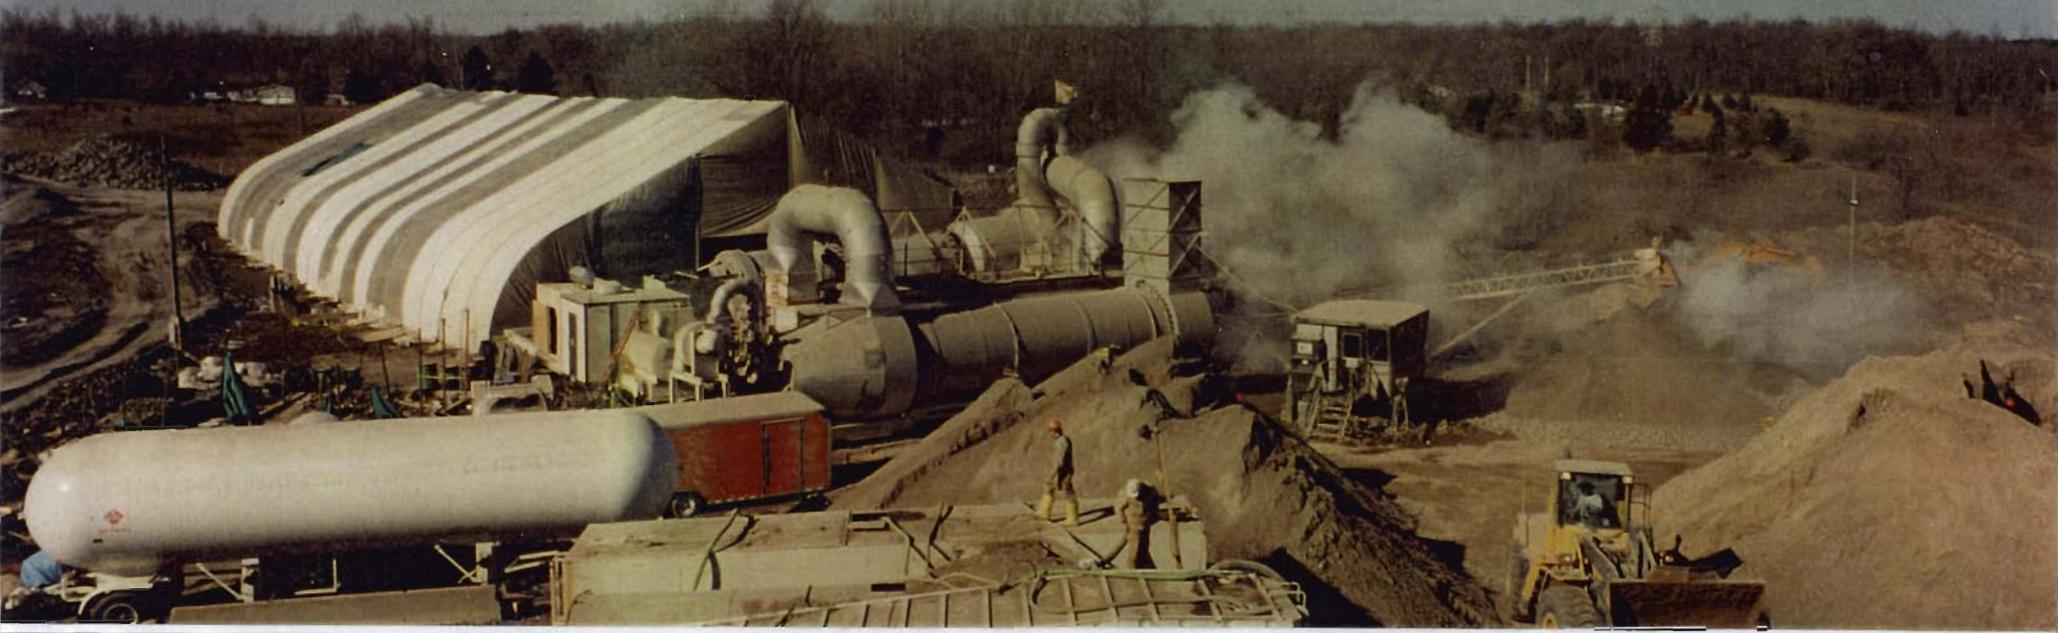
LTTD staging pad and the Feed Process Building ( looking west )

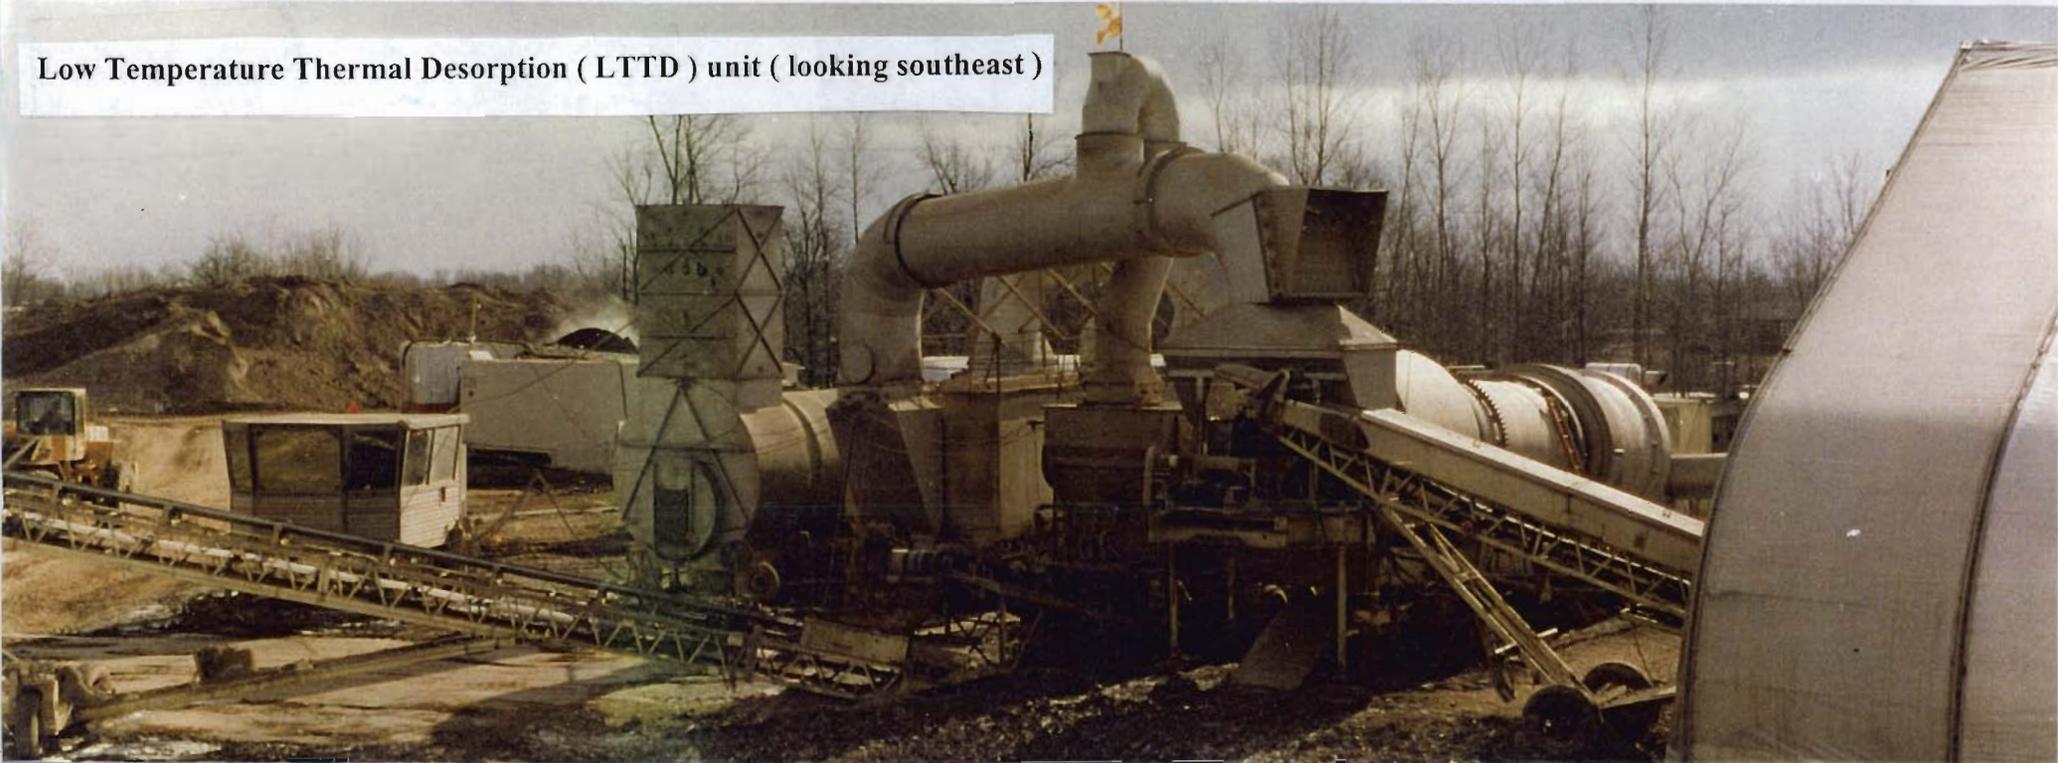
Low Temperature Thermal Desorption ( LTTD ) unit ( looking southeast )

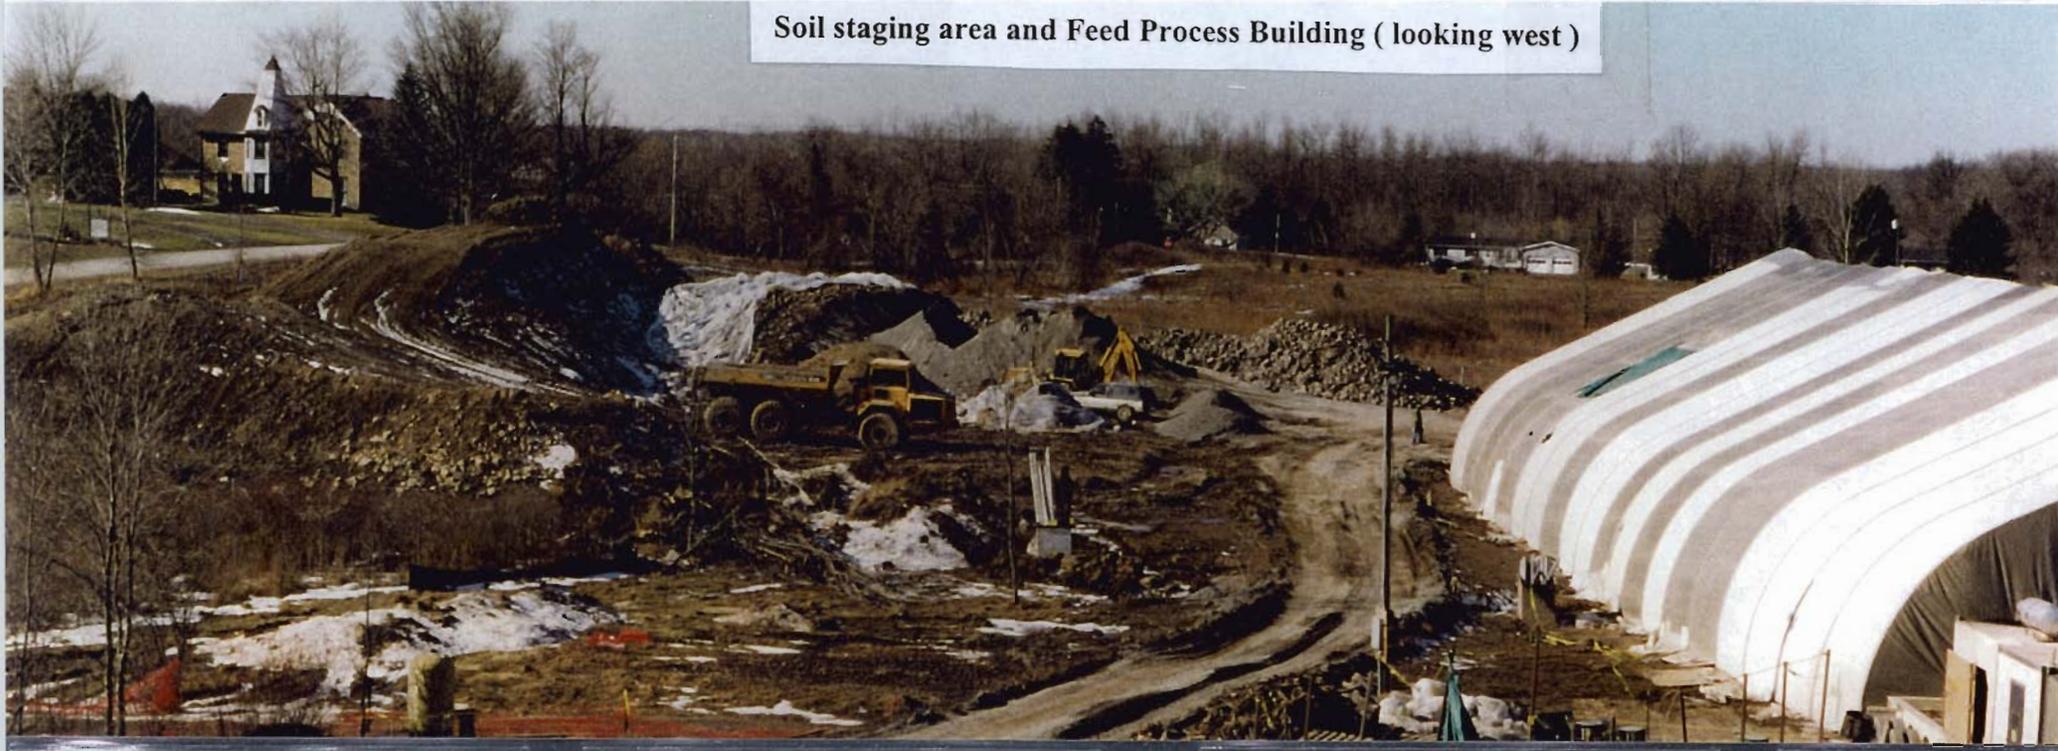
Soil staging area and Feed Process Building ( looking west )

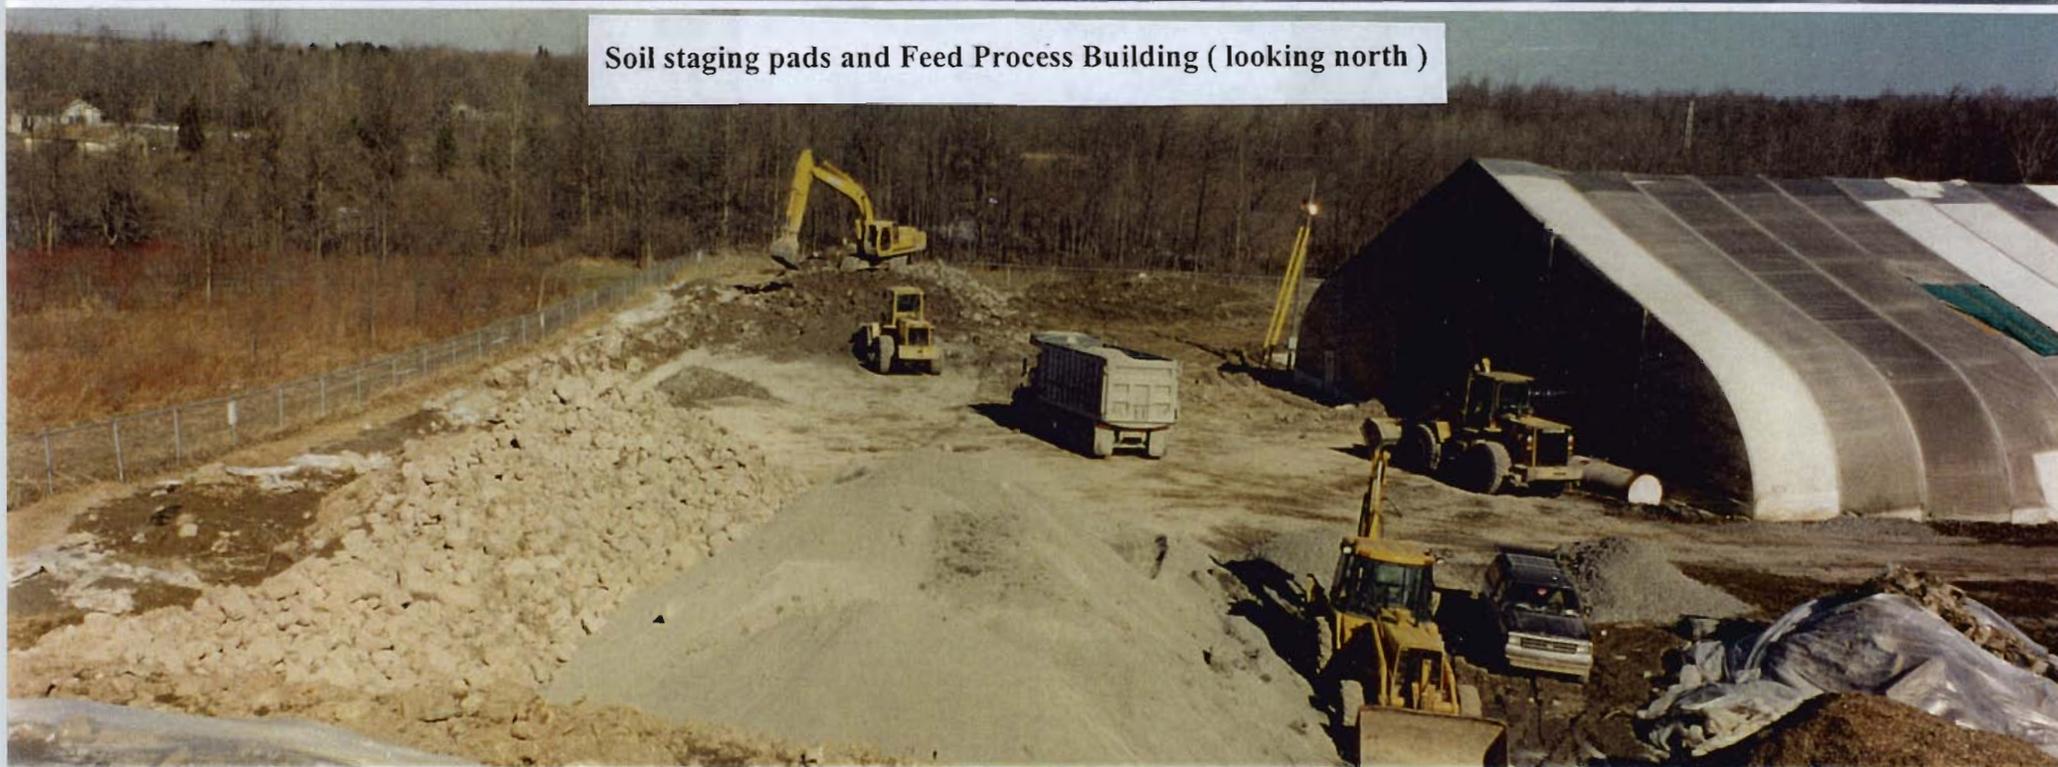
Soil staging pads and Feed Process Building ( looking north )

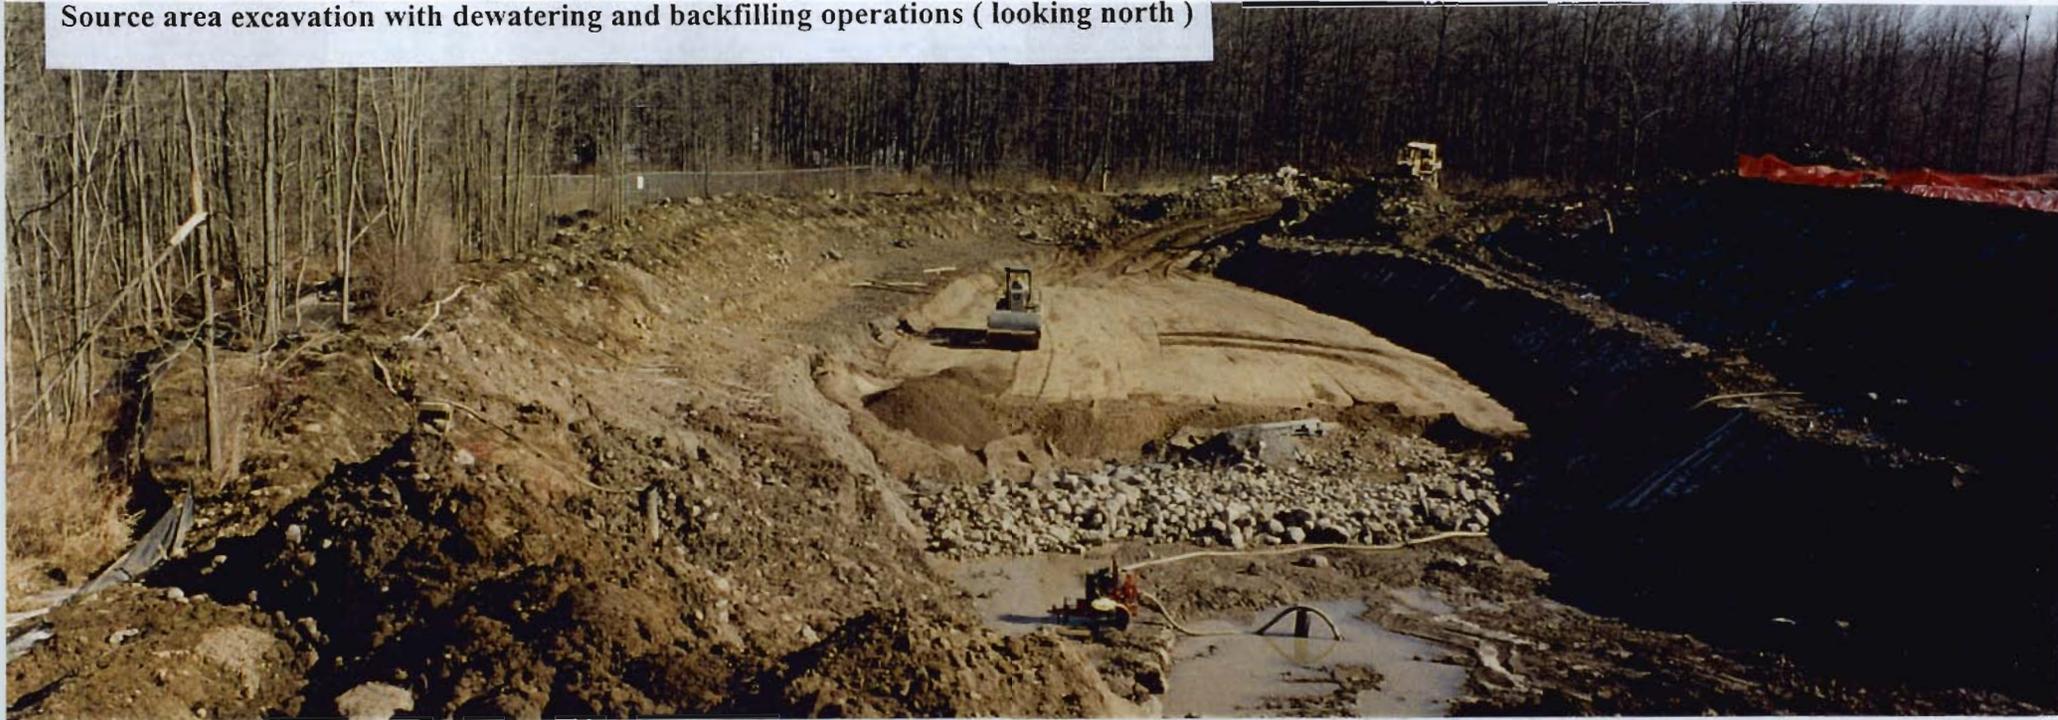
Source area excavation with dewatering and backfilling operations ( looking north )

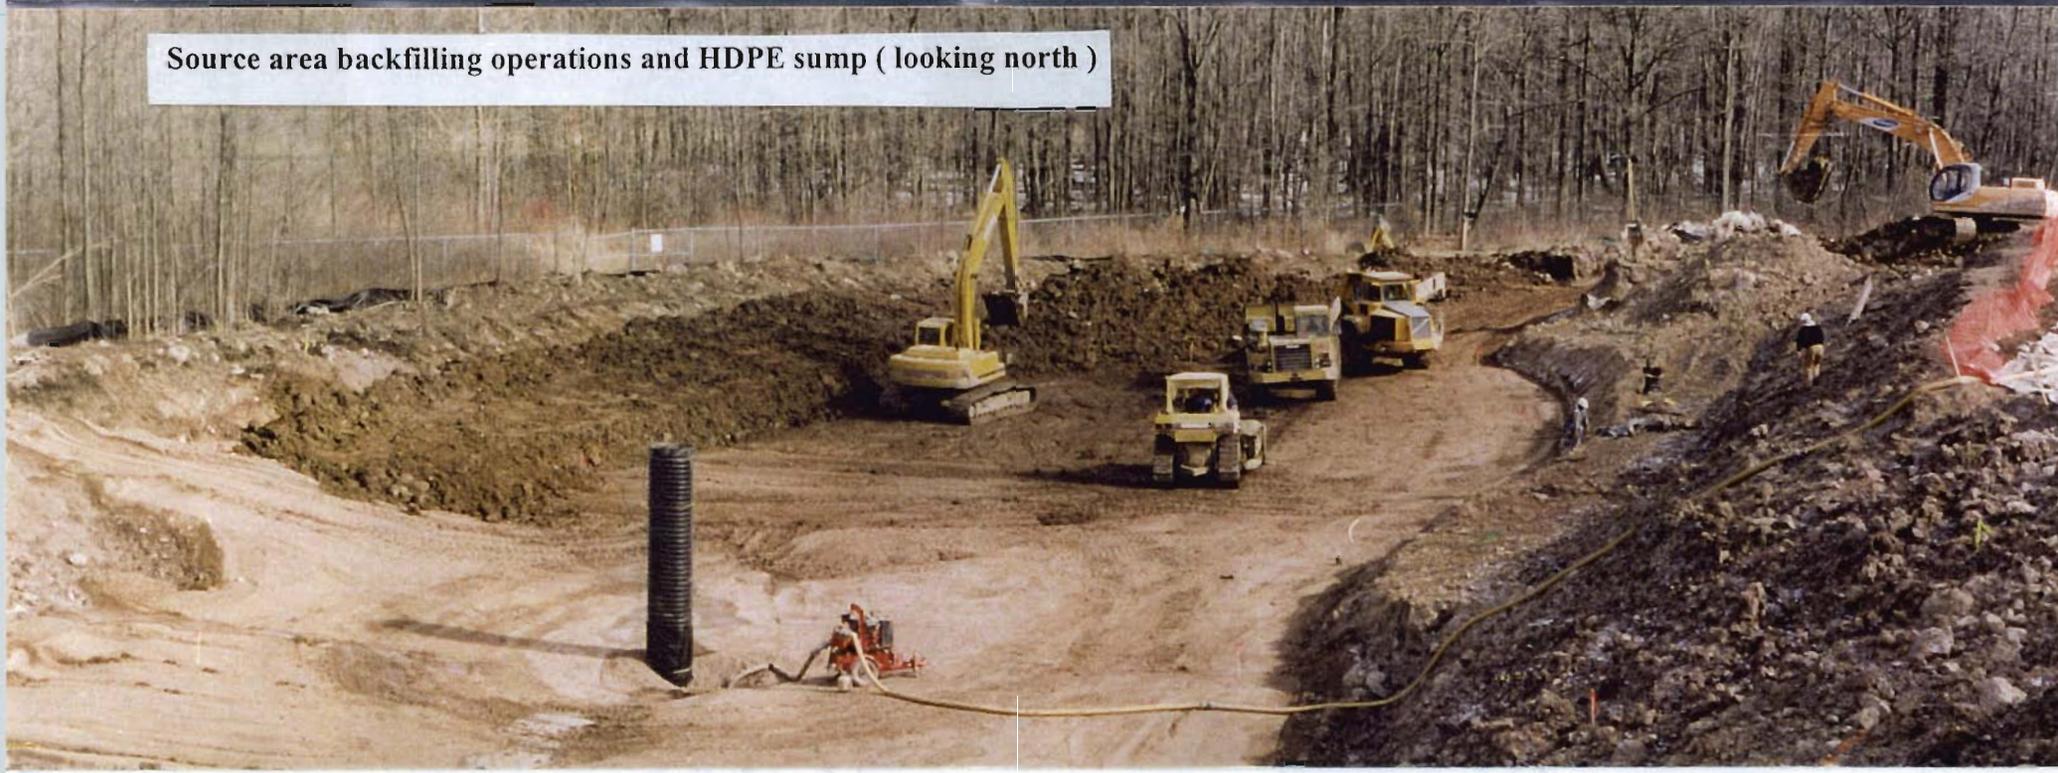
Source area backfilling operations and HDPE sump ( looking north )

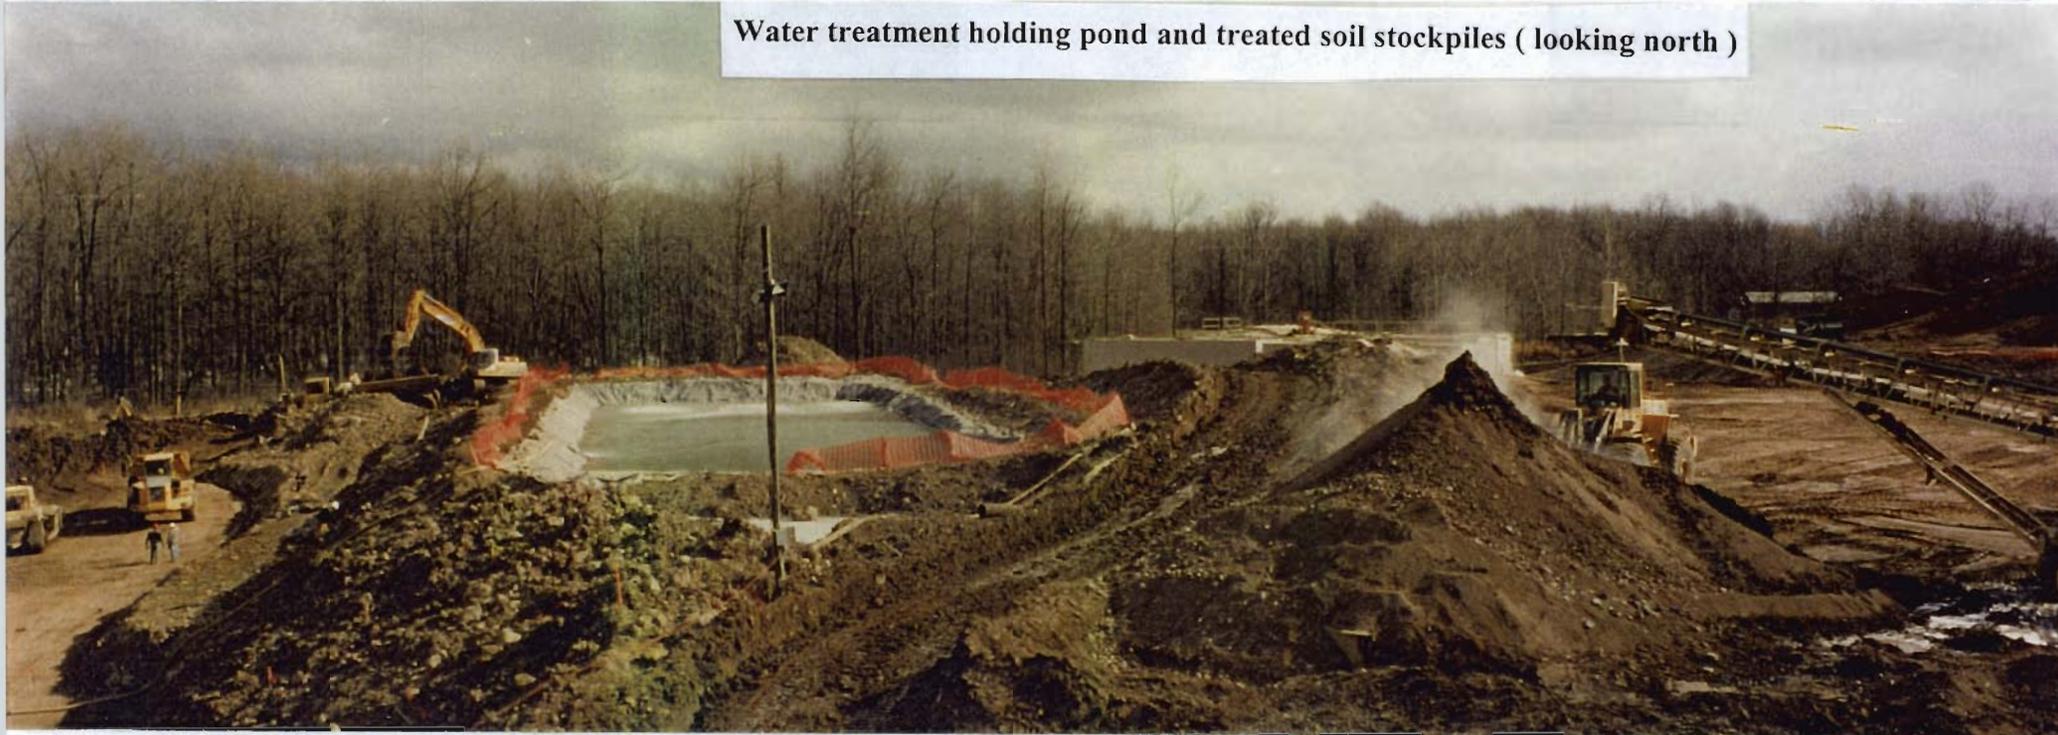
Water treatment holding pond and treated soil stockpiles ( looking north )

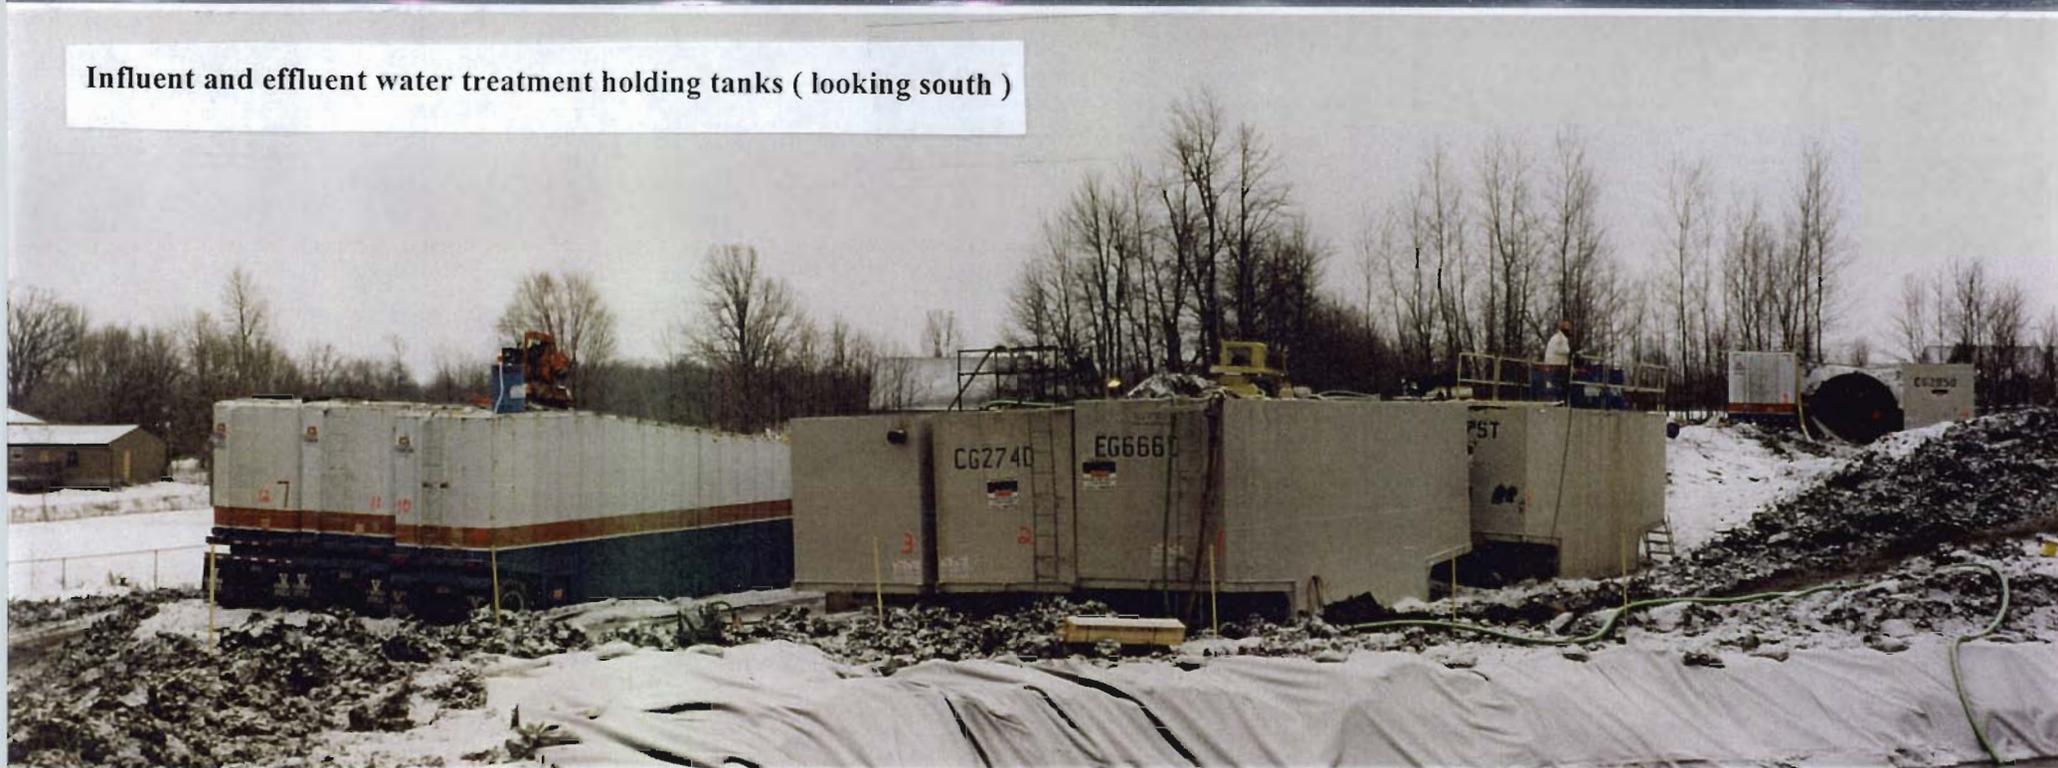
Influent and effluent water treatment holding tanks ( looking south )

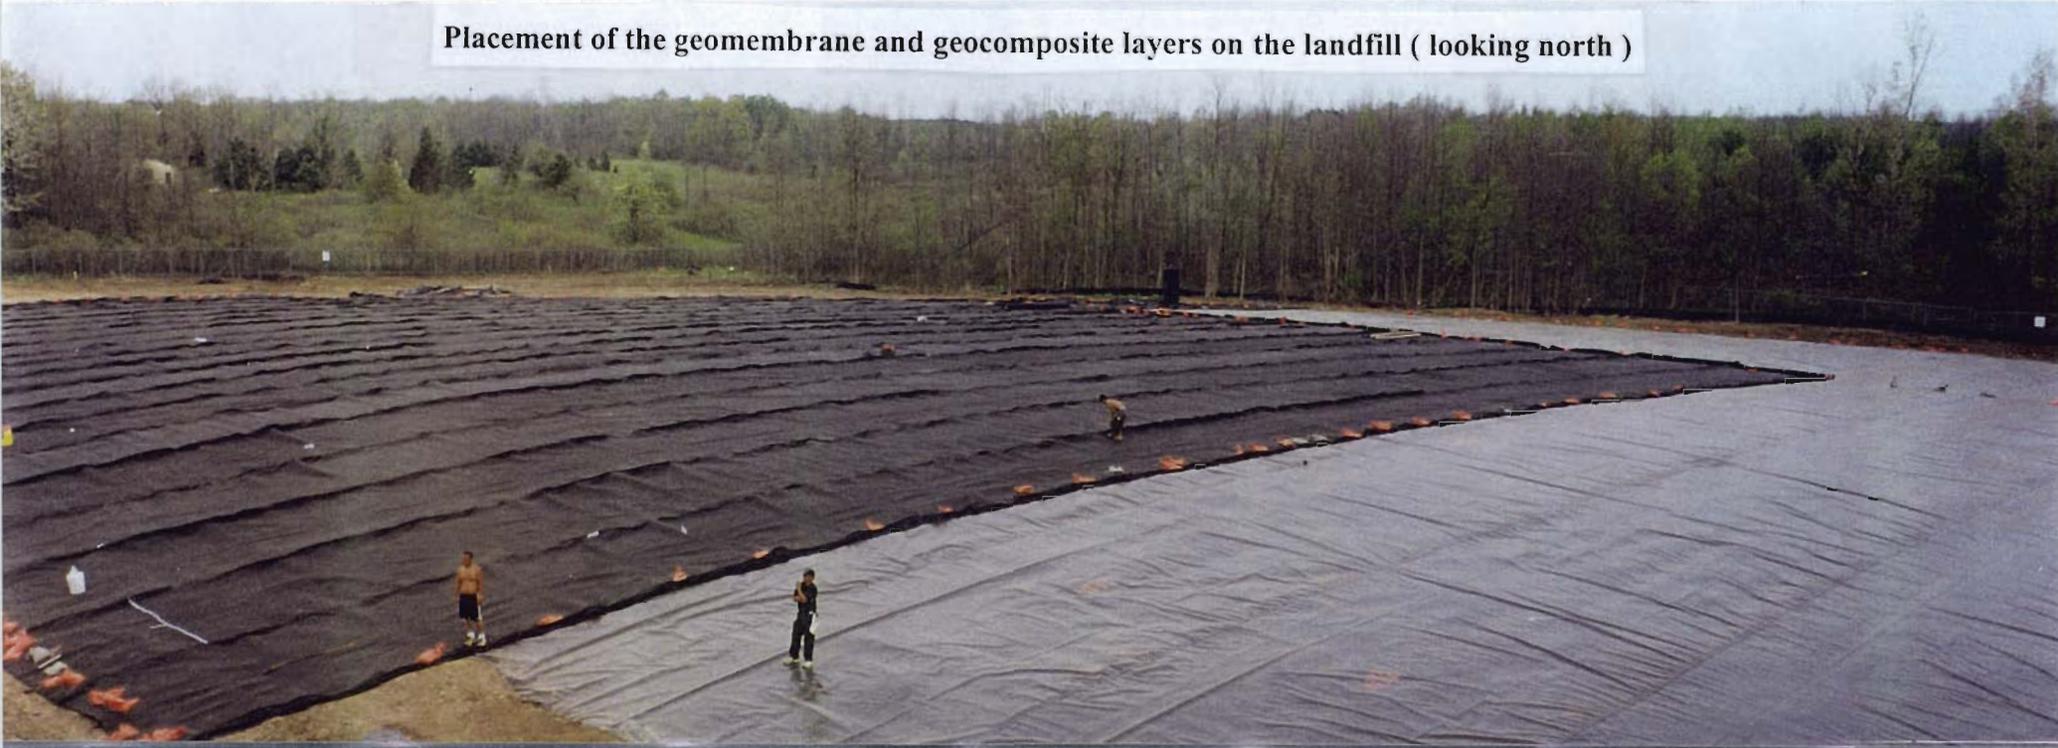
Placement of the geomembrane and geocomposite layers on the landfill ( looking north )

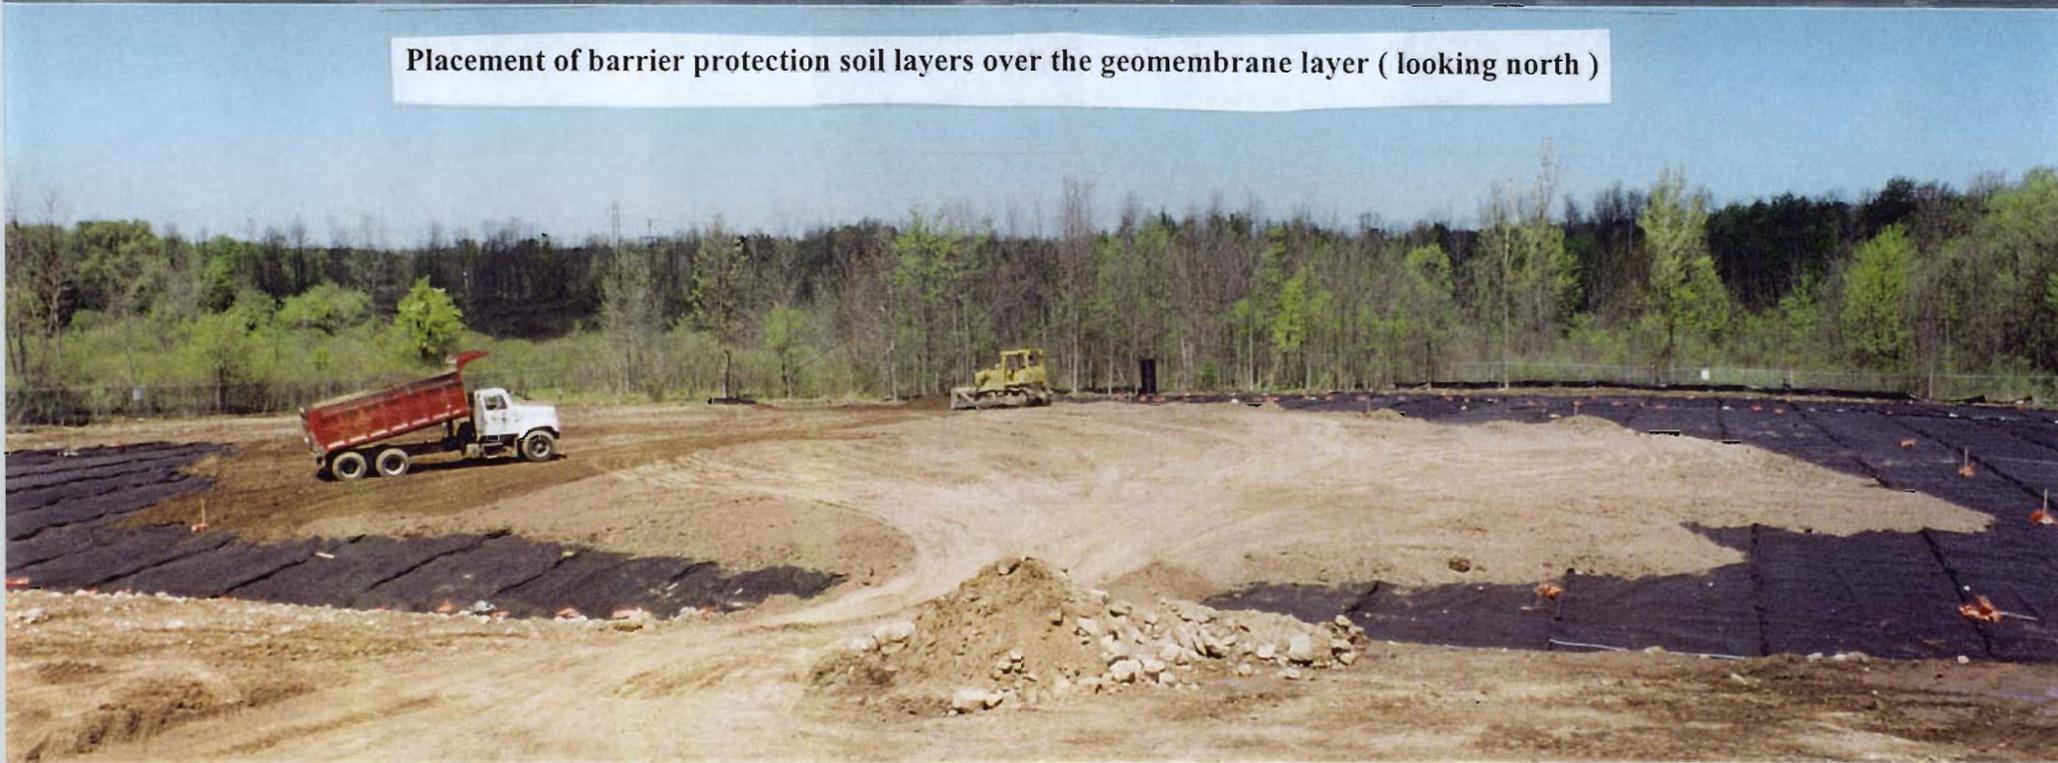
Placement of barrier protection soil layers over the geomembrane layer ( looking north )
