RE: RG&E – Phase 2 Data Summary Package – Assessment of MGP-Related NAPL Residual  
in Sediments in the Genesee River Project Area

## **Phase 2 Data Summary Package Assessment of MGP-Related NAPL Residuals in Sediments in the Genesee River Project Area**

March 31, 2010  
Project #091980-1004

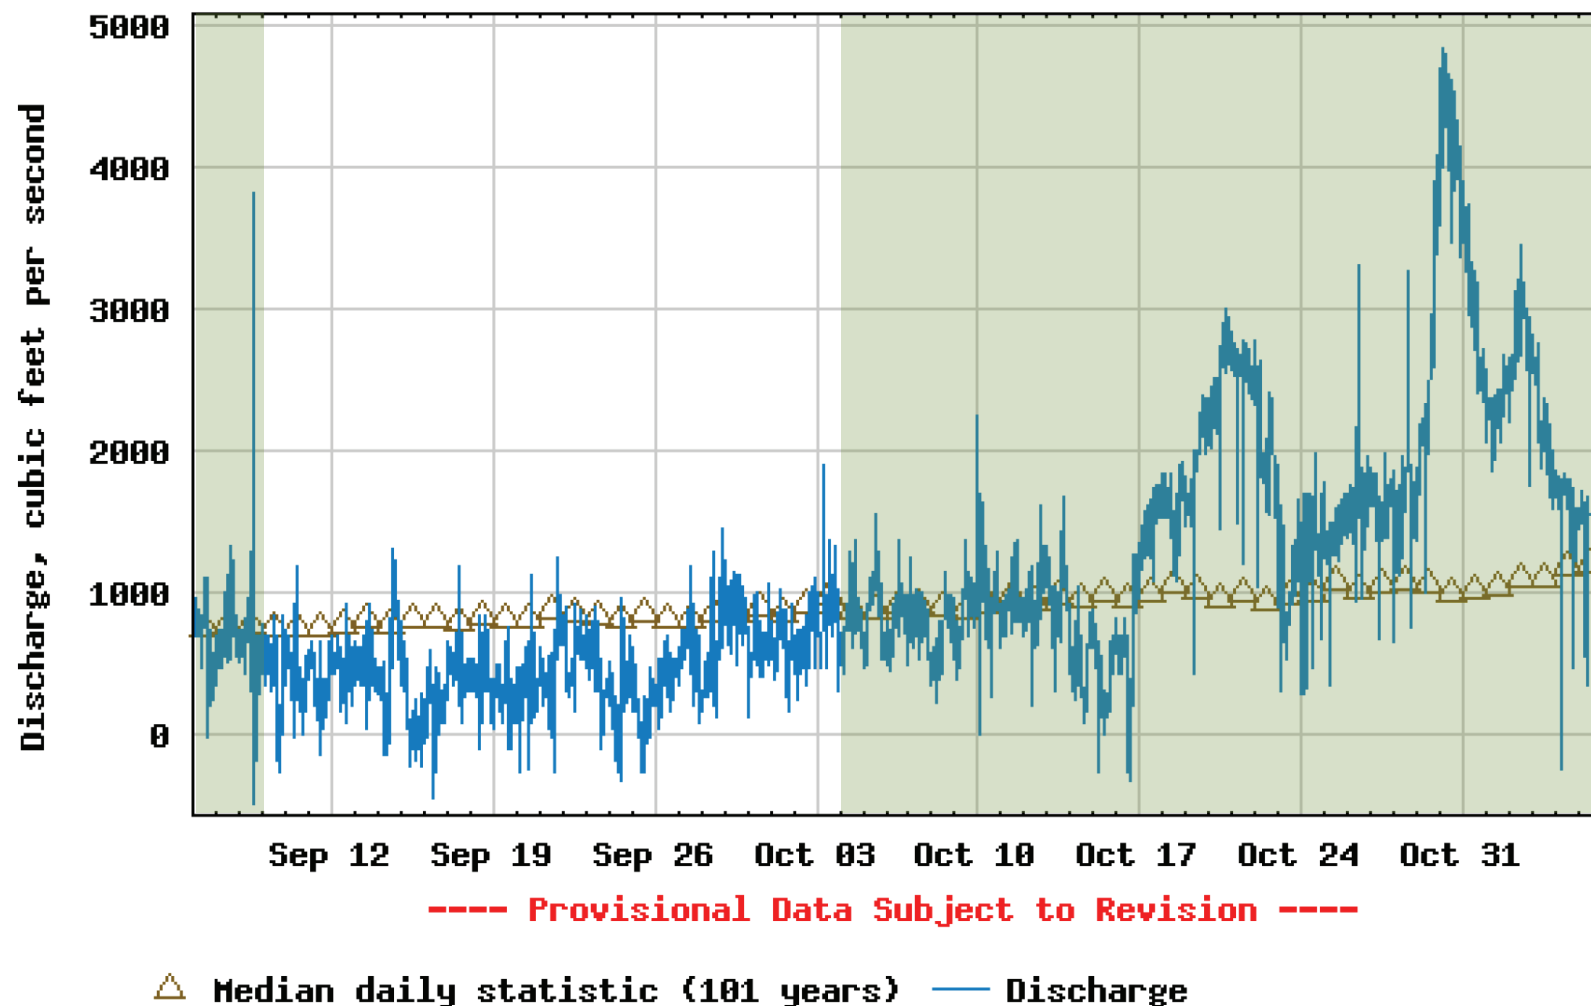
Figure 3-5

## USGS 04231600 GENESEE RIVER AT FORD STREET BRIDGE, ROCHESTER NY

Indicates period where no fieldwork being conducted

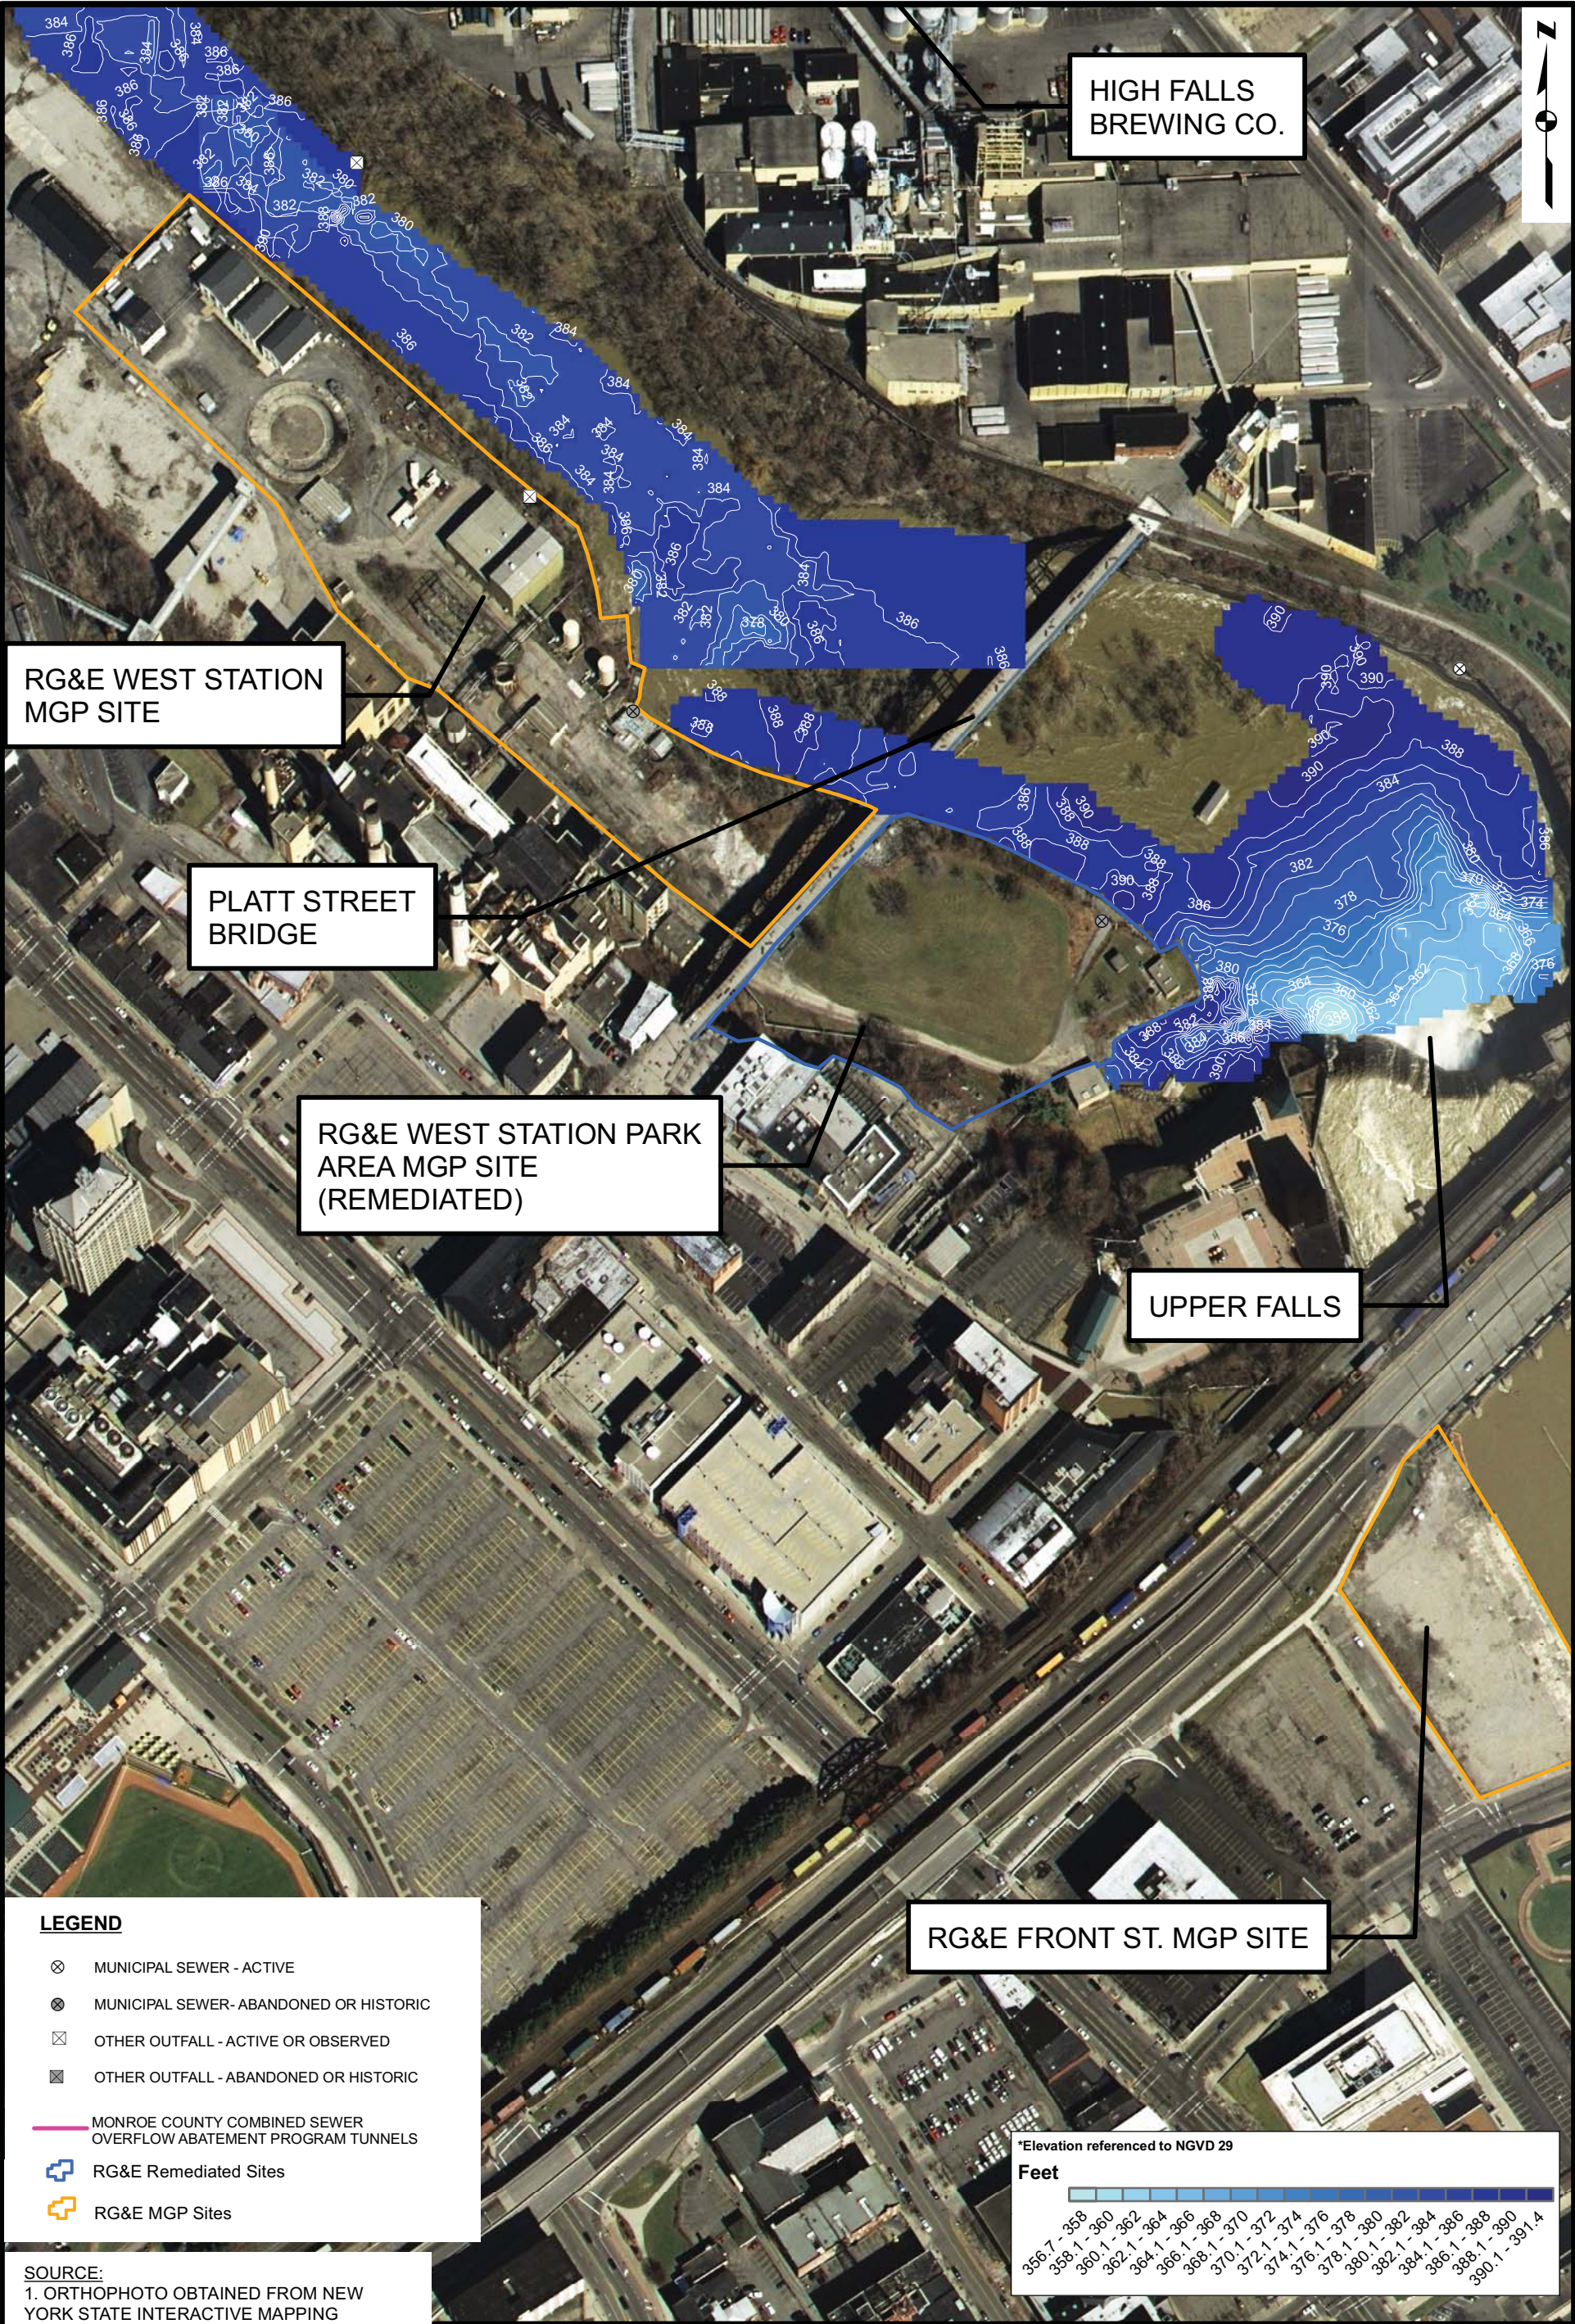
Figure 4-1a

The results of the bathymetric survey of Area A are found in Figures 4-1a, -b, and -c. The survey results and observations are discussed below, from upstream to downstream. The

From the north end of West Station to the middle of East Station the river shows a discontinuous thalweg (the line of maximum water depth). This is likely due to the blocky, jointed nature of the bedrock which make up the river bottom. At the middle of East Station, a more continuous thalweg is observed. At the north end of East Station, the thalweg is along the west side of the river, against the base of a rock face, while the inner bend of the river shows the development of a shallow depositional bar. This bar extends along the Bausch and Lomb property, and ends just upstream of the abandoned railroad bridge. At this point, the river bends back to the east and flow is directed against the western shore. Two deep holes are evident near the railroad bridge, which are likely due to localized narrowing of flow and scouring of sediments between bridge supports. The deepest hole extends approximately 16 feet deeper than the surrounding river bottom. These scours appear to extend to the top of bedrock, as probing confirmed a rock surface at their base. Note that NAPL or sheens were not observed at these locations.

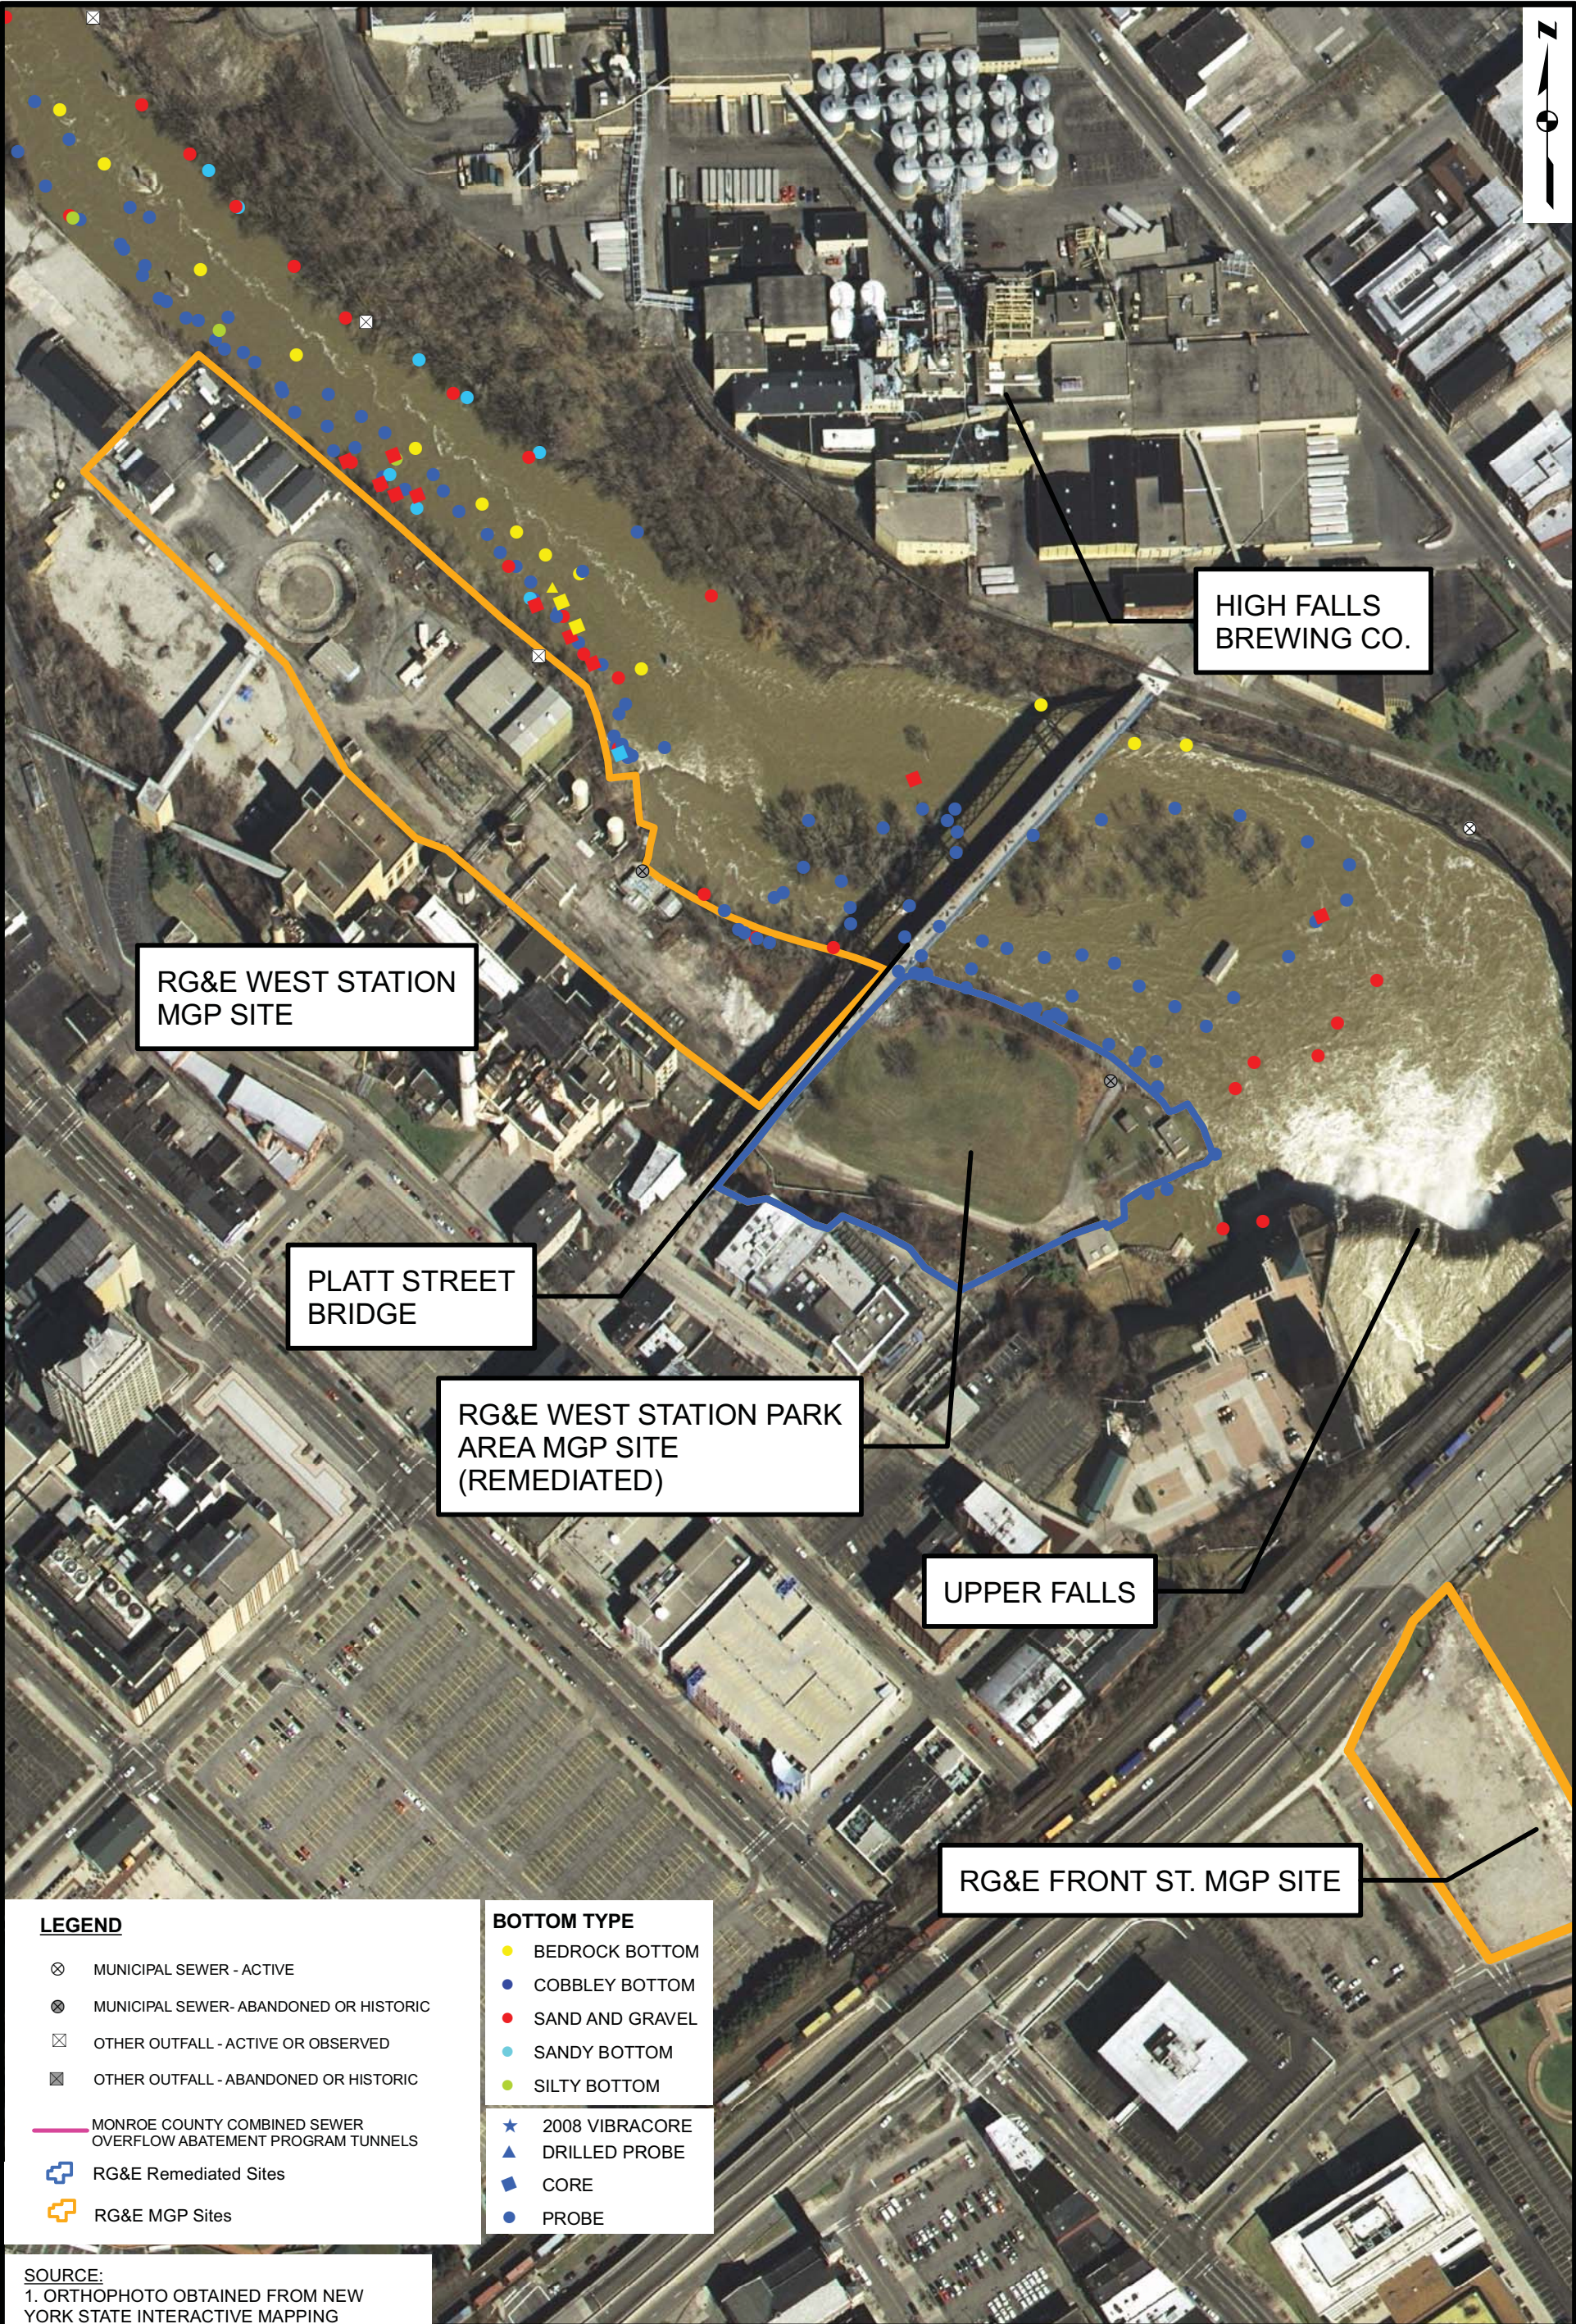
Figure 4-3a

The results of the sediment probing are displayed in Figures 4-3 through 4-6. The observations of sediment types and thickness are grouped together, followed by the observations of sheens and sediment quality. As noted in Section 3, the thickness of the sediment was to be assessed both by direct probing and by sub-bottom profiling. The sub-bottom profiling was not successful, therefore, the observations presented here are limited to those made during probing.

The area offshore of West Station which could not be surveyed during Phase 1 was found during Phase 2 to consist primarily of exposed bedrock. The thickness of sediments found along the shoreline of West Station generally thin towards the center of the river and then disappear before reaching the channel. Upstream of the weir at West Station the cobbley sediments form a continuous cover over the river bottom, with no exposed bedrock. It is likely that the transition from an area with deposition to erosion occurs below the weir area, where the river narrows and the two channels around the central island merge back into one channel.

In the middle third of Area A, from the Bausch Street Bridge to downstream of the abandoned railroad bridge, the probes could be advanced to generally less than 2 feet below the sediment surface, and areas of exposed bedrock in the river bottom in the channel area were widely encountered. Sediments were found to consist of sand and gravel, with boulders and cobbles present more along the shorelines than in the channel. Note that an area along the upstream portion of East Station where NAPL was observed was also the location where sandier sediments were present, and where sediment thickness ranged up to about 4 feet. Most other areas along East Station were found to be dominated by cobbles and to have a thinner layer of sediment over bedrock.

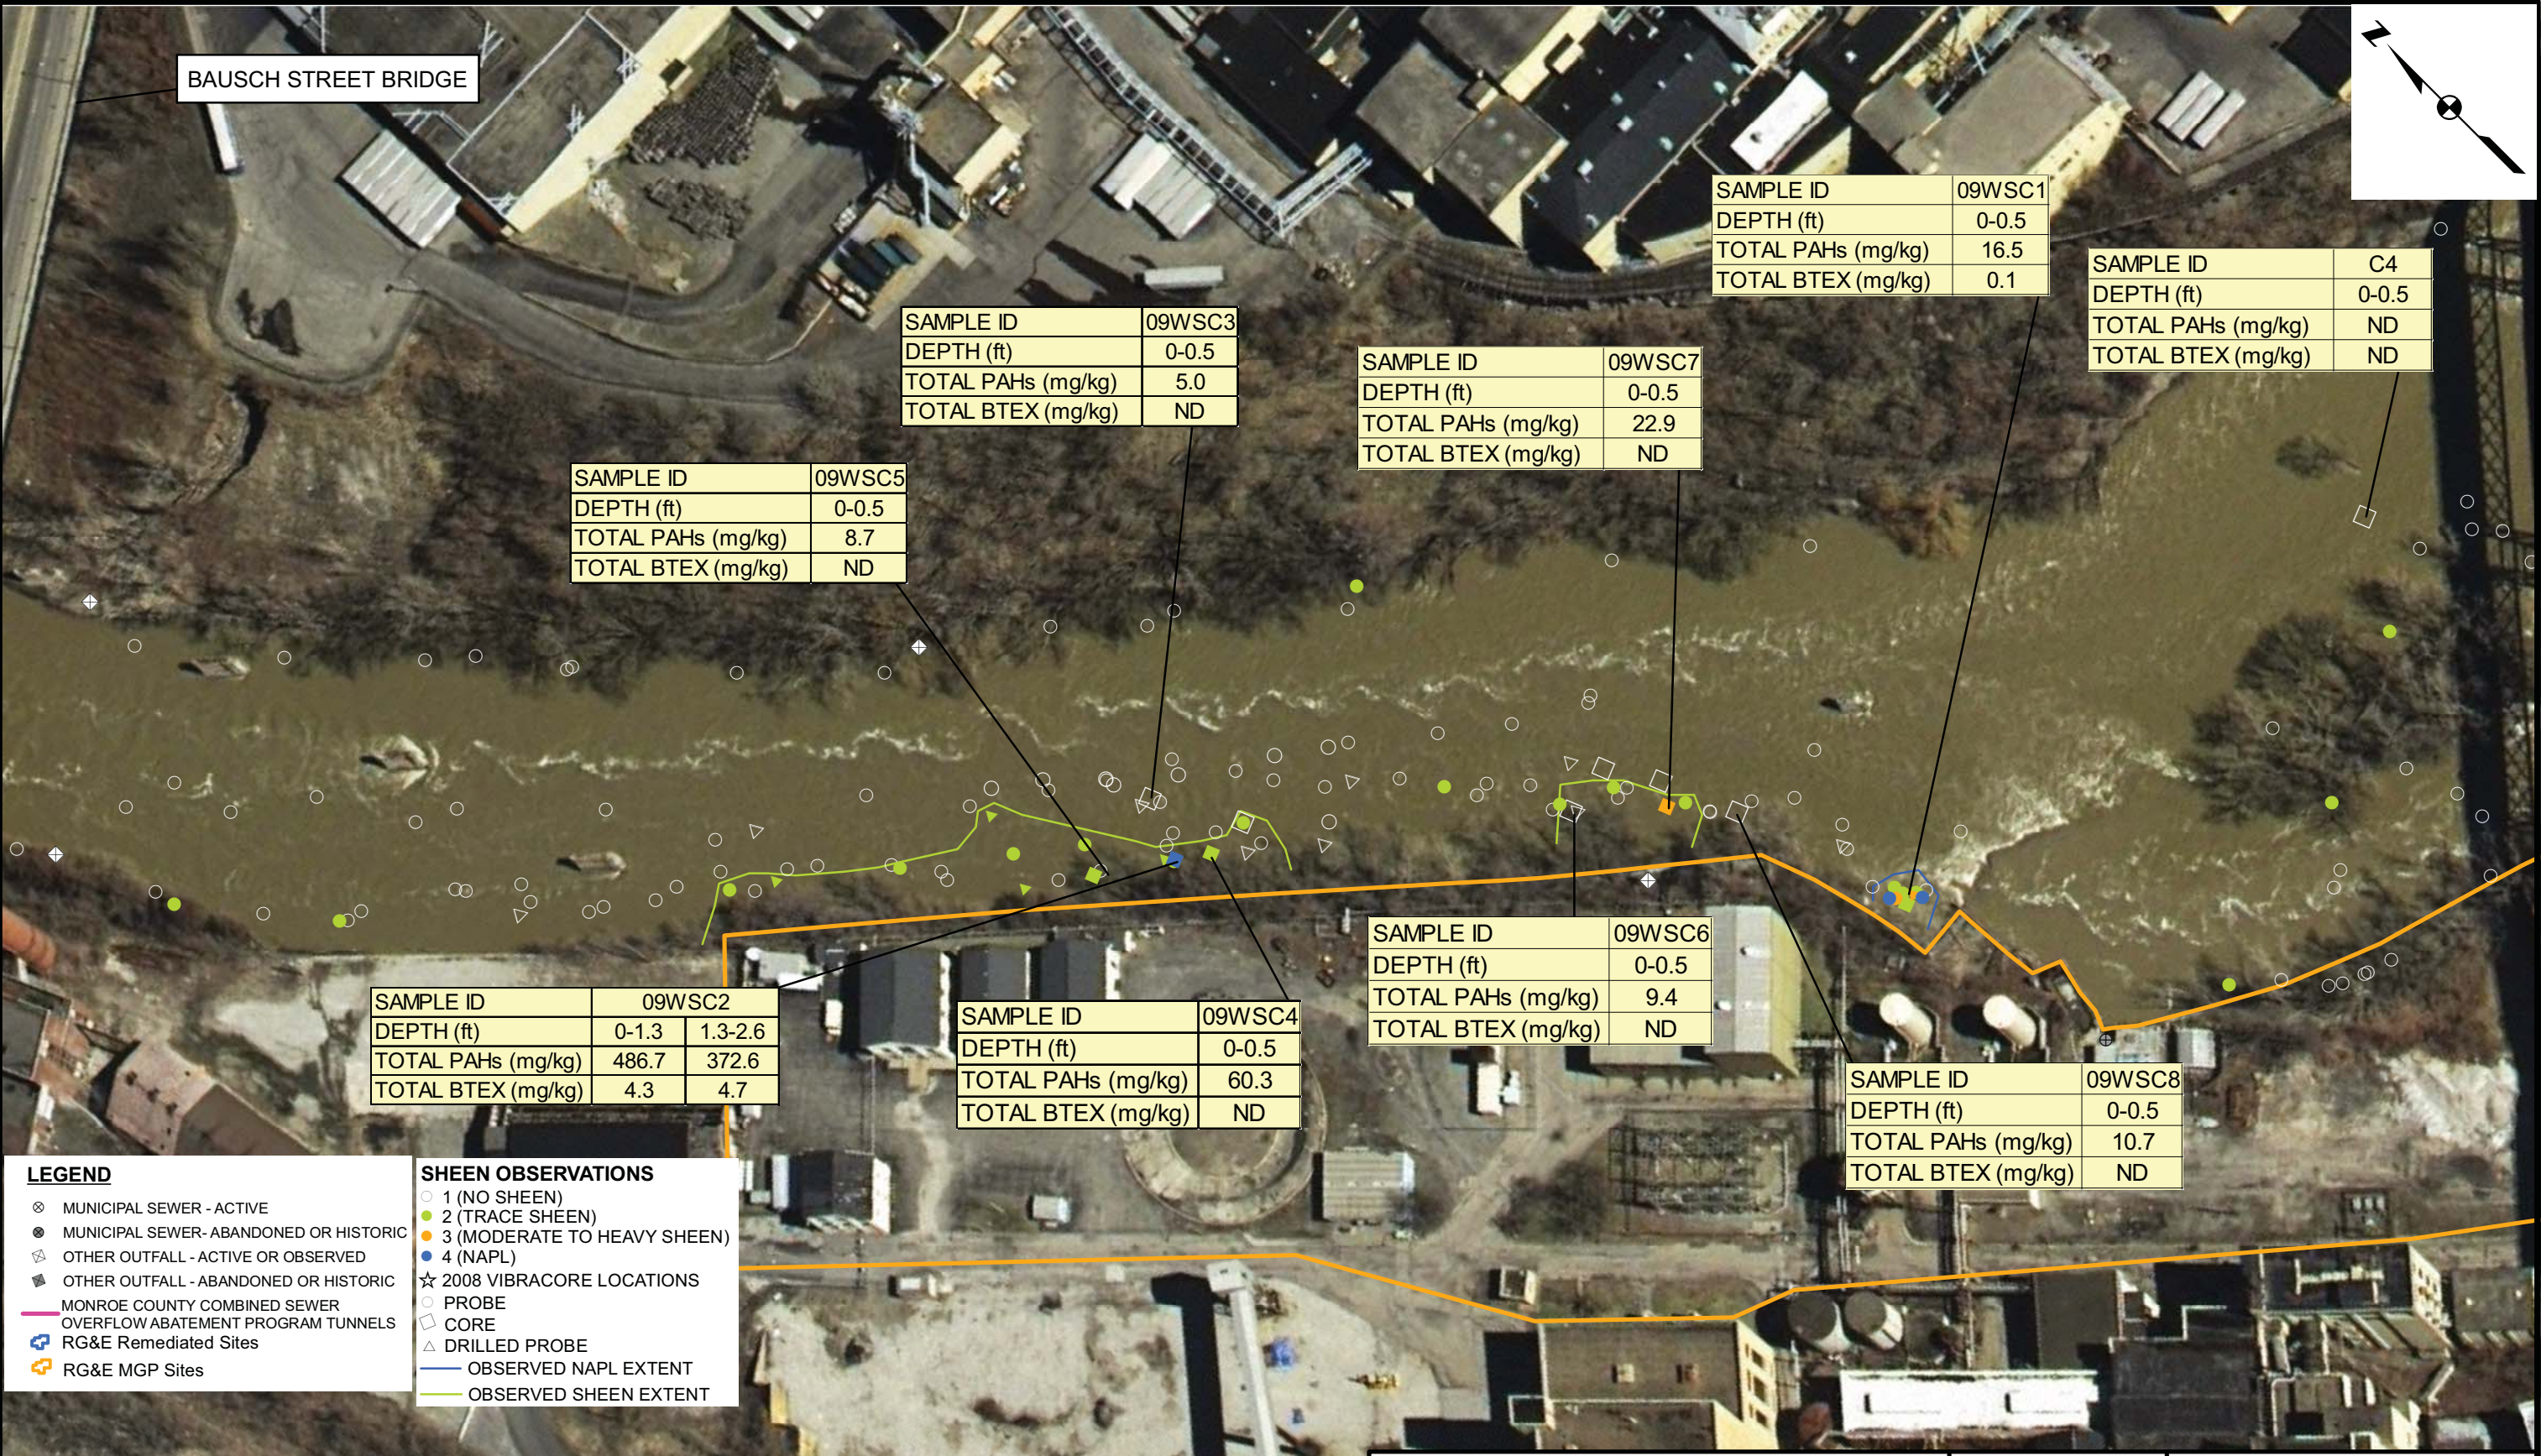
Plate 1

SOURCE:  
1. ORTHOPHOTO OBTAINED FROM NEW YORK STATE INTERACTIVE  
MAPPING GATEWAY (<http://www1.nysgis.state.ny.us/MainMap.cfm>),  
IMAGE DATE: APRIL 2005.

2008 & 2009 SHEEN OBSERVATIONS  
AND ANALYTICAL RESULTS

Observations from the Phase 1 and Phase 2 investigations are presented below for Area A (Figure 4-7a-c) and Area C (Figure 4-8a-b). The combined observations from the entire Project Area are also shown on Plate 1. Throughout the Project Area, very few locations were observed to display evidence of coal tar NAPL impacts at the shoreline, at the sediment surface, or in subsurface sediments. Sheens which were observed were often (though not always) spatially correlated with potential areas of coal tar NAPL at West and East Stations. Detailed figures showing the observations of NAPL and sheen, along with a summary of the analytical results, are provided as Figures 4-9 (West Station) and 4-10 (East Station).

The results of the analyses are presented in Tables 1 through 3, with the laboratory data packages and Data Usability Summary Reports (DUSRs) attached on CD-ROM as Appendix C. The total BTEX and PAH results for the samples are also shown on the figures for Section 4 which present the sheen observations, and on Plate 1.

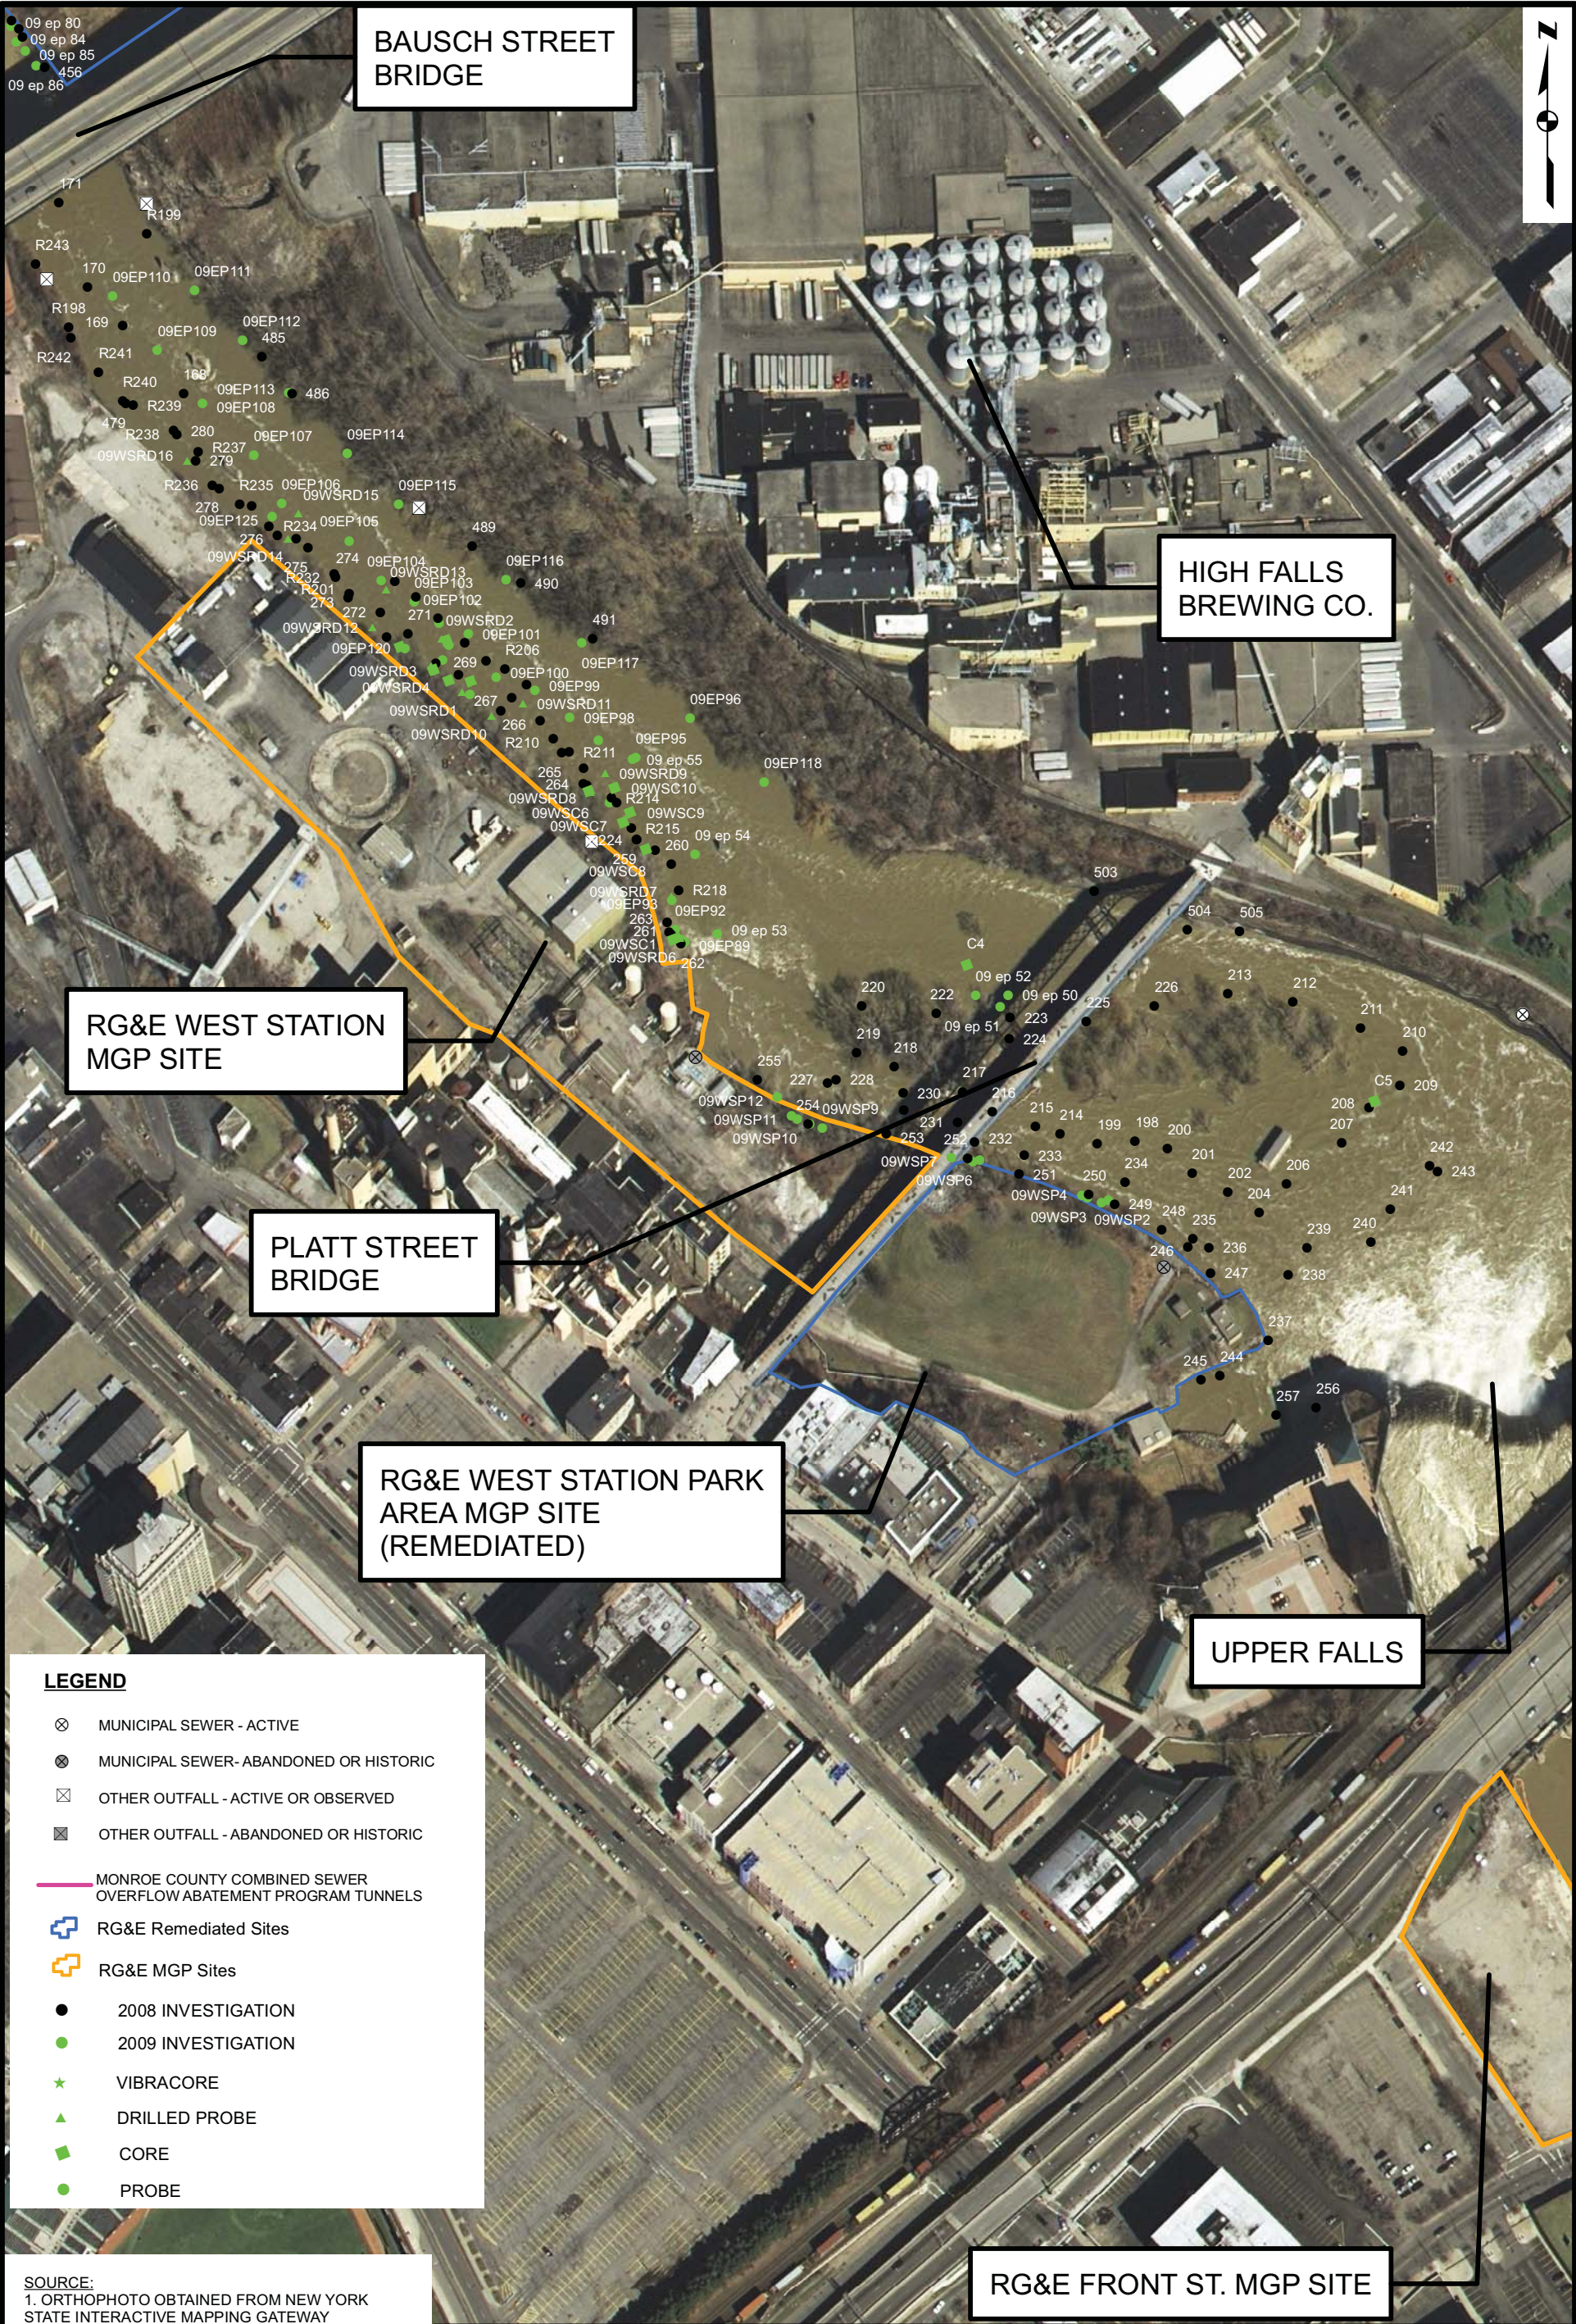
Figure 1

SURVEY POINTS  
2008 & 2009 RESULTS  
AREA A  
March 2010
