**Subject: More Fire and Glass Studio – Sub-Slab Depressurization System Upgrade
Scobell Chemical – NYSDOT Site (828076) Remedial Design WA D007619-32
MACTEC Engineering and Consulting, P.C. Project No. 3617147328**

More Fire Glass Studio Sub-Slab System Installation Oversight

CONSTRUCTION COMPLETION REPORT

80 Rockwood- More Fire Glass Studio- Photos

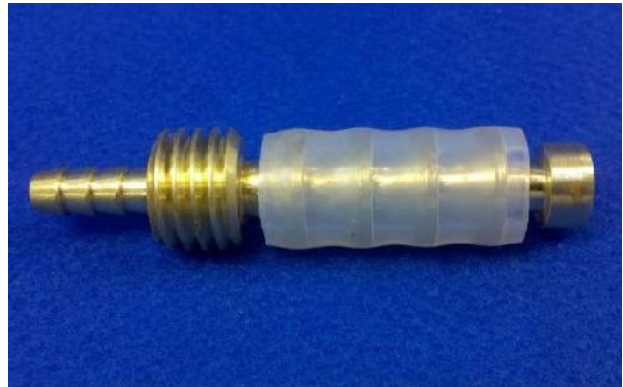
Figure 1. Assembled Vapor Pin™

- Assembled Vapor Pin™ [Vapor Pin™ and silicone sleeve(Figure 1)]; Because of sharp edges, gloves are recommended for sleeve installation;
- Hammer drill;
- 5/8-inch (16mm) diameter hammer bit (hole must be 5/8-inch (16mm) diameter to ensure seal. It is recommended that you use the drill guide). (Hilti™ TE-YX 5/8" x 22" (400 mm) #00206514 or equivalent);
- 1½-inch (38mm) diameter hammer bit (Hilti™ TE-YX 1½" x 23" #00293032 or equivalent) for flush mount applications;
- ¾-inch (19mm) diameter bottle brush;
- Wet/Dry vacuum with HEPA filter (optional);
- Vapor Pin™ installation/extraction tool;
- Dead blow hammer;
- Vapor Pin™ flush mount cover, if desired;
- Vapor Pin™ drilling guide, if desired;
- Vapor Pin™ protective cap; and

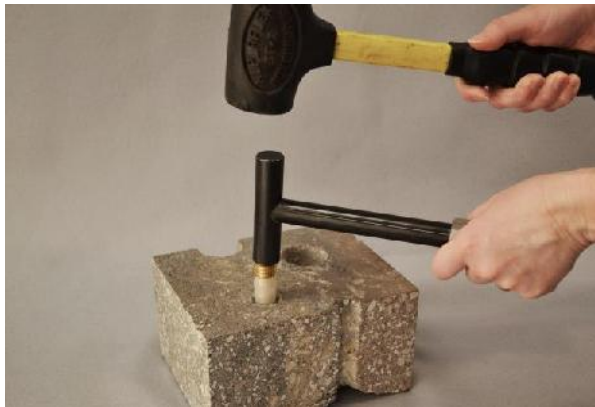
Figure 2. Installing the Vapor Pin™.

- 5) Remove the drill bit, brush the hole with the bottle brush, and remove the loose cuttings with the vacuum.
- 6) Place the lower end of Vapor Pin™ assembly into the drilled hole. Place the small hole located in the handle of the installation/extraction tool over the Vapor Pin™ to protect the barb fitting, and tap the Vapor Pin™ into place using a dead blow hammer (Figure 2). Make sure the installation/extraction tool is aligned parallel to the Vapor Pin™ to avoid damaging the barb fitting.

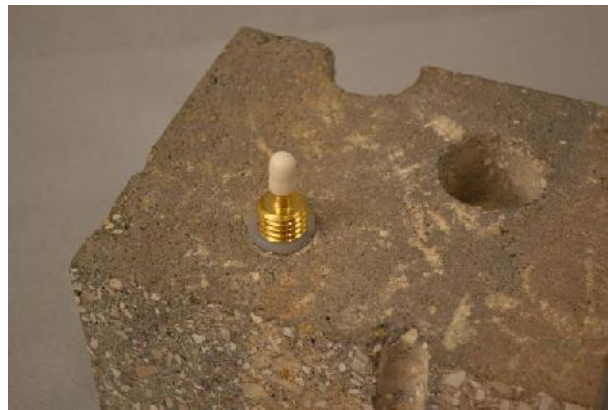
Figure 3. Installed Vapor Pin™

During installation, the silicone sleeve will form a slight bulge between the slab and the Vapor Pin™ shoulder. Place the protective cap on Vapor Pin™ to prevent vapor loss prior to sampling (Figure 3).

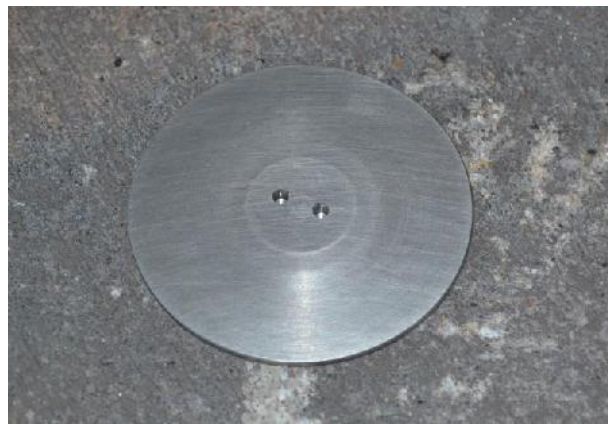
Figure 4. Secure Cover Installed

- 7) For flush mount installations, cover the Vapor Pin™ with a flush mount cover, using either the plastic cover or the optional stainless-steel Secure Cover (Figure 4).

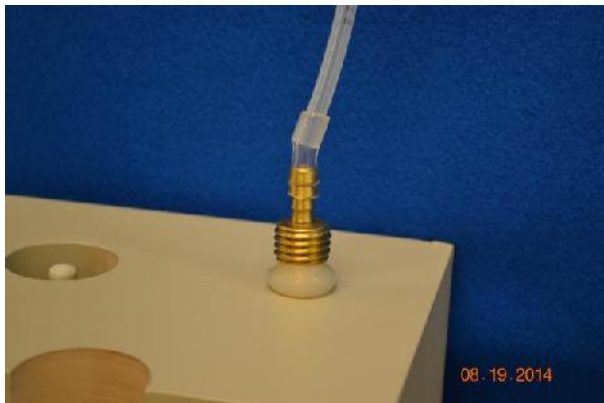
Figure 5. Vapor Pin™ sample connection.

tubing (Figure 5). Put the Nylaflow tubing as close to the Vapor Pin as possible to minimize contact between soil gas and Tygon™ tubing.

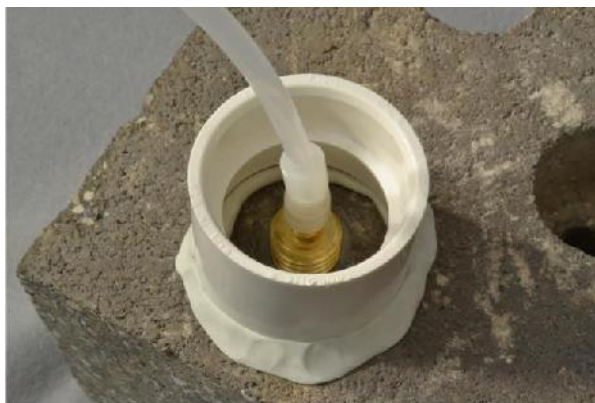
Figure 6. Water dam used for leak detection

10) Conduct leak tests in accordance with applicable guidance. If the method of leak testing is not specified, an alternative can be the use of a water dam and vacuum pump, as described in SOP Leak Testing the Vapor Pin™ via Mechanical Means (Figure 6). For flush-mount installations, distilled water can be poured directly into the 1 1/2 inch (38mm) hole.

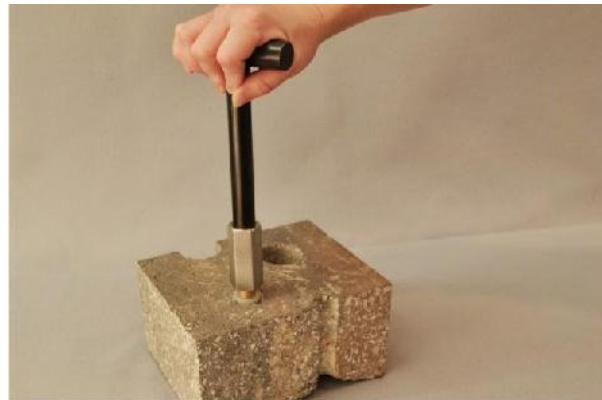
Figure 7. Removing the Vapor Pin™.

- 1) Remove the protective cap, and thread the installation/extraction tool onto the barrel of the Vapor Pin™ (Figure 7). Continue turning the tool clockwise to pull the Vapor Pin™ from the hole into the installation/extraction tool.
- 2) Fill the void with hydraulic cement and smooth with a trowel or putty knife.

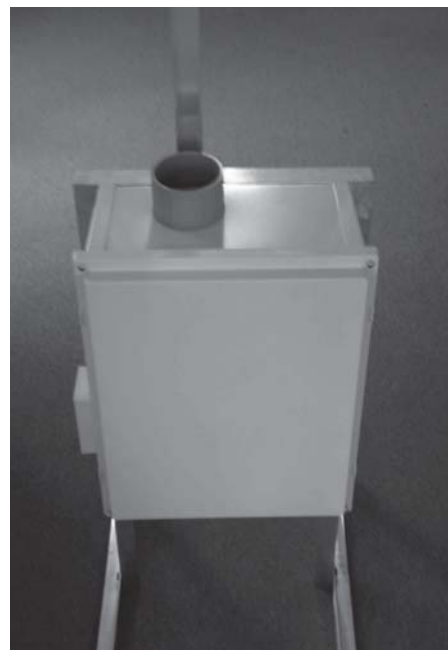
GBR76 WITH ROOF MOUNT

- GBR76 SOE 16" WC @ 0 Max flow 155 cfm.
- GBR76 HO 41" WC @ 0 Max flow 160 cfm.
- Built in speed control to customize performance.
- Condensate bypass built in.
- 18 month warranty 40,000 hr sealed bearings.

- Our modular design means the blower and manifold assembly can be removed and replaced as a unit. This makes repairs cost effective and easy and allows contractors to upgrade systems simply by swapping assemblies.
- The GBR series is based on a bypass blower designed to handle combustible materials.
- The housing is not required to be air tight so you can add gauges and alarms without compromising the system.
- Built in condensate bypass.
- Built in speed control.
- Quick disconnect electrical harness.
- All UL listed components including UL listed enclosure for outside use.
- Wall fastening lugs included.
- GBR series roof and wall mounts available to quickly configure the blowers for your installation while providing a custom built look.
- Compact design 16"x 14"x 8" weighing only 18 lbs.

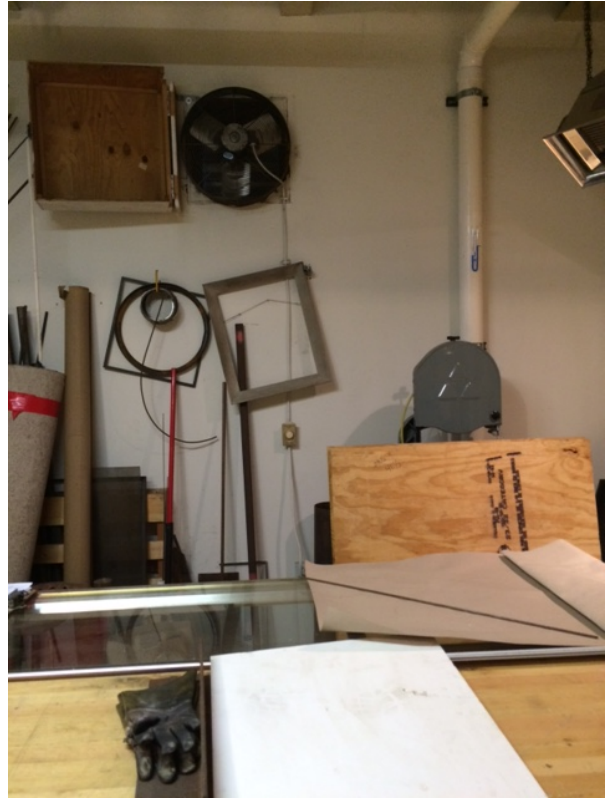
Interior Tool Room (inside fan) (New Suction Point 5 – September 2015

- Adding two additional suction points in the affected Tool Room (SP4 and SP5)
- Utilize a new high volume fan dedicated to SP5 (near the foundation crack)
- Tie SP4 into the existing SSDS and replace that existing fan with a high pressure fan allowing more vacuum.

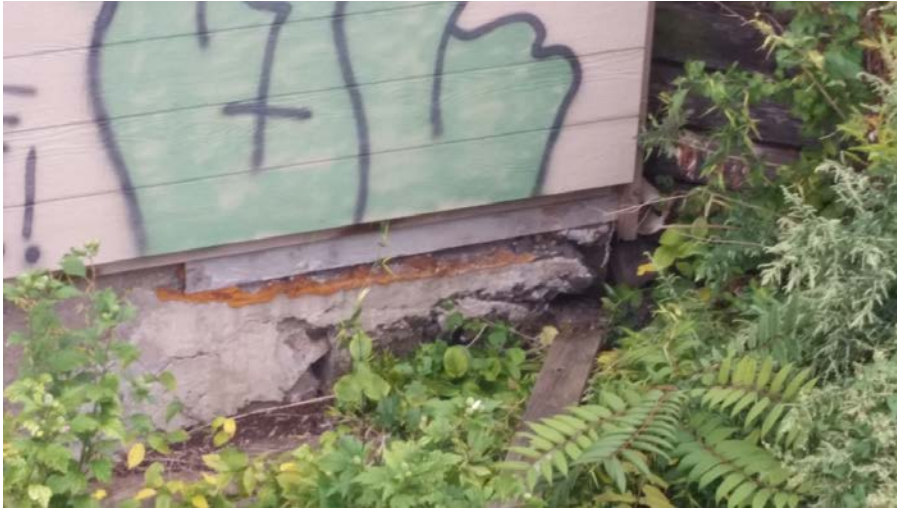
Cracks were observed in the foundation wall in the area of the affected tool room. These cracks likely allowed air to enter from beneath the slab and reduced the effectiveness of the SSDS. MTG utilized two-inch rolled foam material to seal the accessible cracks (the property owner did not want expanding spray foam utilized). Sealing these cracks reduced the positive pressure beneath the slab of the tool room though it was still unacceptable.

Cracked Foundation
– NE corner -2015

Mitigation Tech recommended that the NW corner of the building be excavated and structural repairs to the masonry be undertaken. In lieu of this, temporary patching of the accessible opening was added using 2" foam board and urethane sealants. *Mitigation Tech* was directed by the landlord not to use expandable foam as part of the repair so that future permanent repairs would not be made more difficult. The repair was somewhat effective; however large volumes of soil vapor were clearly entering the vicinity of the NW corner and the existing system configuration was determined to be ineffective in mitigation vapor intrusion.

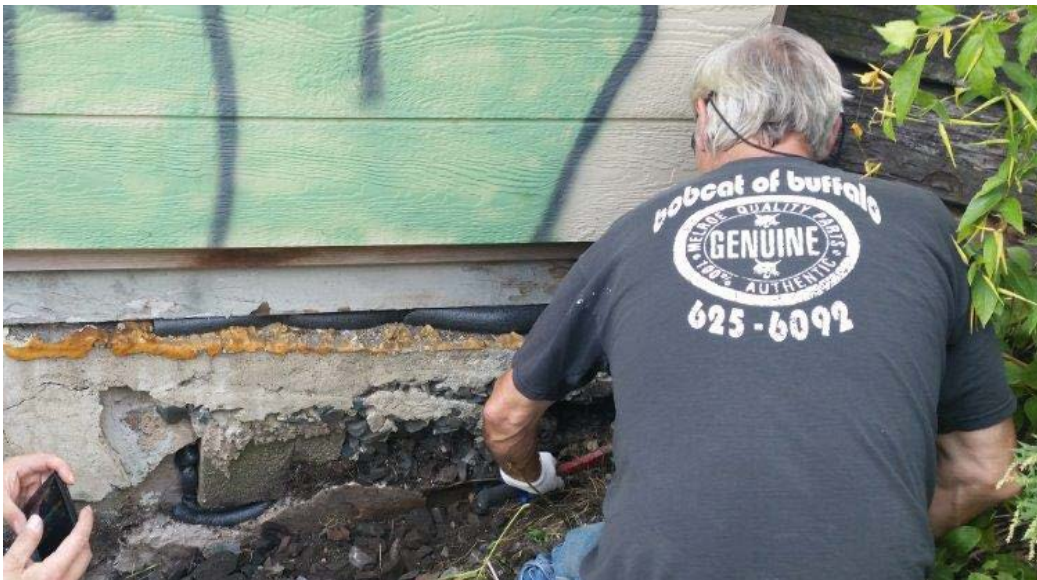
Sealing gaps with
rigid insulation
September 2015

- Sealing of observed floor cracks.
- Sealing the northeast corner of the foundation with 2-inch foam board insulation and urethane sealants.
- Installation of a new, single extraction point in the northeast corner of the MFGS building connected to a Radonaway RP-265 Fan.
- Installation of a new extraction point, connected to the original three extraction points system.
- Upgrade of the original blower/fan to a high pressure radial blower (OBAR 76-UD fan).
- Installation of four permanent vacuum measurement points to serve as sub-slab vapor sampling and sub-slab vacuum measuring points.

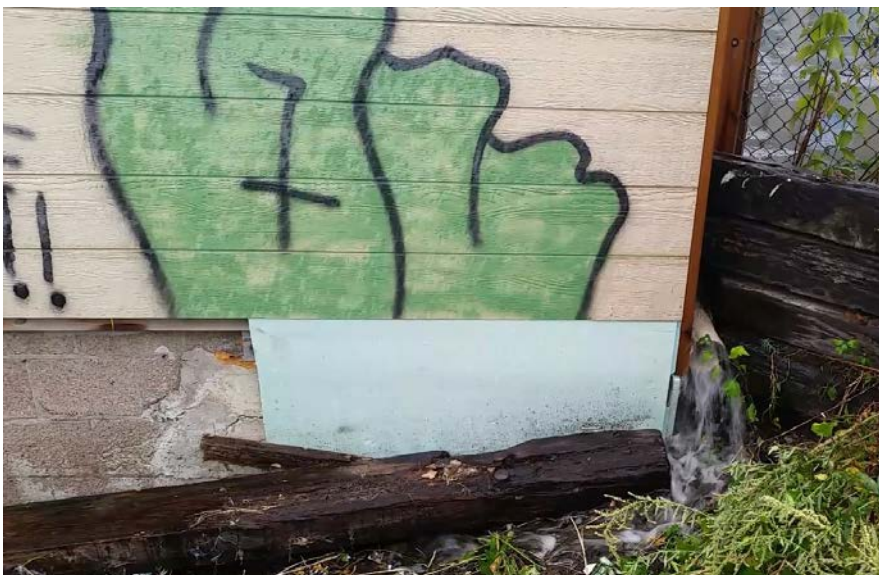
Two-inch insulation
board over sealed
area. Rain water
shown coming off
parking lot and
around corner.
– September 2015

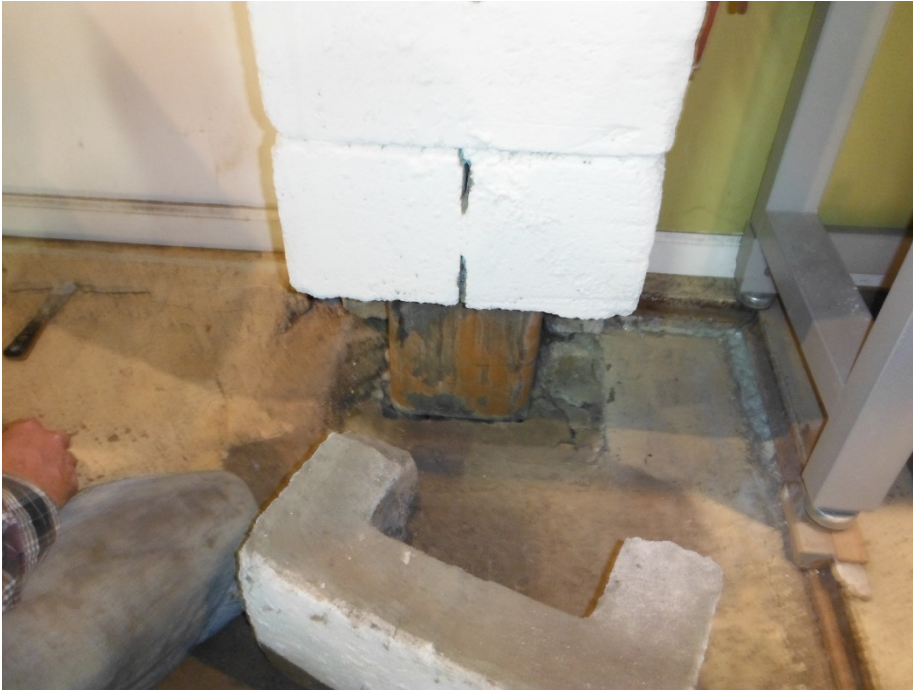
Sealing floor cracks and cracked chimney in tool room – August 2015

3.7. Sealing measures. Polyurethane sealants and mechanical barriers have been applied to floor cracks, slab penetrations and other openings to enhance the barriers between sub-slab and ambient air and improve the efficiency of the SSD System. The barrier applied to the exterior NW corner of the building should be considered as temporary and in addition, permanent measures are recommended as structural deterioration has been observed. Sealant has been applied in the vicinity of suction points and at cracks in concrete. Additional enhancement of the barrier between the basement boiler room and ambient air is recommended and would be expected to improve system performance.

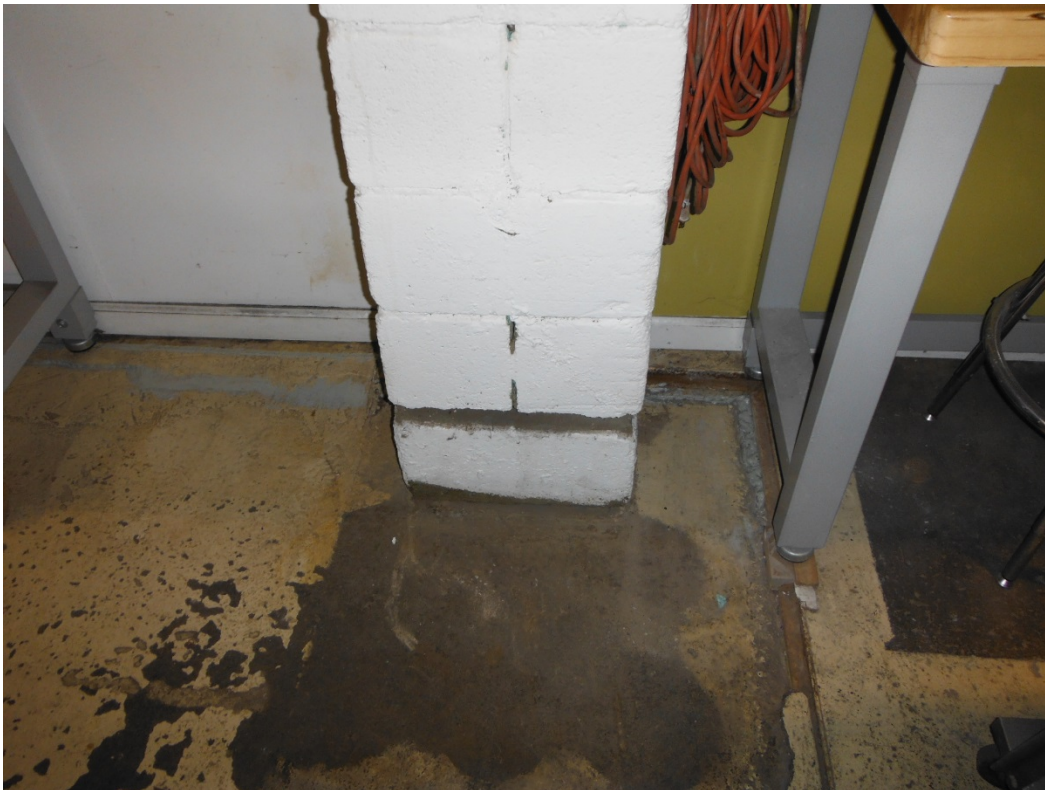
Floor Cracks and Chimney Sealed-
August 2015

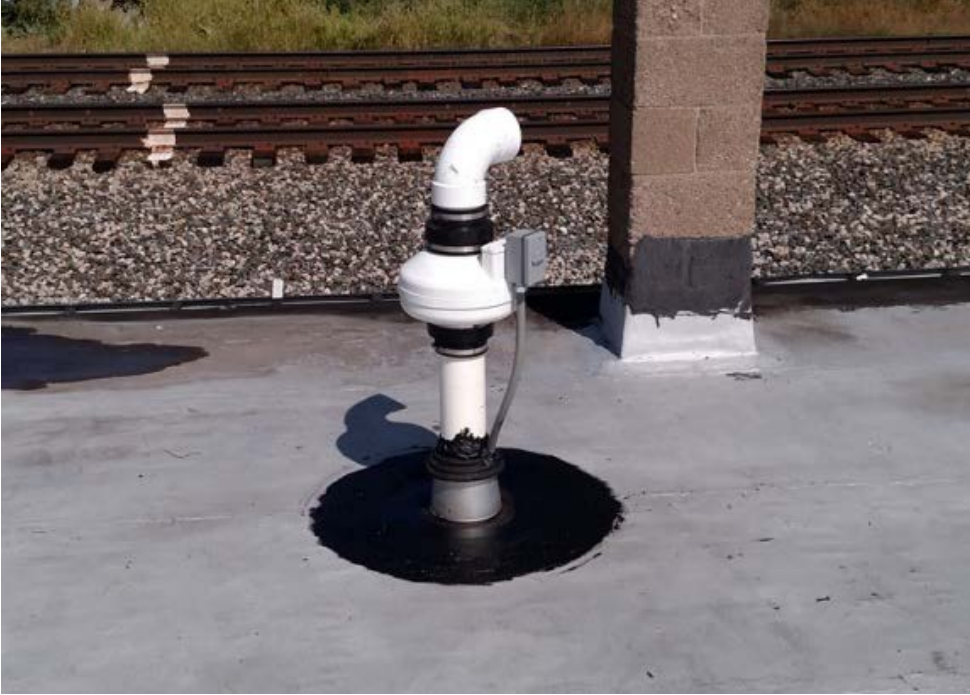
New Fan – RadonAway – RP365 – on roof, looking north -
September 2015

3.4. Exhaust Fans. NW System exhaust fan consist of (1) RADONAWAY RP-265 centrifugal fan which consumes approximately 120w of electricity and produces a static pressure differential of up to 2.3 water column inch (wci). Central System exhaust fan consist of (1) OBAR UD-76 radial blower which consumes approximately 350w of electricity and produces a static pressure differential of up to 36 water column inch (wci). Fans have a roof disconnect switch connected to a circuit in the vicinity. Fans are mounted with rubber Fernco couplings, for simplified replacement.

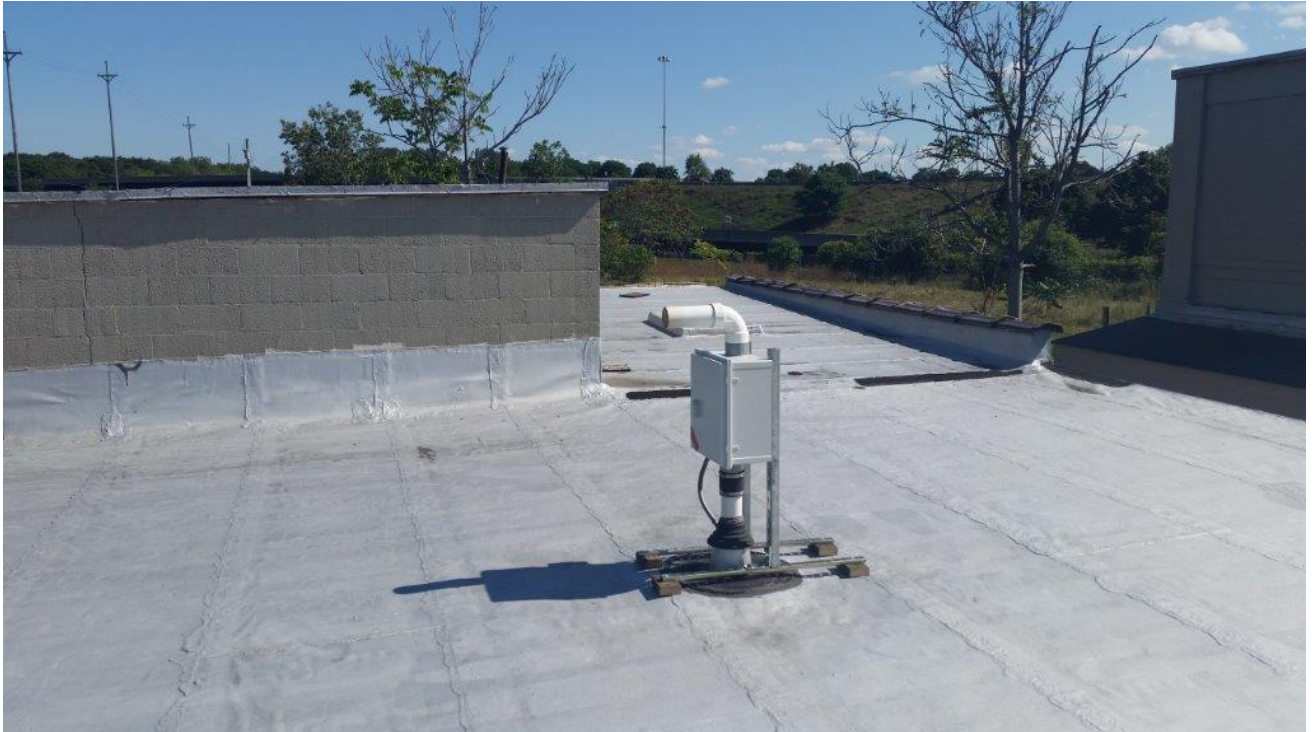
New High Pressure Fan – Obar – 76 UD on roof, looking east
September 2015

Continuing monitoring and measurement during the construction process informed additional refinements to the mitigation system. Given the below set of conditions, it was determined that the original radon fan should be replaced with a high pressure radial blower. The conditions are as follows:

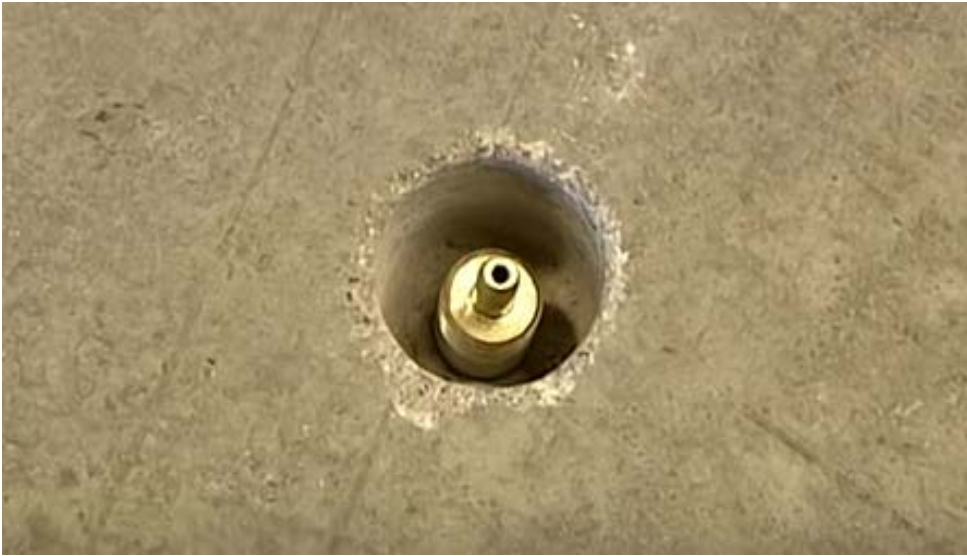
VaporPin® permanent vacuum measurement/vapor sampling point (TP) set in concrete; ¼-inch barbed fitting will attach to ¼-inch outside diameter rigid/Teflon tubing with small piece of ¼-inch inside diameter Tygon tubing.

Four permanent vacuum test points (VaporPins®) were installed at previous vacuum locations:

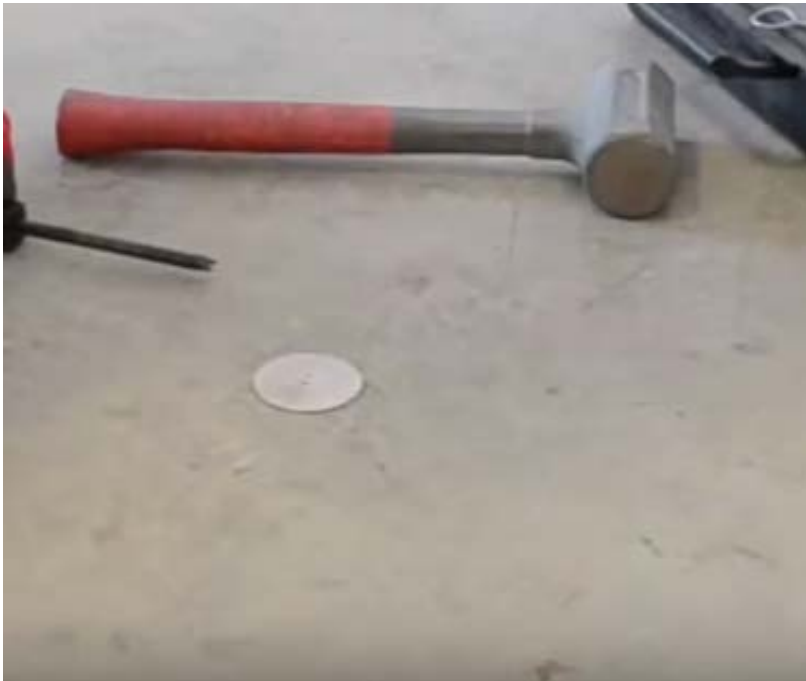
VaporPin® stainless steel cover installed over vacuum measurement point (TP). Cover unscrews counterclockwise from VaporPin®.
