Revised Supplemental Final Engineering Report
Former Roehlen Engraving (NYSDEC Site #828077)
Henrietta, New York

REVISED SUPPLEMENTAL FINAL ENGINEERING REPORT

Former Roehlen Engraving Site
Henrietta, New York

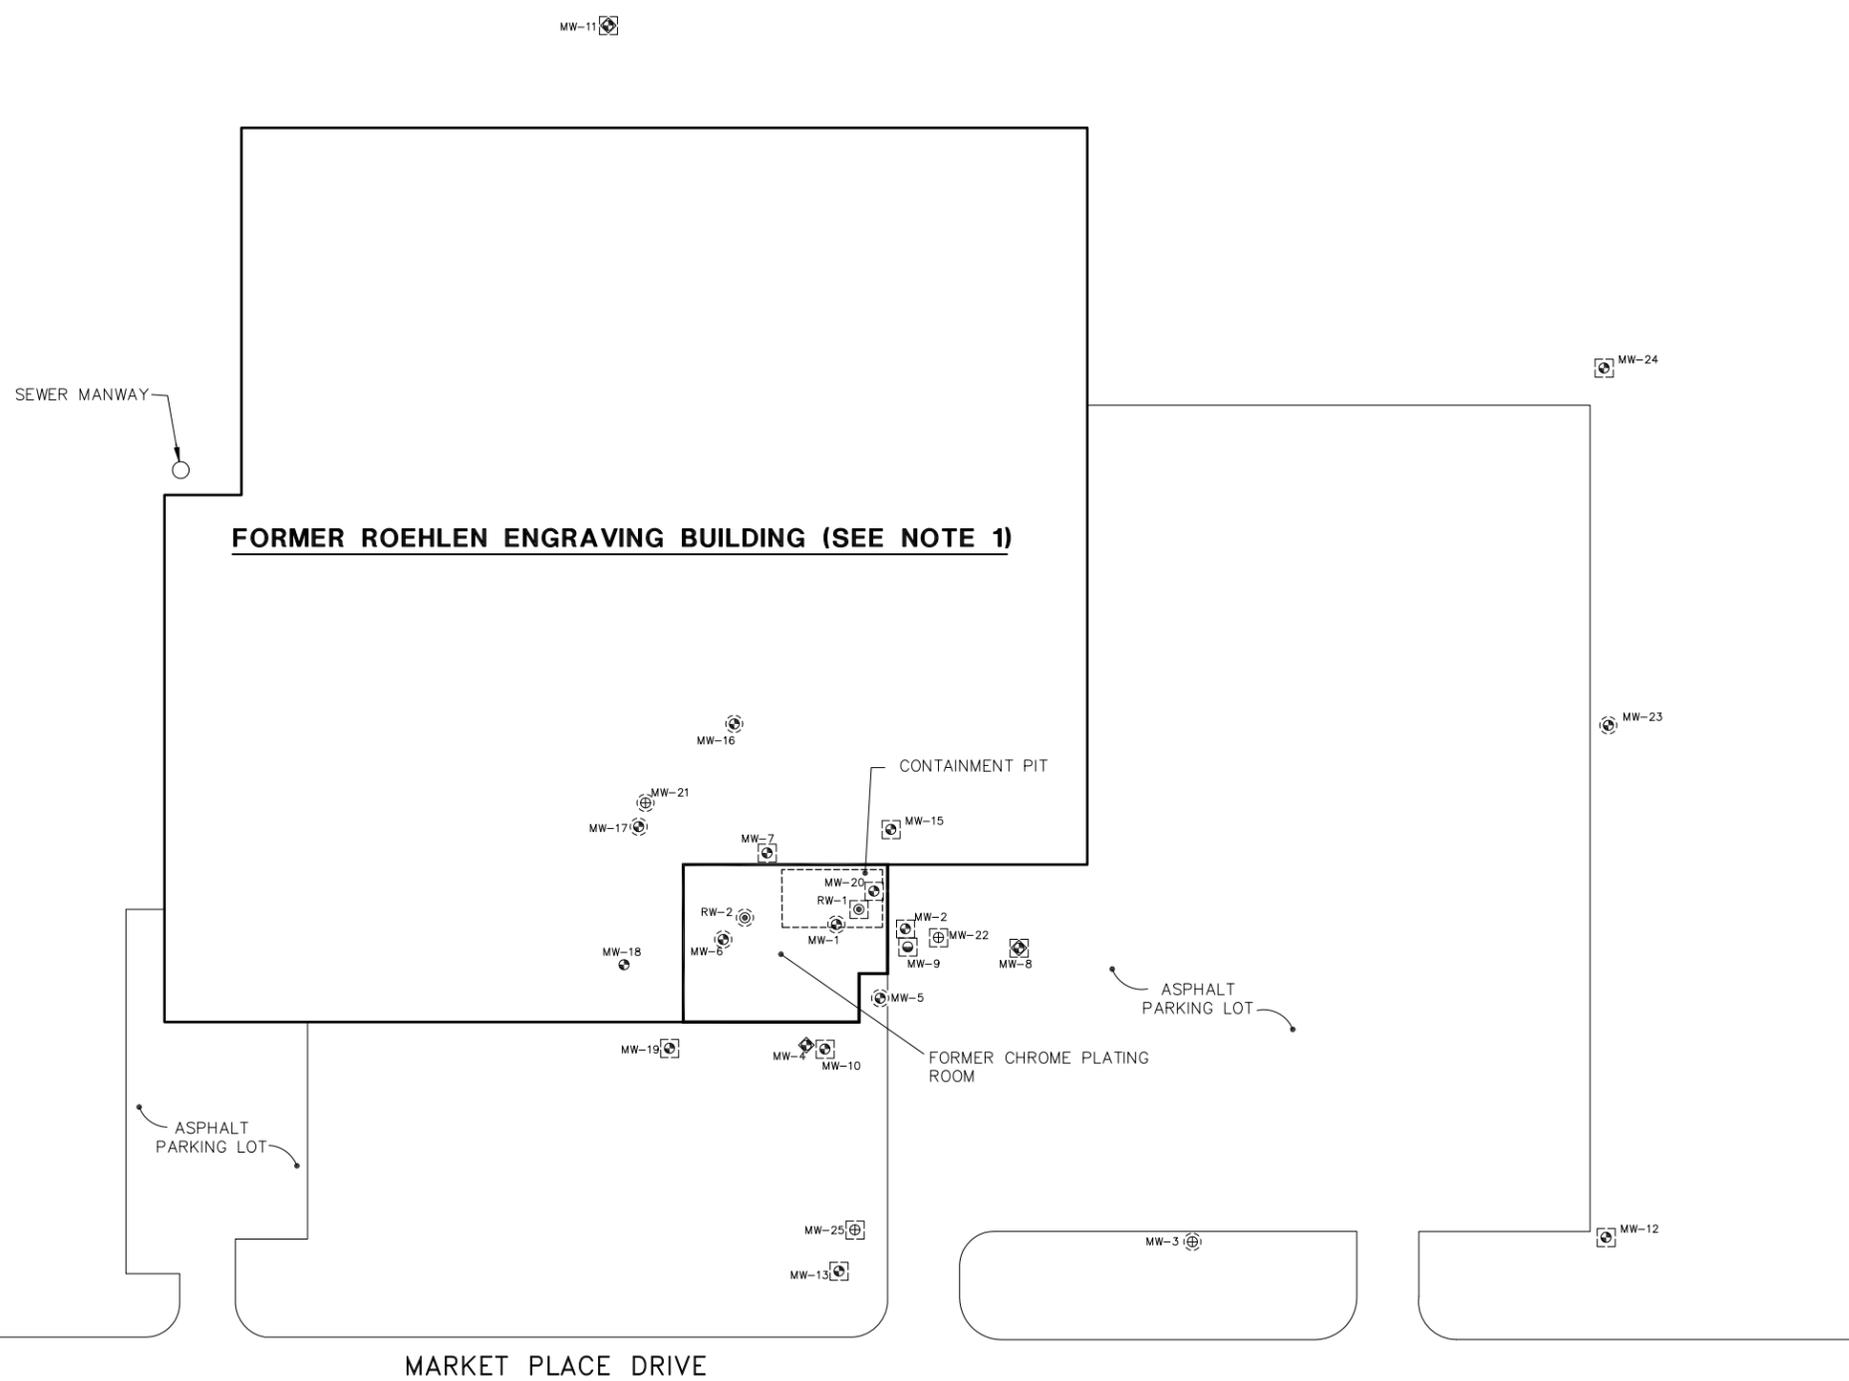
FIGURE
2

The site is located on the northern 4 acres of the 12.8-acre former Roehlen facility, and is bordered by several businesses. Figure 1 presents the location of the former Roehlen facility, and Figure 2 presents the pre-excavation site plan for the facility.

- NOTE:**
1. FORMER ROEHLLEN ENGRAVING BUILDING DEMOLISHED IN APRIL/MAY 2008
 2. ABANDONED MONITORING WELLS INDICATES WELLS THAT WERE DAMAGED DURING THE DEMOLITION ACTIVITIES, AND COULD NOT BE RELOCATED.
 3. DECOMMISSIONED MONITORING WELLS INDICATES WELLS THAT WERE DECOMMISSIONED IN ACCORDANCE WITH THE NEW YORK STATE DEPARTMENT OF ENVIRONMENTAL CONSERVATION'S GROUNDWATER MONITORING WELL DECOMMISSIONING PROCEDURES.

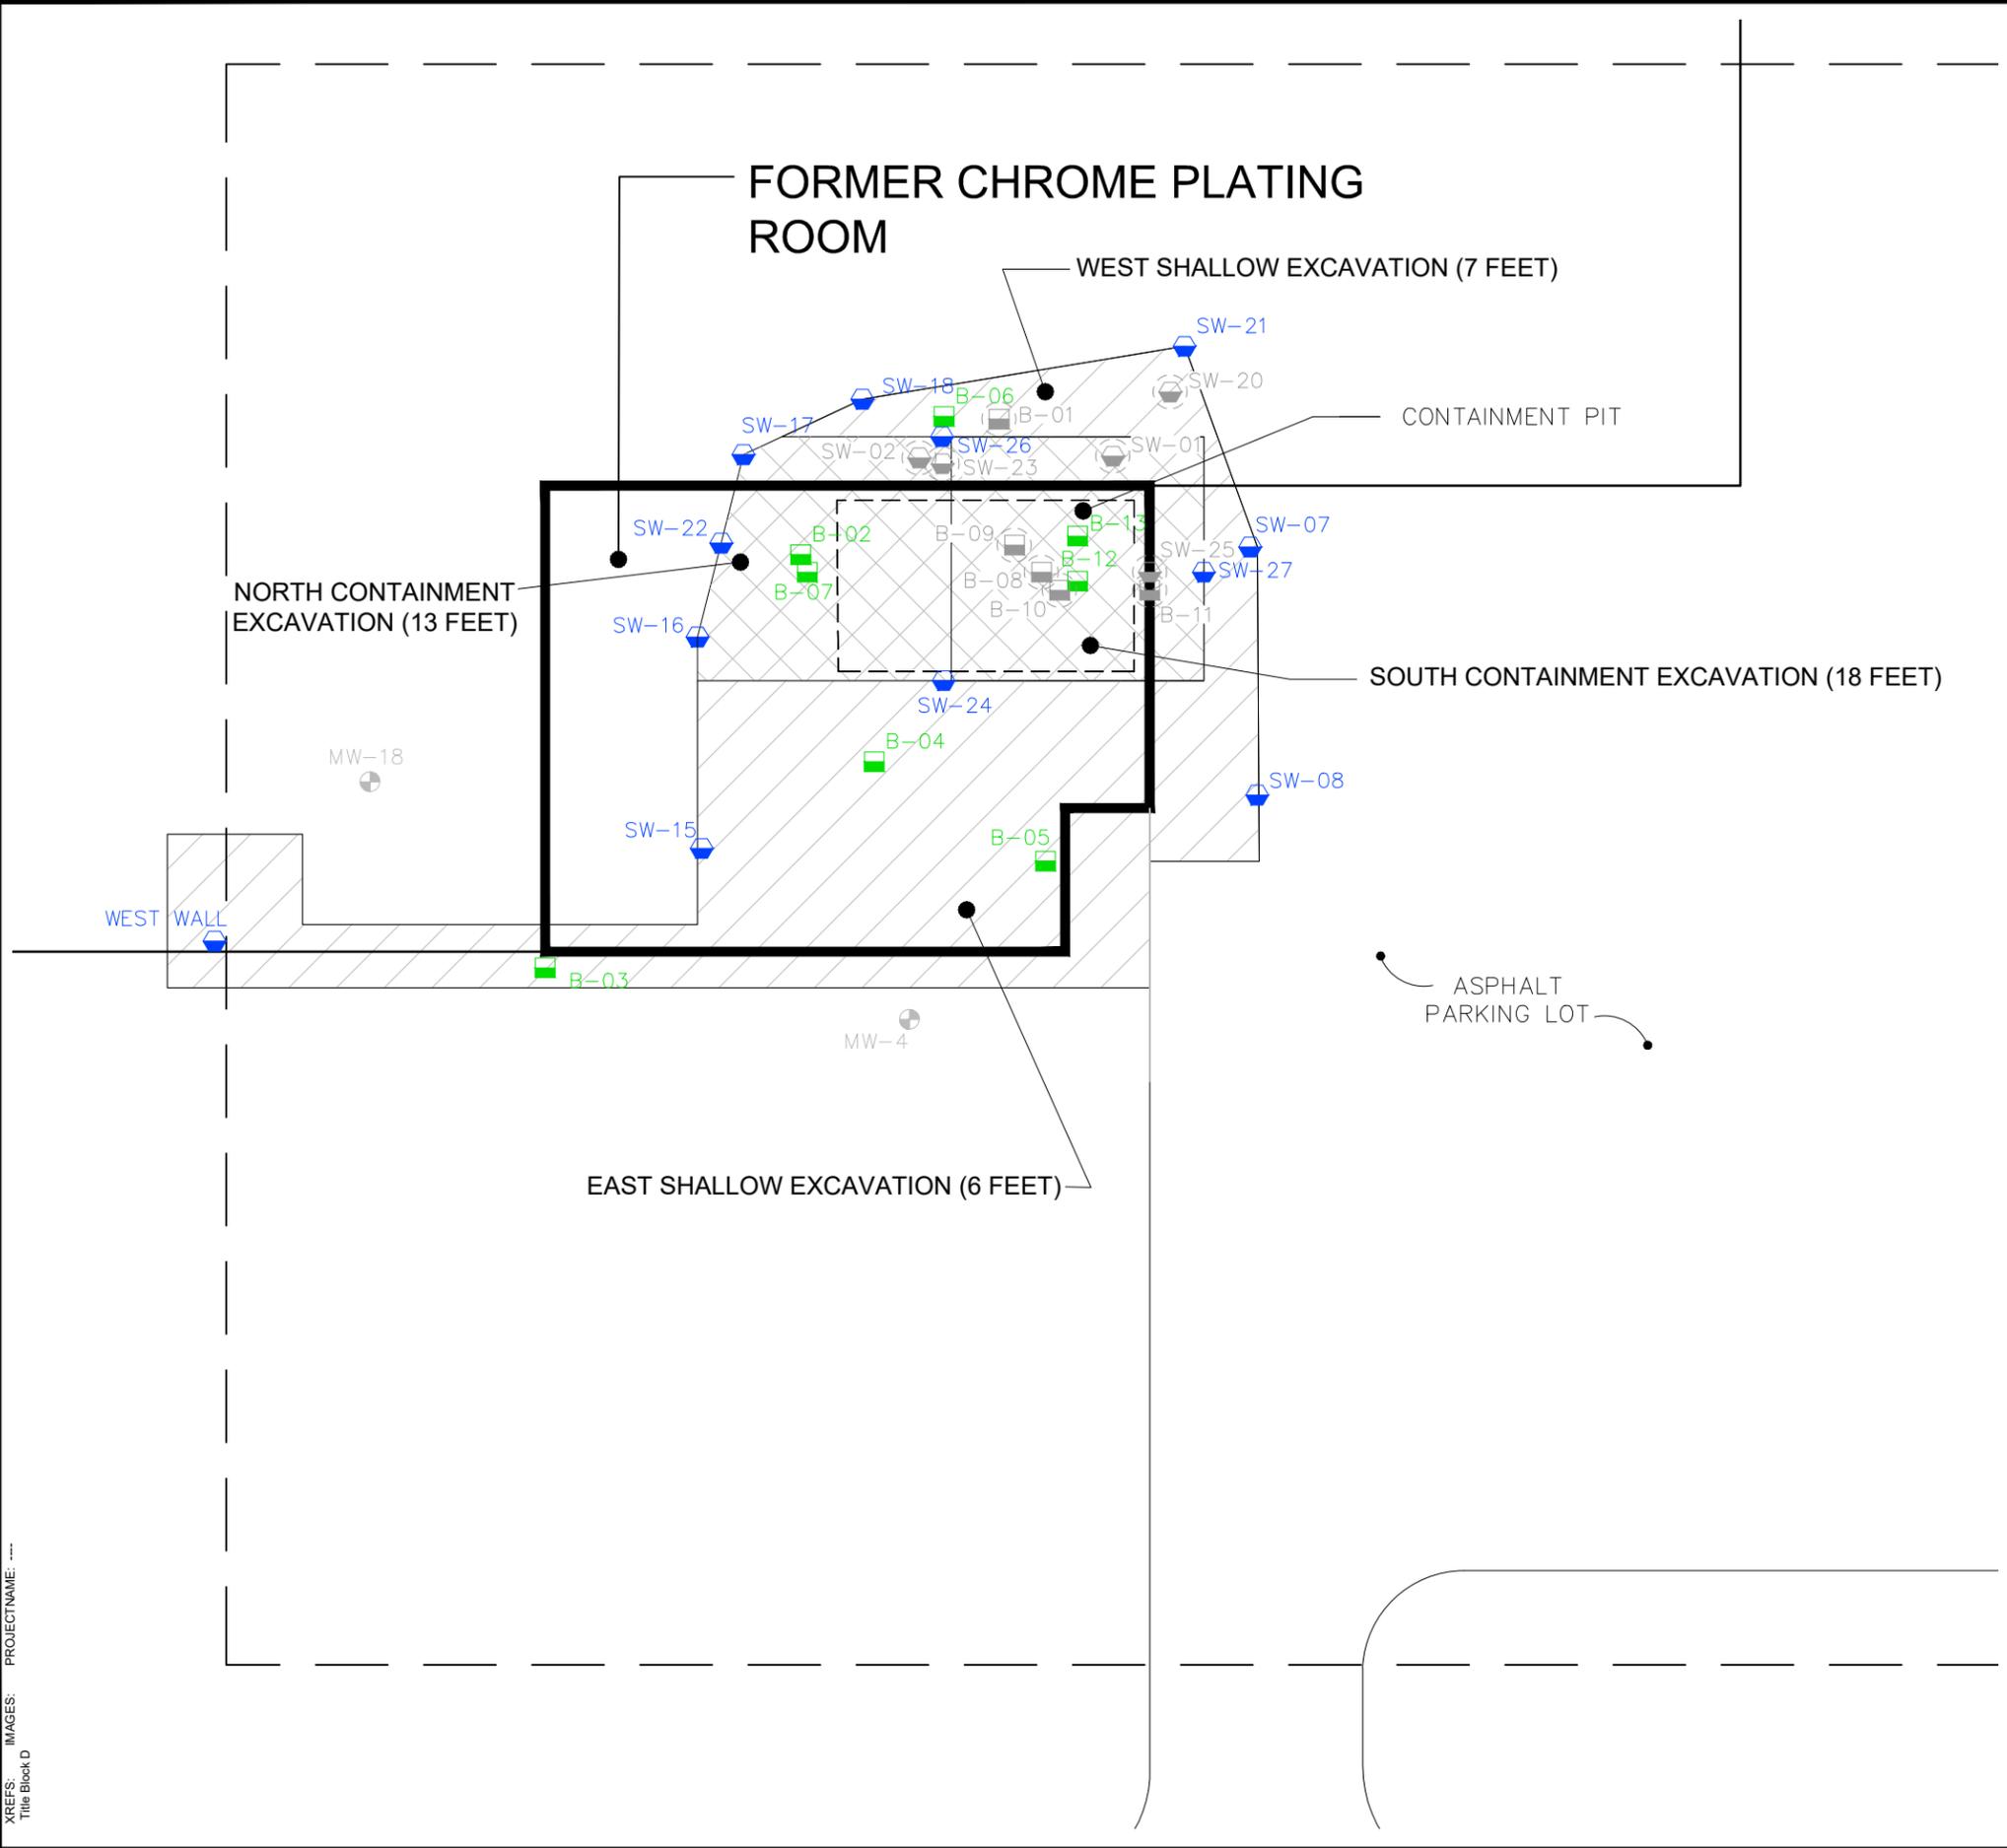
Bottom samples B-01 through B-05 were collected at the locations shown on Figure 4 to confirm that the vertical limits of the shallow excavation had been achieved. Bottom samples B-2 through B-4 were below the cleanup objective of 35 mg/kg. Because the chromium concentration for bottom sample B-01 (51 mg/kg) exceeded the site-specific cleanup criteria, this area was excavated an additional 1 foot vertically and resampled (B-06). The analytical results for bottom sample B-06 was 20 mg/kg, which is below the cleanup objective. Laboratory analytical results for bottom sample B-05 reported a chromium concentration of 37.0 mg/kg. However, after discussing these results with the NYSDEC, it was determined by the NYSDEC that the soil removal in this location was adequate to satisfy the intentions of the cleanup objective for the site.

Soil samples SW-22 through SW-27 were collected from the sidewalls of the deep (i.e., containment area) excavation, at the locations indicated on Figure 4, to confirm that the horizontal limits of the deep excavation had been achieved. Analysis of sidewall soil samples SW-23 (60 mg/kg) and SW-25 (47 mg/kg) for chromium exceeded the site-specific cleanup criteria. Therefore, excavation of the eastern sidewall and the southern sidewall continued to the east (approximately 2 feet) and the south (approximately 6 feet) to remove the additional soil (SW-23 and SW-25 locations). Sidewall soil samples SW-26 and SW-27 were then collected from the eastern and southern sidewalls, respectively, and analyzed for chromium for confirmation purposes. Post-excavation sidewall soil samples SW-22 (21 mg/kg), SW-24 (21 mg/kg), SW-26 (21 mg/kg), and SW-27 (22 mg/kg) represent the final excavation limits of the deep containment pit excavation confirming that the cleanup objective for chromium (35 mg/kg) was achieved.

Bottom samples B-07 and B-08 were collected from the base of the northern and southern halves, respectively, of the containment area excavation. The analytical result for bottom sample B-07 (19 mg/kg) indicated that the northern half of the containment area excavation had been vertically delineated at approximately 13 feet below existing grade. The analytical result for bottom sample B-08 (64 mg/kg) exceeded the site-specific cleanup criteria; therefore, an additional 1 foot of soil was excavated and removed from the southern half of the containment area excavation, and an additional bottom sample (B-09) was collected. Because the analytical result for bottom sample B-09 (190 mg/kg) also failed to meet the cleanup criteria, an additional 1 foot of soil was excavated, and bottom sample B-10 was collected. The analytical result for bottom sample B-10 (160 mg/kg) also exceeded the site-specific cleanup criteria; therefore, further excavation was required. After removing an additional 1 foot of soil, bottom sample B-11 (56 mg/kg) was collected. The analytical result for bottom sample B-11 again failed to meet the site-specific cleanup criteria. As a result, an additional 2 feet of soil was then excavated and removed, with the bottom of the excavation now at approximately 18 feet below existing grade. At this point, a bottom sample (B-12) was collected and a test pit was excavated an additional 3 feet within the bottom and another soil bottom sample (assessment) (B-13) was collected. The analytical results for bottom samples B-12 (17 mg/kg) and B-13 (26 mg/kg) confirmed that the cleanup criteria was achieved at approximately 18 feet below grade, and therefore, excavation activities were complete and no further excavation was conducted.

The locations of all confirmatory soil samples are shown on Figure 4. Analytical results for confirmatory sidewall and bottom samples are summarized in Tables 1 and 2, respectively. Each of these tables
