2018 ANNUAL REPORT

WORK ASSIGNMENT D007622-08.1

**STUART OLVER HOLTZ SITE
HENRIETTA (T)**

**SITE NO. 828079
MONROE (C), NY**

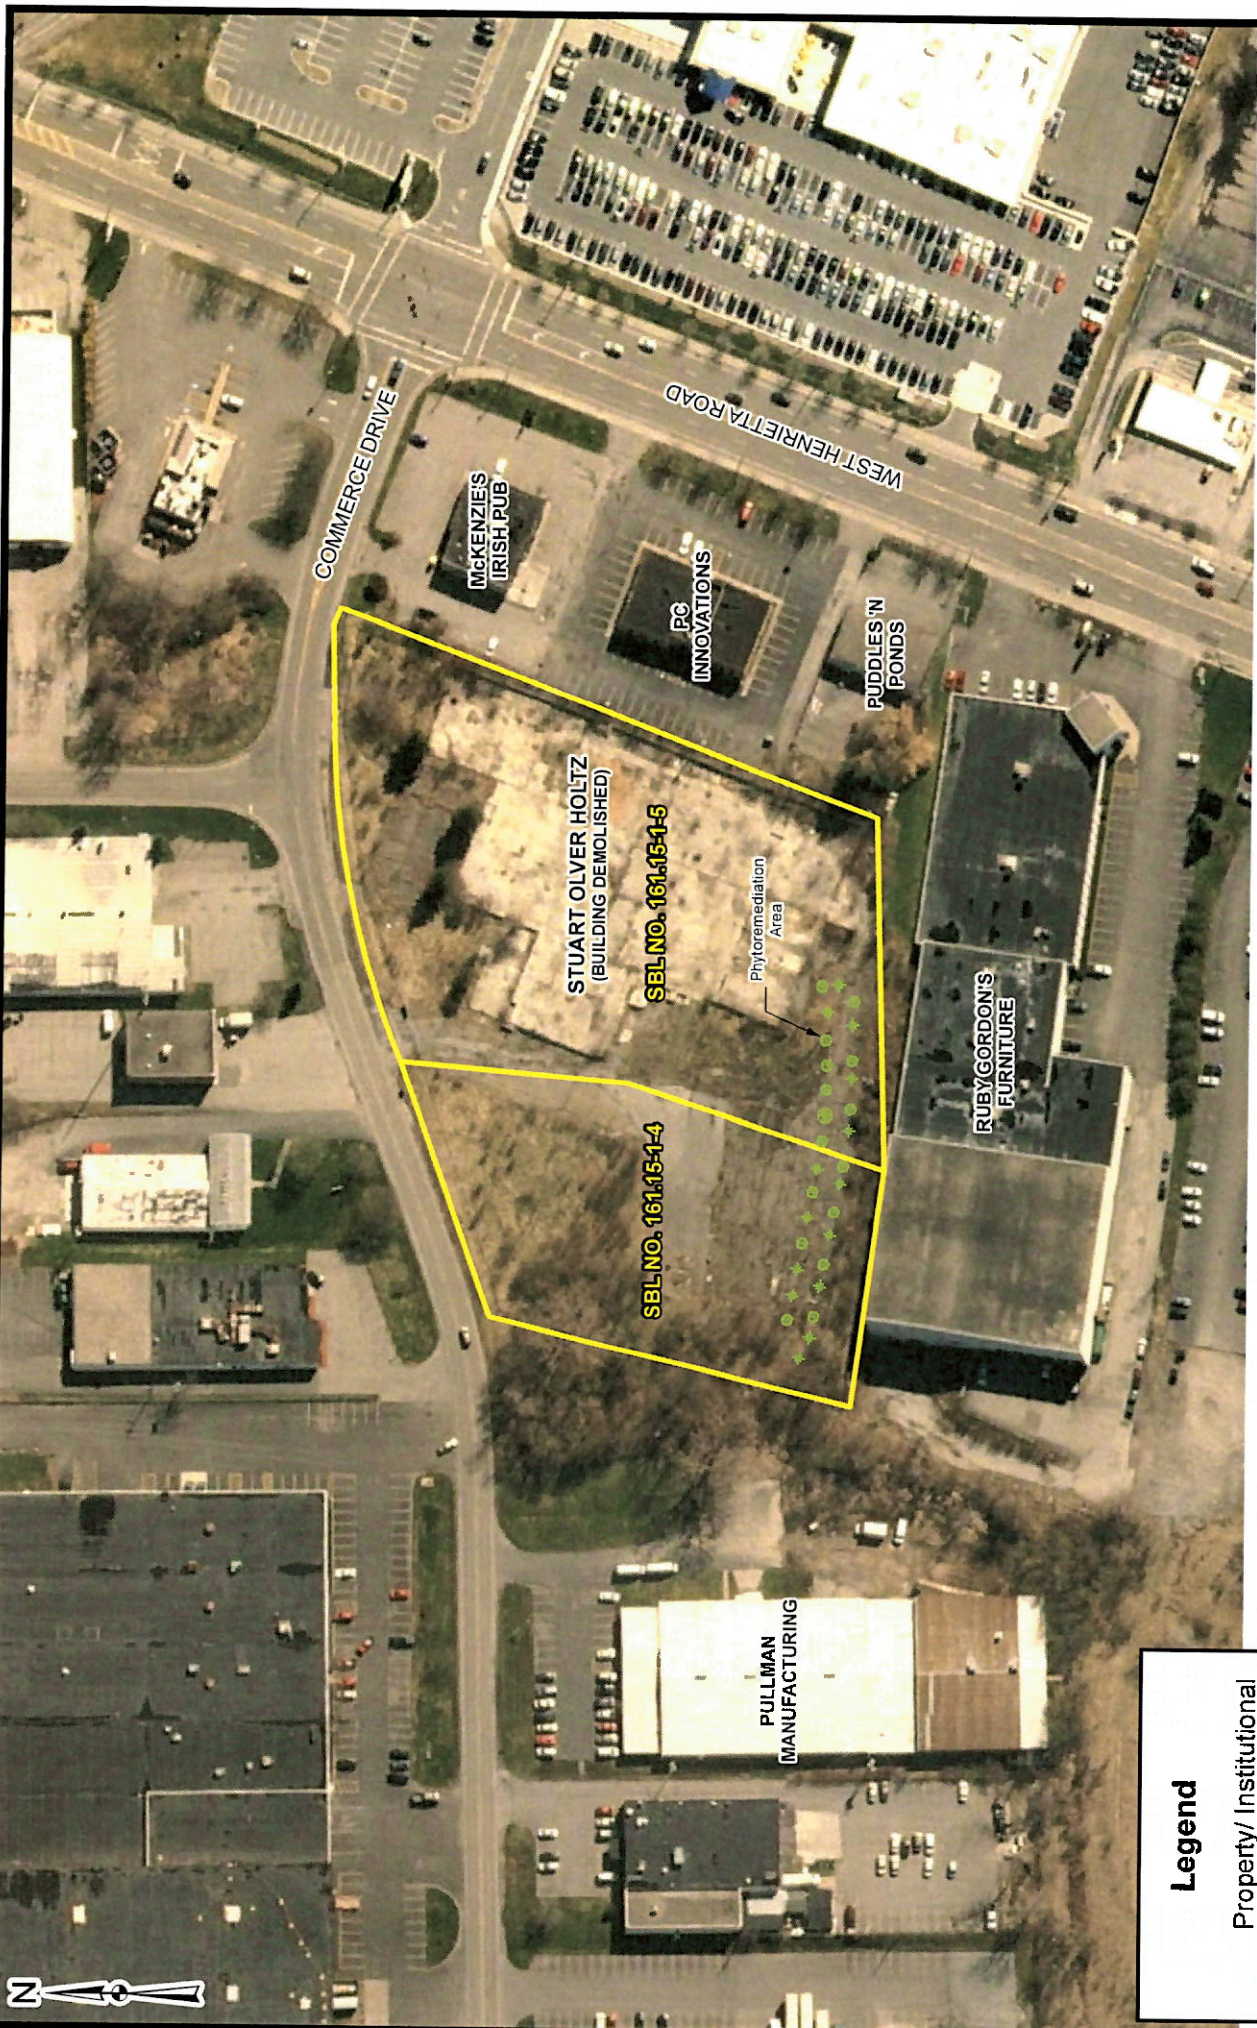
FIGURE 2

STUART OLVER HOLTZ SITE SITE PLAN

A series of ICs is required by the ROD to: implement, maintain and monitor Engineering Controls; prevent future exposure to remaining contamination; and, limit the use and development of the Site to commercial or industrial uses only. Adherence to these ICs is required by the Environmental Easement and implemented under the SMP. ICs may not be discontinued without an amendment to, or extinguishment of, the Environmental Easement. The ICs are implemented to the extent of the Site boundary, which is shown on Figure 2. The site-specific ICs are:
