**2023 Annual Report
Dinaburg Distributing, Inc. Site
Rochester, New York
NYSDEC Site Number 828103**

November 2024
Version: FINAL
EA Project No. 1602534.18

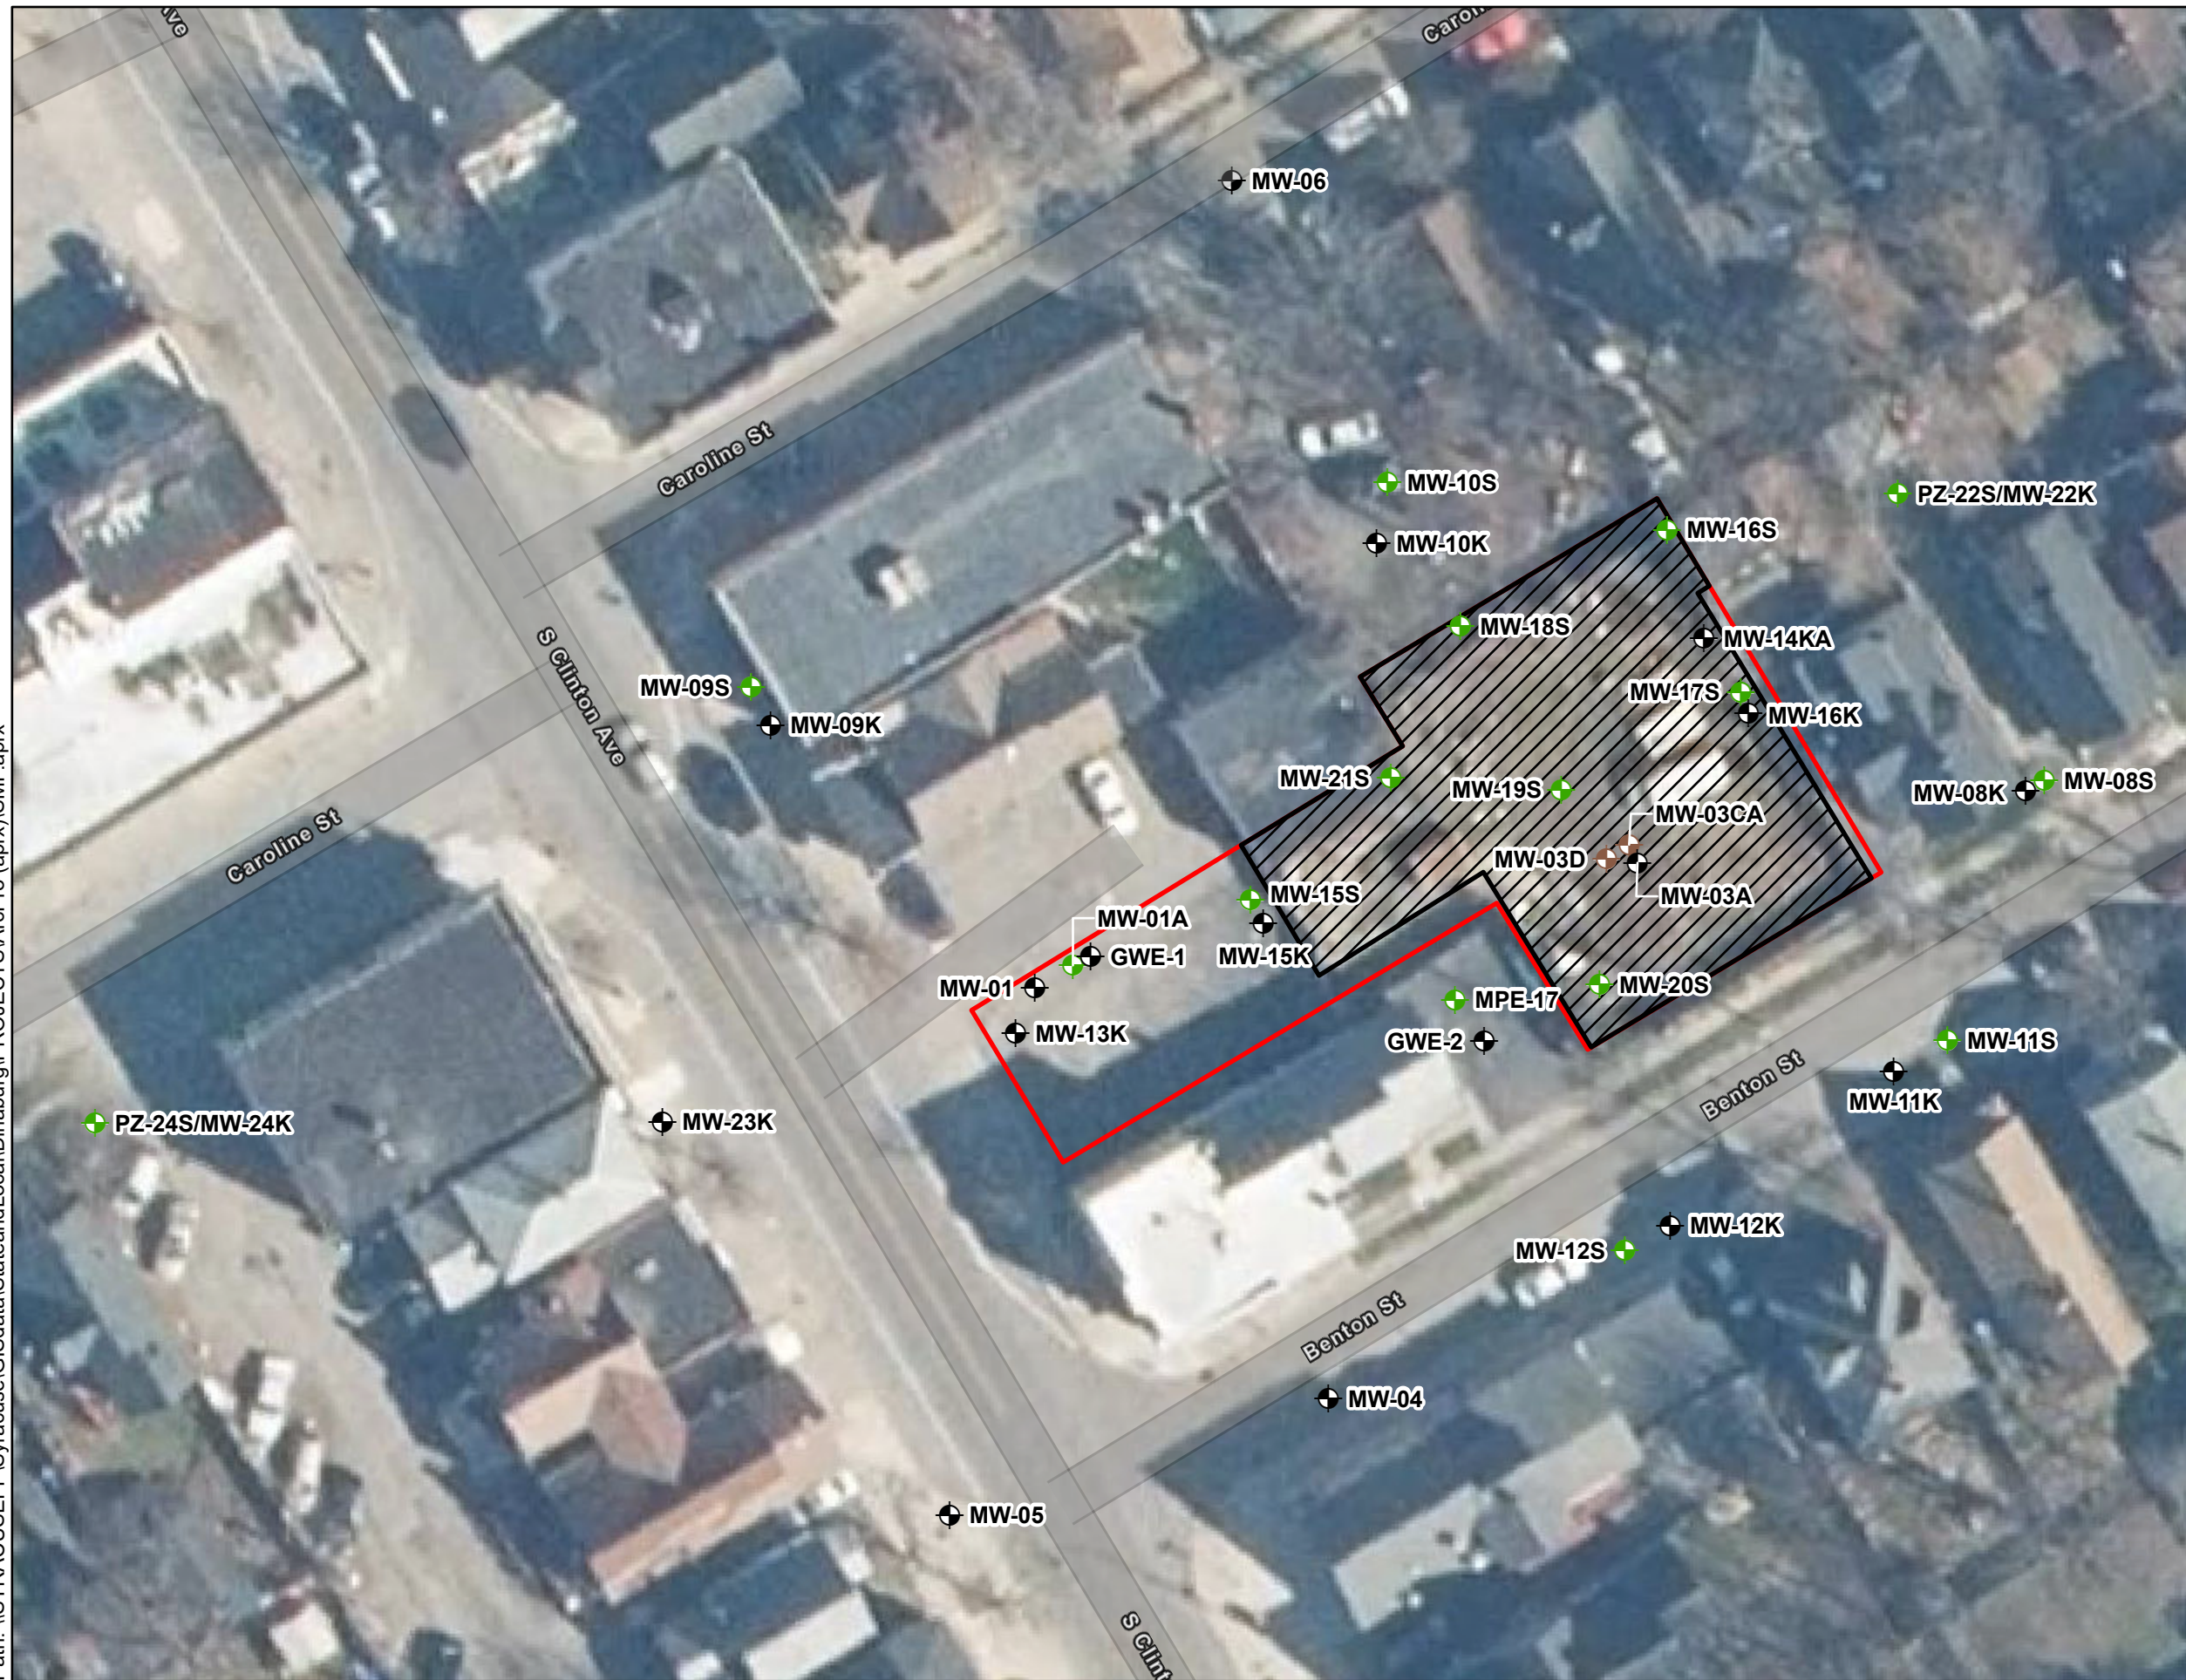
Figure 1-2
Site Layout
Dinaburg Distributing, Inc. (828103)
Rochester, New York

- ▬ Site Boundary
- ERH Treatment Area
- + Overburden Monitoring Well
- + Overburden/Bedrock Interface Monitoring Well
- + Bedrock Monitoring Well

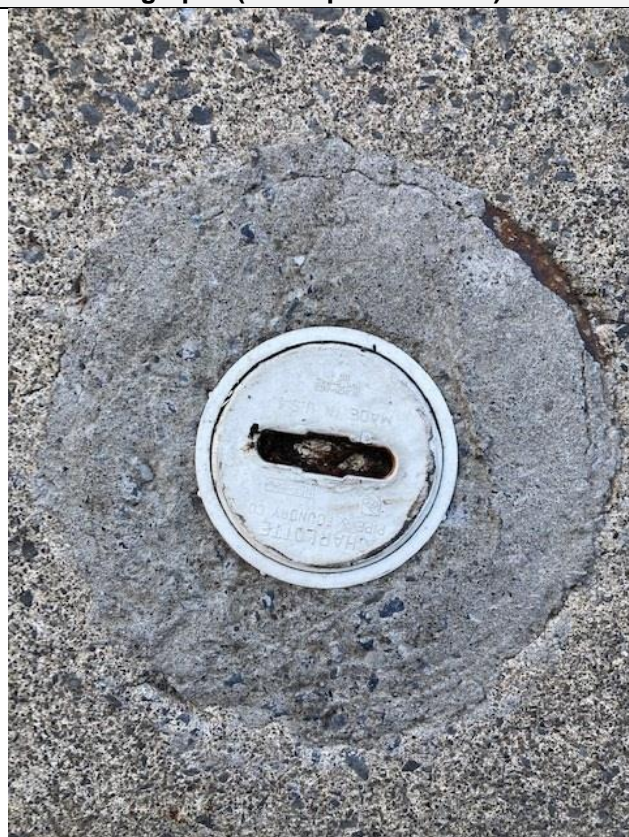
Plastic cap on MW-9S

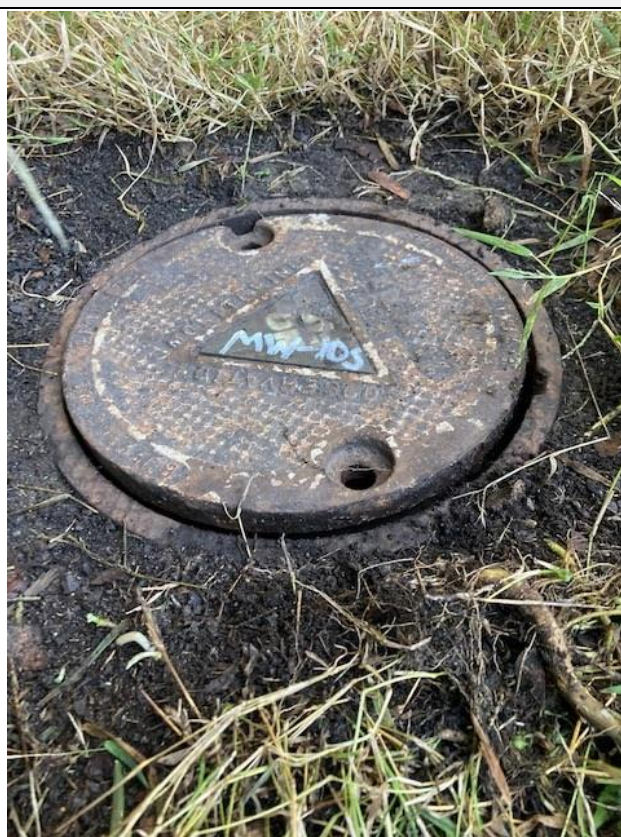
MW-10S not flush with J-plug

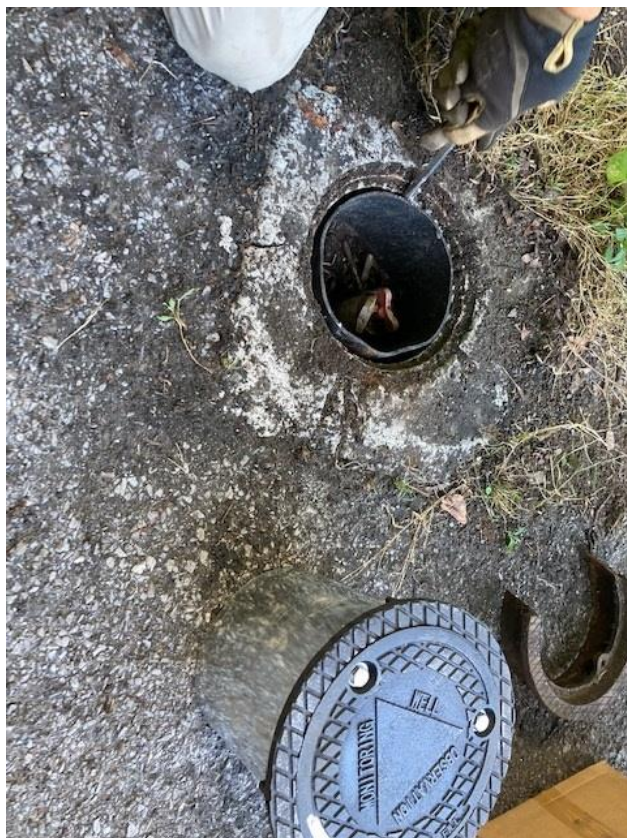
Removal of destroyed MW-10K well cap

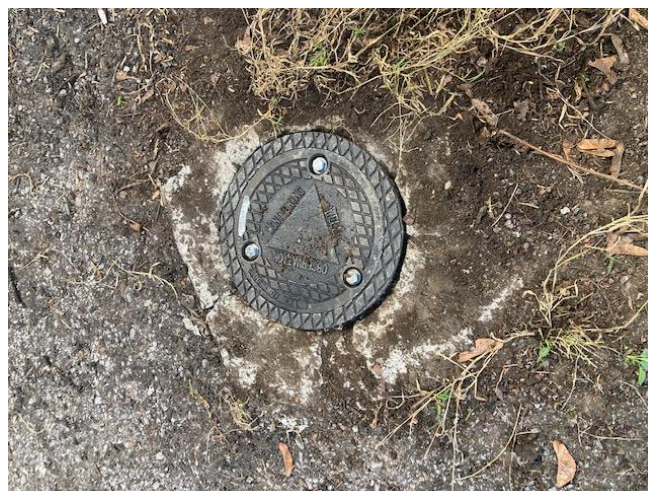
Newly installed MW-10K well cap

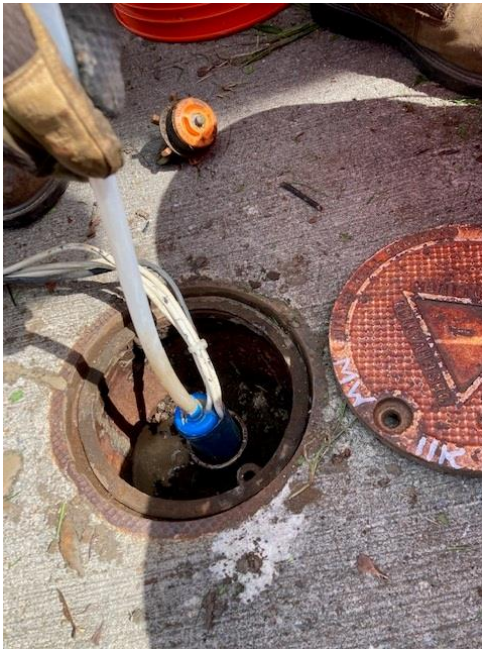
MW-11K showing depth at which Whale Pump could not descend further.

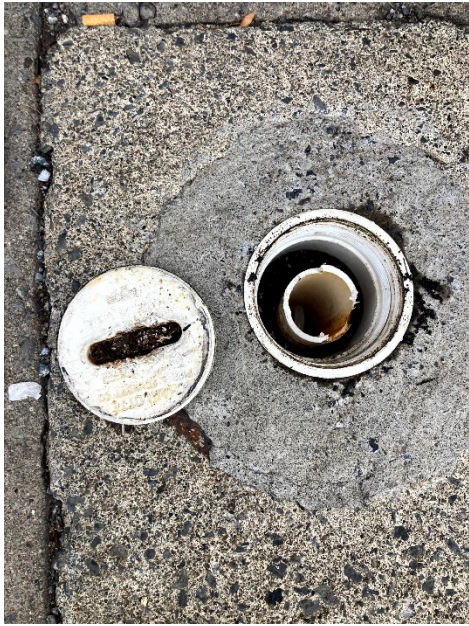
MW-9S with cap off

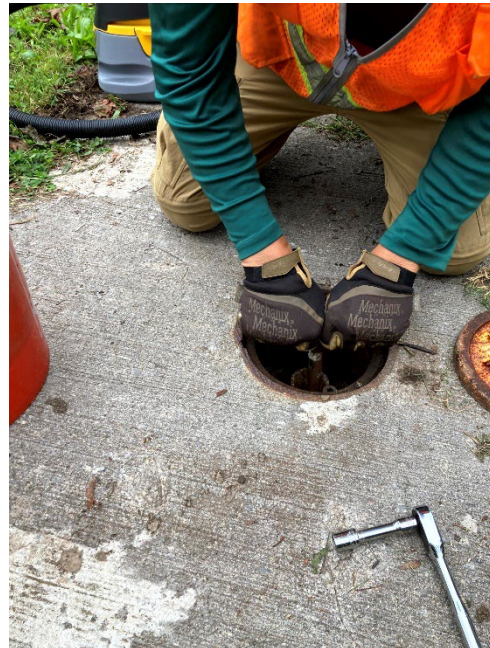
Attempting to remove sediment from MW-11K

Down-hole view of MW- 11K after removing sediment revealing broken PVC at ~3.5 ft

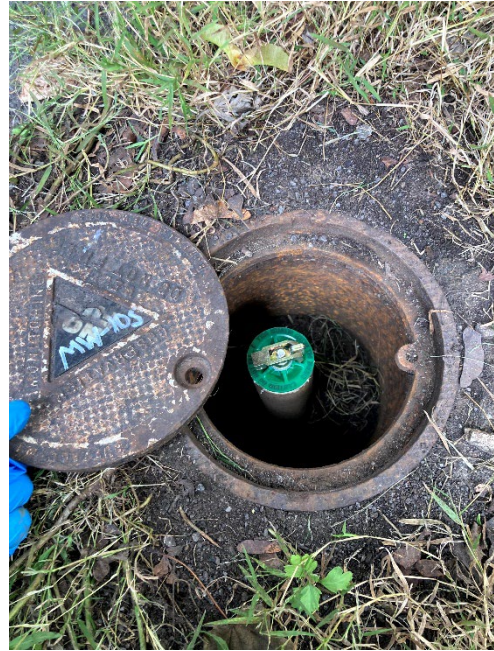
J-plug installed on MW-10S after shortening PVC

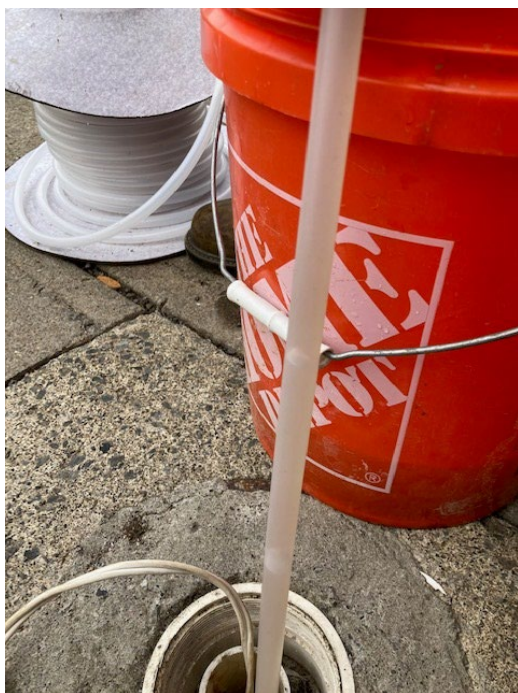
Turbid water being purged from MW-9S

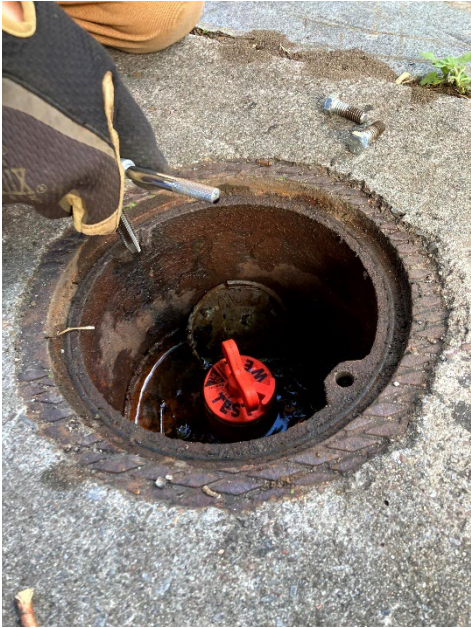
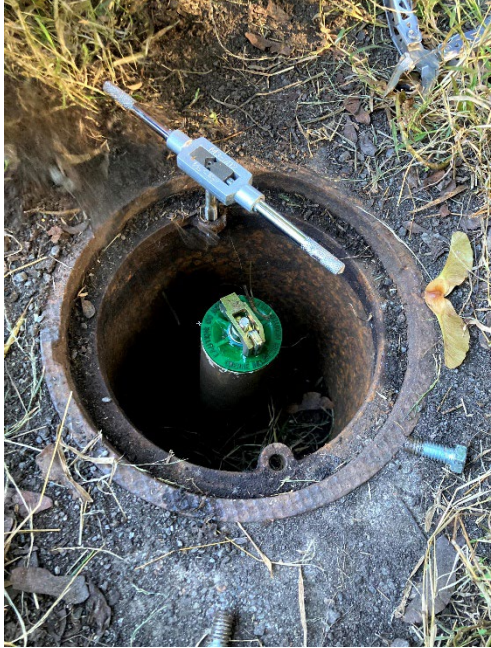
MW-06: Attempting to rethread a broken bolt seat	MW-10S: Successfully rethreaded bolt seat.		
<u>WELL MONITORING TABLE</u>			
Well ID	DTW	DTB	Notes
Site Inspector(s): Cody Badman, Alex Stoogenke			Date: 09/14/2023
