**Report for the Preliminary Site  
Assessment at the Abandoned  
Chemical Sales Facility Site,  
Rochester, New York**

**Site Number: 8-28-105**

**March 2002**

**NEW YORK STATE DEPARTMENT OF ENVIRONMENTAL CONSERVATION**

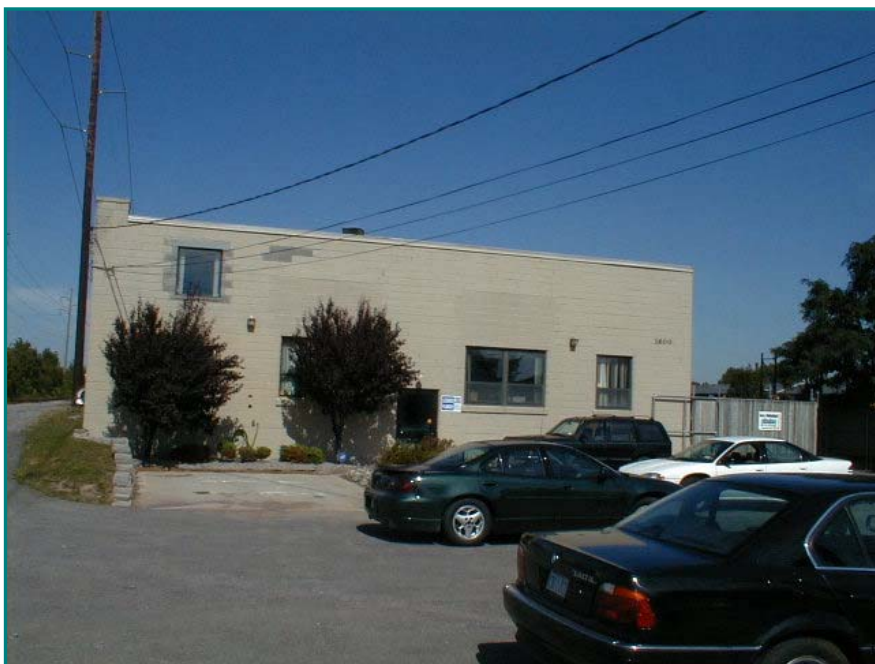
**Photo B-1 MA Ferrauilo Plumbing building at 1600 Jay Street. This building was constructed in the 1950s.**

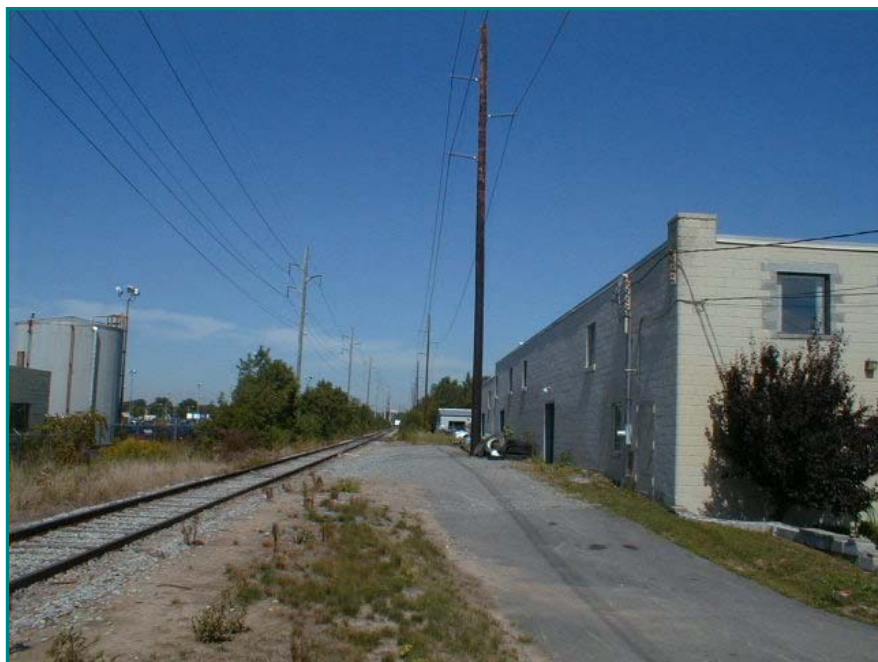
**Photo B-2 Looking north, with MA Ferrauilo Plumbing to the right, and railroad tracks and Valeo Electrical Systems to the left.**

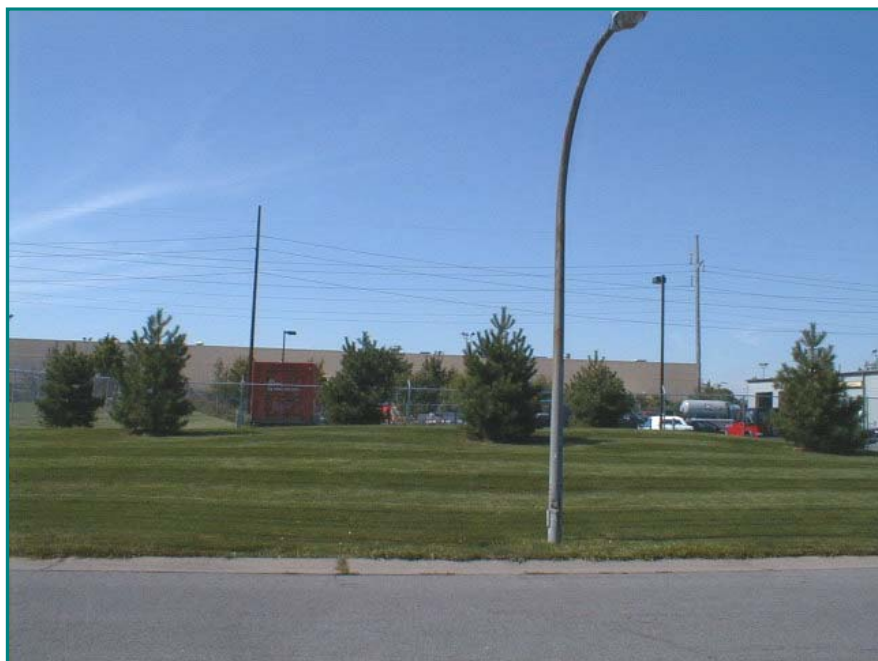
**Photo B-3 Open field north of MA Ferrauilo Plumbing building at 1600 Jay Street.**

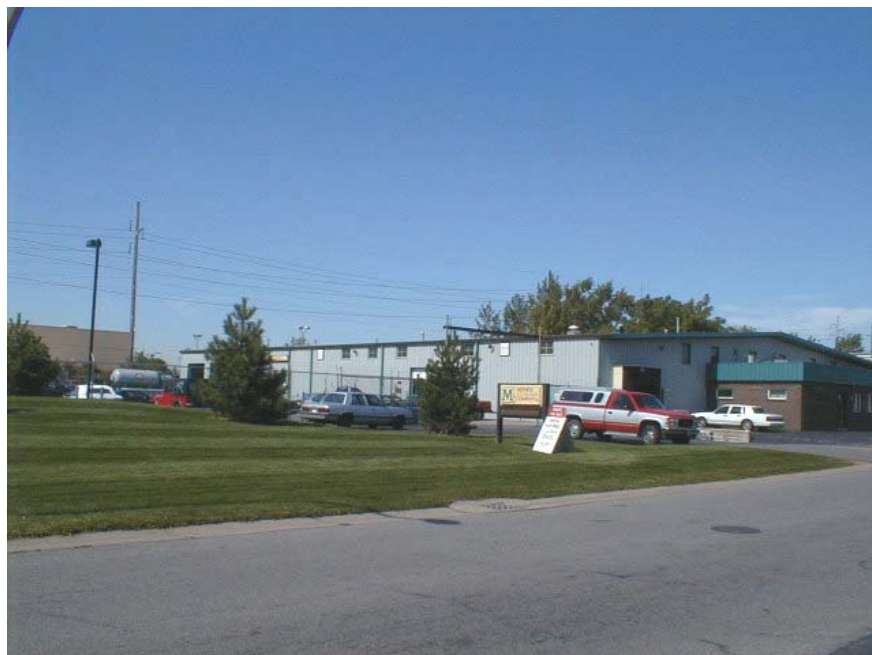
**Photo B-4 Northern portion of the open field at 1600 Jay Street, and Monroe Extinguisher Company building at 105 Dodge Street.**

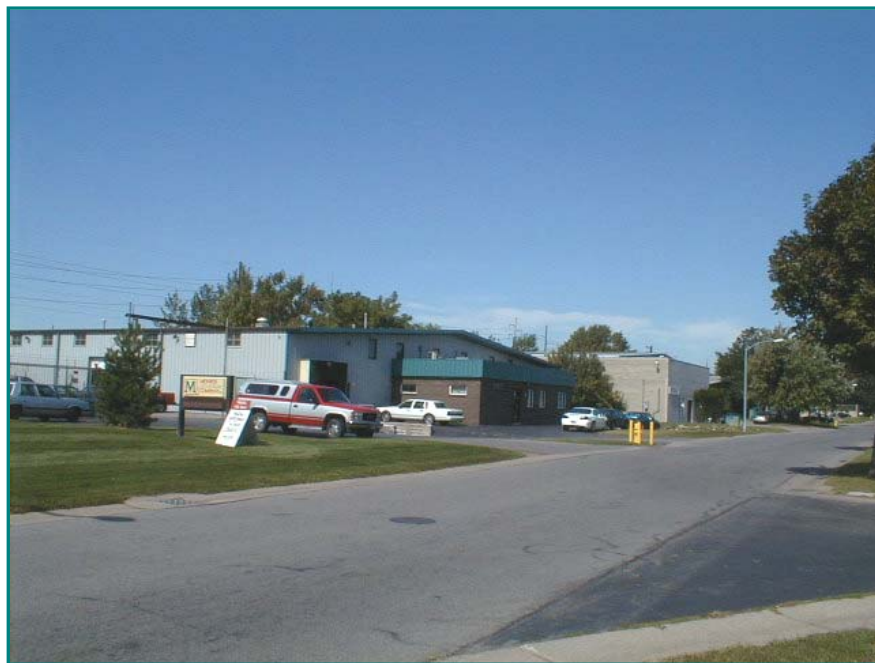
**Photo B-5 Looking north on Dodge Street with Monroe Extinguisher, 105 Dodge Street, (foreground) and Buell Specialty Steel, 107 Dodge Street, (background) shown.**

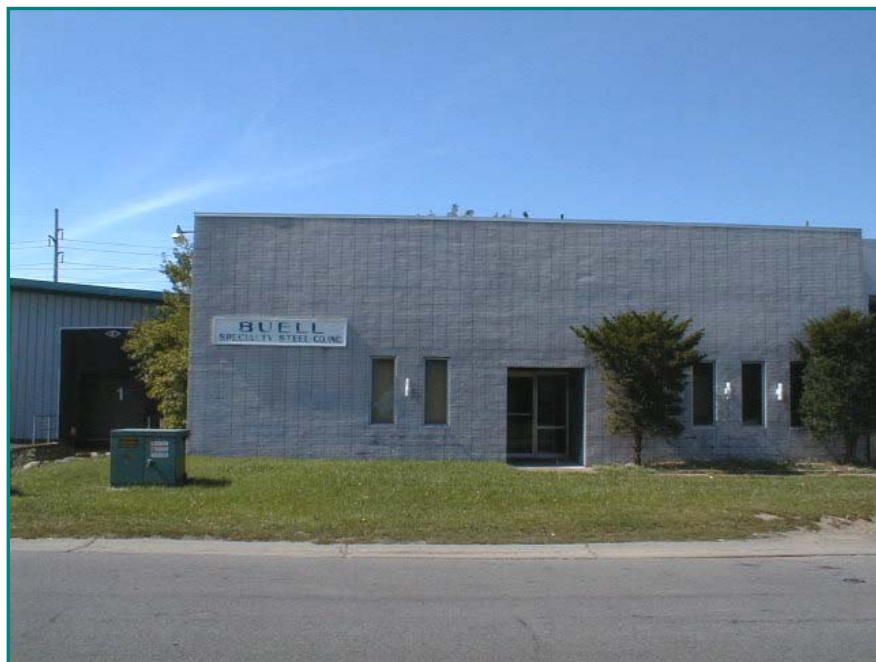
**Photo B-6 Buell Specialty Steel (107 Dodge Street).**

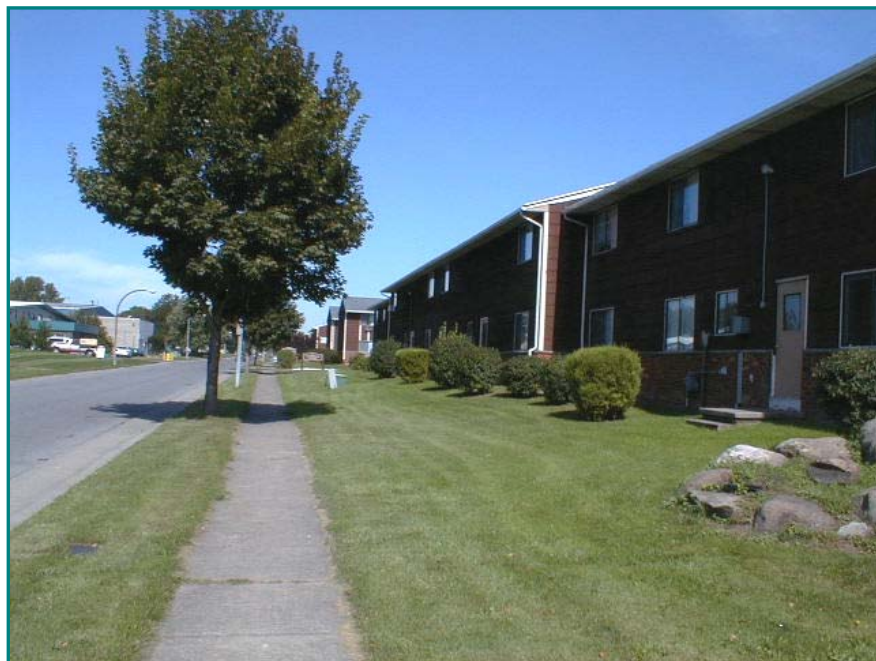
**Photo B-7 Looking north on the east side of Dodge Street with residential apartments to the right. Background surface soil samples were taken on easements between sidewalk and road.**
