**NEW YORK STATE DEPARTMENTS OF ENVIRONMENTAL CONSERVATION AND HEALTH  
INACTIVE HAZARDOUS WASTE DISPOSAL SITE PRIORITY RANKING WORKSHEET**

<b>Site Name:</b> Edward Allen Landfill	<b>Site Code:</b> 851001
Class Code: 4      Region: 8      County: Steuben	EPA Id: NYD980506240
Address: Bailey Creek Road	City: Corning      Zip: 14830
Latitude: 42 5' 47"      Longitude: 77 4' 9"	
Site Type: Landfill	Estimated Size: 25 Acres

**FIGURE 3-1**  
**AREA OF GEOPHYSICAL SURVEY**  
**PRELIMINARY SITE ASSESSMENT REPORT**  
**SPEEDY'S CLEANERS SITE**  
**PITTSFORD, NEW YORK**  
 Harding Lawson Associates

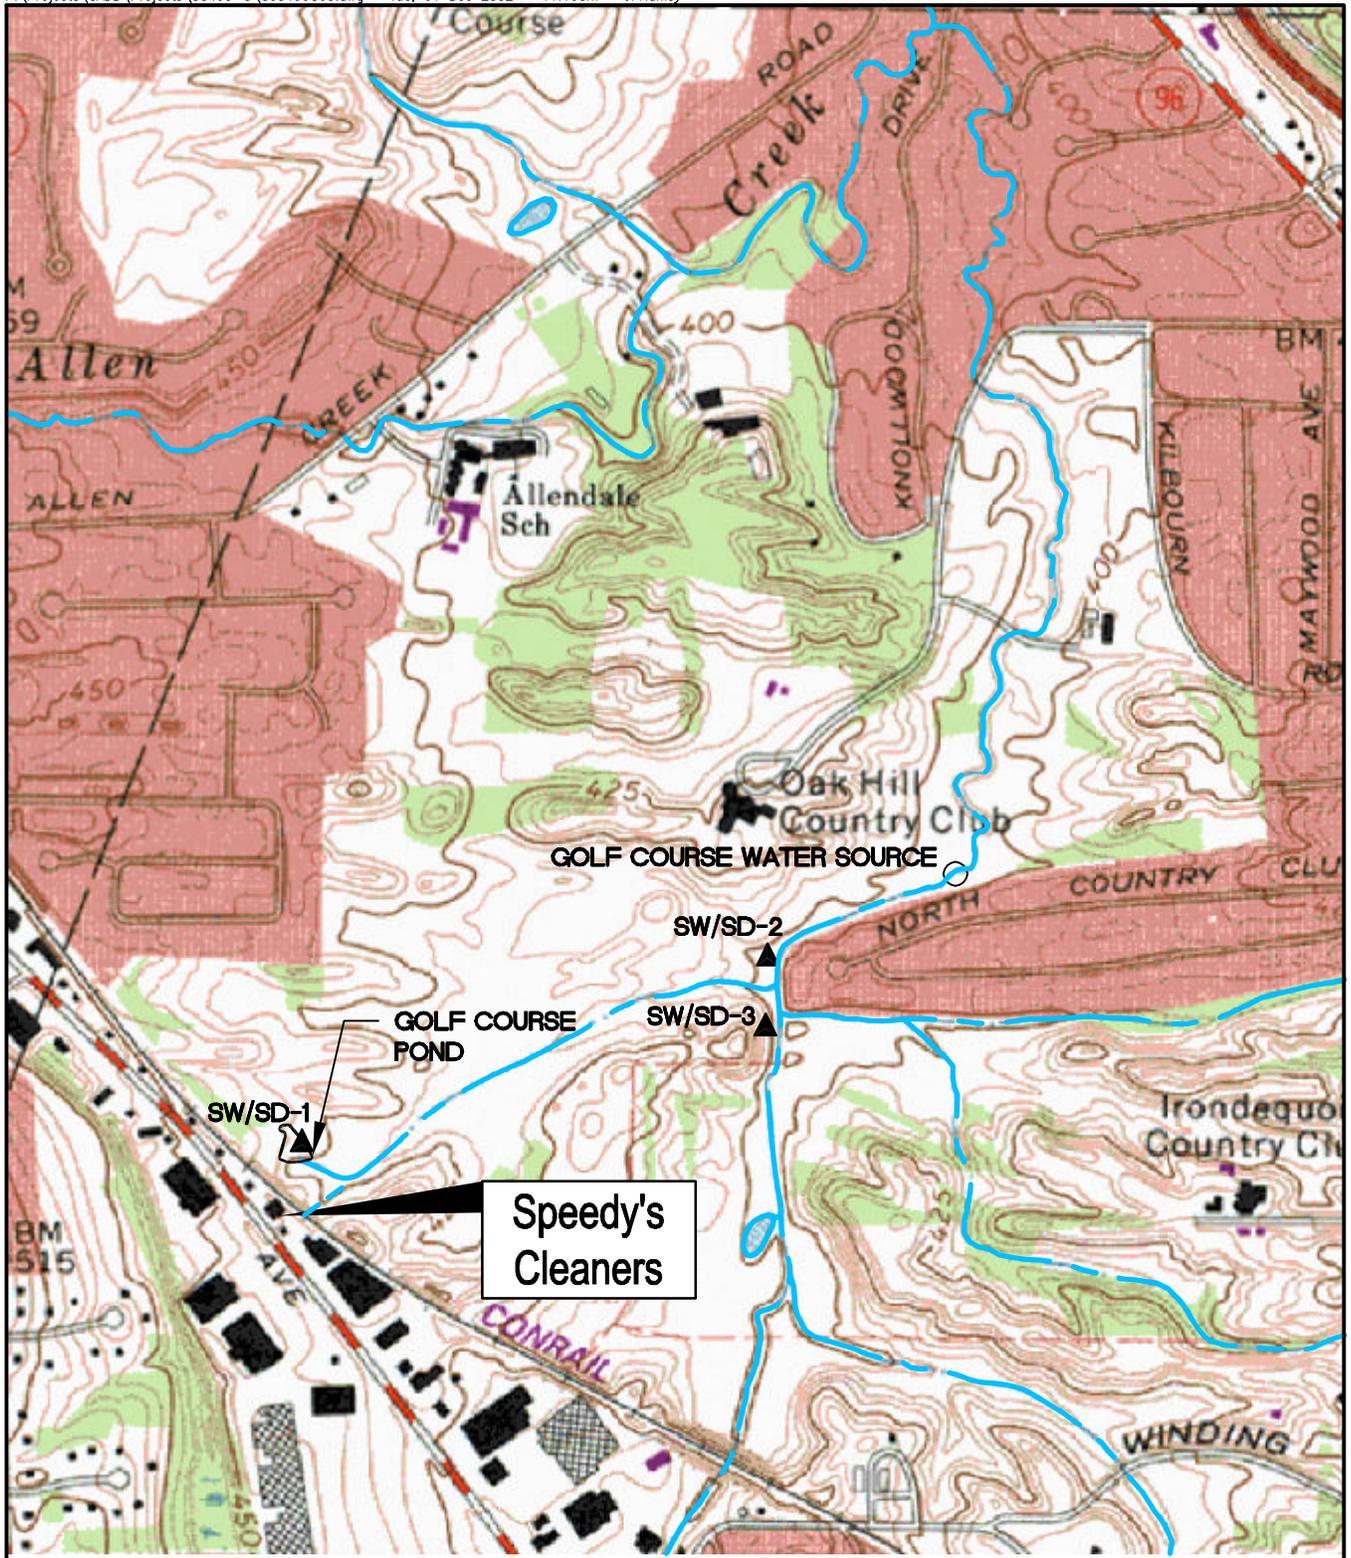
**FIGURE 3-2**  
**SURFACE WATER AND SEDIMENT SAMPLE LOCATIONS**  
**PRELIMINARY SITE ASSESSMENT REPORT**  
**SPEEDY'S CLEANERS SITE**  
**PITTSFORD, NEW YORK**

SW/SD-1 ▲ SURFACE WATER AND SEDIMENT SAMPLE LOCATION

No VOCs were detected in the three surface water or sediment samples collected. Surface water results are presented in Table 4-2; sediment sample results are presented in Table 4-3.

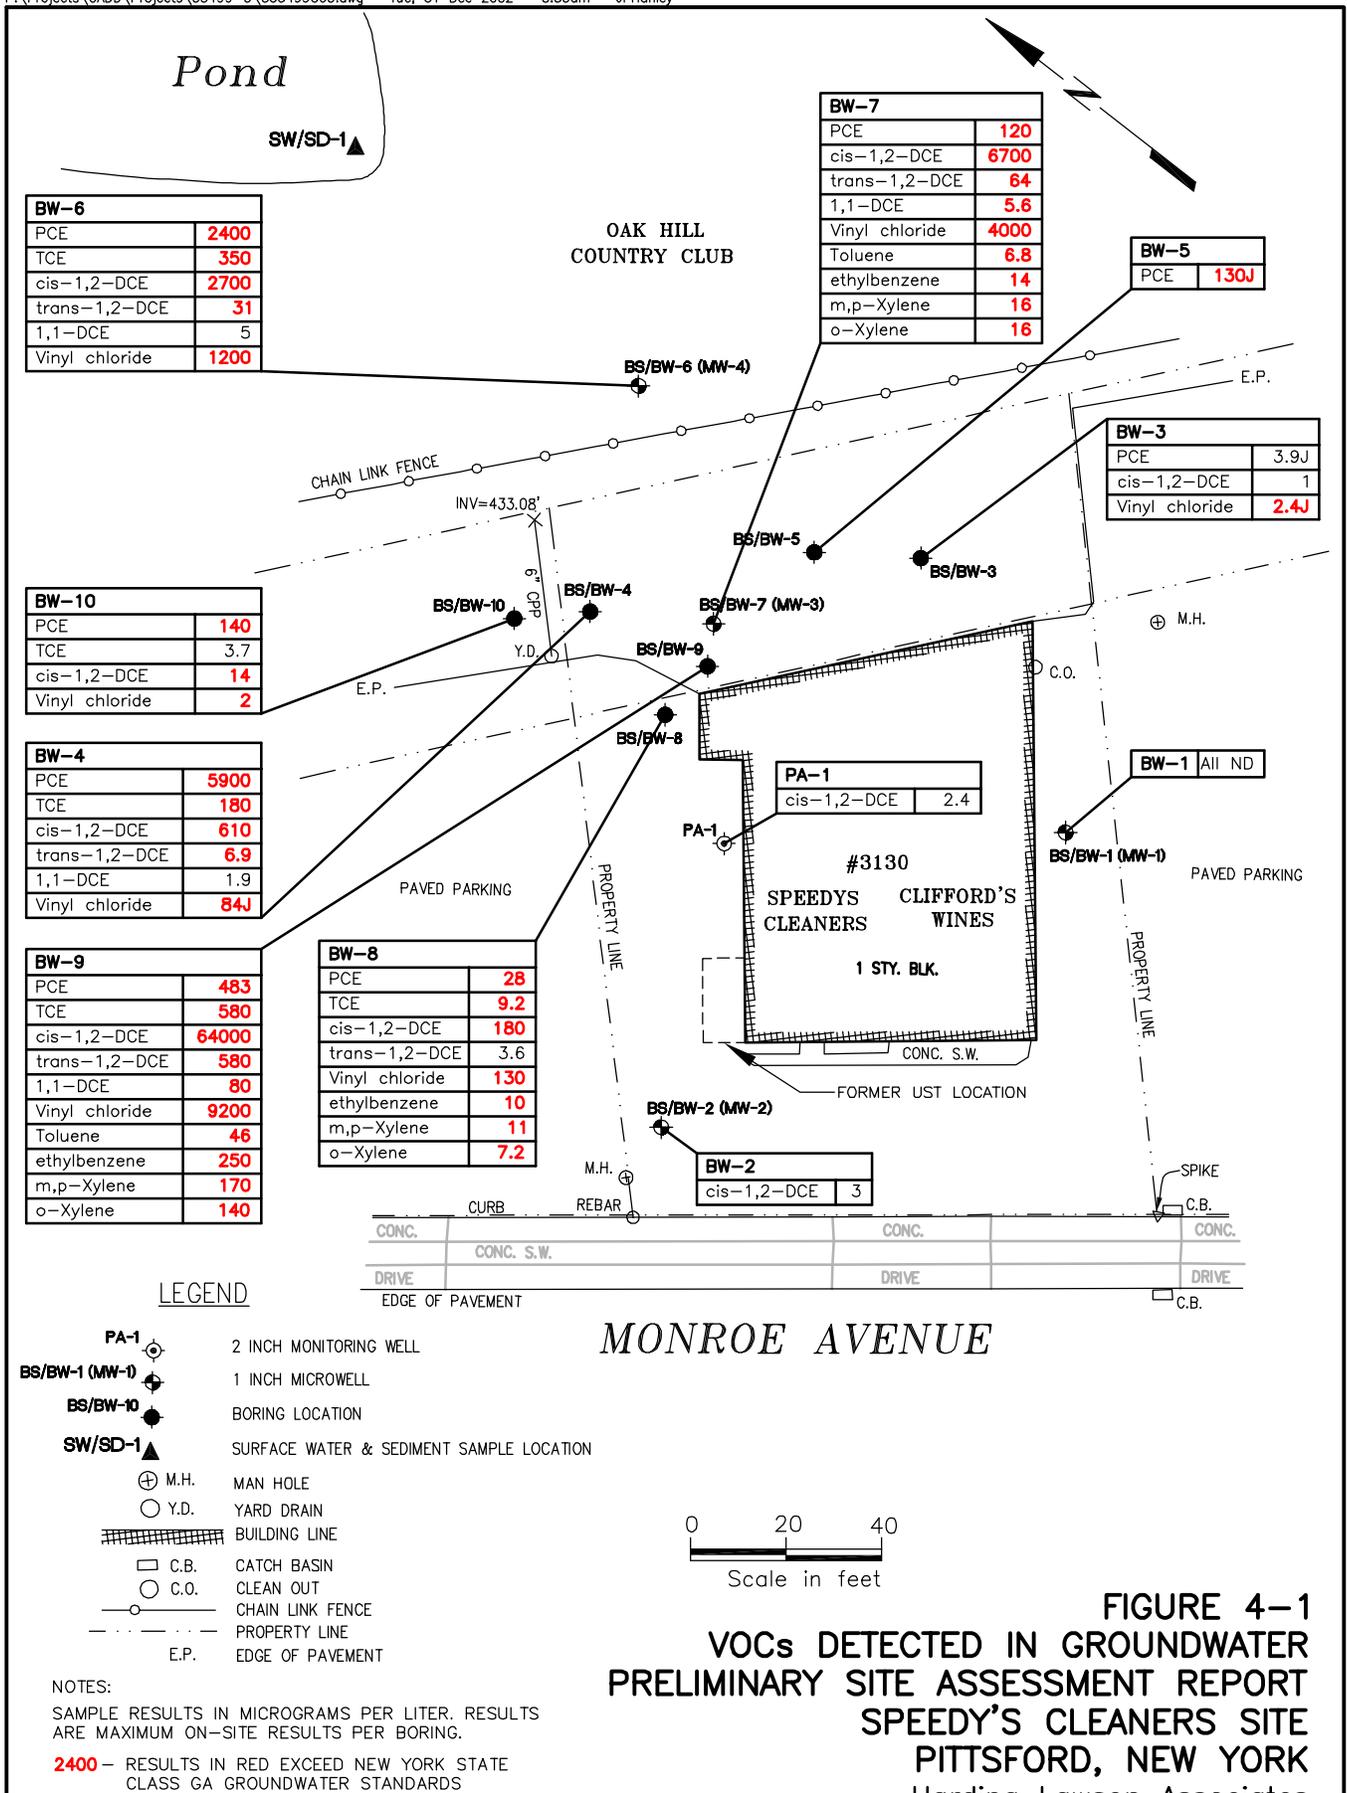
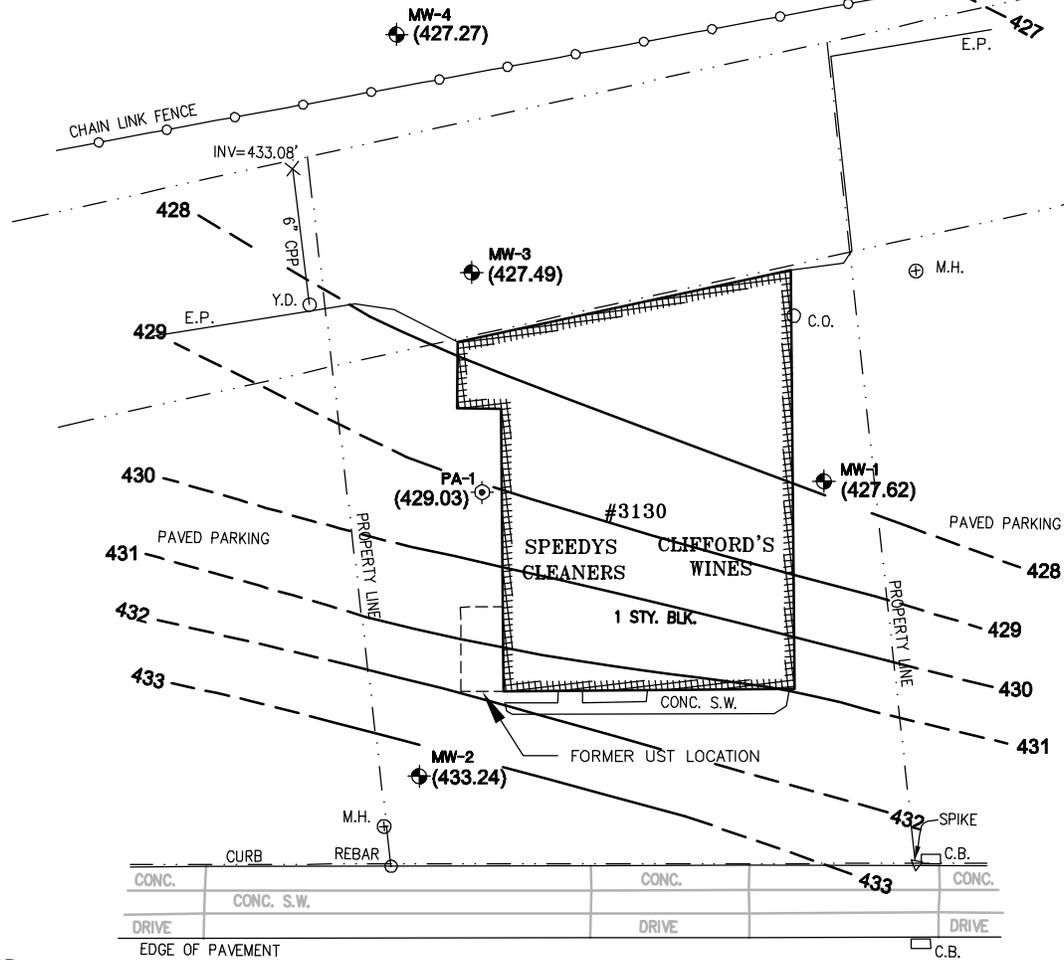
**FIGURE 4-2**  
**POTENTIOMETRIC SURFACE MAP**  
**PRELIMINARY SITE ASSESSMENT REPORT**  
**SPEEDY'S CLEANERS SITE**  
**PITTSFORD, NEW YORK**

Well and pond survey and depth to water measurements from September 26, 2002 were used to create a potentiometric surface map (Figure 4-2). Microwell survey and water elevation data are presented in Table 4-3. To preclude introduction of possibly false high water levels caused by heavy rains during the evening of September 26 and day of September 27, groundwater measurements collected on September 27, 2002 were not used for contouring groundwater data. Measured groundwater elevations on September 26 varied from a high of 433.24 feet above msl southwest of the Site buildings, to a low of 427.13 feet above msl at the golf course pond. Interpreted groundwater surface contours indicate that groundwater flows to the northeast. Because MW-7 was located adjacent to the public sewer lines, groundwater levels in MW-2 may be artificially high due to the presence of localized drainage in the gravel trenches of the utility lines.

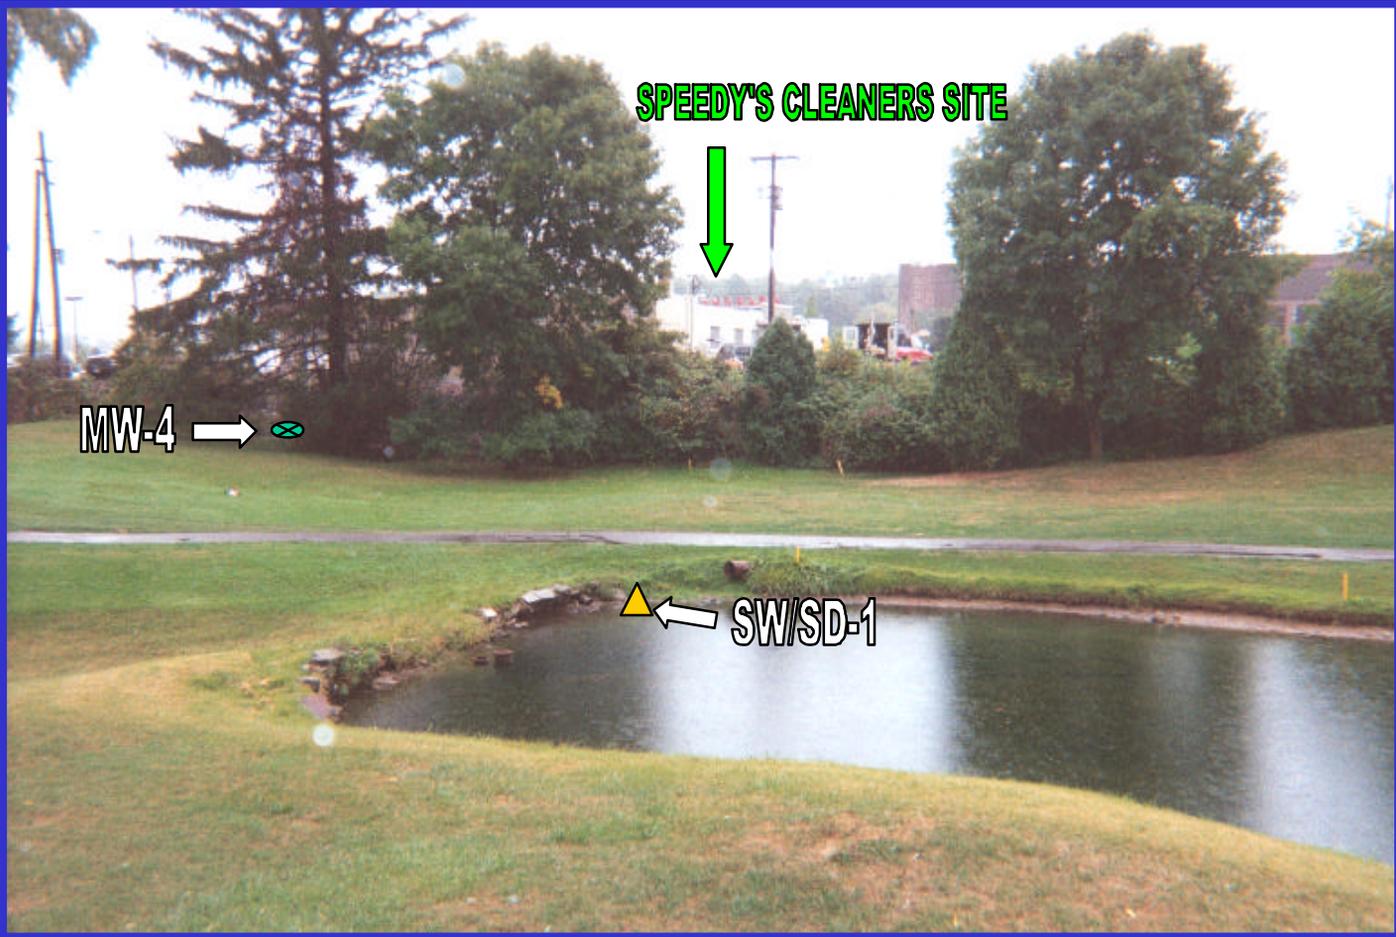
Looking south from small pond on Oak Hill Country Club fairway #13 to Site

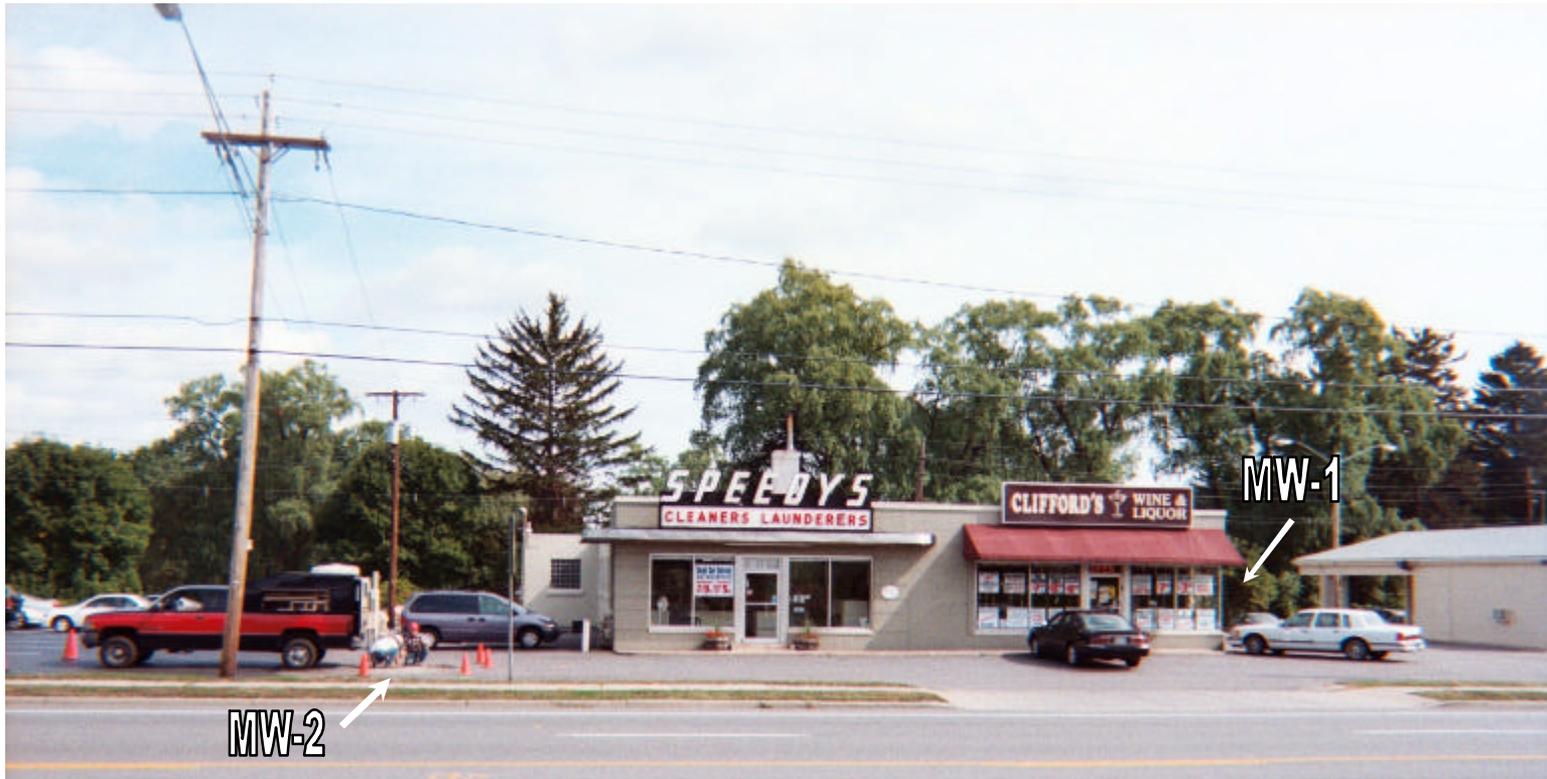
Looking northeast across Monroe Avenue towards Site
