Re: 595 Trabold Rd., Gates, NY
NYSDEC Site #C828110
Soil Vapor Intrusion Mitigation System Completion Report

CONSTRUCTION COMPLETION REPORT

SUB-SLAB DEPRESSURIZATION SYSTEM DIAGRAM
 Installed by: Mitigation Tech, 55 Shumway Rd., Brockport, NY 14420
 595 Trabold Rd., Gates, NY NYSDEC Site #C828110

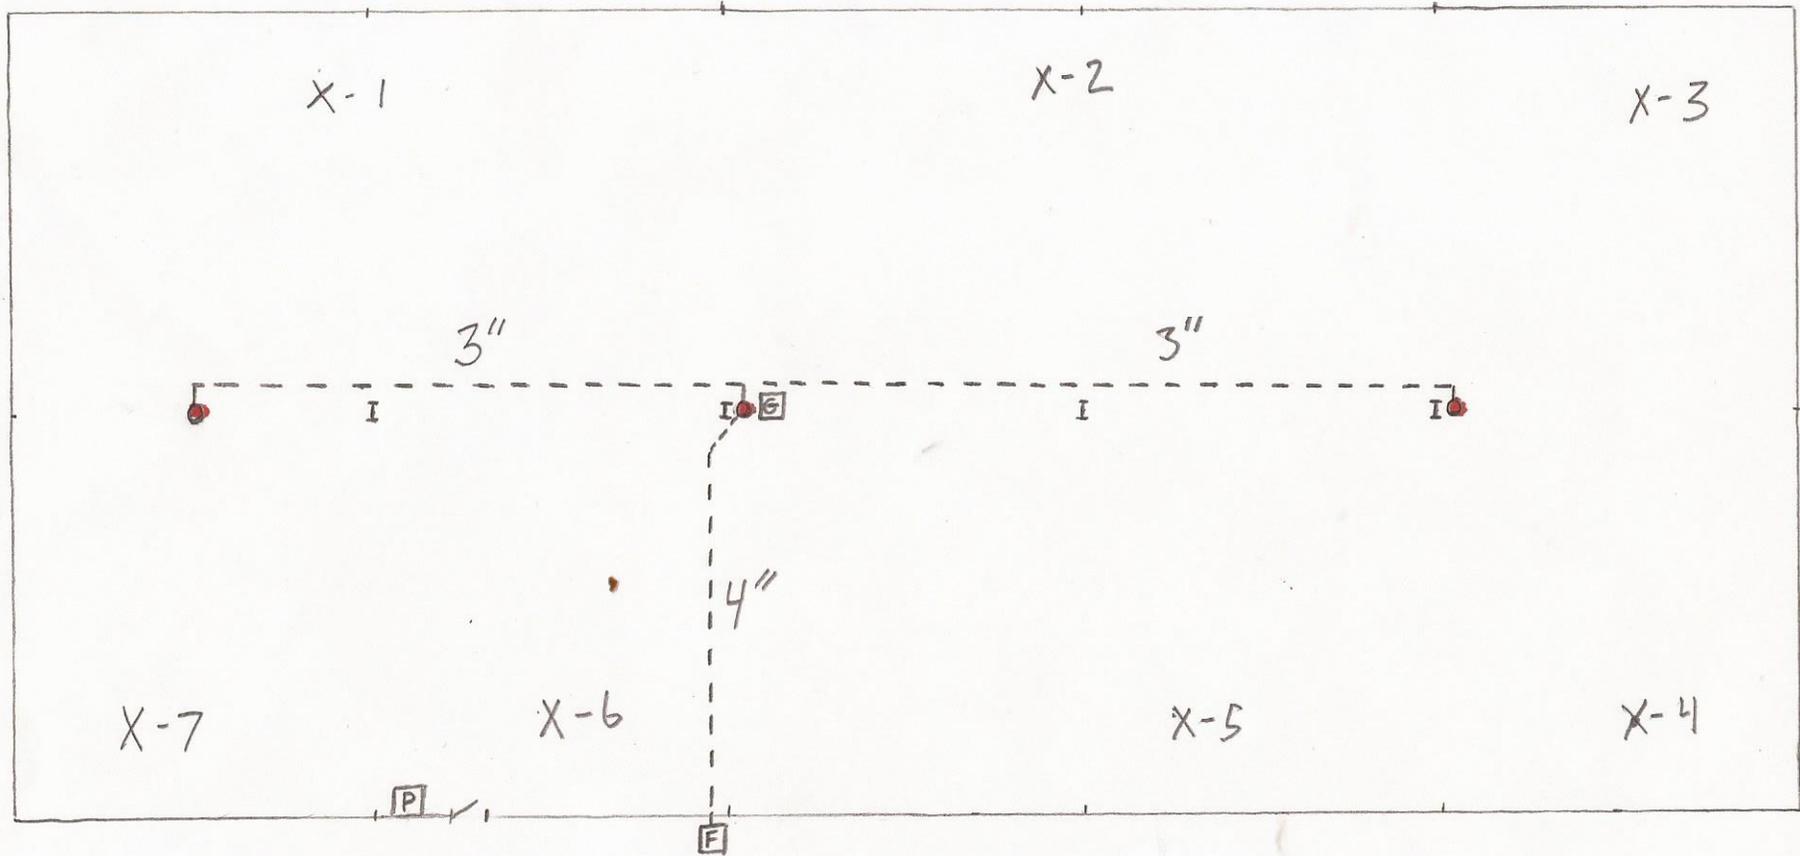
3.1. Introduction. The SSDS is maintaining sub-slab vacuum at all subject areas. The system consists of a sidewall mounted fan and three vapor extraction points. The system was constructed using principles and equipment typically used for radon mitigation in buildings as detailed in the United States Environmental Protection Agency (EPA) EPA 402-K-03-007 (May 2006), and the final NYSDOH Guidance for Evaluating Soil Vapor Intrusion in the State of New York (October 2006). The SSDS was installed as permanent, integral addition to the structure. The key components of the SSDS are described below and are shown on attached diagrams titled "Sub-Slab Depressurization System".

3.2. Suction Points. The location of each suction point (vapor extraction point) is given in the attachment to this document titled "Sub-slab Depressurization System" which shows a site diagram. The suction point consists of a 5" core boring into the slab through which 1- 2 cubic feet of sub-slab material has been removed. Mechanically suspended Schedule 40 3" steel pipe (eastern pipe is SCH 80 PVC) has been inserted into the boring and sealed with urethane sealant.

3.3. Riser Piping. The riser piping consists of 3" schedule 80 PVC pipe and SCH 40 Steel pipe that follows a route from the extraction point to a 4" manifold then to an exterior mounted vacuum fan, through a sidewall penetration. Weatherproof flashing or sealant has been applied to all penetrations. Vent pipes were installed at a pitch that ensures that any rainwater or condensation within the pipes drains downward into the ground beneath the slab. Piping is independently supported, and not supported from existing building mechanical systems. Piping is labeled at each level as "Sub-Slab Vent". Risers are protected by the columns in which they are installed.

3.5. Instrumentation and Control. There is no centralized instrumentation or control for the SSDS. The fan can be switched either from the roof positioned disconnect or at the breaker. The exhaust fan system is equipped with a vacuum indicator mounted in a visible location on a riser pipe as shown on the attached document titled "Sub-Slab Depressurization System. The indicator consists of an oil filled U-tube style manometer. The indicator is inspected by observing the level of colored fluid. This indicator is designed primarily to give a simple visual check that vacuum is present in the riser pipe, specifically by observation that the fluid levels on each side of the indicator are not even. Indicators are marked at levels observed on May 1, 2015.

3.6. Monitoring Points. Monitoring Points are indicated on the attached system diagrams. These consist of 3/4" drill points through the slab into which a digital micromanometer probe can be inserted. They are semi-permanently closed with closed cell backer rod and polyurethane sealant. These were established to aid in original system design and confirmatory testing, and in some cases are difficult to access. The primary future use would be in recertification of system effectiveness.

- (1) RADONAWAY GP-501 fan, sidewall mount, to provide sub-slab depressurization via 3" schedule 40 PVC pipe to roof exhaust
- (3) Suction points, east, central and west, following existing columns
- (1) U-tube manometer
- Electrical connection
- Concrete patching and urethane sealant

(Measurement date – May 1, 2015- In order to verify system effectiveness and as a performance evaluation, test points were established at various distances from the suction cavities suitable to determine that the sub-slab of the entire subject area was being depressurized at least to the objective, as shown in the following table: (locations per schematic)
