NEW YORK STATE DEPARTMENT OF ENVIRONMENTAL CONSERVATION  
DIVISION OF ENVIRONMENTAL REMEDIATION  
**Site Classification Report**

<b>Site Code:</b>	828113	<b>Site Name:</b>	Luster-Coate
<b>City:</b>	Churchville	<b>Town:</b>	Riga
<b>Region:</b>	8	<b>County:</b>	Monroe
<b>Current Classification:</b>	N	<b>Proposed Classification:</b>	02
<b>Estimated Size (acres):</b>	3.20	<b>Disposal Area:</b>	Structure
<b>Significant Threat:</b>	-	<b>Site Type:</b>	
<b>Priority ranking Score:</b>	415	<b>Project Manager:</b>	Frank Sowers

### State Superfund Site Classification Notice

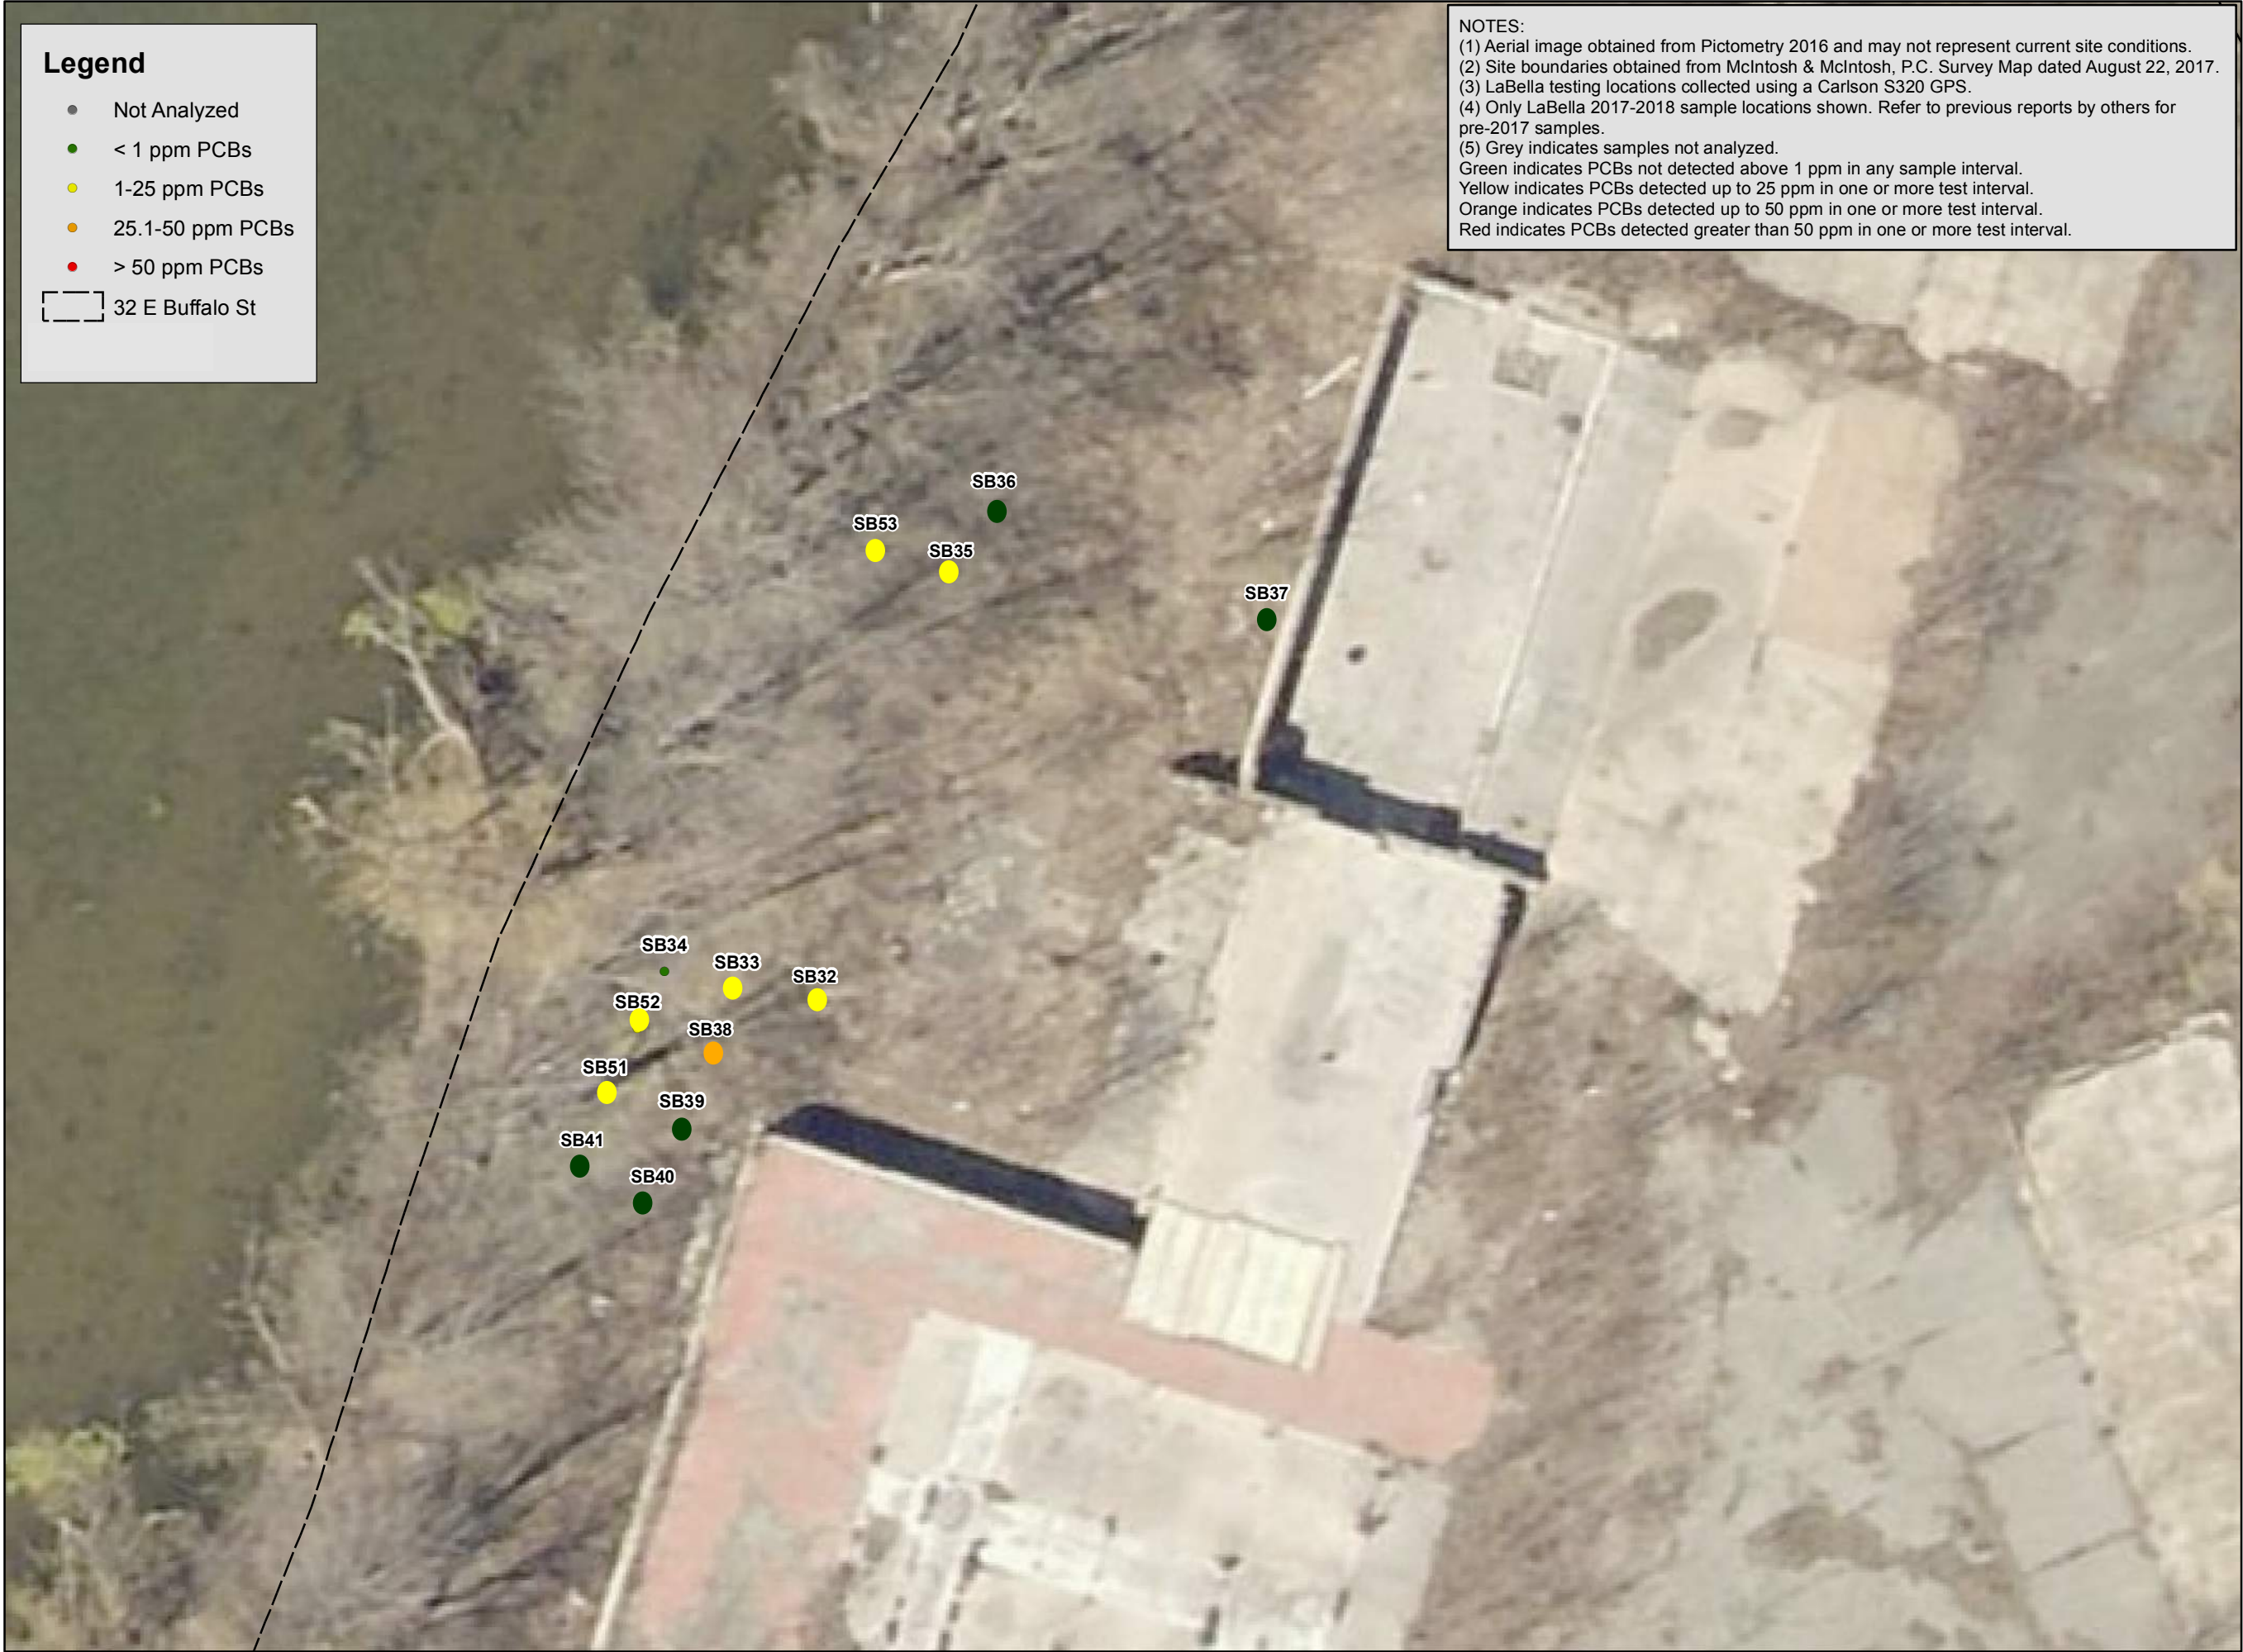
FIGURE 2B

NOTES:  
(1) Aerial image obtained from Pictometry 2016 and may not represent current site conditions.  
(2) Site boundaries obtained from McIntosh & McIntosh, P.C. Survey Map dated August 22, 2017.  
(3) LaBella testing locations collected using a Carlson S320 GPS.  
(4) Only LaBella 2017-2018 sample locations shown. Refer to previous reports by others for pre-2017 samples.  
(5) Grey indicates samples not analyzed.  
Green indicates PCBs not detected above 1 ppm in any sample interval.  
Yellow indicates PCBs detected up to 25 ppm in one or more test interval.  
Orange indicates PCBs detected up to 50 ppm in one or more test interval.  
Red indicates PCBs detected greater than 50 ppm in one or more test interval.
