**RE: NYSDEC Standby Engineering Contract D007625
WA#24 IRM Remedial Design - Former Air Force Plant 51
Pre-Design Investigation Summary Report**

Henningson, Durham & Richardson Architecture and Engineering, P.C. (HDR) has prepared this letter report to summarize the results of the pre-design investigation (PDI) conducted at two interim remedial measure (IRM) areas at the Former Air Force Plant 51 site located in Greece, New York (Figure 1). The purpose of the pre-design investigation was to collect additional site-specific data necessary to better define the horizontal and vertical limits of excavation within the two IRM areas, provide data that can be used for waste characterization purposes, locate subsurface features associated with the IRM areas, and refine dewatering and other field needs during future IRM implementation. The PDI tasks completed and summarized in this report included the collection of soil, sediment, and water samples and excavation of testpits in the Former Septic System / Leach Field IRM and Stormwater Outfall IRM areas.

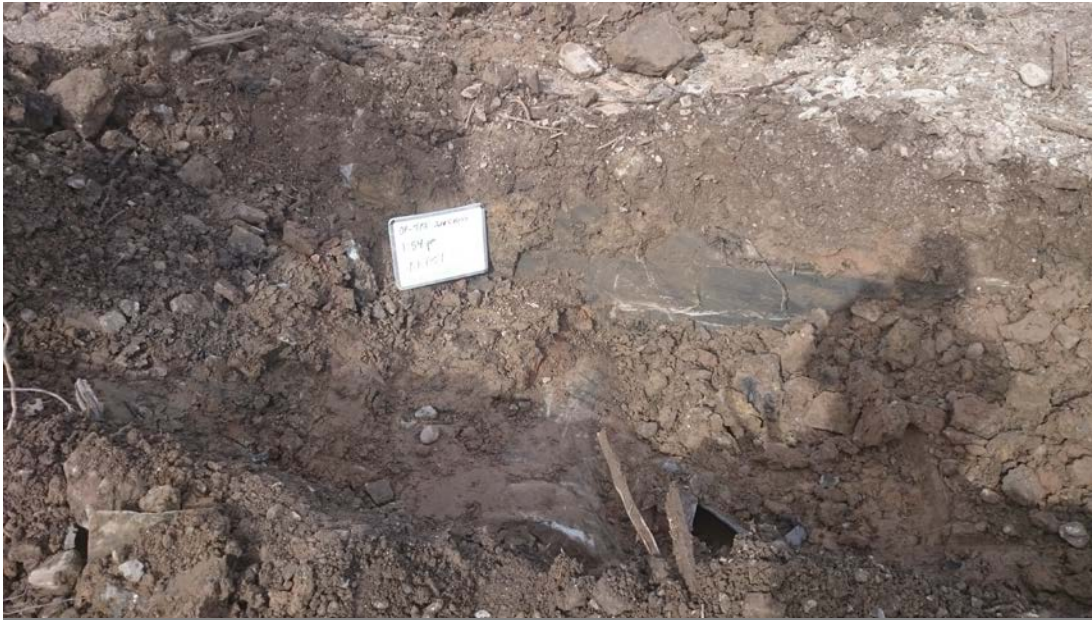
Client Name/Contract NYSDEC D007625		Site Location: NYSDEC AFP51	Project No. 147-258214
Photo No. 1	Date: 10/27/15

Description OF-TP2 looking N-NW. 18” stormwater pipe entering below grade retaining wall. Note damaged clay tile pipe entering stormwater pipe at oblique angle.

The 18" stormwater pipe between CB-2 and CB-1 (see Figure 2) was located in testpits OF-TP1, OF-TP2 and CB1S. The pipe is spaced 12 – 14 feet west of the former Building #1 at a depth of 2 – 3.5 feet bgs. The pipe itself is composed of concrete with no evidence of pipe cracks / separations noted in any of the testpits. Depth to top-of-pipe was noted to be approximately 2.5 feet bgs at OF-TP1. This particular testpit is located about halfway between CB-2 and the loading dock. The ground surface-to-pipe depth varies between CB-2 and CB-1, as top-of-pipe was measured at 2.2 feet bgs to the top of the pipe at OF-TP2, where it appears to enter a subsurface concrete structure (perhaps part of a historic foundation or wall) (see Photo 1 in Appendix D). This subsurface concrete feature is likely associated with an old building that historically existed next to this portion of the former Building #1 (as evidenced on historic site maps). Excavation of the pipe in this section will thus need to consider the buried concrete and other subsurface debris encountered in this area. In addition, smaller clay tile pipes were observed to enter the 18" stormwater pipe likely from the former Building #1 foundation (from the east) at OF-TP2.

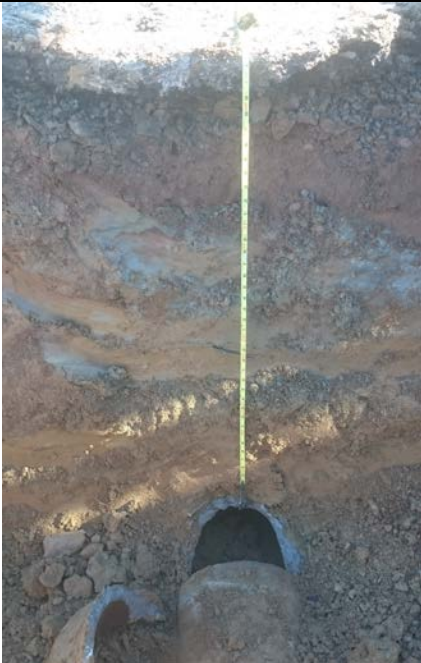
Client Name/Contract NYSDEC D007625		Site Location: NYSDEC AFP51	Project No. 147-258214
Photo No. 3	Date: 10/26/15

Description LFS-TP1 facing E. 12” concrete septic line at 4 ft bgs.

The 12" concrete septic pipe was located in testpits LFS-TP8, LFS-TP1, LFS-TP2 and LFS-TP3 before terminating at the concrete septic box at the top the leach field (Figure 3A and 3B; Photo 3 in Appendix D). It is noted that the historic septic system / leach field which is the subject of this IRM is no longer in-service (and was reportedly abandoned in-place several years ago). Depths of the 12" pipe range between 0.5 – 4 feet bgs, and the pipe is structurally compromised in several areas. The pipe condition as observed in testpit LFS-TP3 was found to be broken and contained evidence of animals possibly living within or around the pipe / pipe corridor. The pipe was observed to terminate at the eastern end of the septic box at the top of the leach field area. The box itself has dimensions of 16 x 21 feet, with a smaller 6 x 10.5 feet portion extending outwards along the western side.

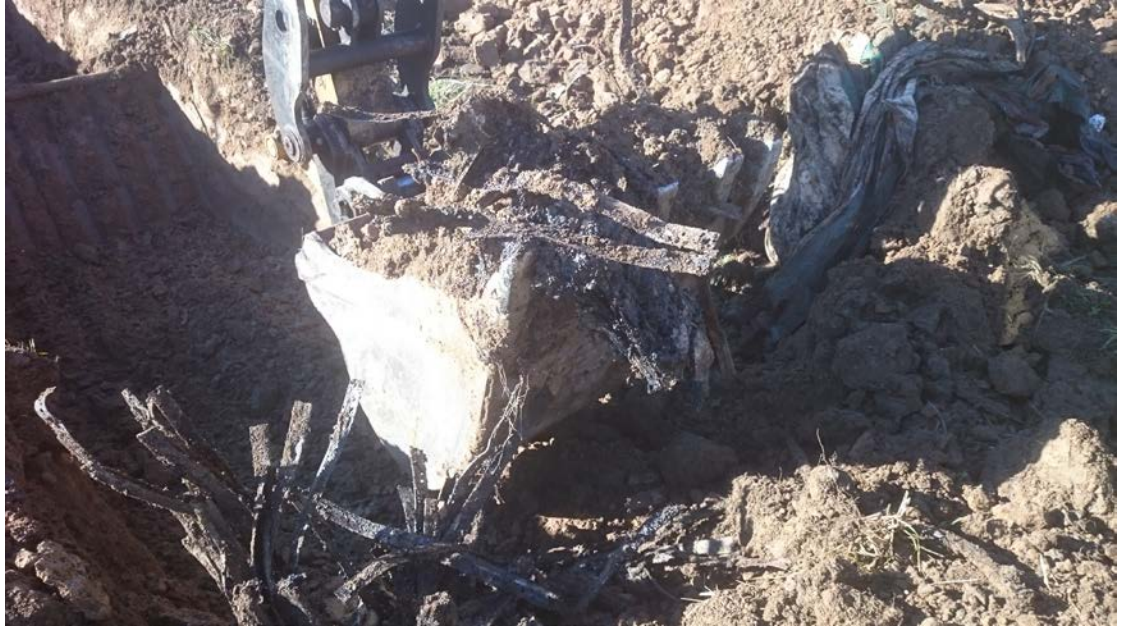
Client Name/Contract NYSDEC D007625		Site Location: NYSDEC AFP51	Project No. 147-258214
Photo No. 5	Date: 10/26/15

Description OF-TP1 looking SW. Scrap metal and tarp visible. Metal is coated in an unknown, tar-like substance. Electrical conduits visible in upper left corner of image.

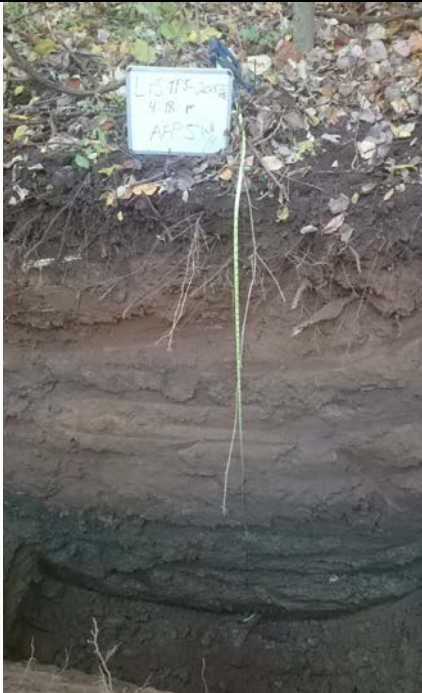
Client Name/Contract NYSDEC D007625		Site Location: NYSDEC AFP51	Project No. 147-258214
Photo No. 6	Date: 10/26/15

Description LFS-TP5 looking N. Note soil horizons, followed by silty, reddish clay. This transitions to grey clay before reaching a compact, reddish glacial till at the base of the test pit.
