**CONSTRUCTION COMPLETION REPORT FOR  
BUILDING NO. 8 MITIGATION AND DEMOLITION**

**Former Air Force Plant No. 51  
(NYSDEC Site Number 828156)**

**NYSDEC STANDBY ENGINEERING CONTRACT  
Work Assignment No. D007625-24**

August 2021

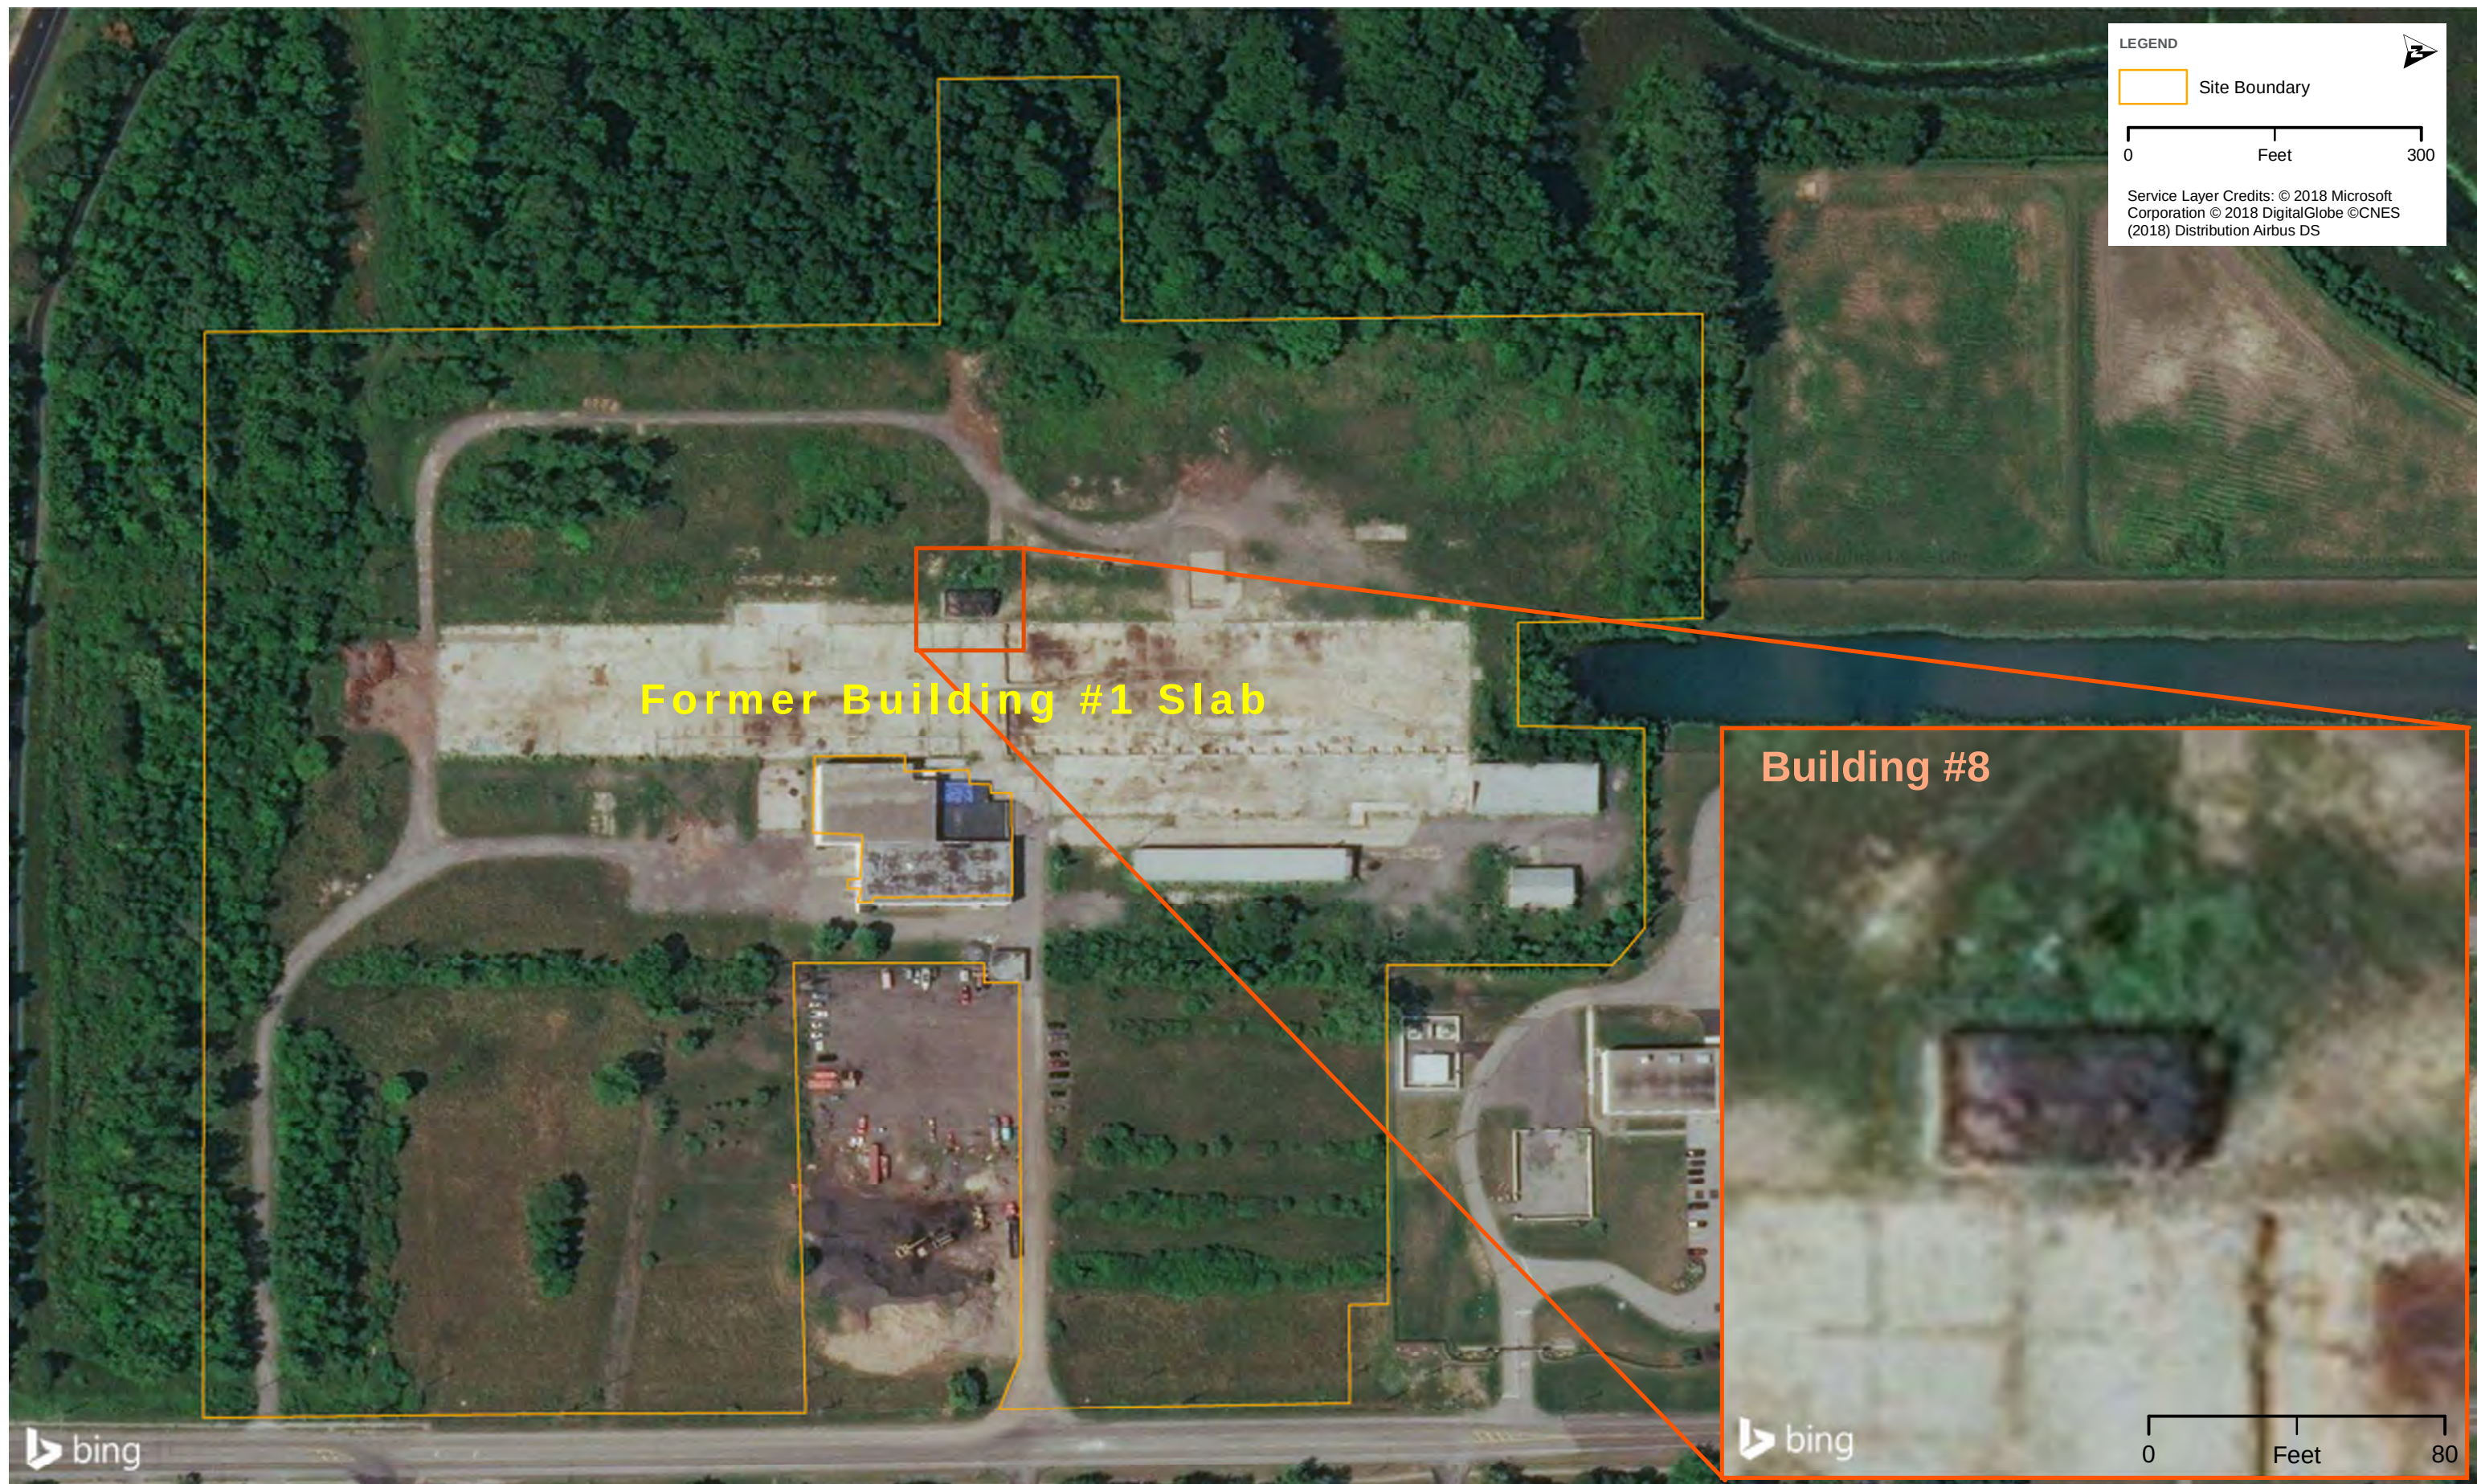
| AFP51-SW-01-20171002 (L) | |
| Water-Filled Trench | |

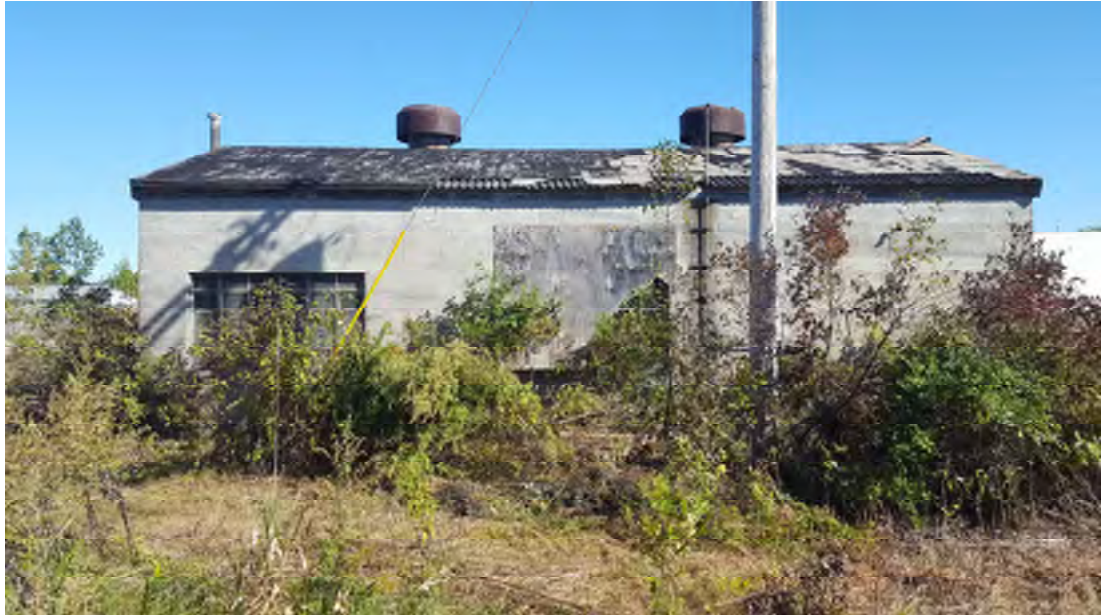
| <b>Photo No.</b><br>1 | <b>Date:</b><br>10/7/17 | | |

| <b>Description:</b><br><br>Exterior view of Building 8. Exterior soil (K) taken directly outside corner windows. | | | |

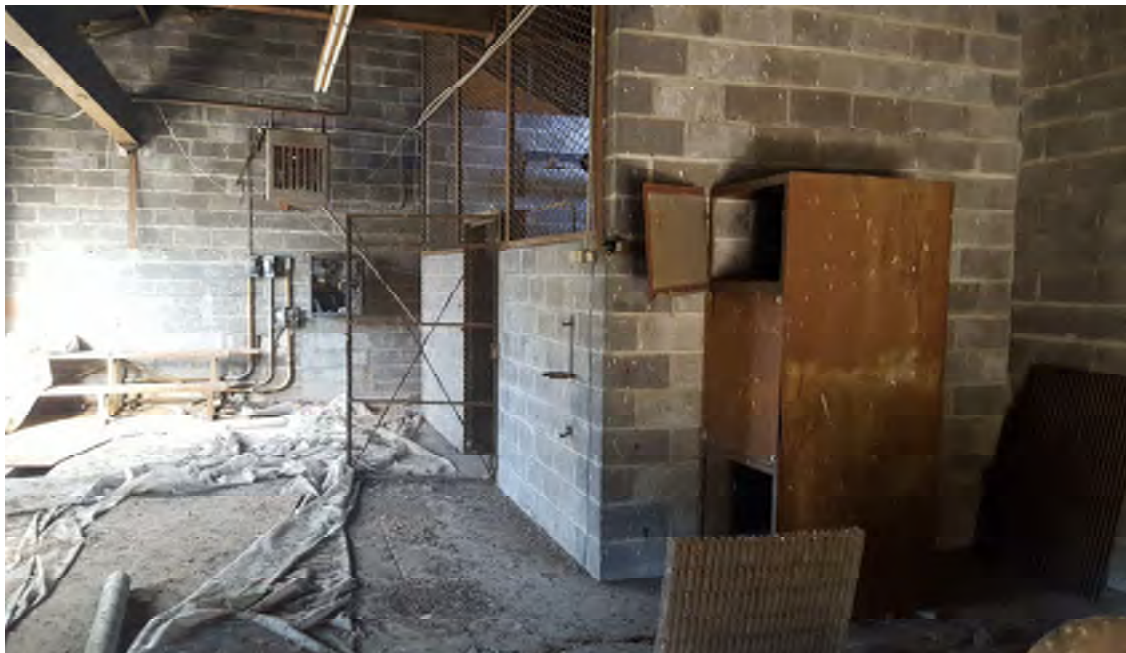
| <b>Photo No.</b><br>2 | <b>Date:</b><br>10/7/17 |

| <b>Description:</b><br><br>Interior view of Northeastern corner. Note the transformer cage. | |

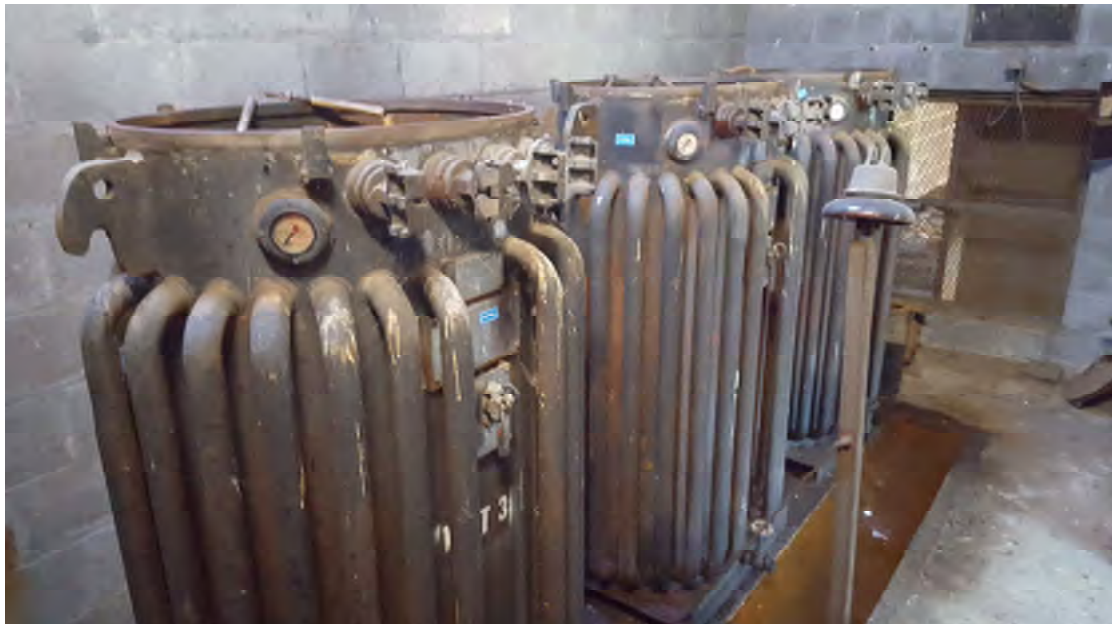
The one aqueous sample location was (L) the water-filled trench directly in front of the three transformers within the transformer cage. PCBs were found within the aqueous sample with Aroclor-1260 detected at 0.78 microgram per liter (ug/L) or parts per billion (ppb). Although the trench contains water, the integrity of the trench is not known and further evaluation is needed.

| <b>Description:</b><br><br>Transformers. Drained of PCBs. Aqueous sample (L) retrieved from water filled trench shown in picture. PCB wipes taken along base of each transformer. Concrete chip sample (A) taken directly in front of drainage trench. Concrete chip sample (C) taken on wall directly behind camera position. | | | |

- For this removal IRM, no pre-design investigation (PDI) is proposed.
- **Water-filled transformer trench**
  - o Containerize water from trench into a 55-gallon drum (characterize and dispose of as non-hazardous liquid)

- Conduct observations of the integrity of the trench for any cracks and document it.
    - Grout and fill trench with concrete and make level with slab

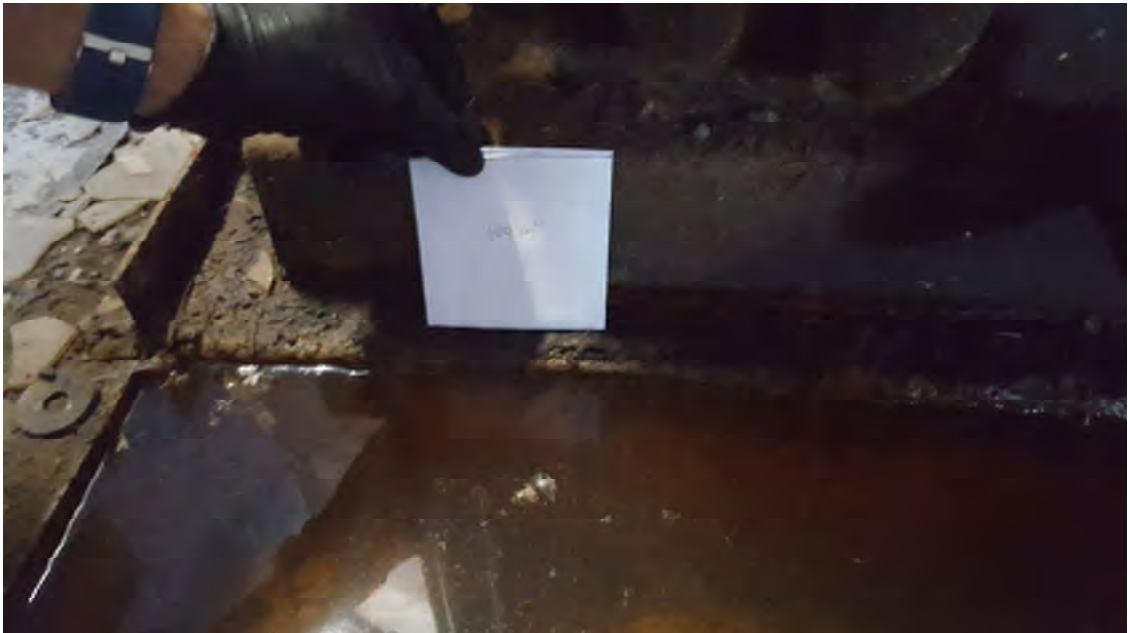
| <b>Photo No.</b><br>6 | <b>Date:</b><br>10/7/17 | |

PCBs were found in three of the four samples / locations. Concentrations of Aroclor-1260 were 4.7 ug/Wipe at the (E) sampling location, 3.1 ug/Wipe at the (G) sampling location, and 5.8 ug/Wipe at the (H) sampling location. In addition, Aroclor-1254 was found at the (G) sampling location with a concentration of 2.2 ug/Wipe. The (F) sampling location was non-detect for PCBs.

| <b>Description</b><br><br>100 cm <sup>2</sup> section used in<br>PCB wipe (E) | | |

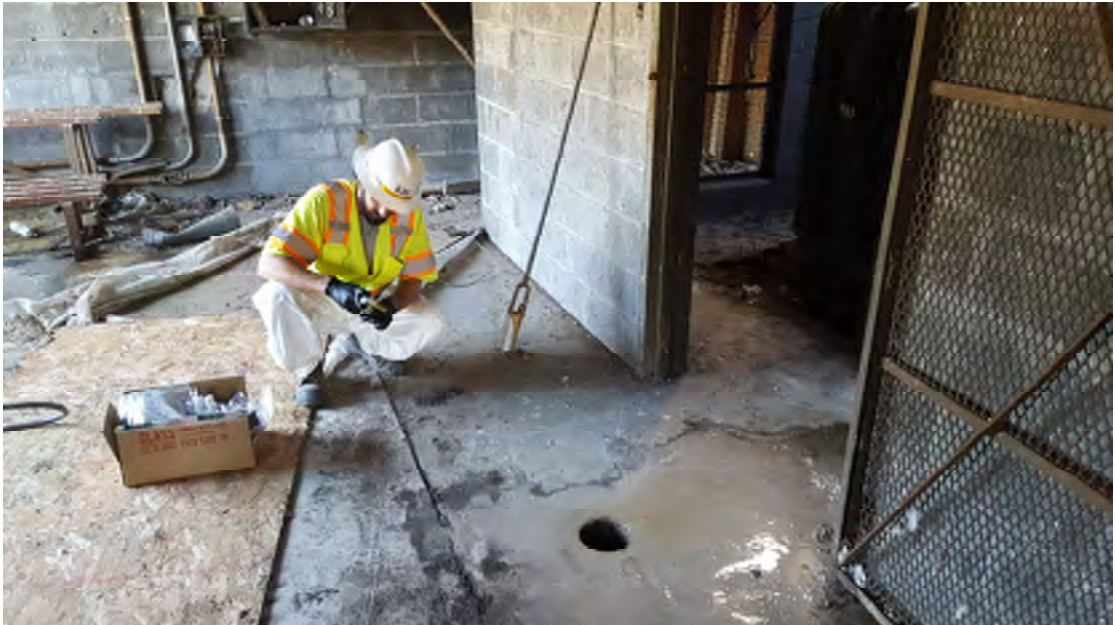
| <b>Photo No.</b><br>7 | <b>Date:</b><br>10/7/17 | | |

PCBs were only found at the floor trench (J) sampling location. The concentration of Aroclor-1260 at this location was 150 mg/kg, with a duplicate sample containing a concentration of 190 mg/kg. Both concentrations exceed the Industrial SCO of 25 mg/kg for PCBs. The sub-slab and exterior soils were non-detect for PCBs.

| <b>Description:</b><br><br>Sample collection of sub-slab soil (I). Slab thickness approx. 10 inches in this section. | | | |

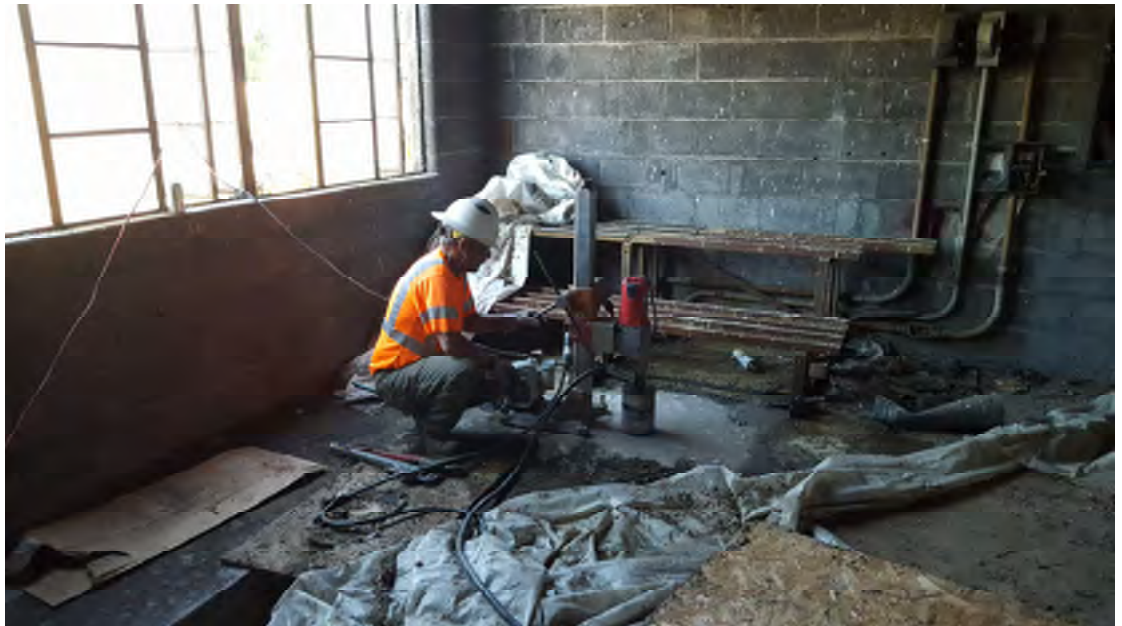
| <b>Photo No.</b><br>10 | <b>Date:</b><br>10/7/17 |

Based on measurements taken during HDR's screening-level sampling event in October 2017, the concrete slab has variable thickness measuring 10-inches to >18-inches. The thickness of the concrete may exceed 24 inches, based on the depths of open pipe trenches and floor drains observed within Building #8.

| <b>Description:</b><br><br>Locations of second sub-slab soil collection point. However, slab thickness exceeded capability of coring machine (slab thickness greater than 18 inches) and hole was abandoned. | |

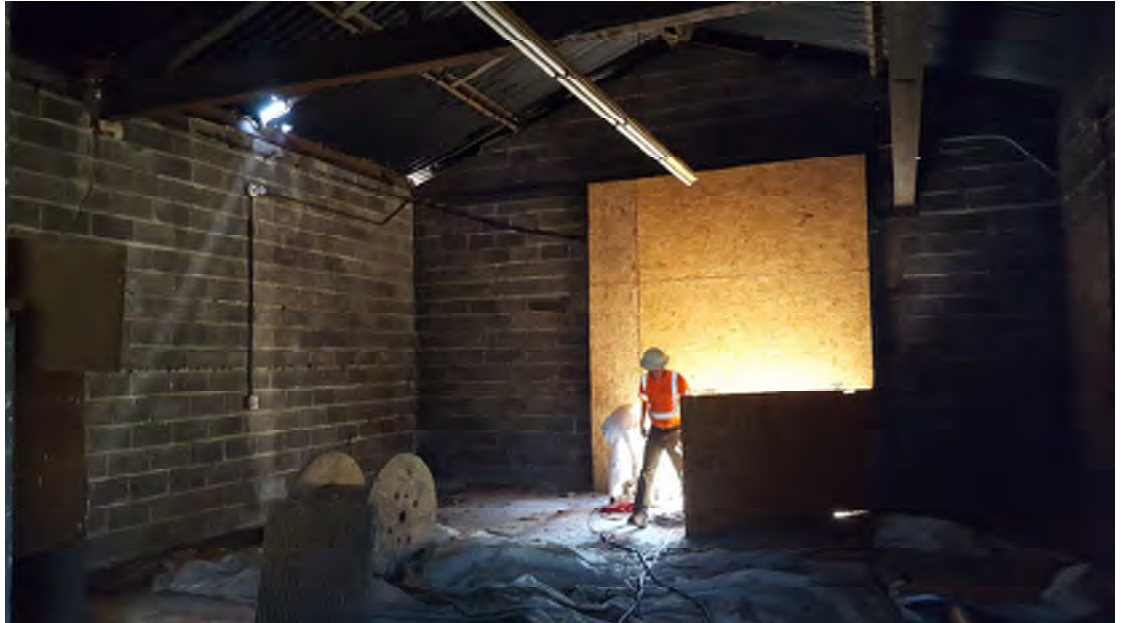
| <b>Photo No.</b><br>13 | <b>Date:</b><br>10/7/17 | | |

PCBs were found in each of the four samples / locations. Concentrations of Aroclor-1260 were reported at 0.25 mg/kg at the (A) sampling location, 1.1 mg/kg at the (B) sampling location, 0.75 mg/kg at the (C) sampling location, and 0.54 mg/kg at the (D) sampling location.

| <b>Description:</b><br><br>Interior view towards the south / entrance. Concrete chip (D) collected along walls / floor immediately to the left of the entrance, and along the right side of the image. | | | |

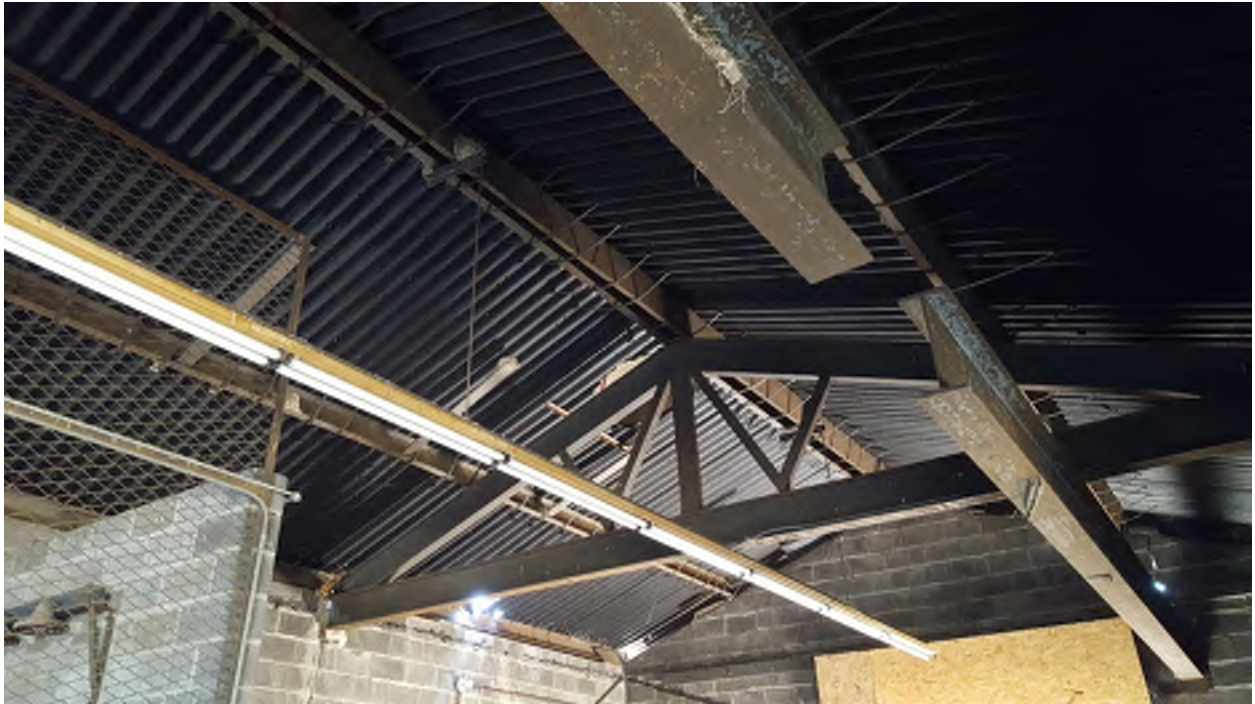
Several areas of Building #8 have suspect structural integrity. There is structural damage in the northeast corner of the building sustained during demolition activities of Building #1. Plywood and two-by-four wood beams in that corner provide temporary walls and structural reinforcement. Several vertical fractures in the cinderblock exist along the eastern wall and southern walls where the cinderblock connects with the steel I-beams. Lastly, the roof has several large holes, which daylight (and wildlife) easily penetrates.

Building ceiling, looking southeast

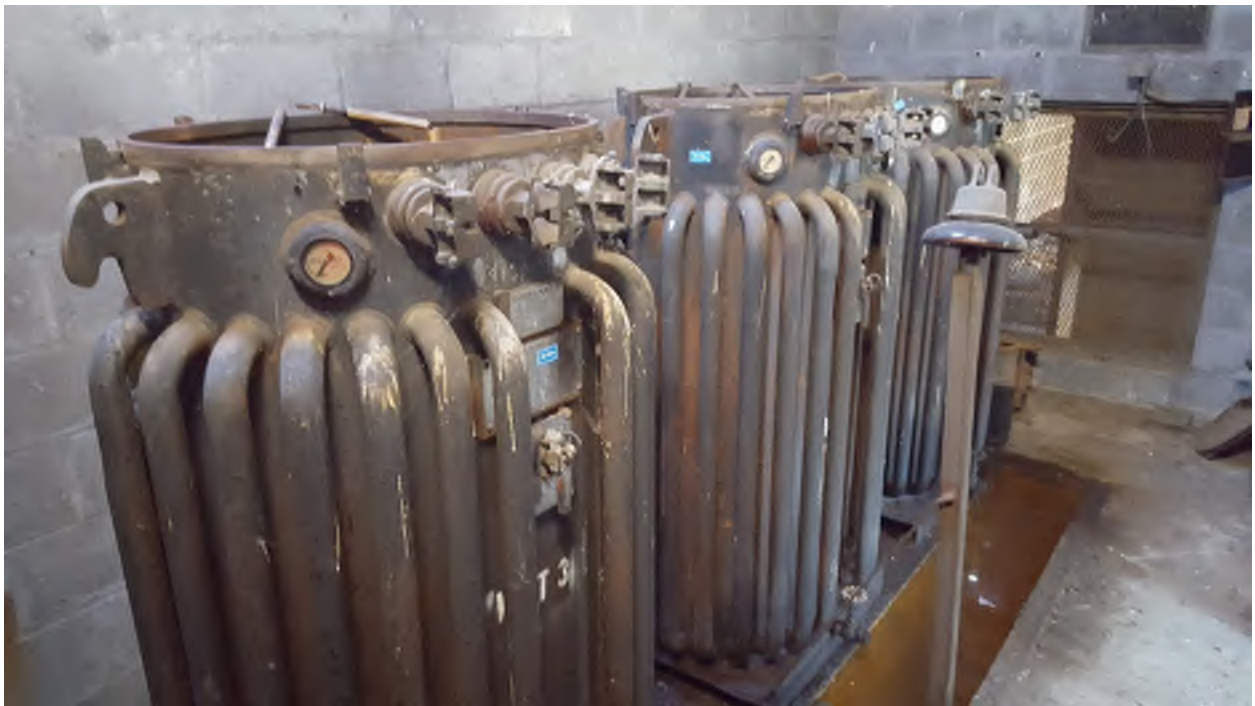
Transformers within Building #8

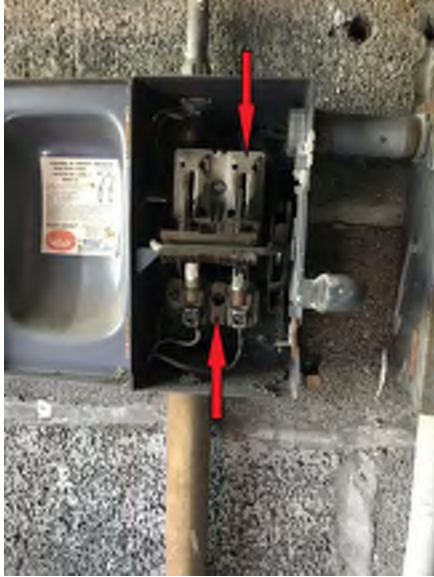
Photo 5

Gray asbestos-containing transite located inside the panel boxes

- Roofing material is suspect ACM and will be removed and disposed as hazardous if confirmed.
  - Any lead based paint material if confirmed hazardous for lead will be removed as hazardous material.
