IRM#1 CONSTRUCTION COMPLETION REPORT

Staubs Textile Services, Inc.
935-951 East Main Street
Rochester, Monroe County, New York
Site Number 828160
Contract Work Authorization Number: D006132-24

CB&I Project No.: 134685.24

April 2013

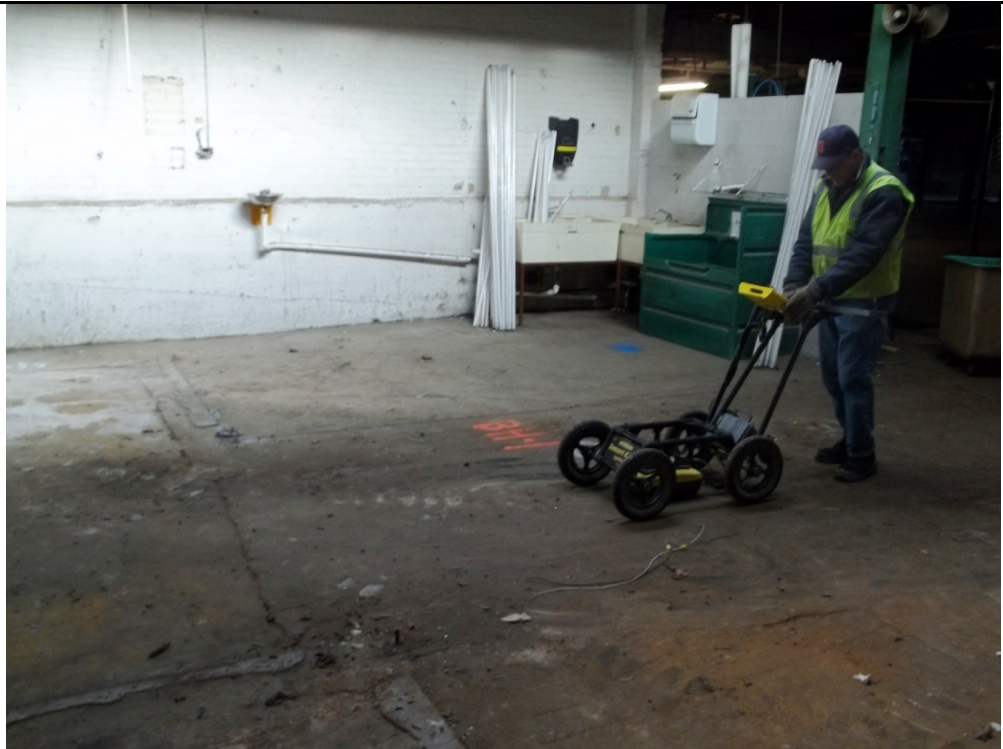
Comments:
GRP survey in dry
cleaning room

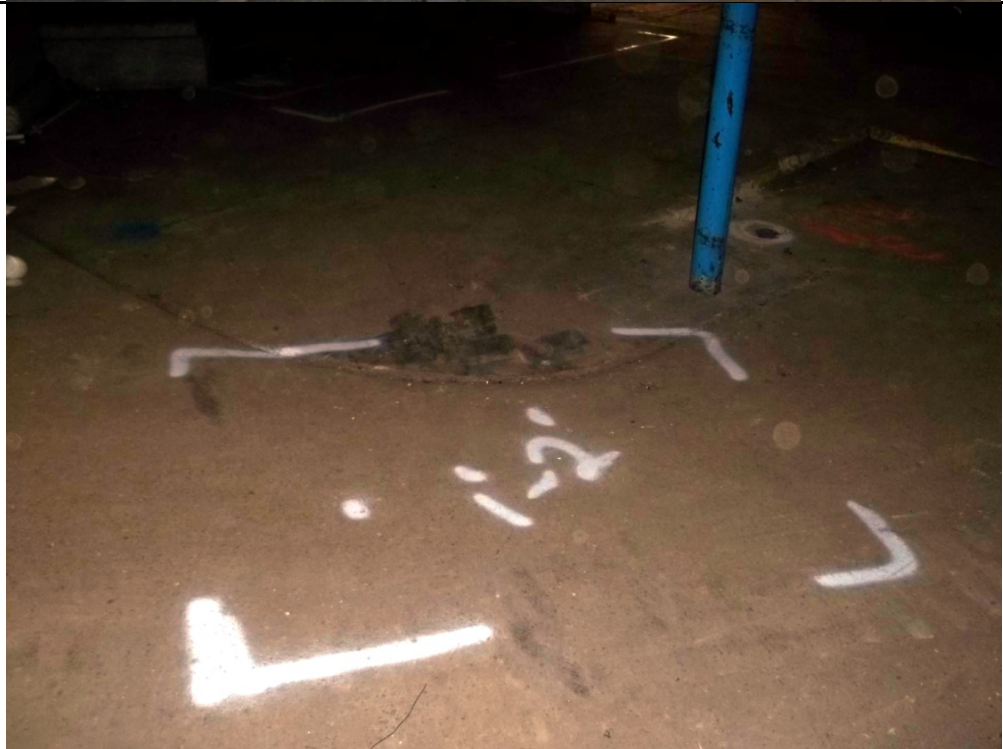
Comments:
Empty UST markout
near BH-3

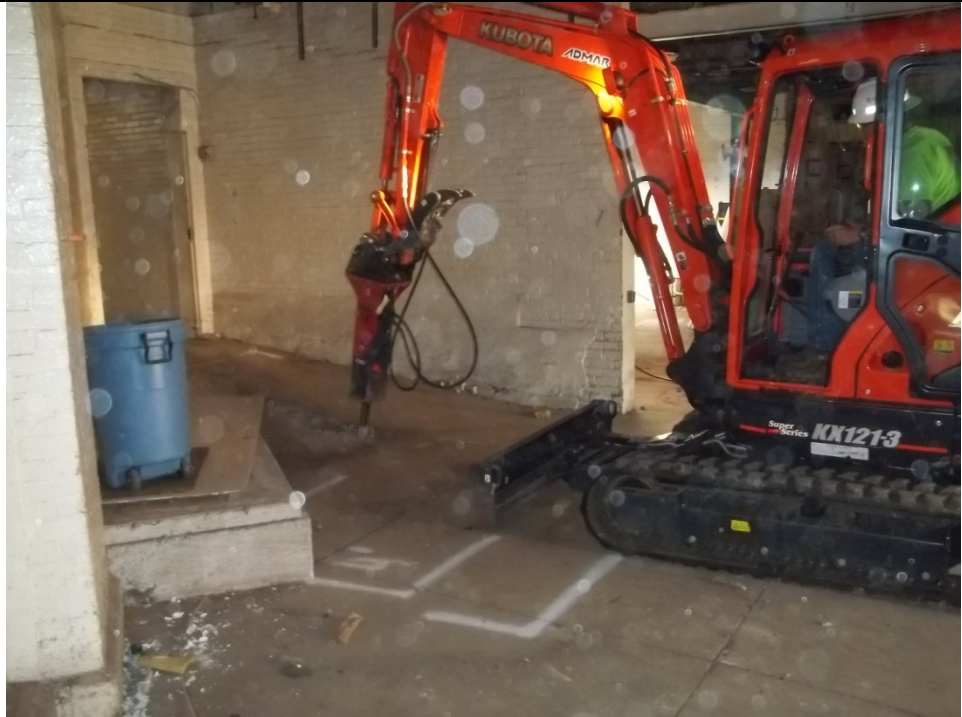
Comments:
Busting concrete for
UST removal in Area
1

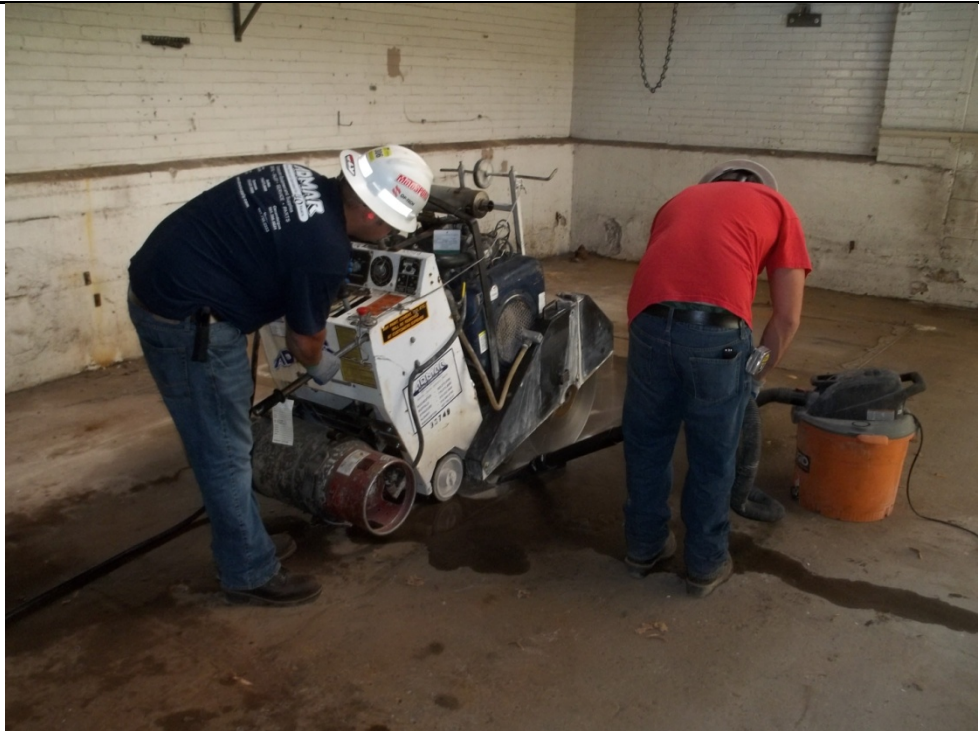
Comments:
Saw cutting interior
floor in Area 4

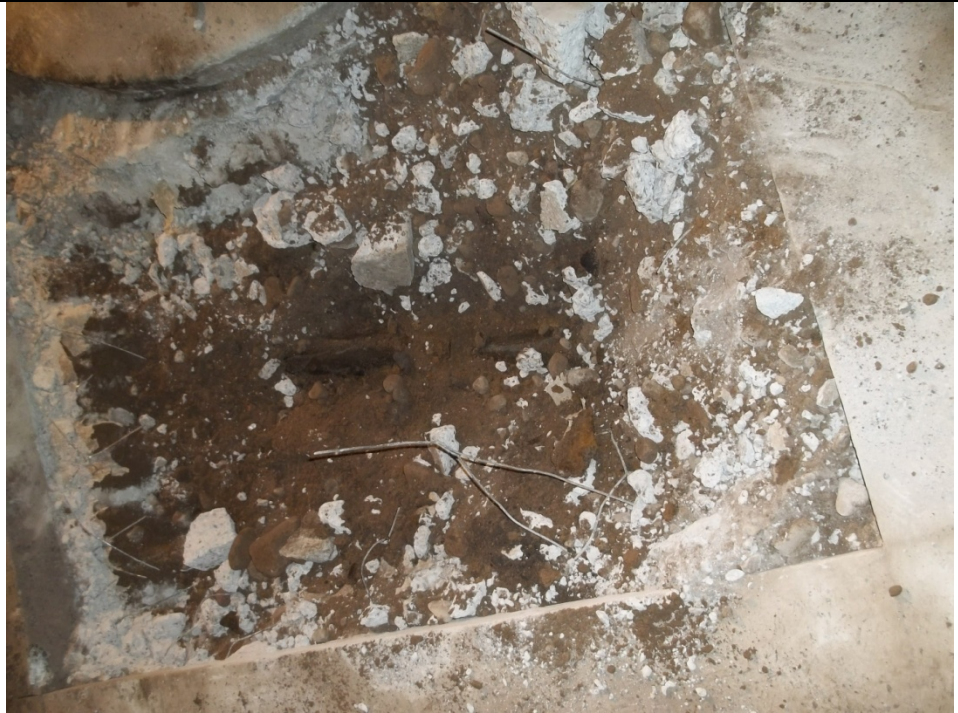
Comments:
Area 2 – Black Iron
Pipe

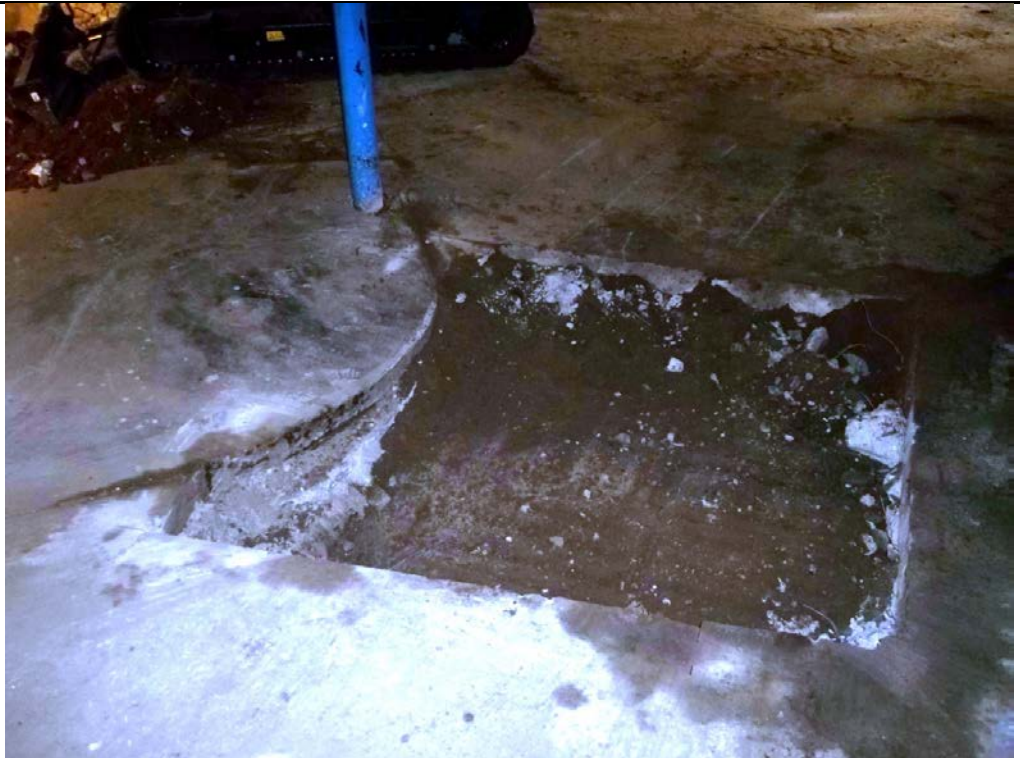
Comments:
Area 2 backfilled

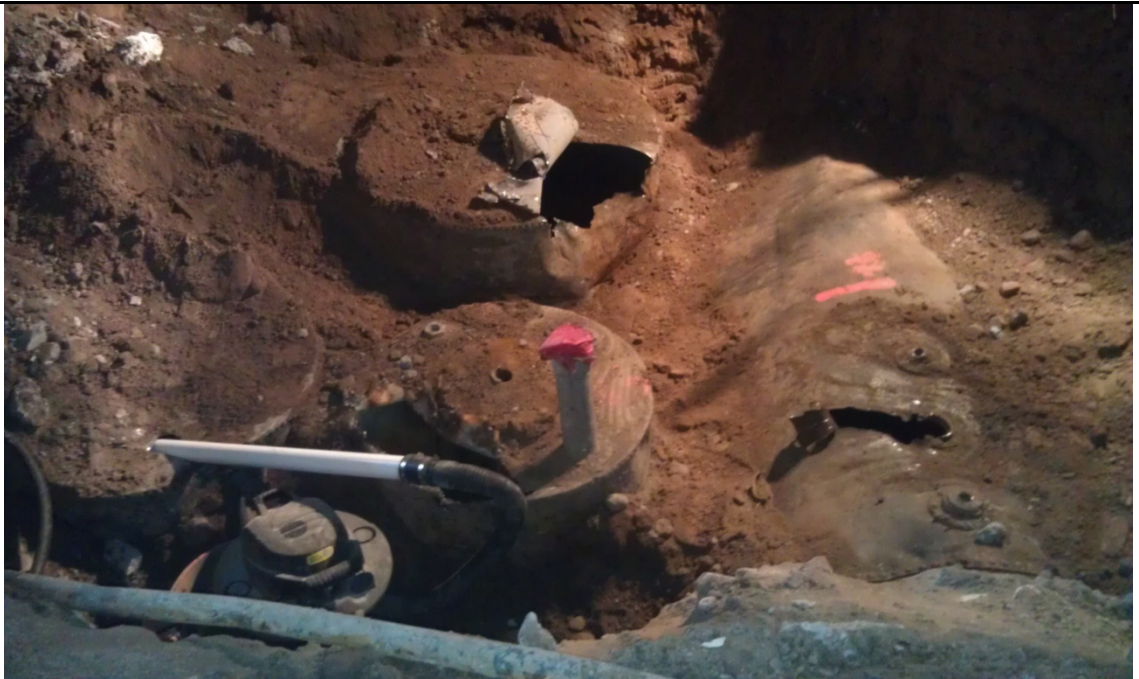
Comments:
Area 1 -USTs

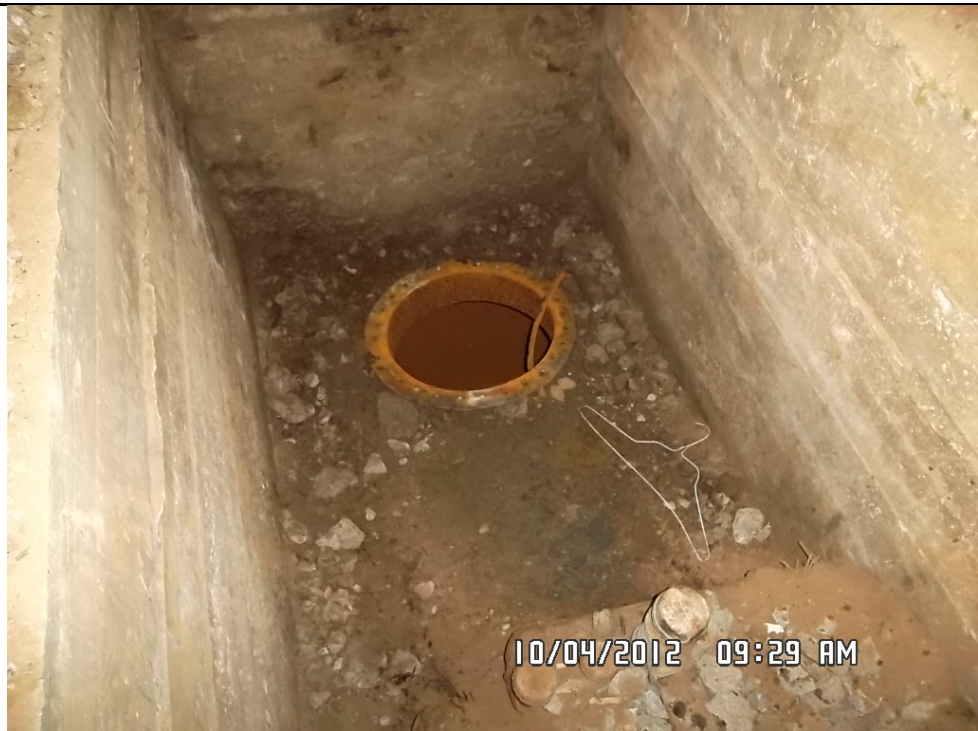
Comments:
Area 3 – Top of
4200 Gal. UST

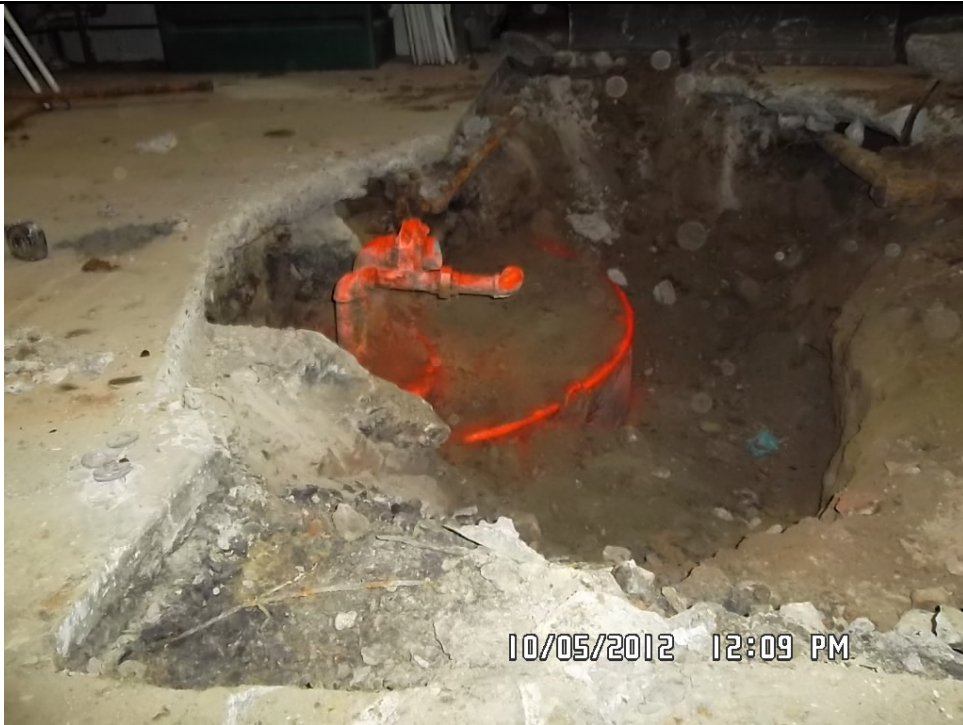
Comments:
Area 4 UST

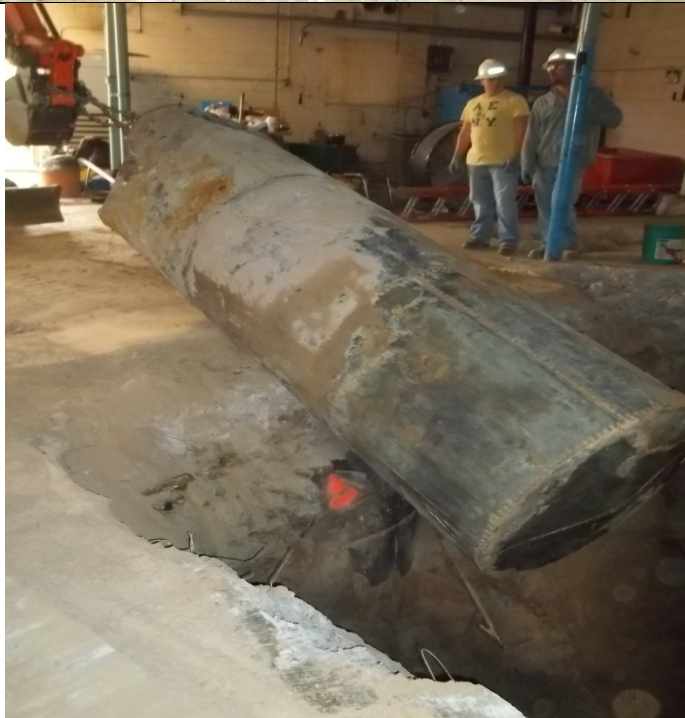
Comments:
Removing UST-2
from Area 1

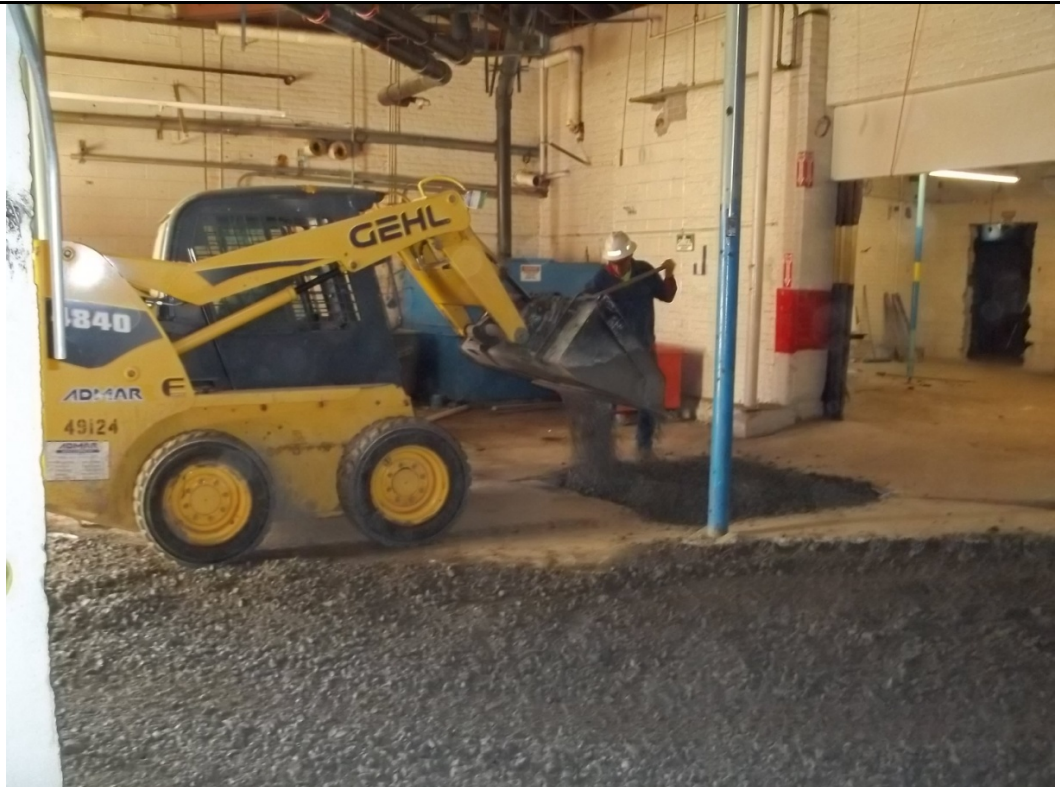
Comments:
Backfilling Area 2
and topping with
gravel

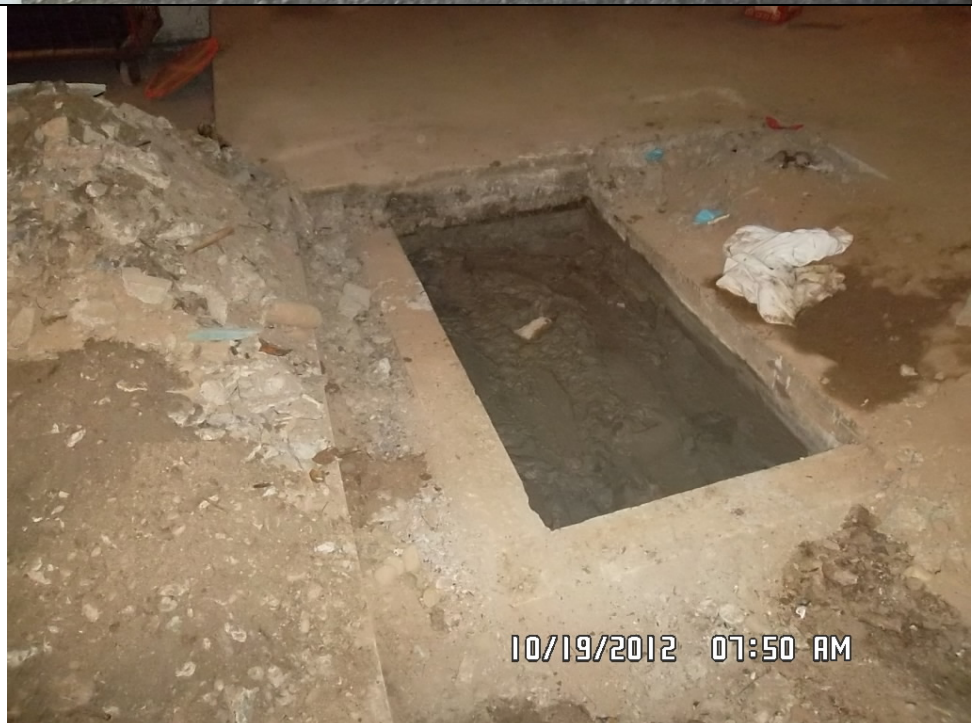
Comments:
Area 3 tank grouted
in place
