Site Management Plan
University of Rochester
S&A Transformer Substation
EPA ID NYD 000631994
Project ID 828166

June 13, 2012

The site is well documented in the "PROJECT REPORT FOR THE PCB CLEAN UP AT THE UNIVERSITY OF ROCHESTER S&A TRANSFORMER SUBSTATION" dated August 1996 that was prepared for the University of Rochester by Leader Environmental. It contains the Background Information, Technical Approach to the Site Management and Clean Up done so far, Data Evaluation, In-Situ PCB Operations and Maintenance Plan, Project Documentation as well as Summary and Conclusion. The report is a part of the project record that this update is meant to supplement.

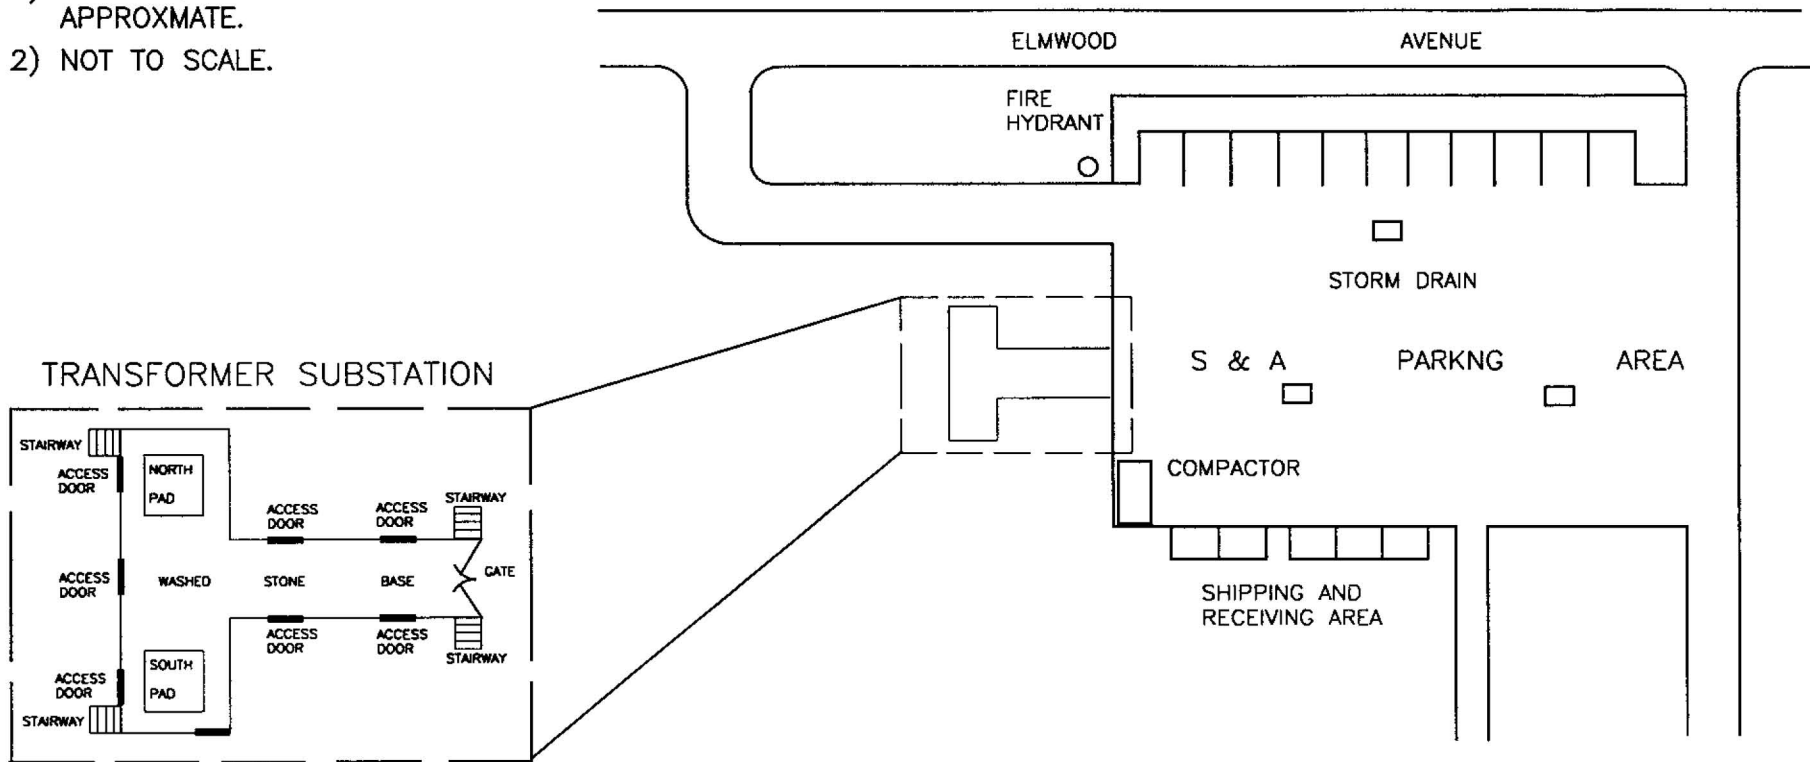
FIGURE: 1

The substation containing the transformers is located adjacent to a shipping and receiving area (known as the "S & A Area") on the north side of the Strong Memorial Hospital (see Site Plan at Figure 1). The substation is in an outdoor courtyard area, surrounded by concrete block building walls and secured by a locked iron gate at the access point (see Substation Plan at Figure 2). The substation is not accessible to the public or unauthorized employees. It is only accessible to University of Rochester maintenance and facilities employees.

TITLE: **SITE PLAN**
 STRONG MEMORIAL HOSPITAL COURTYARD
 UNIVERSITY OF ROCHESTER

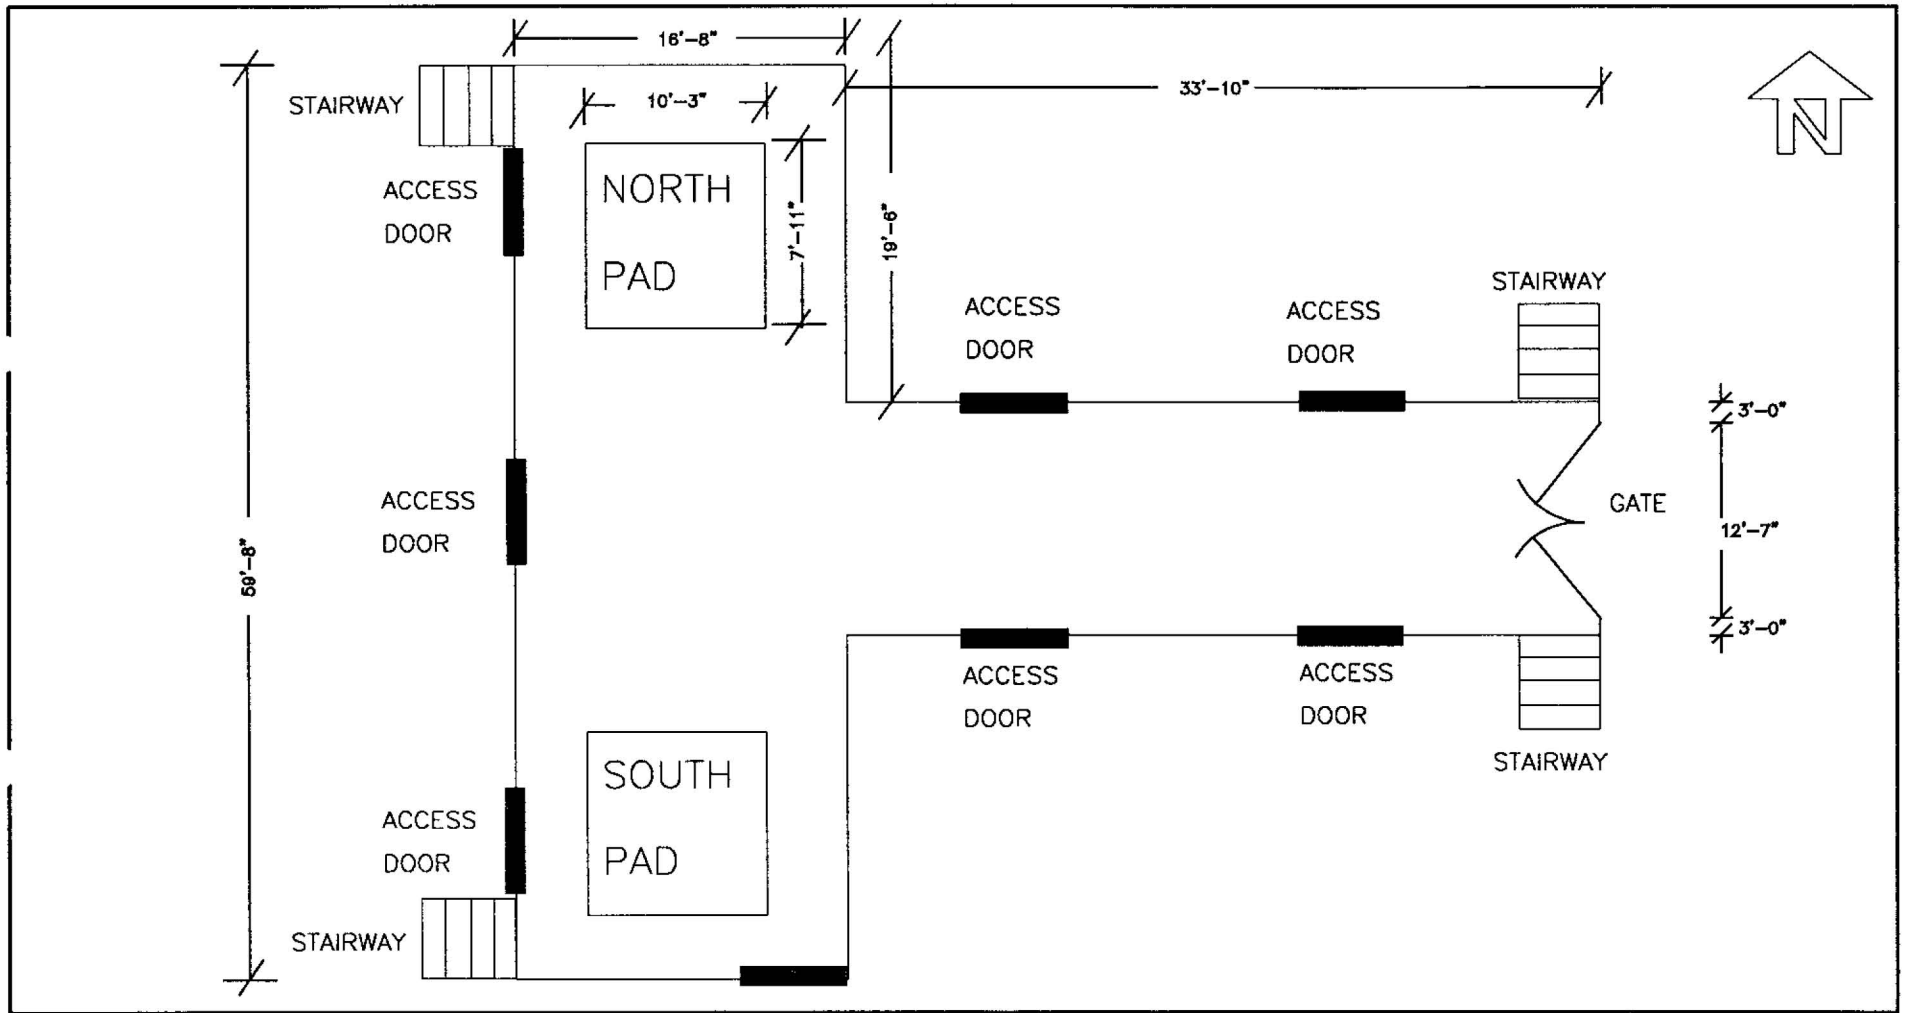
TITLE: TRANSFORMER SUBSTATION
 STRONG MEMORIAL HOSPITAL COURTYARD
 UNIVERSITY OF ROCHESTER

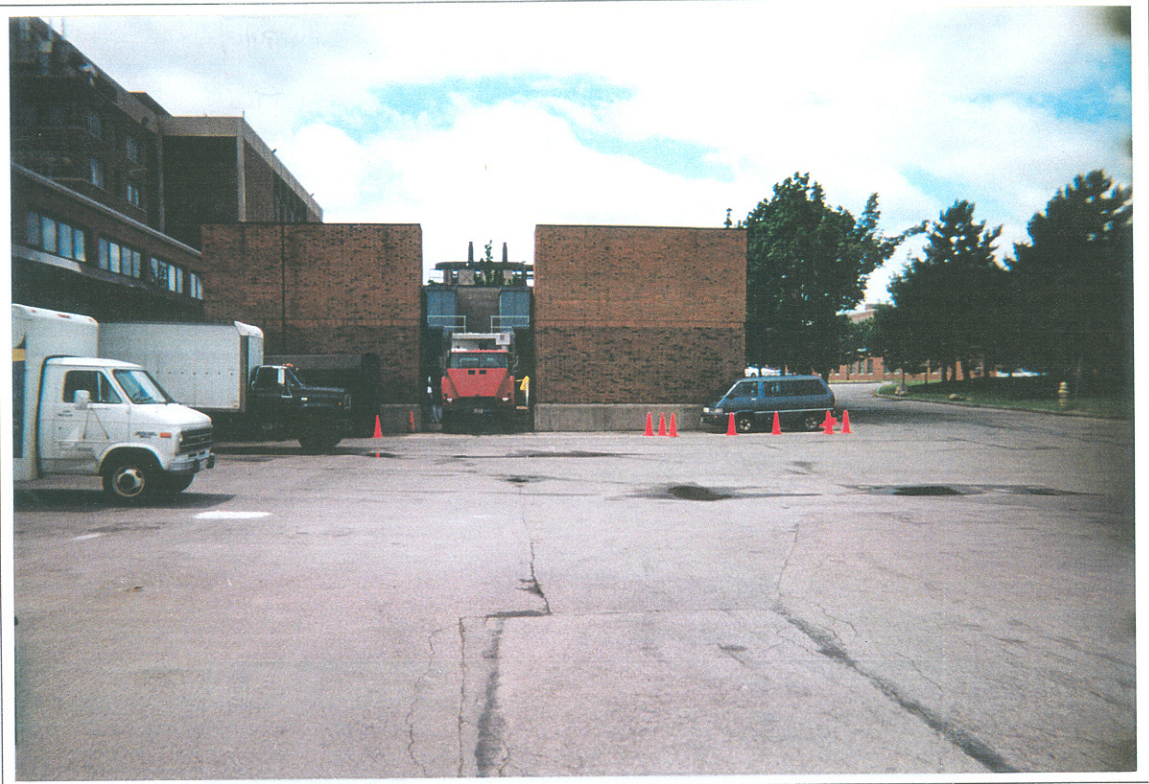
Photo 1

1. View of substation across S & A Parking area, looking west, note AWI Vactor vac truck spotted in substation area.
2. South transformer cooling vanes showing absorbent affixed to tap valves, tarpaulin installed end of each day covering excavation.
3. AWI field technician removing stone with vacuum, south upper high voltage duct visible.
4. Overhead view of AWI removal operations in substation area.
5. AWI field technician using Capsur extraction agent on stain on surface of south duct.
6. AWI field technician using vacuum to remove material from lower high voltage duct.
7. Installation of poly barrier over south and lower high voltage ducting.
8. Transfer operations between Vactor vac truck and roll-offs using backhoe.
9. Substation area after site restoration.
10. View of substation looking west - note locking iron gates.

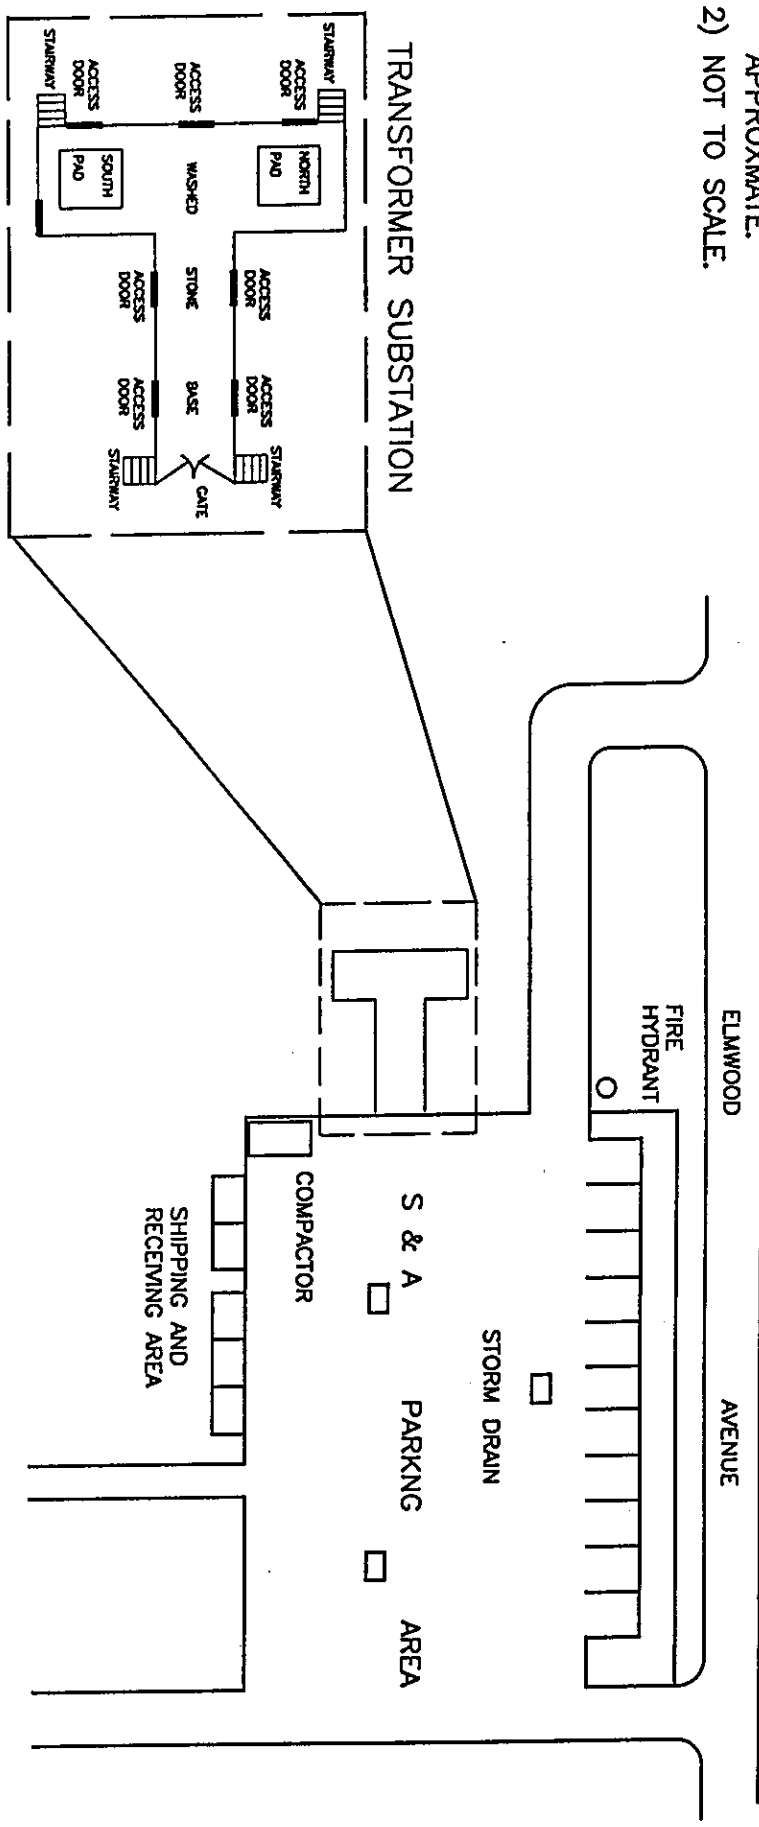
The S & A substation containing the transformers is located adjacent to the shipping and receiving area (known as the S & A Area) on the north side of the Strong Memorial Hospital (see Figure 1). The substation is in an outdoor courtyard area, surrounded by concrete block building walls and secured by a locked iron gate at the access point. The substation is not accessible to the public. It is only accessible to University of Rochester maintenance and facilities employees.

<small>LEON SWANSON, INC.</small>	TITLE:	SITE PLAN		SCALE:	AS SHOWN	DATE:	7/17/96	PROJECT NO.:	135.001	FIGURE:	1
	STRONG MEMORIAL HOSPITAL COURTYARD UNIVERSITY OF ROCHESTER			DRAWN:	WSW	CHECKED:	MPR	PREPARED FOR:	UNIVERSITY OF ROCHESTER

During July 1996, personnel from the University of Rochester Environmental, Health and Safety and Facilities Design/Construction Departments investigated a spill of transformer oil at a substation located in the S & A Parking Area of Strong Memorial Hospital (see Figure 1). According to the University of Rochester, the reported concentration of PCBs in the oil contained in the transformers is 80% (800,000 ppm). Upon visual examination of the two transformers located in the substation, it was observed that very small amounts of transformer oil were accumulating on some of the tap valves and fittings located on the underside of cooling vanes on the transformers. The transformers are scheduled to be removed and replaced in 1997 with non-PCB equipment by an approved contractor. The transformers are currently located at the north and south sides of the S & A Substation.

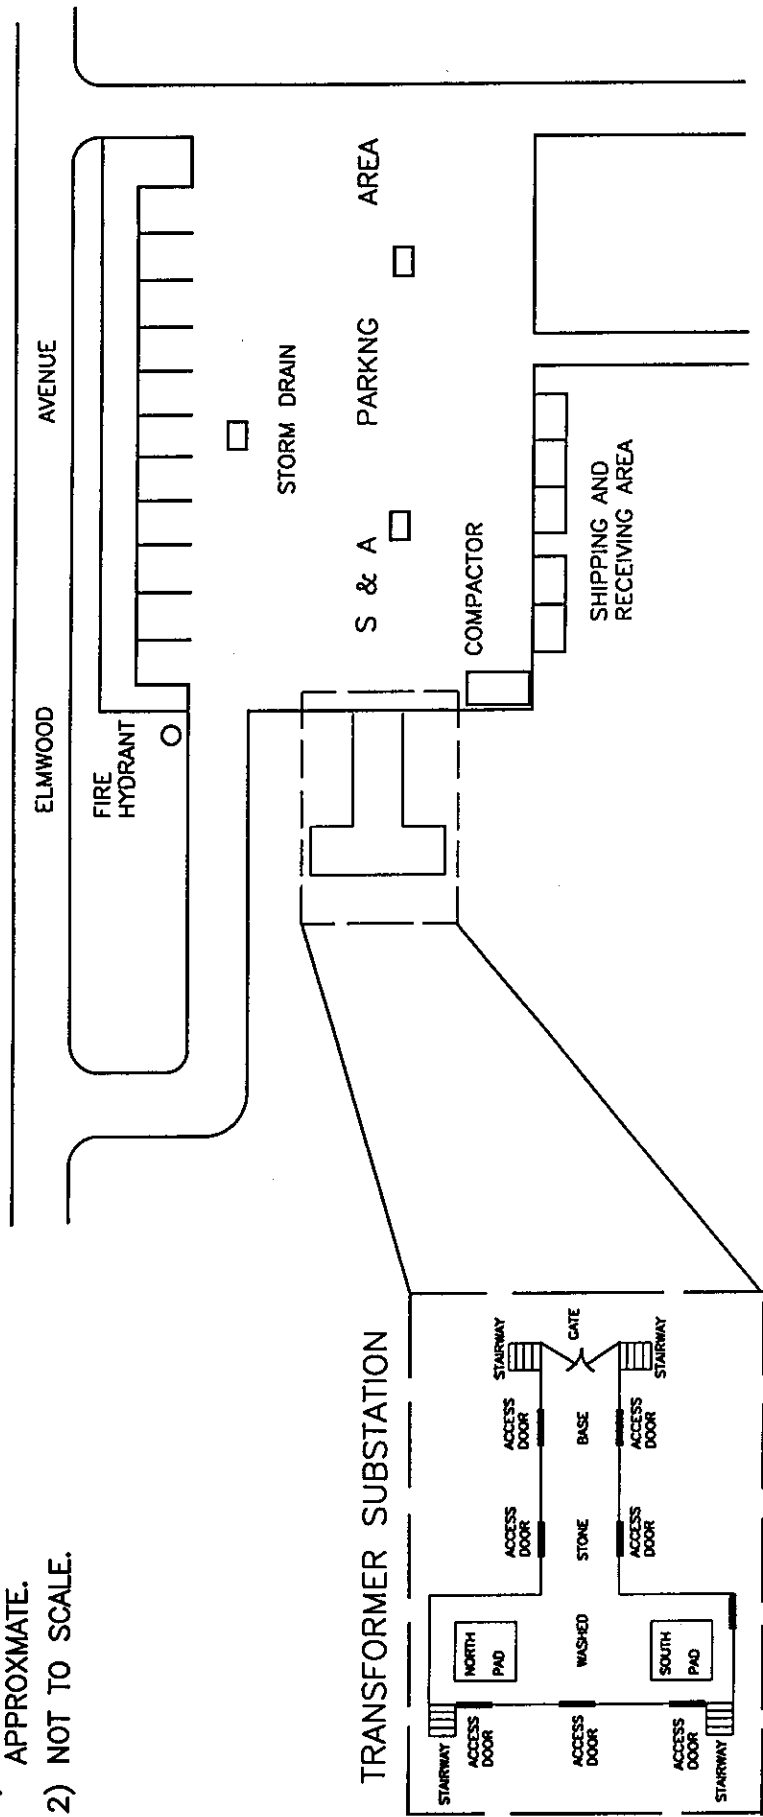
This project will be conducted within the transformer substation in the S & A parking area at Strong Memorial hospital. The Work Area will be defined as the substation area, bounded by the walls of the substation and the gate at the east end. The exclusion area will include the substation and the area immediately outside the substation gate, which will be marked with orange traffic cones and yellow warning tape. All unauthorized personnel will be prohibited from the work area and the exclusion zone. Due to traffic concerns, the waste roll-offs will be staged at the opposite (east) side of the S & A parking area from the substation. For site location, see Figure 1.

TITLE: SITE PLAN STRONG MEMORIAL HOSPITAL COURTYARD UNIVERSITY OF ROCHESTER		SCALE: AS SHOWN DRAWN: WSW CHECKED: MPR	DATE: 7/17/96	PROJECT NO.: 135.001 PREPARED FOR: UNIVERSITY OF ROCHESTER	FIGURE: 1
