# UNDERGROUND STORAGE TANK REMOVAL REPORT

Former Silver Cleaners Site No. 828186

February 2019

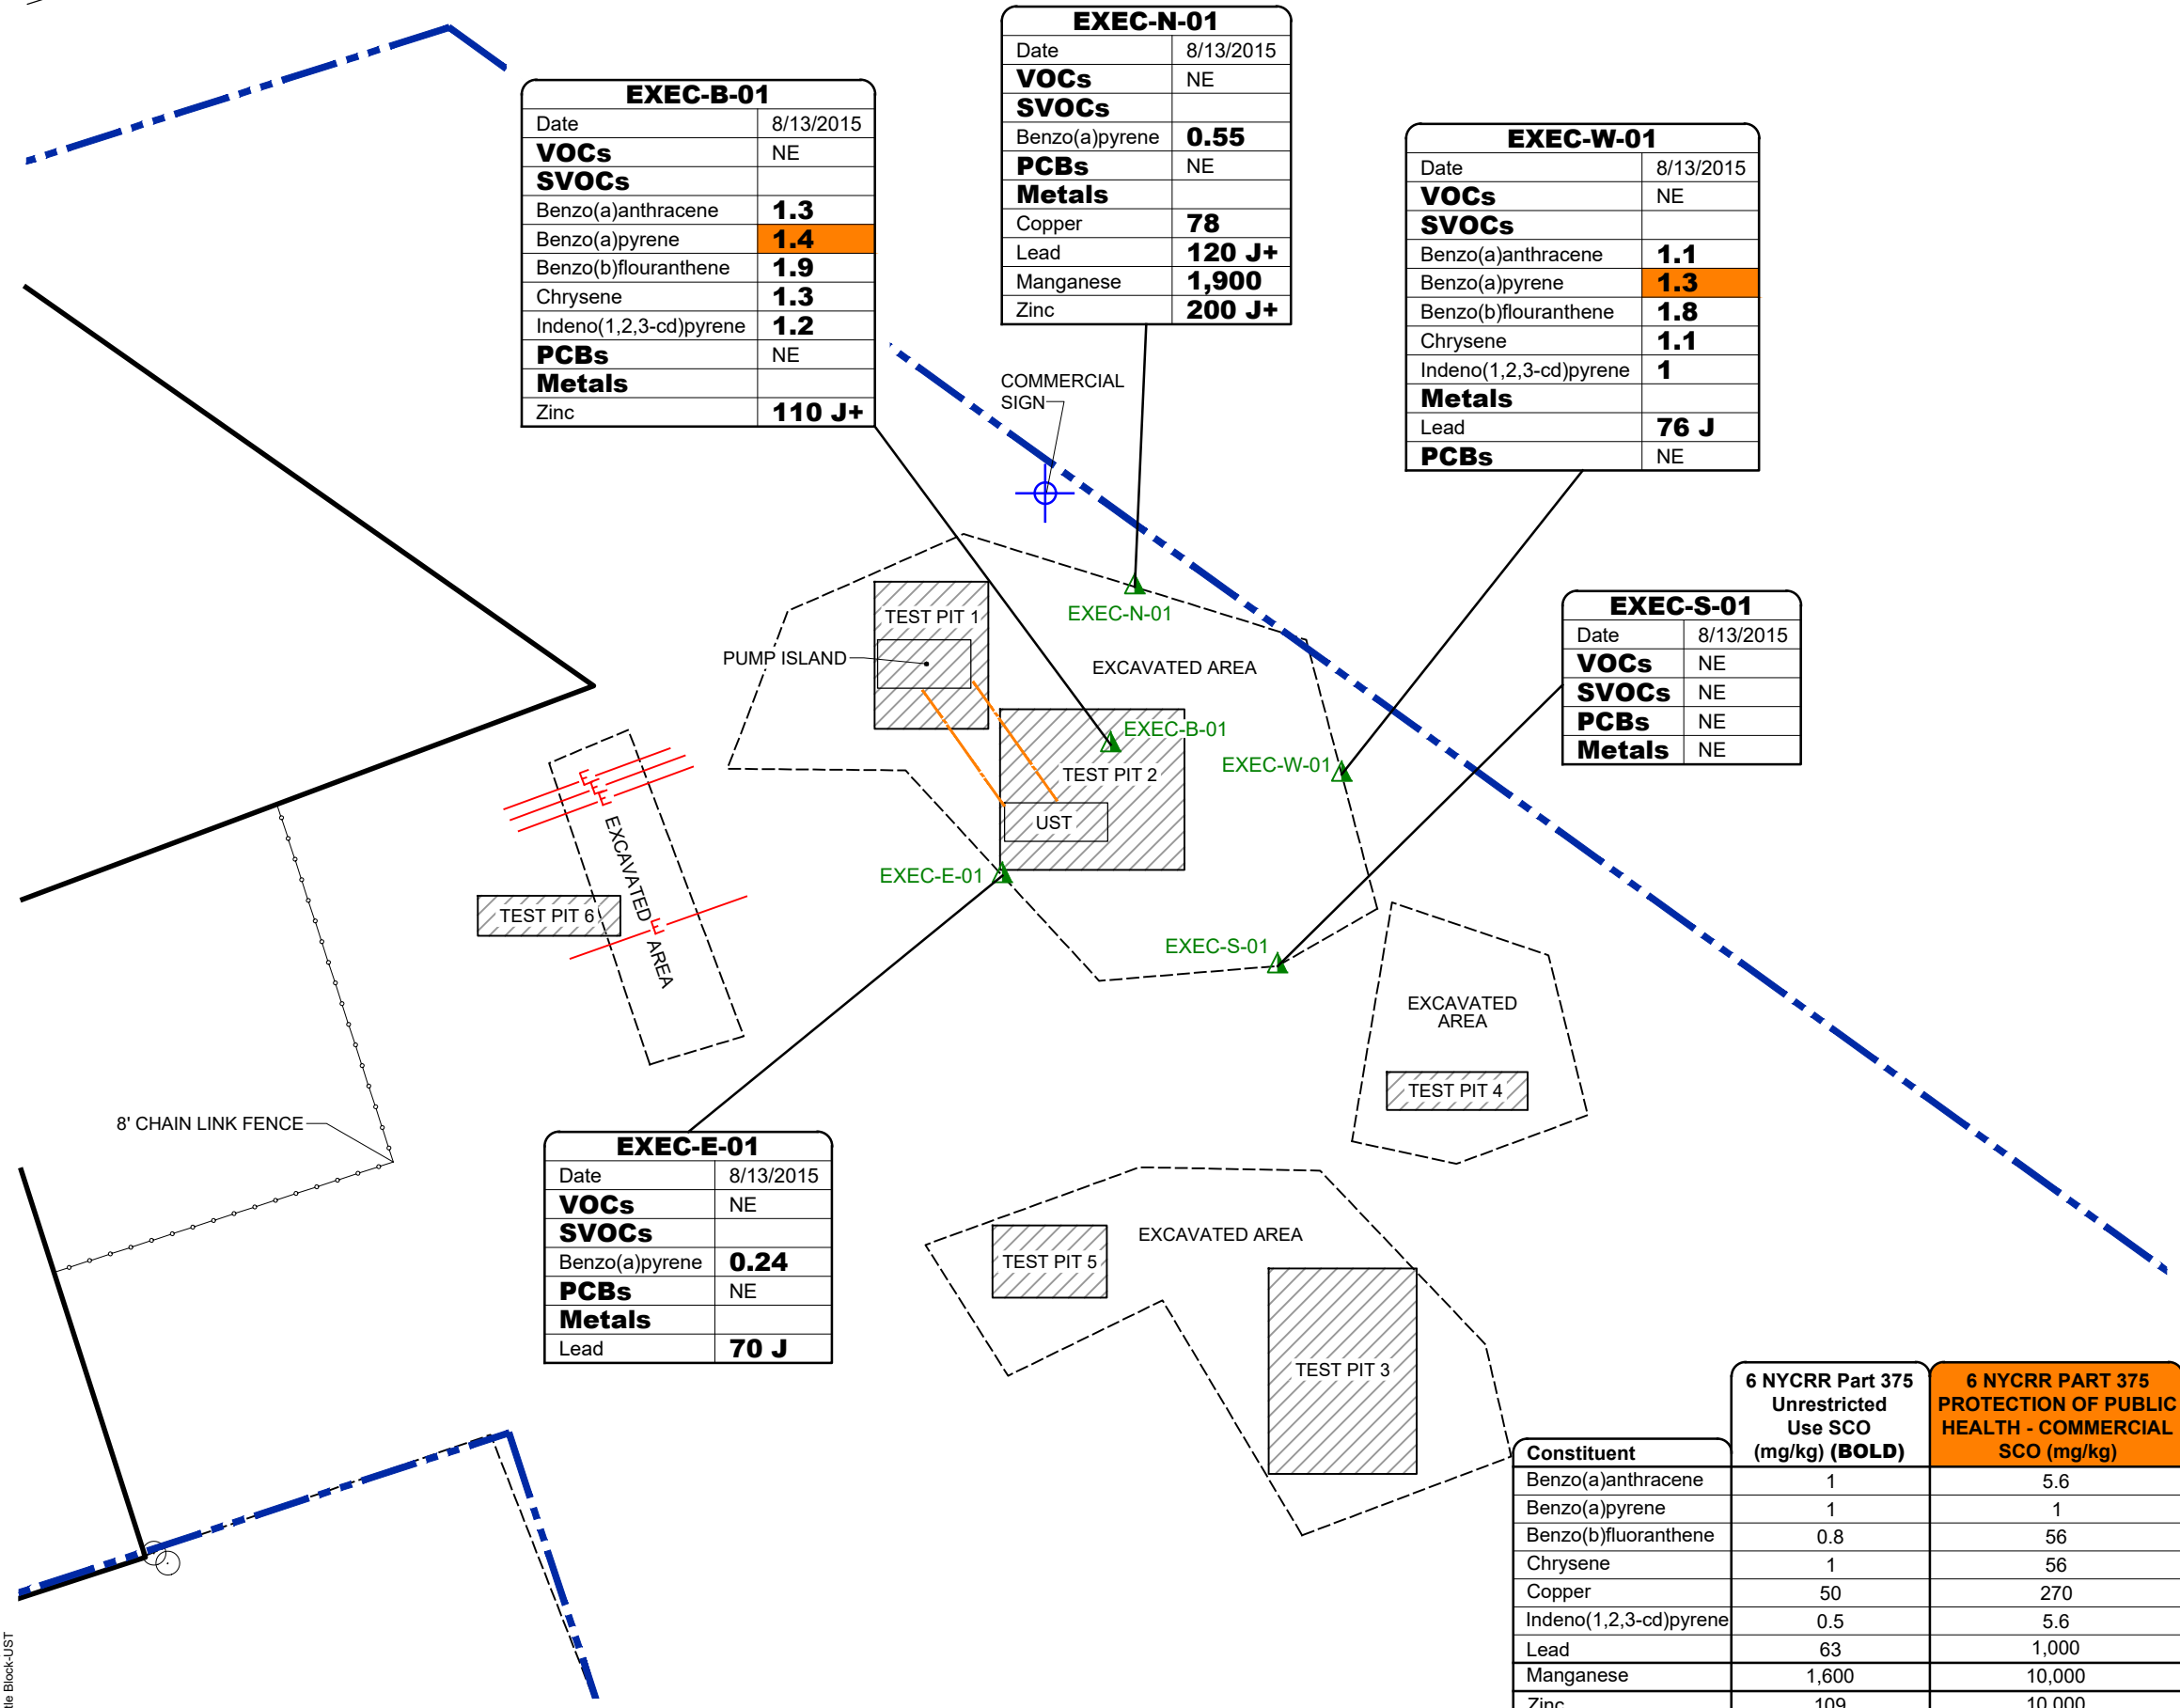
Five confirmatory soil samples (EXEC-N-01, S-01, W-01, E-01, and B-01) were collected from the UST excavation; one from each of the sidewalls and one from the bottom of the UST excavation (Figure 3). Sample locations were selected based on spatial representation as no odors or elevated PID readings were observed. Samples were submitted to Con-Test Laboratories located in Longmeadow, Massachusetts for analysis of target compounds list (TCL) VOCs, TCL semi volatile organic compounds (SVOCs), target analyte list (TAL) metals, and total polychlorinated biphenyls (PCBs). After UST removal and confirmatory sample collection, the excavation was backfilled with number 2 stone and compacted in lifts.

Five confirmatory soil samples were collected from each of the excavation side walls and one from the excavation floor (EXEC-N-01, S-01, W-01, E-01, and B-01). No PCB were detected in these soil samples. Acetone was the only VOC detected, the concentration of which was estimated below the respective Commercial SCO (Table 1). A total of 62 SVOC detections comprised of 19 compounds were reported in the five soil samples. As shown on Figure 3, benzo(a)pyrene was the only SVOC detected at a concentration greater than Commercial SCOs [1.4 mg/kg at EXEC-B-01 (bottom of the excavation) and 1.3 mg/kg at EXEC-W-01(west side wall)]. No metals were detected at concentrations greater than their respective Commercial SCOs (Table 1).
