**FINAL
REMEDIAL INVESTIGATION
REPORT**

Former Hall Welter Site

(NYSDEC Site Number 828194)

**NYSDEC STANDBY ENGINEERING CONTRACT
Work Assignment #D007625-39**

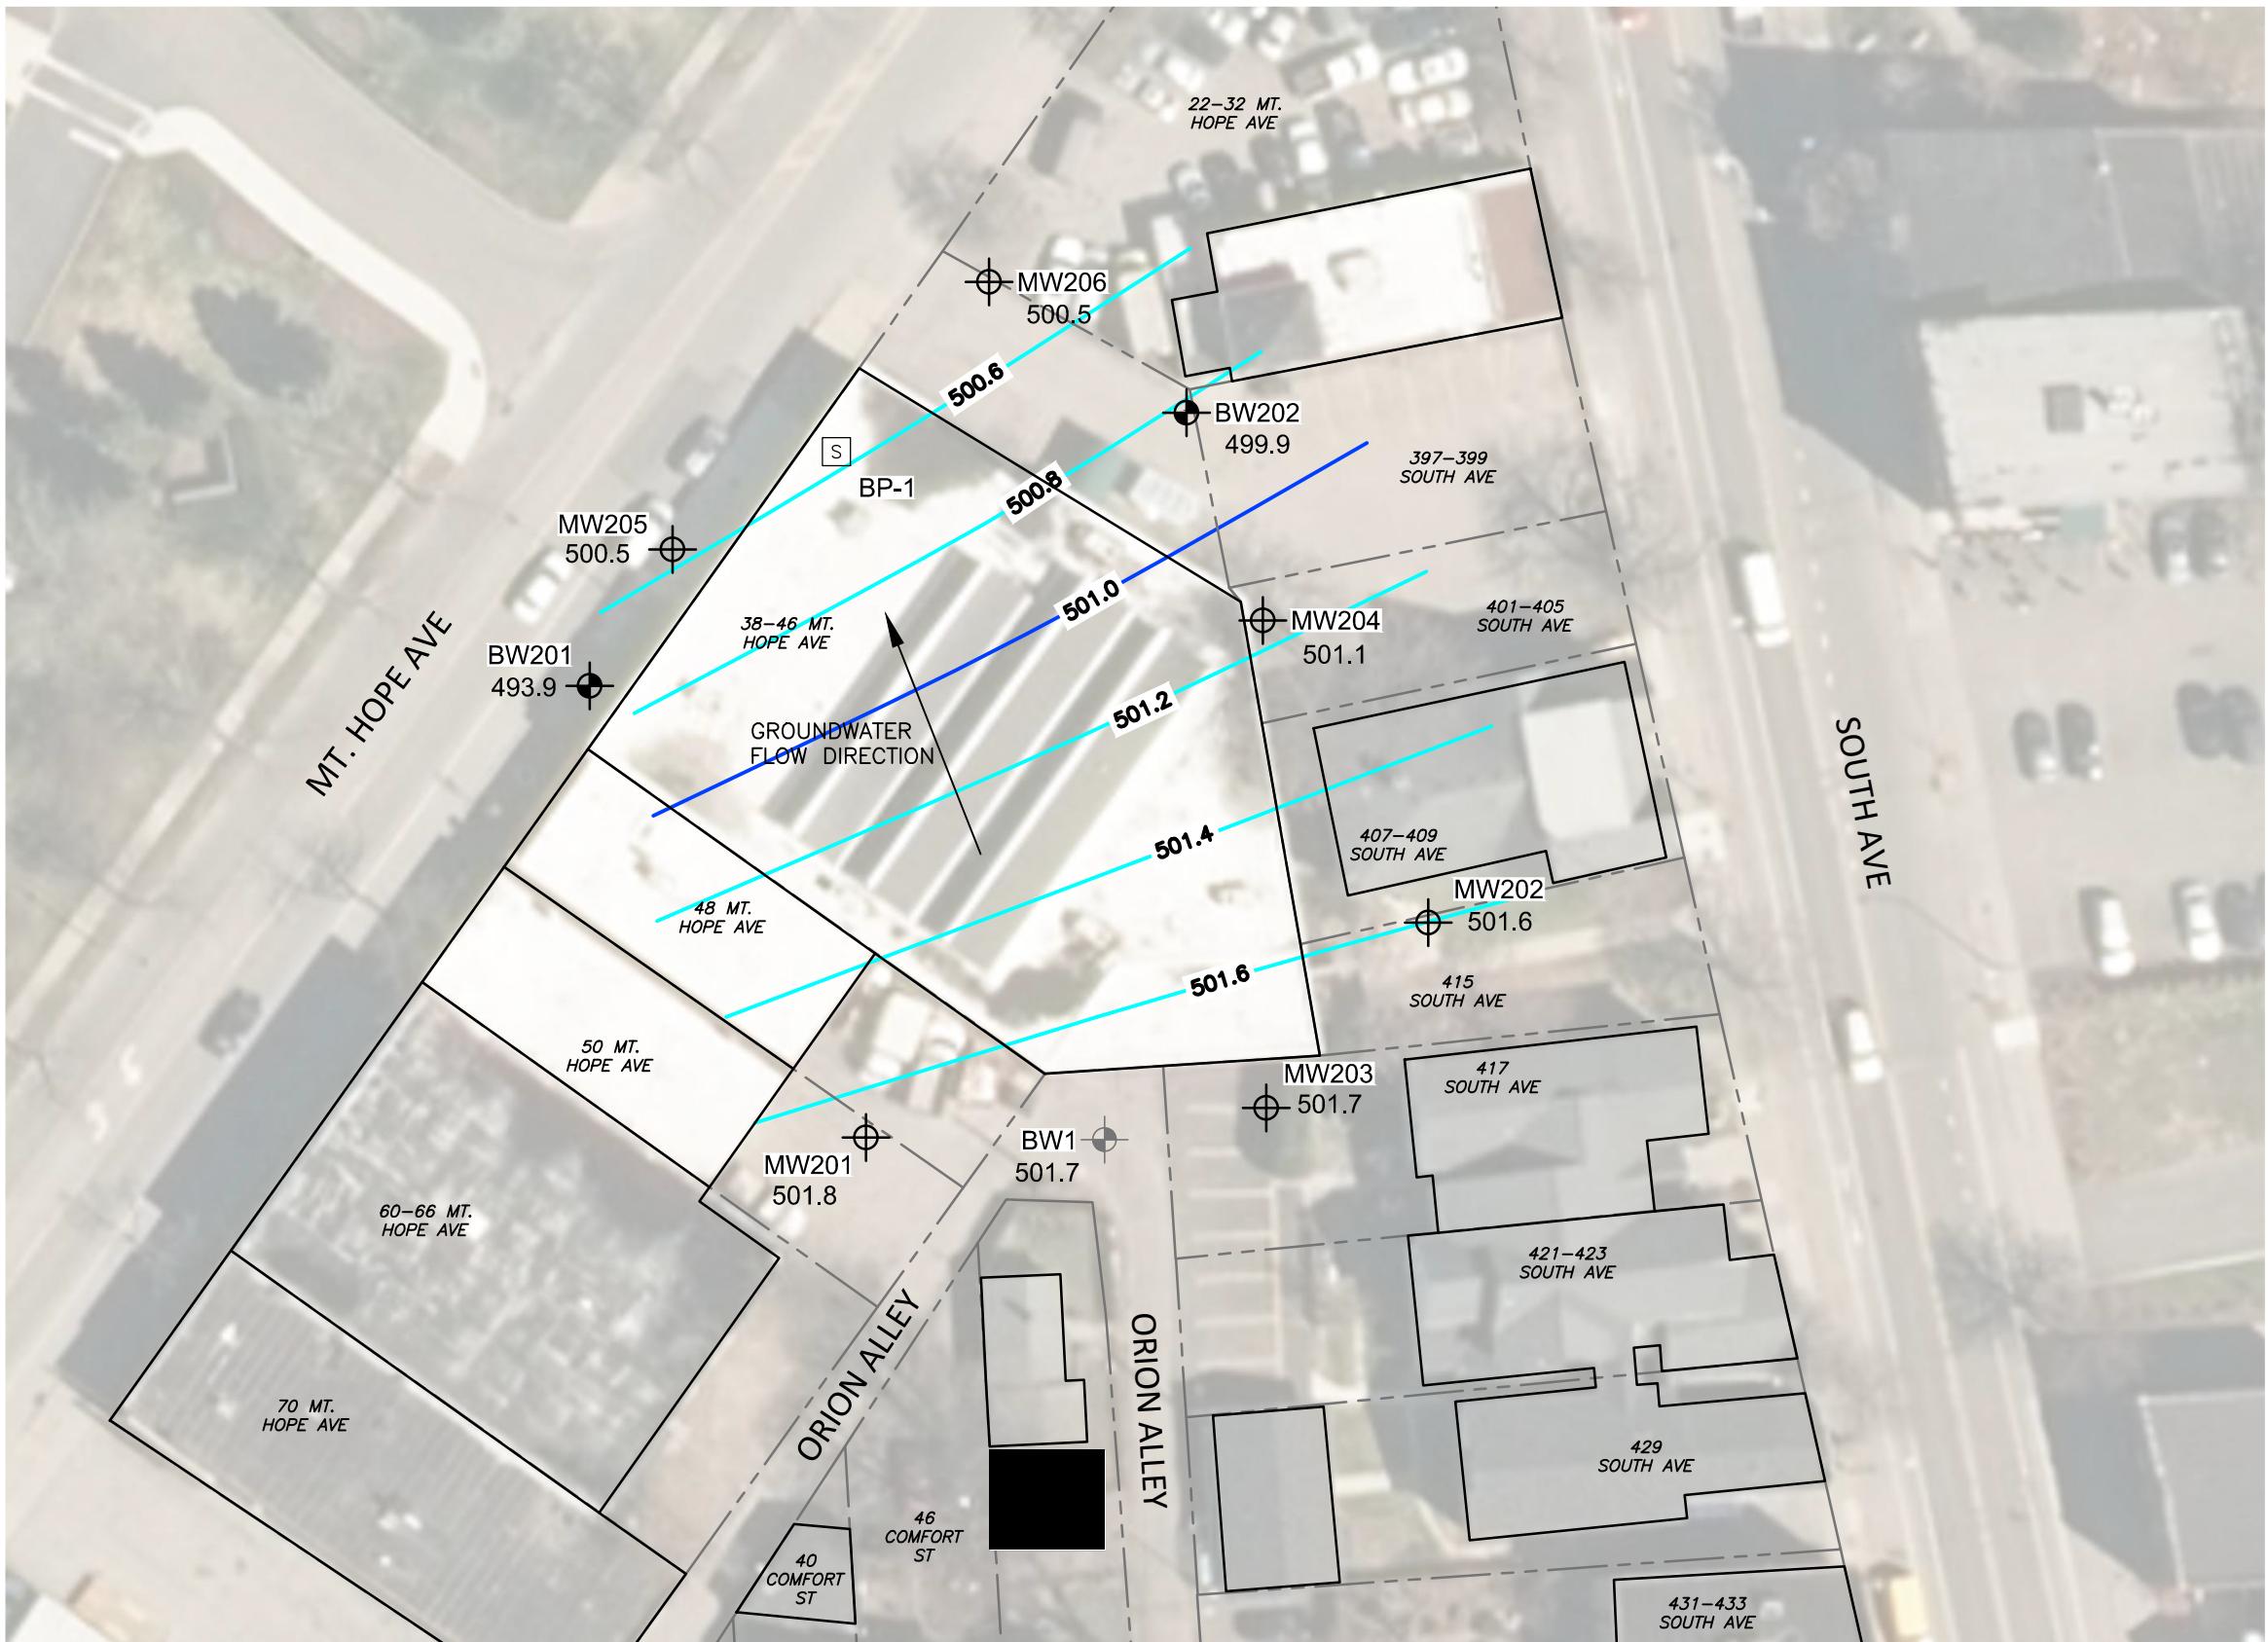
DATE 2020-02
FIGURE 3

INTERPRETED GROUNDWATER ELEVATION MAP (JUNE 2018)

The water table was encountered at a depth of 9 to 12 ft bgs during the gauging event conducted in June 2018 and in January 2020. Groundwater elevations are provided in **Table 6**. The highest groundwater elevation was observed at MW203, located north (upgradient) of the site building (501.7/501.95 ft amsl). The lowest groundwater elevation was observed at MW205 and MW206 (500.5 ft and 500.64 ft amsl), located northwest (downgradient) of the site. Groundwater gauging conducted during the June 2018 sampling event indicated a groundwater flow direction to the northwest, with an overall horizontal hydraulic gradient of 0.007 feet/foot (ft/ft) between wells MW203 and MW205.

Similarly, the highest bedrock groundwater elevation was observed at BW1, located north (upgradient) of the site building (501.7/502.09 ft amsl). The lowest bedrock groundwater elevation was observed at BW201 (493.9 ft amsl), located northwest (downgradient) of the site. Groundwater gauging conducted during the June 2018 sampling event indicated a bedrock groundwater flow direction to the northwest, similar to overburden groundwater, with an overall horizontal hydraulic gradient of 0.05 ft/ft between wells BW1 and BW201. An interpreted groundwater contour map illustrating the direction of groundwater flow for the June 2018 event is shown in **Figure 3**.

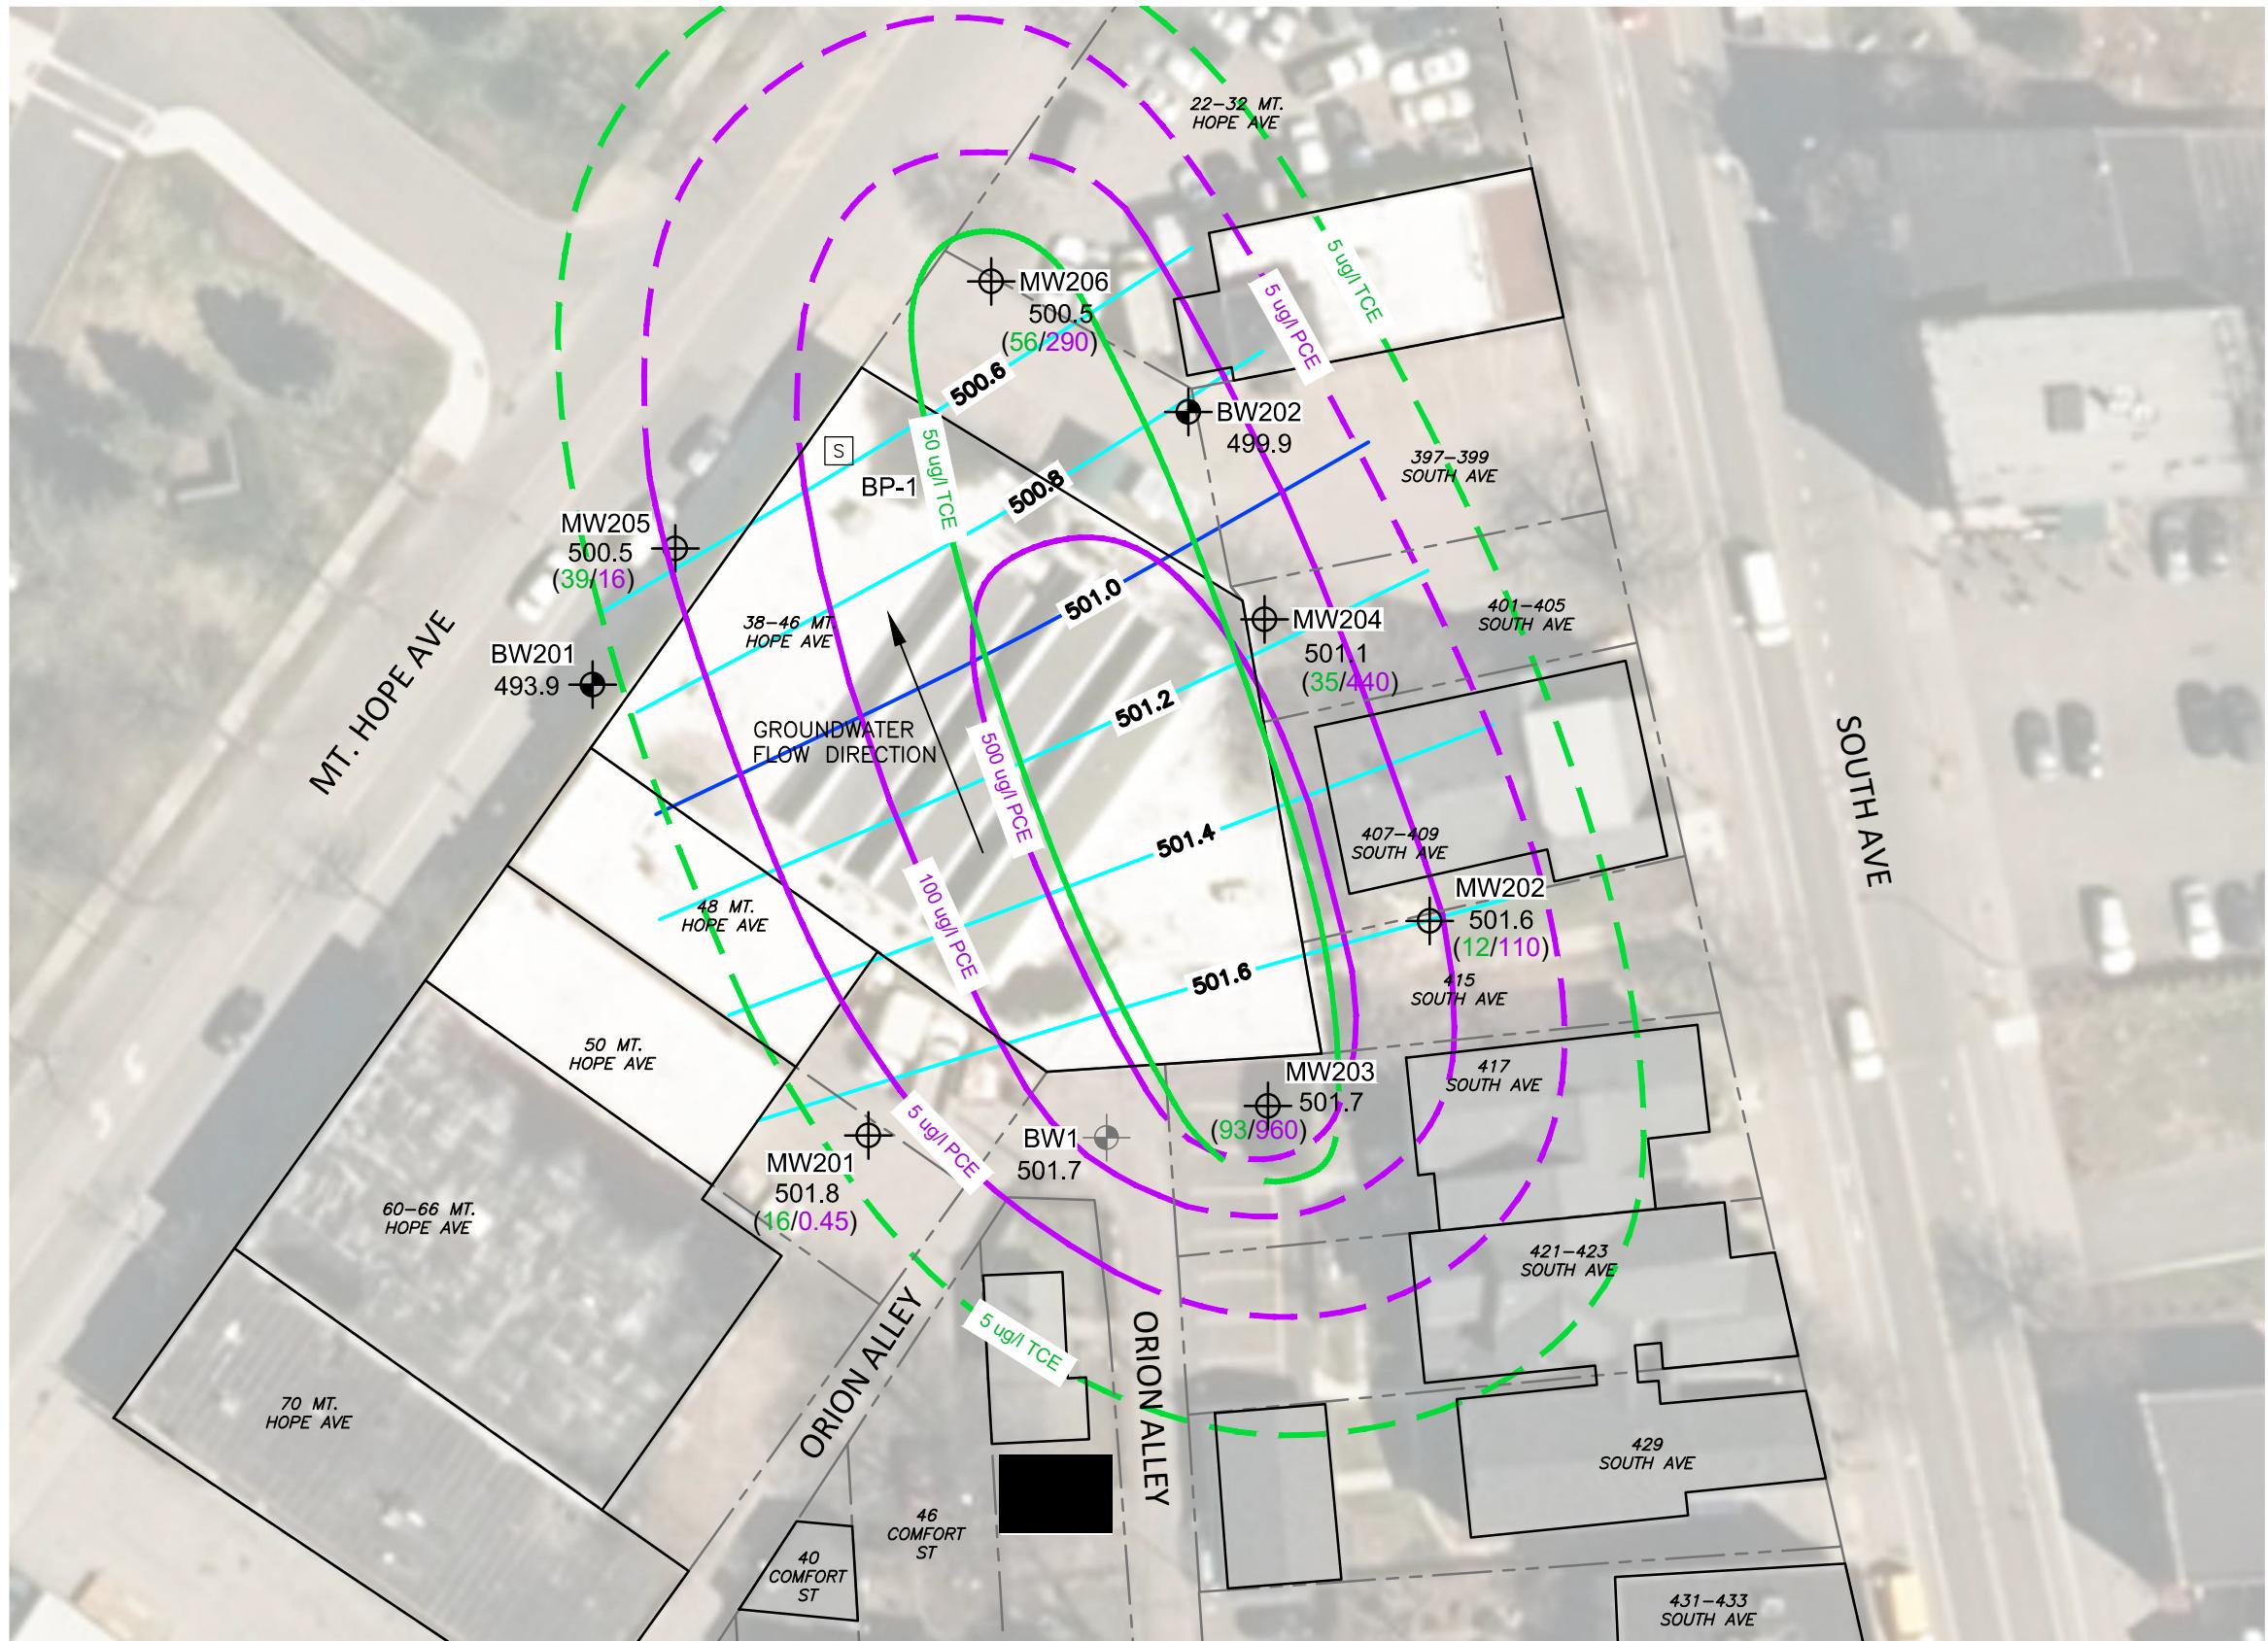
INTERPRETED GROUNDWATER ISO-CONCENTRATION MAP (JUNE 2018)
