FEASIBILITY STUDY AND REMEDIAL ALTERNATIVES ANALYSIS

Former Hall Welter

38-46 Mt. Hope Ave.
Rochester, New York, 14620

Issued On: November 1, 2021

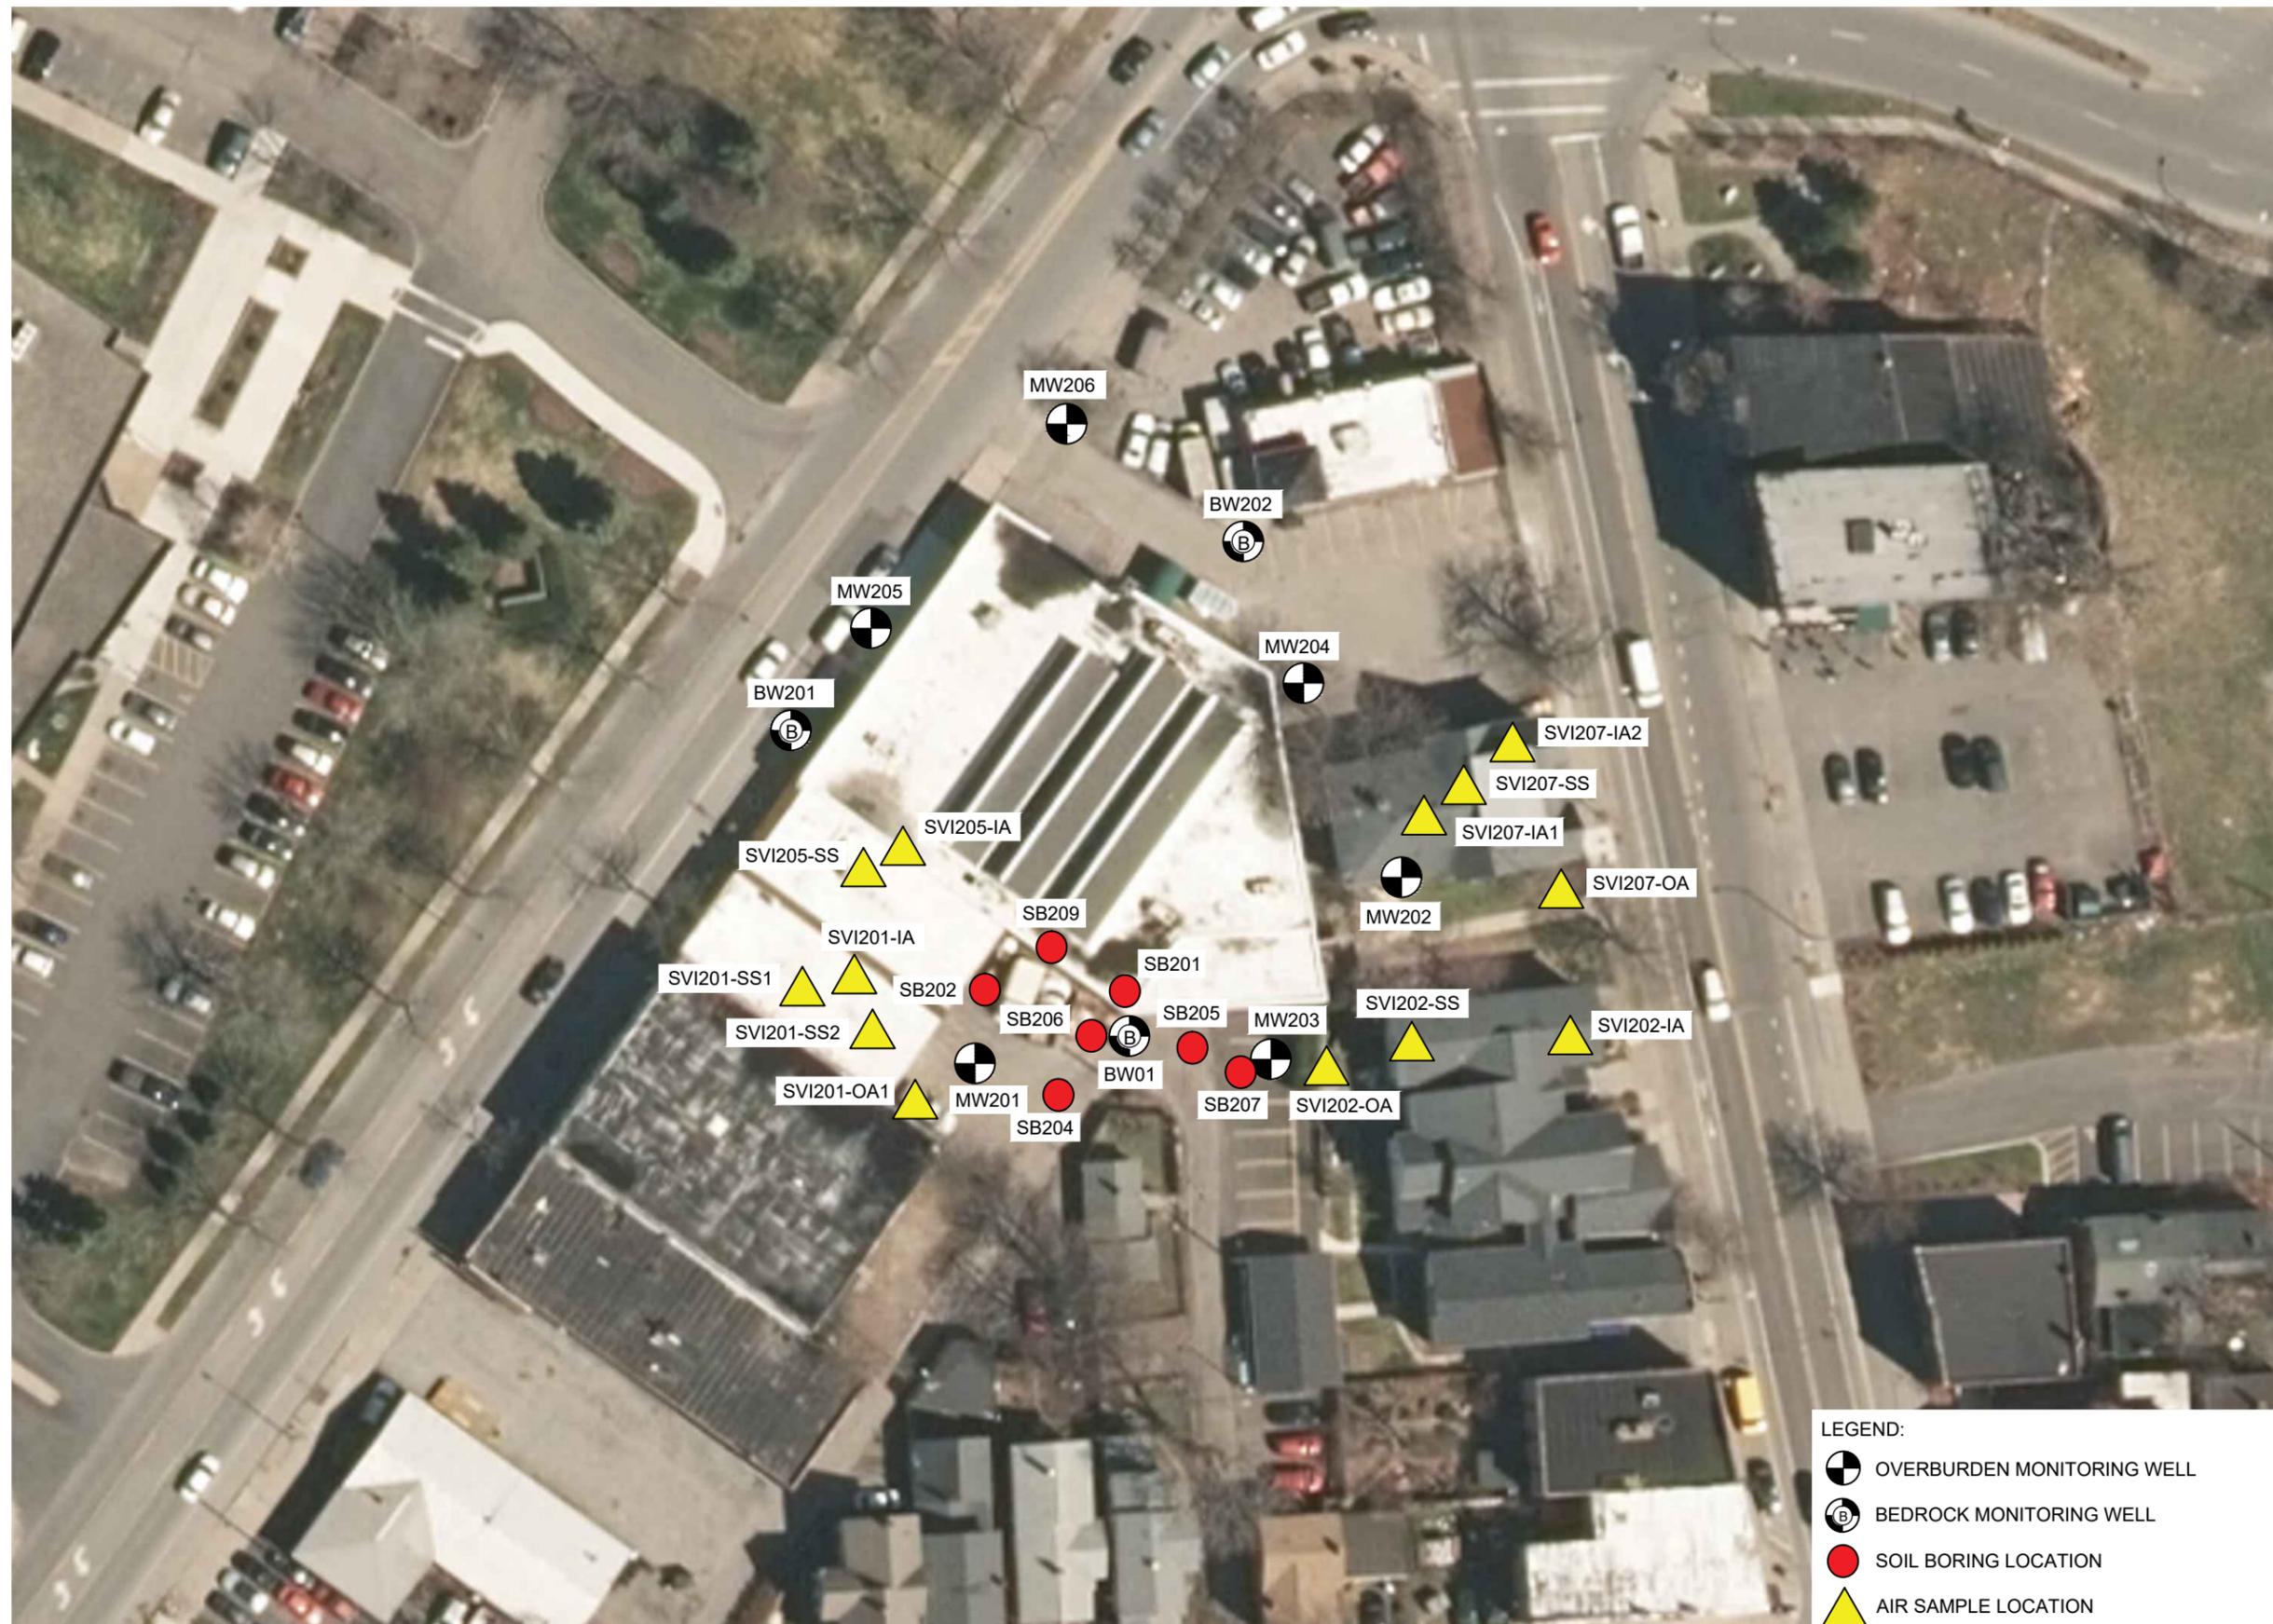
FIGURE
2

SITE PLAN
 FORMER HALL WELTER SITE
 (#828194)
 ROCHESTER, NEW YORK

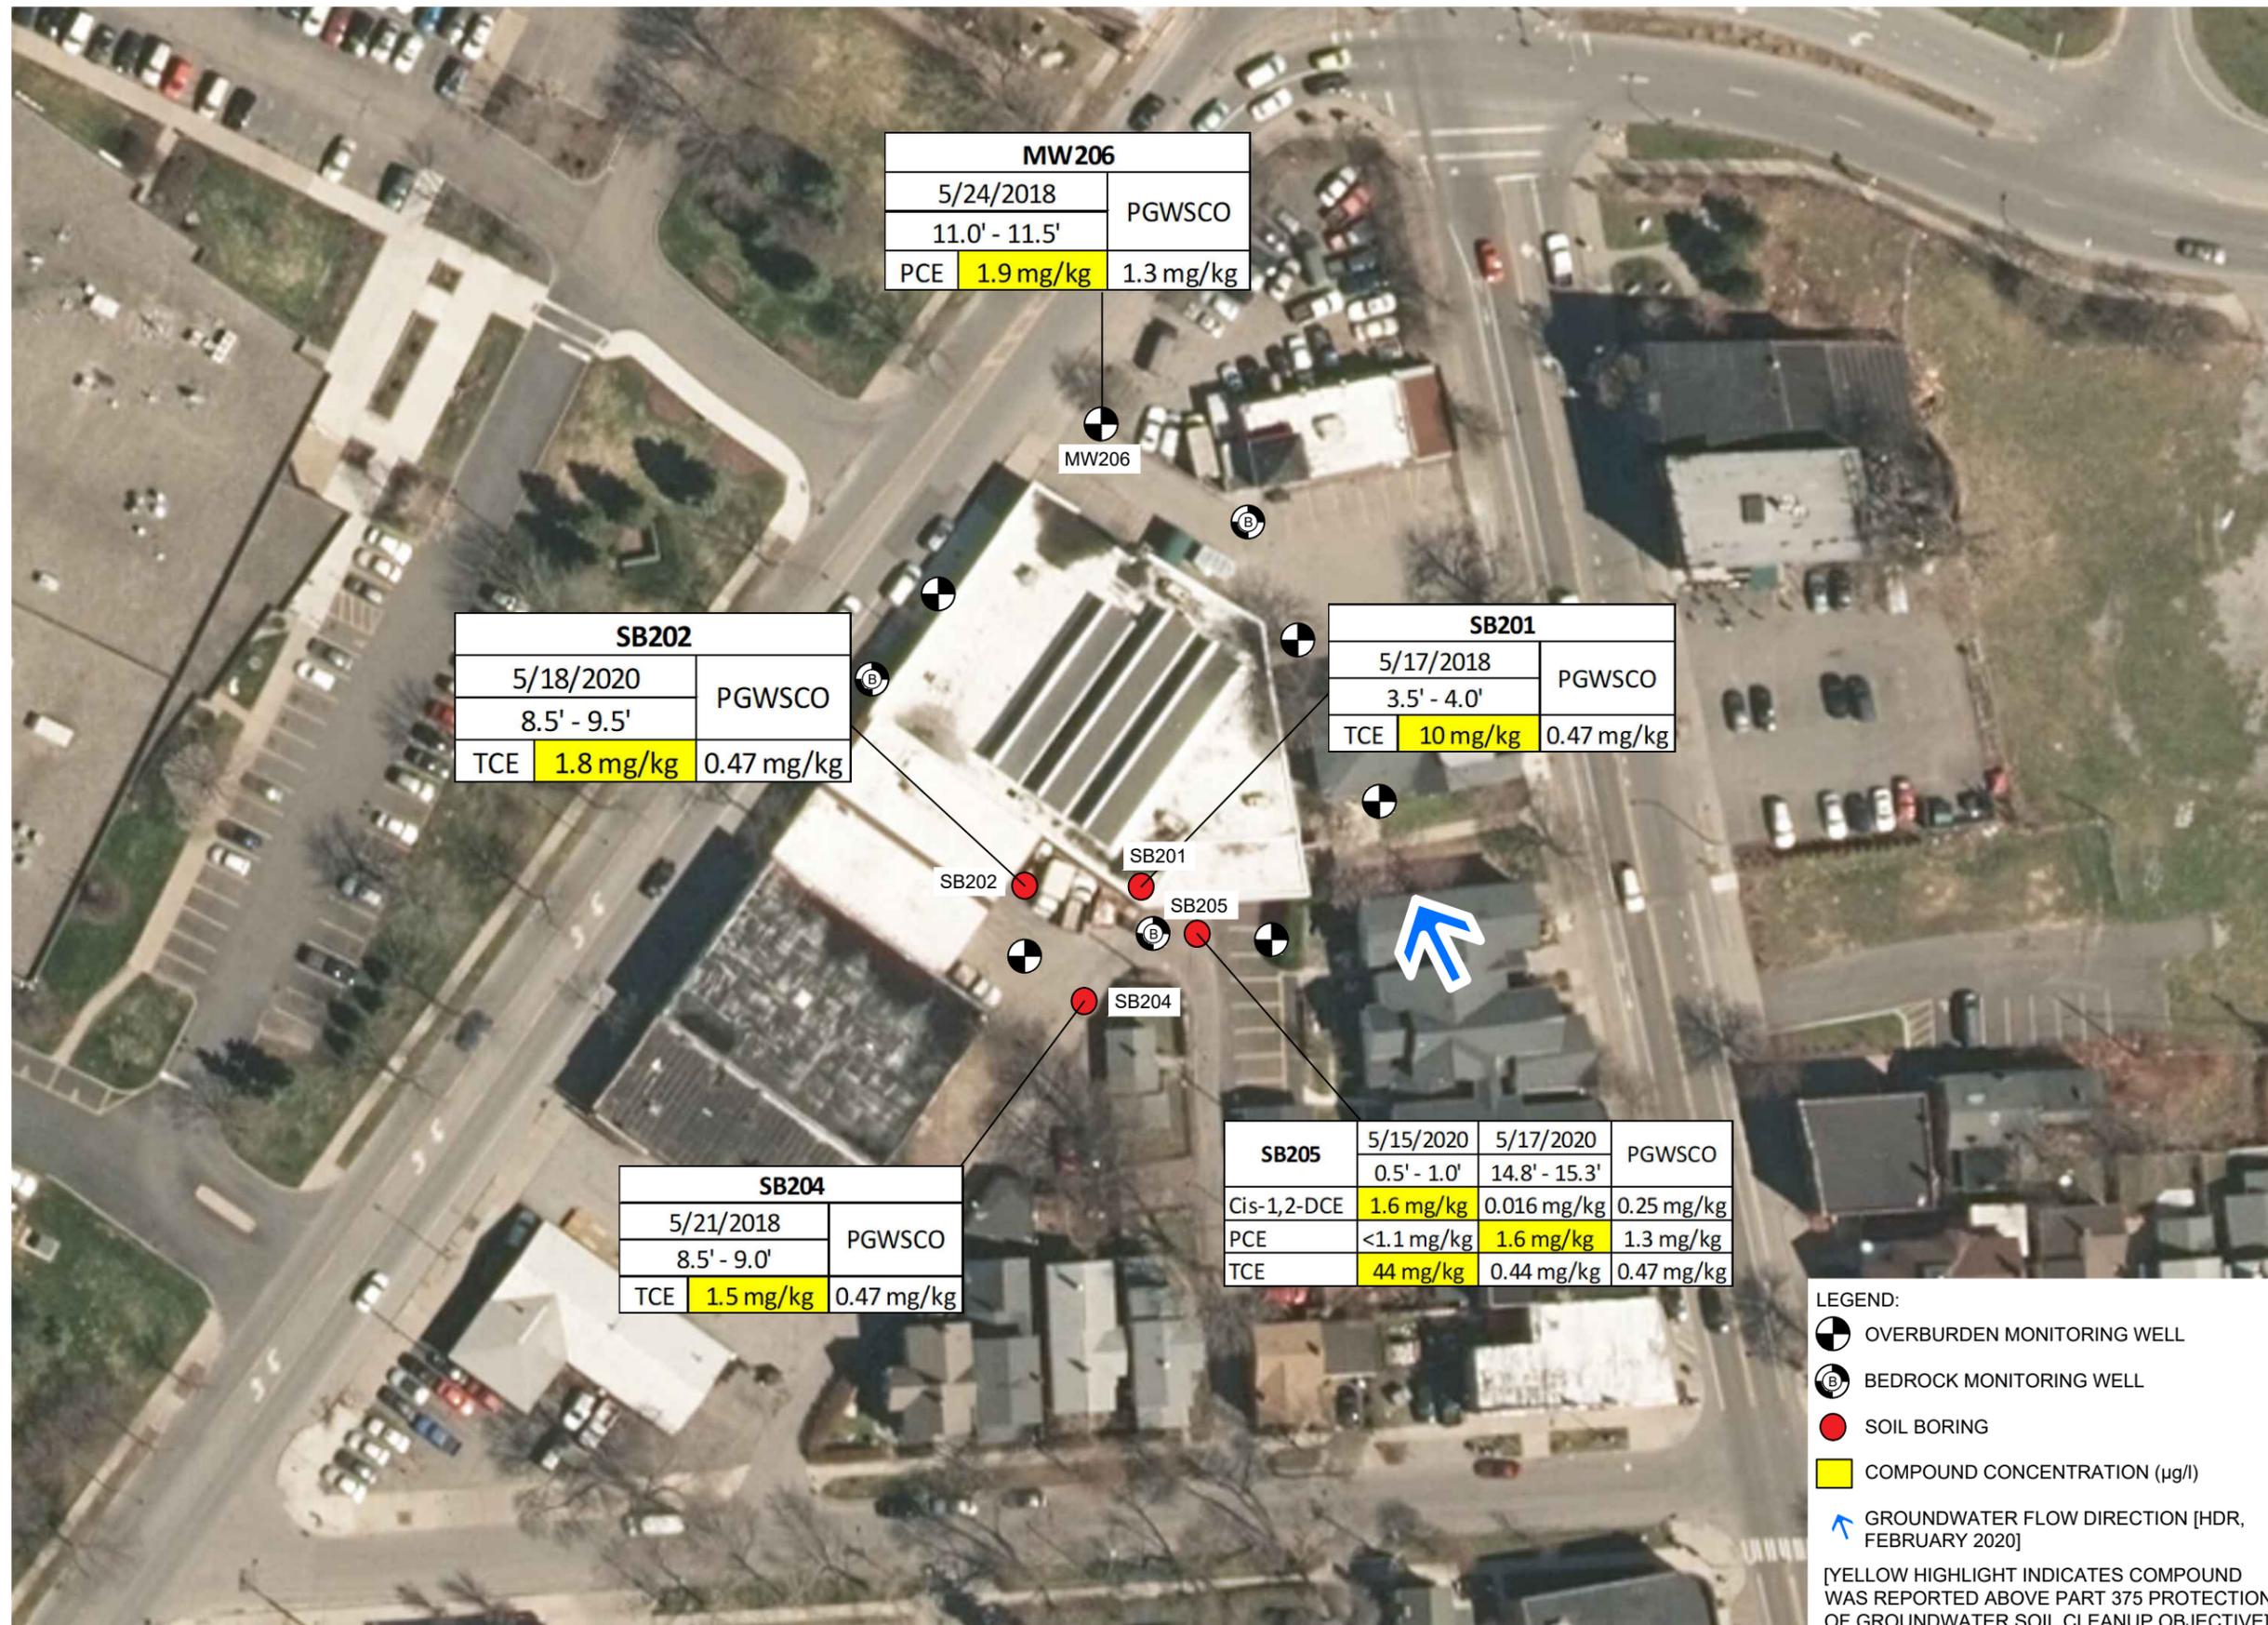
FIGURE 3

MW206		
5/24/2018	PGWSCO	
11.0' - 11.5'		
PCE	1.9 mg/kg	1.3 mg/kg

SB202		
5/18/2020	PGWSCO	
8.5' - 9.5'		
TCE	1.8 mg/kg	0.47 mg/kg

SUMMARY OF SOIL ANALYTICAL RESULTS ONLY EXCEEDANCES SHOWN
 FORMER HALL WELTER SITE (#828194)
 ROCHESTER, NEW YORK

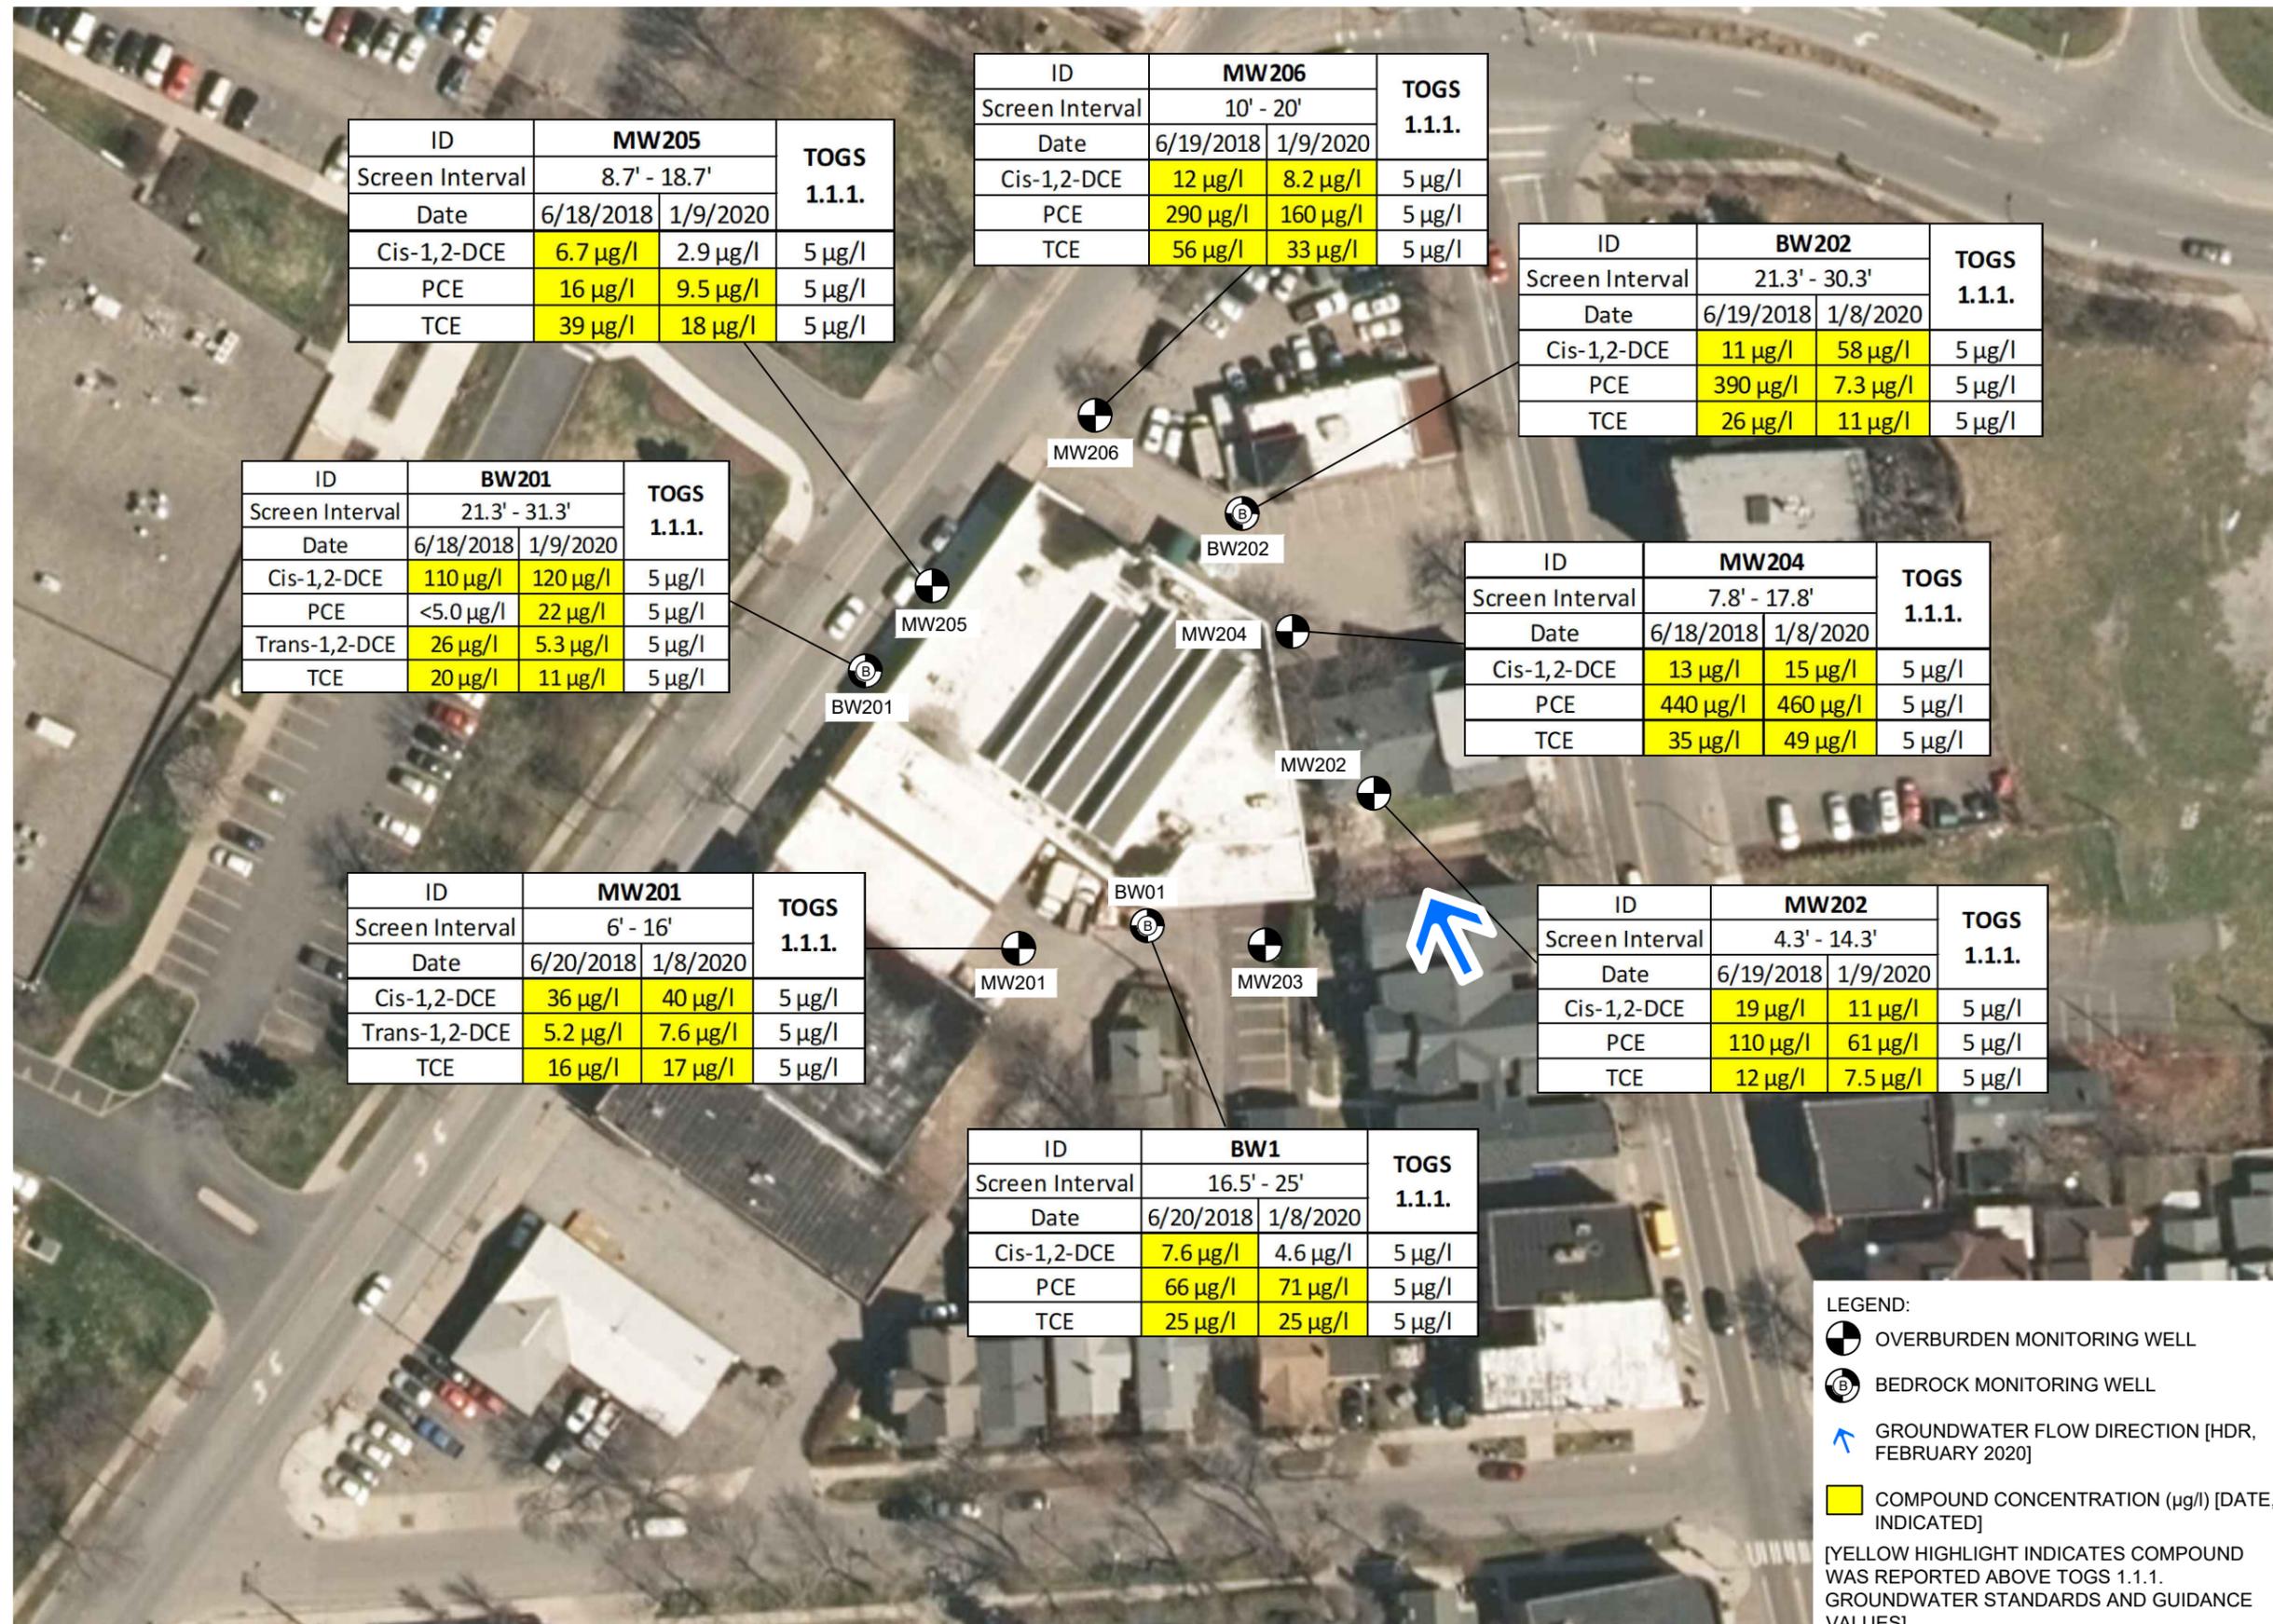
FIGURE 4

ID	MW205		TOGS 1.1.1.
Screen Interval	8.7' - 18.7'		
Date	6/18/2018	1/9/2020	
Cis-1,2-DCE	6.7 µg/l	2.9 µg/l	5 µg/l
PCE	16 µg/l	9.5 µg/l	5 µg/l
TCE	39 µg/l	18 µg/l	5 µg/l

ID	MW206		TOGS 1.1.1.
Screen Interval	10' - 20'		
Date	6/19/2018	1/9/2020	
Cis-1,2-DCE	12 µg/l	8.2 µg/l	5 µg/l
PCE	290 µg/l	160 µg/l	5 µg/l
TCE	56 µg/l	33 µg/l	5 µg/l

SUMMARY OF GROUNDWATER ANALYTICAL RESULTS ONLY EXCEEDANCES SHOWN
 FORMER HALL WELTER SITE (#828194)
 ROCHESTER, NEW YORK

During the RI sampling events, chlorinated volatile organic compounds (VOCs), mainly PCE and its degradation products (TCE and cis-1,2-DCE) were detected at concentrations exceeding TOGS 1.1.1 criteria in all six overburden monitoring wells. The highest concentrations were detected in MW203, which is located southwest of the Site building, at the most upgradient edge of the Site boundary. The lowest concentrations were detected in MW-205, located downgradient and side gradient from MW-203. Well locations and detected concentrations of COCs are depicted on **Figure 4**.

During the RI sampling events, chlorinated VOCs, mainly PCE and its degradation products (TCE and cis-1,2-DCE), were detected at concentrations exceeding TOGS 1.1.1 criteria in all three bedrock wells. In general, the highest detected concentrations were observed in BW-1, the most upgradient location, located to the south of the building, and the lowest detected concentrations were observed in BW-202, the most downgradient location, located to the north of the building. Well locations and detected concentrations of COCs are depicted on **Figure 4**.

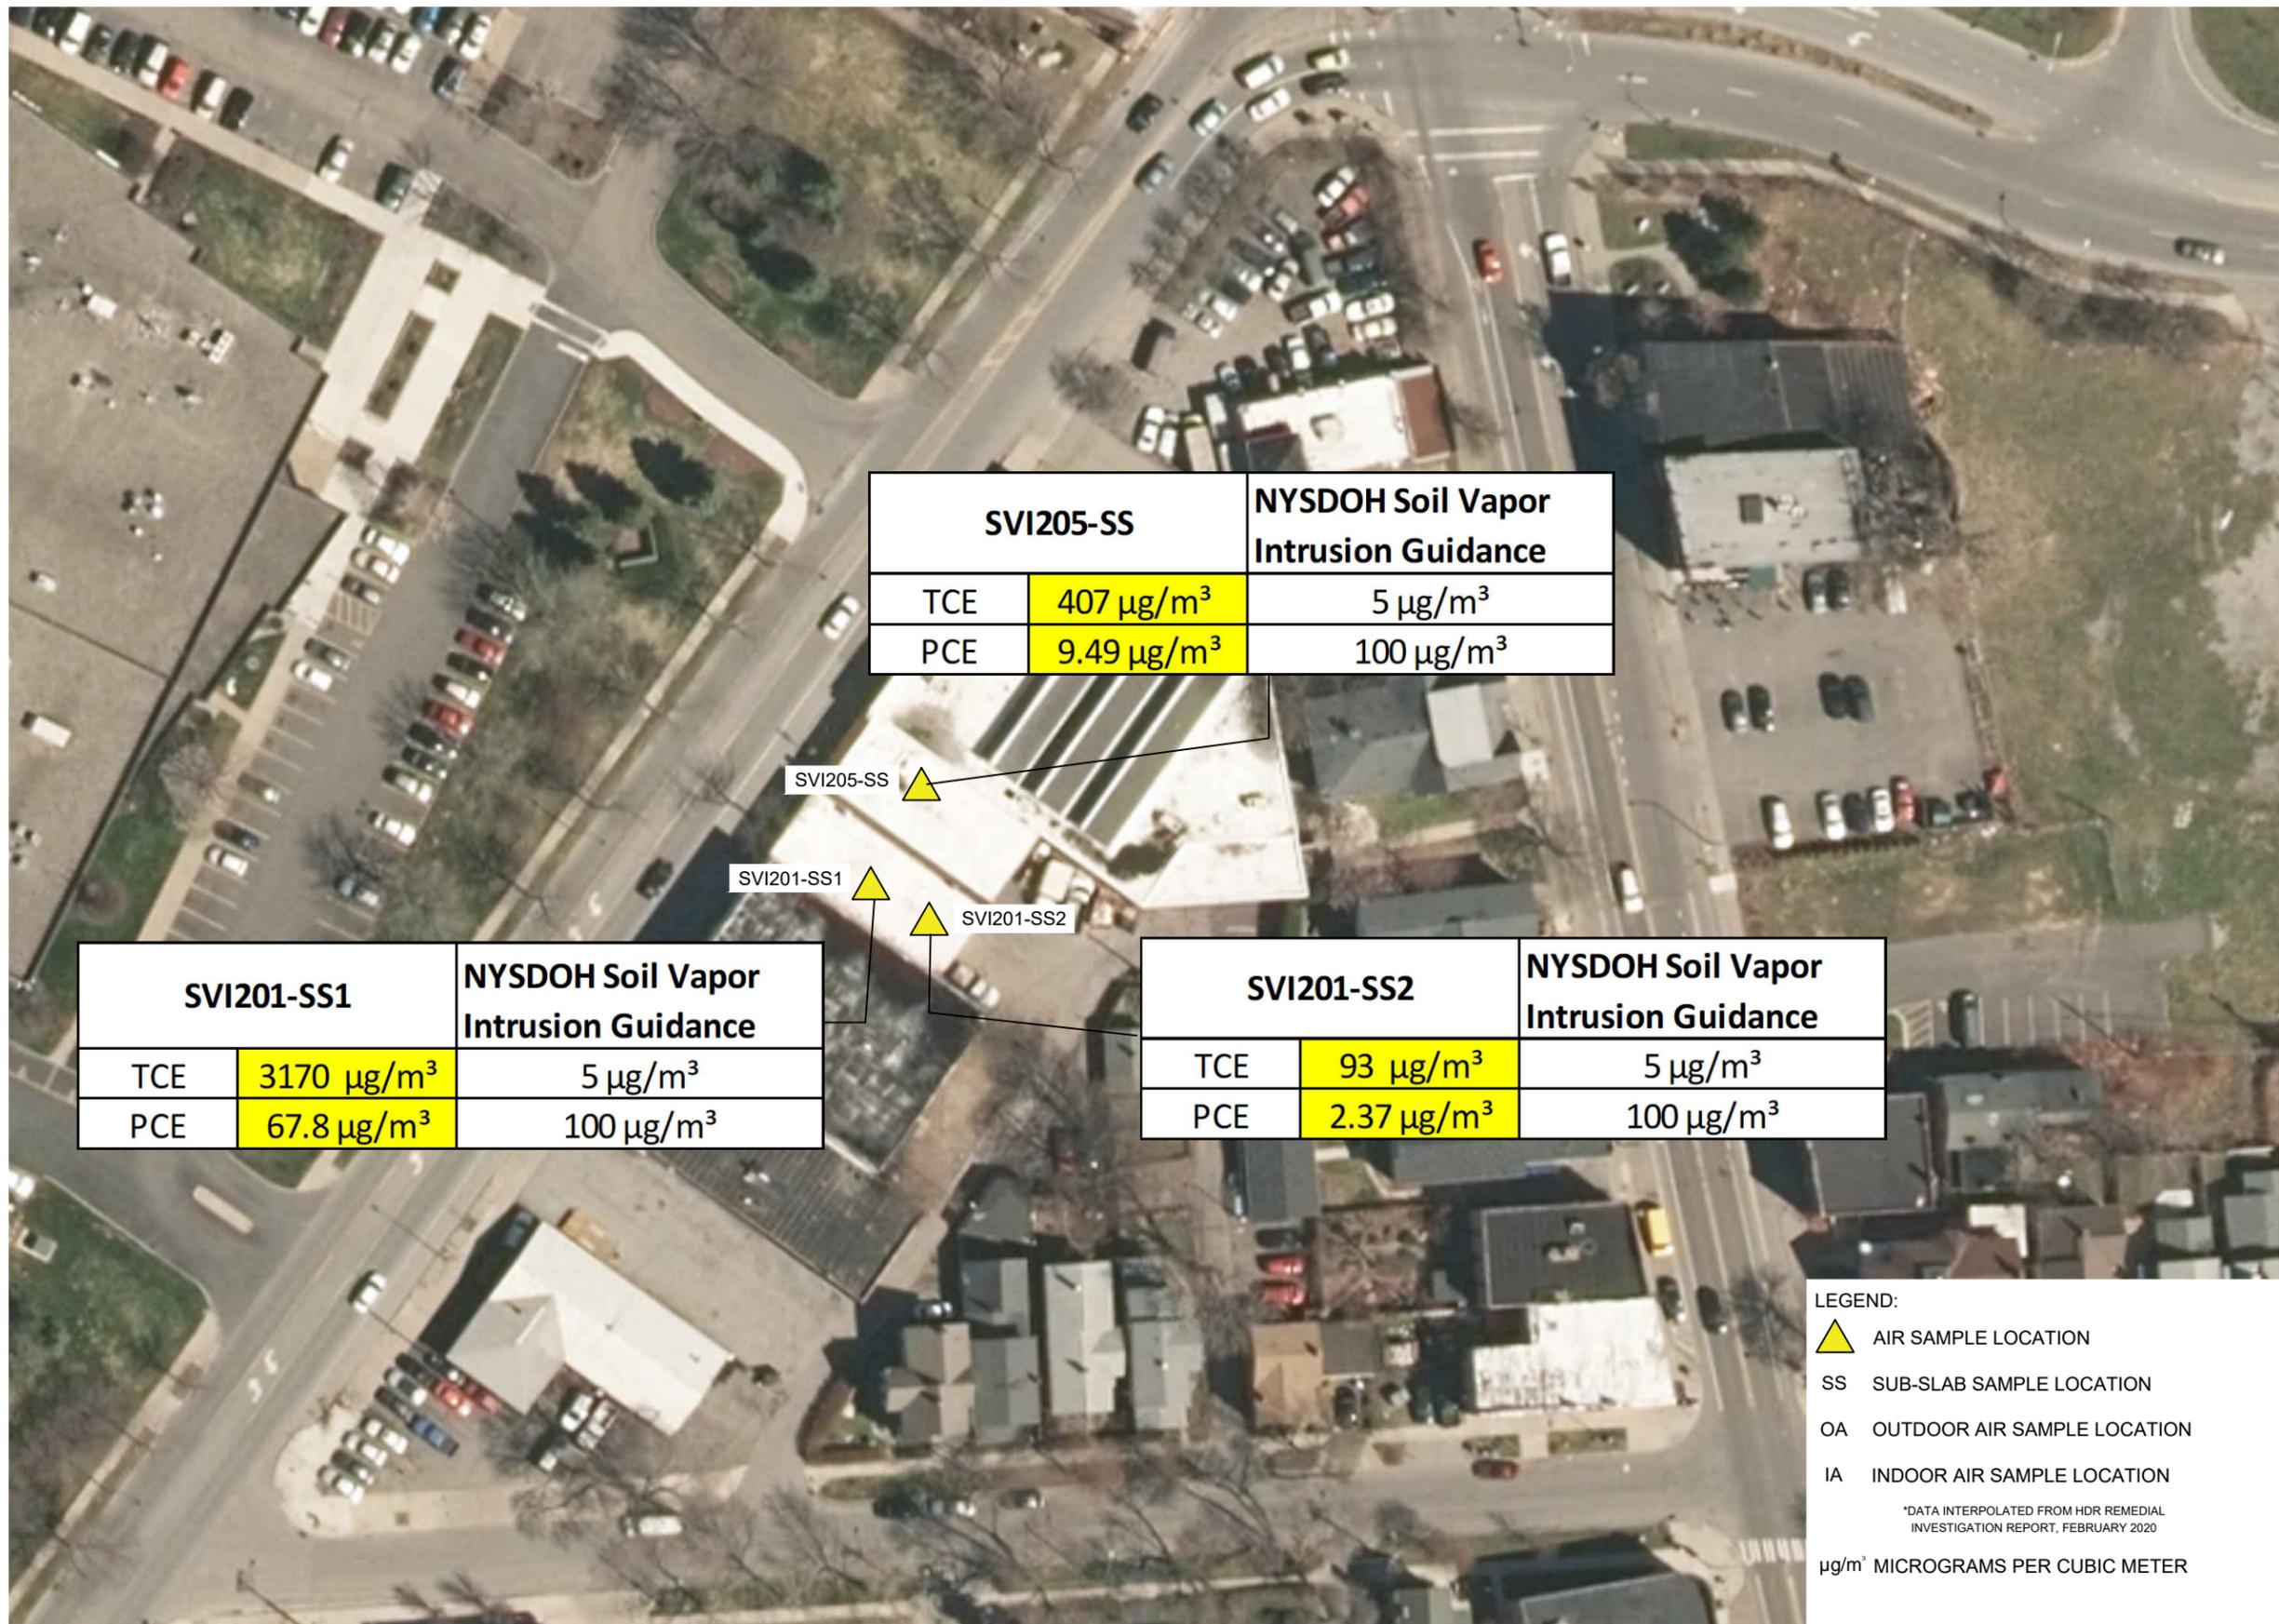
FIGURE
5

SVI205-SS		NYSDOH Soil Vapor Intrusion Guidance
TCE	407 µg/m ³	5 µg/m ³
PCE	9.49 µg/m ³	100 µg/m ³

SVI201-SS1		NYSDOH Soil Vapor Intrusion Guidance
TCE	3170 µg/m ³	5 µg/m ³
PCE	67.8 µg/m ³	100 µg/m ³

SUMMARY OF SOIL VAPOR ANALYTICAL RESULTS ONLY EXCEEDANCES SHOWN
 FORMER HALL WELTER SITE (#828194)
 ROCHESTER, NEW YORK

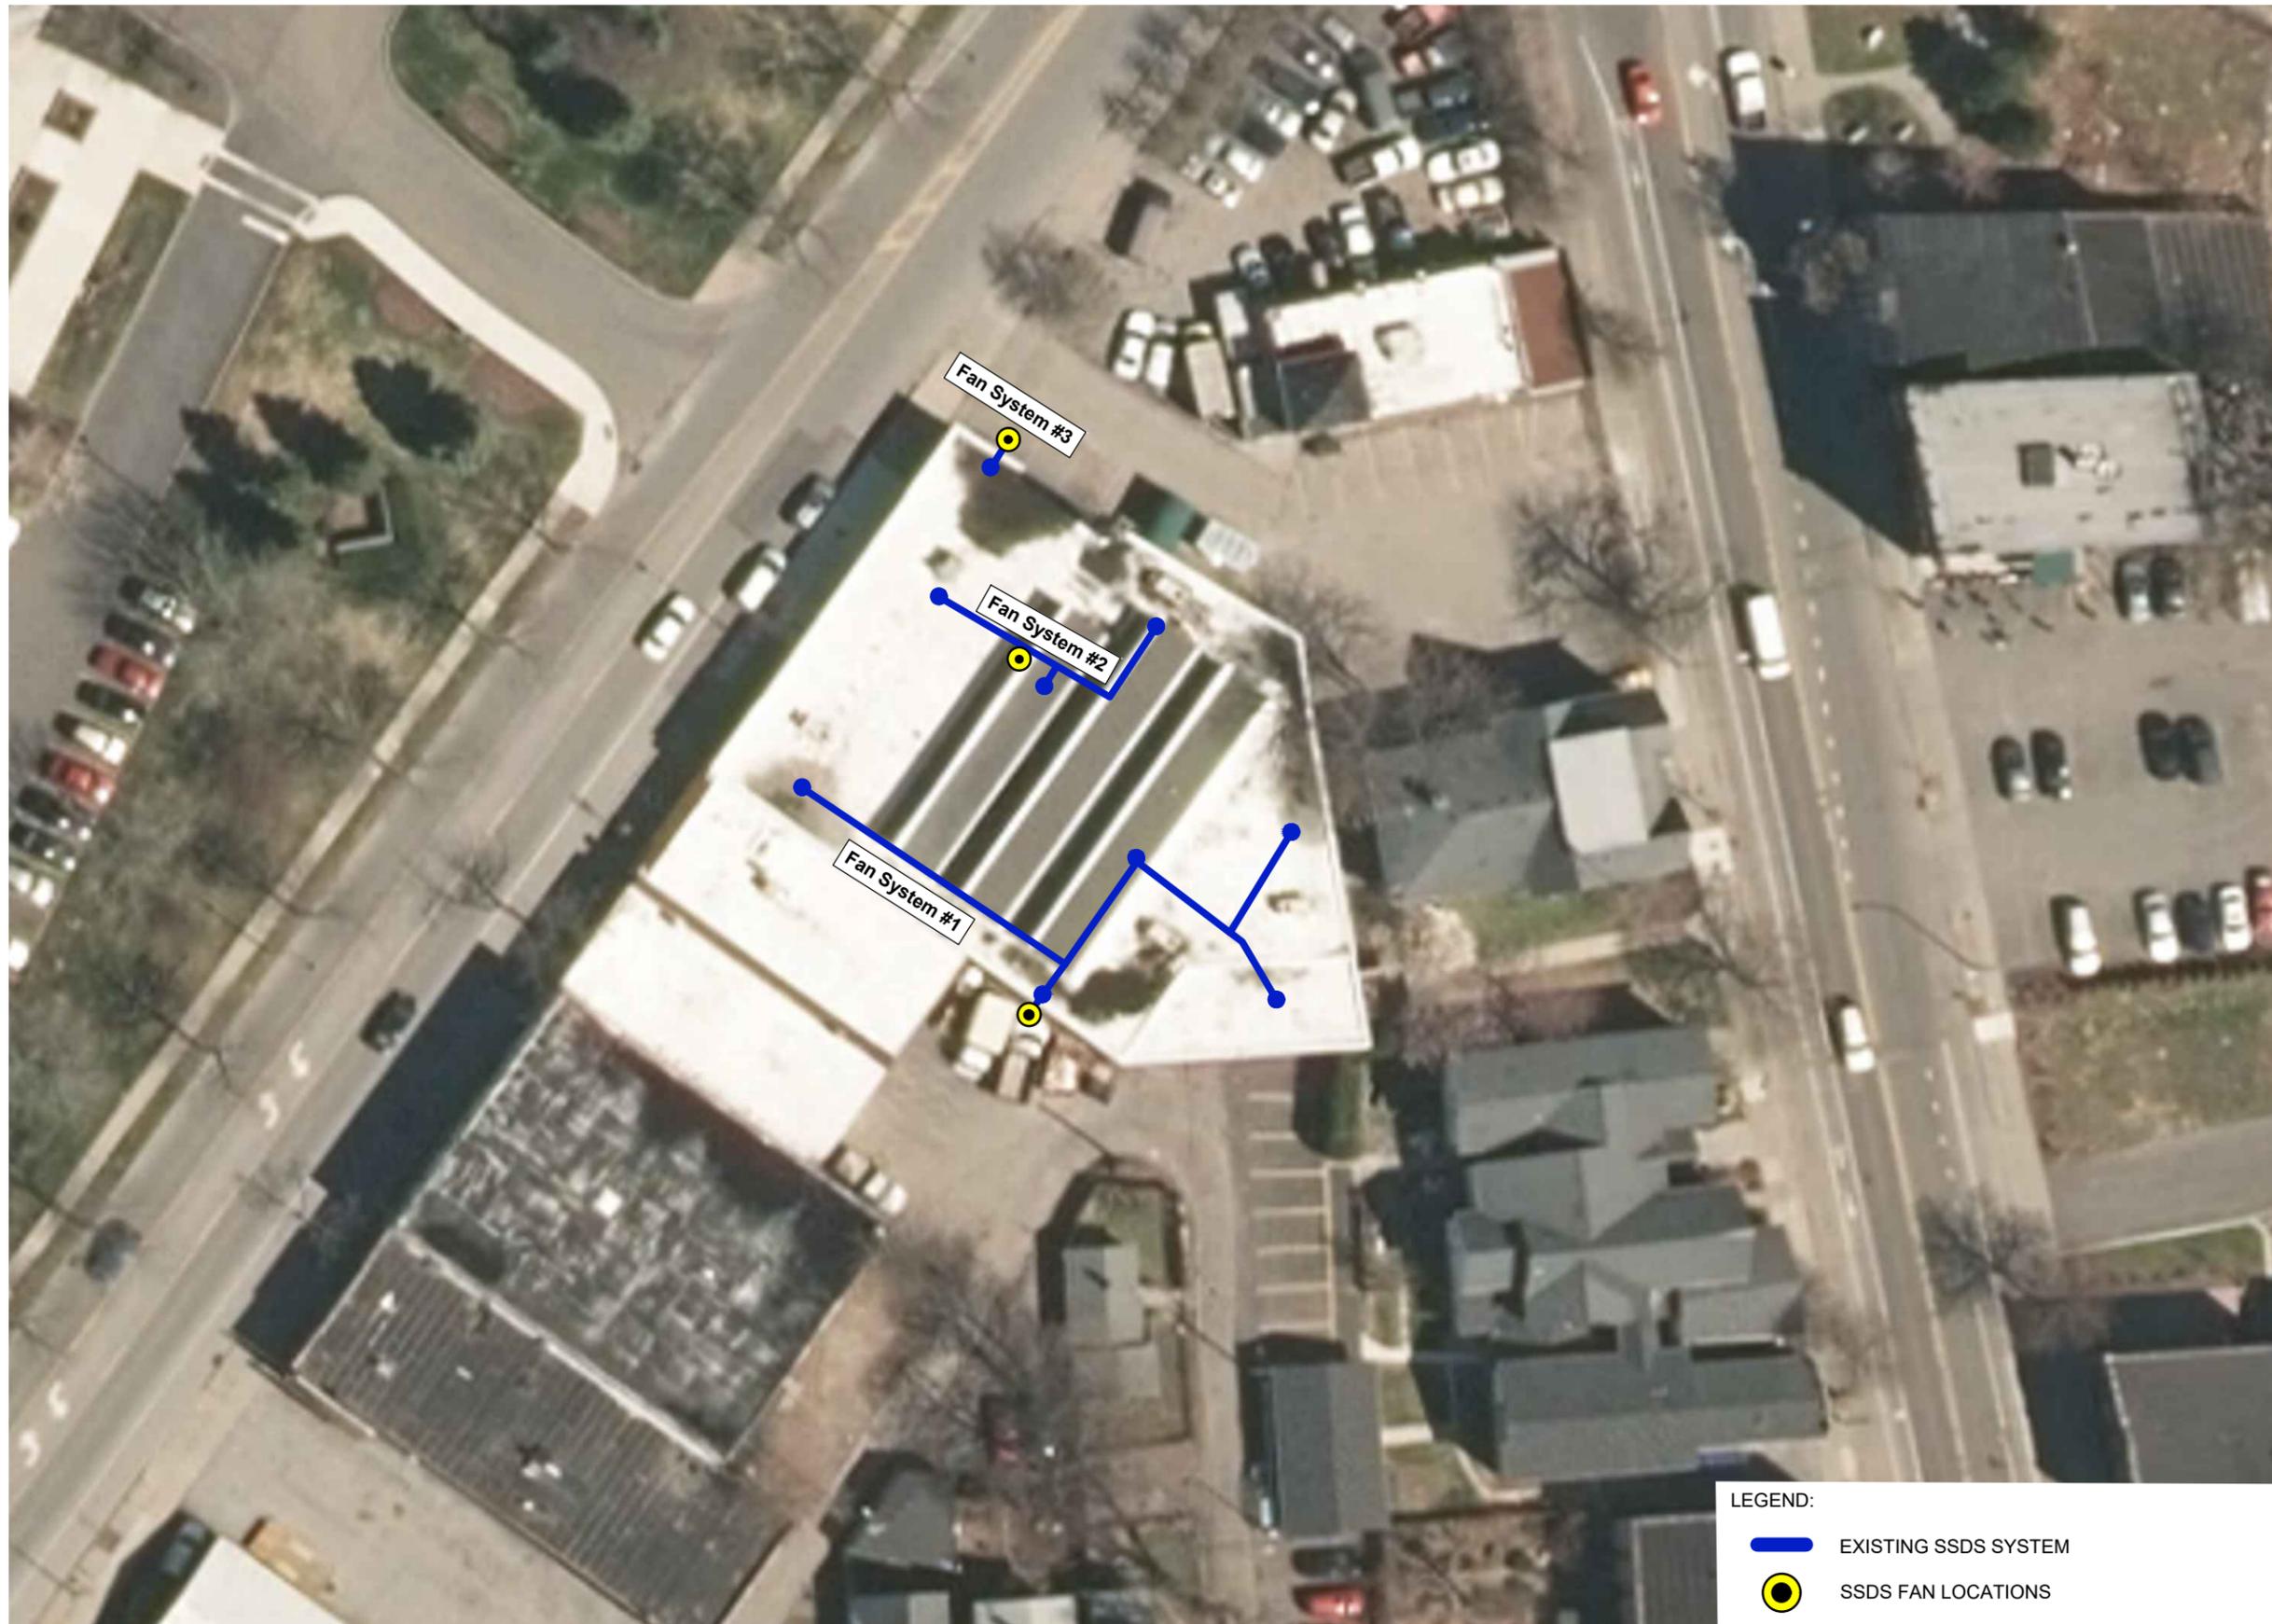
FIGURE
6

CONCEPTUAL LAYOUT OF
 REMEDIAL ALTERNATIVE #2
 FORMER HALL WELTER SITE
 (#828194)
 ROCHESTER, NEW YORK

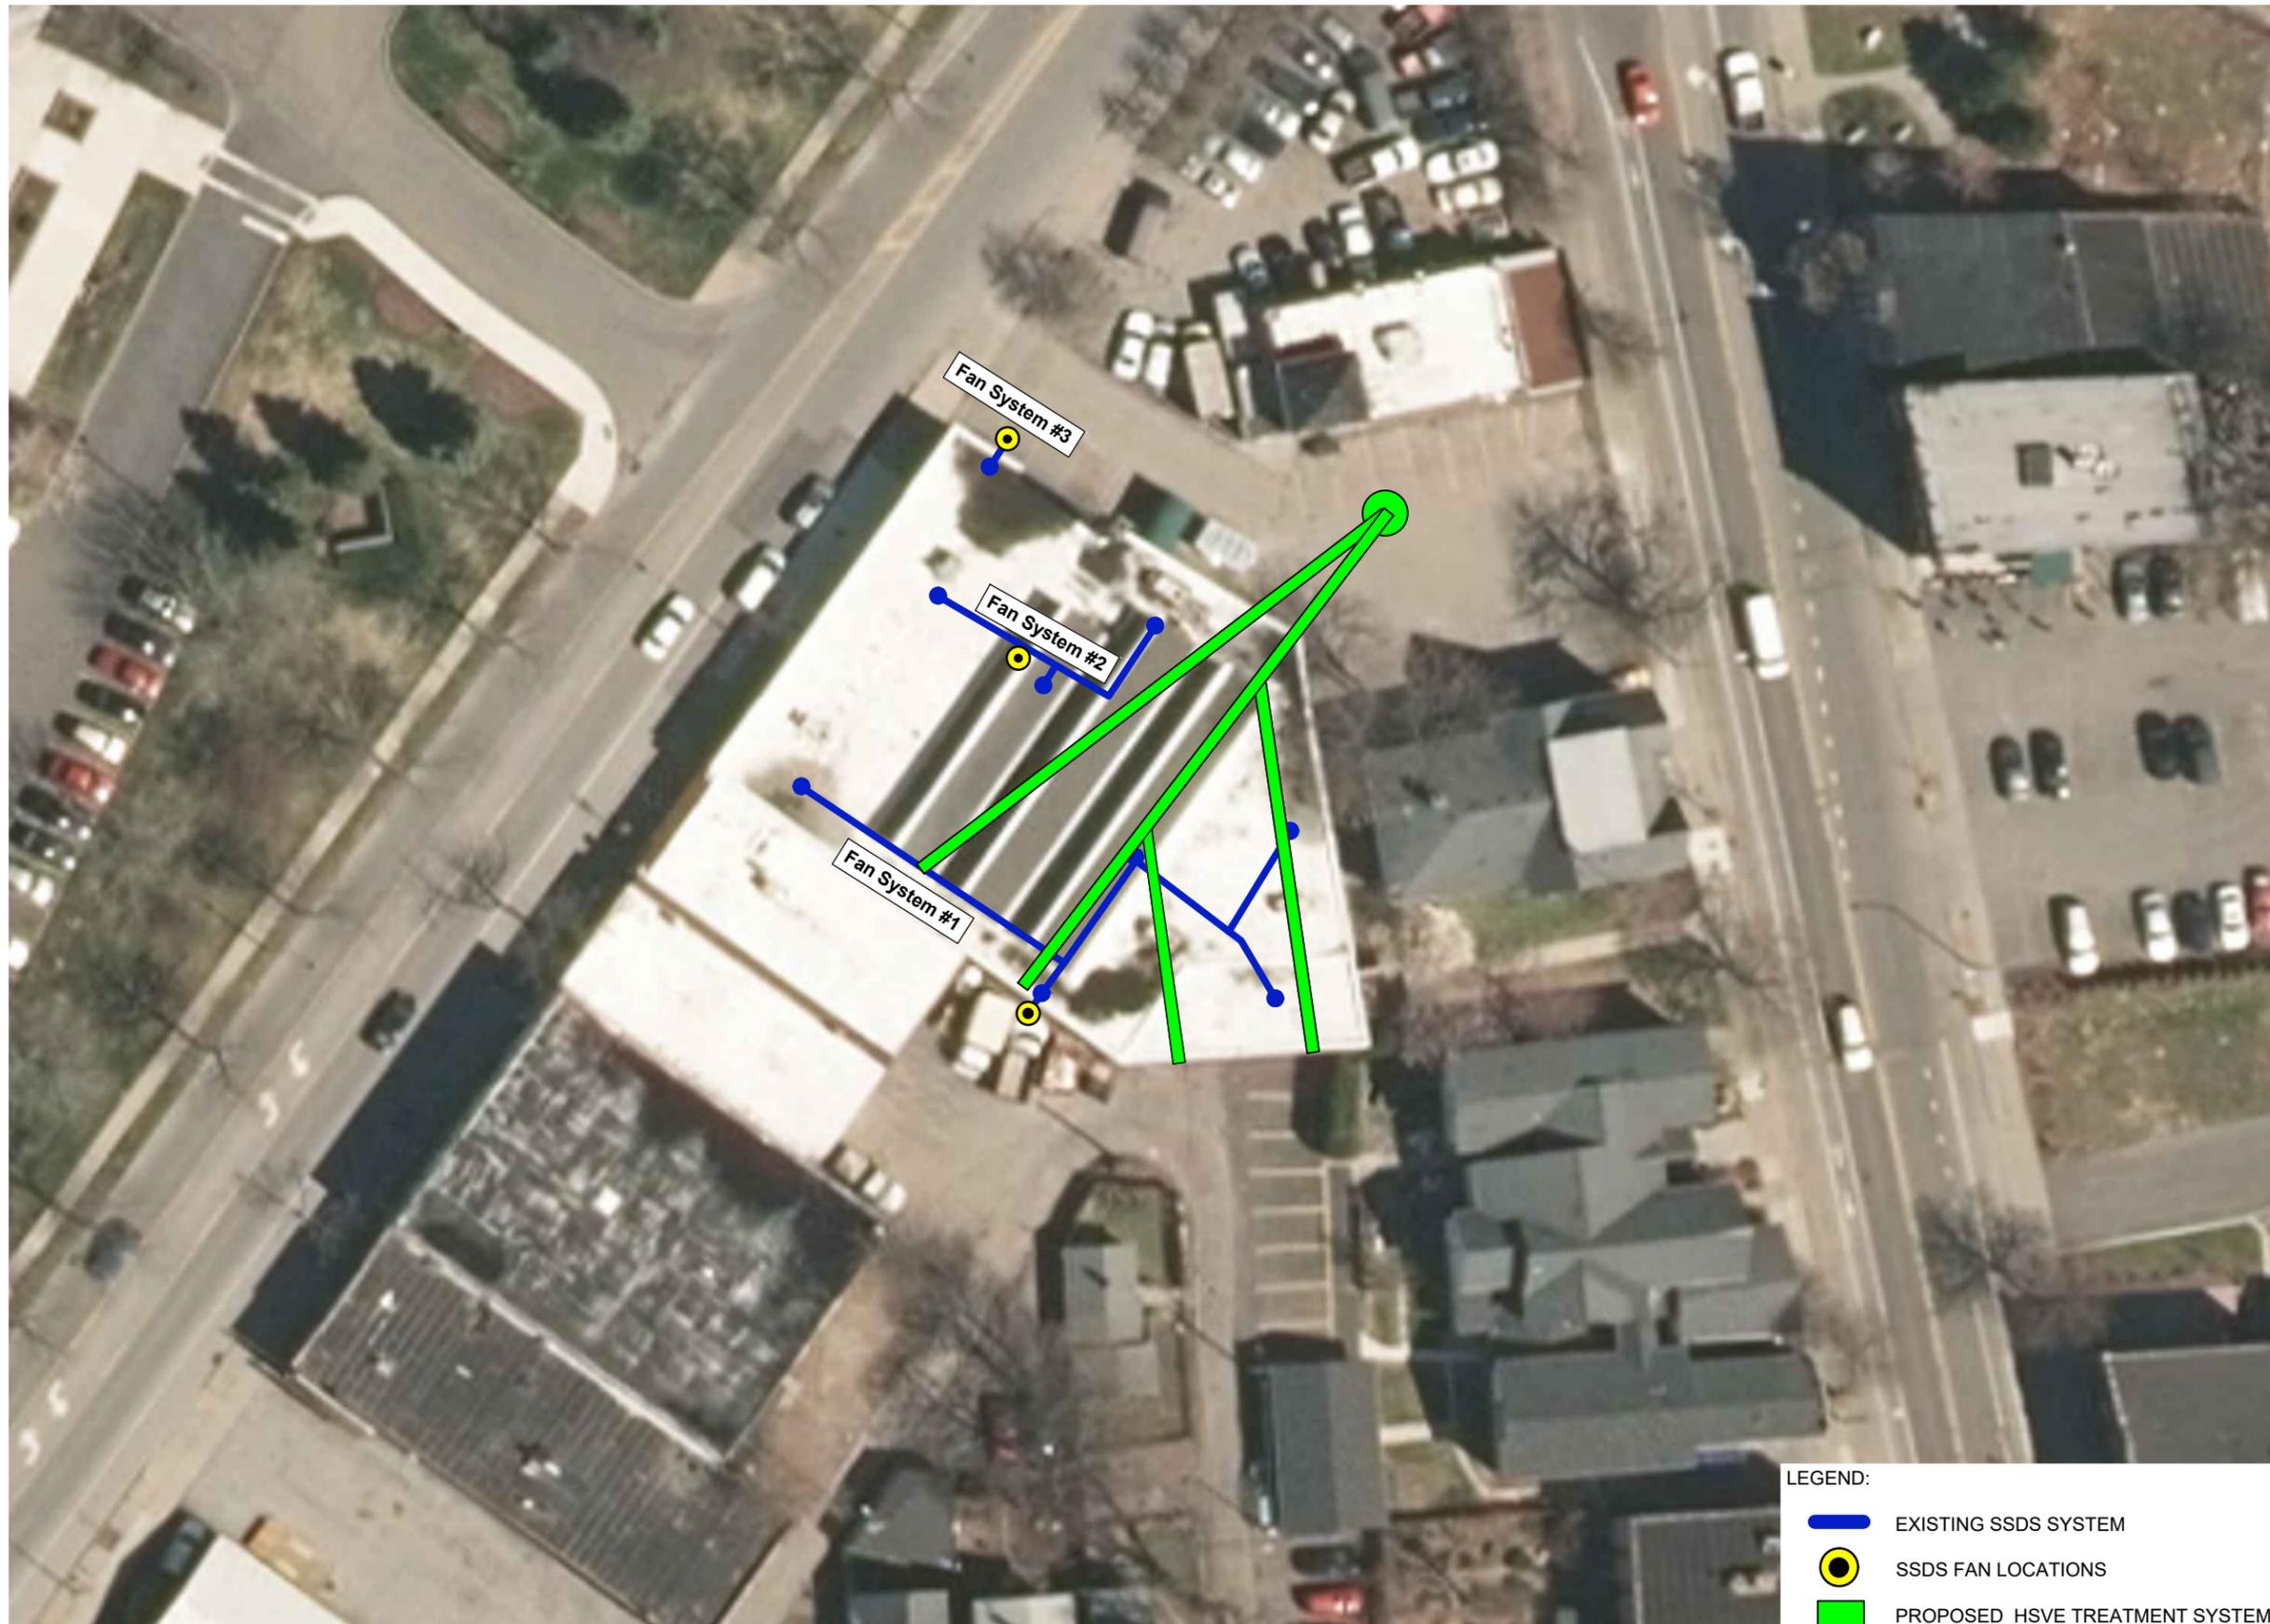
FIGURE
7

- EXISTING SSDS SYSTEM
- SSDS FAN LOCATIONS
- PROPOSED HSVE TREATMENT SYSTEM

CONCEPTUAL LAYOUT OF
 REMEDIAL ALTERNATIVES #3
 FORMER HALL WELTER SITE
 (#828194)
 ROCHESTER, NEW YORK

SVE can be used in combination with ongoing SSDS as an engineering control, as well as monitoring of soil vapor and groundwater conditions through an SMP. This approach would be effective at removing mass if air permeability testing of the Site soils supports soil venting in support of long-term monitored natural attenuation of groundwater, as well as reducing the period that SSDS operation may be necessary at the Site and neighboring properties.
