FEASIBILITY STUDY AND REMEDIAL ALTERNATIVES ANALYSIS

Former Hall Welter

38-46 Mt. Hope Ave.
Rochester, New York, 14620

Issued On: November 1, 2021

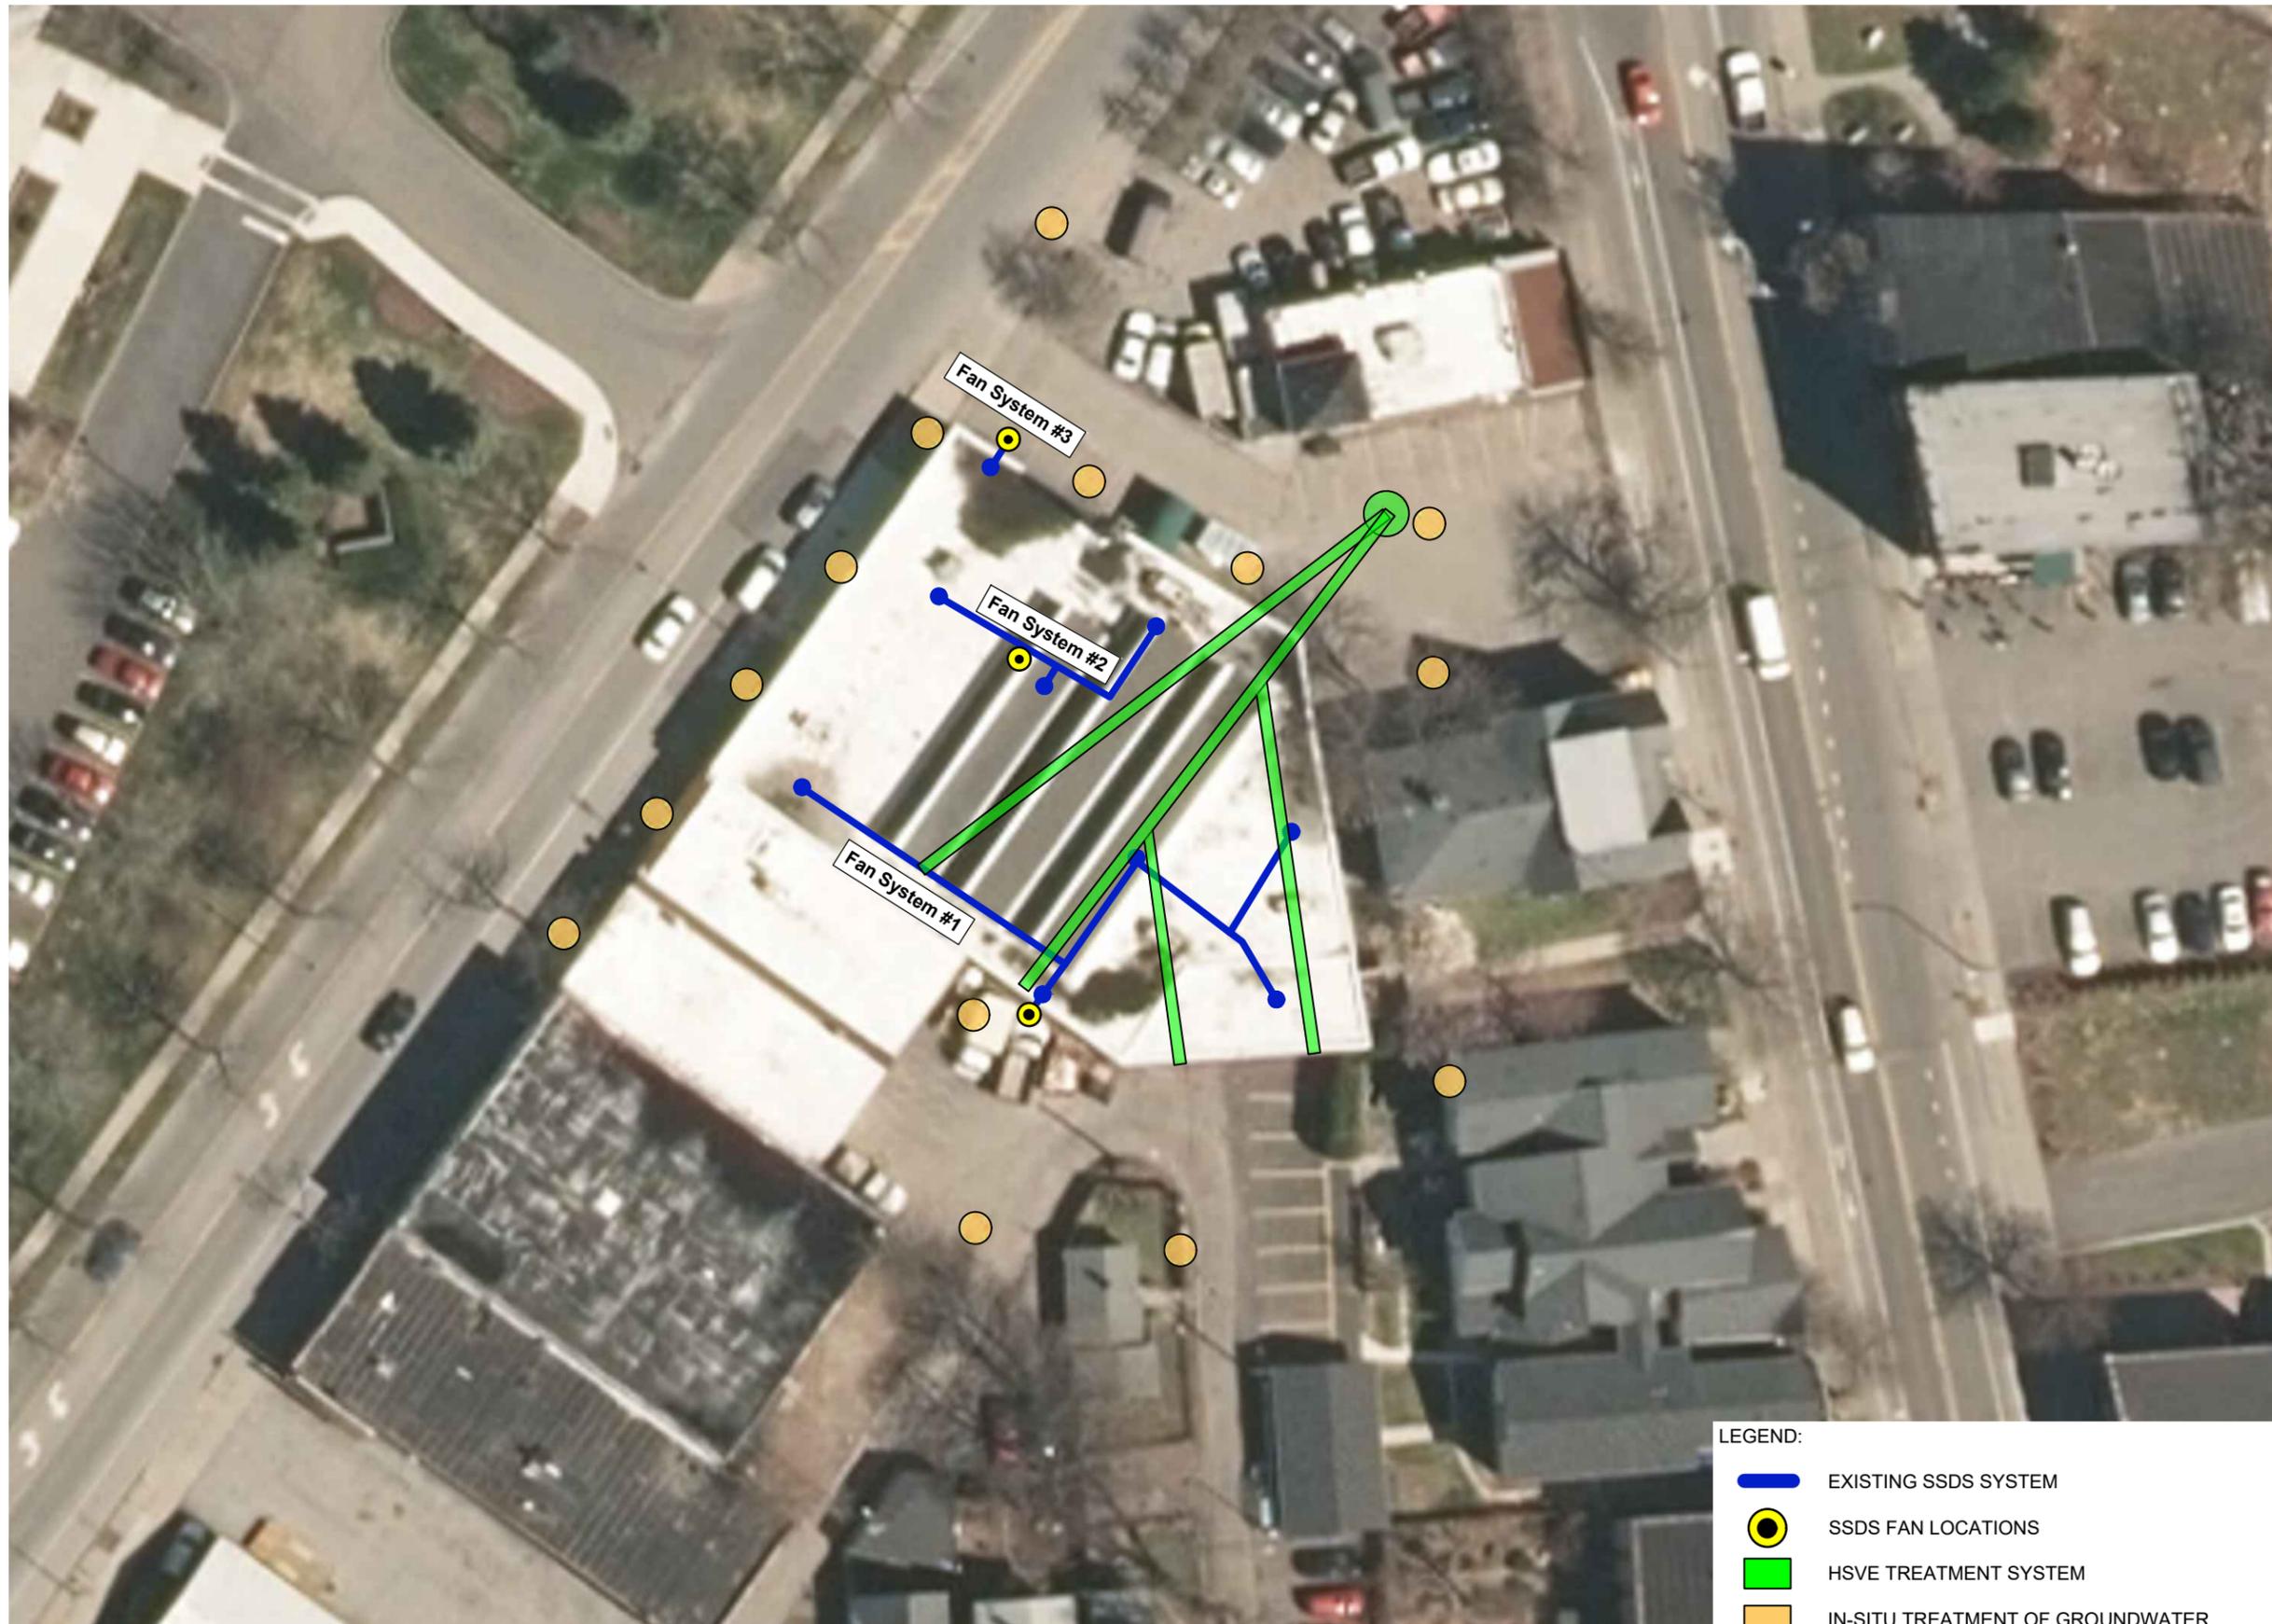
FIGURE
8

- LEGEND:
- EXISTING SSDS SYSTEM
 - SSDS FAN LOCATIONS
 - HSVE TREATMENT SYSTEM
 - IN-SITU TREATMENT OF GROUNDWATER

CONCEPTUAL LAYOUT OF
 REMEDIAL ALTERNATIVE #4
 FORMER HALL WELTER SITE
 (#828194)
 ROCHESTER, NEW YORK

This Alternative includes all Alternative 3, plus one additional active remedy to reduce concentrations in the dissolved phase beneath the Site. This Alternative includes SVE to address source mass in the vadose zone, an engineering control to continue operation of the SSDSs, as well as long-term monitoring under the SMP. The presence of PCE degradation products in groundwater presently suggest that anaerobic degradation is occurring at the Site, the degree of which should be confirmed

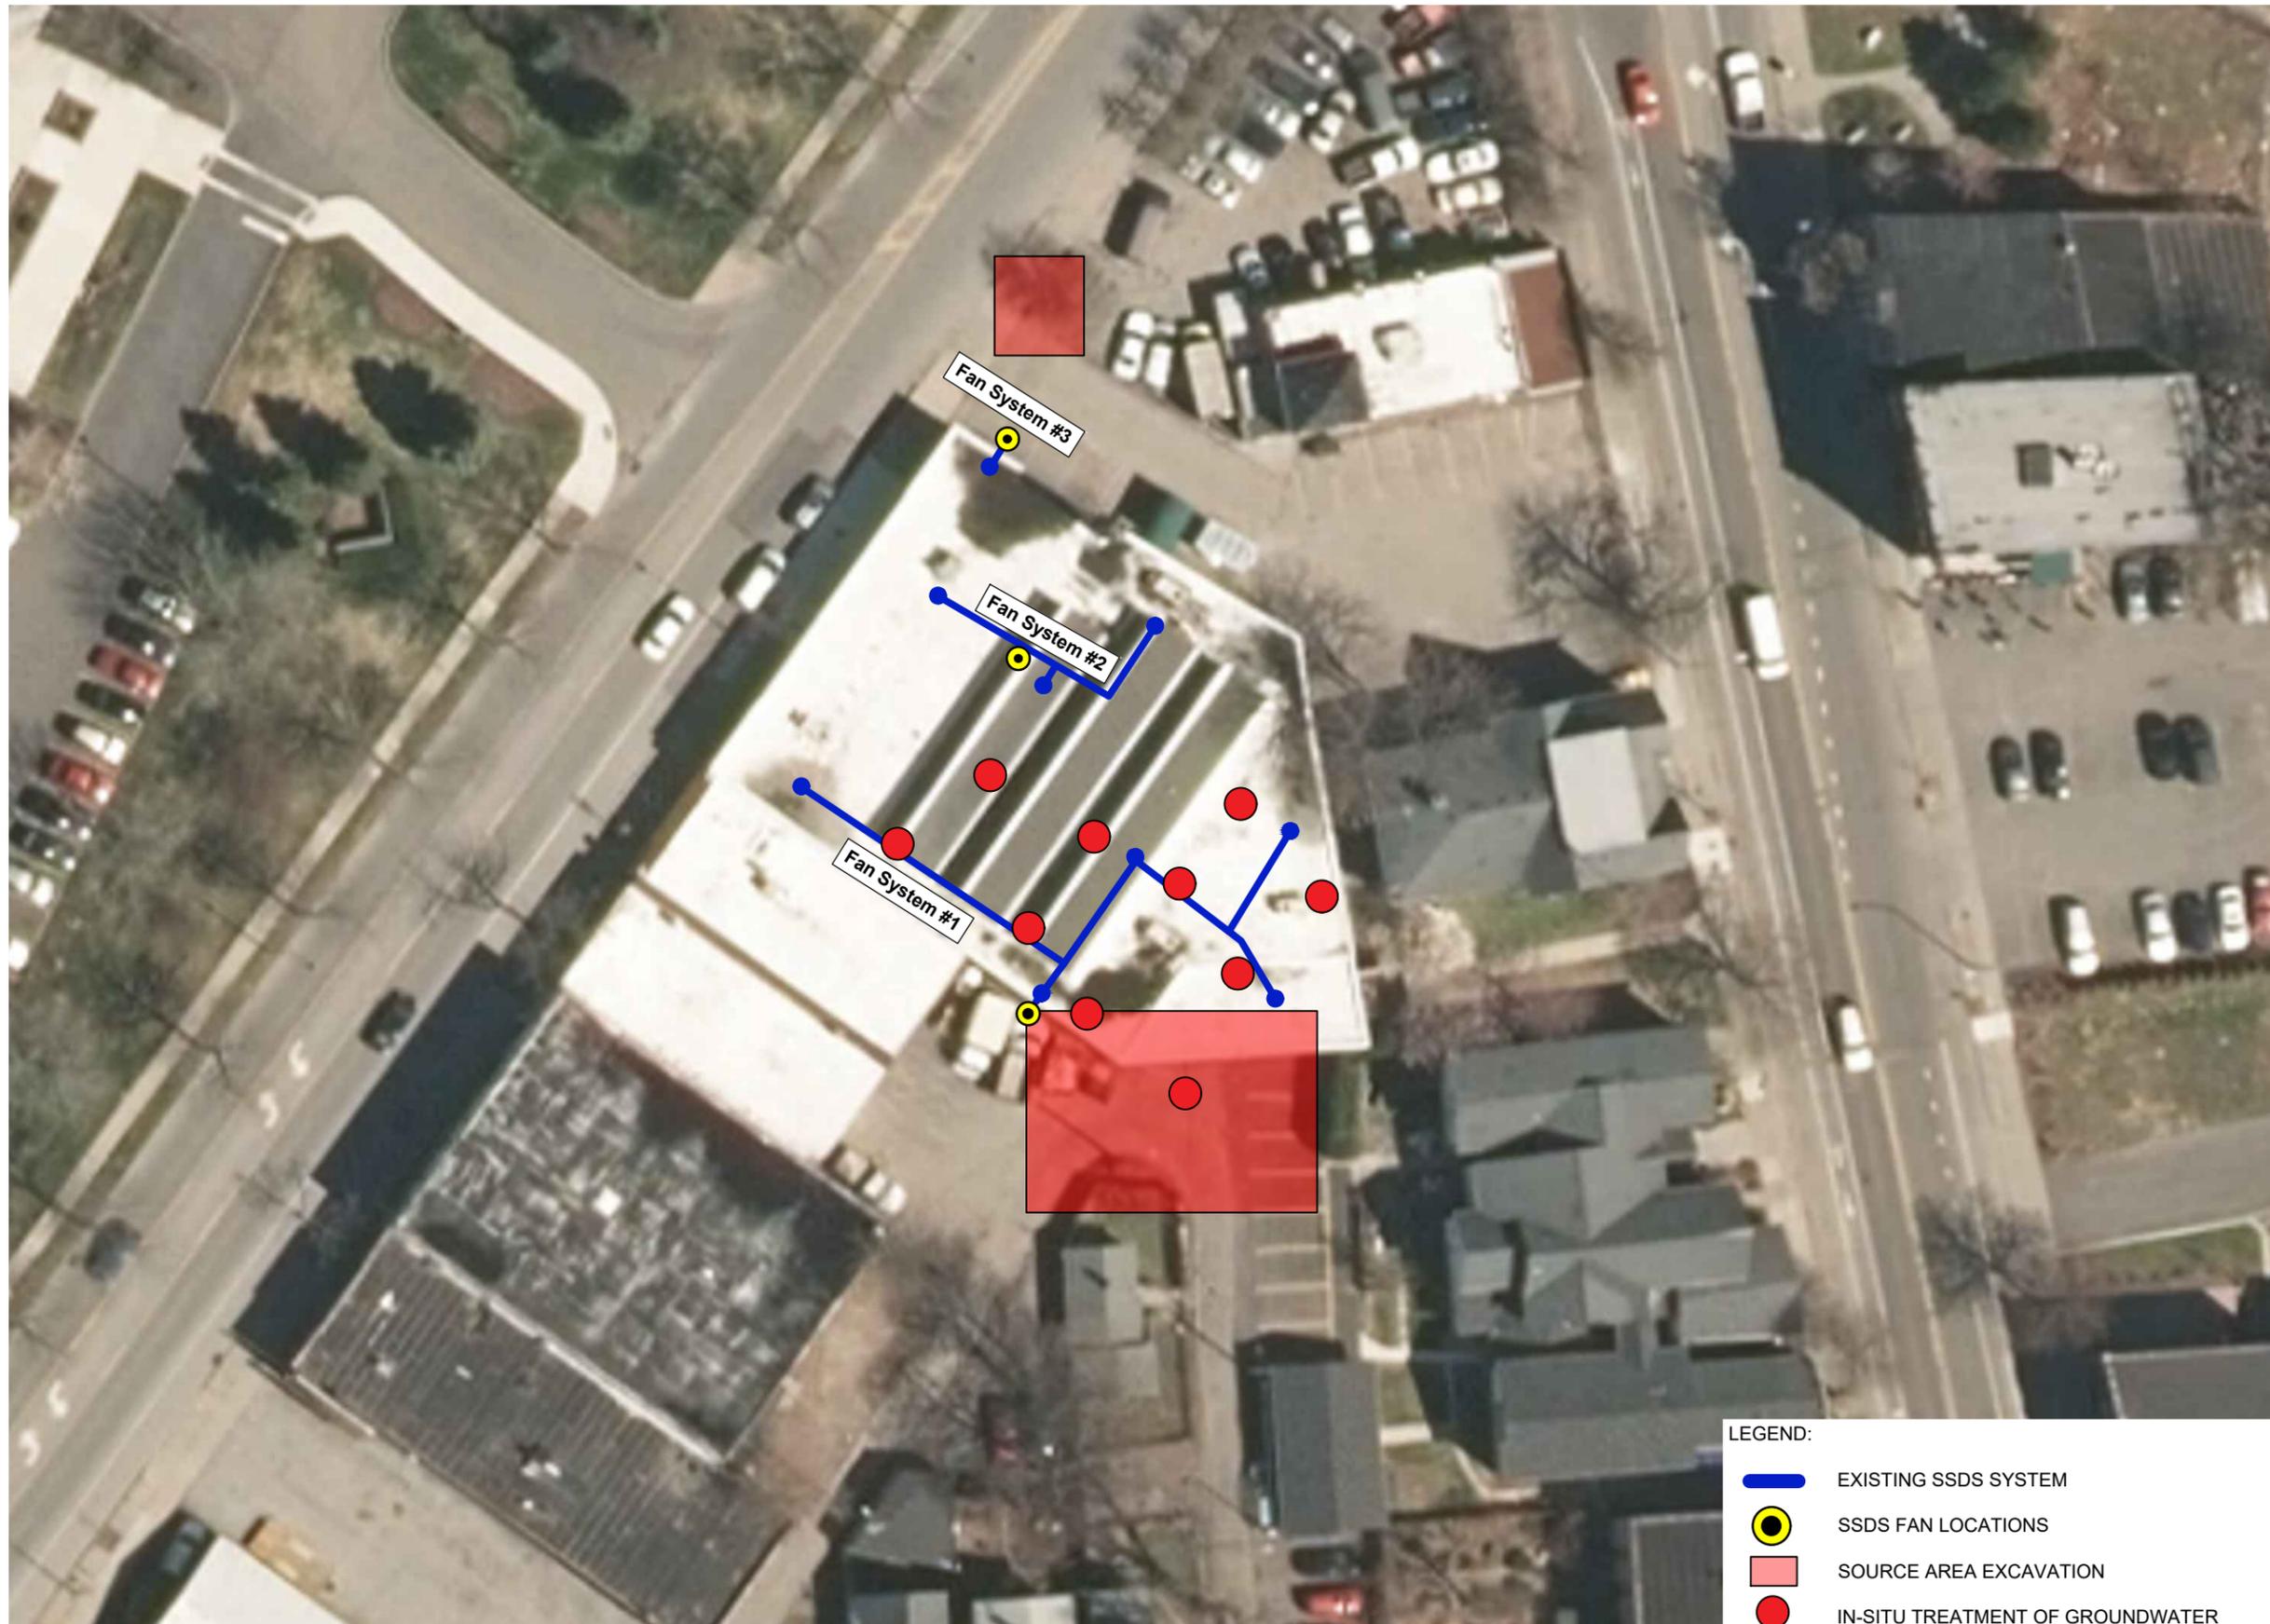
- EXISTING SSDS SYSTEM
- SSDS FAN LOCATIONS
- SOURCE AREA EXCAVATION
- IN-SITU TREATMENT OF GROUNDWATER

In order to return the Site to pre-release conditions, removal of source material and active remediation of dissolved-phase contamination is the best means of achieving this objective. Based on the data available, it is probable that subsurface soils are impacted beneath the thickest part of the Site building's slab. For this reason, this remedy is most likely to be implemented in a scenario where the building would be razed allowing free access to the slab and what lies beneath.

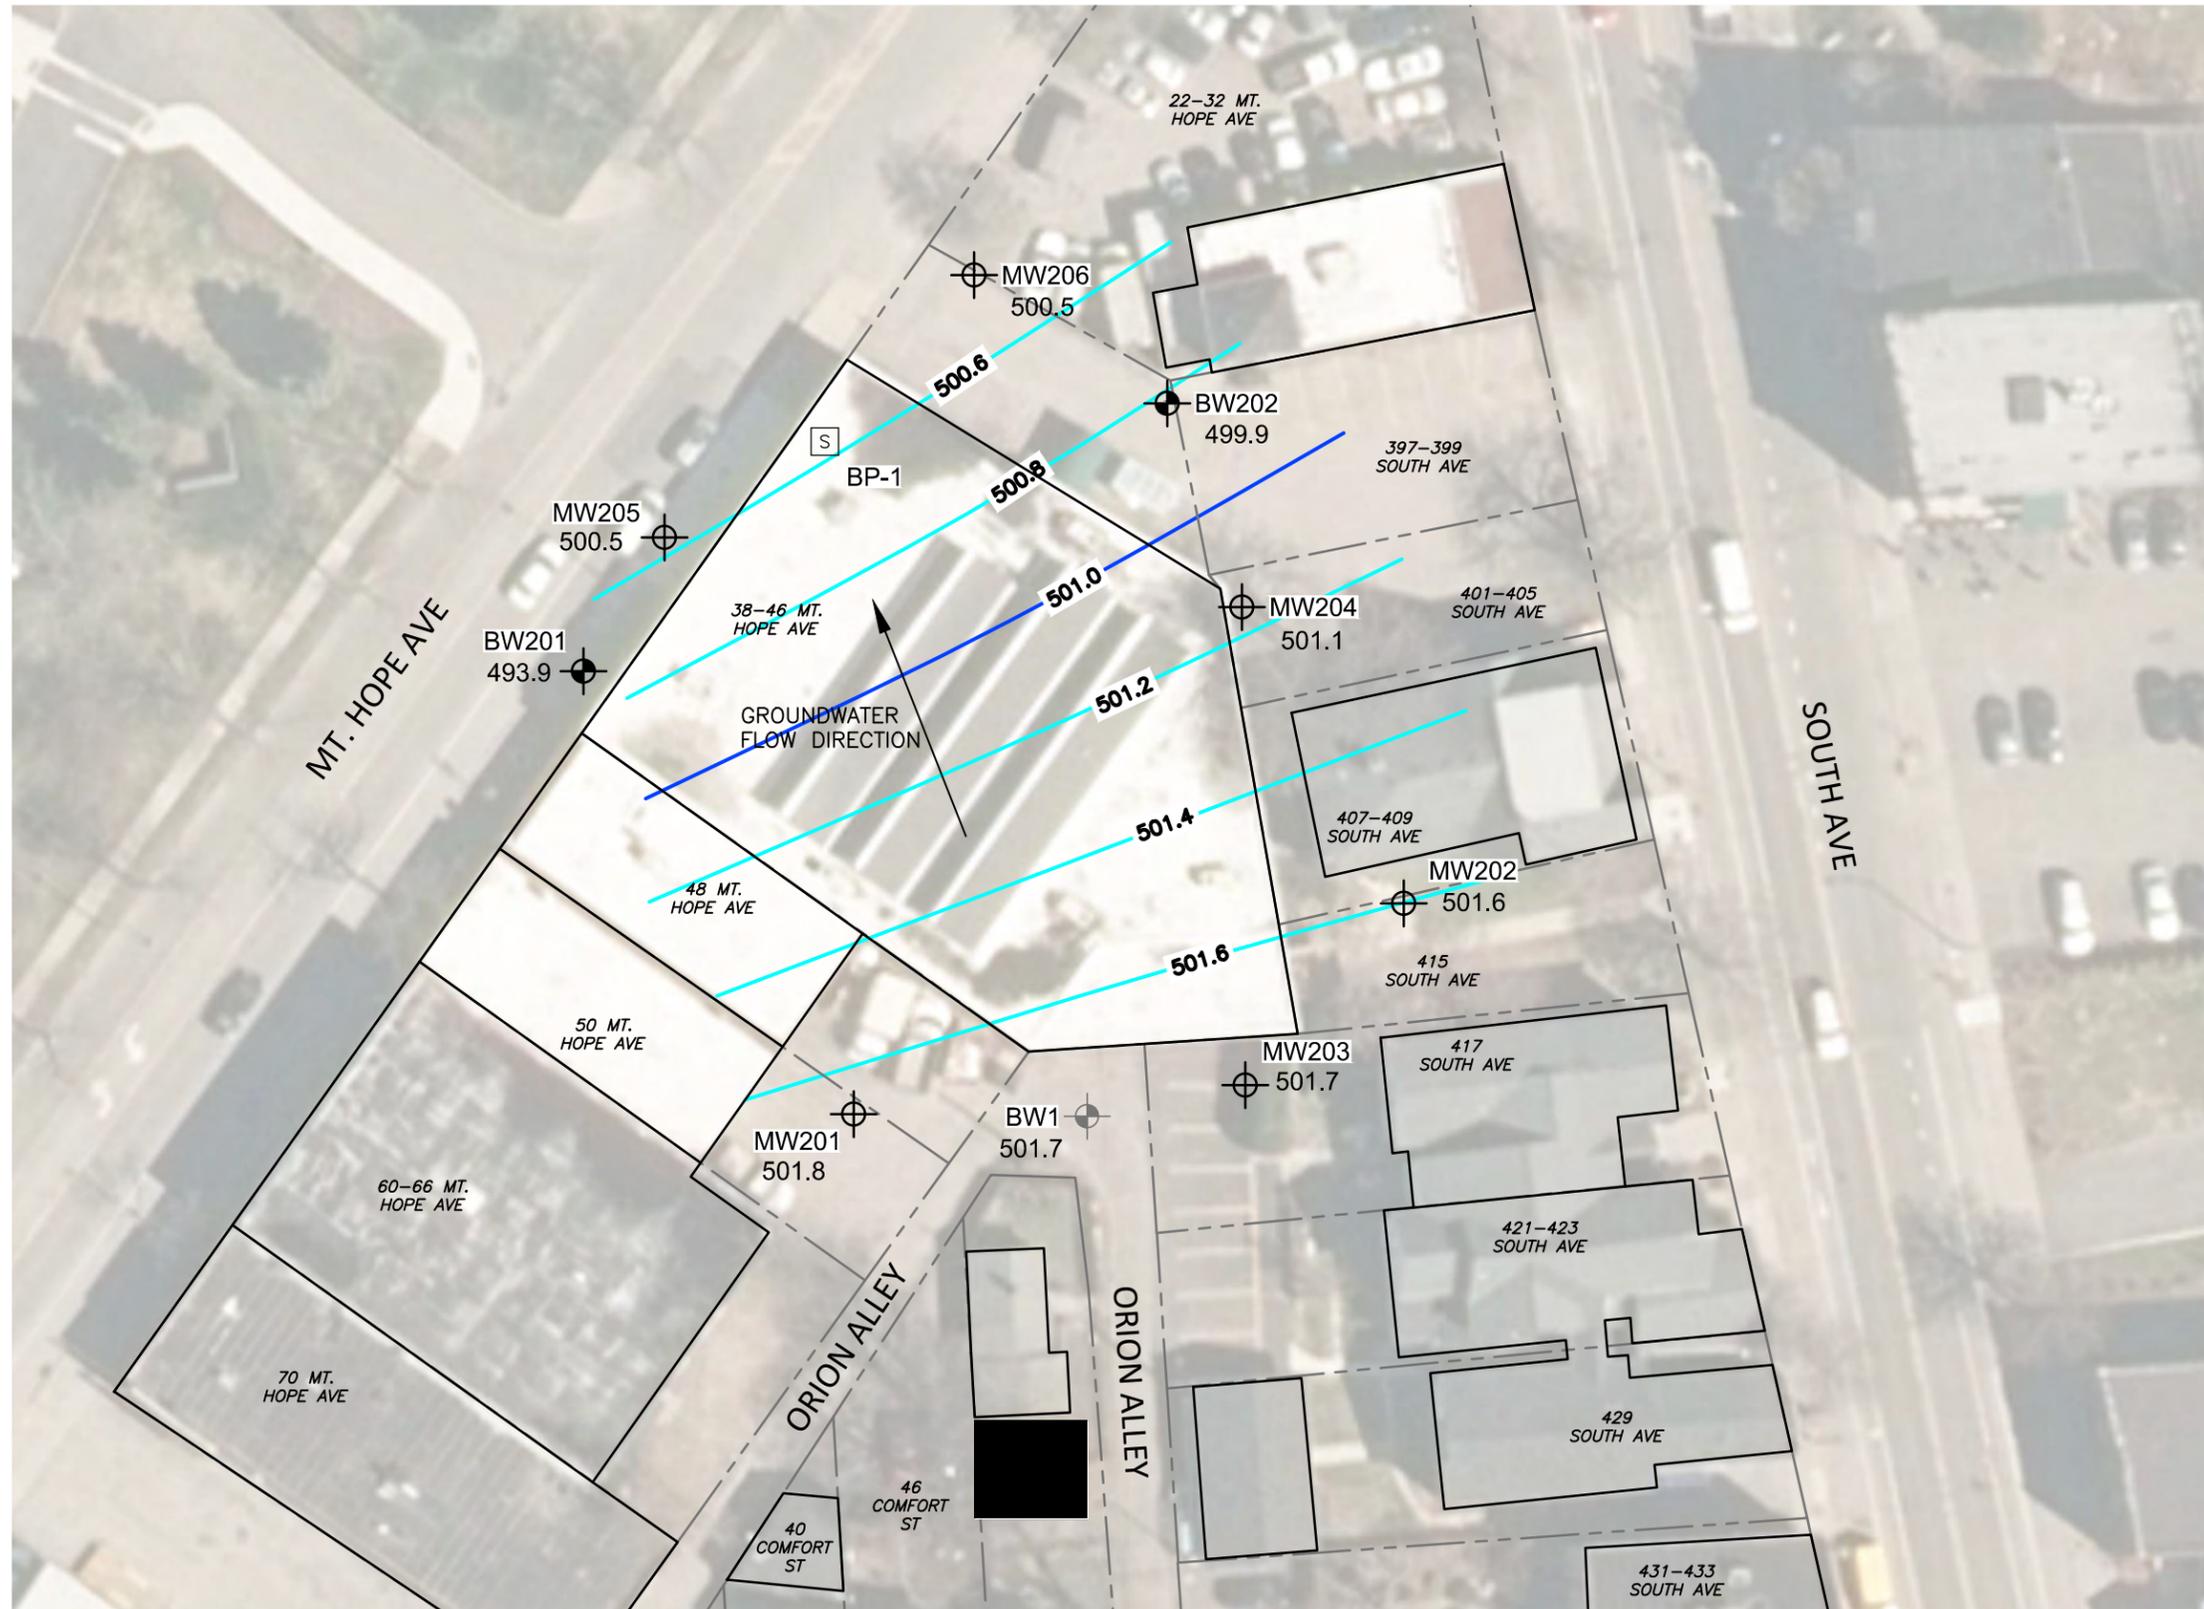
DATE
 2020-02
 FIGURE
 3

FORMER HALL WELTER SITE
 REMEDIAL INVESTIGATION
 NYSDEC SITE# 828194
 ROCHESTER, NEW YORK

Similarly, the highest bedrock groundwater elevation was observed at BW1, located north (upgradient) of the site building (501.7/502.09 ft amsl). The lowest bedrock groundwater elevation was observed at BW201 (493.9 ft amsl), located northwest (downgradient) of the site. Groundwater gauging conducted during the June 2018 sampling event indicated a bedrock groundwater flow direction to the northwest, similar to overburden groundwater, with an overall horizontal hydraulic gradient of 0.05 ft/ft between wells BW1 and BW201. An interpreted groundwater contour map illustrating the direction of groundwater flow for the June 2018 event is shown in **Figure 3**.

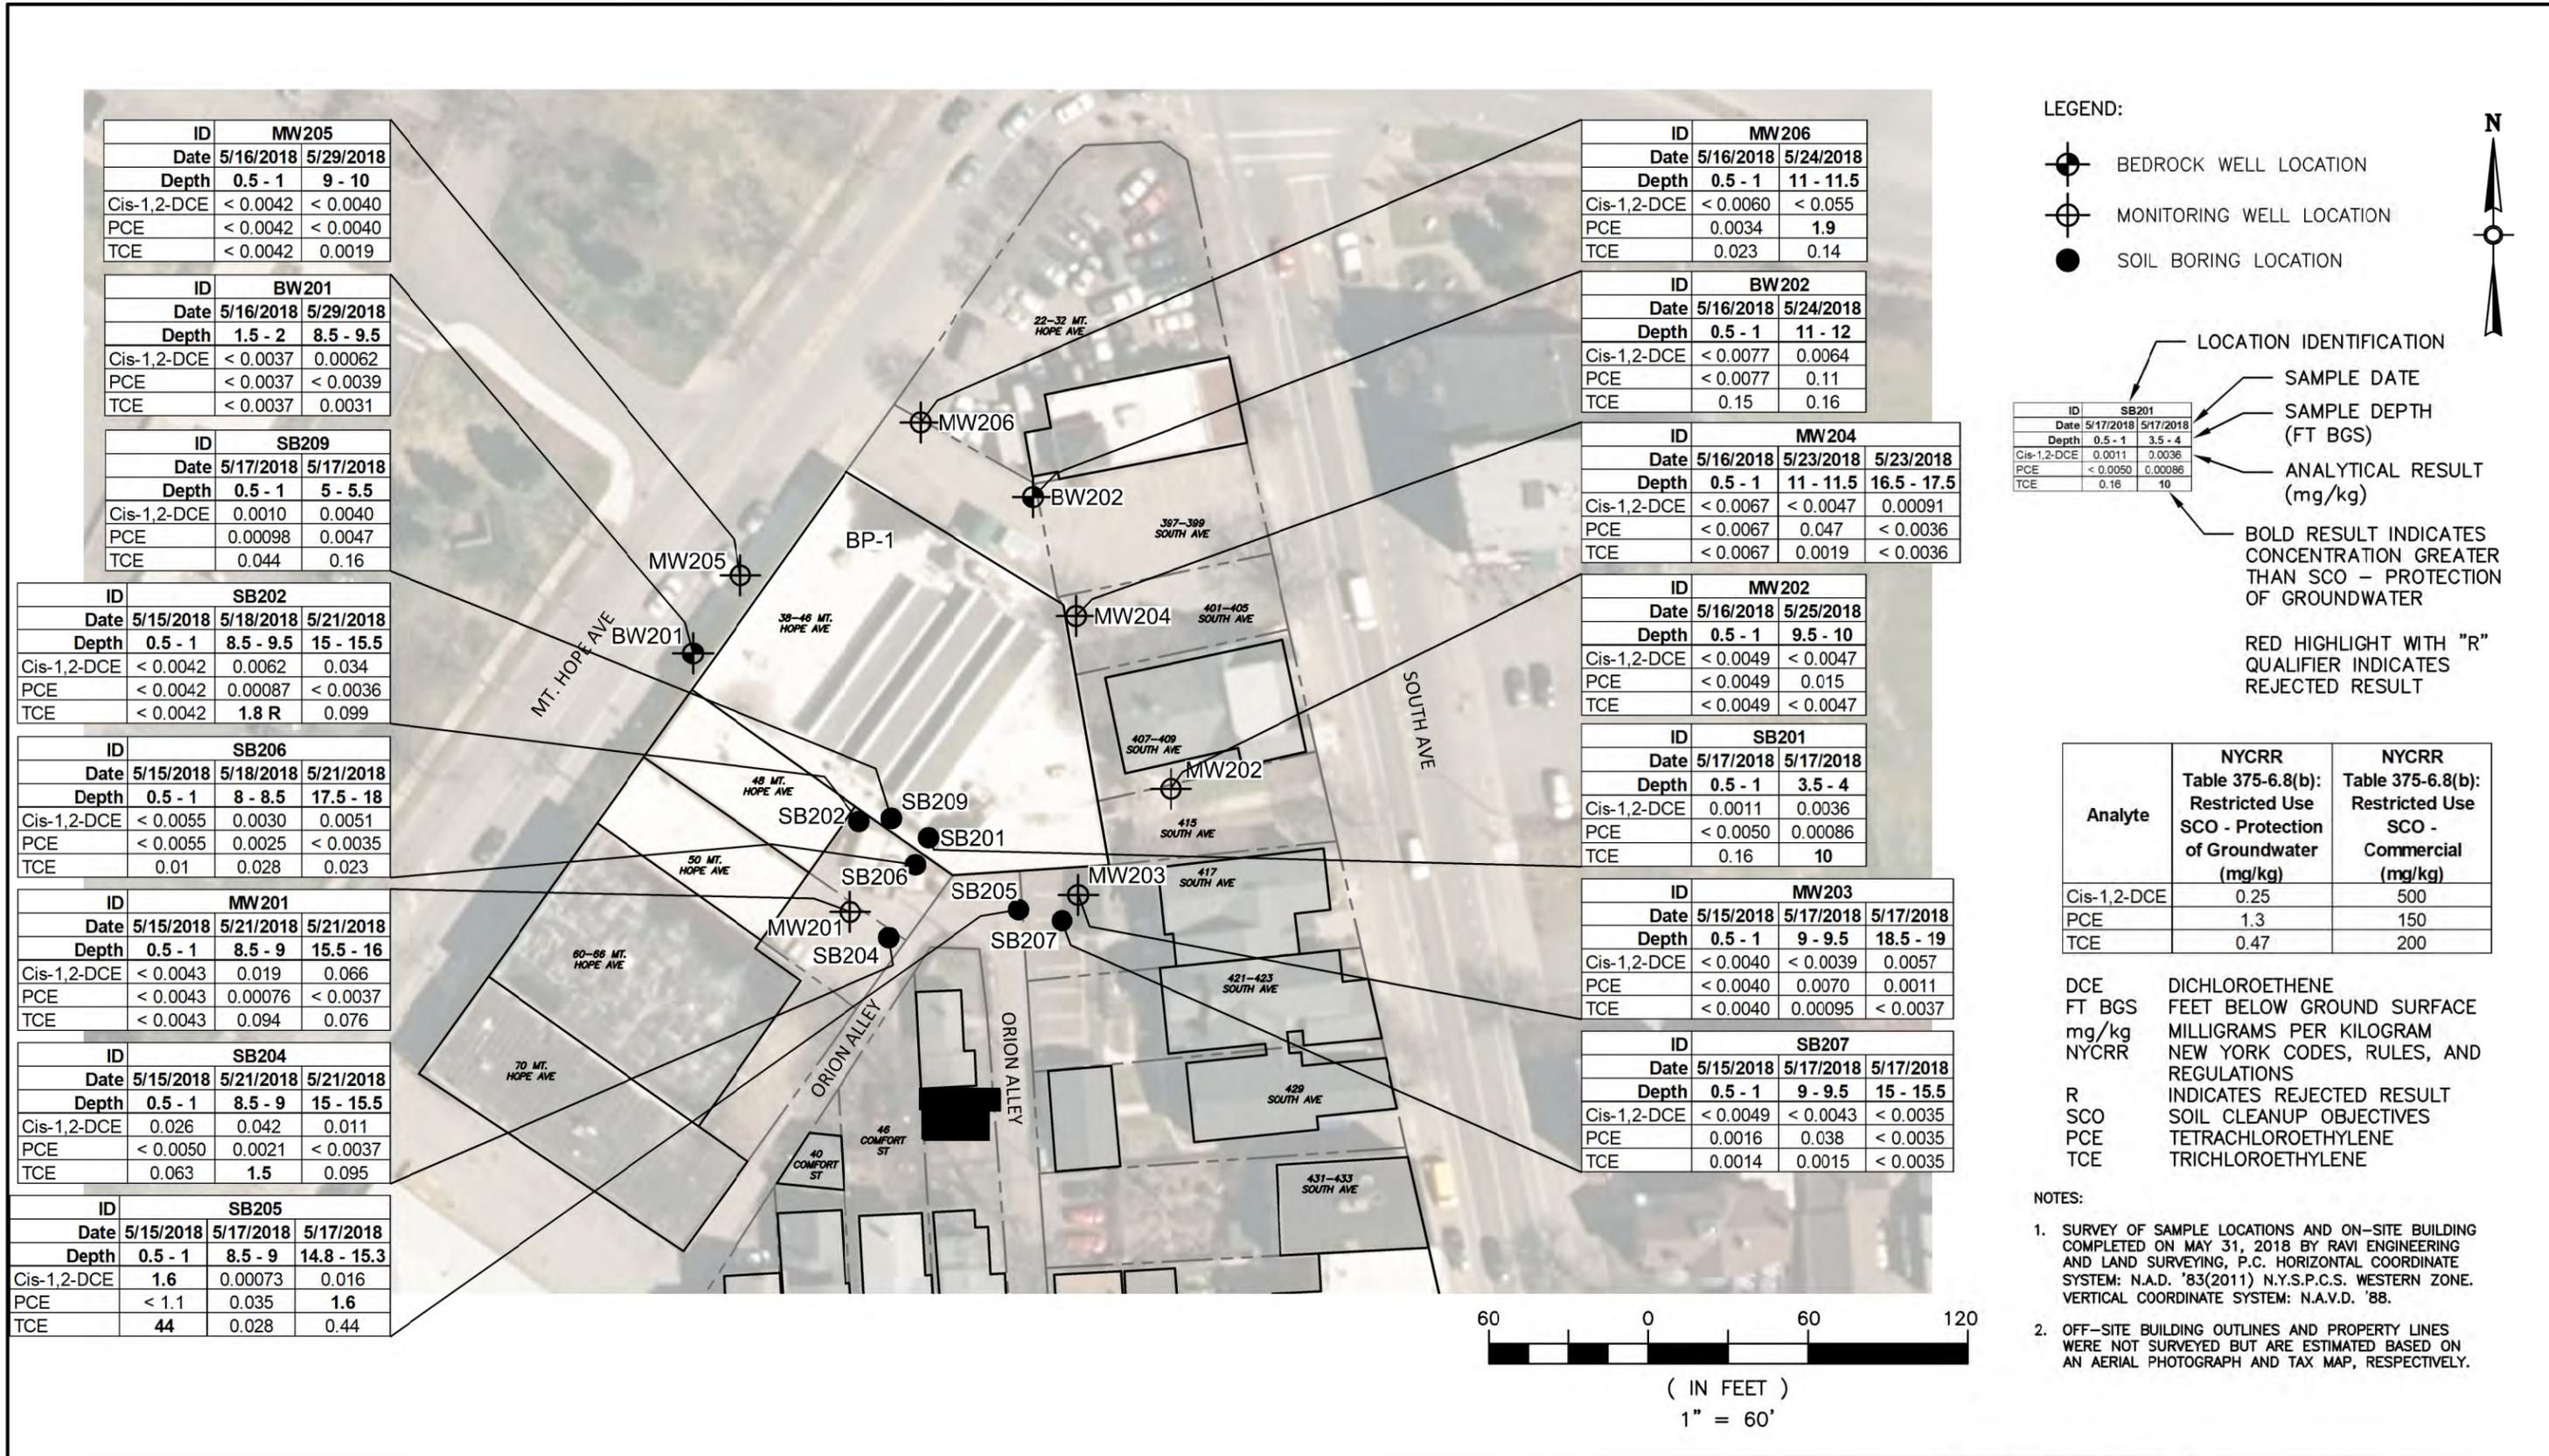
FIGURE
 5

SUMMARY OF SOIL SAMPLE ANALYTICAL RESULTS

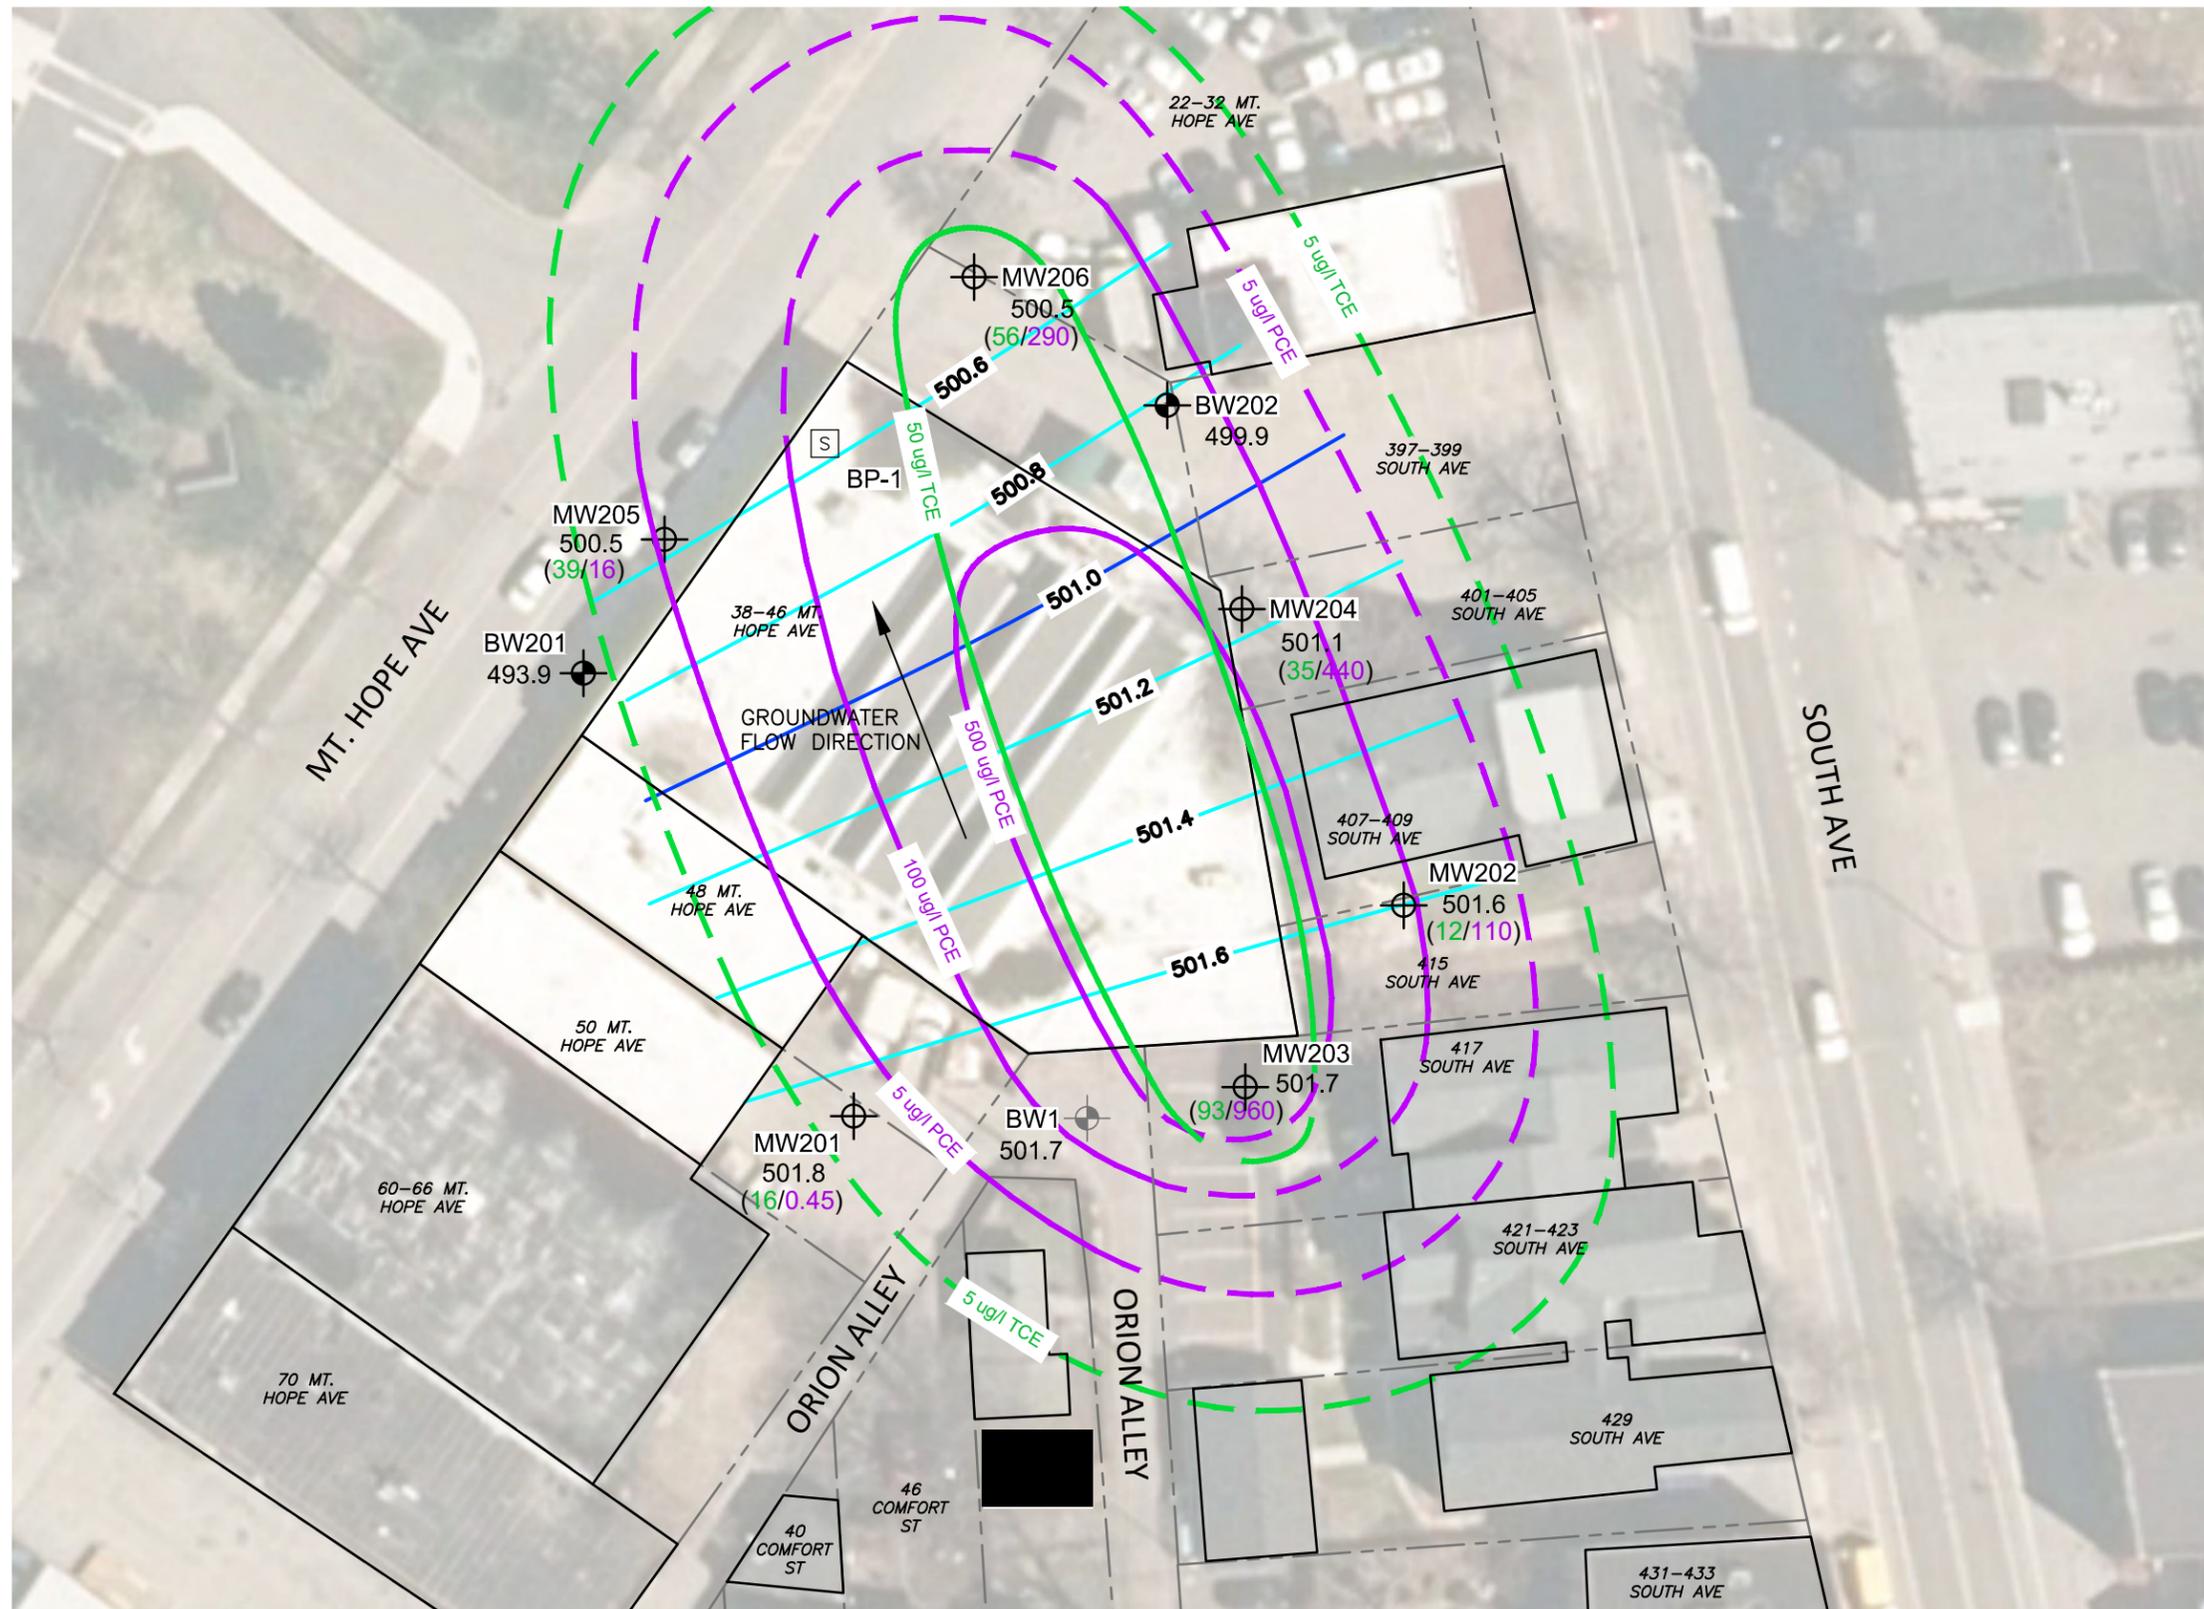
- LEGEND:**
- BEDROCK WELL LOCATION
 - EXISTING BEDROCK WELL LOCATION
 - MONITORING WELL LOCATION
 - MAJOR GROUNDWATER CONTOUR LINE (JUNE 2018) (INTERPRETED)
 - MINOR GROUNDWATER CONTOUR LINE (JUNE 2018) (INTERPRETED)
 - TCE ISO-CONCENTRATION LINE (JUNE 2018; DASHED WHERE INFERRED)
 - PCE ISO-CONCENTRATION LINE (JUNE 2018; DASHED WHERE INFERRED)
