**Former Hall-Welter Site
MONROE COUNTY
Rochester, NEW YORK**

INTERIM SITE MANAGEMENT PLAN

NYSDEC Site Number: 828194

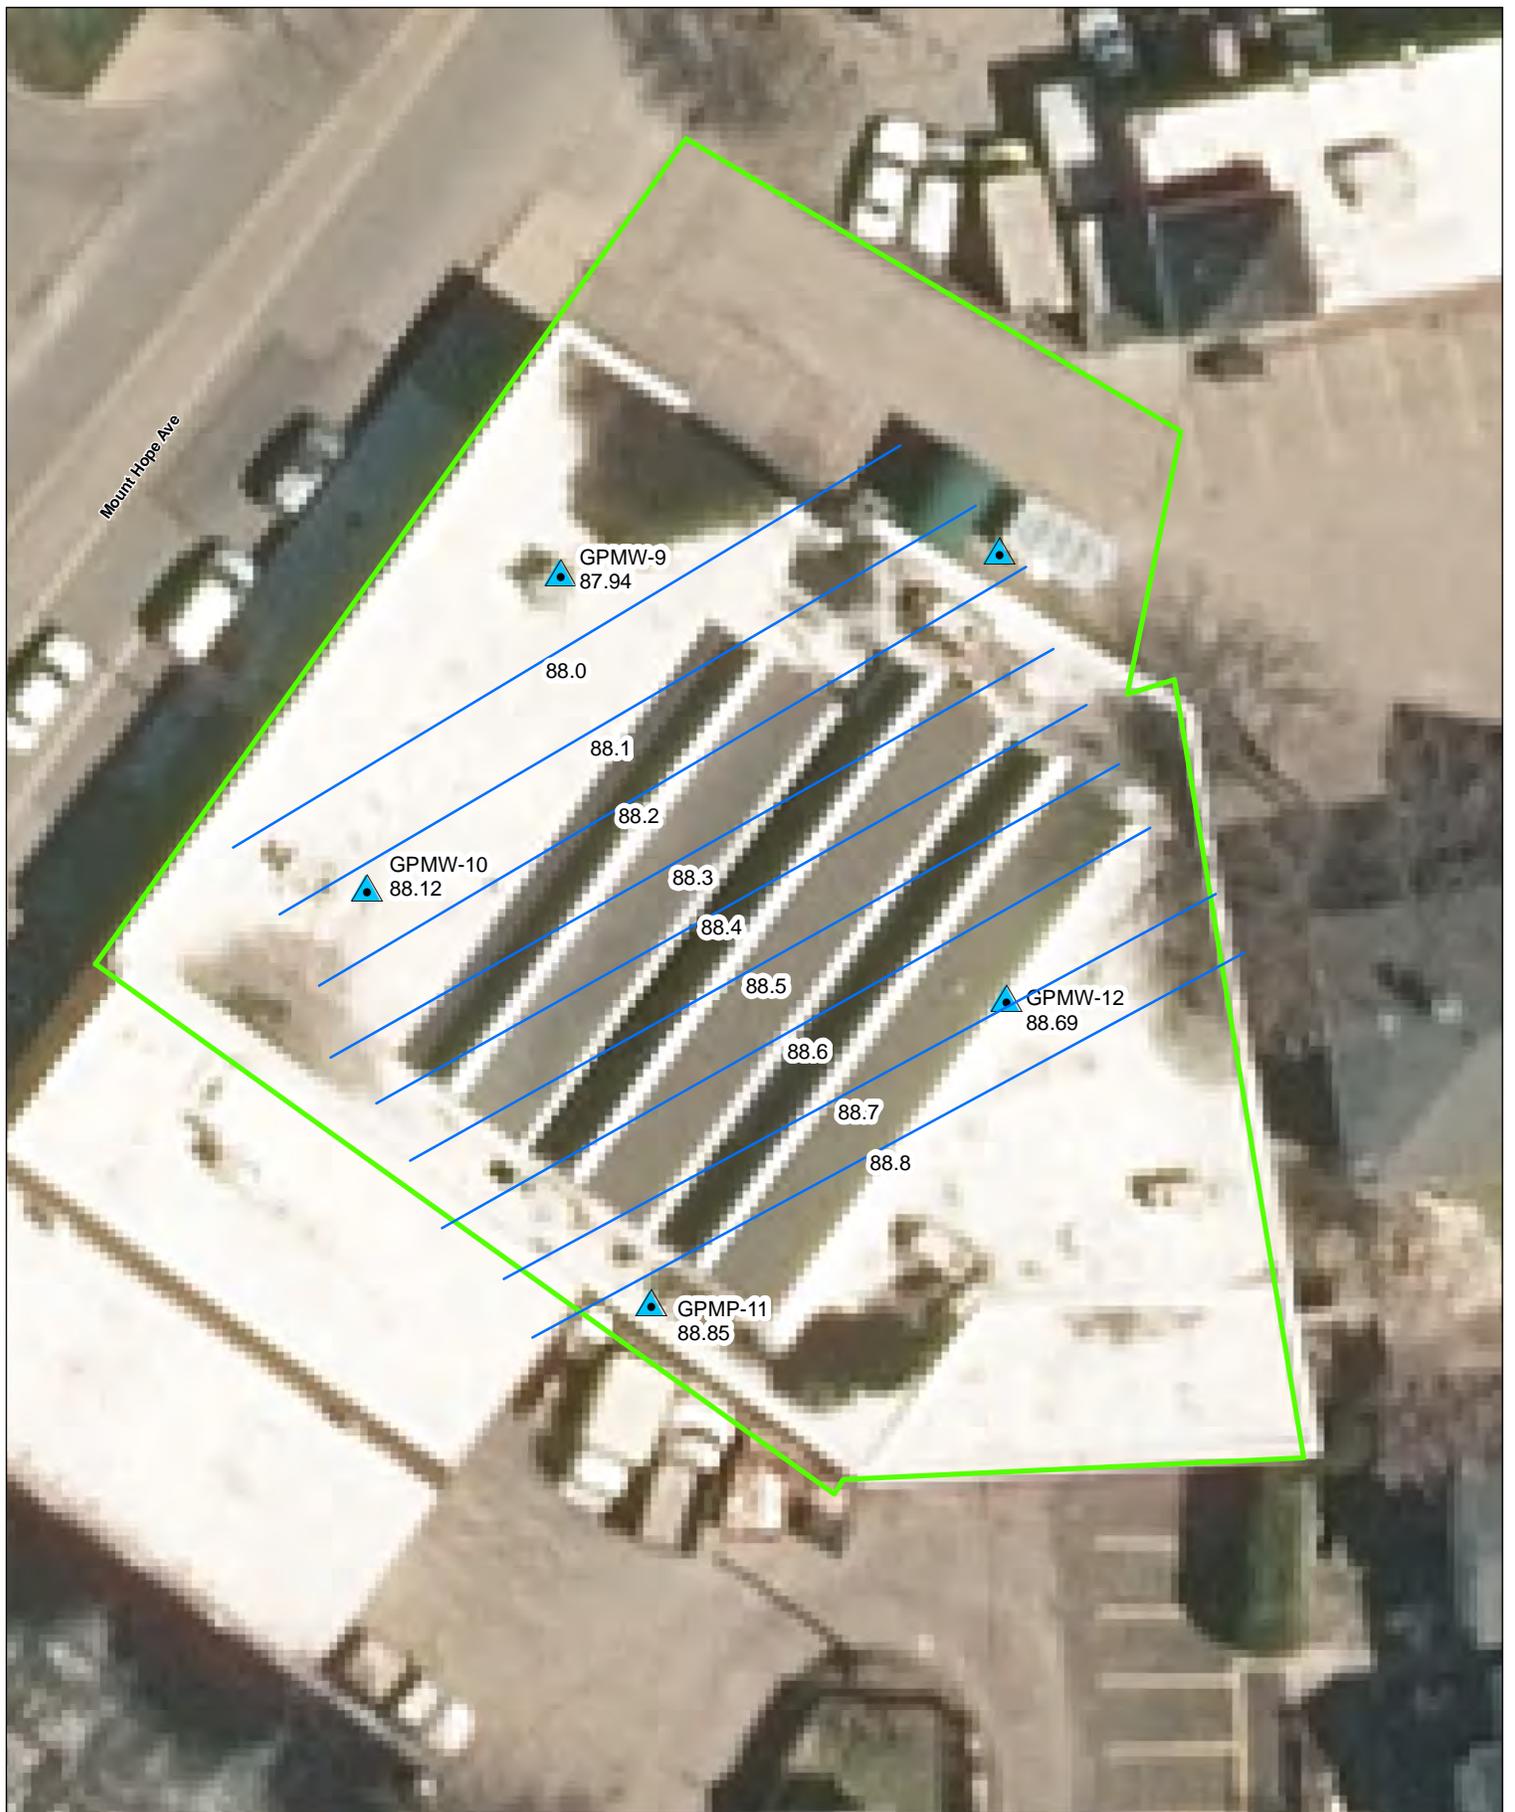
<p>PROJECT #/DRAWING #/DATE:</p> <p>2160225</p> <p>FIGURE 4</p> <p>11/15/2018</p>	<p>DRAWING NAME:</p> <p>GROUNDWATER CONTOUR MAP</p> <p>NOVEMBER 2013</p>	<p>CLIENT:</p> <p>CENTER PROPERTIES OF ROCHESTER, INC.</p> <p>PROJECT:</p> <p>Interim Site Management Plan Former Hall-Welter Site 38-46 MOUNT HOPE AVENUE ROCHESTER, NEW YORK</p>	<p>0 10 20 Feet</p> <p>1 inch = 25 feet</p> <p>INTENDED TO PRINT AS: 8.5" X 11"</p>
---	--	--	---

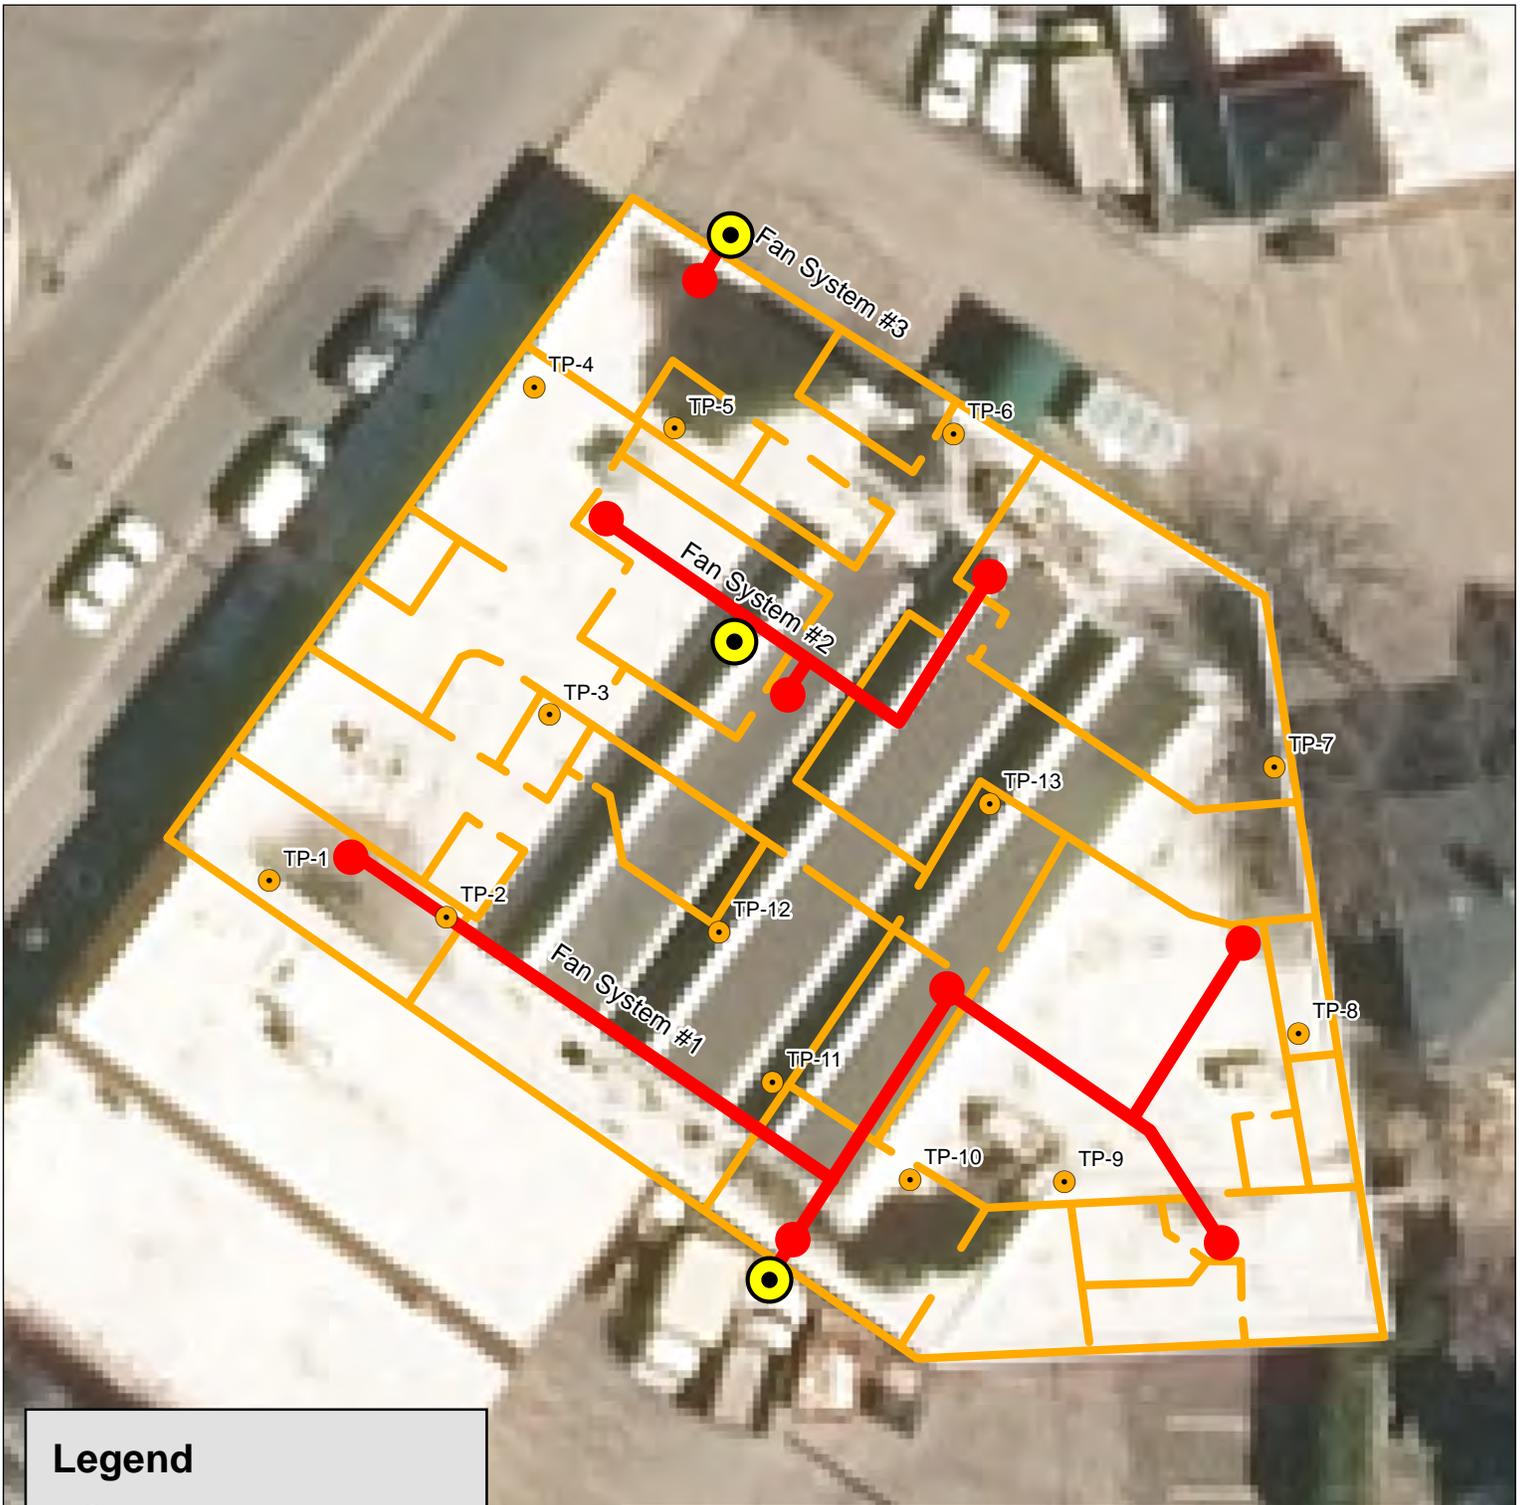
- Suction_Point
- Sub Slab System Piping
- SSDS Fan Location
- Approx. Interior Walls
- Vacuum test points

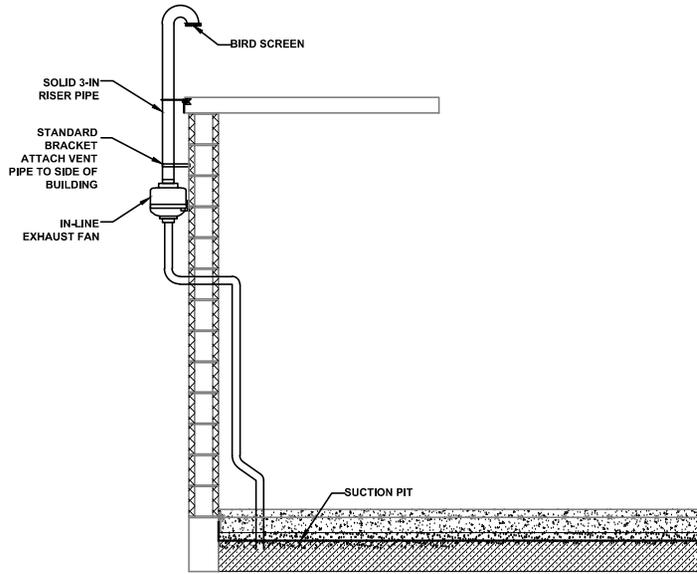
CROSS SECTION VIEW AT EXTERIOR WALL (TYPICAL)
SCALE: NONE

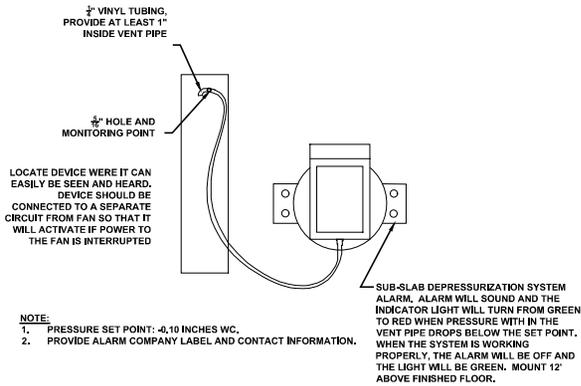
- NOTE:**
1. PRESSURE SET POINT: -0.10 INCHES WC.
 2. PROVIDE ALARM COMPANY LABEL AND CONTACT INFORMATION.

SUB-SLAB DEPRESSURIZATION SYSTEM ALARM. ALARM WILL SOUND AND THE INDICATOR LIGHT WILL TURN FROM GREEN TO RED WHEN PRESSURE WITH IN THE VENT PIPE DROPS BELOW THE SET POINT. WHEN THE SYSTEM IS WORKING PROPERLY, THE ALARM WILL BE OFF AND THE LIGHT WILL BE GREEN. MOUNT 12" ABOVE FINISHED FLOOR.

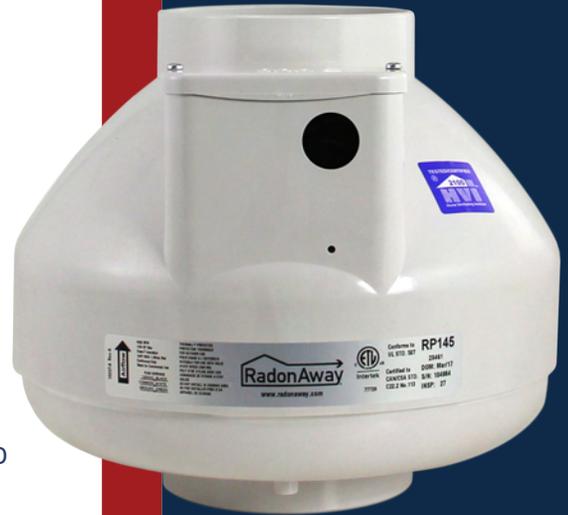
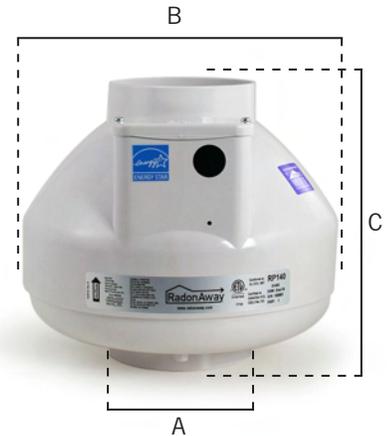
- NEW Stay-White™ housing
- Energy efficient
- RP140 - ENERGY STAR Most Efficient 2018
- Ultra-quiet operation
- Meets all electrical code requirements
- Water-hardened motorized impeller
- Seams sealed to inhibit radon leakage (RP140 & RP145 double snap sealed)
- ETL Listed - for indoor or outdoor use
- Thermally protected motor
- Rated for commercial and residential use

MODEL	P/N	FAN DUCT DIAMETER	WATTS	RECOM. MAX. OP. PRESSURE "WC	TYPICAL CFM vs. STATIC PRESSURE WC				
					0"	.5"	1.0"	1.5"	2.0"
RP140	28460	4"	15-21	0.7	135	70	-	-	-
RP145	28461	4"	41-72	1.7	166	126	82	41	3
RP260	28462	6"	47-65	1.3	251	157	70	-	-
RP265	28463	6"	95-139	2.3	375	282	204	140	70
RP380*	28208	8"	96-138	2.0	531	415	268	139	41

Model	A	B	C
RP140	4.5"	9.7"	8.5"
RP145	4.5"	9.7"	8.5"
RP260	6"	11.75"	8.6"
RP265	6"	11.75"	8.6"
RP380	8"	13.41"	10.53"

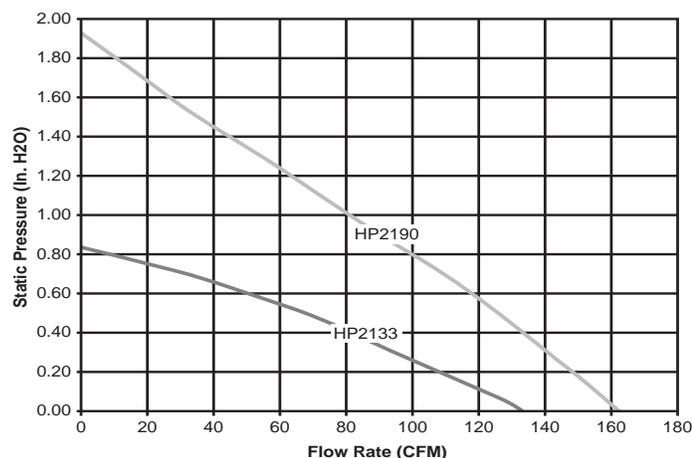
HP2133 & HP2190 RADON MITIGATION FANS

Tested with 4" ID duct and standard couplings.

HP2133 – For applications where lower pressure and flow are needed. Record low power consumption of 14-20 watts! Often used where there is good sub slab communication and lower Radon levels.

HP2190 – Performance like the HP190 but in a smaller housing. Performance suitable for the majority of installations.

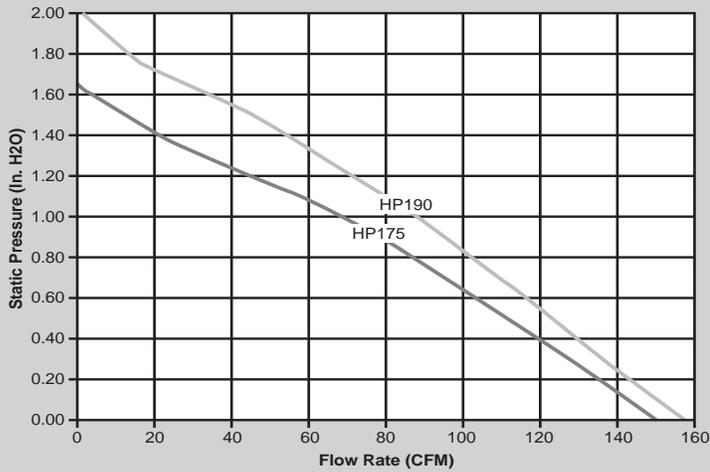
HP175 & HP190 RADON MITIGATION FANS

Tested with 4" ID duct and standard couplings.

HP175 – The economical choice where slightly less air flow is needed. Often used where there is good sub slab communication and lower Radon levels.

HP190 – The standard for Radon Mitigation. Ideally tailored performance curve for a vast majority of your mitigations.

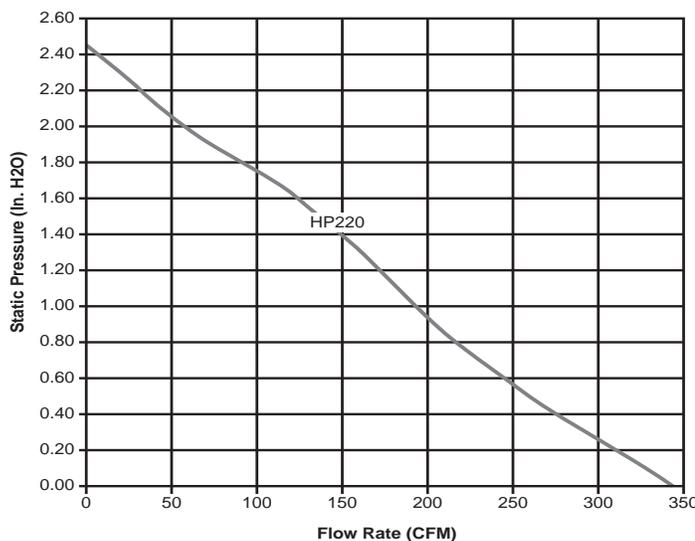
HP220 RADON MITIGATION FAN

Tested with 6" ID duct and standard couplings.

HP 220 – Excellent choice for systems with elevated radon levels, poor communication, multiple suction points and large subslab footprint. Replaces FR 175.

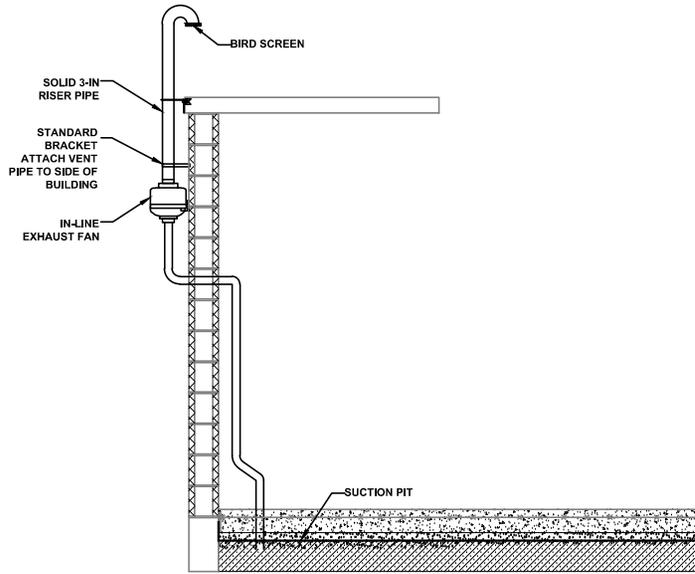
CROSS SECTION VIEW AT EXTERIOR WALL (TYPICAL)
SCALE: NONE

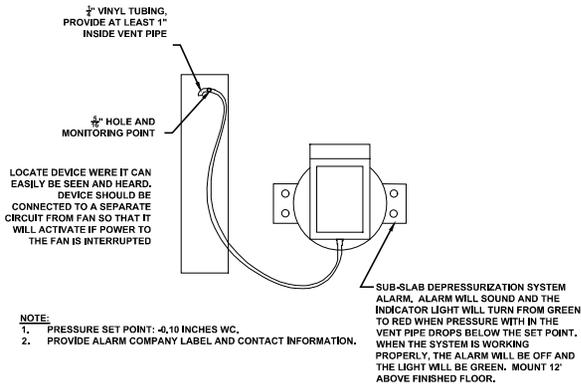
SUBSLAB DEPRESSURIZATION SYSTEM ALARM DETAIL (TYPICAL)
SCALE: NONE
