Subject: **October 2024 Monthly Progress Report
Patriot Way Site No. 828223
293 Patriot Way, Chili, NY**

SUBJECT: Application Summary Report for Remedial Services at the Kaddis Manufacturing site

Roux-Kaddis Manufacturing: Photo Log

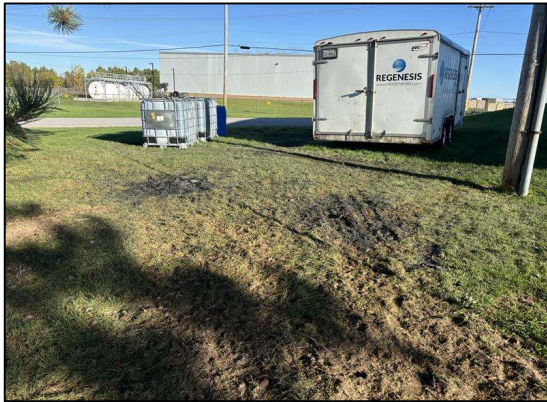
Photo 1: Staged RRS Injection trailer.

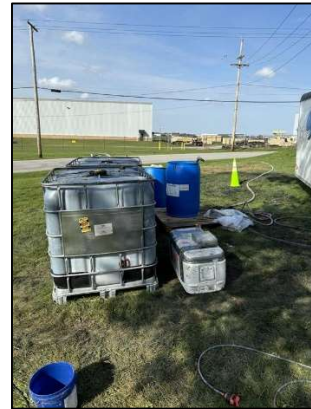
Photo 2: Example of product staging area.

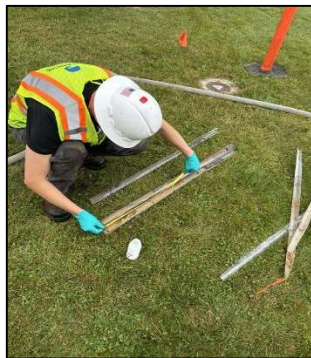
Photo 3: Image of Pre-Injection Cores being sampled.

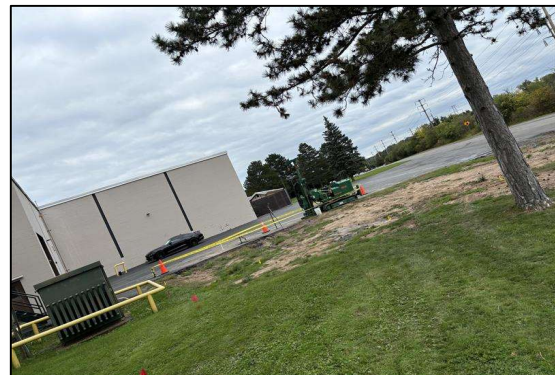
Photo 4: Example of end of day eastern most PRB area.

backfilled boreholes with sodium bentonite chips to grade and finished with blacktop for the eastern most permeable reactive barrier on the driveway.

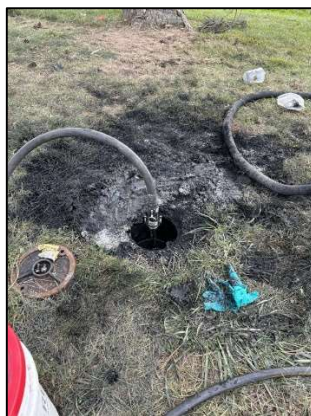
Photo 5: Active injection of monitoring well MW-3.

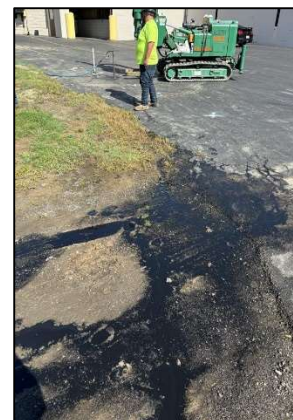
Photo 6: Surfacing occurring as a result of injection of eastern most PRB.

1. Redistribution occurred across several points due to refusal and high pressure.
 Design change approved and implemented on 10/03/2024 due to surfacing across many points.

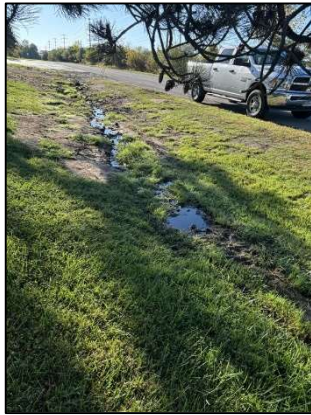
Photo 7: Example of Surfacing that occurred overnight after injection of product into eastern most PRB.

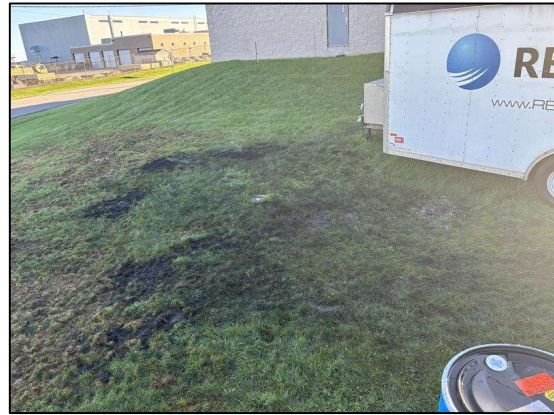
Photo 8: Example of MW-4B area after completion of injections.

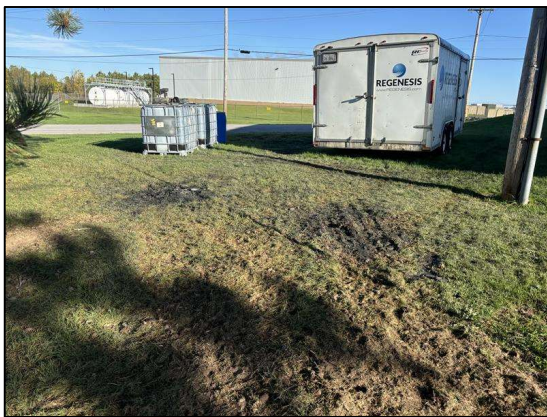
Photo 9: View of area surrounding MW-3 after completion of injections.

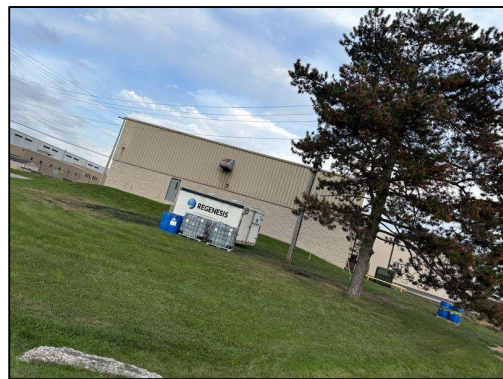
Photo 10: Overview of jobsite prior to demobilization of RRS injection trailer.

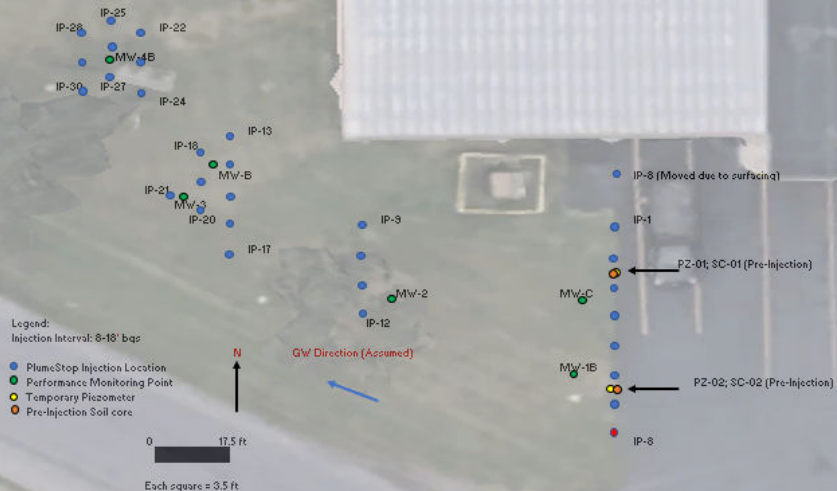
Injection Area Map

Treatment Area 1 consisted of two wells, MW-4B and MW-7B. MW-7B is located North of the former underground storage tank (UST), on the far side of the Kaddis Manufacturing building. MW-4B is located West of the former UST. Both locations are detailed within Appendix-C. Work within Treatment Area 1 began on Monday September 30th. An expansion plug was used to begin pumping on MW-4B. Injection occurred at a bottom application depth of 48.5 ft bgs, and a top application depth of 38.5 ft bgs. Throughout the workday a total of 852.5 gallons were injected. Consisting of 801.48 gallons of water, 100 lbs of S-MicroZVI (6.62 gallons), 400 lbs of PlumeStop (44.40 gallons), and 2.5 liters of BDI. Regarding well MW-7B, an NPT PVC Injection Cap was attached to the begin injecting the product. Injection occurred at a bottom application depth of 48.5 ft bgs, and a top application depth of 43.5 ft bgs. In total 852.5 gallons was injected consisting of 801.48 gallons of water, 100 lbs of S-MicroZVI (6.62 gallons), 400 lbs of PlumeStop (44.40), and 2.5 liters of BDI. Following the completion of product injection, well MW-4B was flushed clear with 51 gallons of water. Upon completion of product injection well MW-7B was flushed with 101 gallons of water. The well was sampled and showed a slightly black color. Following, 50 more gallons were added to achieve a clear flush, totaling 151 gallons. Injection data regarding flowrates and pressure for MW-4B and MW-7B is listed below.
