**Post Sub-Slab Depressurization
System Installation Vapor
Intrusion Evaluation Summary
Report**

Geneva Former MGP Site
Geneva, New York

March 2010

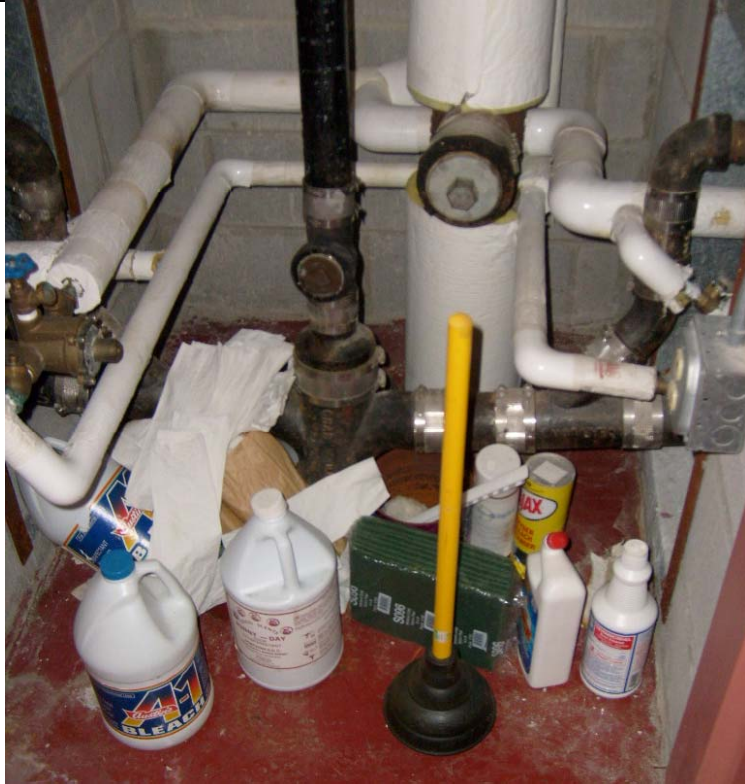
DESCRIPTION: Pipe chase contents in
Women's Cell area

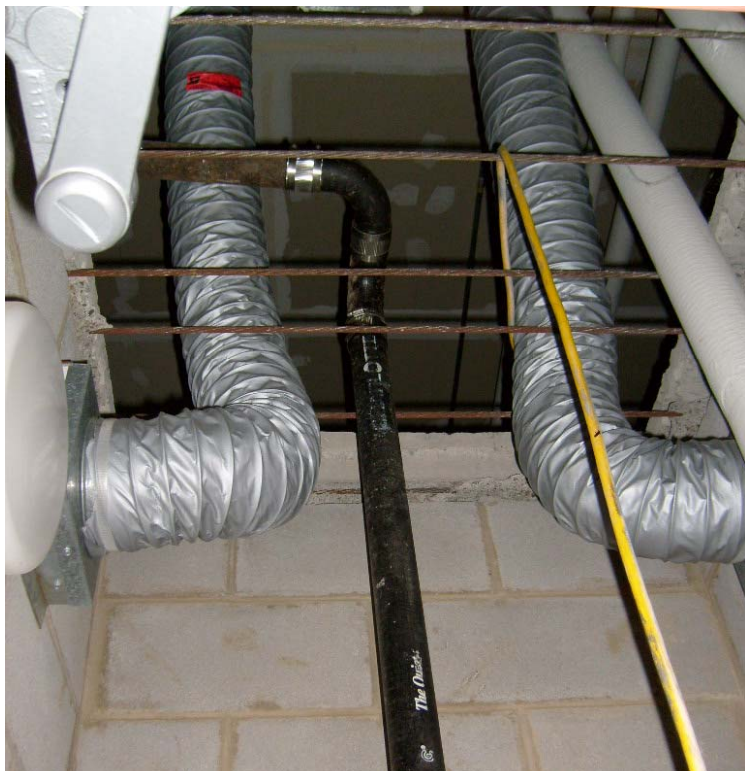
PHOTO #: S6300168.JPG

DESCRIPTION: Ceiling of pipe chase in
Men's Cell area (location of suction
point #1); yellow cord is the
contractor's extension cord

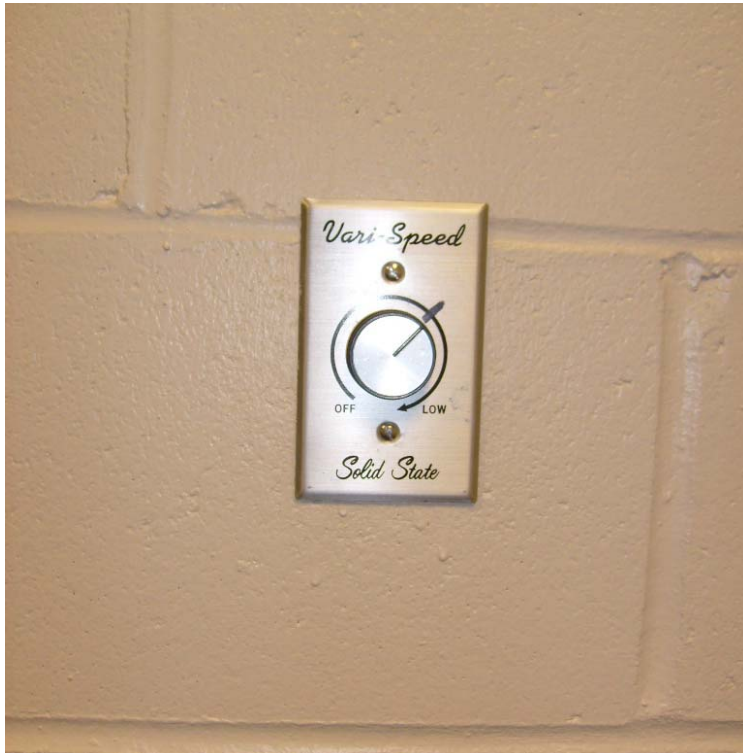
DESCRIPTION: PRE 2 control dial
(located in jury room); marked at
designed exhaust setting

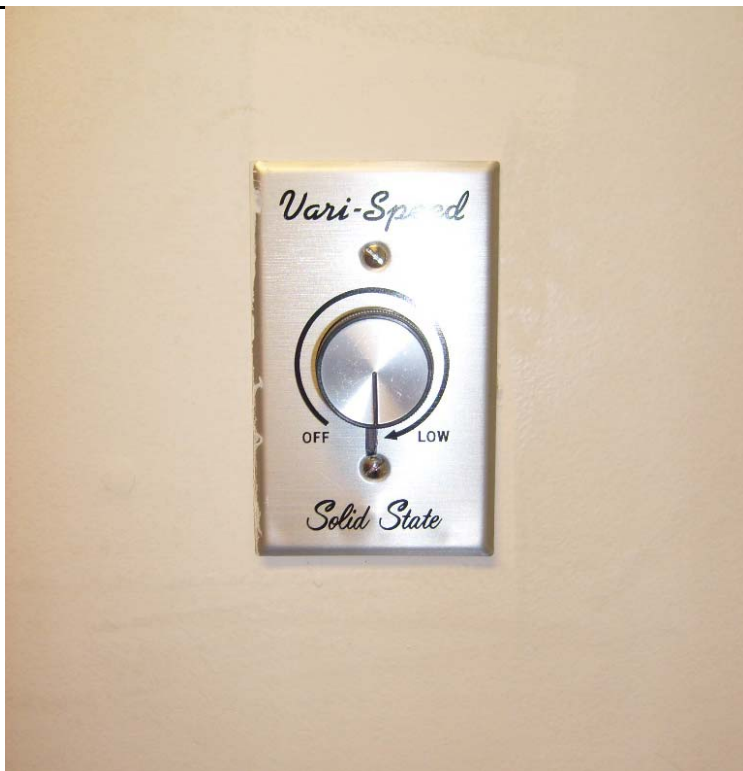
PHOTO #: S6300170.JPG

DESCRIPTION: PRE 3 control dial
(located in store room #204); marked
at designed exhaust setting; services
the store room and toilets adjacent
to the jury room and clerk's office

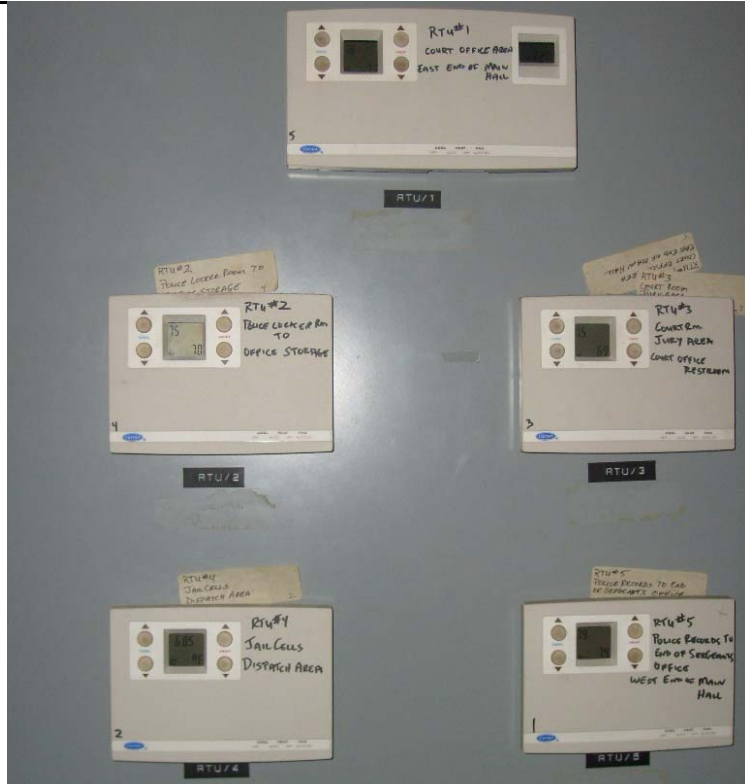
DESCRIPTION: Temperature controls for the five RTUs (located in the custodian's closet)

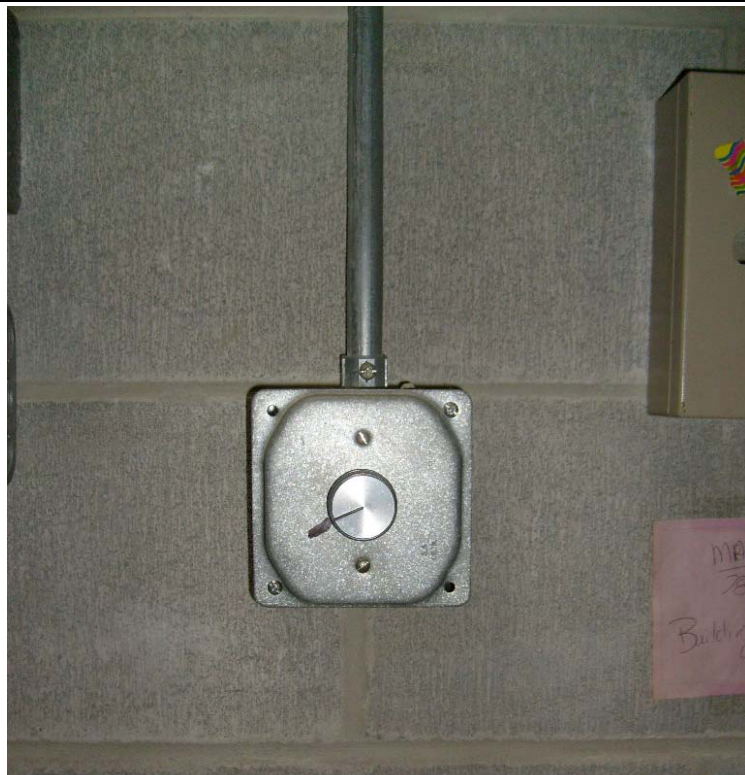
PHOTO #: S6300172.JPG

DESCRIPTION: PRE 4 control dial (located in custodian's closet); marked at designed exhaust setting; services the janitor's closet and the men's and women's bathrooms across from the courtroom

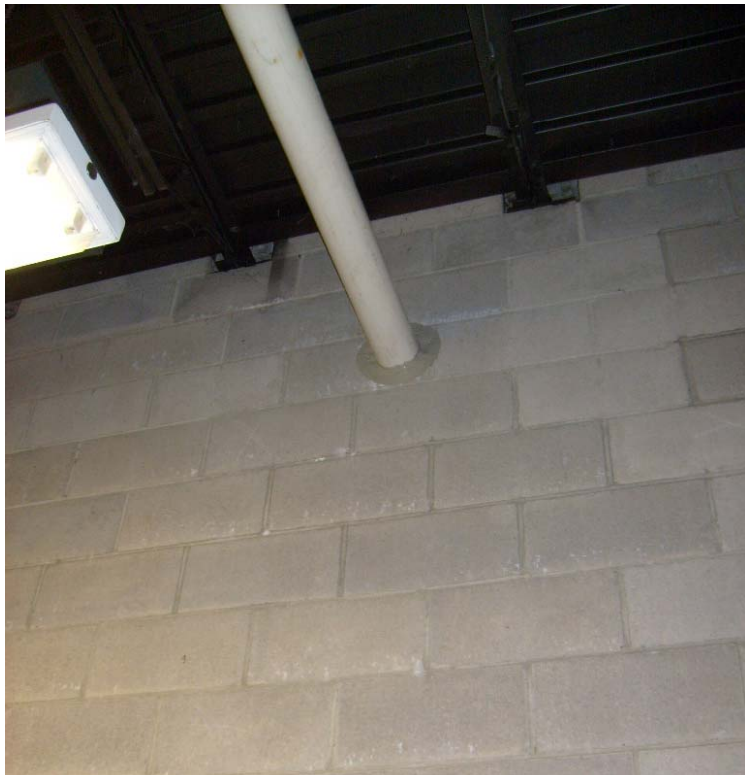
PHOTO #: S6300176.JPG

DESCRIPTION: VI discharge pipe at the exterior wall to the sally port (view from inside sally port), facing north

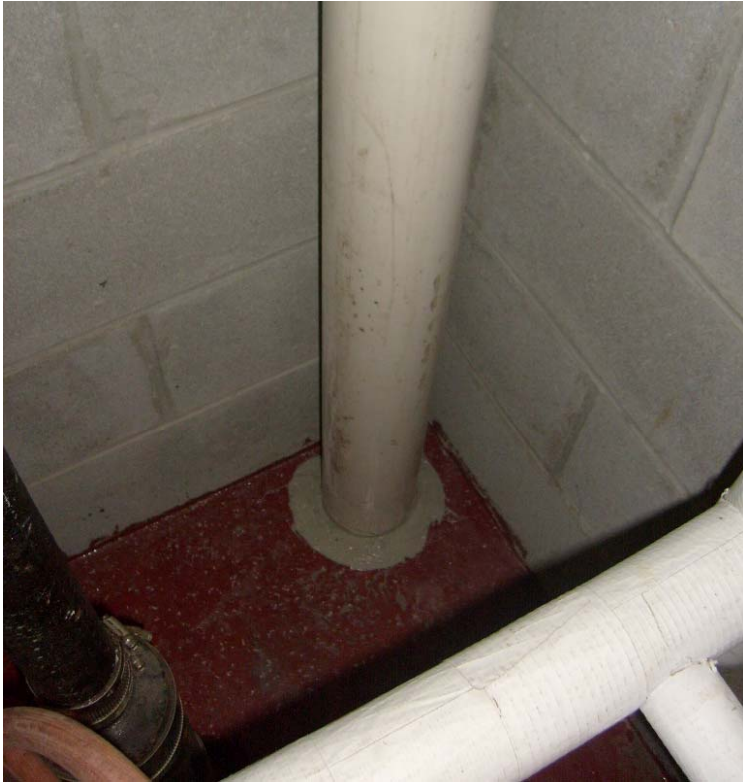
DESCRIPTION: VI suction pipe #1 /
floor interface; located within the
men's cell area pipe chase (west side
of men's cell area)

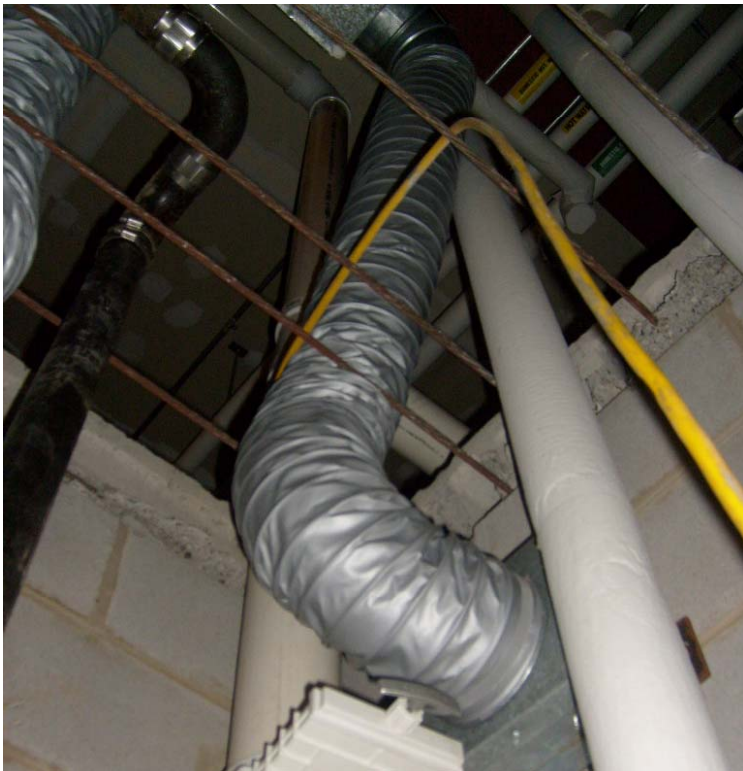
PHOTO #: S6300179.JPG

DESCRIPTION: VI suction pipe #1 /
"ceiling" interface

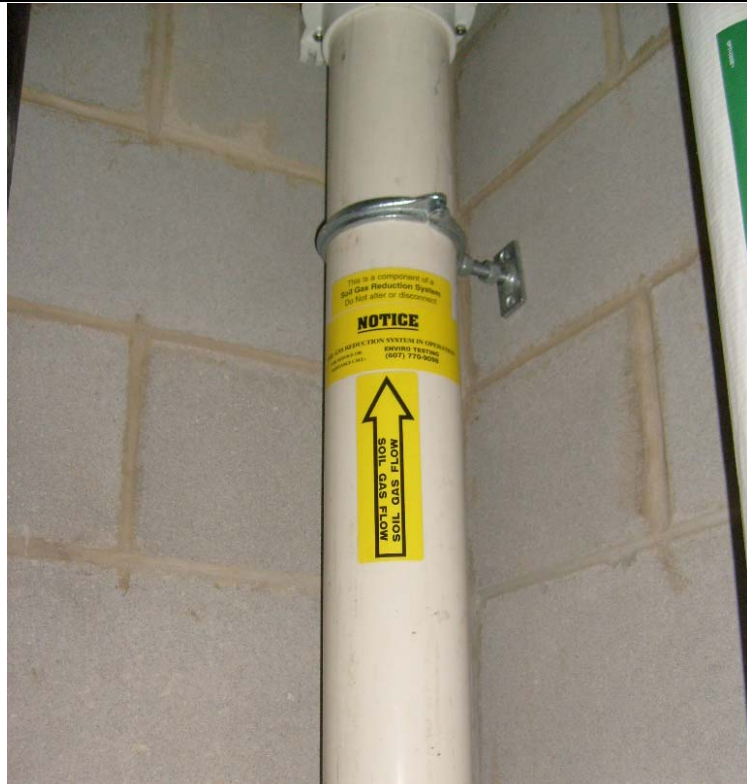
PROJECT #: B0013085
PHOTO#: S6300180.JPG
DATE: November 20, 2008
DESCRIPTION: VI suction
pipe #1 (advisory stickers)

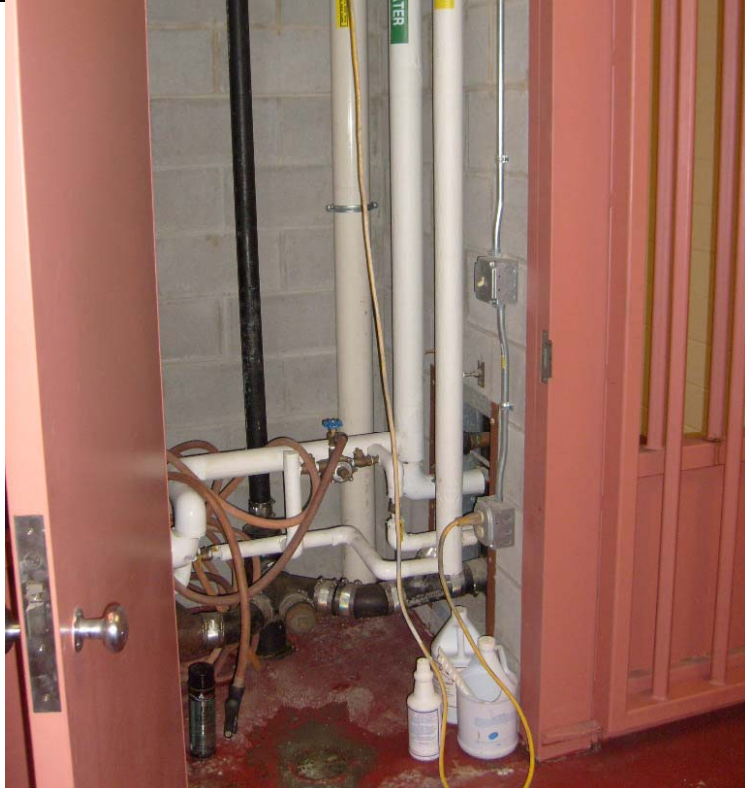
DESCRIPTION: VI suction pipe #1 –
entire closet view

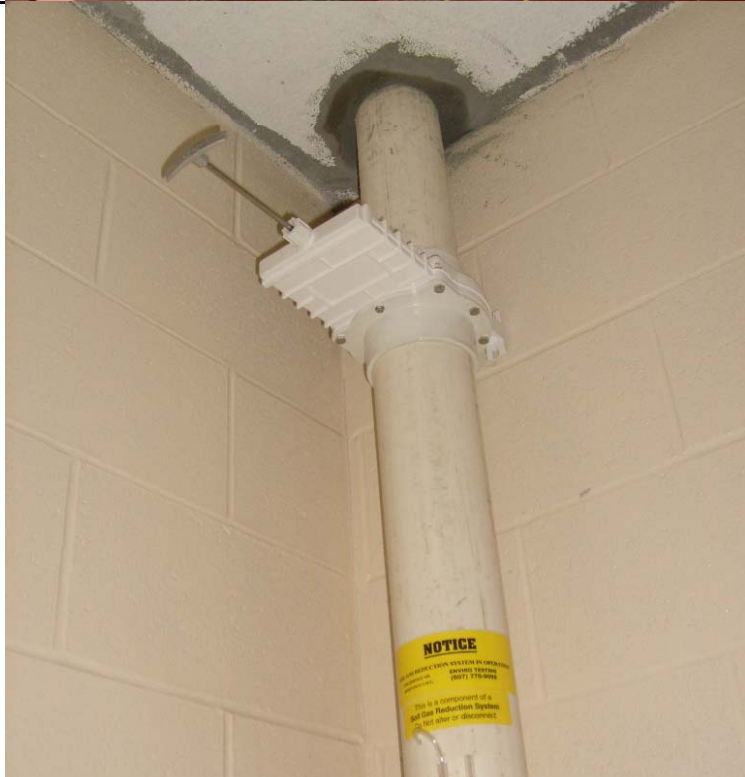
PHOTO #: S6300186.JPG

DESCRIPTION: VI suction pipe #2 /
ceiling interface; located within the
closet in the interview/line-up room

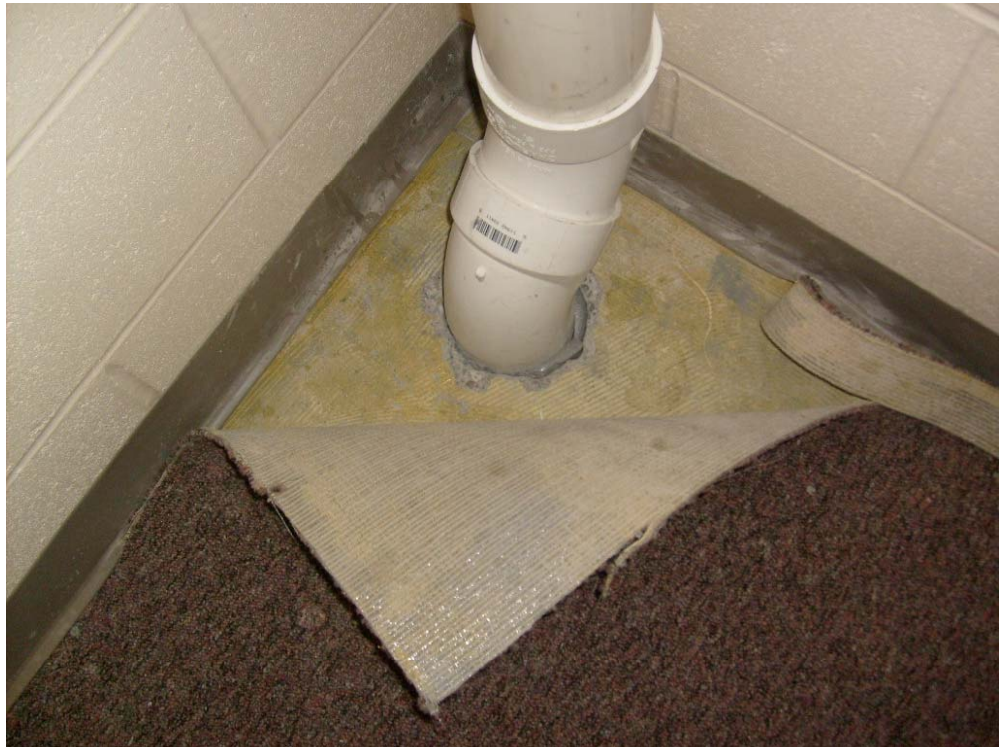
PROJECT #: B0013085
PHOTO#: S6300187.JPG
DATE: November 20, 2008
DESCRIPTION: VI suction pipe #2 / floor interface;
note: foam around pipe
within the void

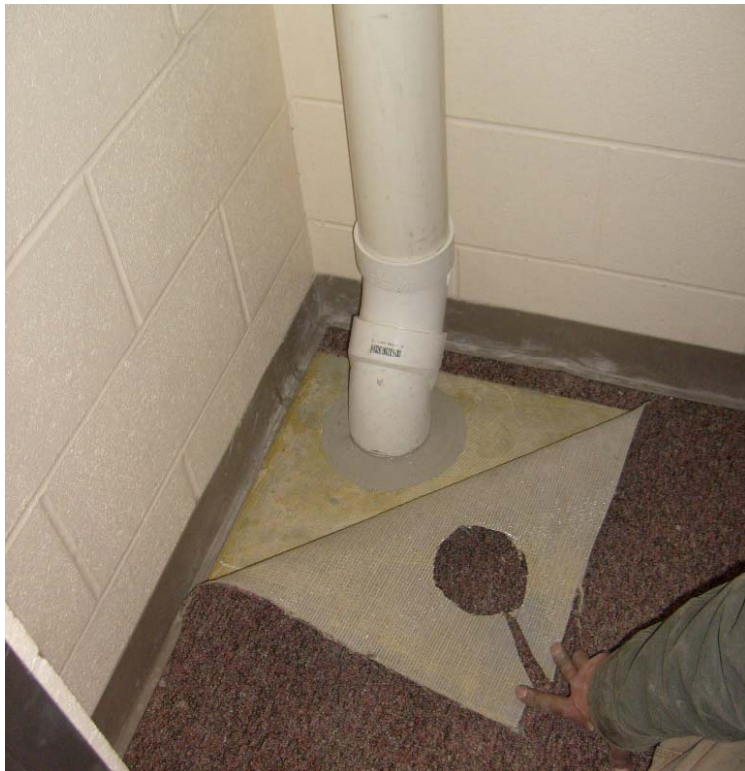
PROJECT #: B0013085
PHOTO #: S6300188.JPG
DATE: November 20, 2008
DESCRIPTION: VI suction pipe #2 /
floor interface; note: caulk in place
over foam

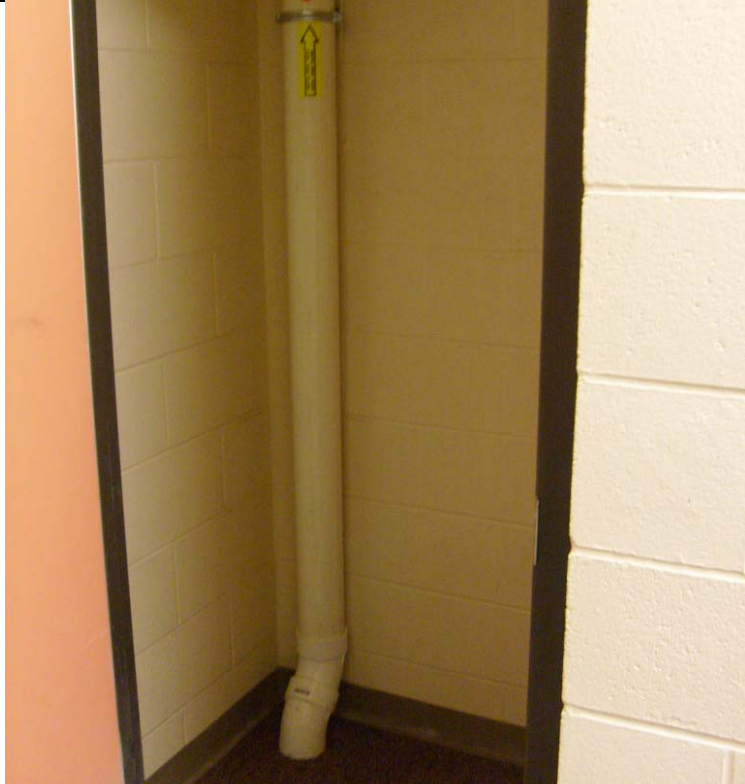
PROJECT #: B0013085
PHOTO#: S6300190.JPG
DATE: November 20, 2008
DESCRIPTION: VI suction
pipe #2 – entire closet view

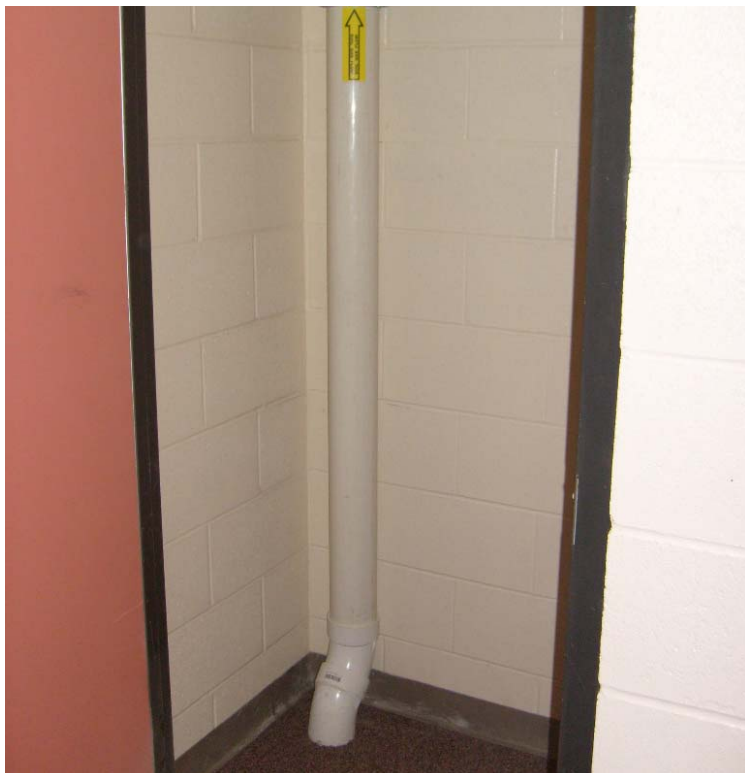
PROJECT #: B0013085
PHOTO #: S6300191.JPG
DATE: November 20, 2008
DESCRIPTION: VI suction
pipe #2 – entire closet view

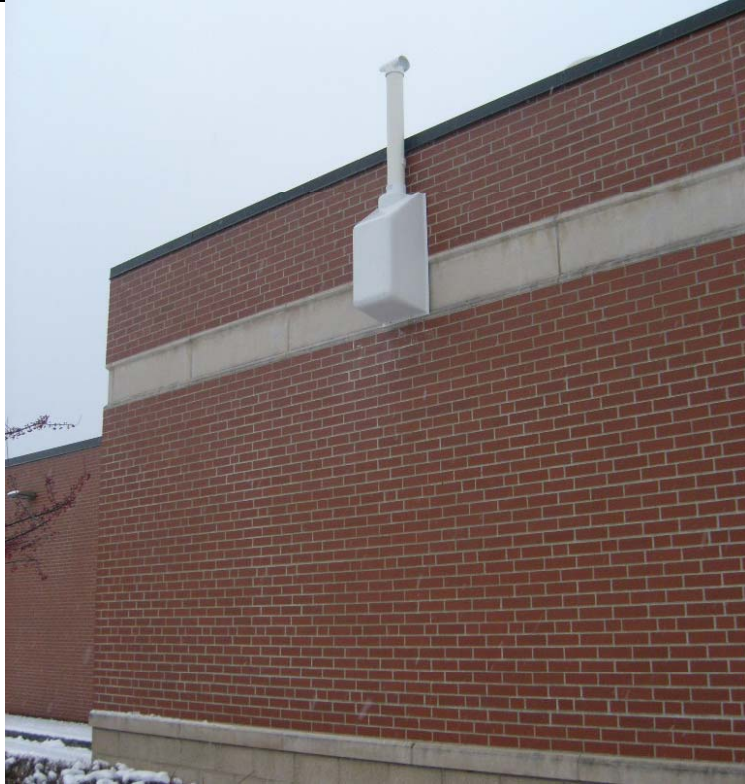
DESCRIPTION: Covered mitigation fan and discharge pipe on the exterior of the sally port, facing southeast

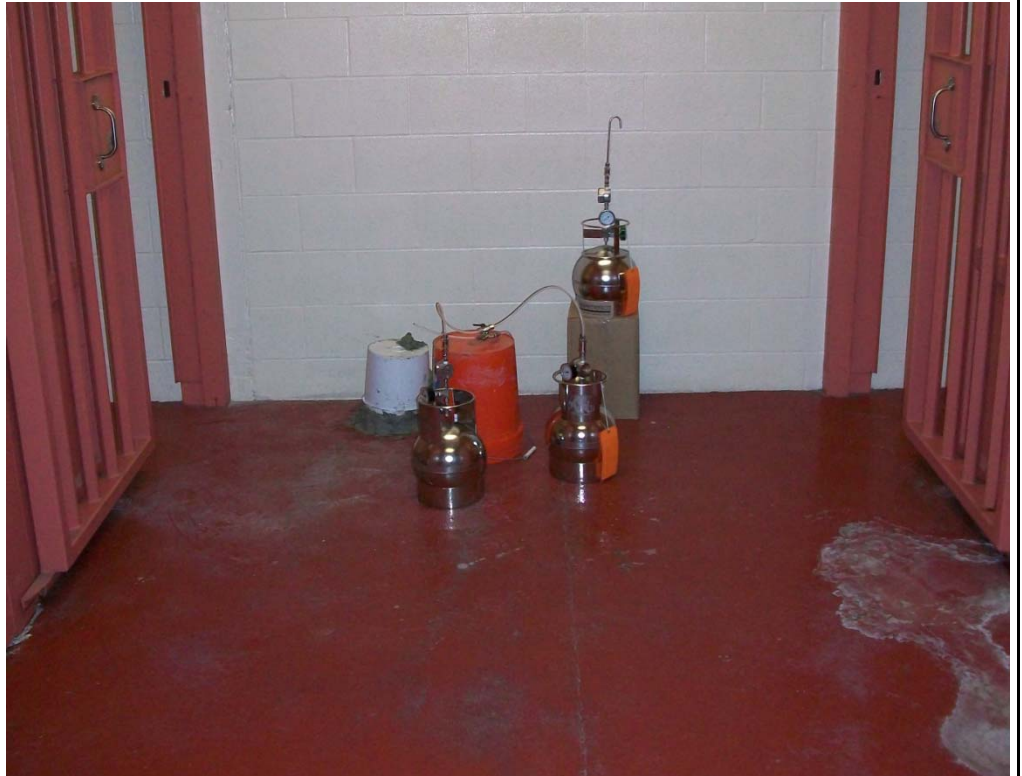
PROJECT #: B0013085
PHOTO#: 100_0165.jpg
DATE: May 14, 2009
DESCRIPTION: Samples
SS-1-09, SS-1-09 DUP,
and IA-1-09 inside the
men's holding cell area

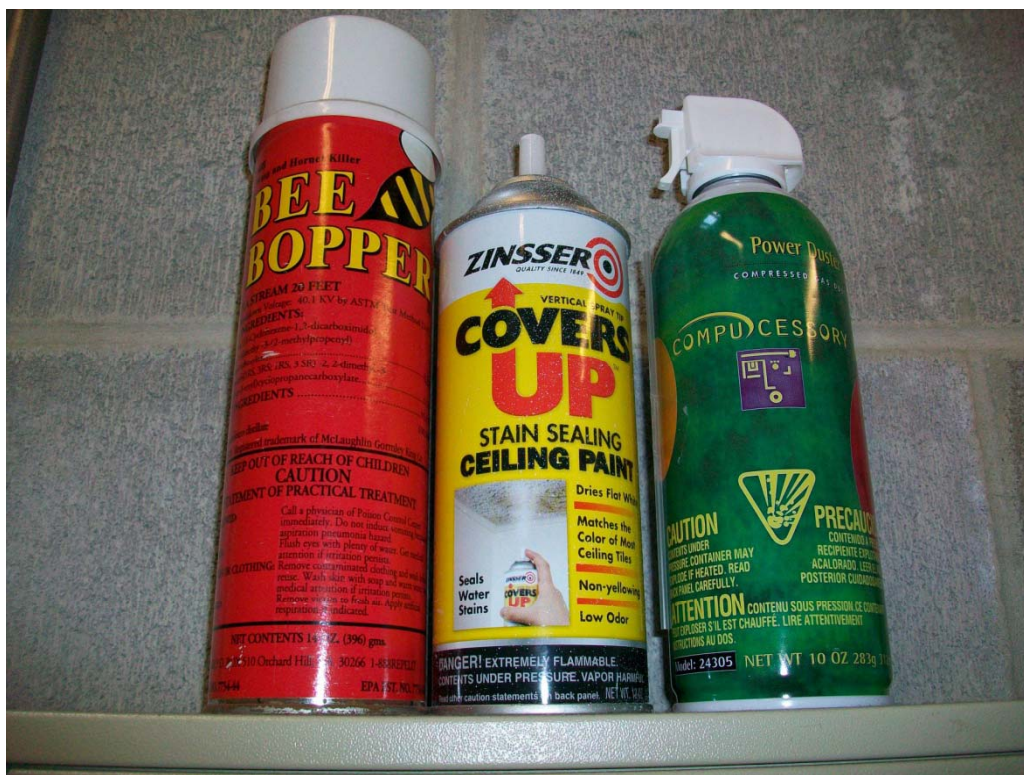
PROJECT #: B0013085
PHOTO #: 100.0172.jpg
DATE: May 14, 2009
DESCRIPTION: Chemicals
located within custodian
closet during sampling

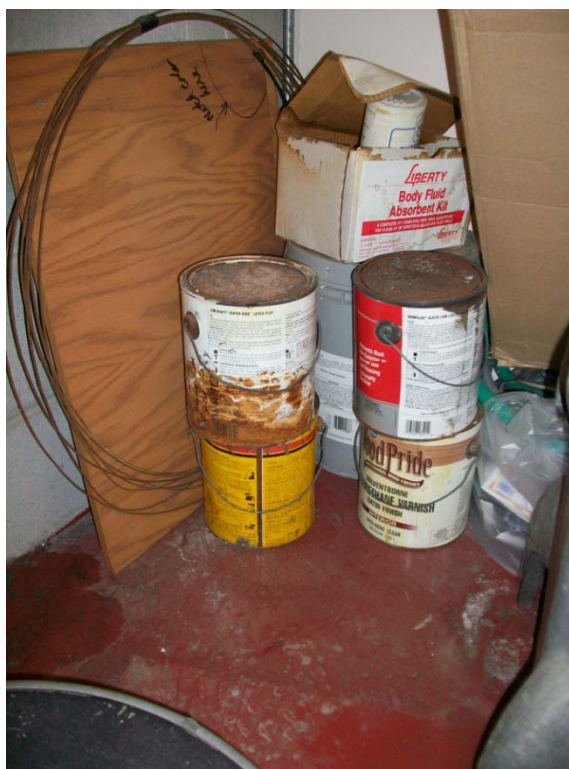
PROJECT #: B0013085
PHOTO #: 100.0174.jpg
DATE: May 14, 2009
DESCRIPTION: Miscellaneous paints located
in custodian closet

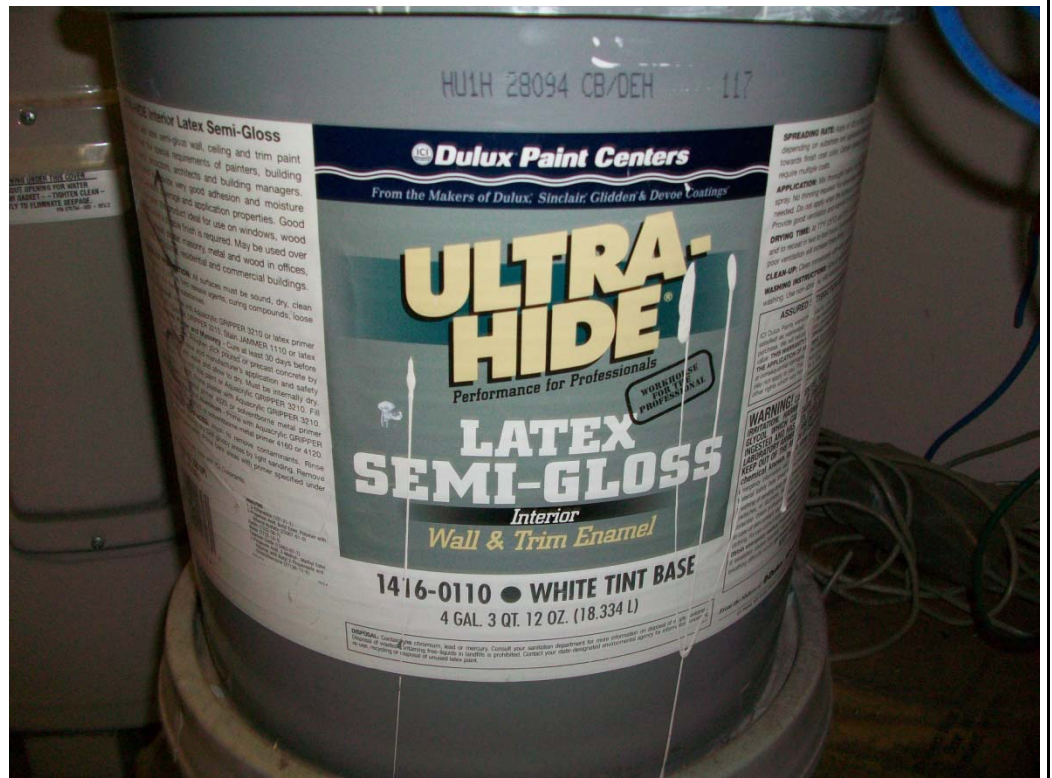
PROJECT #: B0013085
PHOTO#: 100_0175.jpg
DATE: May 14, 2009
DESCRIPTION:
Miscellaneous paints
located in custodian
closet

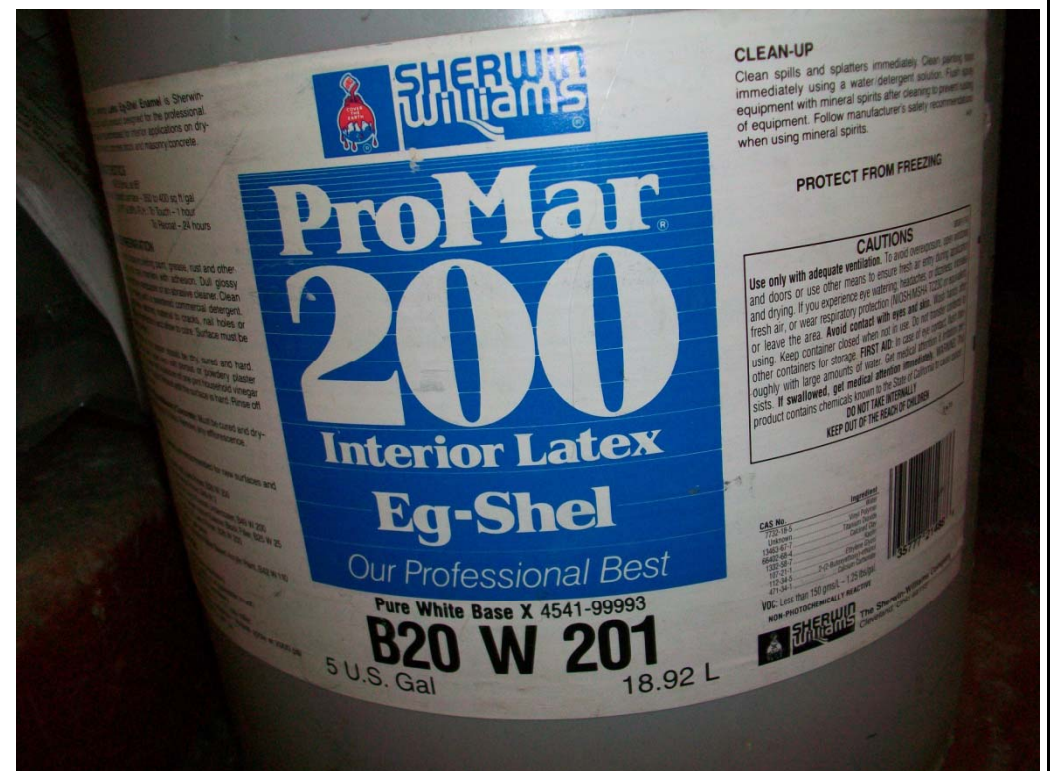
PROJECT #: B0013085
PHOTO #: 100.0176.jpg
DATE: May 14, 2009
DESCRIPTION:
Miscellaneous paints
located in custodian
closet

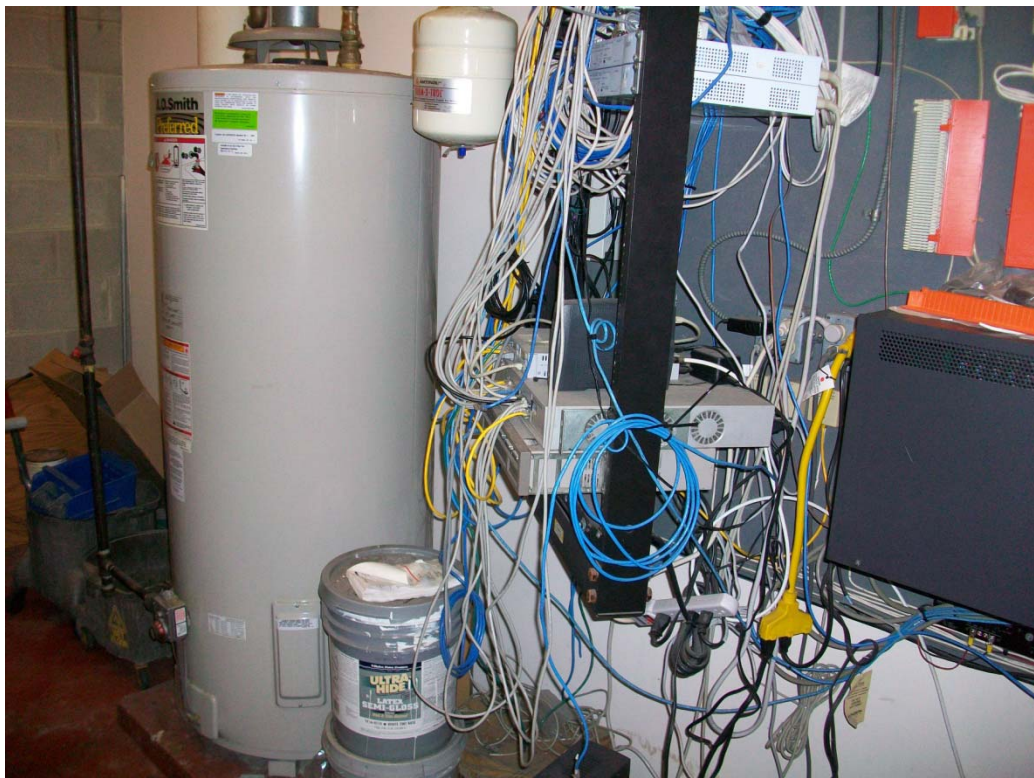
PROJECT #: B0013085
PHOTO#: 100_0179.jpg
DATE: May 14, 2009
DESCRIPTION: Interior of
custodian closet

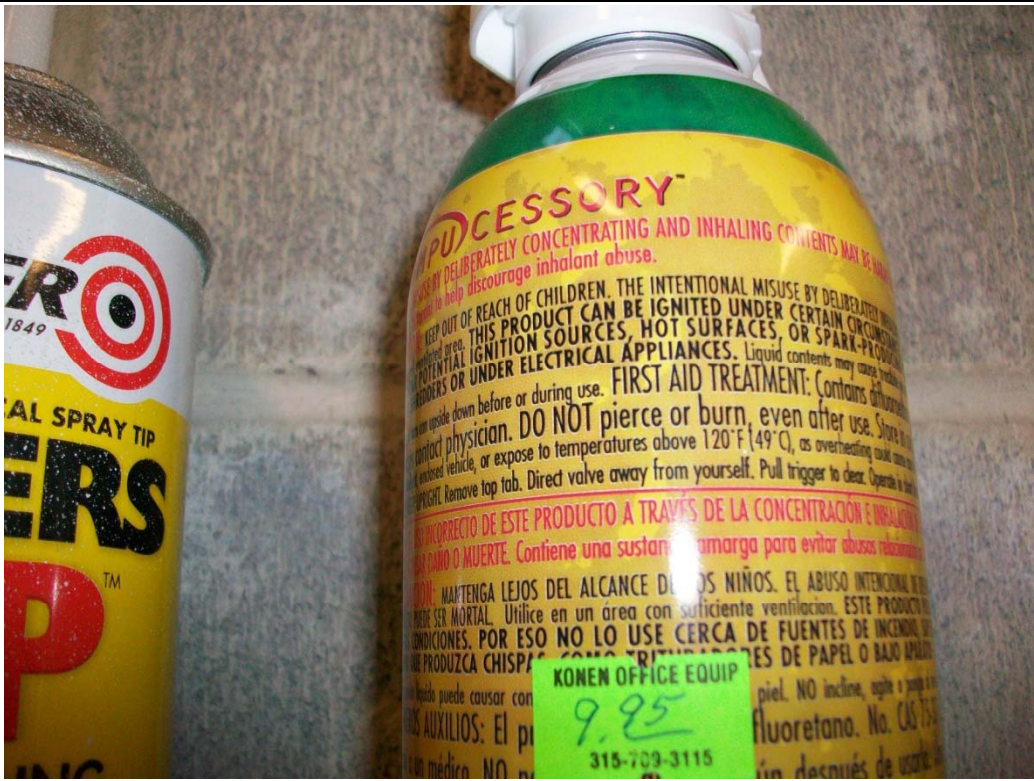
PROJECT #: B0013085
PHOTO#: 100_0187.jpg
DATE: May 14, 2009
DESCRIPTION: Chemicals located within custodian closet
