Periodic Review Report

For the Period March 25, 2024 through July 31, 2025

NYSDEC Site No. 835030

220 Saltonstall Street

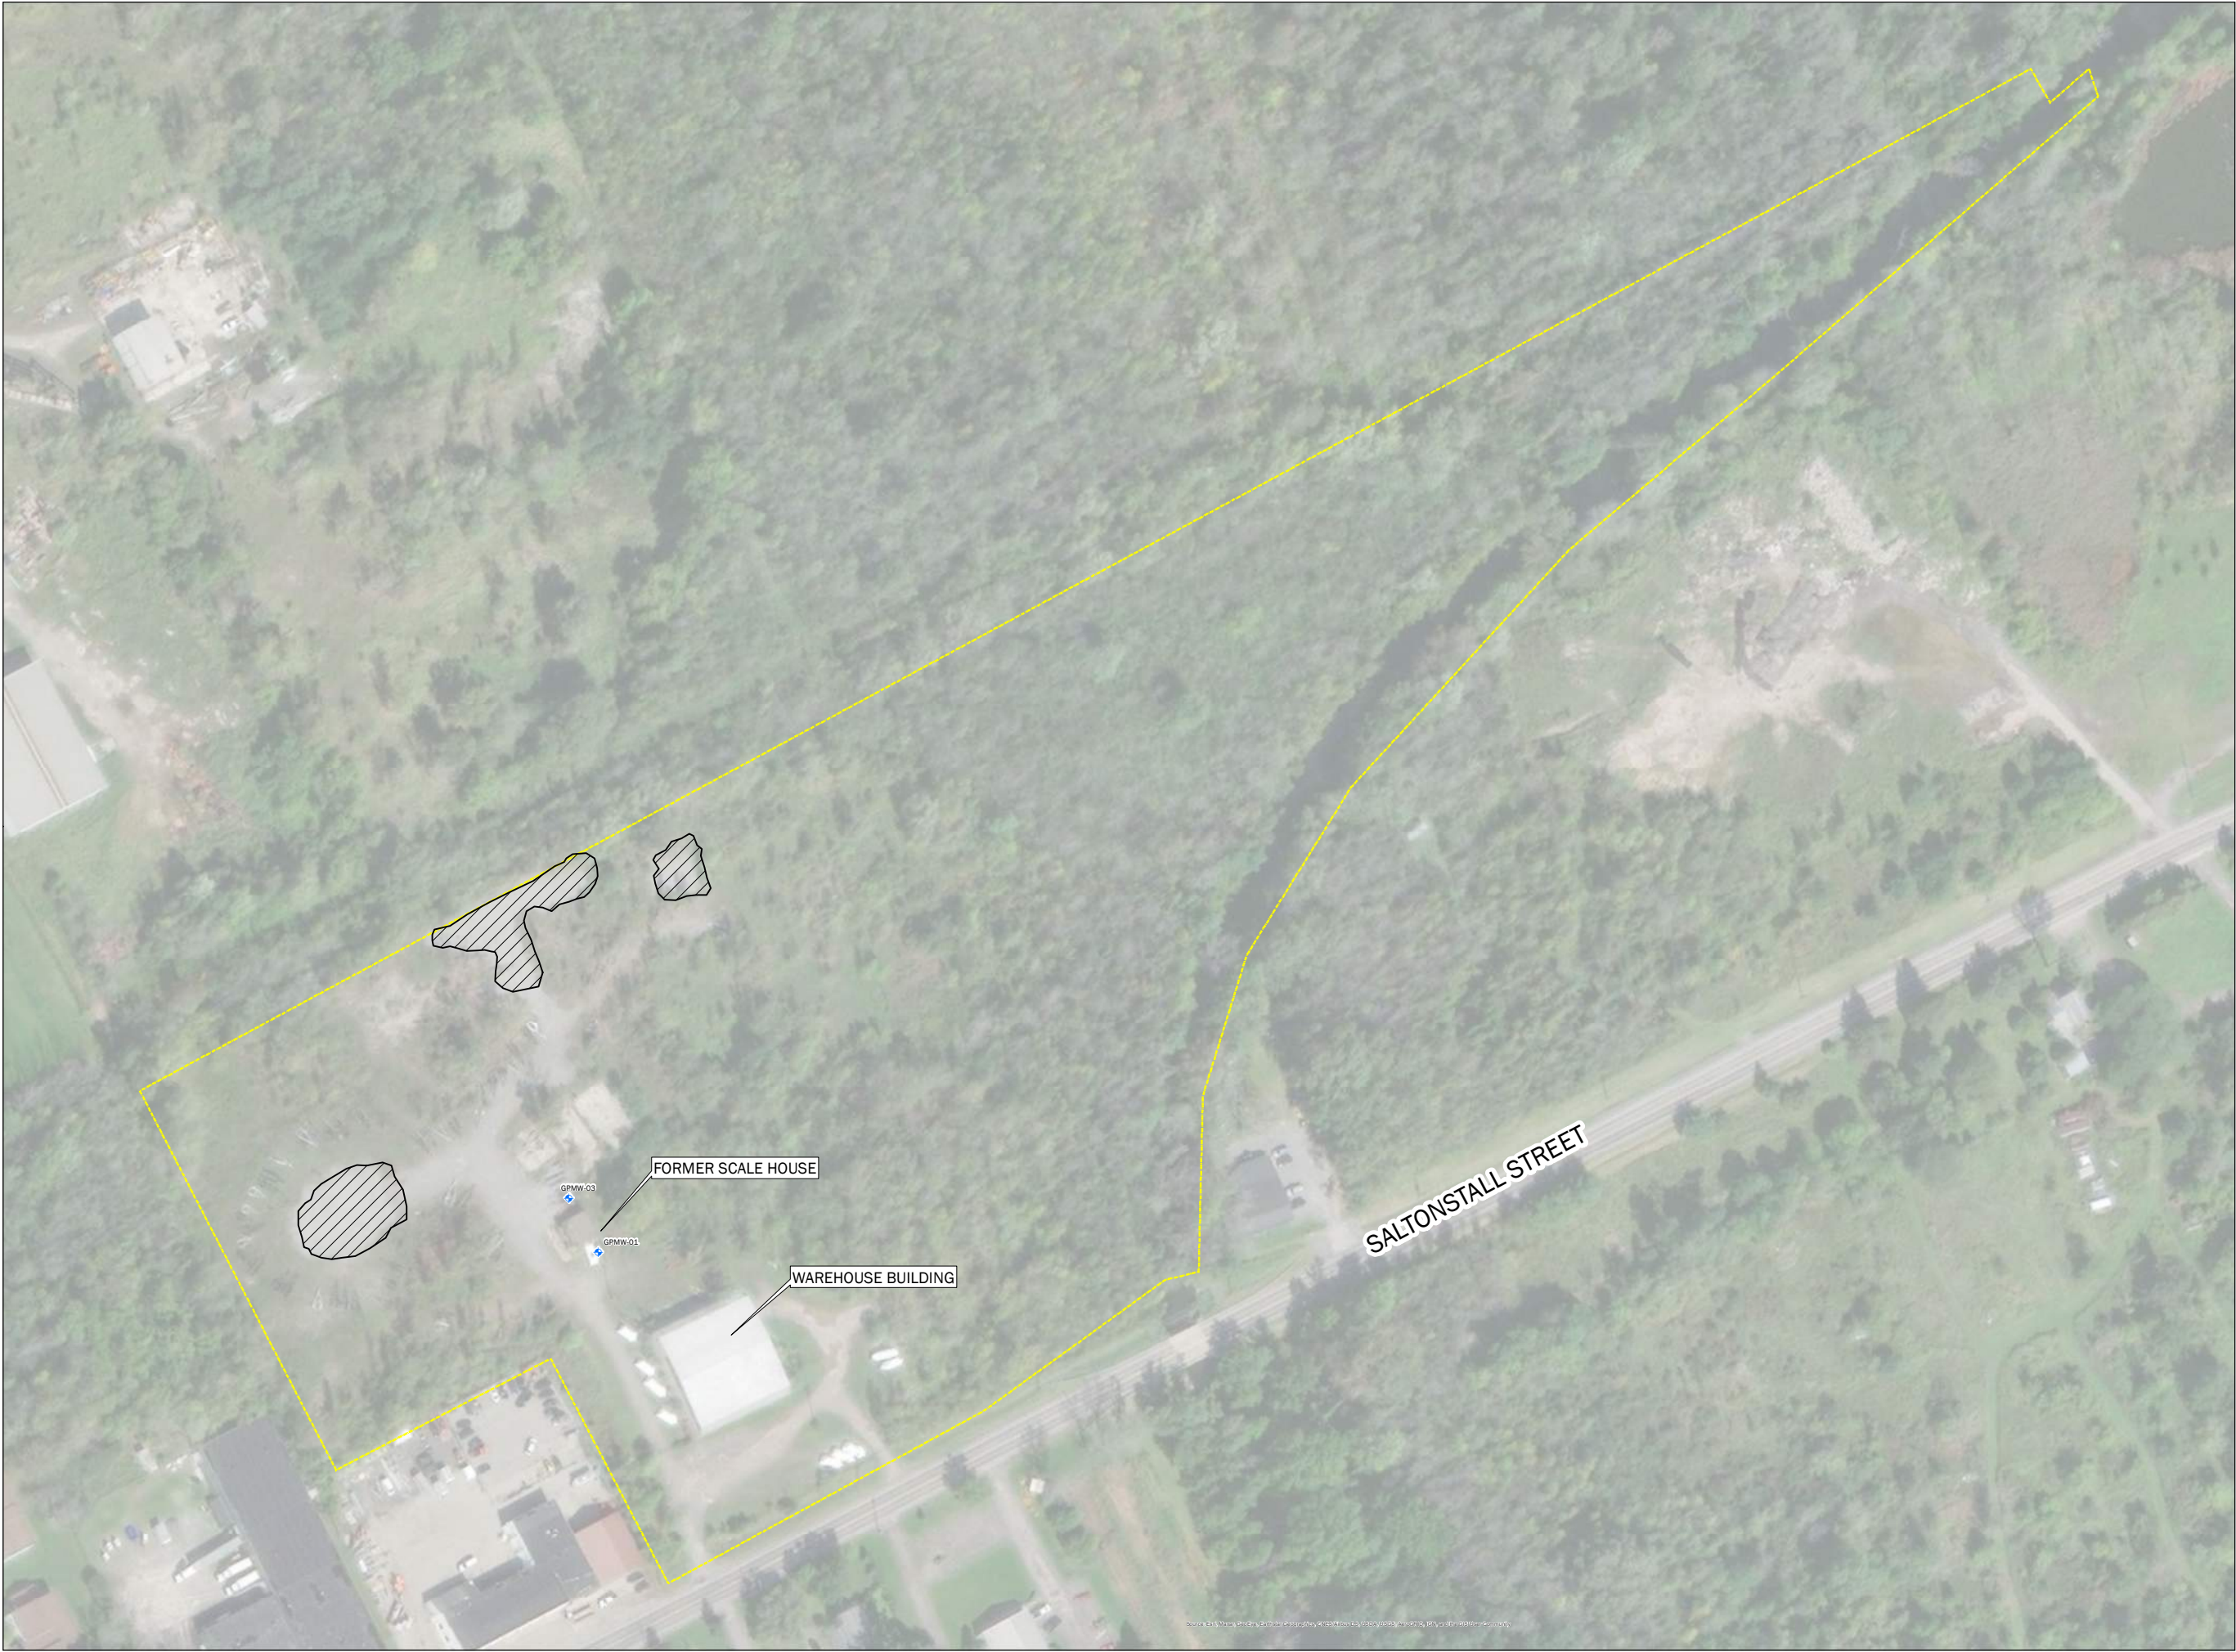
[FIGURE 2]

1. Base aerial photography obtained from ESRI ArcGIS (accessed April 3, 2024) and may not represent current conditions.
2. Monitoring well locations measured from existing Site features and are considered to be approximate.
3. Site boundary georeferenced from survey map completed by Years Boundary Land Surveying.

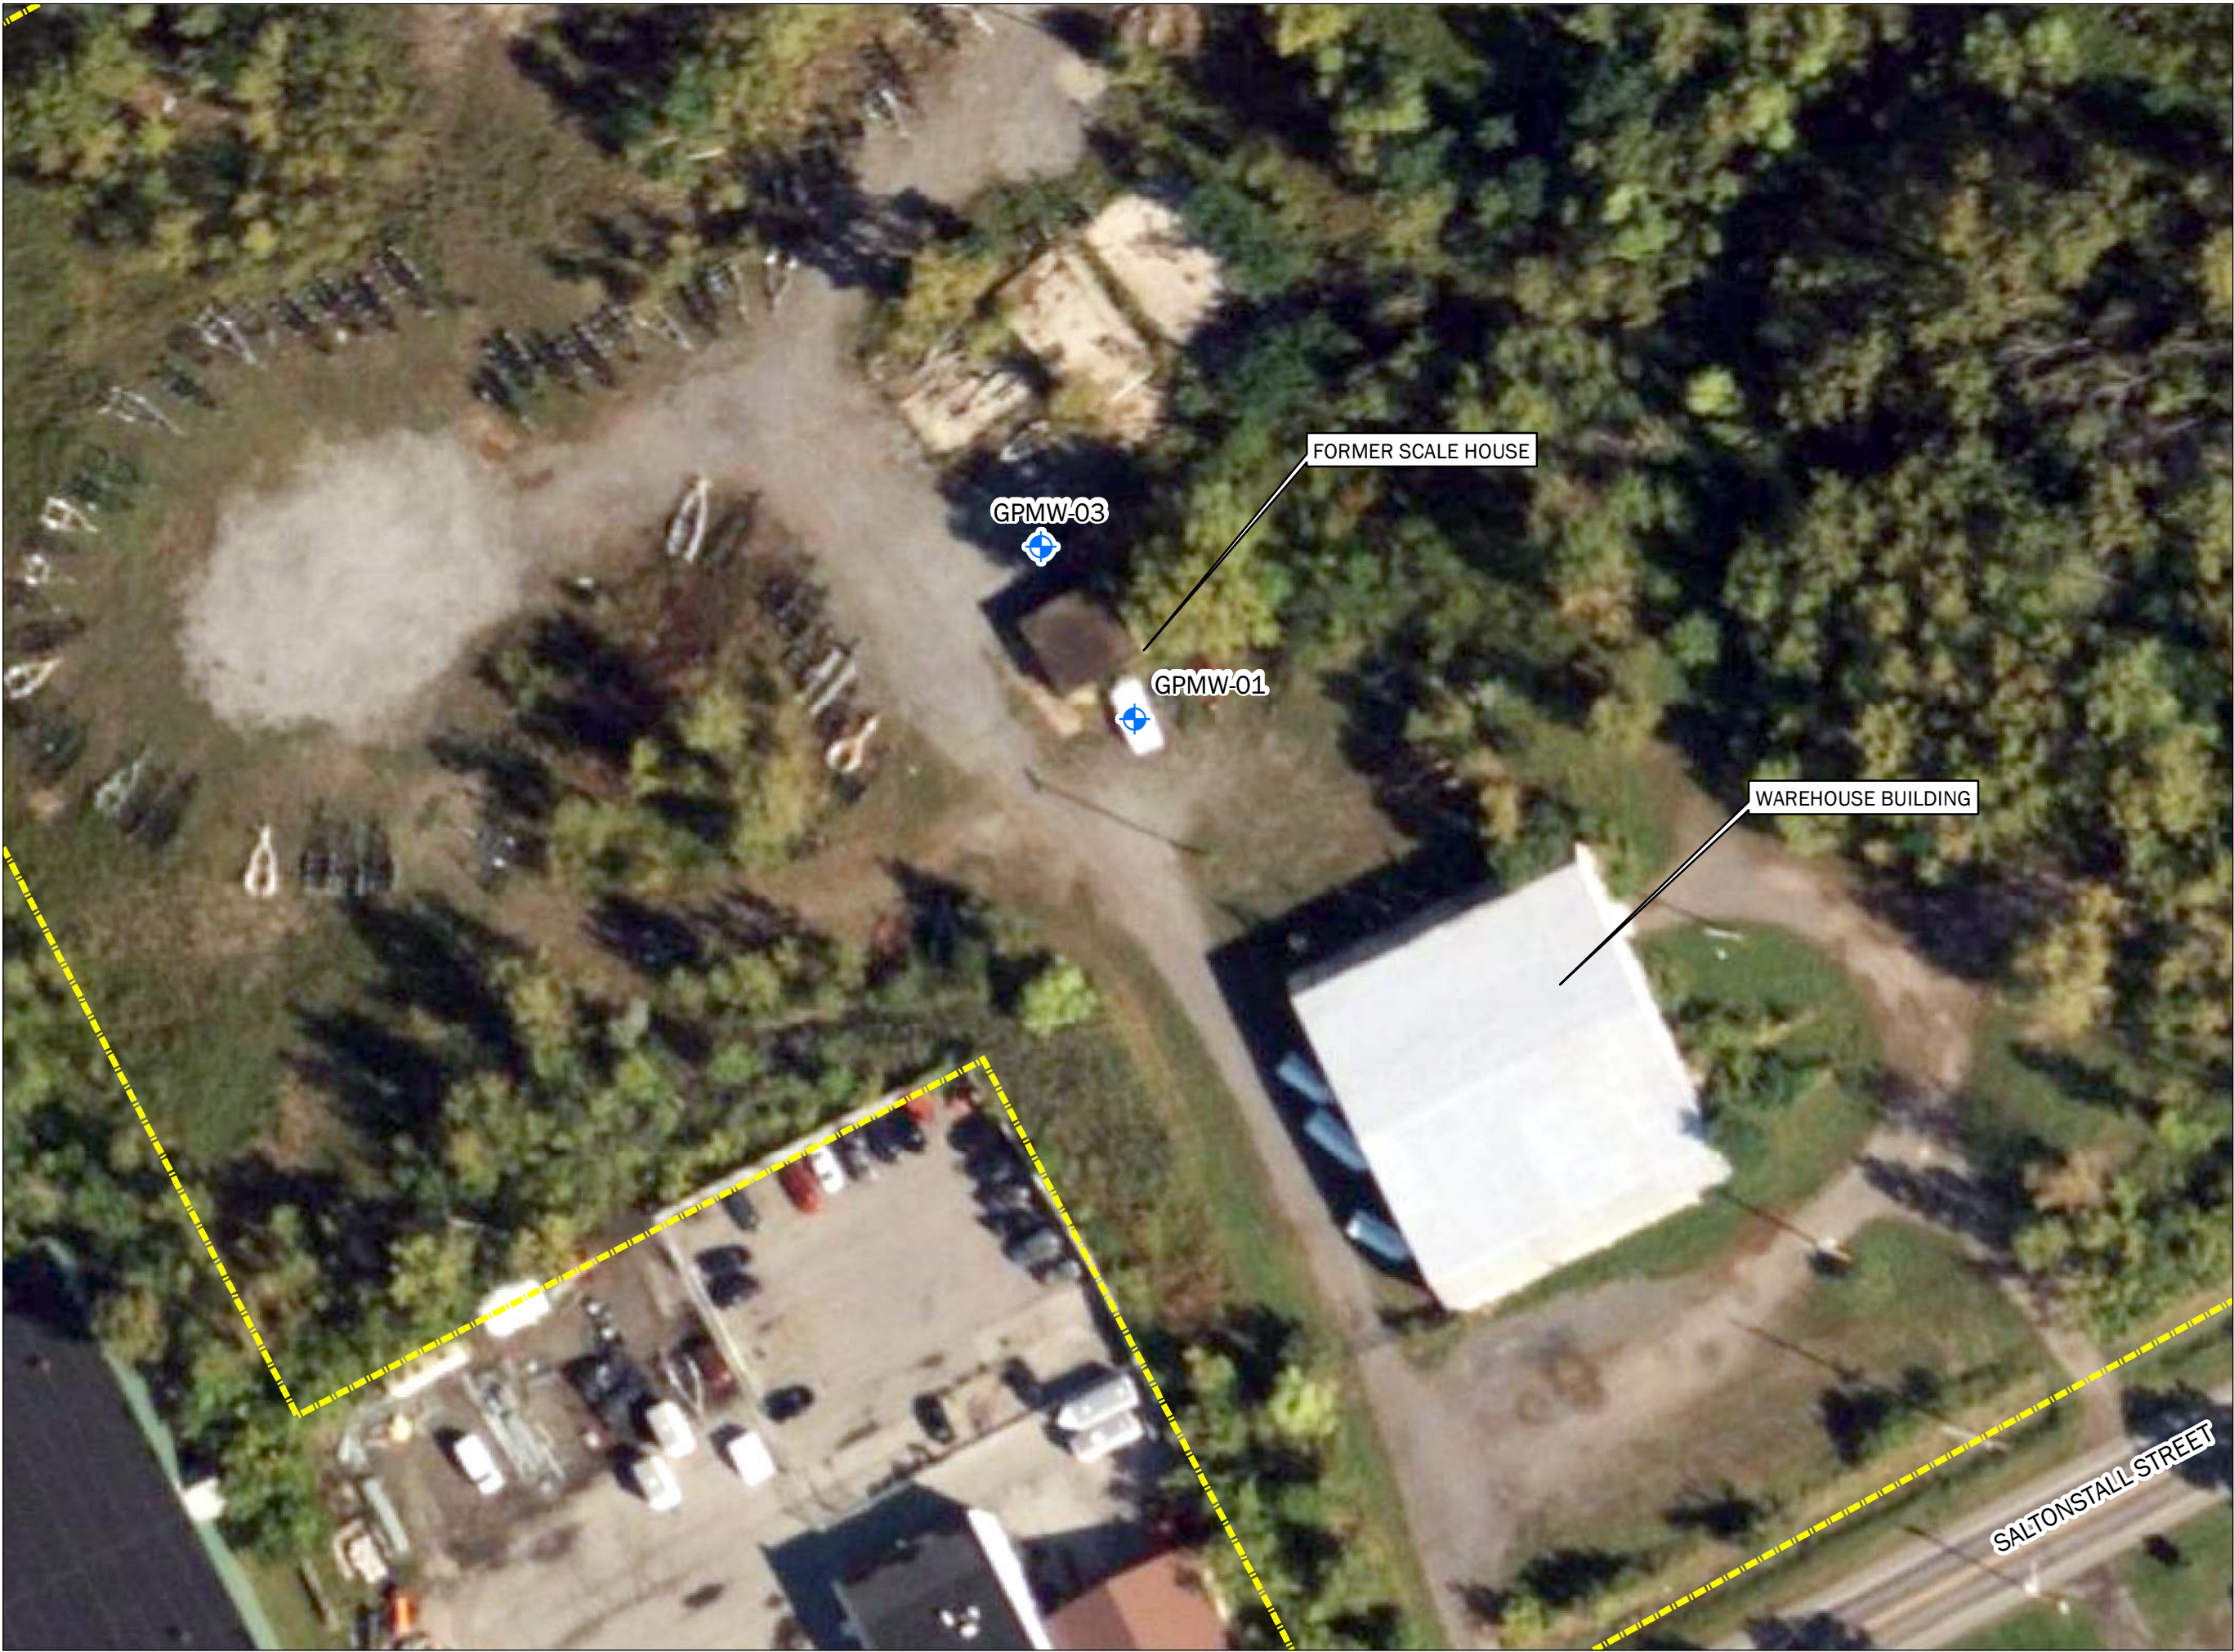
1. Aerial photography obtained from Pictometry (accessed March 25, 2024) and may not represent current conditions.
2. Monitoring well locations measured from existing Site features and are considered to be approximate.
3. Site boundary georeferenced from survey map completed by Years Boundary Land Surveying.

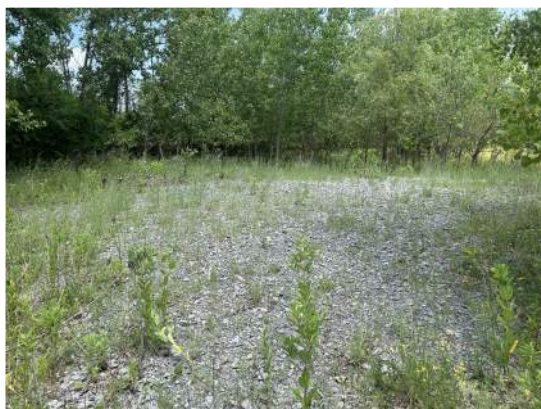
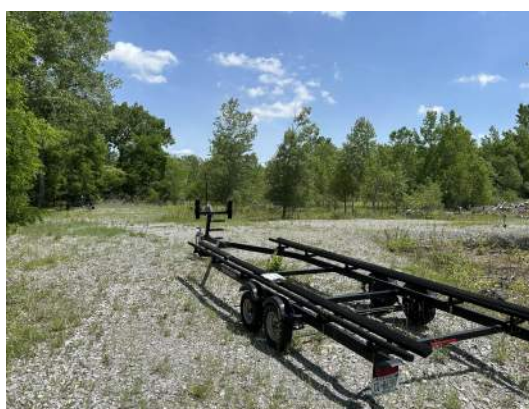
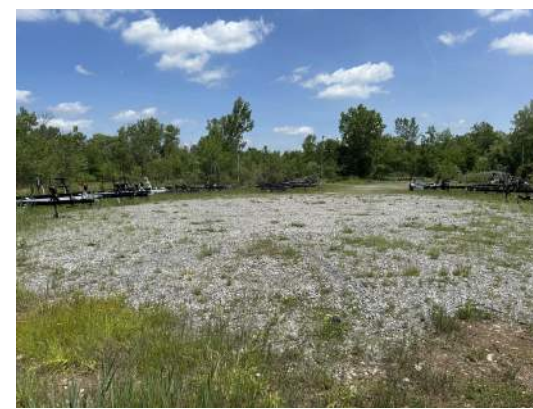
COVER TYPE	OVERALL CONDITION	ANY LOCATIONS REQUIRE REPAIR OR MAINTENANCE	PHOTOS TAKEN	COMMENTS
SOIL COVER	Storage yard for trailers	NO	YES	GRAVEL COVER INTACT, MINOR VEGETATION GROWTH, ONLY BOAT TRAILER STORAGE USE
ASPHALT SURFACE	NA	NA	NA	
CONCRETE SURFACE	NA	NA	NA	
BUILDING SLAB	NA	NA	NA

WELL ID	EVIDENCE OF DAMAGE	EVIDENCE OF FROST HEAVING	EVIDENCE OF CASING DAMAGE OR WEAR	LOCK IN PLACE	EVIDENCE OF WELL SUBSIDENCE	STANDING OR PONDING WATER	CORRECTIVE ACTION MEASURES TAKEN	COMMENTS
MWGP-01	NO	NO	NO	NO	NO	NO	NO	
MWGP-03	NO	NO	NO	NO	NO	YES	NO	WATER BELOW TOC ~ 2" WITHIN ROADBOX - NO ACTION NECESSARY
